### Spill/Release Report

Appears to be water pumpback line leak from SCS/Cotter well 1 #333

Along pumpback line south of chain link gate towards SCS

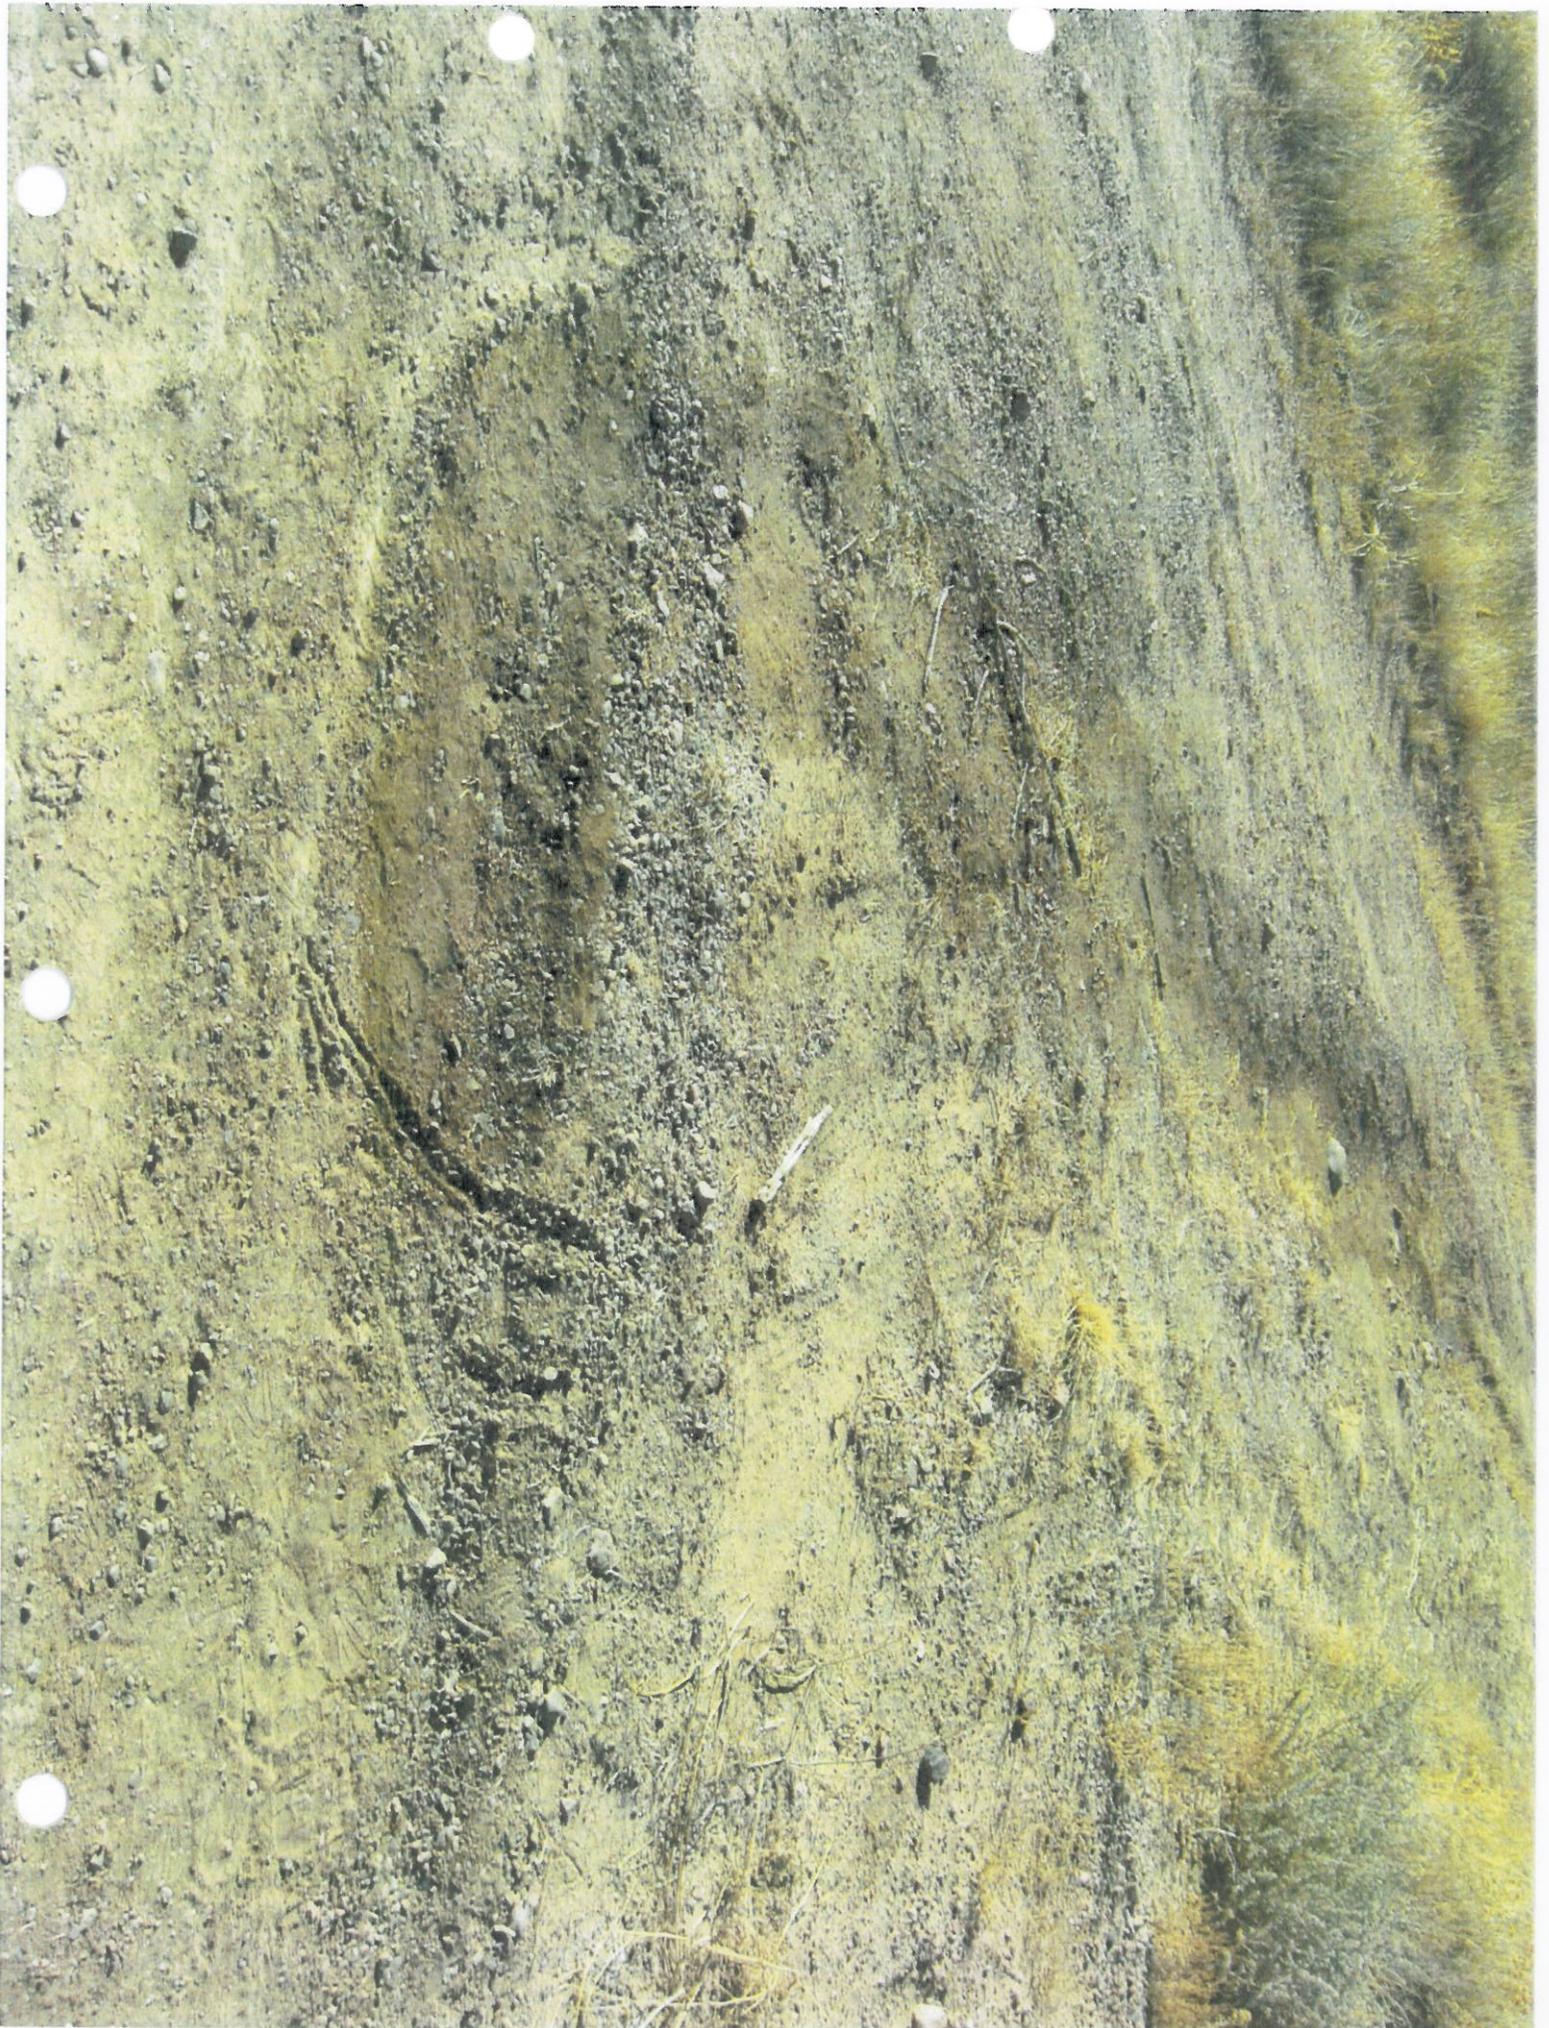
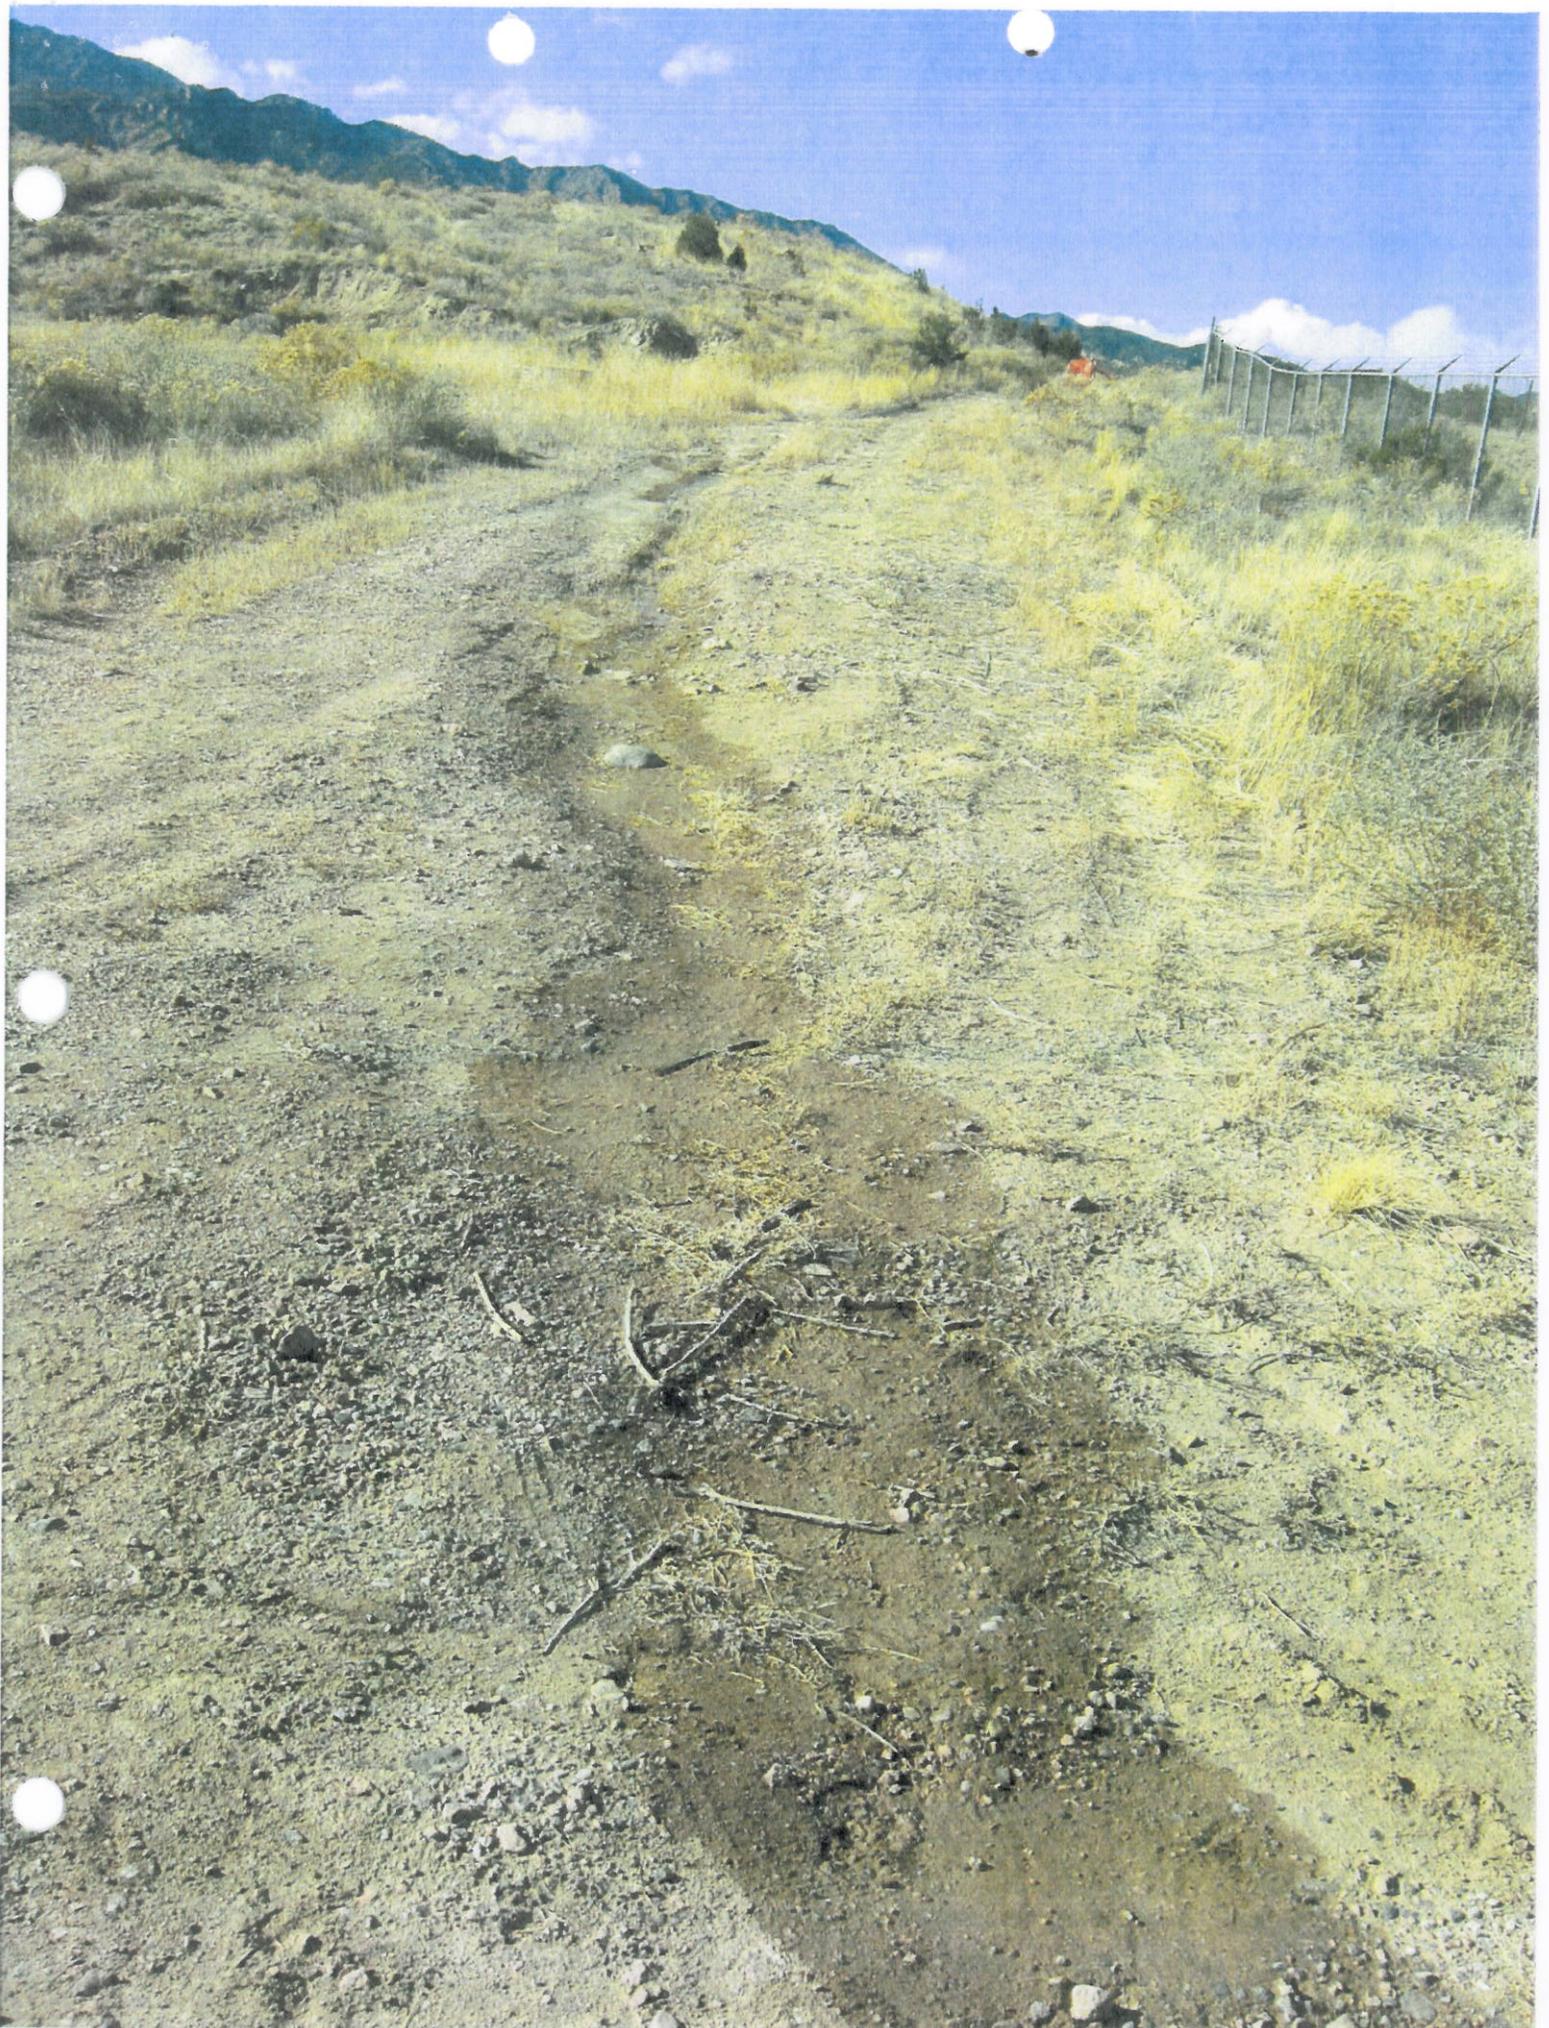
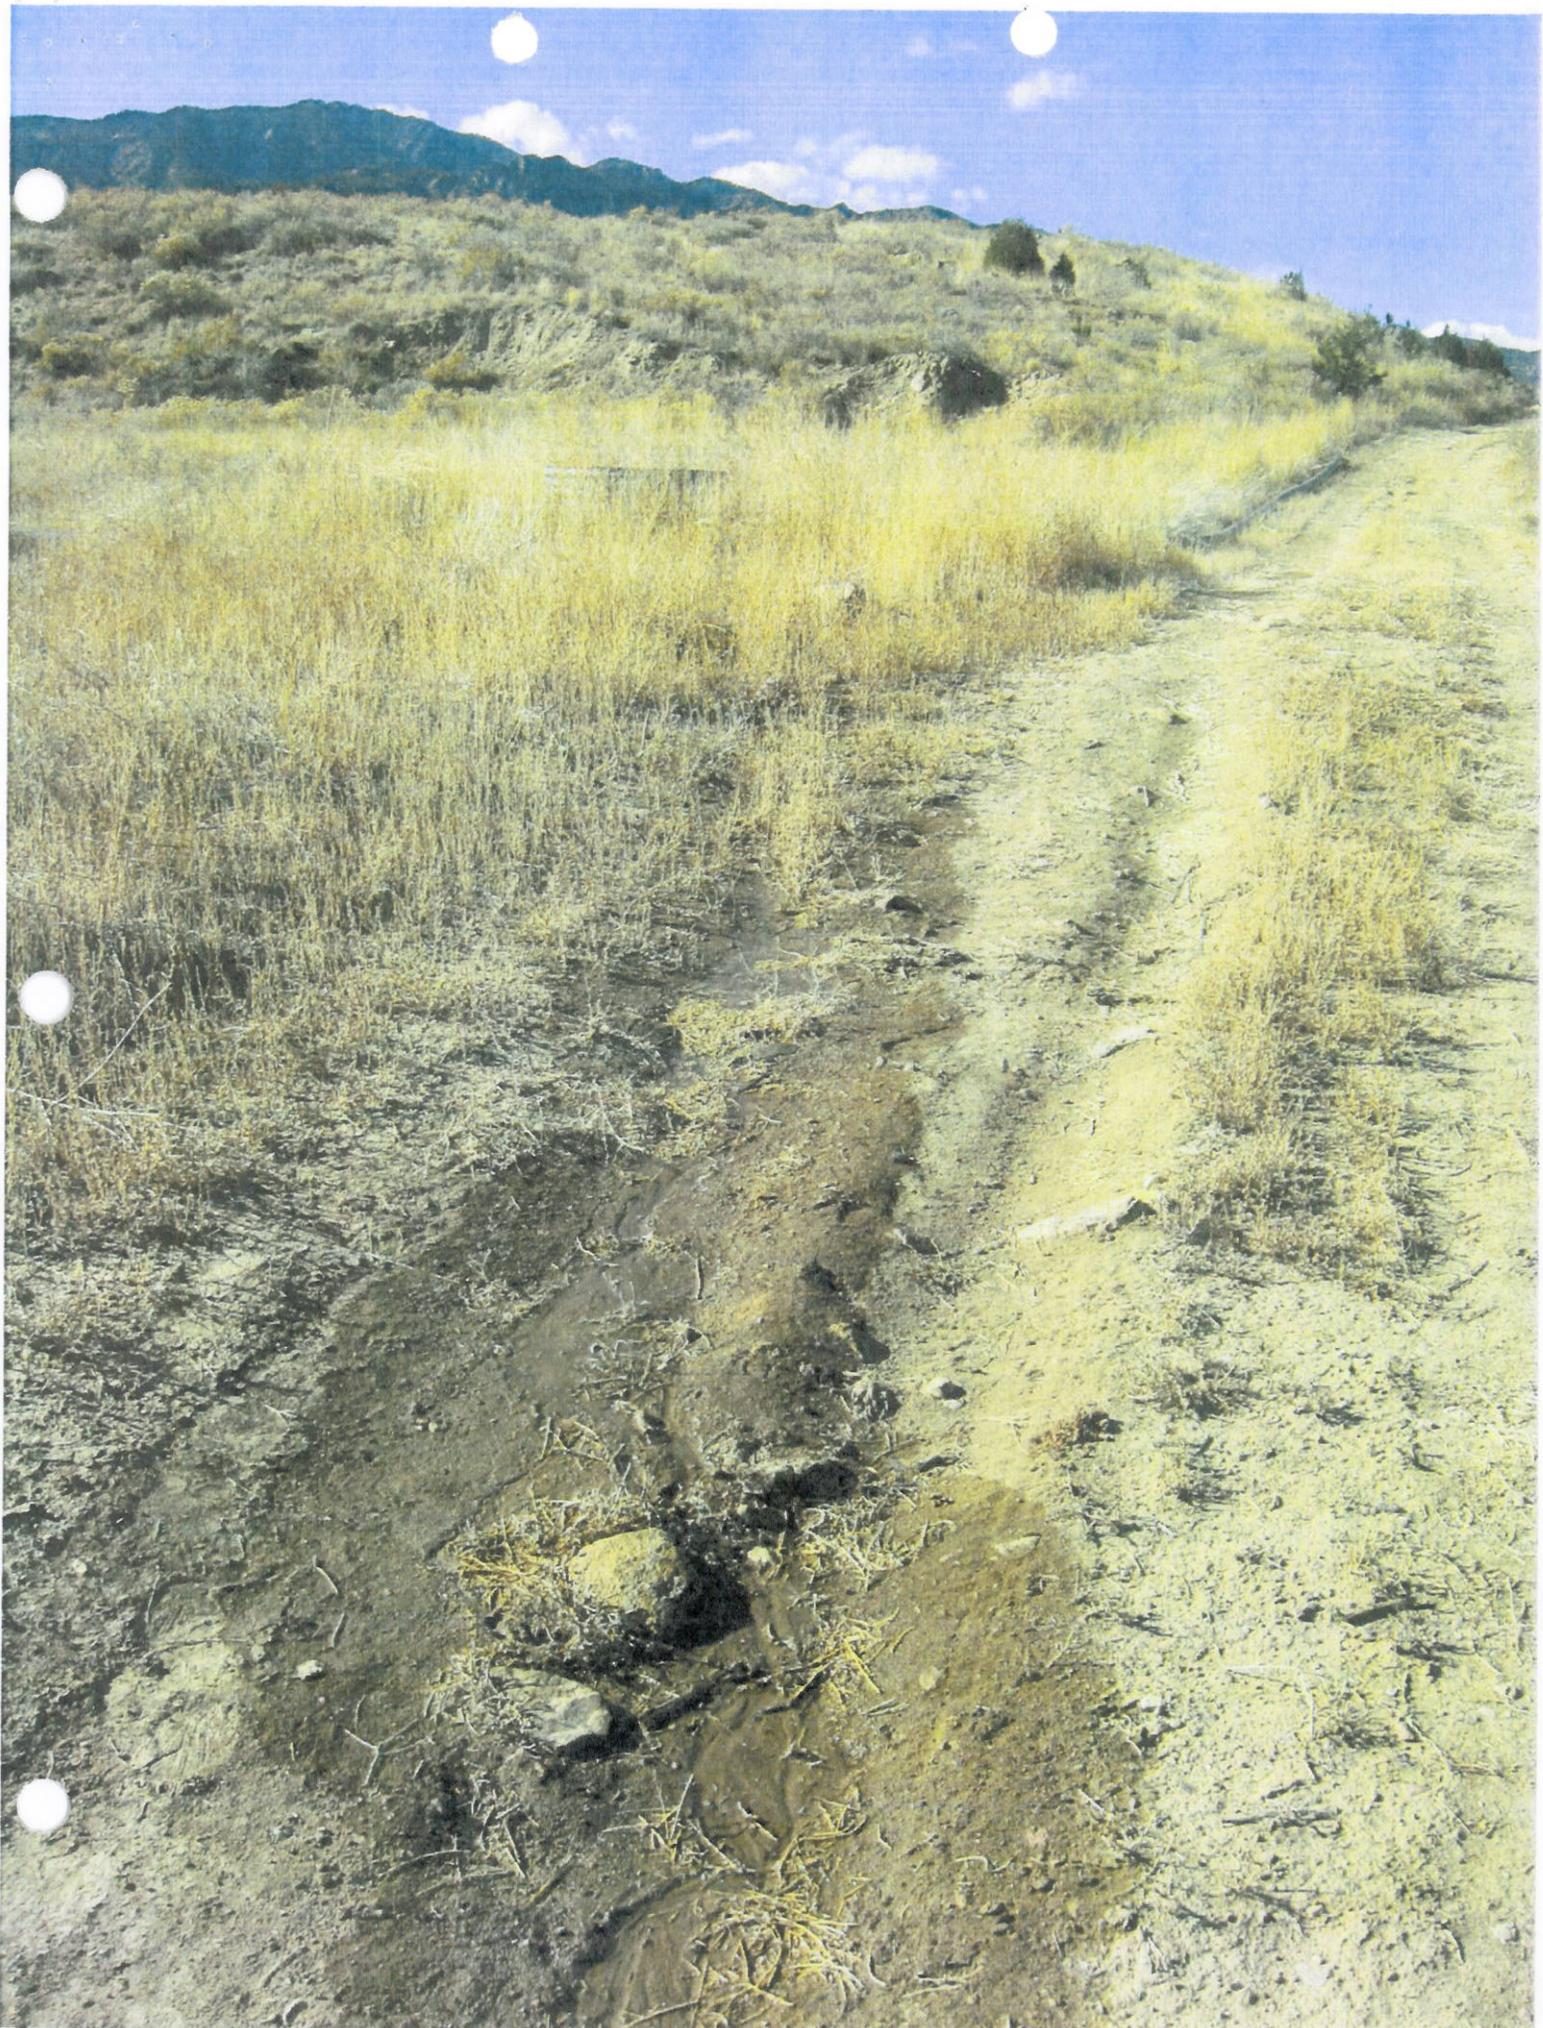
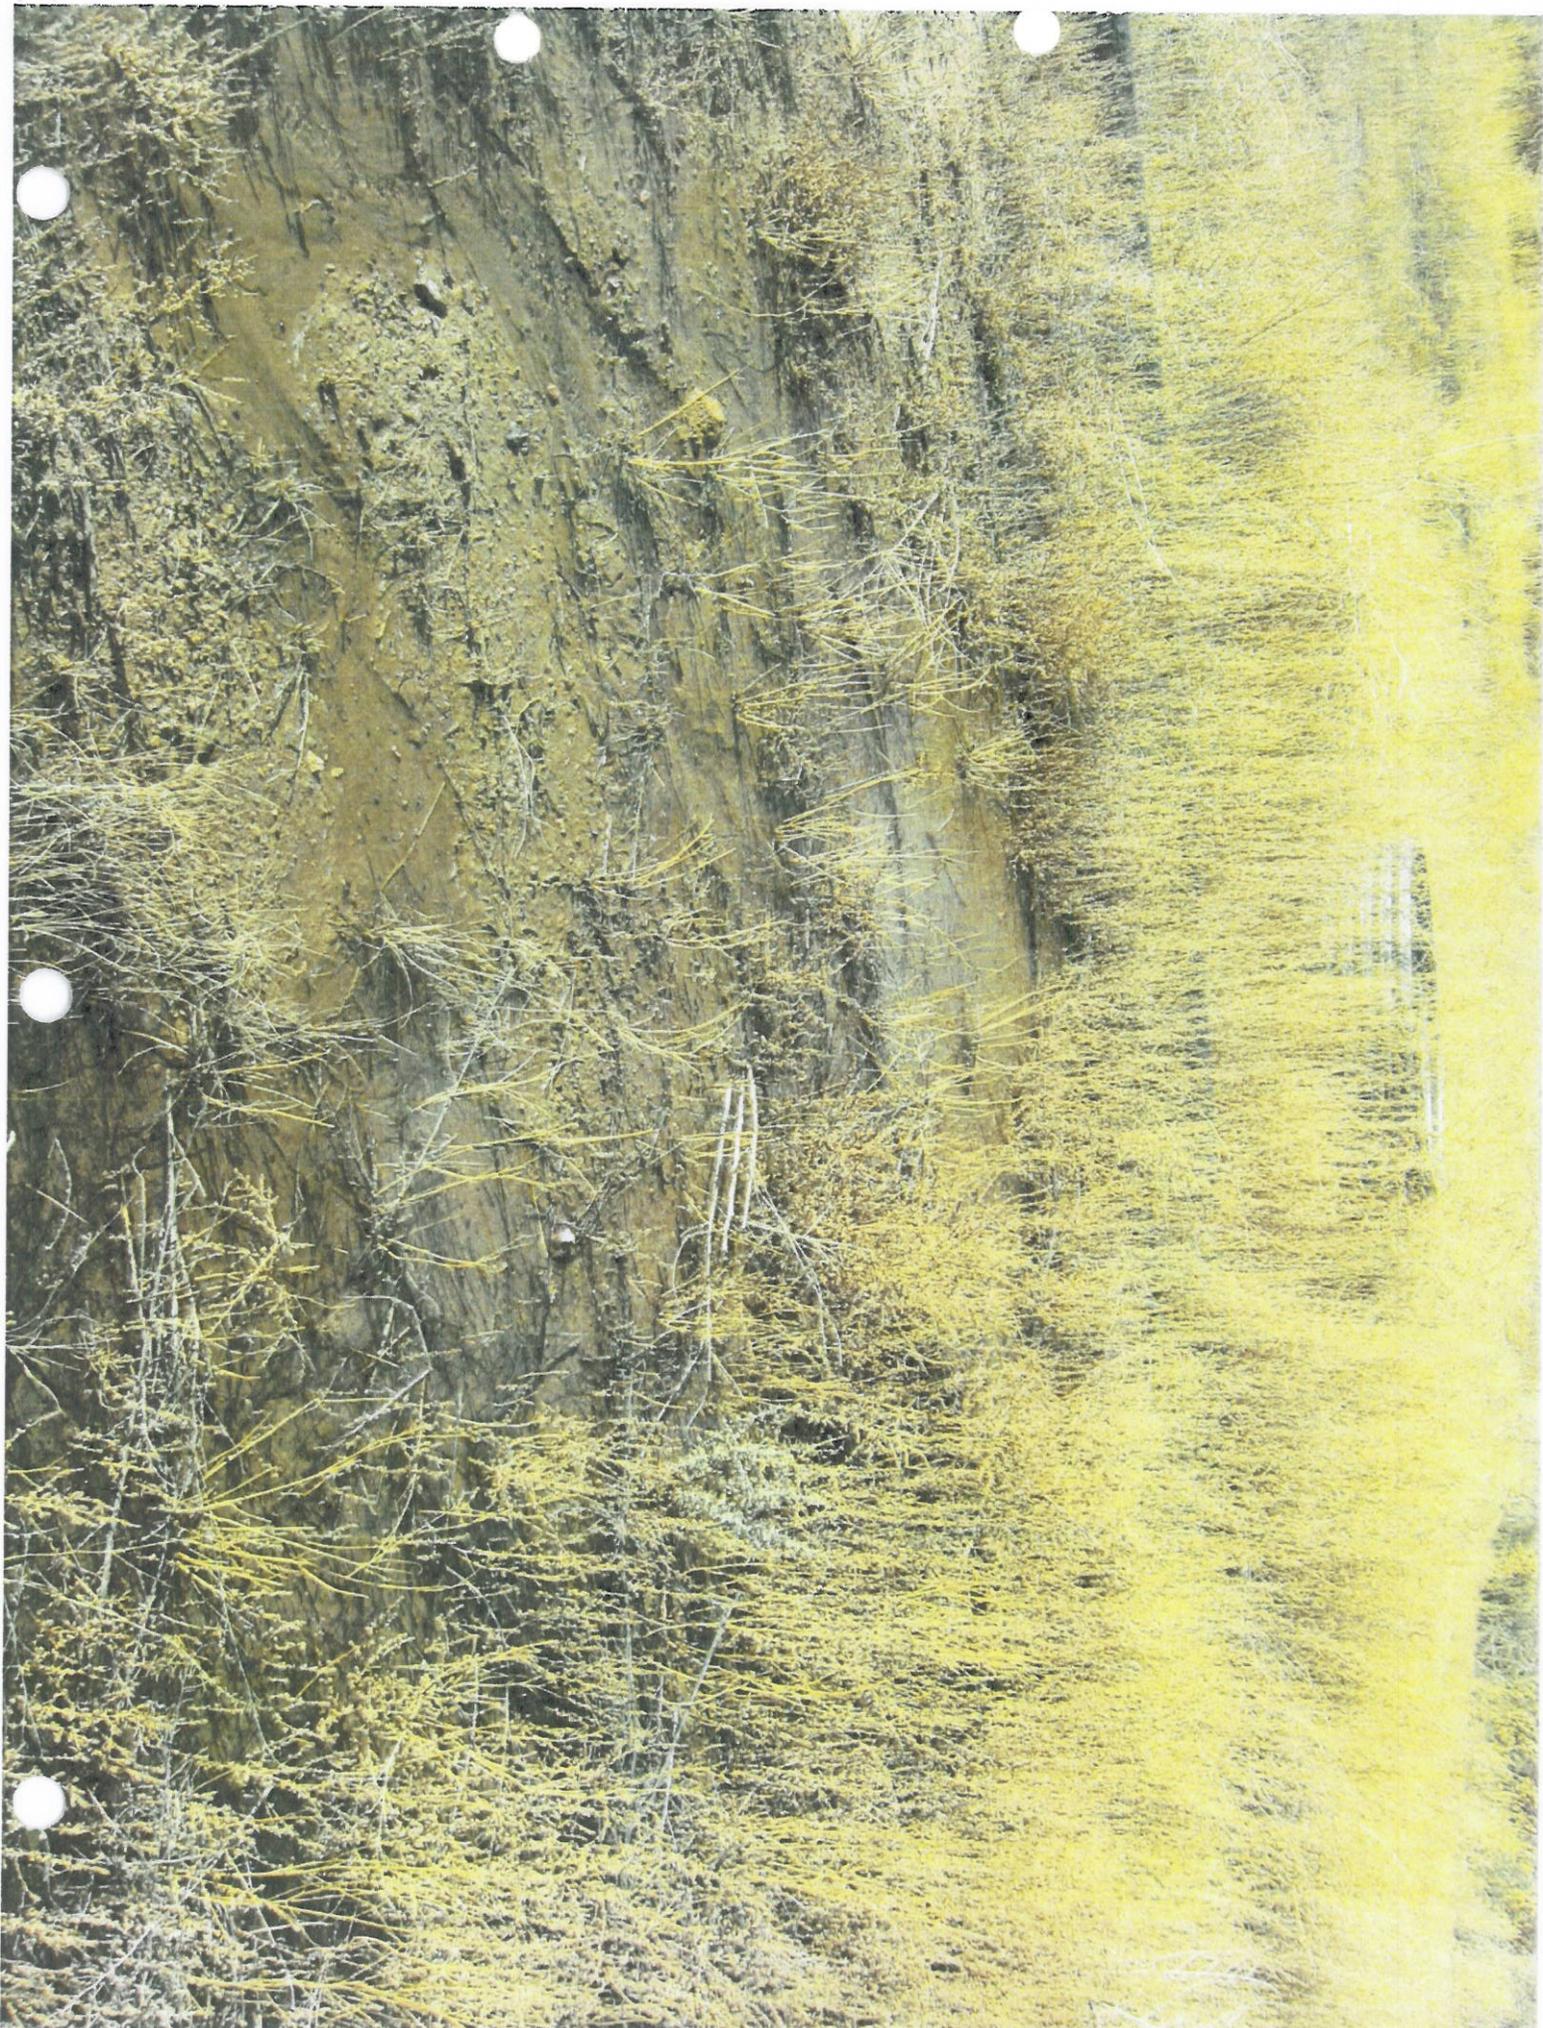
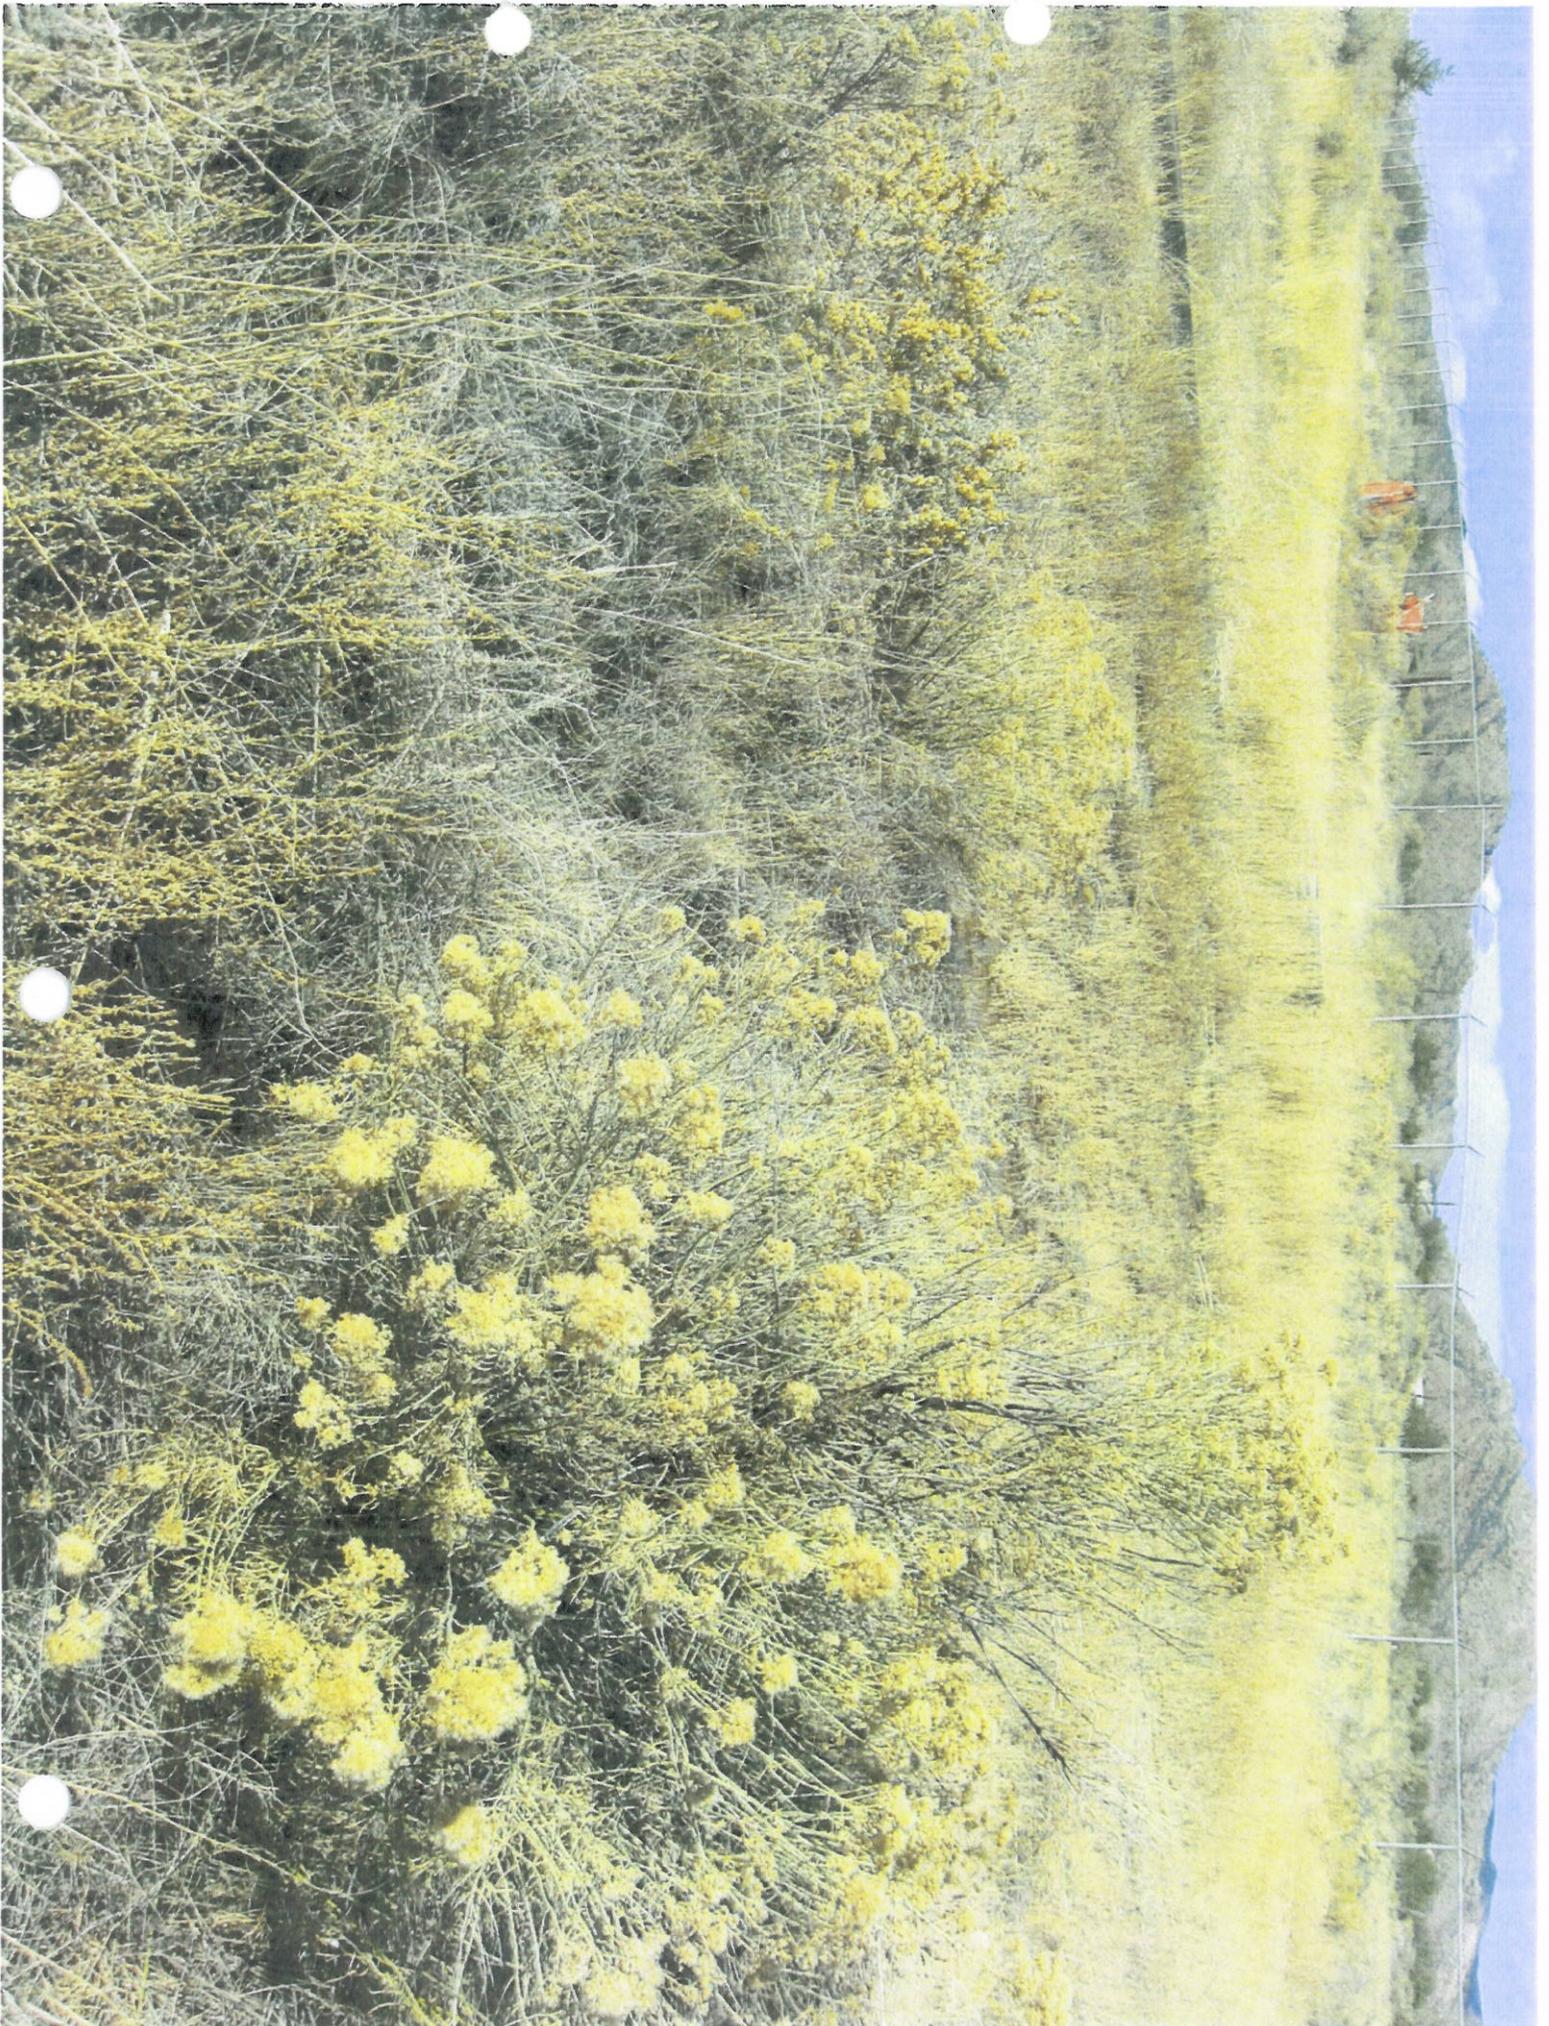
Appears to be leak in underground water pumpback line, ground surface in muddy with some water flow.

N/A Water sample collected from pooled solution on ground, Temp. 11.5 C, pH 7.94, Cond. 4.06 ms/cm

The cause of the leak in the SCS pump back line was a cracked PVC flange. Most likely from the cold weather. The lid for the valve pit had blown off the pit and let the cold air in the pit. The lid will be secured so this will not happen in the future. From the ground saturation it looks like it has been leaking for sometime.

SCS pumps and Cotter 1 well pump turned off 11-28-10 at about 0915
