## MEMORANDUM

Date: November 9, 2011  
To: Steve Tarlton, File  
From: Edgar Ethington *EFE*  
Subject: Cotter primary impoundment analysis

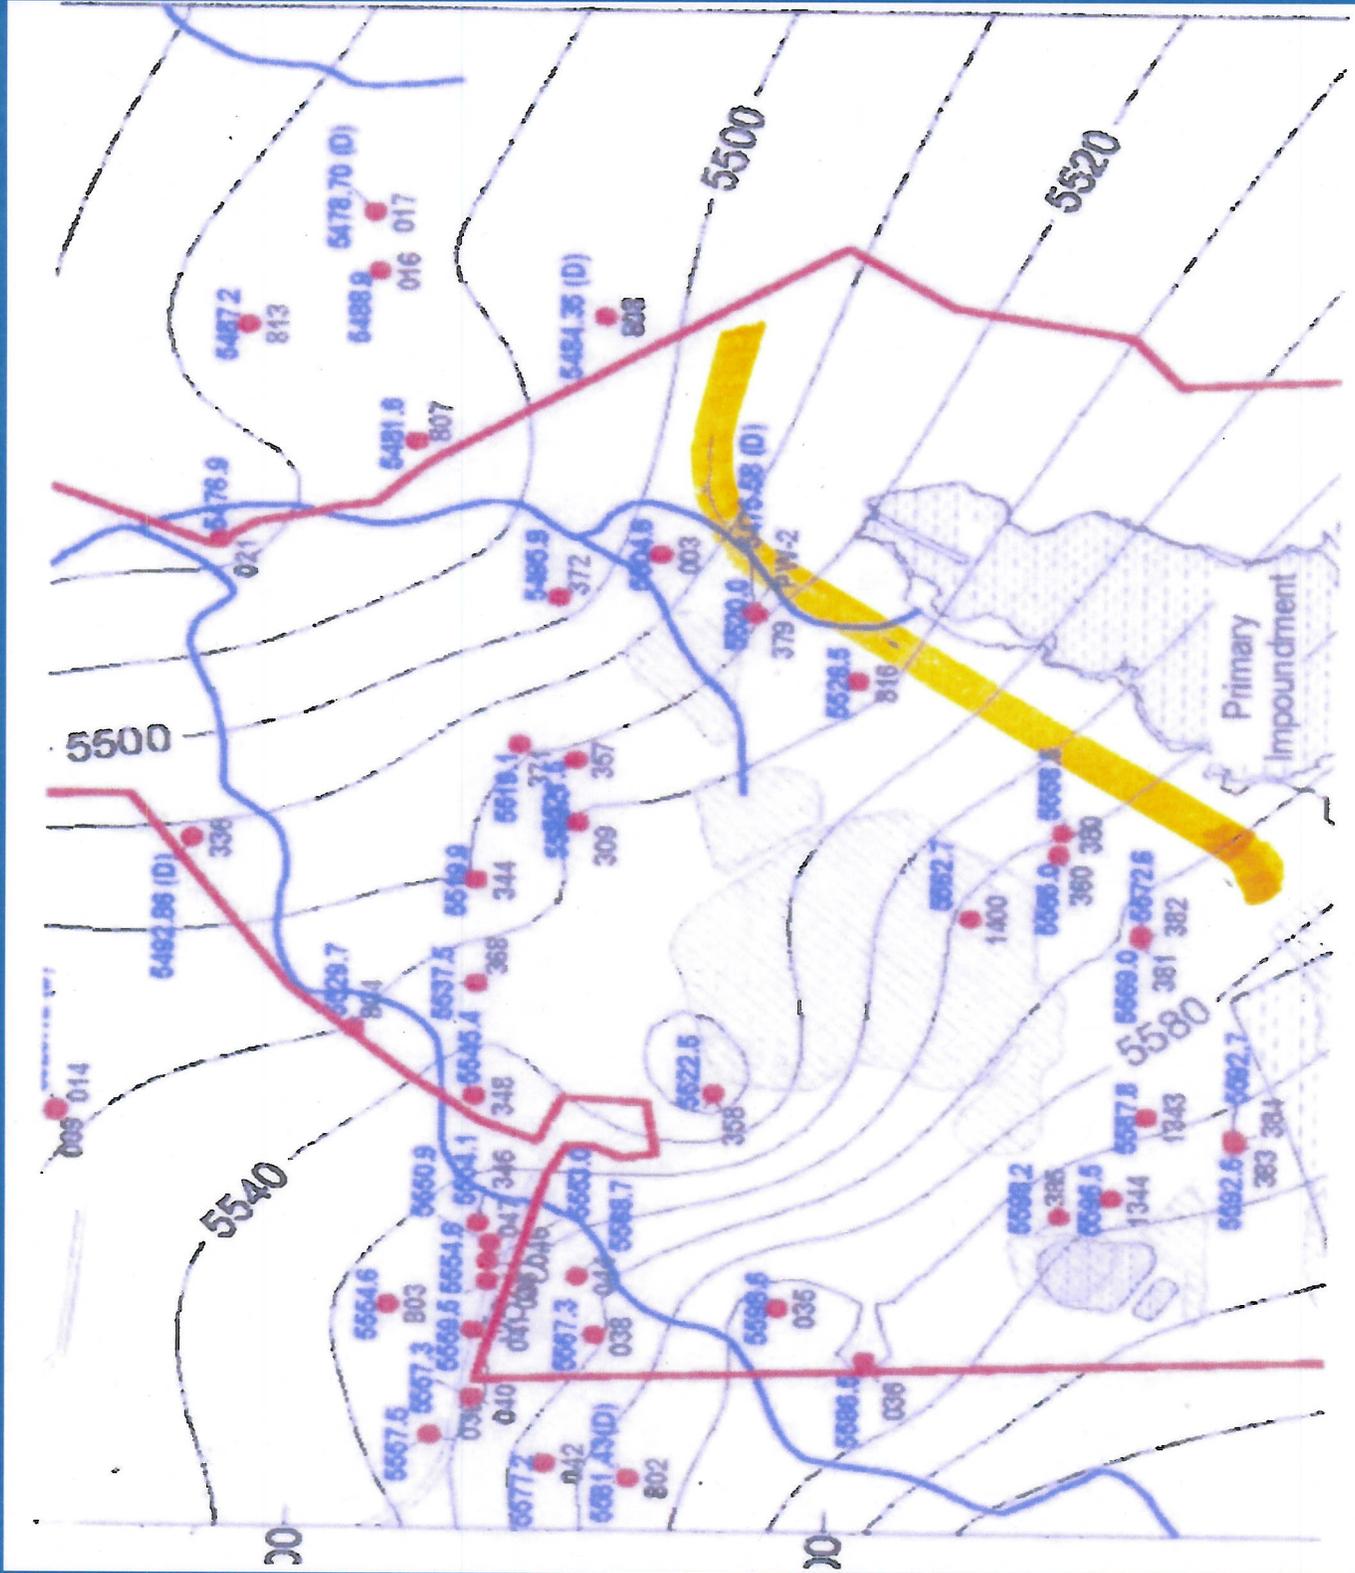
Figure 2

The second direct line of evidence is the hydrology of the surface aquifer north of the impoundments along the line of wells from 383 in the southwest to 003 in the northeast. Water elevations are measured in the wells noted in Figure 2. The orange line represents the embankment of the primary impoundment. The thin black contour lines show the slope or gradient of the ground water surface. These contour lines run almost perpendicular to the base of the impoundment embankment and in a regular interval. This means that ground water flow is parallel to the base of the impoundment. The rate at which ground water elevations is changing is fairly even indicating no significant addition of water. Water flowing out of the impoundment would change both the slope of ground water flow and the water chemistry. I do not see ground water displacement indicative of a significant release.

However, there are two areas where I see some "stretching" of the ground water slope. These are the areas around well 382 and well 379. Reasons for the "stretching" can be related to addition of water, or change of rock type or change of hydraulic conductivity. This characteristic alone is not sufficient evidence of a leak.

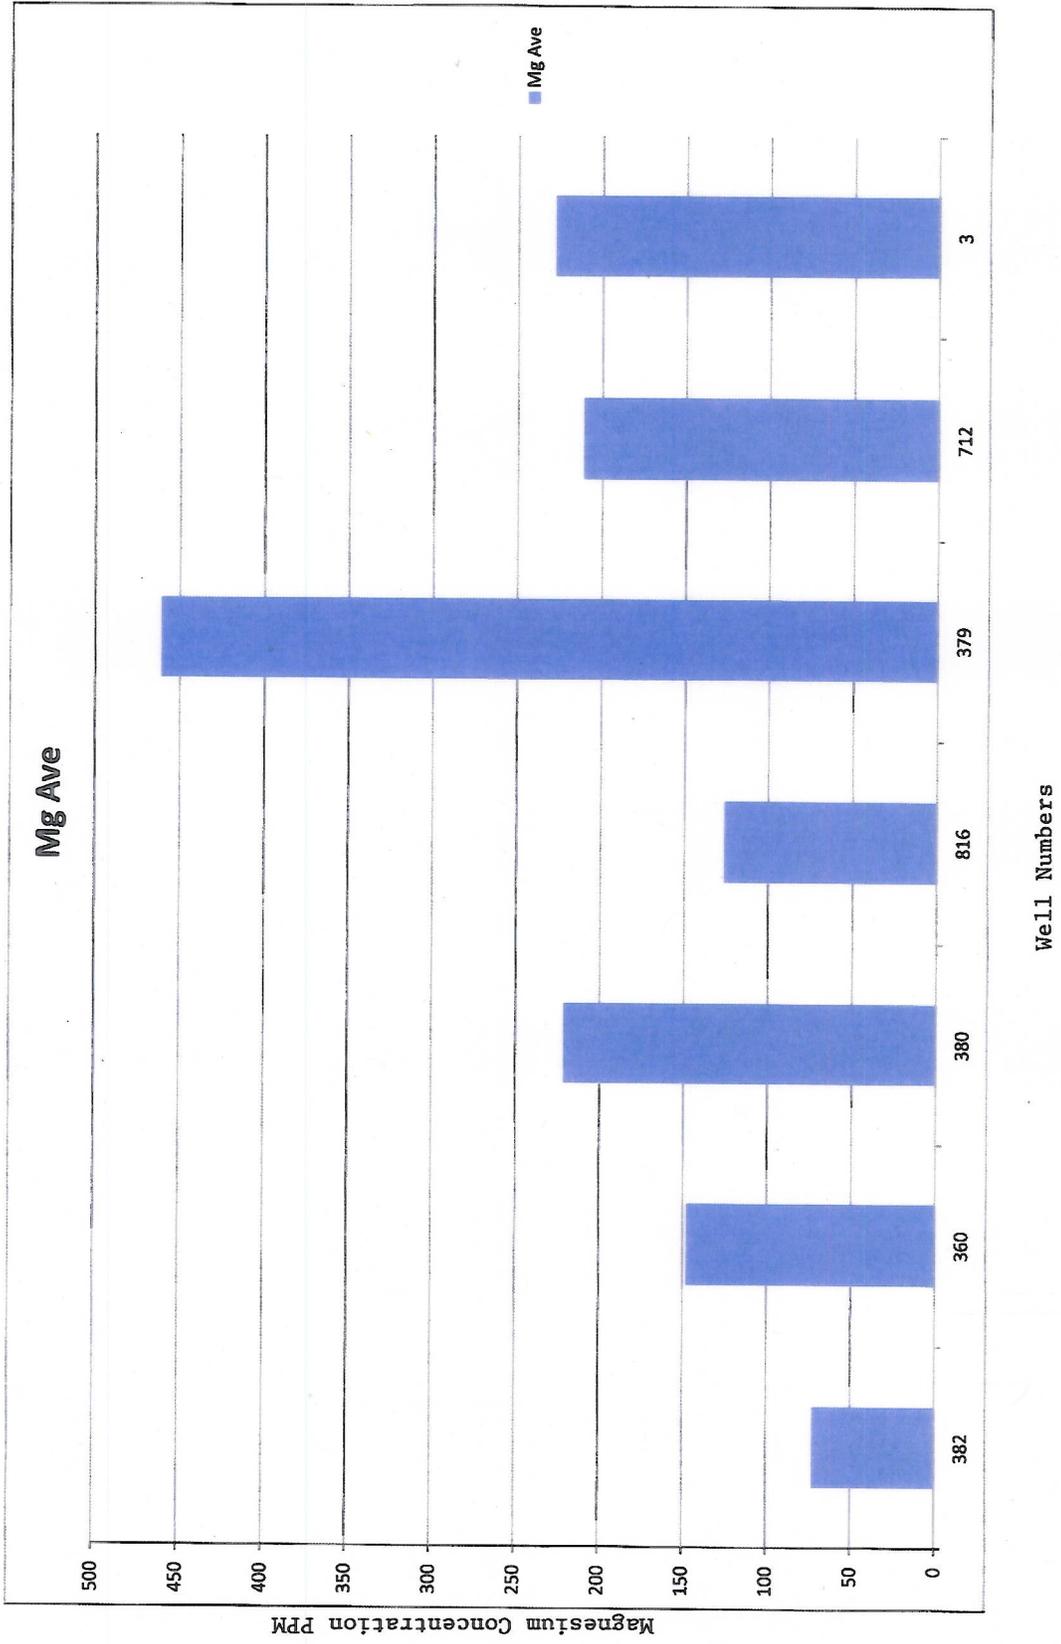
Figure 3 shows the average magnesium values for the past year from monitoring wells along the base of the primary impoundment from southwest to northeast: monitor wells 382, 360, 380, 816, 379, and 003. Well 712 samples spring waters from beneath the impoundment liner. Well 003 samples are representative of average values in this drainage.

The magnesium concentration in well 379 is twice the average. This data coupled with the hydrology information may indicate a minor leak. There are other explanations equally plausible. However, it is the practice of the HMWMD to make the conservative assumption.
