EXPEDITED SETTLEMENT AGREEMENT

Number: ES-091014-1

Re: Facility Inspection / **Compliance Advisory**
Steamboat Ski & Resort Corp — Base Area Regrading Project
CDPS Permit No. COR03 C126
Routt County

Stormwater Inspection Report

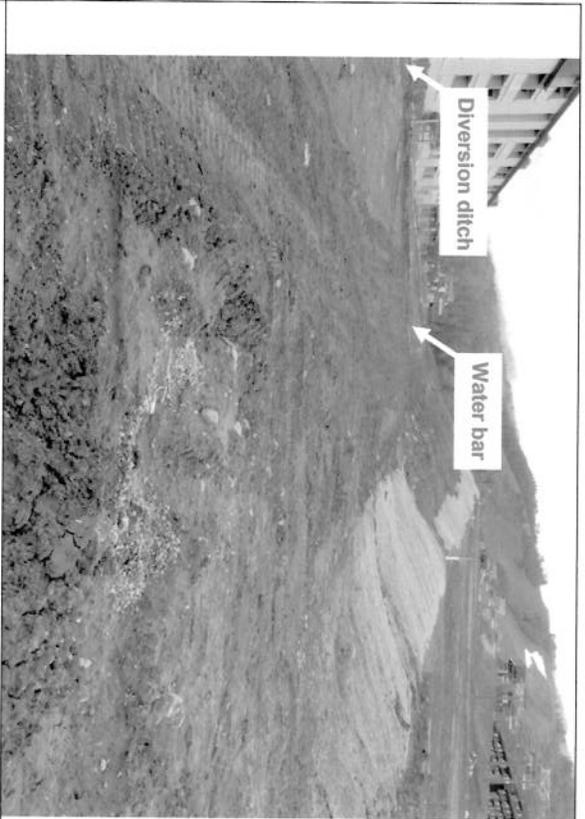
- a. Inadequate BMPs were implemented along the disturbed slope at the northwest portion of the site, between the north perimeter diversion ditch and the erosion control blanketed slopes south of the diversion ditch (see attached photograph 1). The water bars implemented diagonally at intervals across the disturbed slope are inadequate to handle the upslope drainage area as the sole BMP for this area (see related Finding #5). Adequate BMPs must be implemented to prevent discharge of sediment from this disturbed slope area.

Photograph 1—NW corner of site. Looking E, at upgradient disturbance.

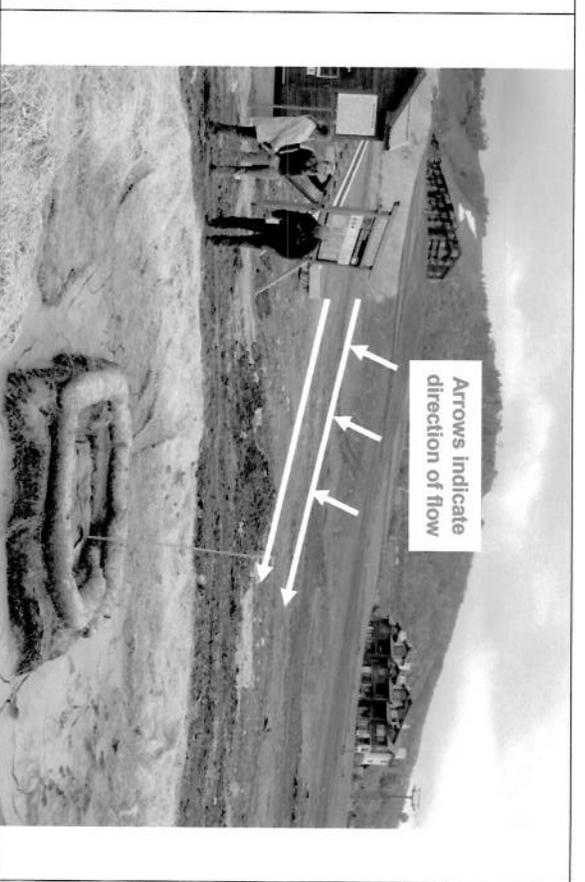
- b. No BMPS were implemented along the disturbed slopes located: i) at the northwest portion of the site, upgradient of the inlet adjacent to the Christy 6 sediment pond (see attached photograph 2) and, ii) at the western portion of the site, upgradient of the inlet located south of the Christy 6 sediment pond (see attached photograph 3). BMPs were not installed to control sheet flow and sediment transport down the disturbed slope toward these inlets. While inlet protection was observed for the drop inlets at the base of the disturbed slope (Dandy Bag, straw bale protection), this BMP is intended to be used as a polishing measure, not as a primary sediment trapping device. Upgradient erosion and sediment control BMPs must be implemented to prevent the discharge of sediment from this disturbed slope area.

8. It was noted during the inspection that BMPs were installed incorrectly and required maintenance at the inlet structures to Burgess Creek (State waters) located at the base of the ski slope (see attached photographs 2 and 3). Specifically, the straw wattle BMPs implemented on top of the straw bale BMPs were not entrenched, and are intended to be implemented on the ground so that an appropriate seal can be established. Furthermore, significant sediment was noted both adjacent to the straw bales inlet protection (photograph 2), and inside the inlet protection (photograph 3). As a result, there was a potential for discharge of sediment to Burgess Creek (State waters). Adequate BMPs must be implemented and maintained to prevent discharge of sediment from to the inlet structures to Burgess Creek.

Photograph 2—NW corner of site. Looking ESE at upgradient disturbance.

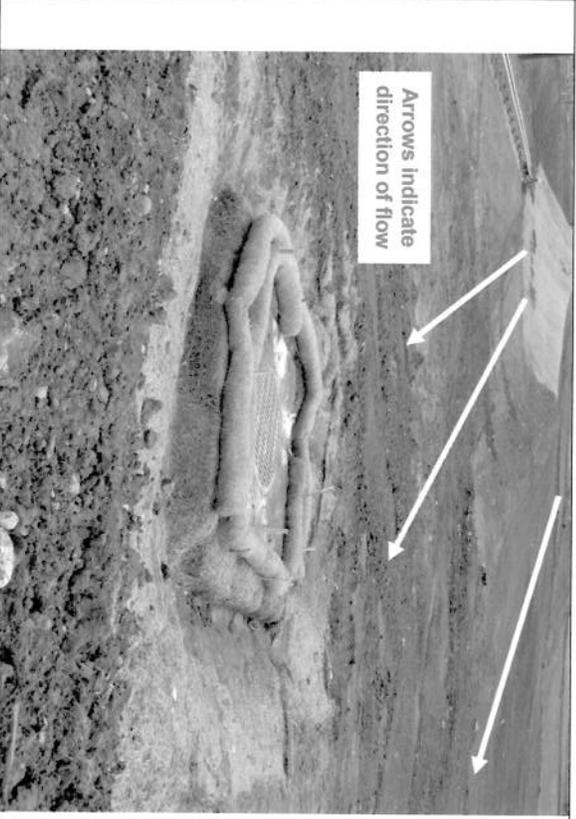
Photograph 3—W portion of site. Looking E across inlet at upgradient disturbance.

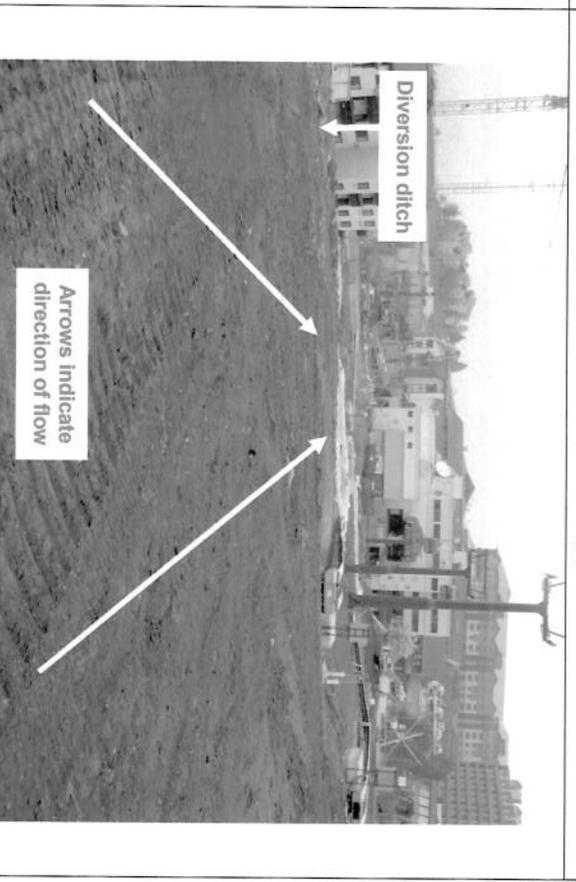
- c. Inadequate BMPs were implemented along the disturbed slope located at the southwest portion of the site, adjacent to the south perimeter diversion ditch (see attached photograph 4). The surface roughening BMP implemented on the disturbed slope is inadequate to handle the upslope drainage area as the sole BMP for this area. Adequate BMPs must be implemented to prevent discharge of sediment from this disturbed slope area.

Photograph 4—SW portion of site. Looking W at downgradient disturbance.

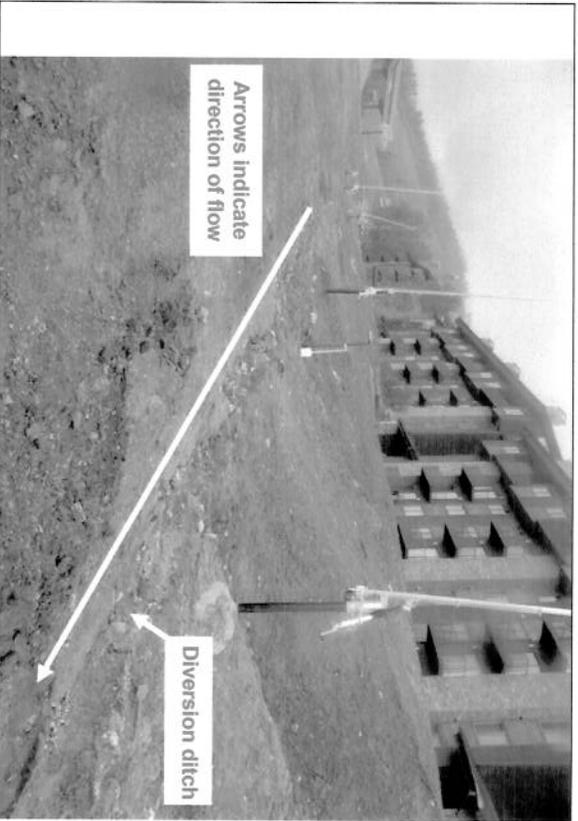
- i) at the SE portion of the site, midway up the slope (south perimeter ditch) (see attached photograph 5),
- ii) at the NW corner of the site (interior ditch) (see attached photographs 12, 13 and 15),
- iii) at the SW portion of the site (interior ditch) (see attached photograph 14) and,
- vi) at the SW corner of the site (south perimeter) (see attached photograph 24).

- d. No BMPS were implemented along the disturbed slopes located: i) at the southeast portion of the site, south of the south perimeter diversion ditch (see attached photograph 5), ii) at the far eastern portion of the site (see attached photograph 6) and, iii) at the far north-eastern portion of the site, downslope and adjacent to the ski lift (see attached photograph 7). BMPs were not installed to control sheet flow and sediment transport down the disturbed slopes, and the slopes themselves were not stabilized. Adequate BMPs must be implemented to prevent discharge of sediment from these disturbed slope areas.

Photograph 5—SE edge of site. Looking NE at upgradient disturbance.

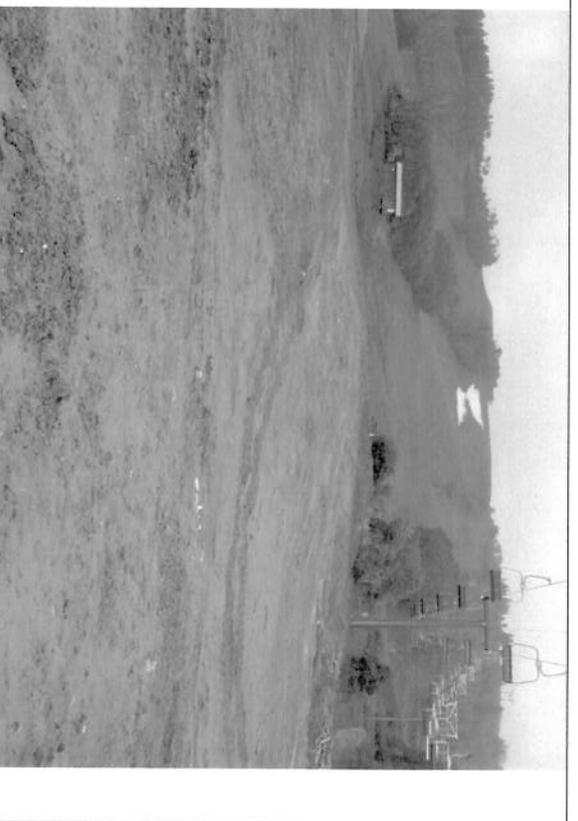
Photograph 6—E edge of site. Looking NE at upgradient disturbance.

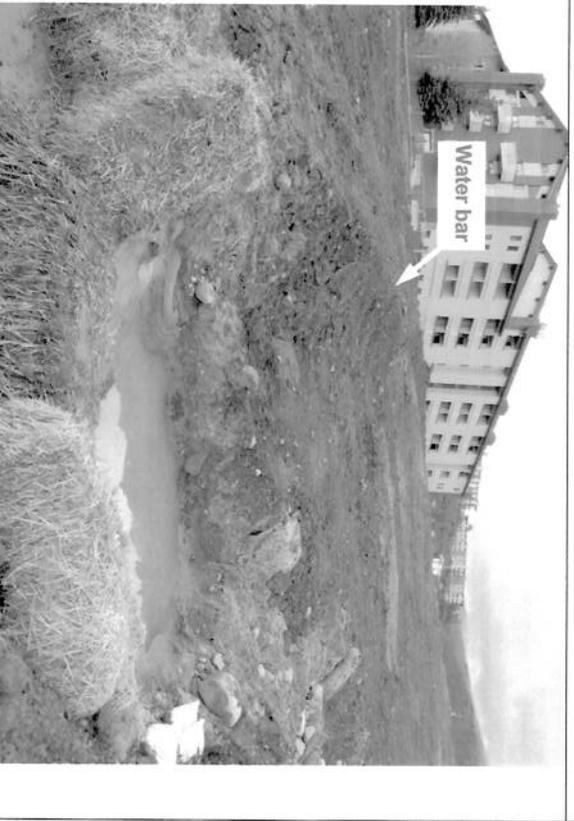
The waterbar BMPs were implemented for erosion and sediment control of the steep disturbed slopes at the site. Waterbars were installed diagonally across the disturbed slopes, and directed flow to the unstabilized diversion ditches referenced in Finding #3. Specific examples noted during the inspection include waterbars installed: i) at the NW corner of the site (see attached photograph 8), ii) at the SW corner of site (see attached photograph 9), iii) at the S edge of site – approximately midsite (see attached photograph 10) and, iv) at the eastern portion of site (see attached photograph 11).

The waterbars implemented on the site are not functioning as adequate BMPs for erosion control or sediment removal. Specifically, the waterbars were not installed according to the installation detail provided in the SWMP—they were not compacted, and did not have checks dams implemented along the length of the water bar. Furthermore, they were not spaced frequently enough for the slope of the disturbed areas, and were directing flow to unstabilized outlets (the diversion ditches). As a result, there was a potential for erosion and failure of the waterbars, concentrated flow and scouring along the bottom of the waterbars, conveyance of sediment to the diversion ditches, and subsequent discharge of sediment down the diversion ditches toward the downgradient drop inlets. Adequate BMPs must be implemented and installed correctly to prevent discharge of sediment from upgradient disturbed slope areas.

Photograph 8—NW corner of site. Looking NE up waterbar from diversion ditch.

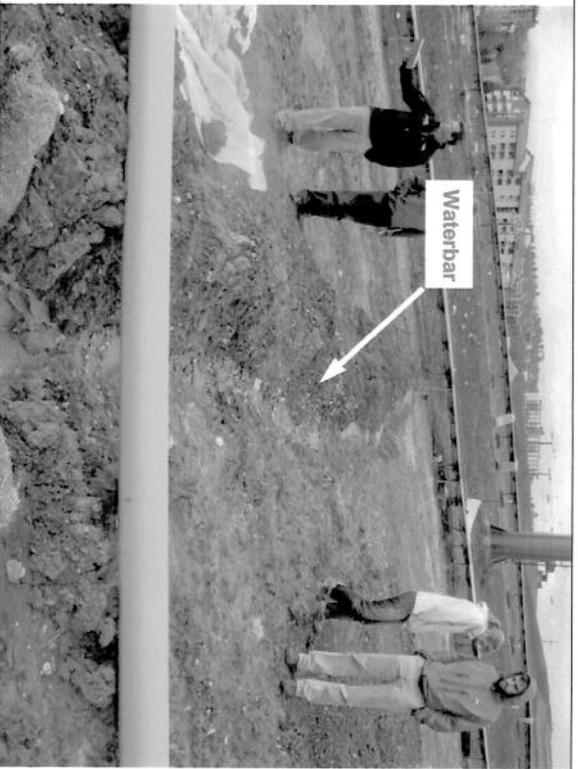
Photograph 9—SW corner of site. Looking NE along waterbar.

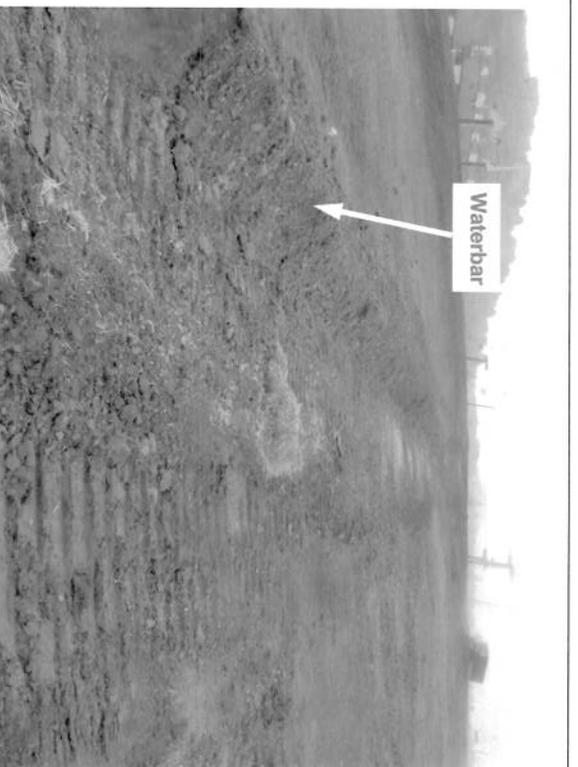
Photograph 10—S portion of site, approximately midsite. Looking N up water bar.

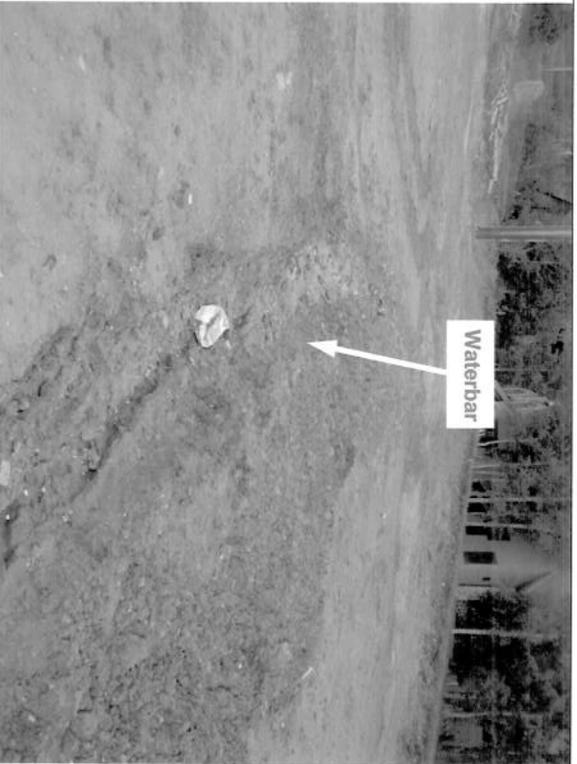
Photograph 11—Eastern portion of site. Looking south up waterbar.

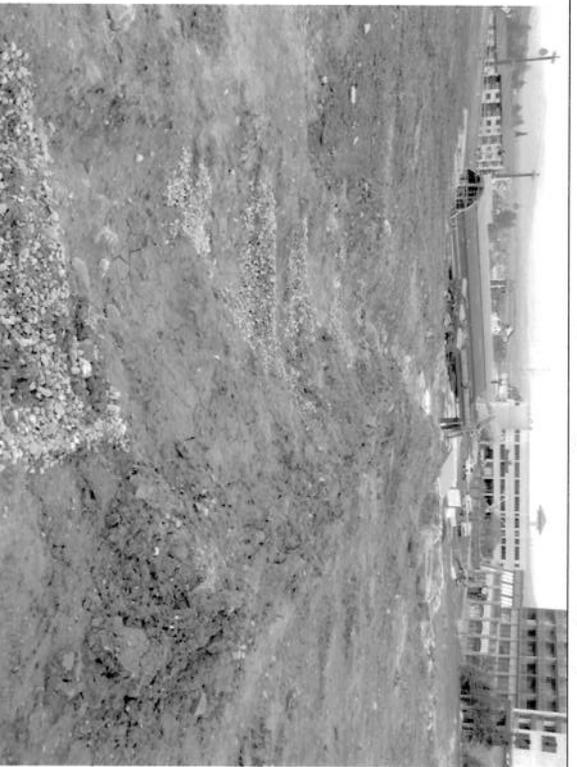
- a. The rock check dams in the diversion ditch located in the NW corner of the site were not installed according to the installation detail provided in the SWMP—the gravel size used for the check dams did not meet the size requirements in the installation detail (see attached photographs 12 and 13). Adequate BMPs must be implemented and installed correctly to prevent erosion and discharge of sediment from the diversion ditches across the site.

Photograph 12—NW corner of site. Looking SW down diversion ditch.

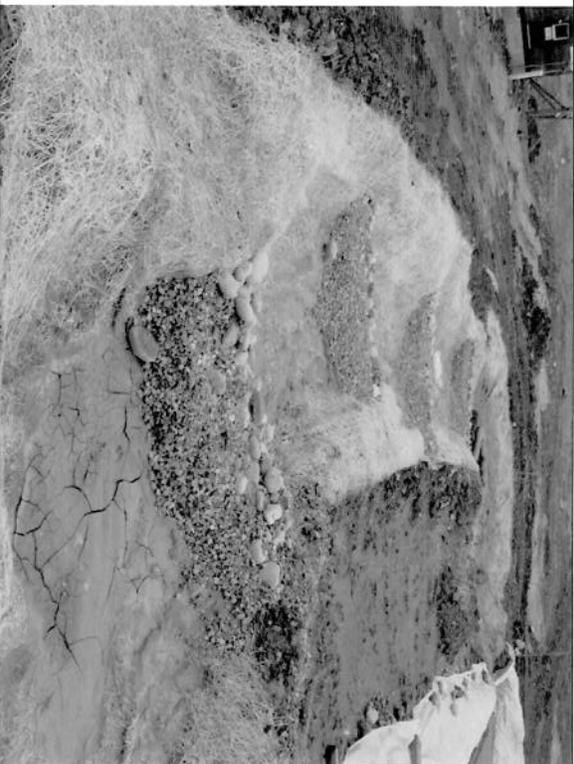
Photograph 13—NW corner of site. Looking SE down diversion ditch.

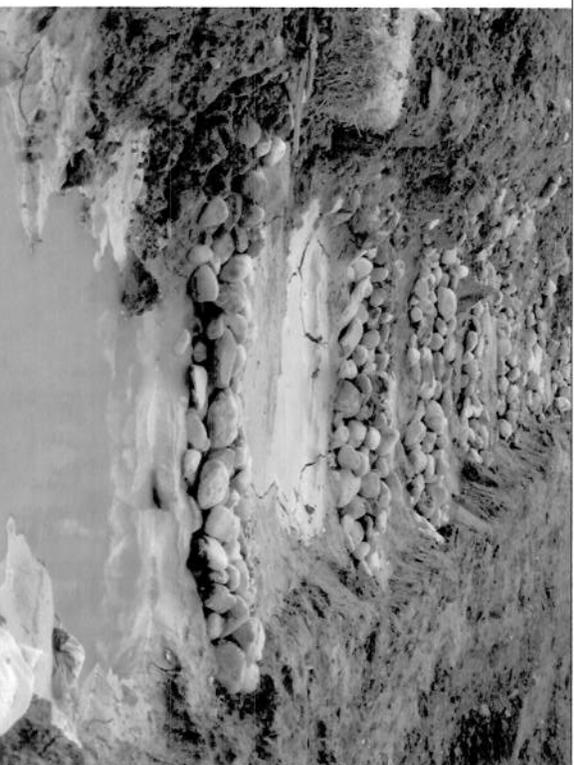
- b. BMPs for maintenance were not implemented for the rock check dams in the diversion ditch located in the SW portion of the site (see attached photograph 14). Sediment had accumulated to more than ½ the height of the dams, and there was evidence of erosive concentrated flow and sediment transport along the bottom of the ditch, and over the check dams. While some sediment will accumulate behind check dams, this BMP is not intended to be used as a primary sediment trapping device. Adequate BMPs must be implemented and maintained to prevent erosion and discharge of sediment from the diversion ditches across the site.

Photograph 14—SW portion of site. Looking E up diversion ditch.

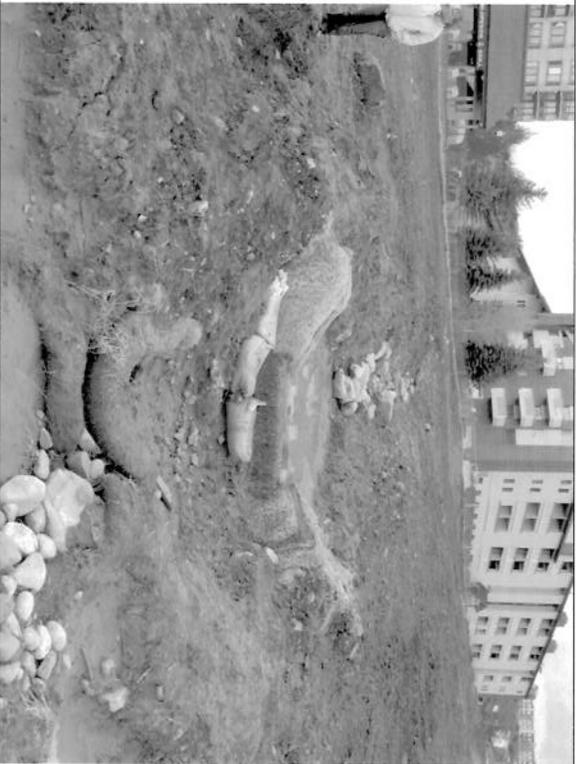
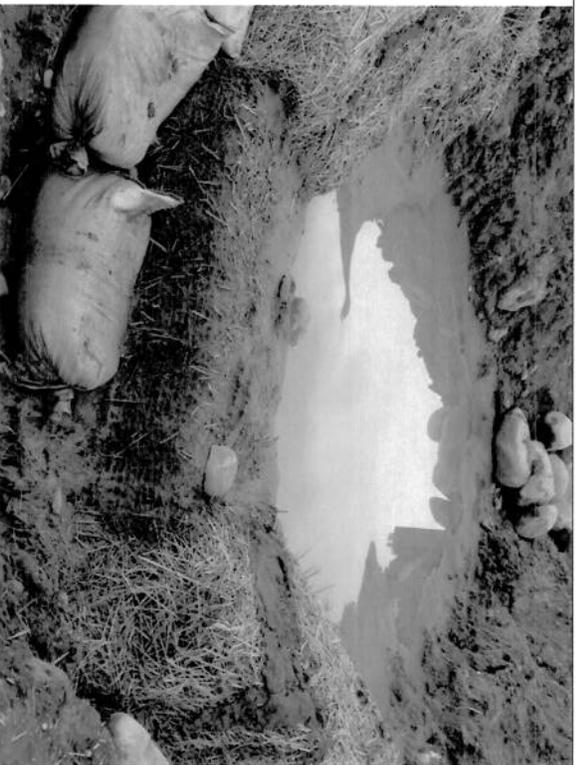
- c. BMPs for maintenance were not implemented for the straw bale check dams in the diversion ditch located at the NW corner of the site (see attached photographs 15 and 16). Sediment had accumulated to the top of the dams, and there was evidence of erosive concentrated flow and sediment transport along the bottom of the ditch, and over the check dams. Adequate BMPs must be implemented and maintained to prevent erosion and discharge of sediment from the diversion ditches across the site.

Photograph 15—NW corner of site. Looking NE up diversion ditch.

Photograph 16—Close up of photograph 15.

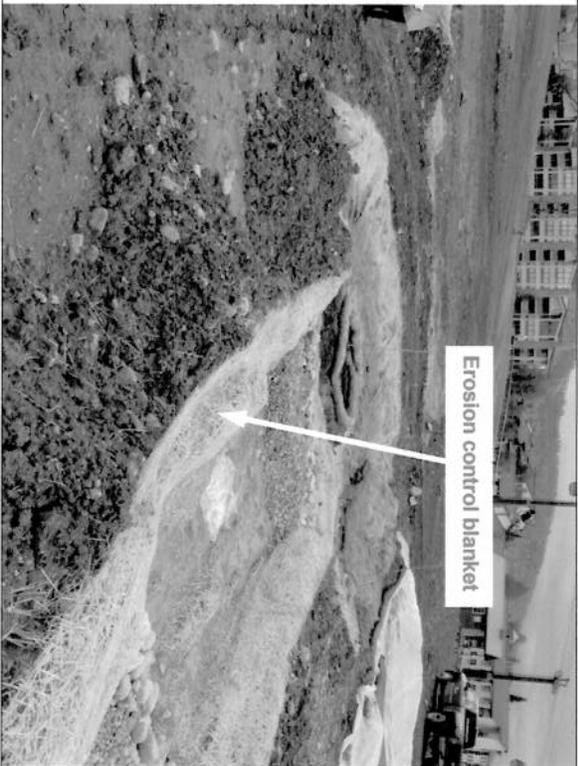
- d. The erosion control blanket BMPs located in: i) the diversion ditch located at the NW corner of the site, leading to the inlet adjacent to the Christy 6 sediment pond (see attached photograph 17), and ii) in the western-most water bar draining to the south perimeter diversion ditch in the SW corner of site (see attached photograph 18), were not installed according to the installation detail provided in the SWMP. The edges of the blanket were not secured (entrenched) to prevent undercutting. Adequate BMPs must be implemented and installed correctly to prevent erosion and discharge of sediment from the diversion ditches across the site.

Photograph 17—NW corner of site. Looking SE at diversion ditch.

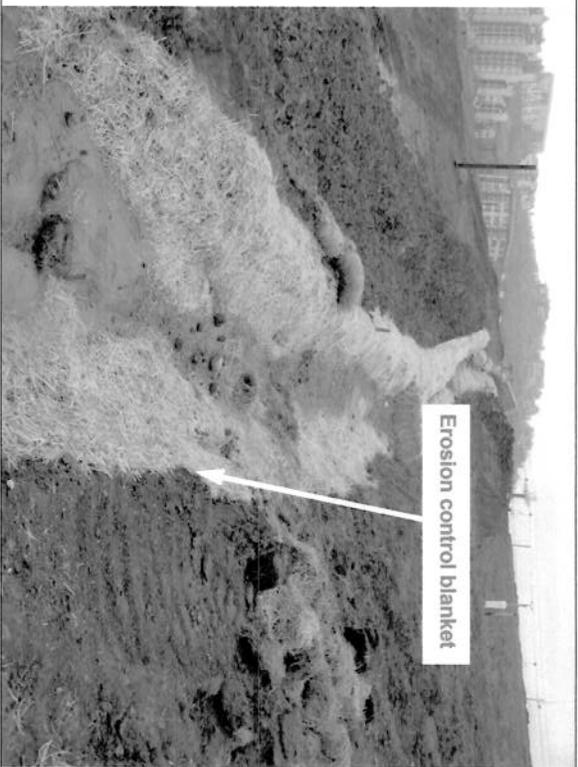
Photograph 18—SW edge of site. Looking N up water bar.

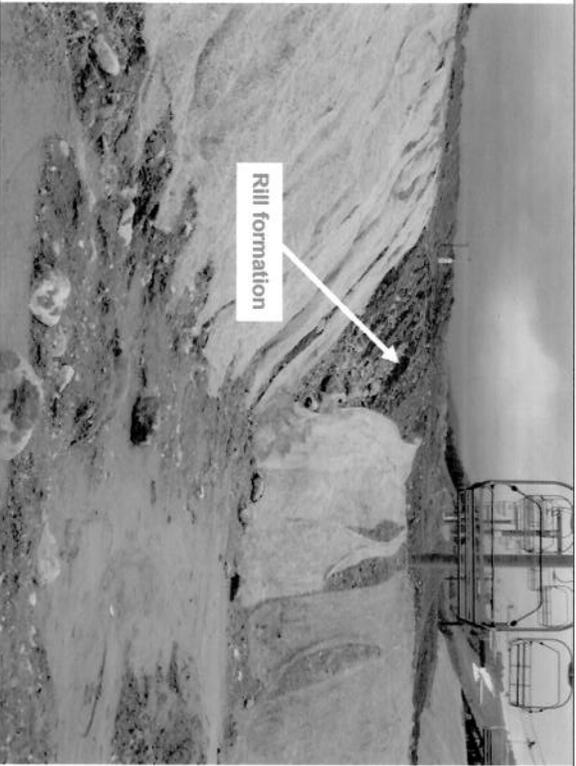
9. It was noted during the inspection that inadequate BMPs were implemented to prevent the discharge of sediment-laden water from a "pond" located at the base of the Christy Peak Express Lift, into the perforated riser pipe, which leads to Burgess Creek (State waters) (see attached photographs 21 and 22). The straw bale inlet protection adjacent to the riser pipe did not surround the entire structure, and the disturbed slope adjacent to the riser pipe was not stabilized. As a result, there was a potential for discharge of sediment to Burgess Creek (State waters). Adequate BMPs must be implemented and maintained to prevent discharge of sediment from to the inlet structures to Burgess Creek.

Photograph 19—NW corner of site. Looking E at base of Christy Peak Express Lift.

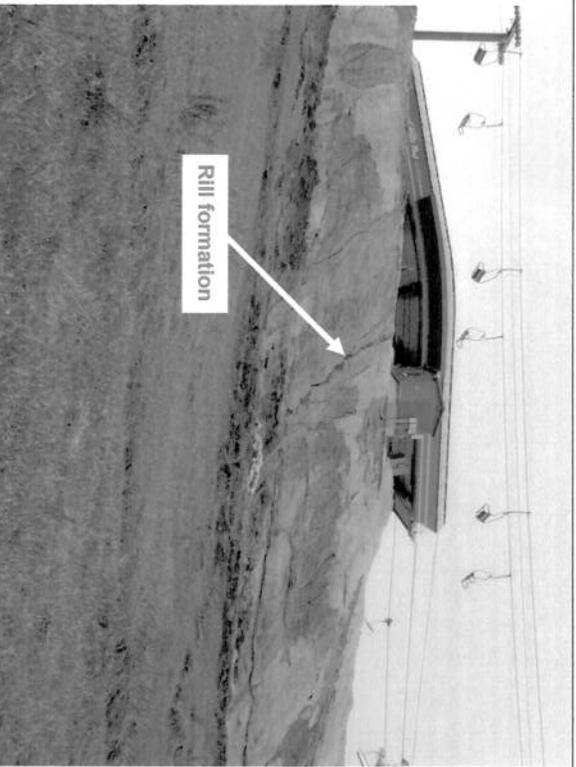
7. It was noted during the inspection that erosion control blanket BMPs were not adequately maintained to prevent erosion and sediment discharge from site disturbed areas. Specific locations noted during the inspection include erosion control blankets installed: i) in the NW corner of site, at base of Christy Peak Express Lift (see attached photograph 19) and, ii) NE edge of site at the top of the slope adjacent to the Christy Peak Express Lift (see attached photograph 20). In both locations, the erosion control blankets were no longer covering the disturbed slope, and erosion of the slope (rill formation) was evident. As a result, there was a potential for discharge of sediment to the downgradient drop inlets connected to Burgess Creek (State waters) located at the bottom of the ski slope, along the western portion of the site. Adequate BMPs must be implemented and maintained to prevent erosion and discharge of sediment from site disturbed areas.

Photograph 20—NE edge of site looking S at blankets on slope.

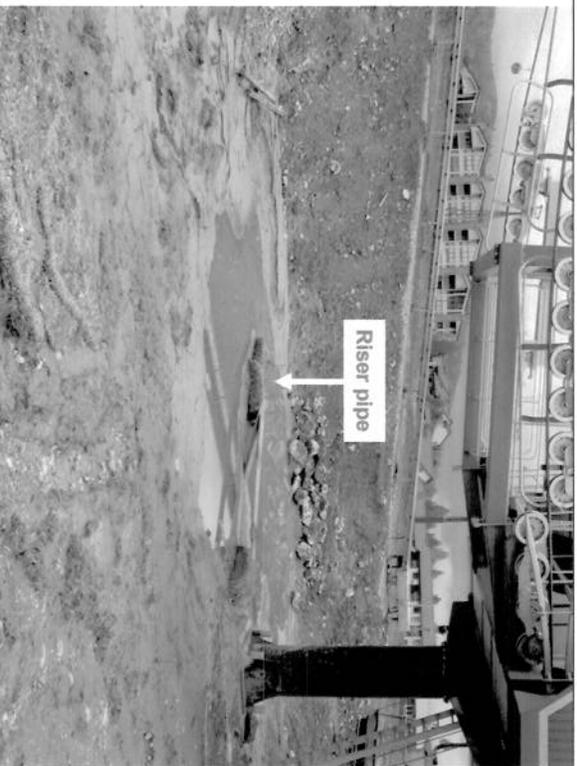
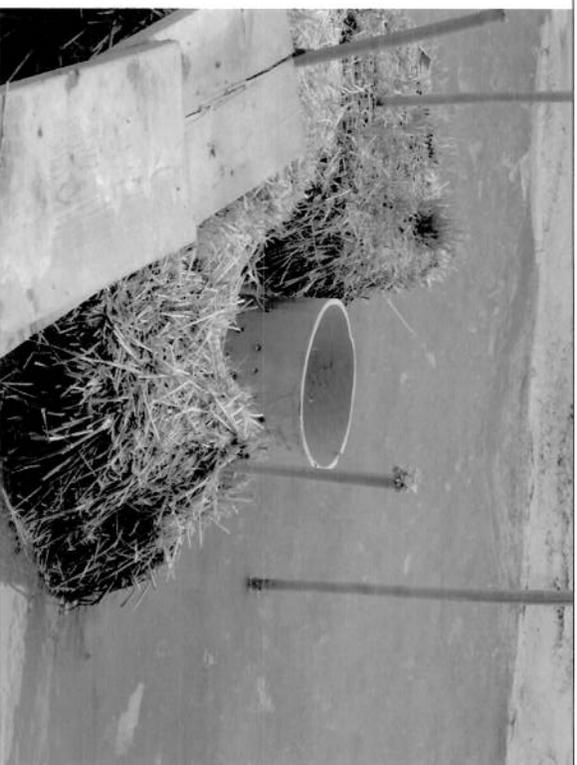
Photograph 21—NW corner of site, base of Christy Peak Express Lift.

Photograph 22—Close-up of riser pipe in photograph 21.

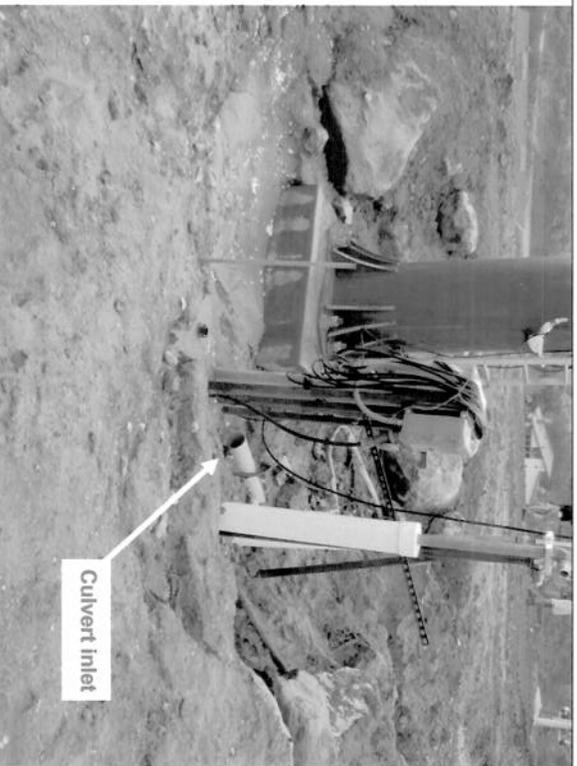
10. It was noted during the inspection that the culvert inlet and outlet located at the eastern portion of site, under the ski lift structure, were not installed with adequate inlet and outlet protection, resulting in erosion and scour of the disturbed areas surrounding the culvert inlet and outlet (see attached photographs 23 and 7). As a result, there was a potential for discharge of sediment to the downgradient drop inlets connected to Burgess Creek (State waters) located at the bottom of the ski slope, along the western portion of the site. All culverts at the facility must be installed with adequate inlet and outlet protection.

Photograph 23—E edge of site (top) – looking WNW at culvert inlet.

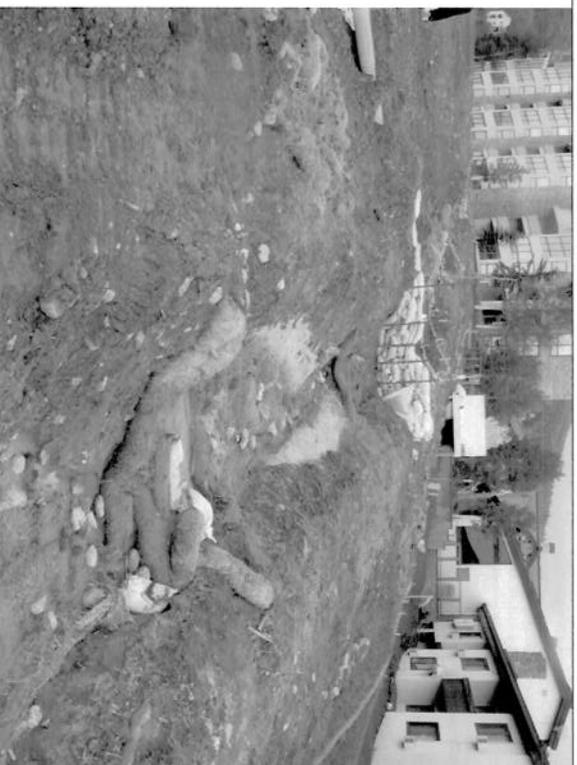
Photograph 24—SW corner of site. Looking E up diversion ditch.
