## EXPEDITED SETTLEMENT AGREEMENT

RE:    Facility Inspection/**Compliance Advisory**  
      Metropolitan Club  
      CDPS Permit No. COR-03D961  
      El Paso County

## Stormwater Inspection Report

| <b>Permittee:</b> Journey Homes CS LLC | <b>Cert. No.</b> COR03D961 | <b>Date(s):</b> 12/21/2010 |

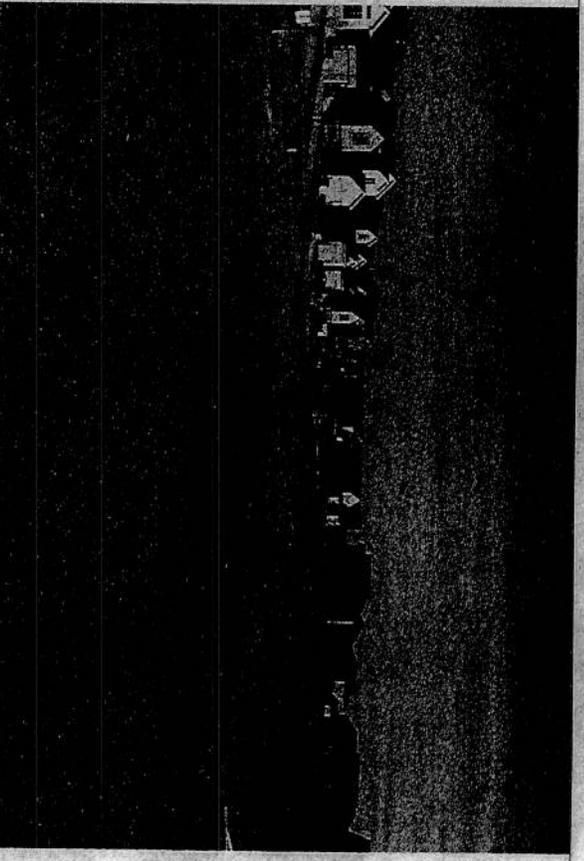
6. It was noted during the inspection that inadequate BMPs were implemented to manage stormwater runoff from the land disturbance and sediment stockpiles located on Lots 67-72 (see photos 1-4). Stormwater runoff from this disturbed area discharges to a down gradient storm sewer inlet located along Shinnecock Court. The storm sewer discharges to Detention Pond 2. A series of curb check rock socks in combination with a plastic pipe wrapped in fabric were placed together in front of the storm sewer inlet to act as an inlet protection device. Inlet protection devices are not designed to function as the sole BMP to remove sediment loading from stormwater runoff coming from the up-gradient disturbed areas. Inlet protection BMPs are intended to be used in conjunction with up gradient BMPs and only as a polishing measure, not as the primary sediment removal device. No other BMPs were implemented up gradient from the inlet protection device for the disturbed area. BMPs to manage the stormwater runoff from the disturbed areas must be

Photograph 2 – Looking east Lots 67-72. Red arrows indicate direction of flow

implemented up-gradient of the storm drain inlet to be used in conjunction with the inlet protection device in order for the inlet protection device to function correctly. All BMPs must be implemented according to installation and implementation specifications outlined in the SWMP.

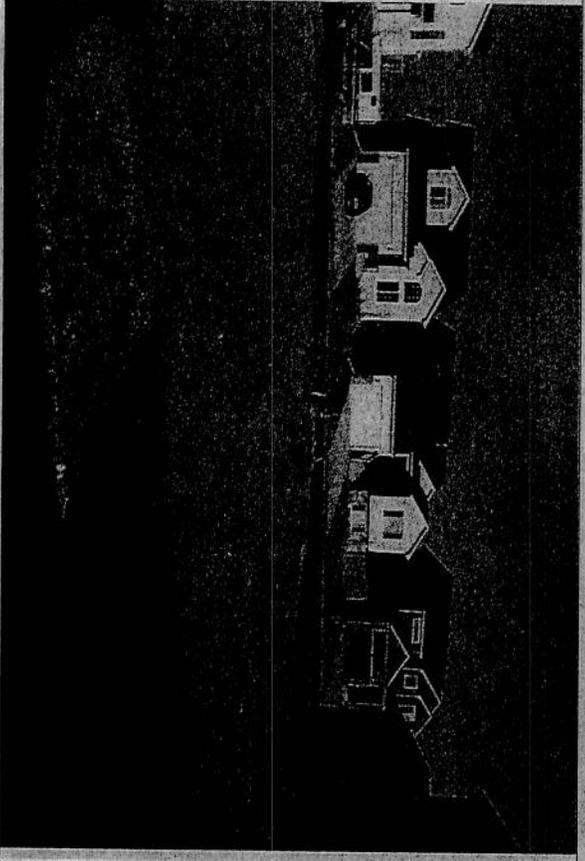
Photograph 3 – Looking northeast Lot 72. Red arrows indicate direction of flow

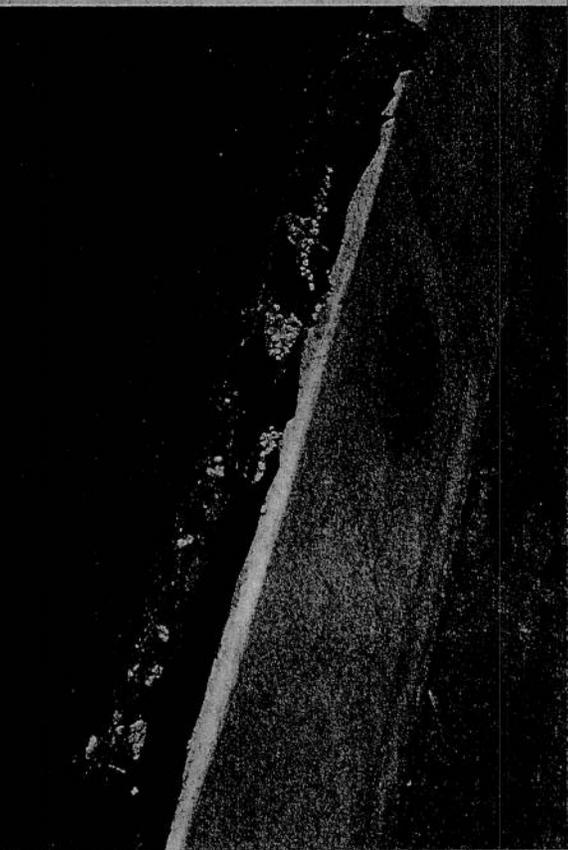
Photograph 7 - Curb inlet west of intersection of Dakota Dunes Ln and Shinnecock Ct

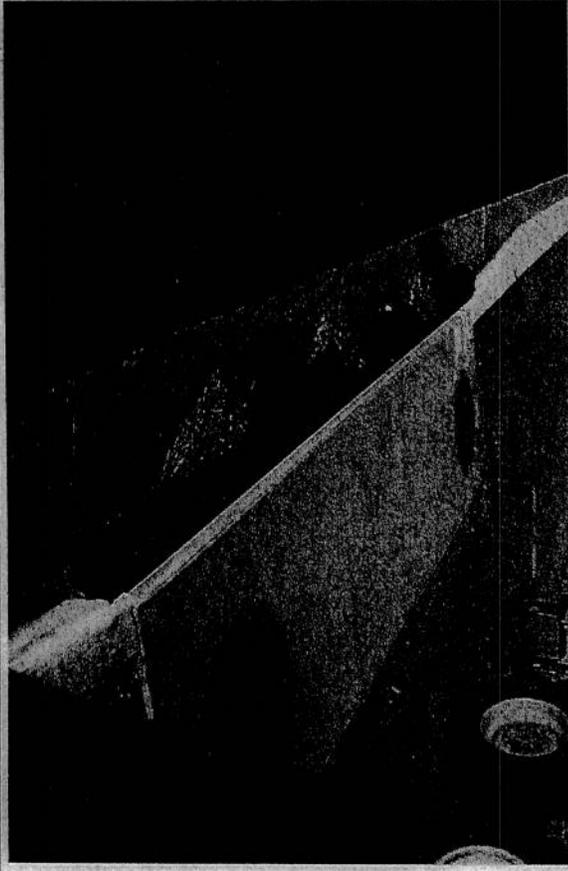
Photograph 8 - Curb inlet located adjacent to Lot 12

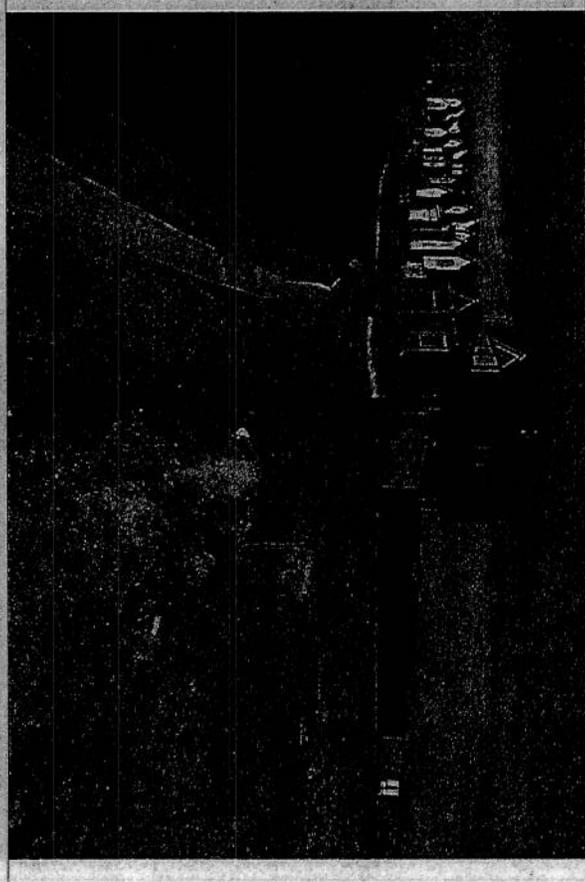
7. It was noted during the inspection that inadequate BMPs were implemented to manage stormwater runoff from the land disturbance located between the straw mulching and the concrete curbing on Lots 8-57 and Lots 78-97 (see photos 9-15). Stormwater runoff from these disturbed areas discharges to down gradient storm sewer inlets. The storm sewer discharges to either Detention Pond 1 or 2. A series of curb check rock socks in combination with a plastic pipe wrapped in fabric were placed together in front of the storm sewer inlets to act as an inlet protection device. In some cases, just a series of curb check rock socks were placed together in front of the storm sewer inlets to act as an inlet protection device. Inlet protection devices are not designed to function as the sole BMP to remove sediment loading from stormwater runoff coming from the up-gradient disturbed areas. Inlet protection BMPs are intended to be used in conjunction with up gradient BMPs and only as a polishing measure, not as the primary sediment removal device. No other BMPs were implemented up gradient from the inlet protection devices for the disturbed areas. BMPs to manage the stormwater runoff from the disturbed areas must be implemented up-gradient of the storm drain inlet to be used in conjunction with the inlet protection device in order for the inlet protection device to function correctly. All BMPs must be implemented according to installation and implementation specifications outlined in the SWMP.

Photograph 10 - Lot 78 land disturbance

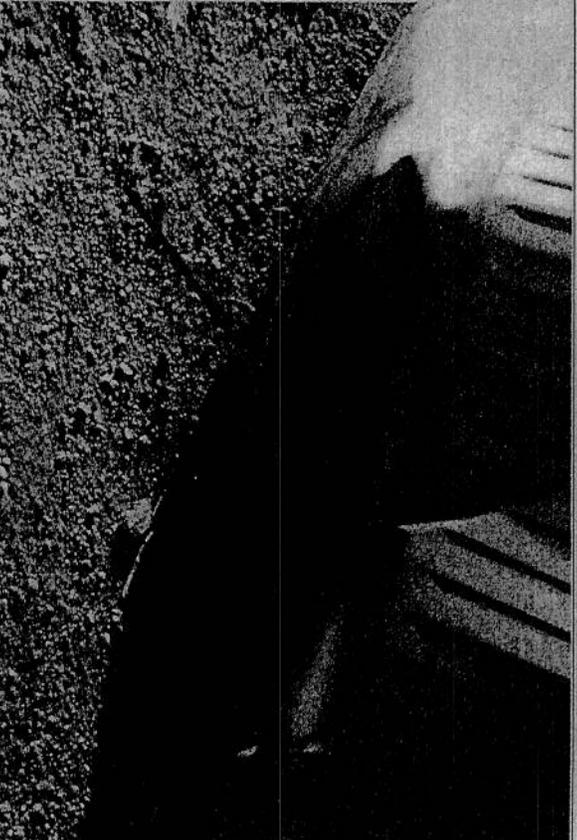
Photograph 20 - red arrow points to hole in containment vessel

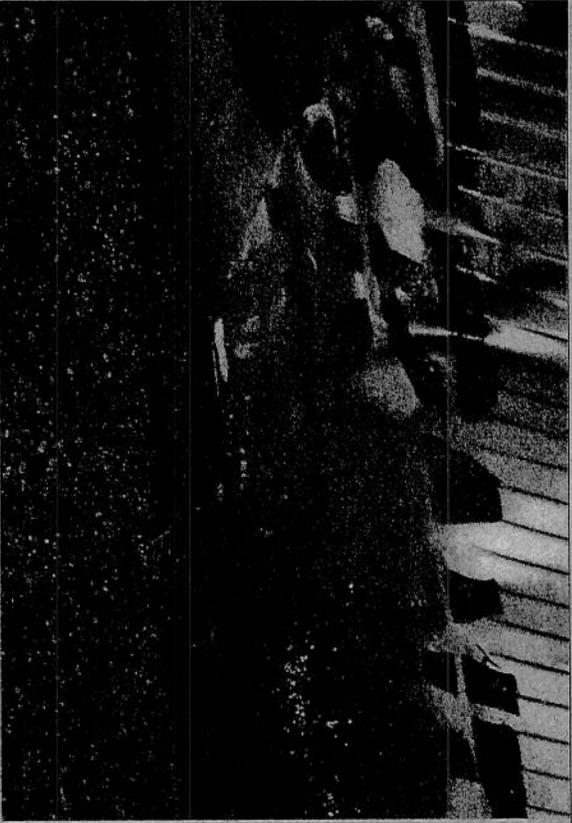
Photograph 21 - Red arrow points to hole in containment vessel

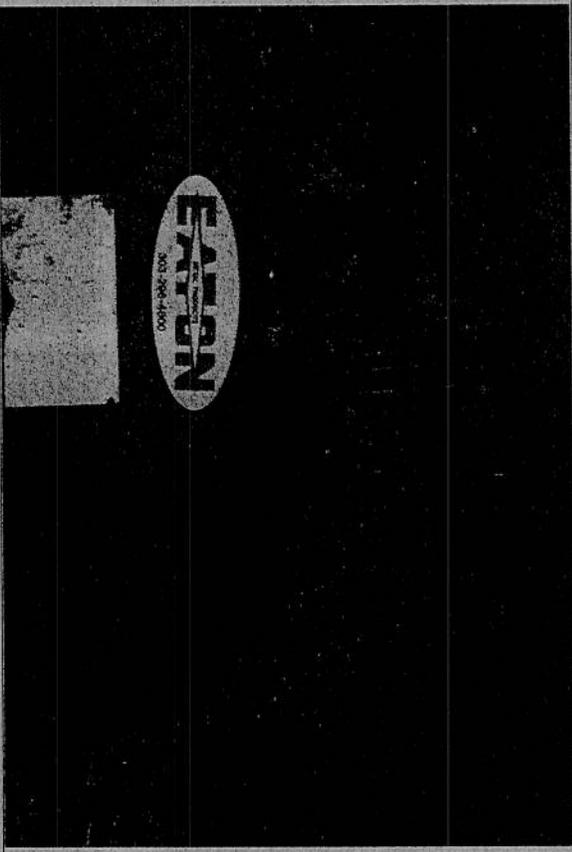
11. It was noted during the inspection that inadequate BMPs for materials handling and spill prevention were implemented for a fuel tank located on Lot 95 (see photos 19 and 22). Part I.D.1.c of the Permit requires that bulk storage structures for petroleum products and any other chemical shall have secondary containment or equivalent adequate protection so as to contain all spills and prevent any spilled material from entering State waters. The fuel tank was placed inside a containment vessel BMP. The containment vessel BMP had holes in it, and therefore could not provide the required secondary containment of the fuel in the event of a spill. (see photos 20 and 21). It should also be noted that the fuel tank was placed approximately 35 feet away from a storm sewer inlet (see photo 23). Stormwater runoff from the fuel tank area discharges 35 feet to the east into a storm inlet. The storm sewer discharges to Pond 2. Adequate BMPs must be implemented to provide secondary containment or equivalent adequate protection for bulk storage structures of petroleum products and any other chemicals so as to contain all spills and prevent any spilled material from entering State waters.

Photograph 22 - fuel tank located at Lot 95
