## EXPEDITED SETTLEMENT AGREEMENT

Number: ES-110713-1

RE: Facility Inspection/**Compliance Advisory**  
Alma Super Storage  
CDPS Permit No. COR-03E512  
Park County

## Stormwater Inspection Report

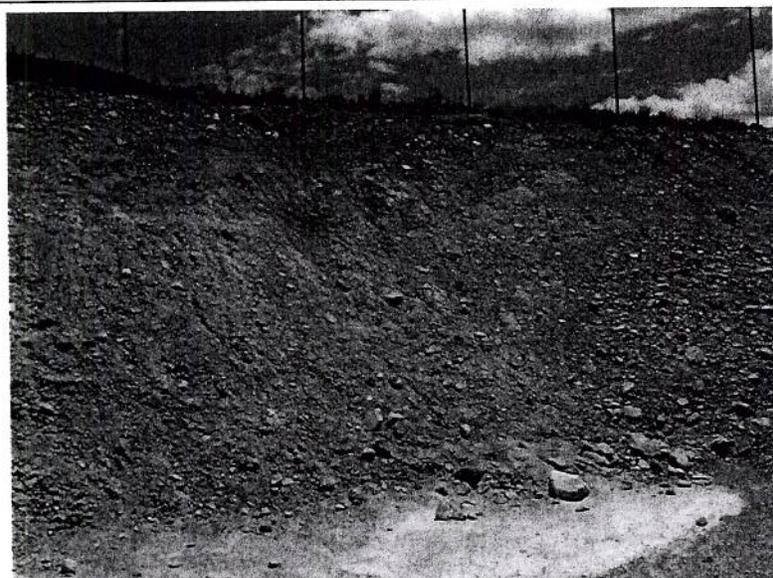
4. It was noted during the inspection that inadequate BMPs were implemented to manage stormwater runoff from the areas of disturbance along the eastern side of the project boundary (photo 1 and 2), the stockpiles of soil located near the south eastern section of the construction site (photo 3 and 4), and areas of disturbance along the north, north-eastern side of the project boundary (photo 5). Erosion rills were observed along the eastern disturbed slope (photo 1). Stormwater runoff from the disturbed areas identified above all drains to the north and discharges through a culvert to a retention pond. Straw wattles were installed down gradient of this drainage area in front of the culvert that drains to a retention pond (photo 5). The SWMP did not identify installation and implementation specifications for the straw wattles. The straw wattles were not installed following good engineering, hydrologic and pollution control practices. According to good engineering, hydrologic and pollution control practices, straw wattles must be trenched in the ground and staked through the wattle in order to create a seal with the ground to prevent undercutting. The installed straw wattles were not trenched nor were they staked through the wattle (photos 5 and 6). All BMPs must be implemented according to installation and implementation specifications outlined in the SWMP. All installation and implementation specifications outlined in the SWMP must follow good engineering, hydrologic and pollution control practices. In addition, the straw wattles were not inspected and maintained in good and effective operating condition. The portion of the straw wattle located west of the culvert was ripped (photo 6). All BMPs must be inspected and maintained in good and effective operating condition.

Photo 1: Land disturbance along the east side of the project boundary. Rill erosion is evident throughout the slope disturbance. The stormwater drains to the north and into the retention pond.

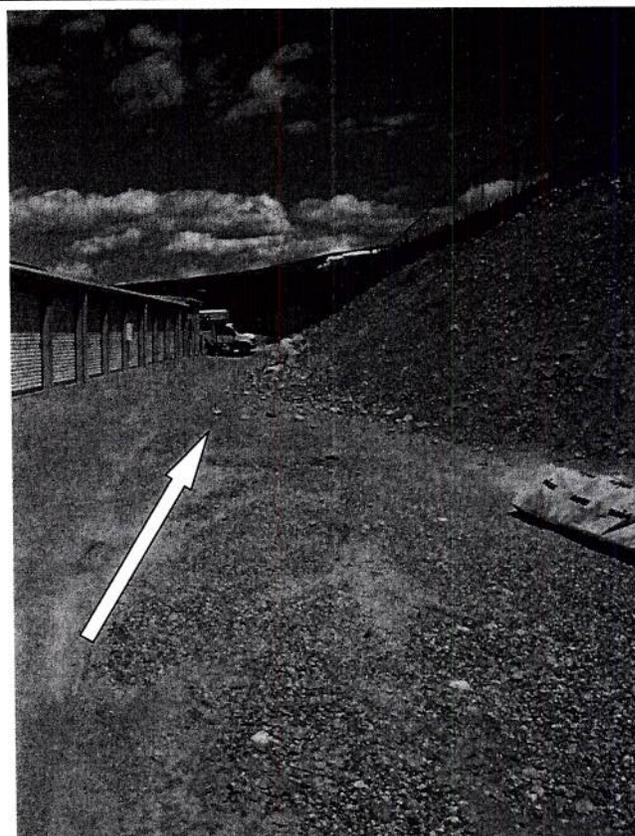
Photo 2: Land disturbance along the east side of the project boundary. The stormwater drains to the north, as indicated by arrows, and into the retention pond.

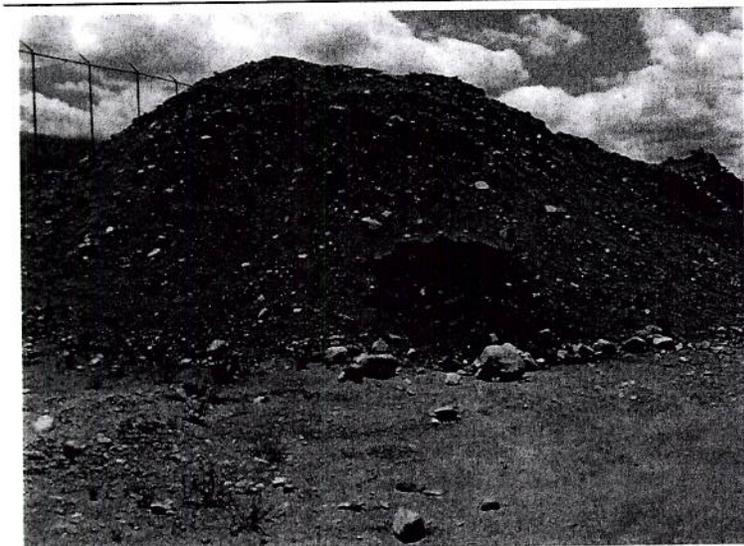
Photo 3: Soil stockpiles located along the south east portion of the construction area. The stormwater drains to the north and into the retention pond.

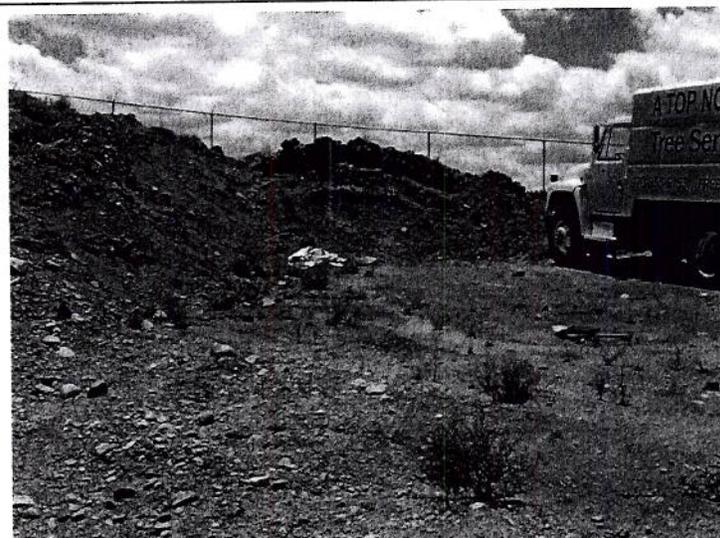
Photo 4: Soil stockpiles located along the southeast portion of the construction area. The stormwater drains to the north and into the retention pond.

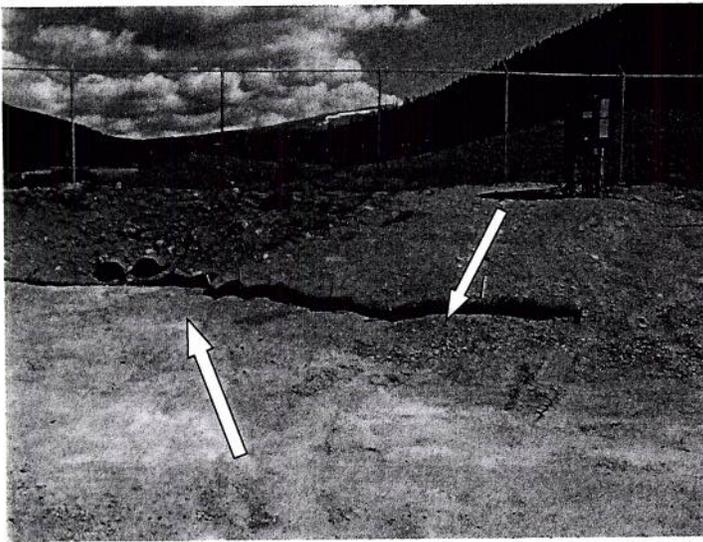
5. It was noted during the inspection that inadequate BMPs were implemented to manage stormwater runoff from the areas of disturbance along the eastern side of the project boundary (photo 1 and 2), the stockpiles of soil located near the south eastern section of the construction site (photo 3 and 4), and areas of disturbance along the north, north-eastern side of the project boundary (photo 5). Erosion rills were observed along the eastern disturbed slope (photo 1). Stormwater runoff from the disturbed areas identified above all drains to the north and discharges through two culverts to a retention pond. The retention pond was not installed according to installation and implementation specifications outlined in the SWMP. The retention pond was not constructed to match the width, length, shape, or depth that is specified on the SWMP site map (photo 7). Additionally, the retention pond spillway was not constructed to match the installation detail provided on the SWMP site map as the spillway was not installed using rip rap as identified in the detail. It was not clear as to whether the design of the retention pond that is currently implemented on site to manage stormwater runoff was designed according to good engineering, hydrologic pollution control practices. If the retention pond is going to be utilized as a BMP to manage stormwater runoff from the site, then installation and implementation specifications for this pond must be included in the SWMP. All installation and implementation specifications for BMPs implemented on site must be in accordance with good engineering, hydrologic and pollution control practices.

Photo 5: Land disturbance along the north, north-eastern side of the construction site. The stormwater drains to the north, as indicated by the arrows, and into the retention pond. The straw wattle is not trenched and the stakes are not through the straw wattle.

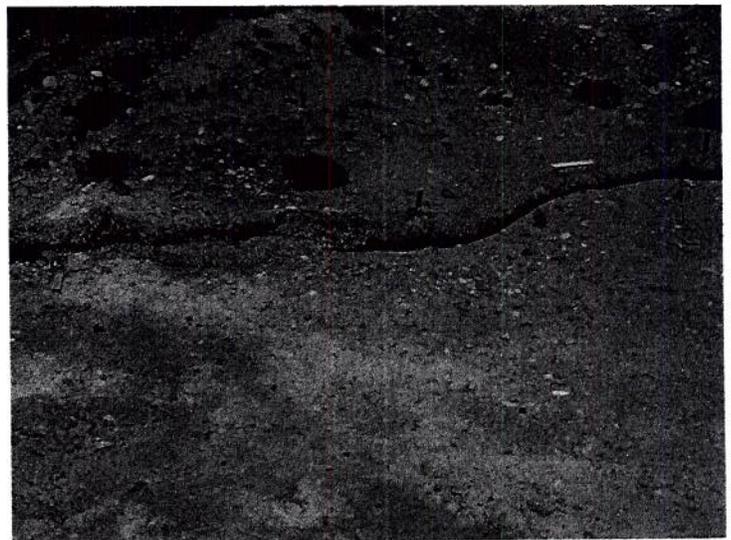
Photo 6: Western portion of straw wattle identified in photo 5. Straw wattle not trenched, stakes are not through the straw wattle, and straw wattle is not being maintained.

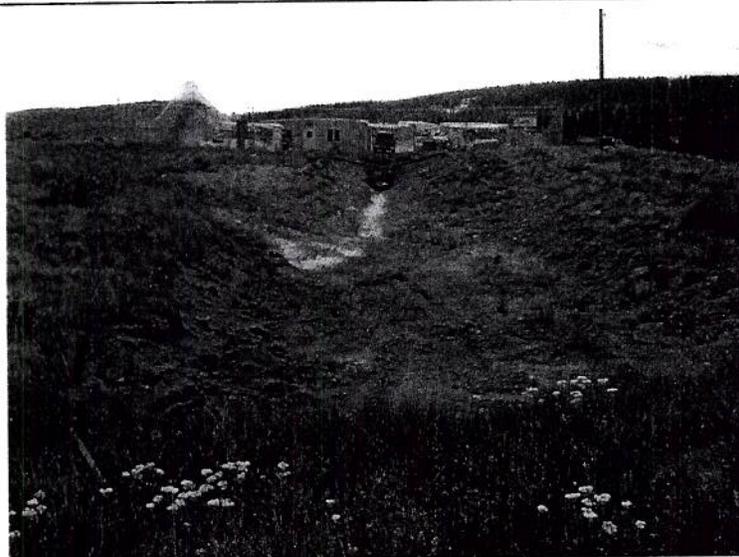
Photo 7: Retention pond located on the north side of project boundary is not installed according to installation detail provided in SWMP site map.

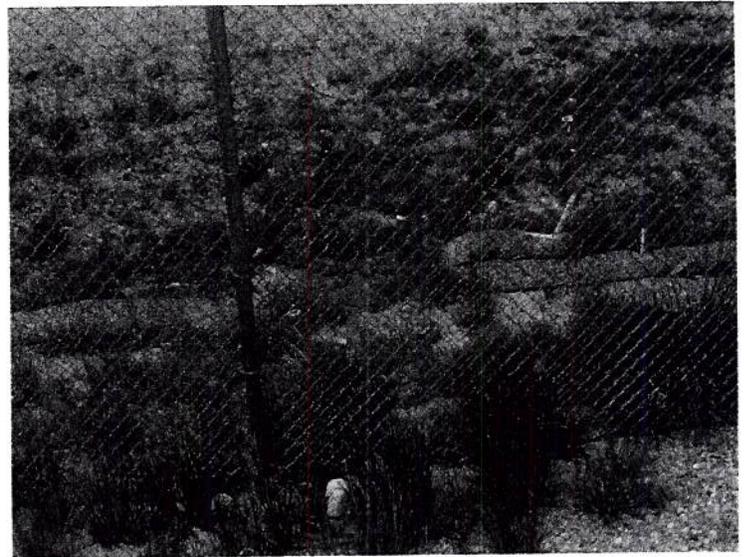
6. It was noted during the inspection that inadequate BMPs were implemented to manage stormwater runoff from the disturbance along the west side of construction boundary. Stormwater runoff from this disturbed area drains to the northwest to a roadside drainage ditch. A series of erosion straw wattles were installed along the western boundary to manage the stormwater runoff from the disturbed area identified above. The straw wattles were not installed according to good engineering, hydrologic, and pollution control practices. The straw wattles were not properly abutted as there were gaps between where one wattle ends and another wattle begins (photo 8). In addition, the straw wattles were not installed on the drainage contour and were not properly staked (photo 9). As a result, there was evidence of a discharge of sediment beyond the straw wattles and deposited offsite into the roadside ditch located west of the construction site boundary, adjacent to Highway 9 (photo 15). The roadside ditch discharges to the Middle Fork South Platte River located approximately 600 feet to the south. All BMPs must be implemented according to installation and implementation specifications outlined in the SWMP. All installation and implementation specifications outlined in the SWMP must follow good engineering, hydrologic and pollution control practices.

Photo 8: Erosion straw wattles along the western side of the construction boundary are not installed correctly as there are gaps between the wattles and the wattles are not properly staked.

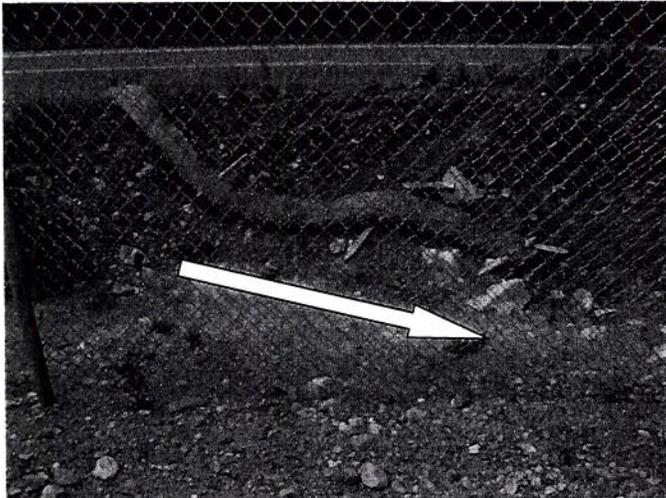
Photo9: Erosion straw wattle along the western side of the construction boundary are not trenched and are not staked. The stormwater drains to the north, as indicated by the arrows, to roadside drainage ditch.

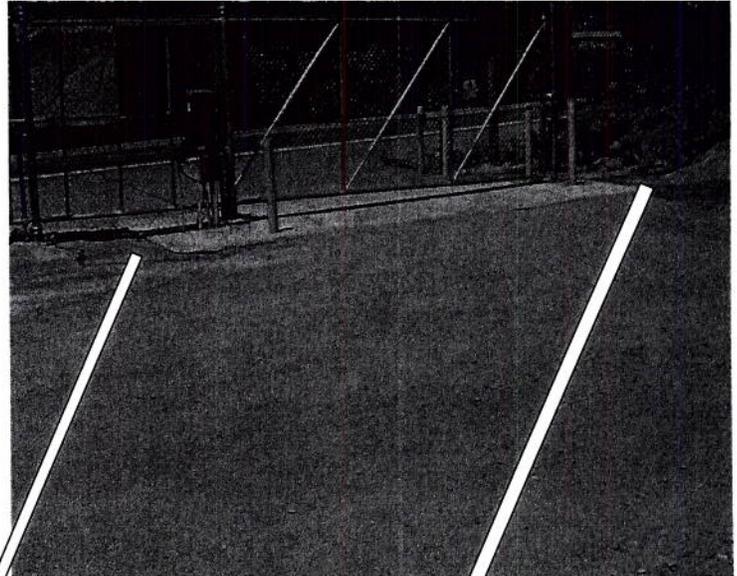
7. It was noted during the inspection that BMPs were not implemented to manage the stormwater runoff from the drivable surfaces located on the west side of the constructed storage facilities, including the entrance. The drivable surfaces were constructed out of a loose road base material that was highly erodible. The road base was comprised of loose dirt, fines, and some aggregate. Stormwater runoff from these drivable surfaces drains to the west and to the northwest side of the construction site boundary, to a roadside drainage ditch. There was evidence of erosion occurring on the drivable surface located at the southeast and northeast side of the entrance gate (photos 10, 11 and 12). As a result, there was a discharge of sediment into the roadside ditch identified in Finding 6 (photo 15). BMPs must be implemented to manage stormwater runoff from all potential pollutant sources. All BMPs must be implemented according to installation and implementation specifications outlined in the SWMP.

Photo 10: Failure to implement BMPs to manage stormwater runoff from the drivable surfaces at the entrance and along the west side of the construction site.

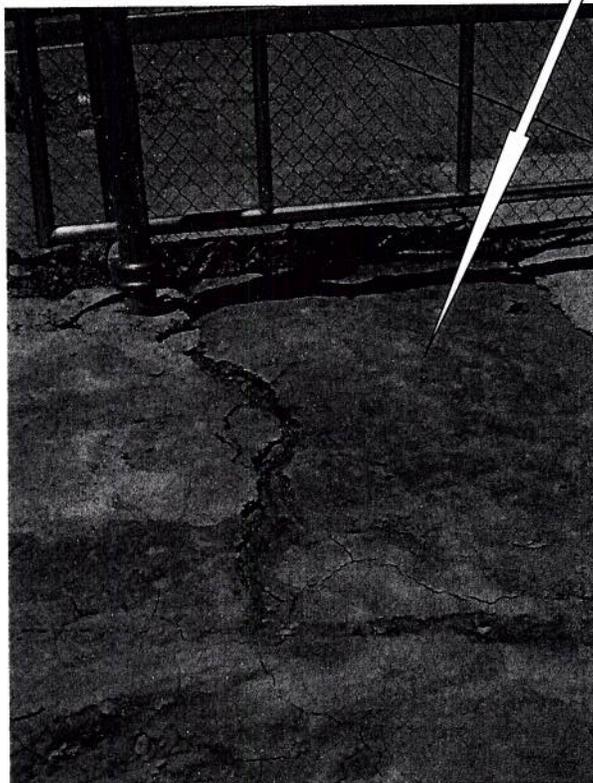
Photo 11: Failure to implement BMPs to manage stormwater runoff from the drivable surfaces. Close up of Photo 9 showing erosion along the southern portion of the entrance.

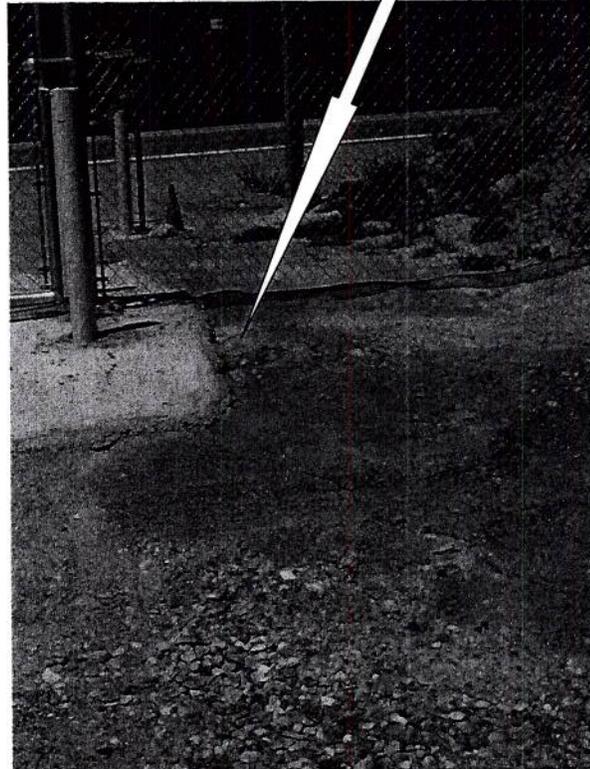
Photo 12: Failure to implement BMPs to manage stormwater runoff from the drivable surfaces. Close up of Photo 9 showing erosion along the northern portion of the entrance.

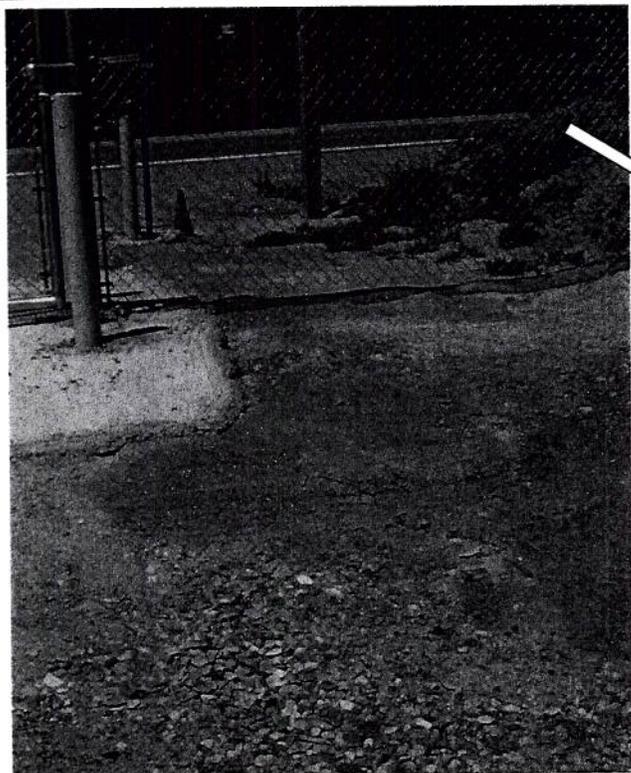
8. It was noted during the inspection that BMPs were not implemented to manage stormwater runoff from the disturbed slope located on the northwest side the construction site, north of the entrance (photos 13 and 14). There was evidence of erosion and a discharge of sediment from the disturbed slope into the roadside drainage ditch identified in Finding 6 (photos 14 and 15). BMPs must be implemented to manage stormwater runoff from all potential pollutant sources. All BMPs must be implemented according to installation and implementation specifications outlined in the SWMP.

Photo 13: Failure to implement BMPs for disturbed soils north of the exit/entrance

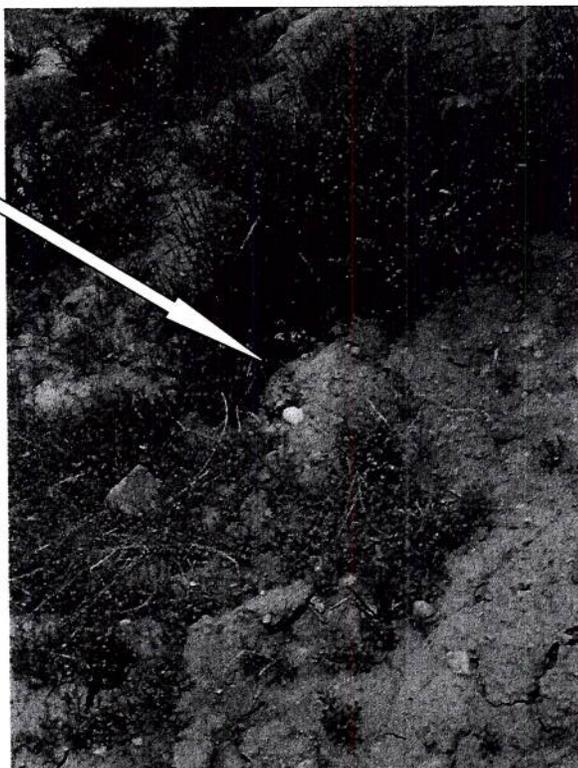
Photo 14: Failure to implement BMPs for disturbed soils north of the entrance (close up of photo 13) north of the entrance.

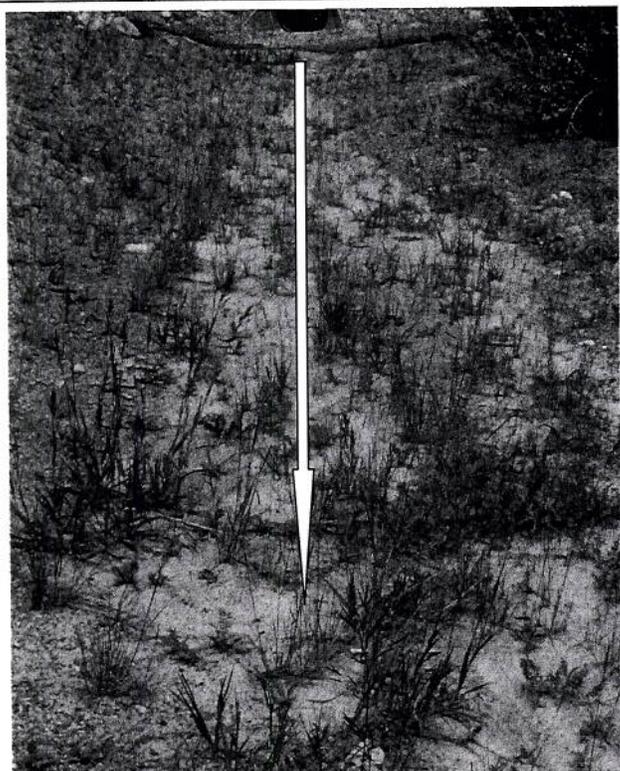
Photo 15: Sediment in the roadside drainage ditch located east of Highway 9 and west of construction site. Ditch ultimately flows to the North Fork of S. Platte River approximately 600 feet to the south.
