CAPITOL COMPLEX MASTER PLAN
FINDINGS & RECOMMENDATIONS (F & R) NEEDS ASSESSMENT
POWER PLANT BUILDING, 1341 SHERMAN STREET (DENVER)

NOVEMBER 2014

FINDINGS & RECOMMENDATIONS (F&R) NEEDS ASSESSMENT

POWER PLANT BUILDING
1341 SHERMAN STREET (DENVER)

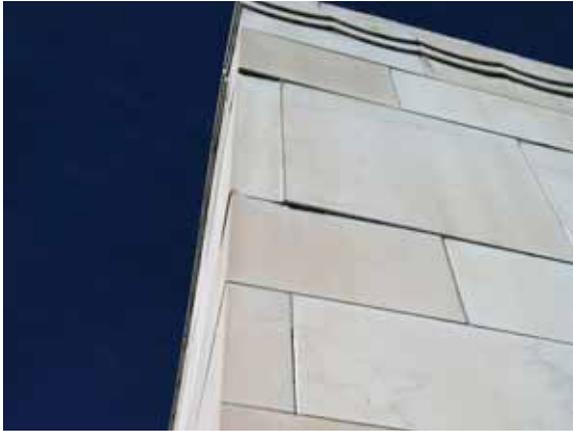
The marble veneer panels cladding the north, east, and a portion of the south facades of the building at the first story are in fair to poor condition. Several panels are no longer flush and appear to be pulling away from the building, creating a potential life-safety hazard for pedestrians below (see Fig. 2.1.A.1). Spalling of the marble was observed in a few locations

Fig. 2.1.A.1 Marble panels moving out of flush and creating a life-safety hazard for pedestrians below.

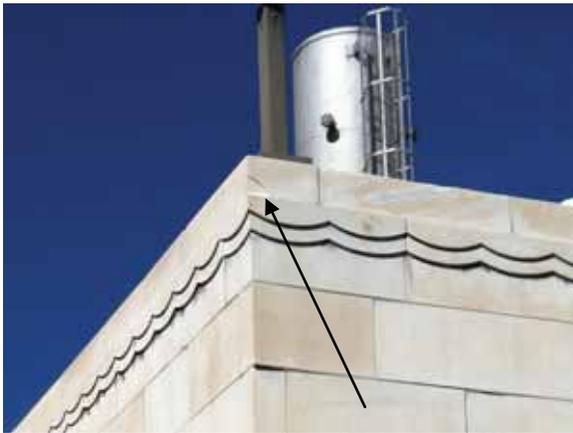
around the exterior of the building (see Fig. 2.1.A.2). The marble panels are generally soiled, which is to be expected after seventy-plus years. It was noted that the mortar between the joints of the marble veneer panels is generally deteriorating and leaving the building envelope vulnerable to water penetration (see Fig. 2.1.A.3 and Fig. 2.1.A.4). The granite panels along the foundation were observed to be in generally fair condition overall with wear-and-tear and deteriorating mortar between the joints noted (see Fig. 2.1.A.5 and Fig. 2.1.A.6). The granite parapet on the west side of the ballasted grade-level roof between the Power Plant Building and the Capitol Annex Building appears to have had new sealant applied recently (see Fig. 2.1.A.7). The sealant appears to have been applied poorly, with gaps noted along the length of the material.

Fig. 2.1.A.2 A few areas of spalling and damage observed at the marble veneer panels.

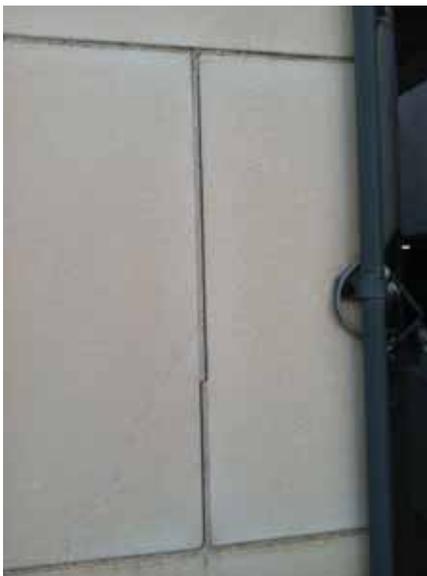
Fig. 2.1.A.3 General deterioration of the mortar leaving the building envelope vulnerable to water penetration.

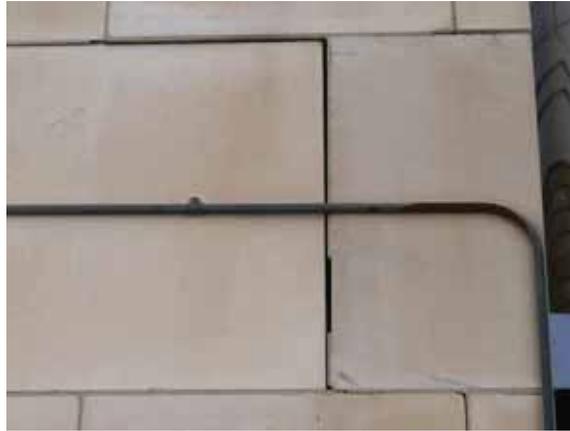
Fig. 2.1.A.4 General deterioration of the mortar leaving the building envelope vulnerable to water penetration.

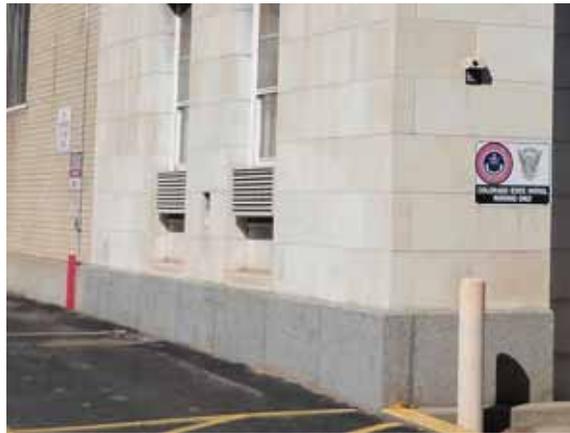
Fig. 2.1.A.5 Wear-and-tear and scuff marks noted at the granite cladding along the foundation, especially on the south side of the building.

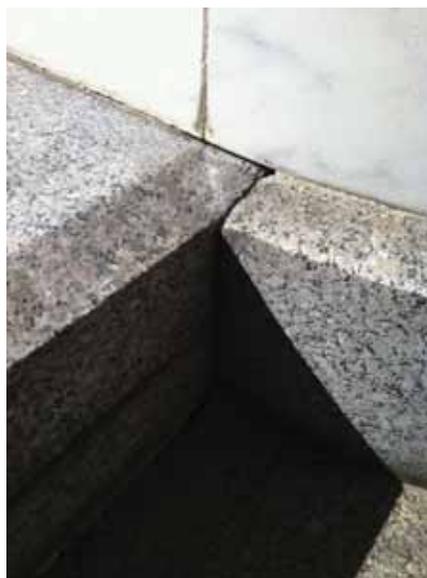
Fig. 2.1.A.6 Deteriorating mortar observed in the joints between the granite panels at the foundation.

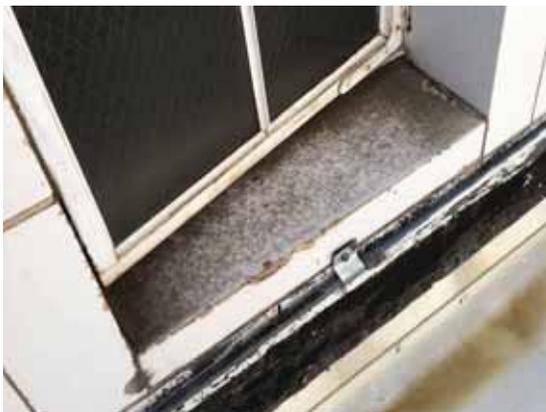
Fig. 2.1.A.9 Soiled and deteriorating glazed white terracotta observed at a window ledge.

- Clean soiled/stained glazed white terracotta panels around the exterior of the building using an approved method.

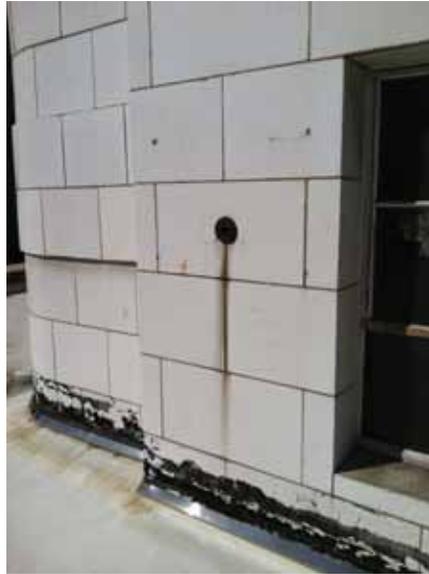
Fig. 2.1.A.10 Unrepaired holes observed at the glazed white terracotta tiles and soiling due to the corrosion of a metal attachment on the wall.

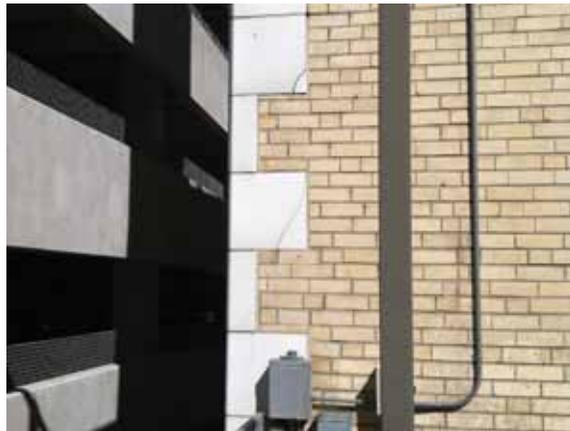
Fig. 2.1.A.11 Cracked glazed white terracotta tiles observed at the southwest corner of the building.

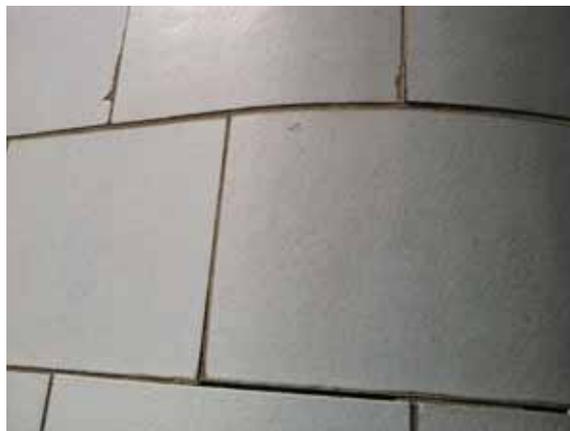
The glazed white terracotta tiles along the east facade of the second story construction and wrapping around both sides to clad a portion of the north and south facades, are in fair condition overall with areas of spalling, cracking, and soiling observed during the site survey visit (see Fig. 2.1.A.8, Fig. 2.1.A.9, Fig. 2.1.A.10, and Fig. 2.1.A.11). It was noted that the mortar between the joints of the glazed white terracotta tiles is generally deteriorating and leaving the building envelope vulnerable to water penetration (see Fig. 2.1.A.12 and Fig. 2.1.A.13).

Fig. 2.1.A.12 Typical instance of deteriorating mortar observed at the joints between the glazed white terracotta tiles.

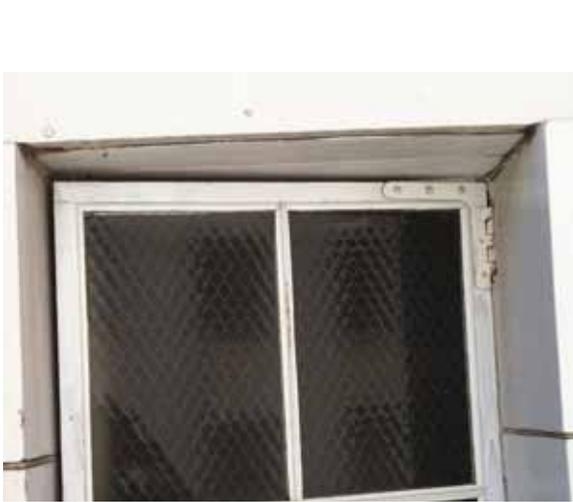
Fig. 2.1.A.13 General deterioration of the mortar noted at the glazed white terracotta tiles surrounding windows.

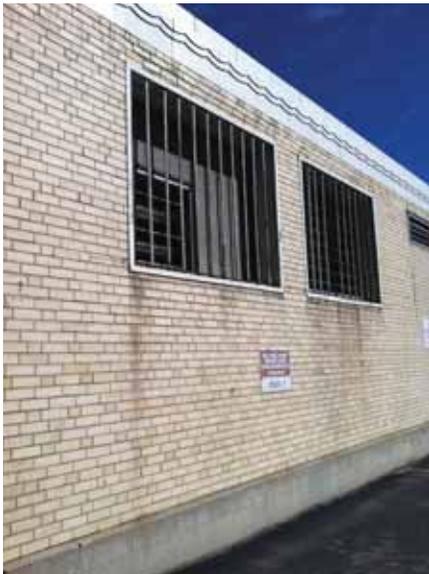
The brick along the south facade at the first story and along the north and south facades at the second story is in generally fair condition overall with soiling (see Fig. 2.1.A.14 and Fig. 2.1.A.15), damage (see Fig. 2.1.A.16 and Fig. 2.1.A.17), and deteriorating mortar observed (see Fig. 2.1.A.18). The concrete foundation along the south facade at the first story was observed to be cracking in several areas (see Fig. 2.1.A.19).

Fig. 2.1.A.14 Generally soiled areas of brick observed around the building.

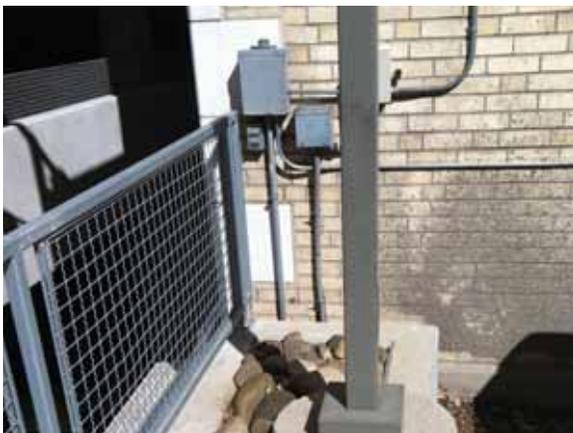
Fig. 2.1.A.15 Extensive soiling of the brick observed at the southwest corner of the building.

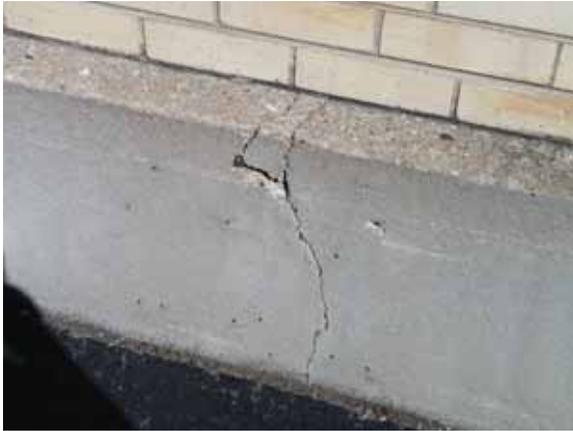
Fig. 2.1.A.19 Widespread cracking of the concrete foundation observed on the south side of the building.

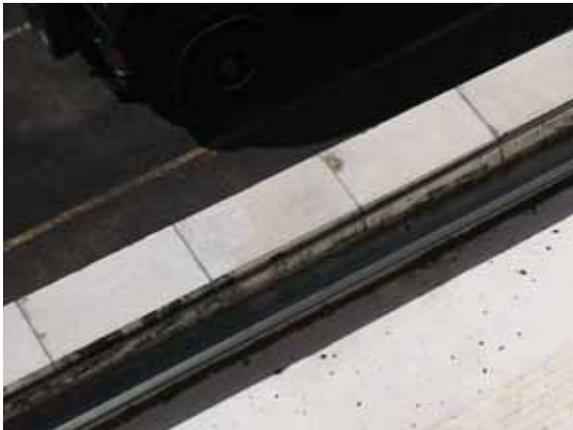
The marble coping blocks along the top of the first-story parapet are in fair condition overall with areas of spalling and deteriorating mortar noted (see Fig. 2.1.A.20 and Fig. 2.1.A.21). The coping blocks along the top of the second-story parapet are in fair to poor condition overall with spalling, deterioration of the glazed protective coating, and overall deterioration of the mortar noted (see Fig. 2.1.A.22).

Fig. 2.1.A.20 Spalling and damaged marble coping blocks observed around the perimeter of the first story parapet.

- All restoration work should be in keeping with the historic status of the Power Plant Building. See 3.0-A Historic Overview.
- Clean soiled/stained marble veneer panels and marble coping blocks around the exterior of the building using an approved method.

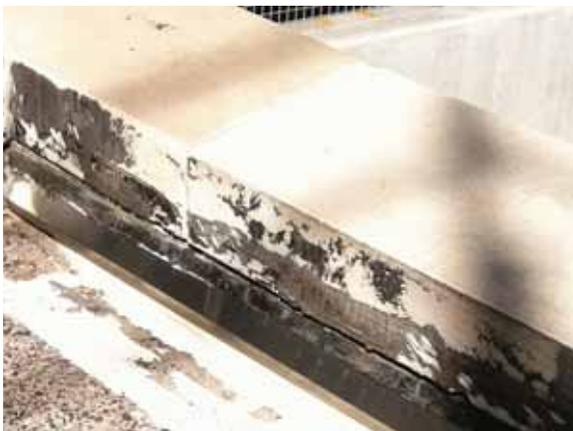
Fig. 2.1.A.21 Mortar observed to be deteriorating, and missing entirely in areas, along the base of the marble coping blocks.

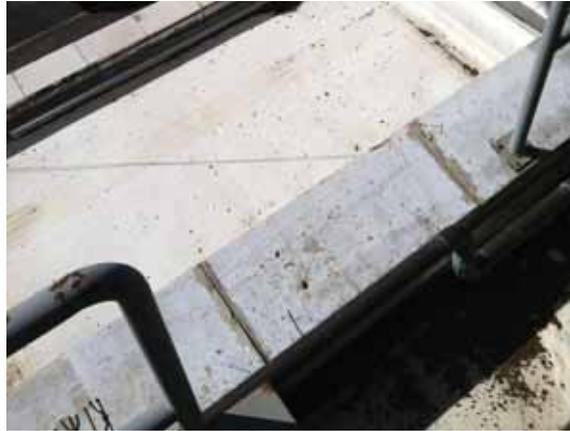
Fig. 2.1.A.22 Spalling, deterioration of the protective coating, and overall deterioration of the mortar noted at the coping blocks around the perimeter of the second story parapet.

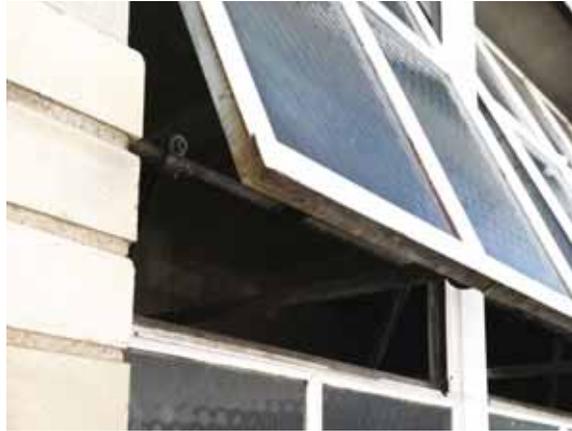
Fig. 2.1.A.23 Corroding metal window frame.

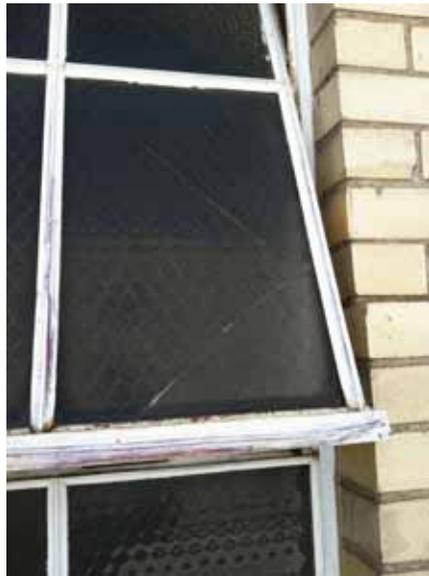
Fig. 2.1.A.24 Broken glass observed at a few windows around the exterior of the building.

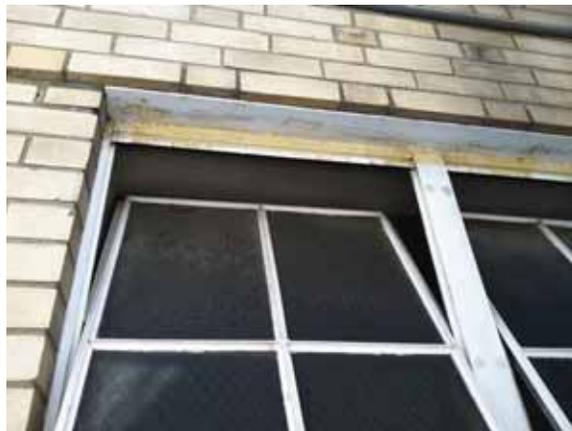
Fig. 2.1.A.25 Residue observed along the top of a few windows around the second story.

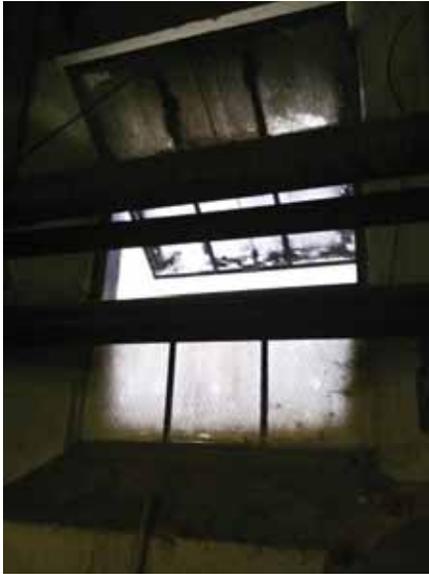
Fig. 2.1.A.26 Generally soiled windows noted on the Sub-basement Floor.

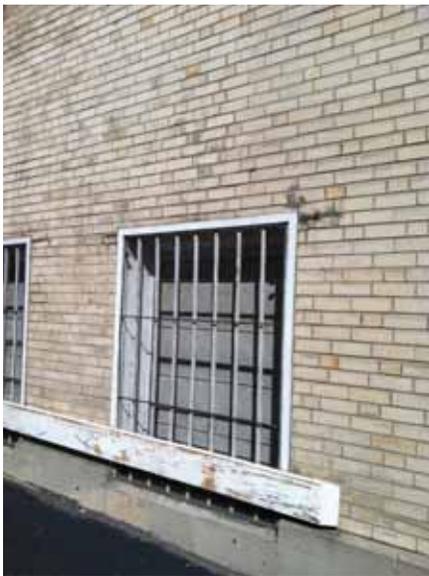
Fig. 2.1.A.27 Scuffed and corroding guardrail protecting the windows at the parking lot level on the south side of the building.

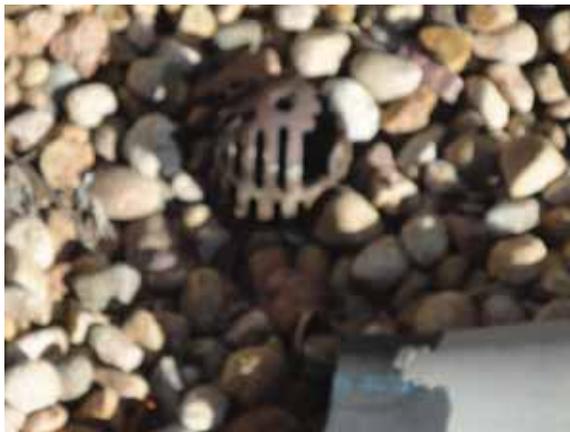
Fig. 2.1.A.31 Corroding drain cover observed at the ballasted grade-level roof between the Power Plant Building and the Capitol Annex Building.

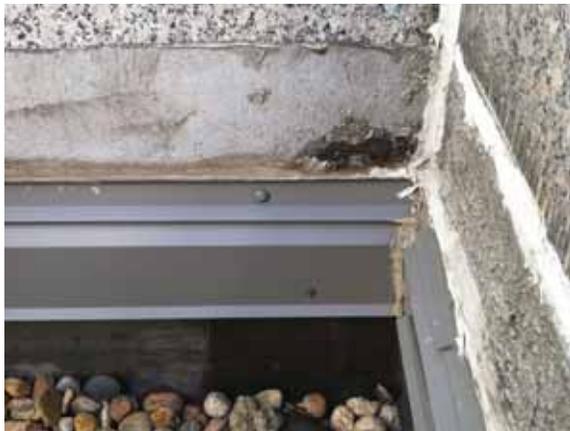
Fig. 2.1.A.32 Deteriorating sealant and a generally deteriorating membrane observed above the flashing along the granite parapet on the west side of the ballasted grade-level roof.

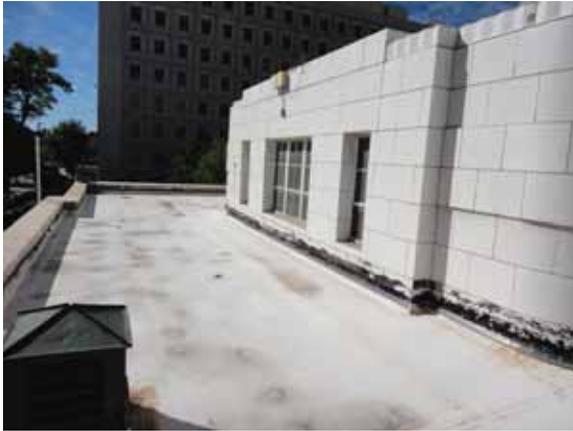
Fig. 2.1.A.33 Deterioration of the membrane observed at the first story roof.

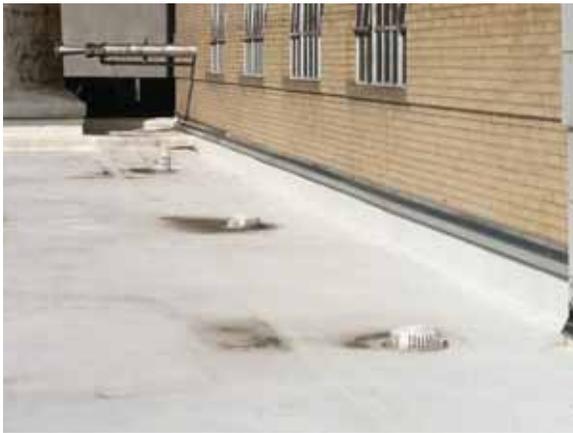
Fig. 2.1.A.34 Soil observed to be collecting around the roof drains at the first story roof.

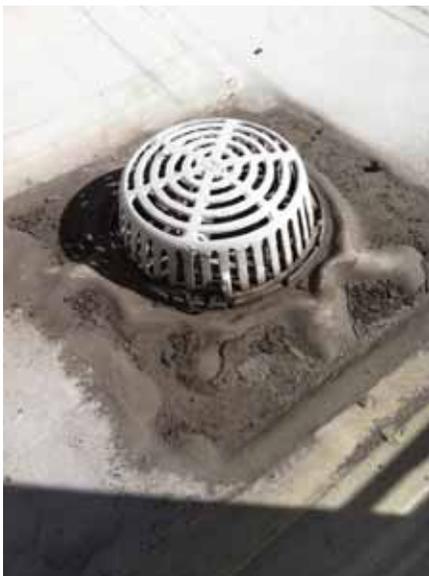
Fig. 2.1.A.35 Deterioration and bubbling of the roof membrane at areas where soil was observed to be collecting around the roof drains at the first story roof.

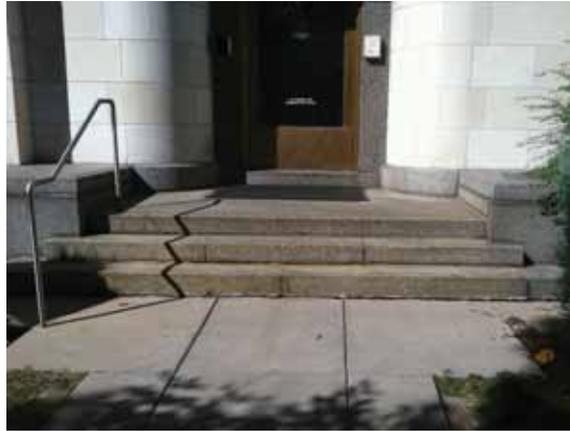
Fig. 2.1.A.43 Generally soiled granite cladding on the stairway at the Sherman Street Entrance.

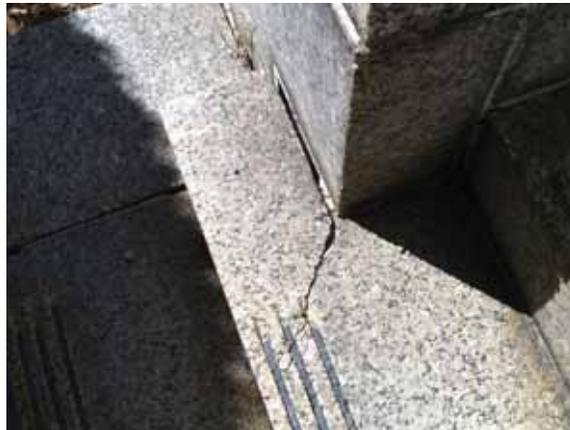
Fig. 2.1.A.44 Cracked granite and missing mortar at the Sherman Street Entrance stairway.

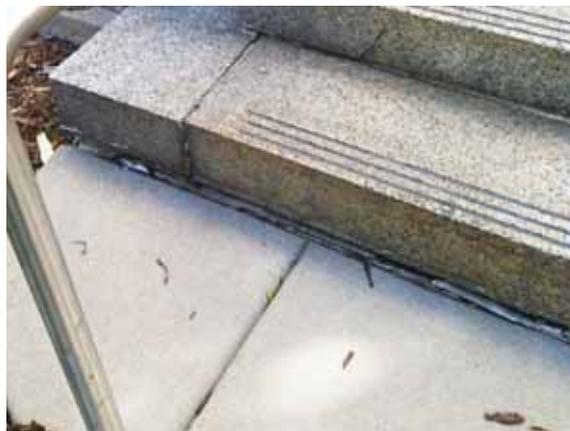
Fig. 2.1.A.45 Deteriorating and missing mortar at the base of the Sherman Street Entrance stairway.

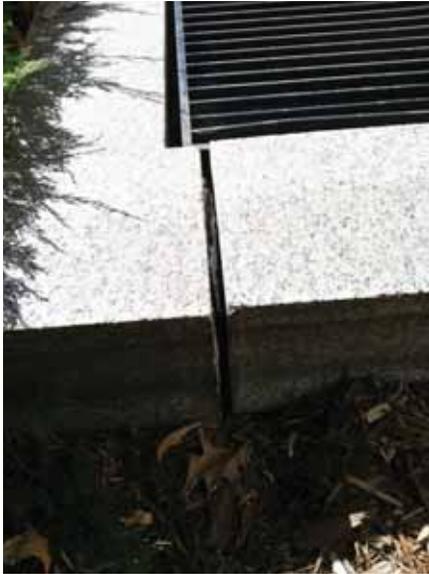
Fig. 2.1.A.46 A stone block moving out of position and missing mortar at the low granite wall surrounding the light well along the east side of the building.

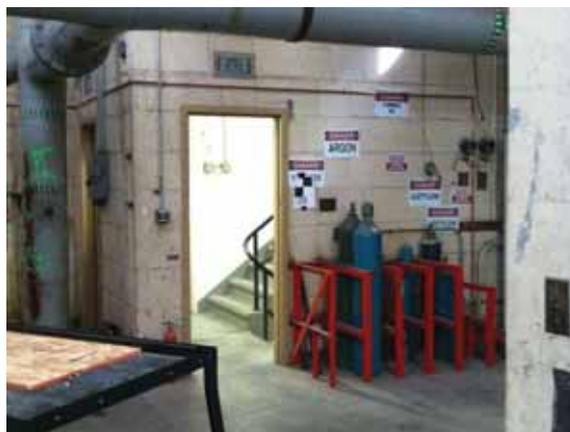
Fig. 2.1.B.1 Hazardous materials observed during the site survey visit.

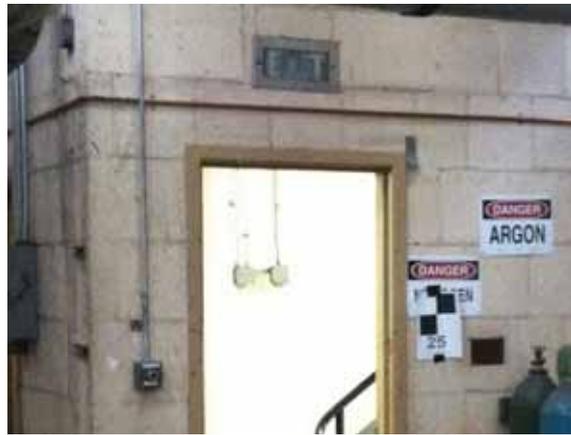
Fig. 2.1.B.2 Unilluminated exit sign observed to the door of the west stairway at the Basement Floor.

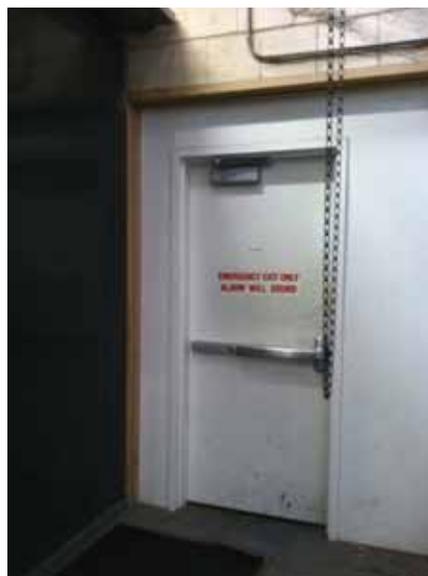
There was a chain observed to be hanging down into the clear floor space near an emergency exit door (see Fig. 2.1.B.3). This chain presents a potential life safety hazard to occupants passing by.

Fig. 2.1.B.3 A chain observed to be hanging down into the clear floor space near an emergency exit.

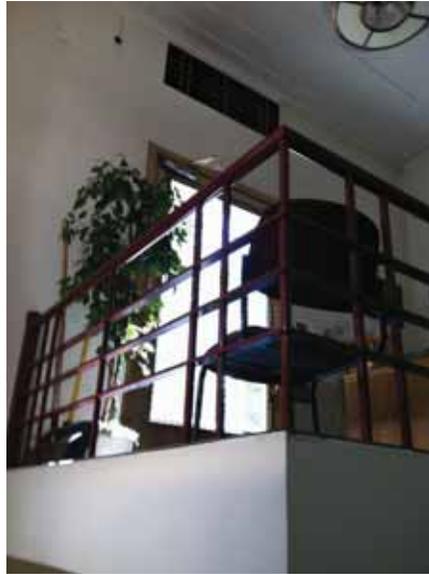
Fig. 2.1.B.7 The distance between the guardrail openings exceeds 4 inches in diameter along the edge of the east stairway in the entrance lobby on the First Floor.

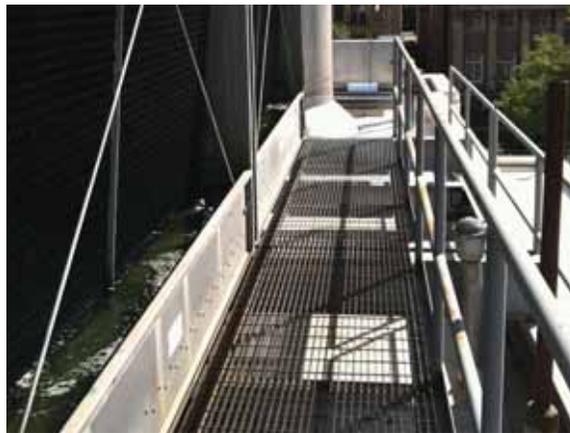
Fig. 2.1.B.8 The guardrails around the cooling tower walkways at the roof of the second story construction do not appear to be securely attached.

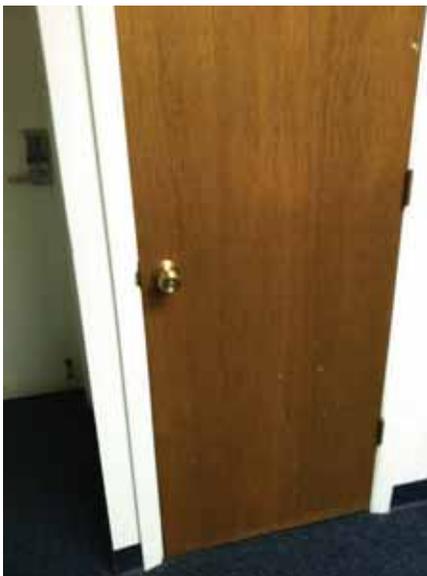
The majority of the interior doors throughout the building are equipped with knob-style door handles (see Fig. 2.1.B.9) According to Section 309.4 of the 2003 edition of ICC/ANSI A117.1, the knob-style handles do not meet the requirement that: operating mechanisms shall be operable with one hand and shall not require tight grasping, pinching, or twisting of the wrist. Section 309.4 further states that the force required to activate operable parts shall be 5.0 pounds (22.2 N) maximum. However, these knob-style handles may be exempt due to the building's historic status. Possible non-historic areas of the building, such as the office areas, industrial areas, and exit stairways, should be reviewed and considered for new lever-style door handles.

Fig. 2.1.B.9 Typical knob-style door handle found throughout the building.

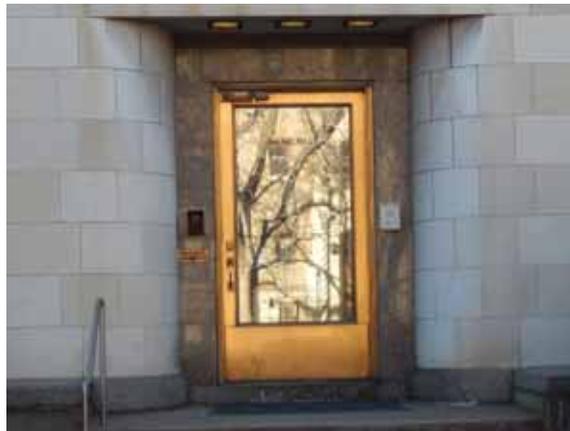
Fig. 2.1.B.10 The Sherman Street Entrance is equipped with a key code entry pad and an intercom system.

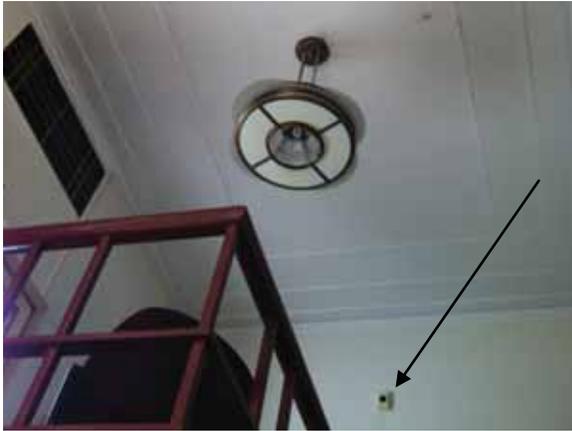
Fig. 2.1.B.11 A security device observed on the wall in the entrance lobby on the First Floor.

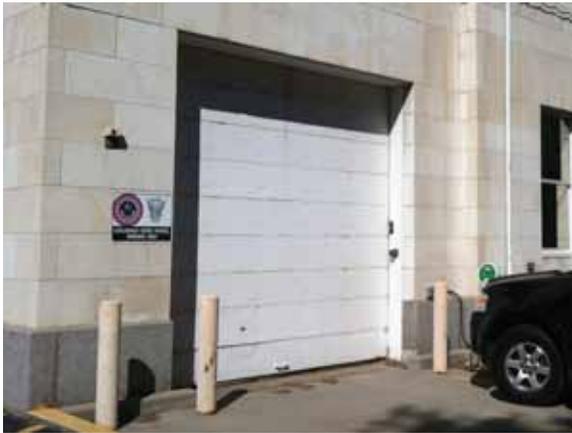
Fig. 2.1.B.12 The overhead rolling door on the south end of the east (front) side of the building is equipped with a variety of devices.

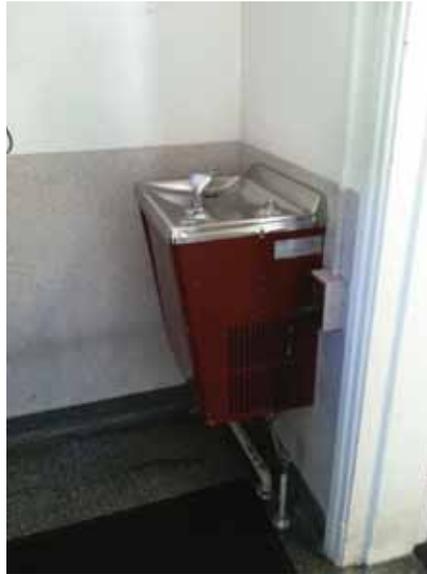
Fig. 2.1.C.1 A non-accessible drinking fountain observed in the entrance lobby on the First Floor.

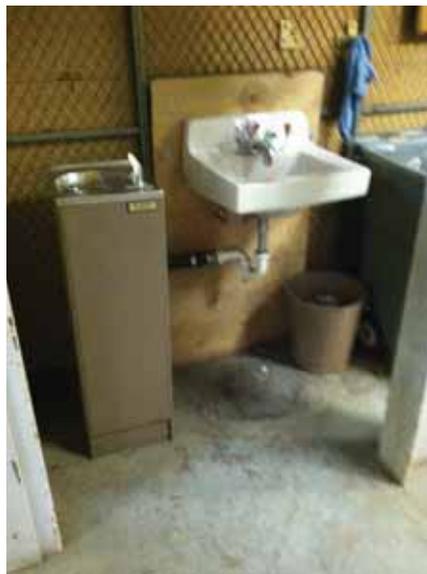
Fig. 2.1.C.2 A non-accessible drinking fountain observed on the Sub-basement Floor.

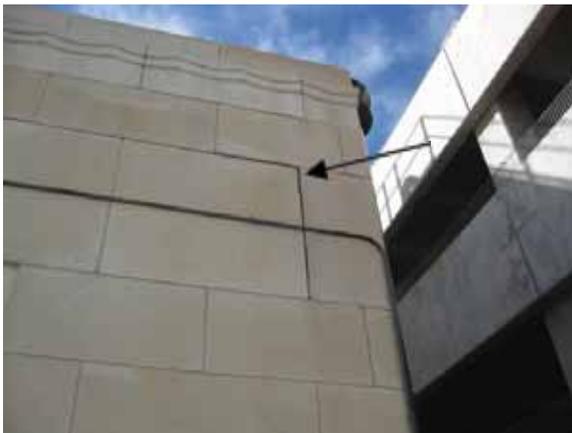
Fig. 2.2.A.1

The building's exterior is showing signs of distress. Some of the veneer tiles are inadequately secured to the building's framing and are loose (Fig. 2.2.A.1). Additional damage may be present behind the panels due to water intrusion and is not readily observable. The condition of the panels also represents a life safety hazard to pedestrians and should be corrected in the near future.

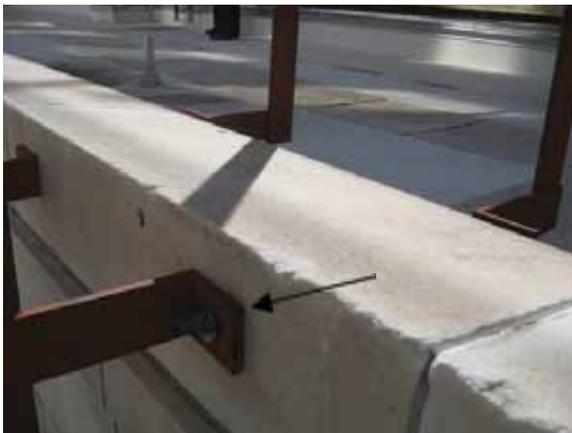
Fig. 2.2.A.2

The connection of the ladder to the stone caps on the north side is not secure (Fig. 2.2.A.2). The stone cap has cracked at the connection, greatly reducing the capacity of the anchor.

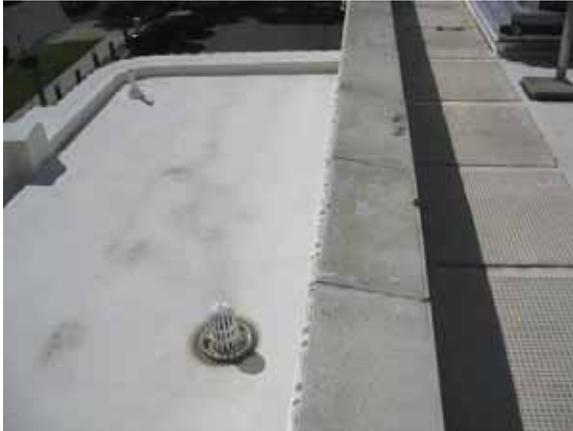
Fig. 2.2.C.1

inches tall or fall protection provided for access near the exposed edges to meet current safety codes.

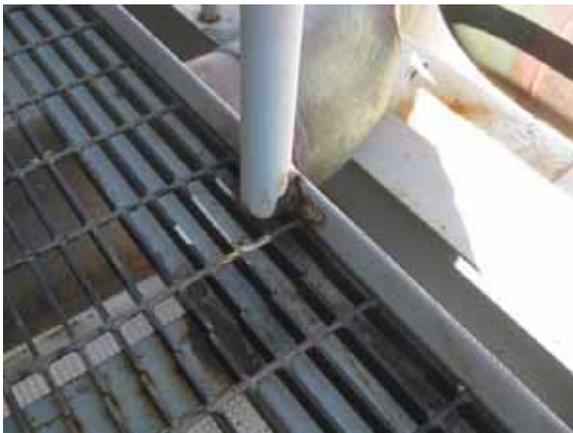
Fig. 2.2.C.2

The guardrails around the cooling towers are inadequately attached to the steel framing (Fig. 2.2.C.2). The posts are attached to a thin edge angle with very little weld. Excessive movement of the guardrails was observed with a minimal amount of lateral force.

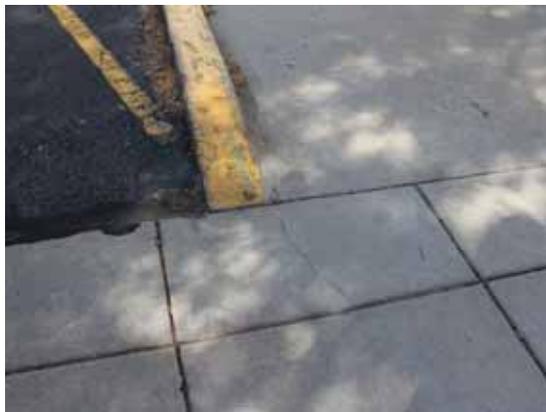
The site paving is generally in good condition. A few locations of broken concrete and concrete cracking was observed. Repair or replace broken or cracked concrete.

Figure 2.3.A.6 Site Concrete Crack

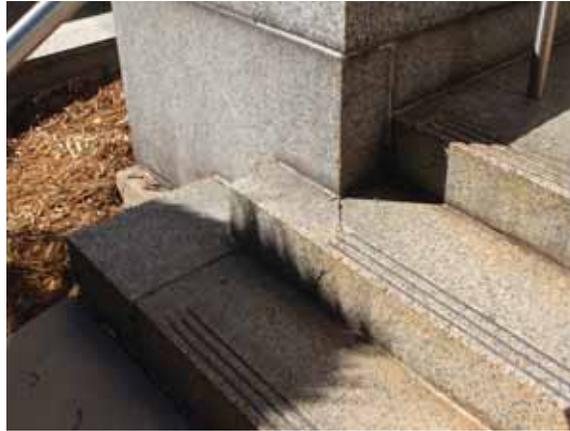
Figure 2.3.A.8 Crack in Entrance Step, Recommended for Repair or Replacement

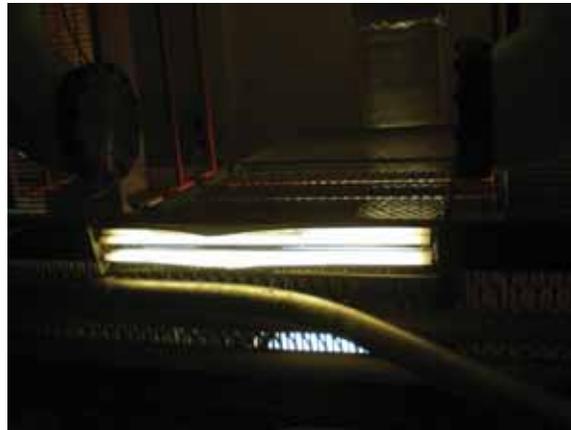
Fig. 2.4.A.5 – Damaged fluorescent light fixture

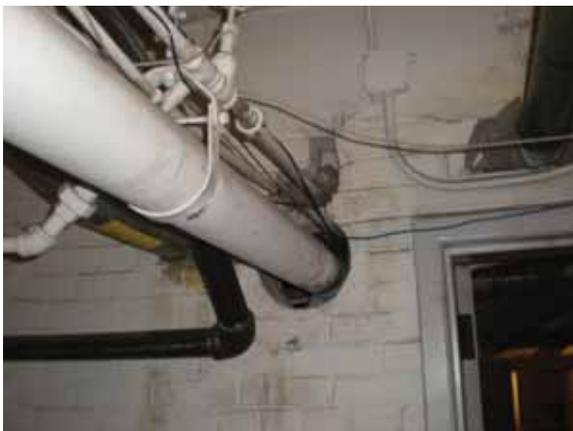
Fig. 2.4.A.9 – Openings around the pipes not sealed

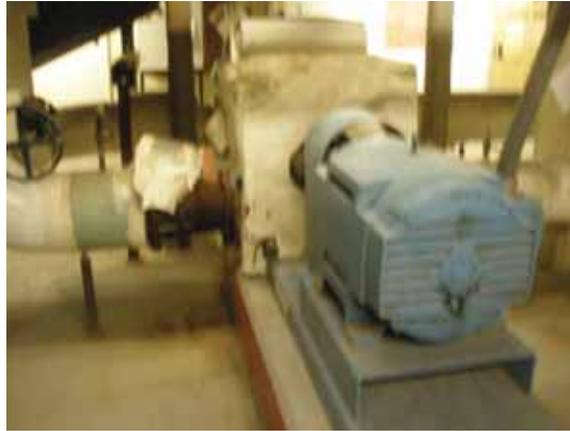
The piping insulation is damaged/missing at certain places. Provide missing insulation or repair the damaged insulation in the building. This will reduce the losses and save heating and cooling energy costs.

Fig. 2.4.A.10 – Damaged insulation at pump fittings

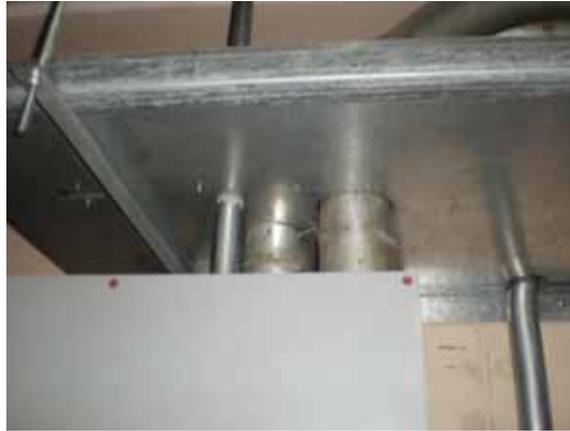
Fig. 2.4.B.2 – Openings in drain pan

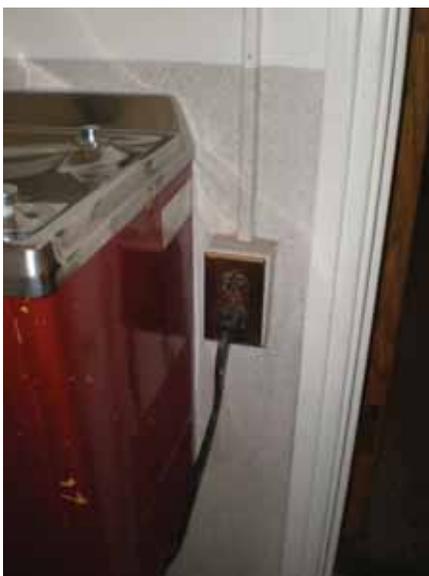
Fig. 2.4.B.7 – No GFI protection

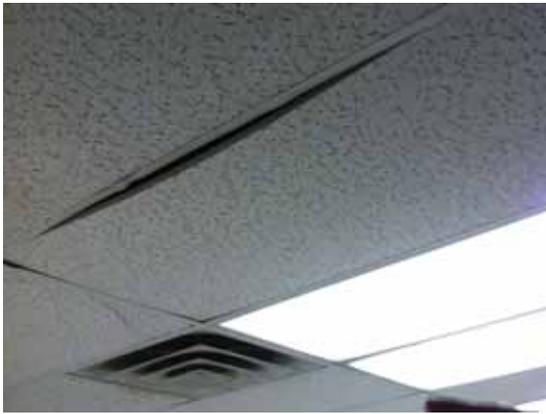
Fig. 3.1.C.2 Generally sagging, soiled, and deteriorating 2x4 acoustic ceiling tiles observed in the office areas included in the site survey visit.

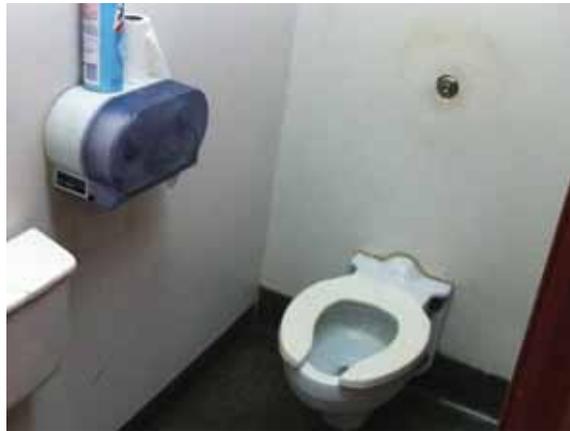
Fig. 3.1.C.9 General wear-and-tear and soiling noted at the plaster and gypsum board walls throughout.

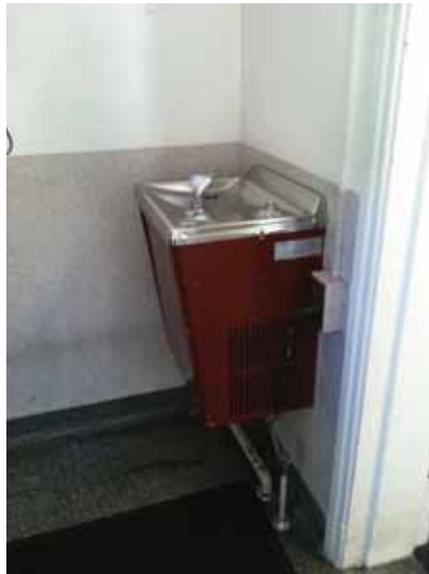
Fig. 3.1.C.10 General wear-and-tear and soiling noted at the wainscoting in the entrance lobby on the First Floor.

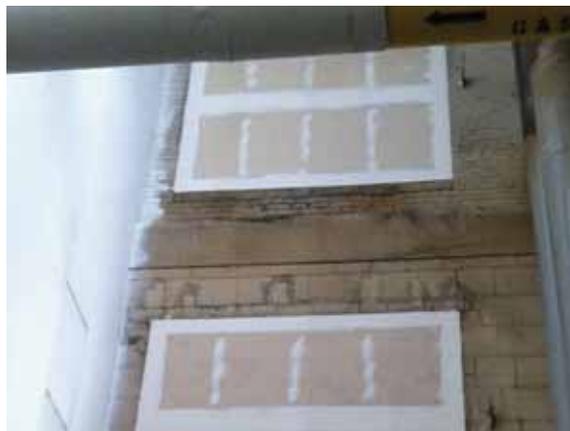
Fig. 3.1.C.11 Deterioration of the brick walls throughout the industrial areas observed during the site survey visit.

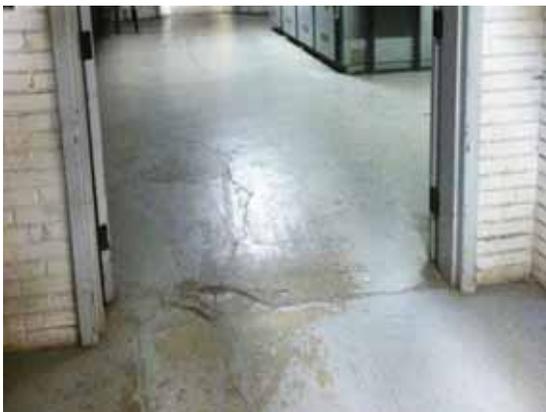
Fig. 3.1.C.18 Cracked and spalling concrete flooring with worn paint observed during the site survey visit.

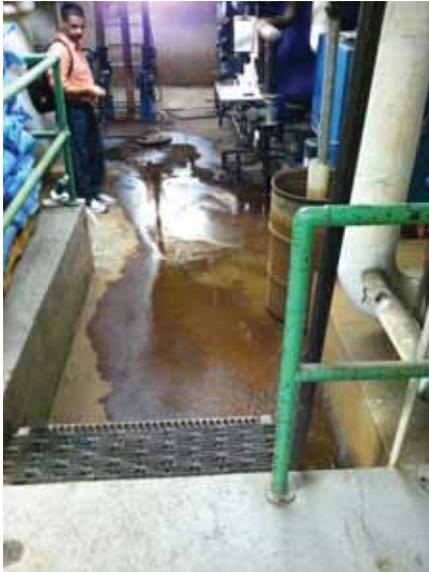
Fig. 3.1.C.22 Standing water observed at an area of concrete flooring on the Sub-basement Floor.

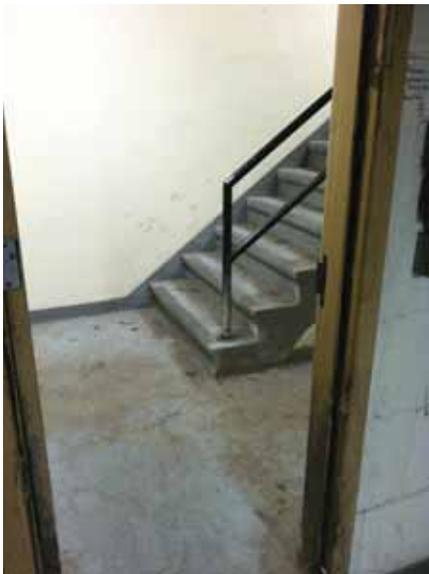
Fig. 3.1.C.23 West stairway observed to be soiled, with dirt and debris covering the concrete floor and stairs, especially at the Sub-basement Floor.

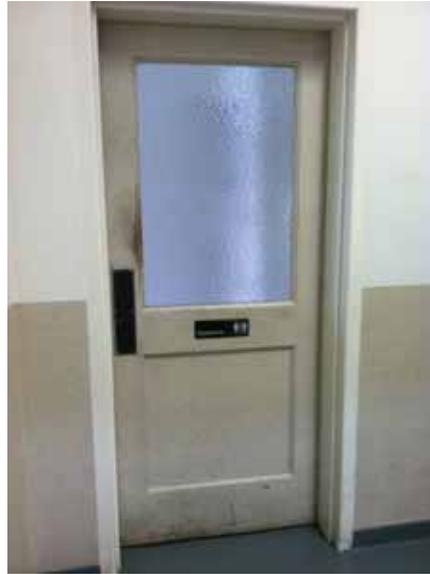
Fig. 3.1.C.24 General wear-and-tear noted at the doors.
