**RE: Expedited Settlement Agreement  
Apex Meridian / CDPS Permit Certification # COR-03K205**

## EXPEDITED SETTLEMENT AGREEMENT

Re: Facility Inspection / Compliance Advisory  
The Weitz Company LLC — Apex Meridian Project  
CDPS Permit No. COR03K205

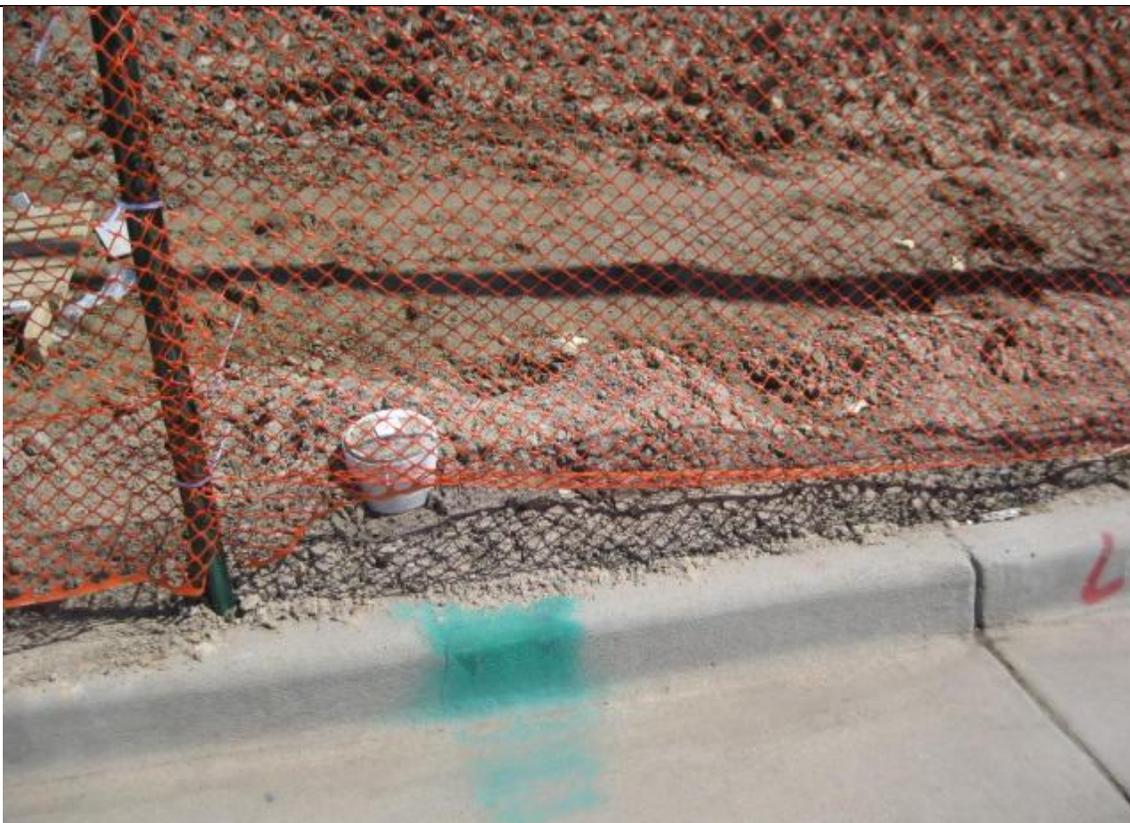
1. It was noted during the inspection that control measures were not implemented to manage pollutant contributions to stormwater runoff from sediment from disturbed areas located on Lot 5 along the south perimeter of the project adjacent to the South Valley Highway (refer to photographs 1, 2).

- Control Measure Observation: Control measures were not implemented to control pollutant contributions to stormwater runoff from the location and pollutant source noted above.
- Control Measure Finding: An installation and implementation specification for perimeter sediment control was provided in Table 10 of the SWMP, but was not implemented.

**Photograph 1:** No control measure between disturbance and flow line along South Valley Highway

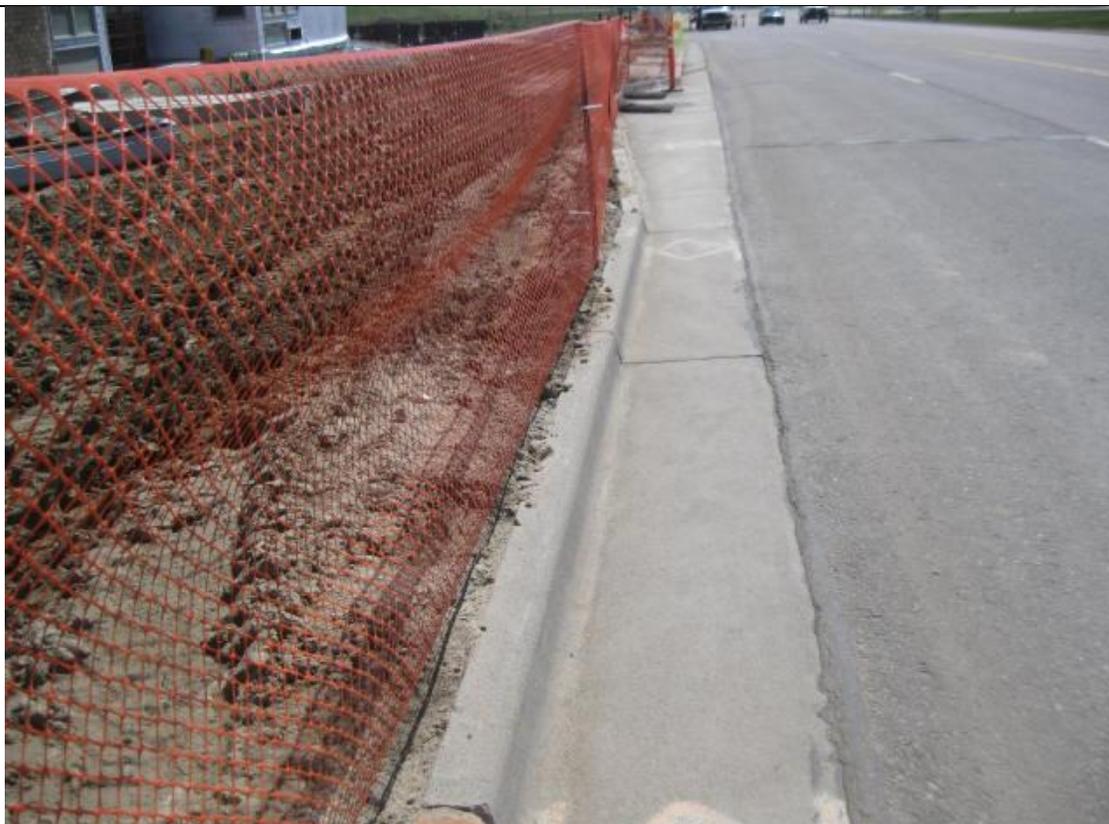
**Photograph 2:** See photograph 1

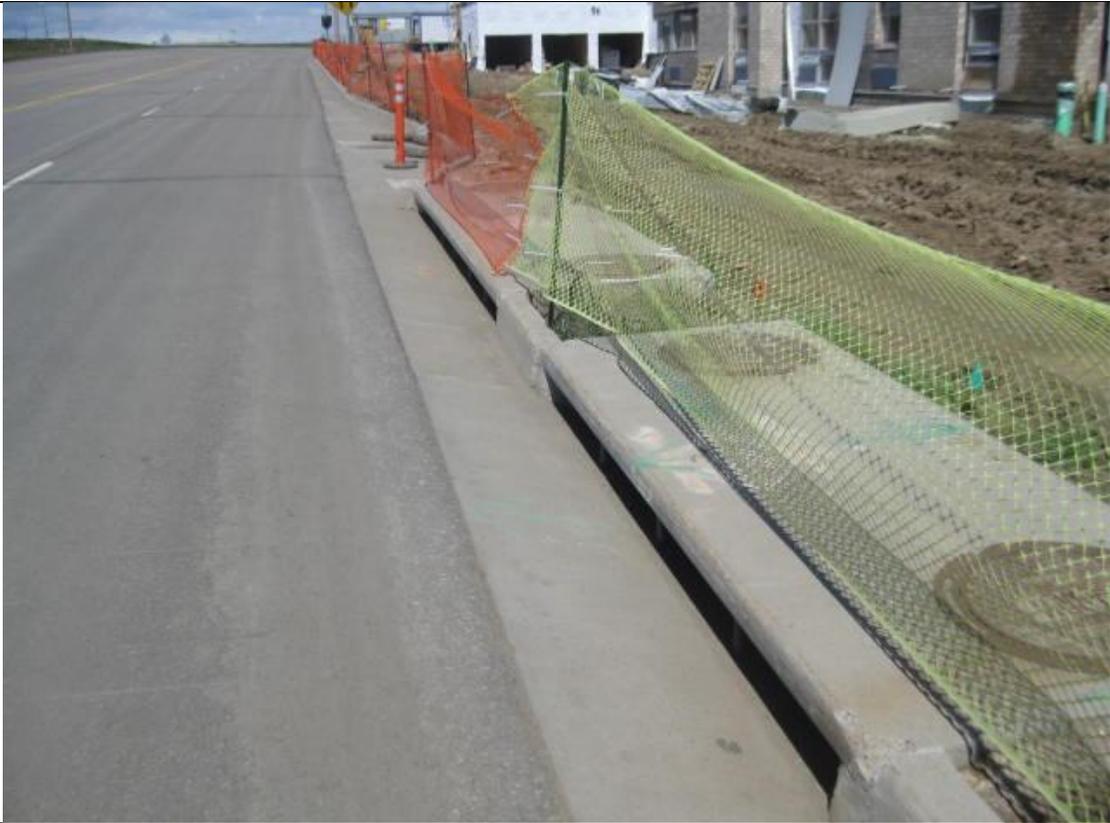
2. It was noted during the inspection that inadequate control measures were implemented to manage pollutant contributions to stormwater runoff from sediment from disturbed areas located in lots 5 & 6 (refer to photographs 3, 4 & 15).

- Control Measure Observation: Type B inlet protection control measures were implemented to manage pollutant contributions to stormwater runoff from the location and pollutant source noted above; however, as a stand-alone the control measure was inadequate.
- Control Measure Finding: An installation and implementation specification was provided in the SWMP but the control measure was not in accordance with good engineering, hydrologic and pollution control practice as required by the permit.

Specifically, inlet protection relied on the use of curb socks as a sole control measure between the disturbed area and the inlet and sediment was observed at the intake of the inlet. Given expected runoff volumes, inlet protection alone does not provide the mechanisms (filtering and/or settling) for pollutant removal from disturbed areas without additional sediment control measures. Therefore, all runoff from disturbed areas must be directed through at least one up-gradient sediment control measure designed and implemented for treatment of runoff from disturbed areas prior to the inlet protection.

**Photograph 3:** Inadequate inlet protection on South Valley Highway

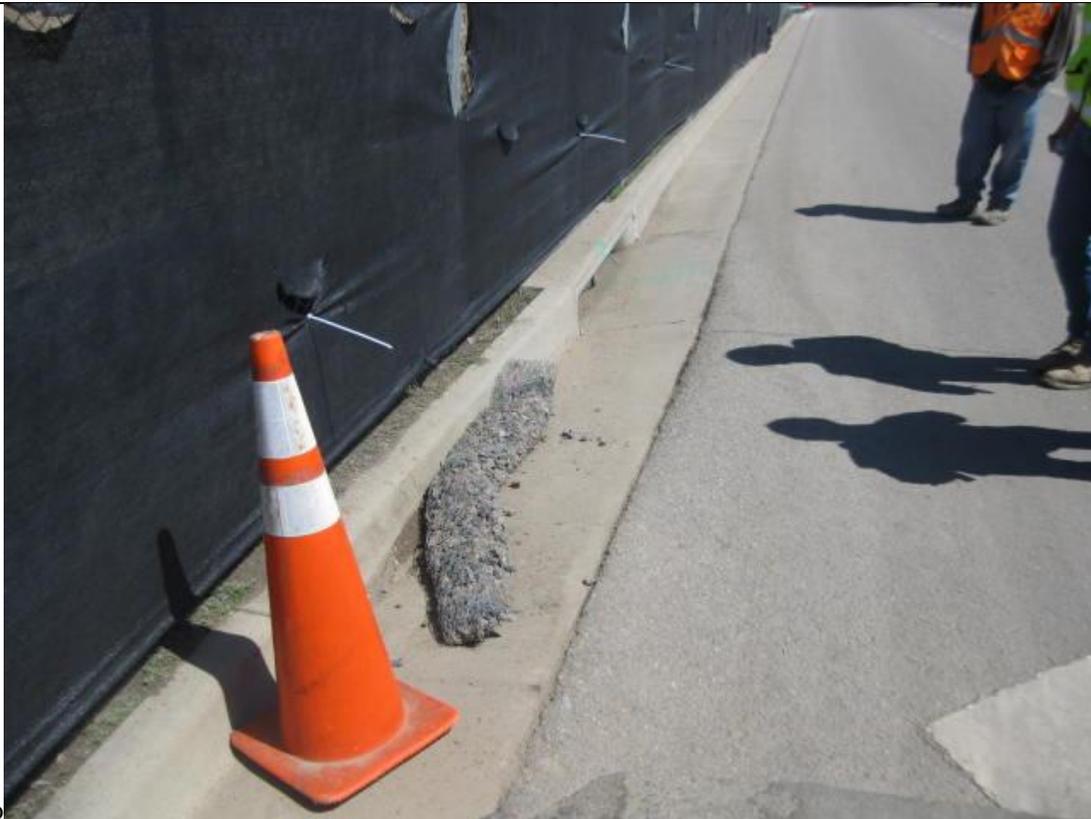
**Photograph 4:** Inadequate inlet protection on west side of Inverness Parkway

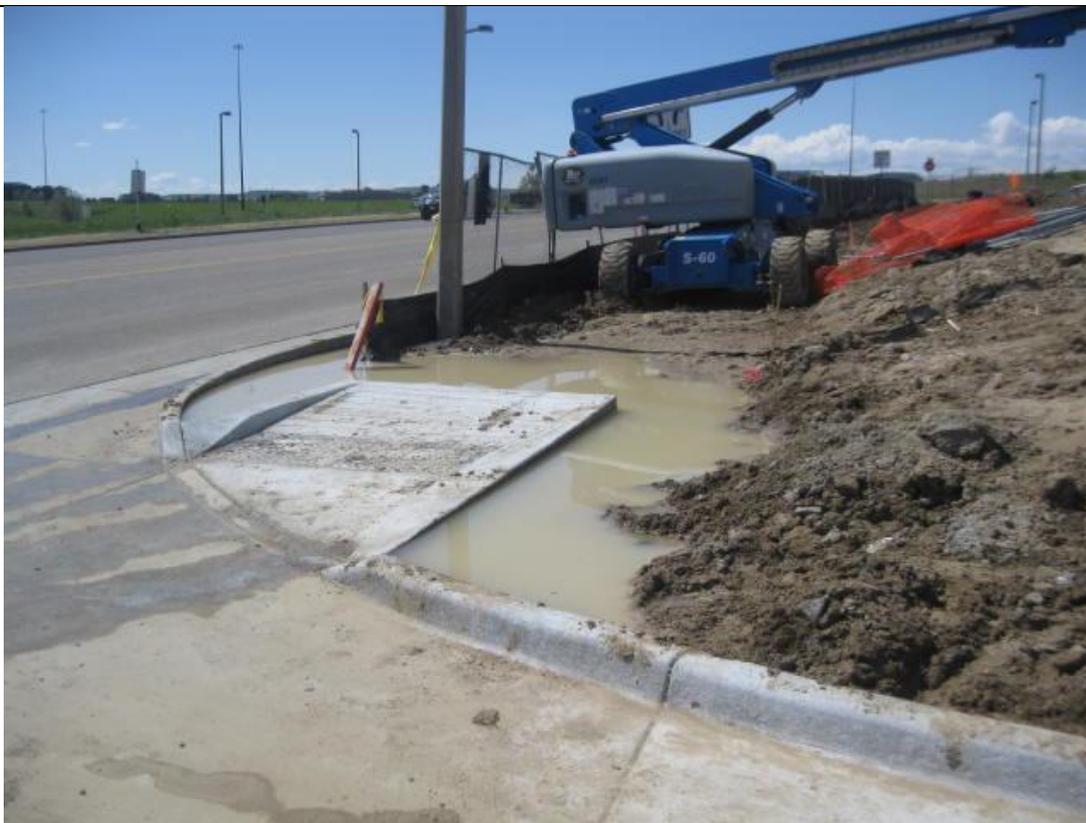
3. It was noted during the inspection that inadequate control measures were implemented to manage pollutant contributions in stormwater runoff from Sediment from disturbed areas located the southeast corner of the east entrance off of Inverness Parkway (refer to photograph 5).

- Control Measure Observation: The Site Map identified silt fence as a perimeter control measure for the location and pollutant source noted above; however the control measure had not been implemented.
- Control Measure Finding: An installation and implementation specification for silt fence was provided in the SWMP, but was not implemented.

Specifically, a grade differential control measure (not indicated on the site map) had been implemented in place of the silt fence (that was indicated on the site map) at the low point of the block however the contributing area exceeded the capacity of the grade differential and a discharge was observed to the roadway.

**Photograph 5:** Inadequate control measures East entrance off Inverness Parkway

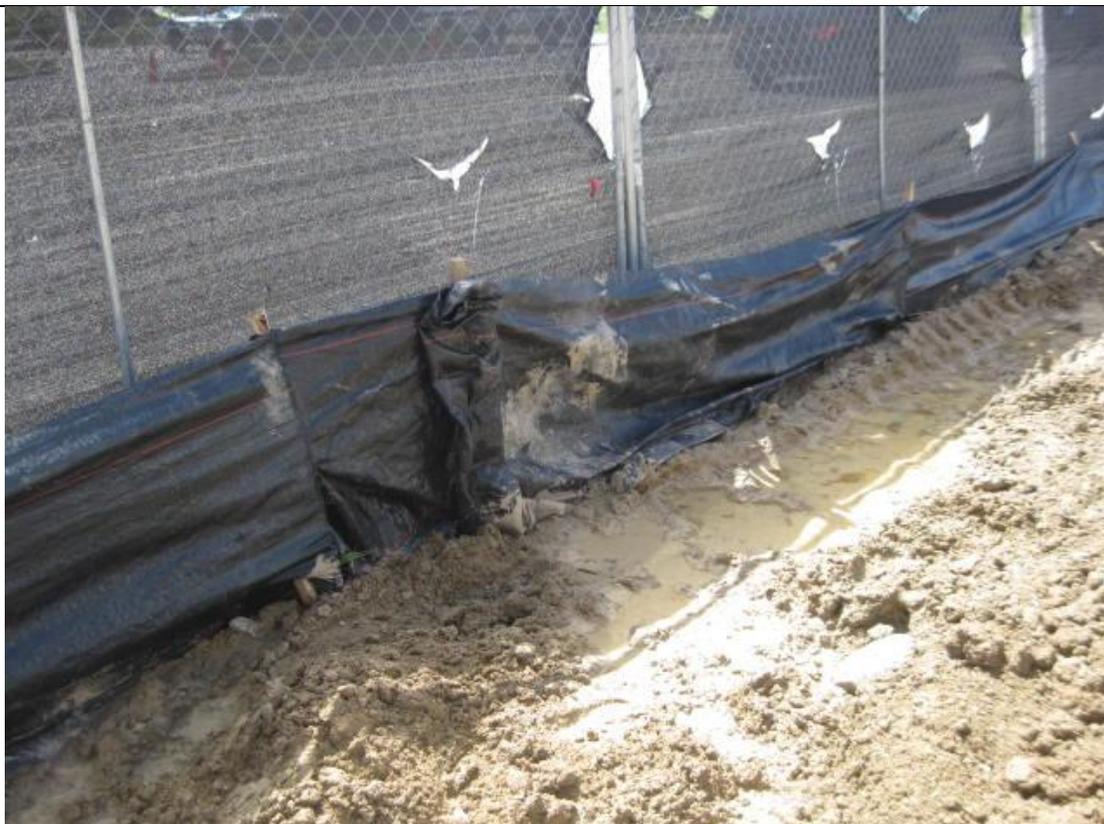
- Control Measure Observation: A silt fence control measure was implemented to manage pollutant contributions to stormwater runoff from the location and pollutant source noted above; however the control measure was inadequate.

**Photograph 6:** Silt fence requires maintenance east side of Lot 5

- Maintain all erosion and sediment control practices and other protective practices in good and effective operating condition.
5. It was noted during the inspection that control measures were not implemented to manage pollutant contributions to stormwater runoff from sediment from disturbed areas located Lot 5 at the end of the newly paved areas (refer to photographs 8, 11 & 12).

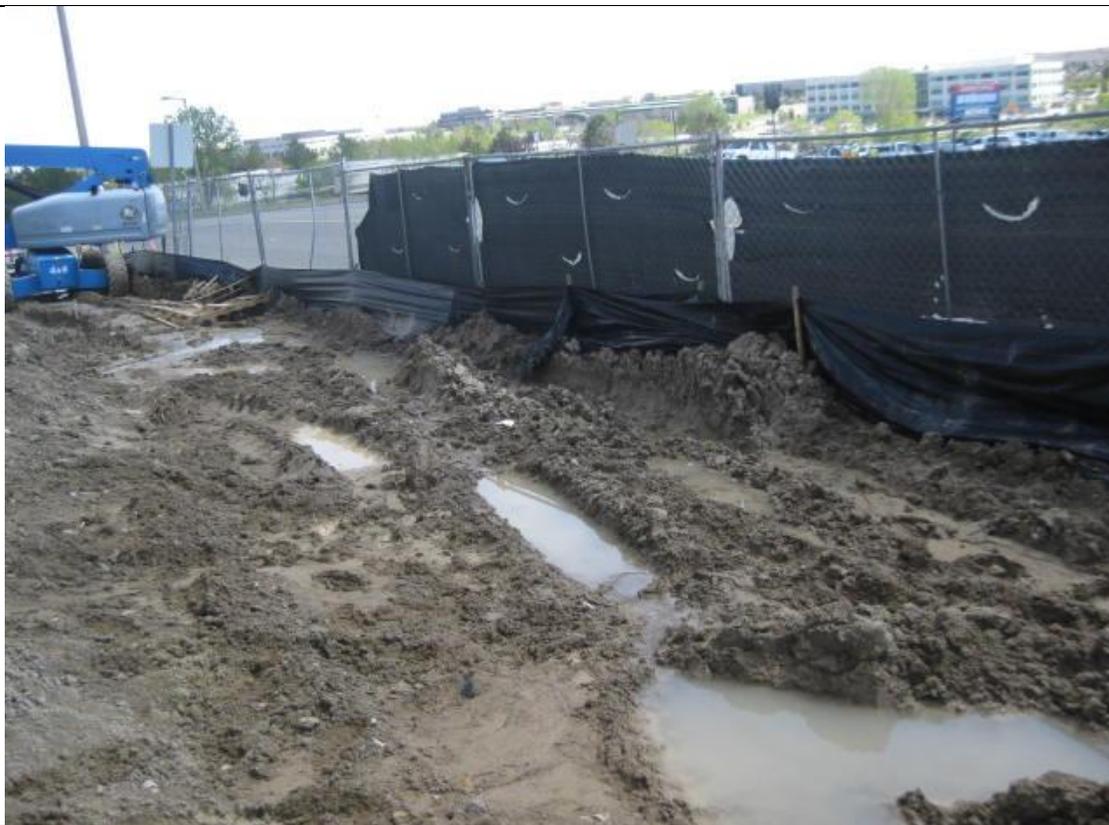
**Photograph 7:** See photograph 6

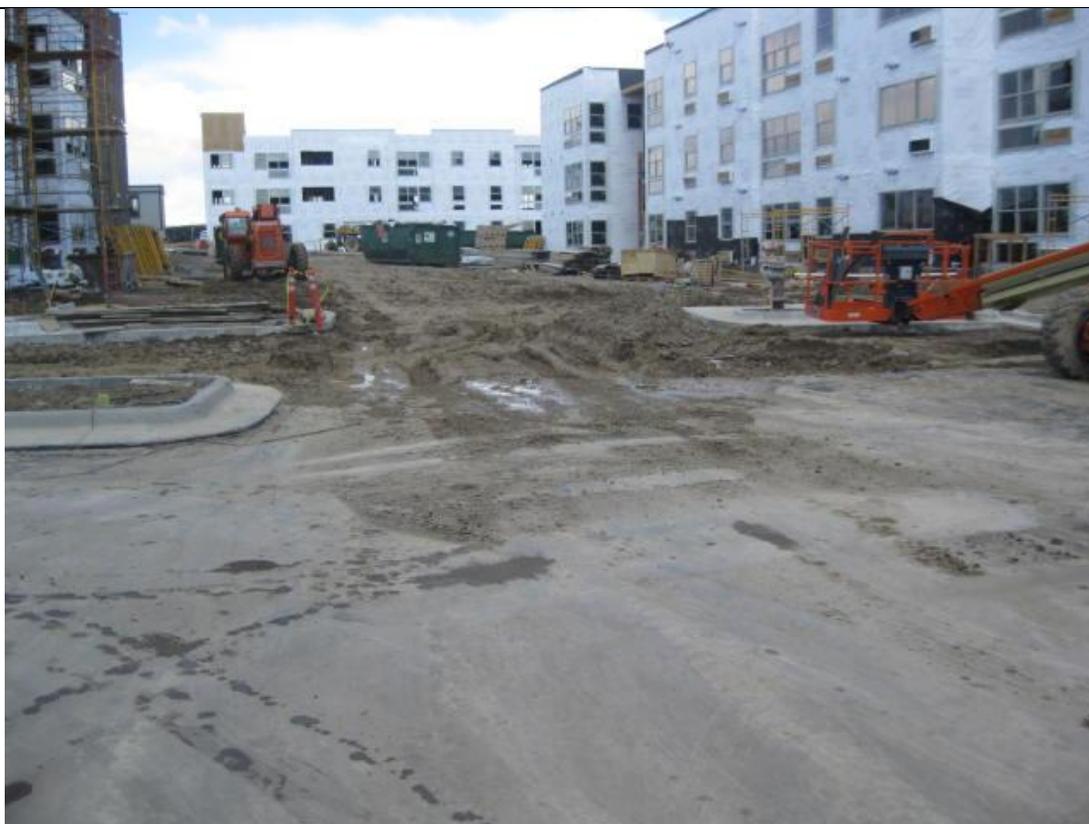
- Control Measure Observation: The SWMP identified a vehicle tracking control measure for the conditions and pollutant source noted above; however the control measure had not been implemented.

**Photograph 8:** Vehicle tracking control missing at access point from new paved area between Bldg. 4 & 5

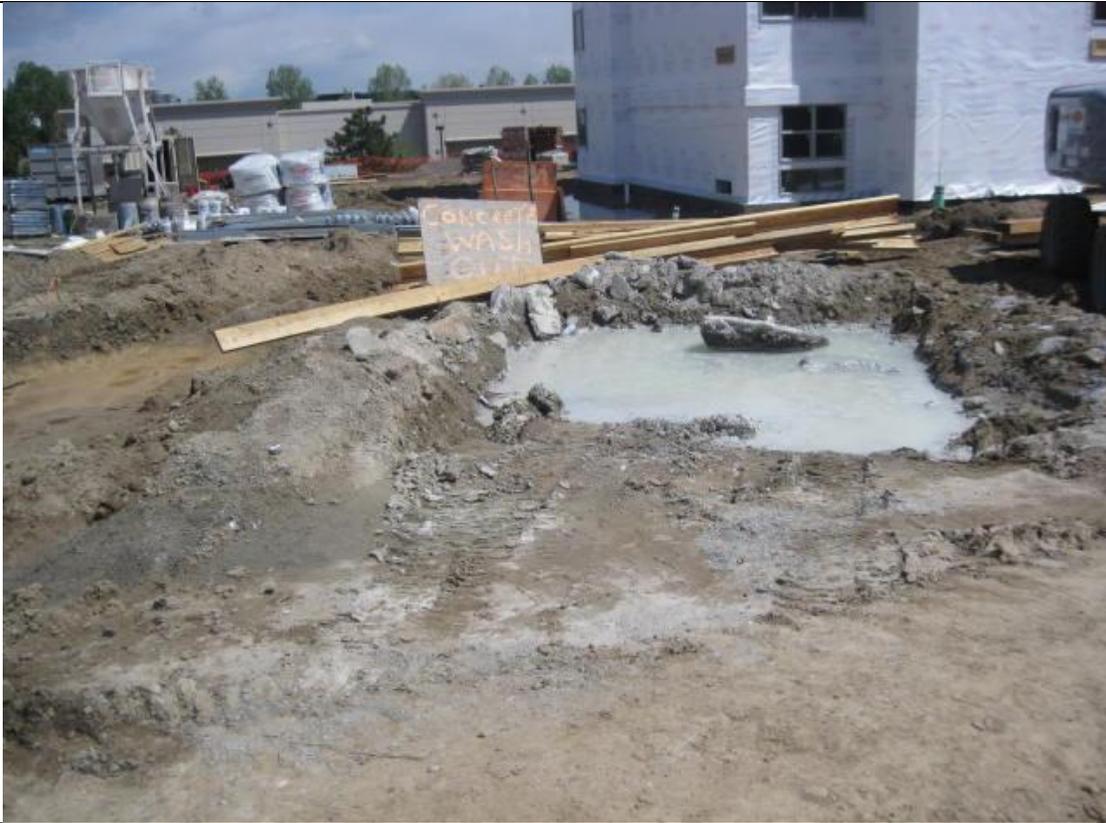
6. It was noted during the inspection that inadequate control measures were implemented to manage pollutant contributions to stormwater runoff from the concrete washout located Lot 5 (refer to photographs 9 & 10).

- **Control Measure Observation:** A concrete washout control measure was implemented to manage pollutant contributions to stormwater runoff from the location and pollutant source noted above; however the control measure was inadequate.
- **Control Measure Finding:** An installation and implementation specification for the concrete washout was provided in the SWMP, but was not consistently implemented.

- The berm surrounding the washout was not the correct dimensions
- The berm had not been compacted.
- Concrete washout was observed outside the washout control measure.

- Concrete waste and washout had exceeded the capacity of the washout.
- **Stormwater runoff from this area is discharged as follows:** Collected by curb and gutter to MS4, discharged to a regional detention pond which discharges to Cottonwood Creek. Additional inadequate control measures for concrete washout were not implemented down gradient of this location (see Note 5).

**Photograph 9:** Concrete washout on Lot 5 not installed per spec and required maintenance.

- Maintain all erosion and sediment control practices and other protective practices in good and effective operating condition.
  - The discharge of concrete washout waste must not leave the site as surface runoff or to surface waters.

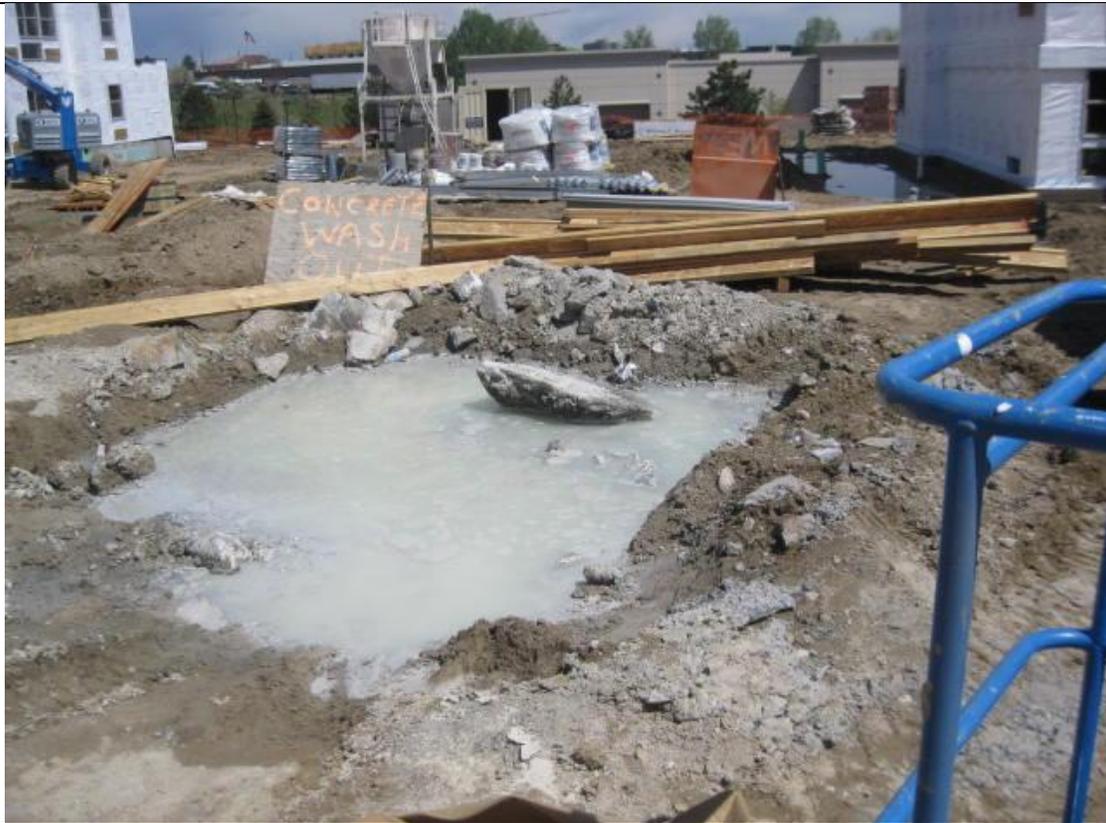
**Photograph 10:** See photograph 10

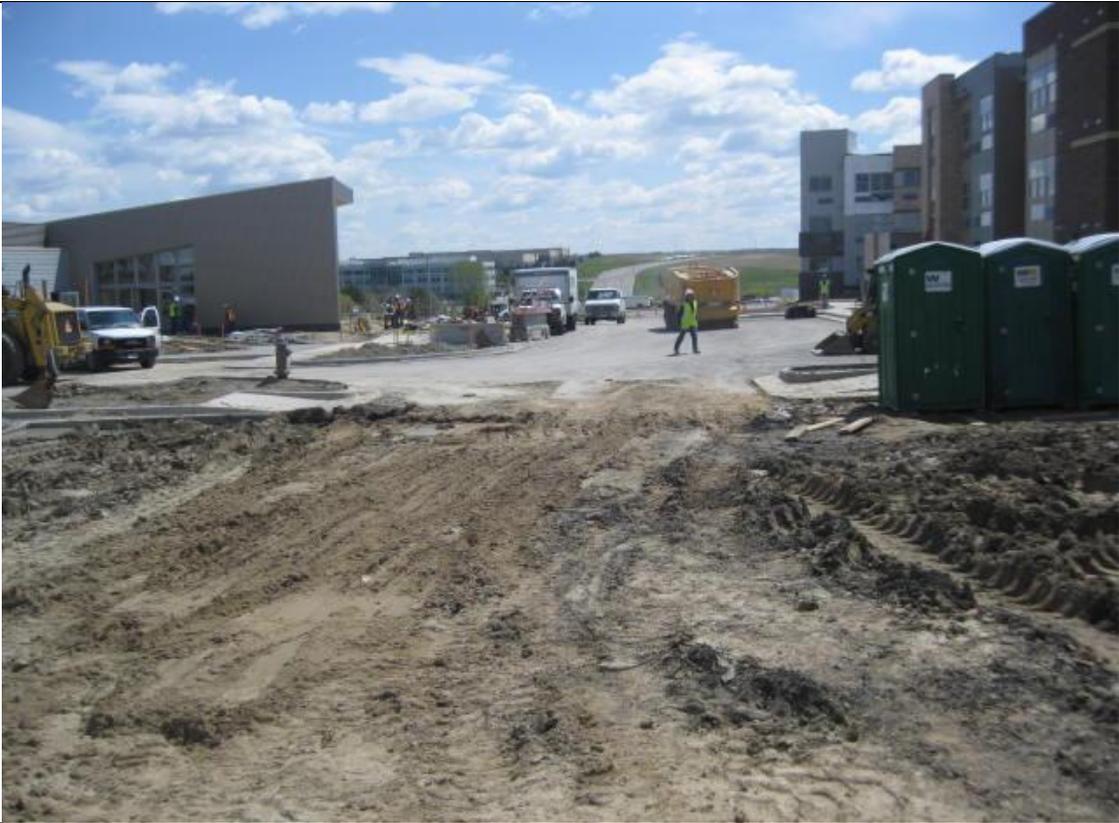
**Photograph 11:** Vehicle tracking control missing at access point from new paved area between Bldg. 5 & 6

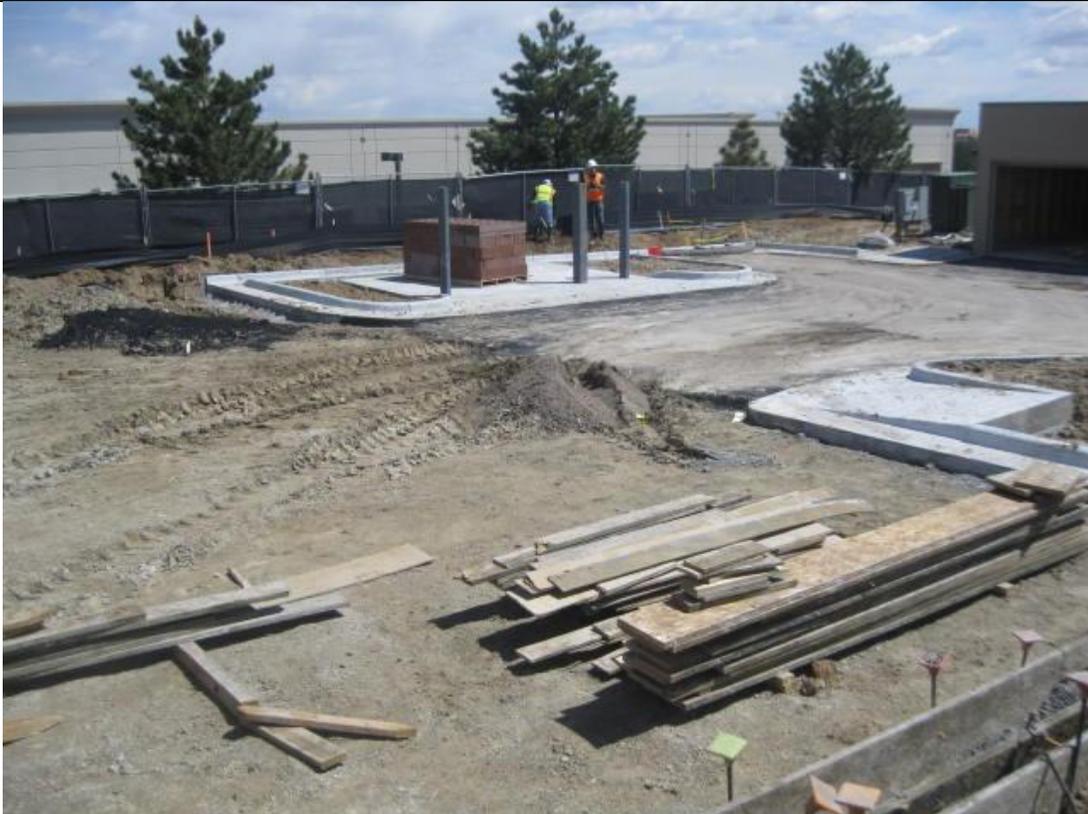
**Photograph 12:** Vehicle tracking control missing at access point from new paved area north of Bldg. 6

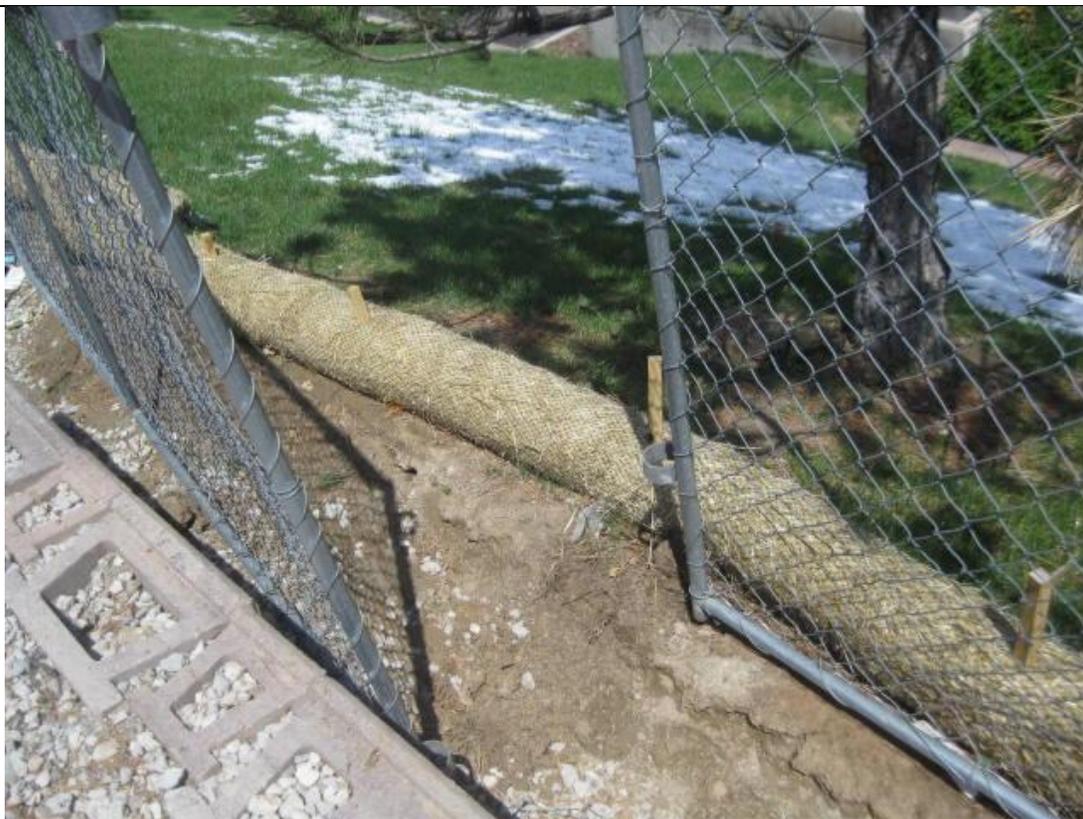
7. It was noted during the inspection that inadequate control measures were implemented to manage pollutant contributions to stormwater runoff from sediment from disturbed areas located at the north border of Lot 5 (refer to photographs 13 & 14).

- Control Measure Observation: A sediment control log control measure was implemented to manage pollutant contributions to stormwater runoff from the location and pollutant source noted above; however the control measure was inadequate.
- Control Measure Finding: An installation and implementation specification for sediment control log was provided in the SWMP, but was not consistently implemented.

**Photograph 13:** Sediment control log installation not per spec.

- Implement control measures consistent with the installation and implementation specifications provided in the SWMP.
  - Update the SWMP when new control measures are installed or control measures are replaced.

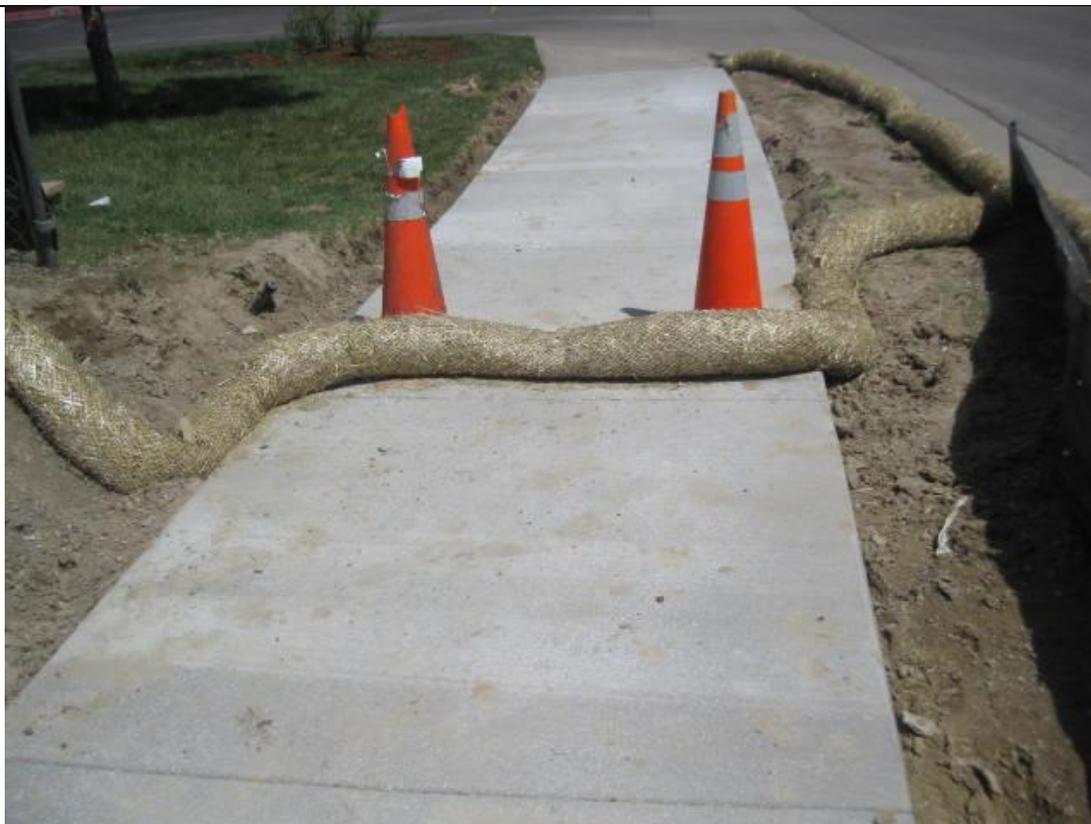
8. It was noted during the inspection that inadequate control measures were implemented to manage pollutant contributions to stormwater runoff from sediment from disturbed areas located by the sidewalk at the northeast corner (refer to photograph 14).

- Control Measure Observation: A sediment control log control measure was implemented to manage pollutant contributions to stormwater runoff from the location and pollutant source noted above; however the control measure was inadequate.
- Control Measure Finding: An installation and implementation specification for sediment control log was provided in the SWMP, but was not implemented.

**Photograph 14:** Inappropriate application of sediment control log.

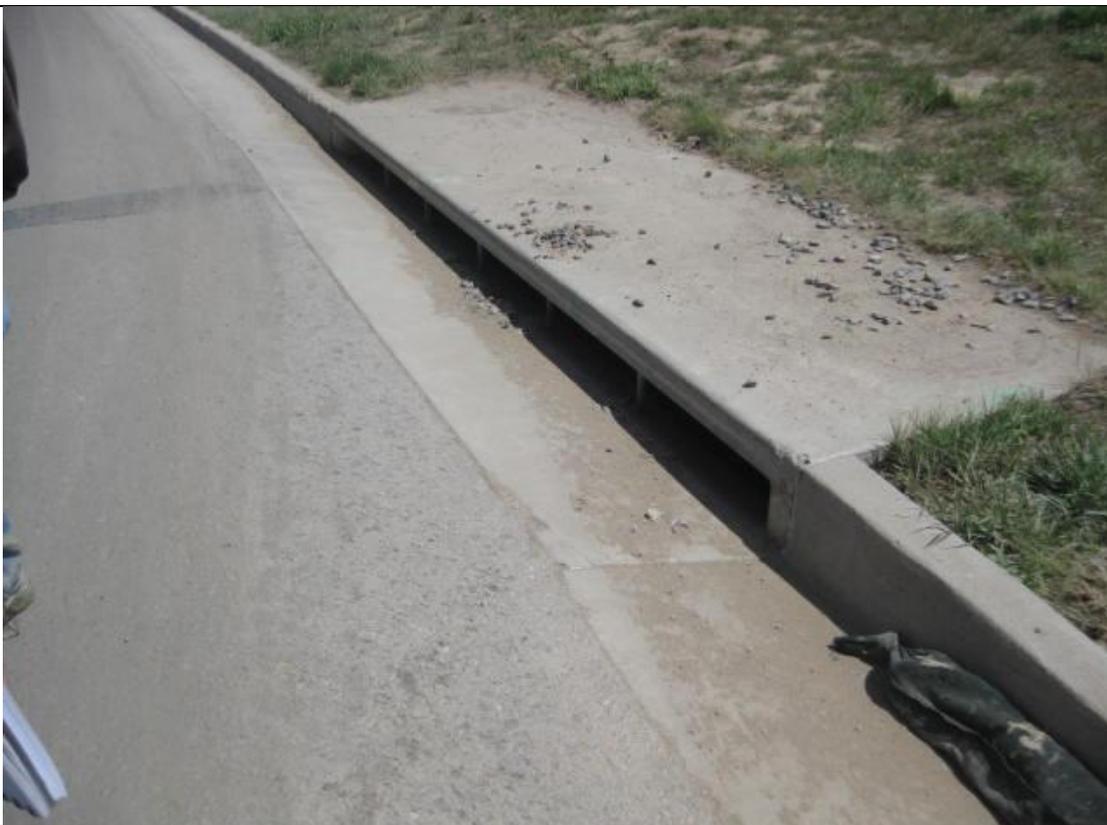
**Photograph 15:** Inadequate inlet protection on east side of Inverness Parkway

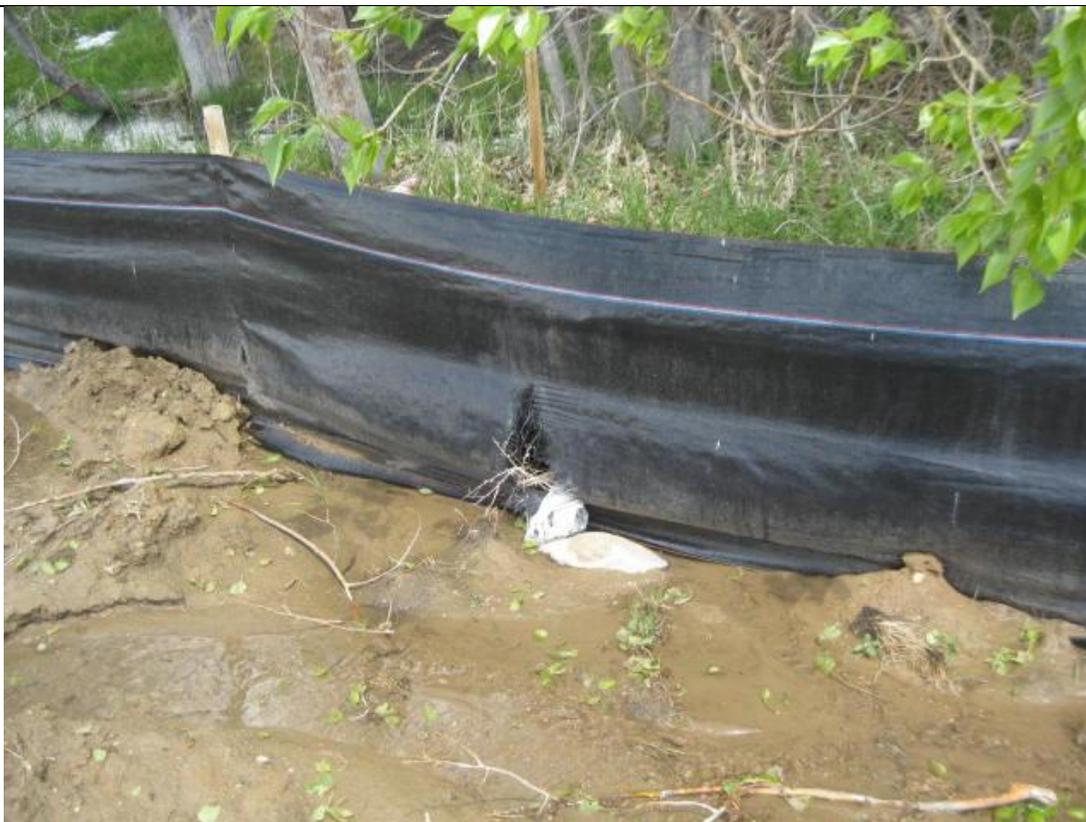
**Photograph 16:** Silt fence requires maintenance on Lot 6

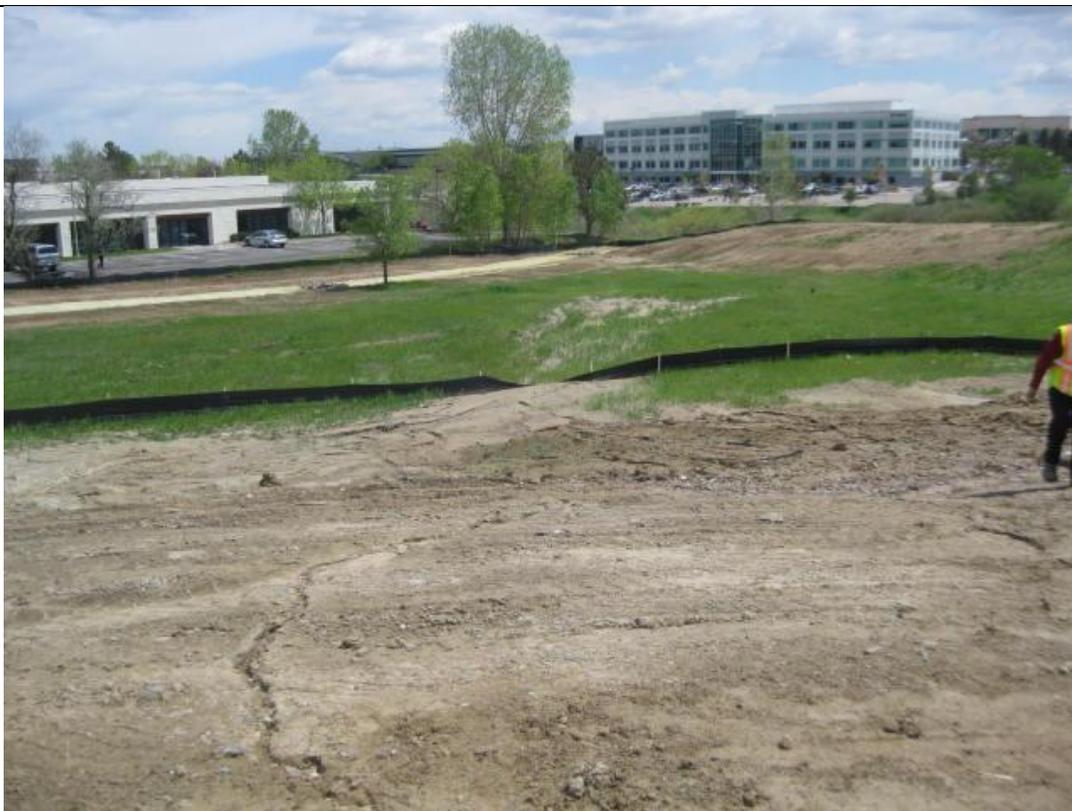
9. It was noted during the inspection that inadequate control measures were implemented to manage pollutant contributions to stormwater runoff from sediment from disturbed areas located at the lower end of the stabilized storage/parking area in lot 6 (refer to photographs 17 - 19).

- Control Measure Observation: A silt fence control measure was implemented to manage pollutant contributions to stormwater runoff from the location and pollutant source noted above; however the control measure was inadequate.
- Control Measure Finding: An installation and implementation specification was provided in the SWMP but the control measure was not in accordance with good engineering, hydrologic and pollution control practice as required by the permit.

**Photograph 17:** Silt fence failure downslope of the Stabilized Staging Area

- Implement control measures consistent with the installation and implementation specifications provided in the SWMP.
  - Update the SWMP when new control measures are installed or control measures are replaced.

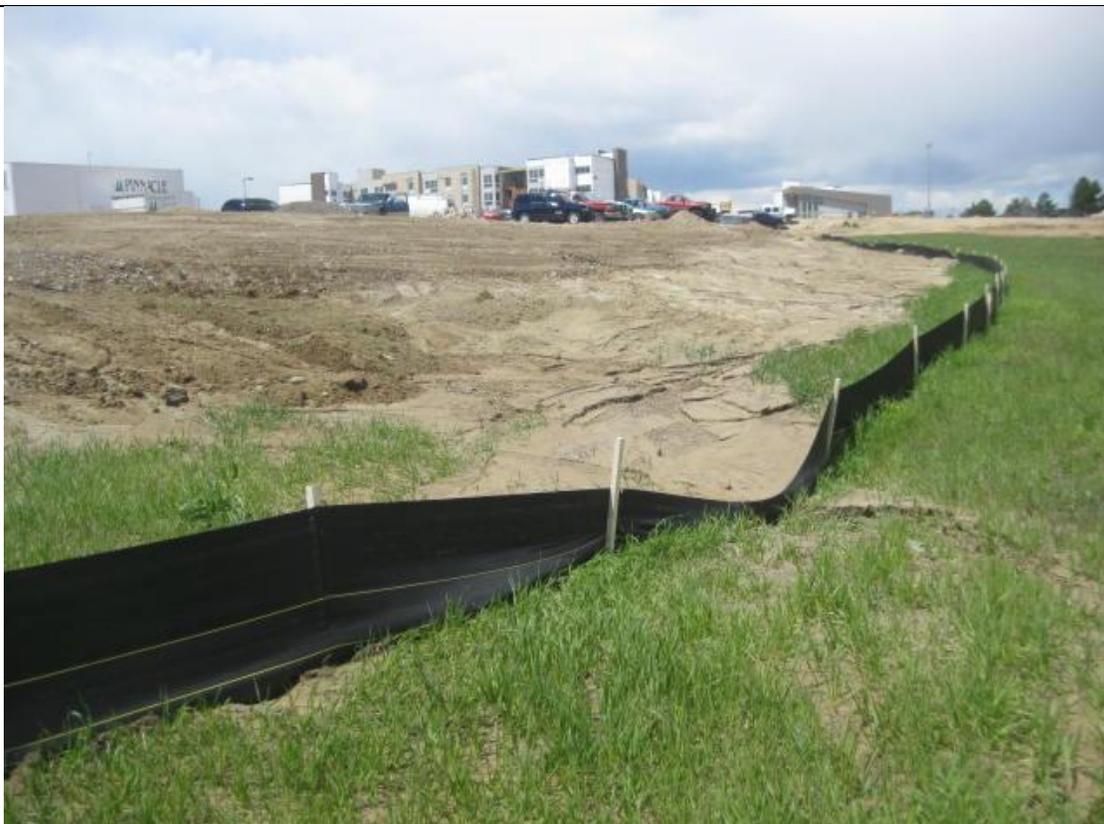
**Photograph 18:** Silt fence failure downslope of the Stabilized Staging Area

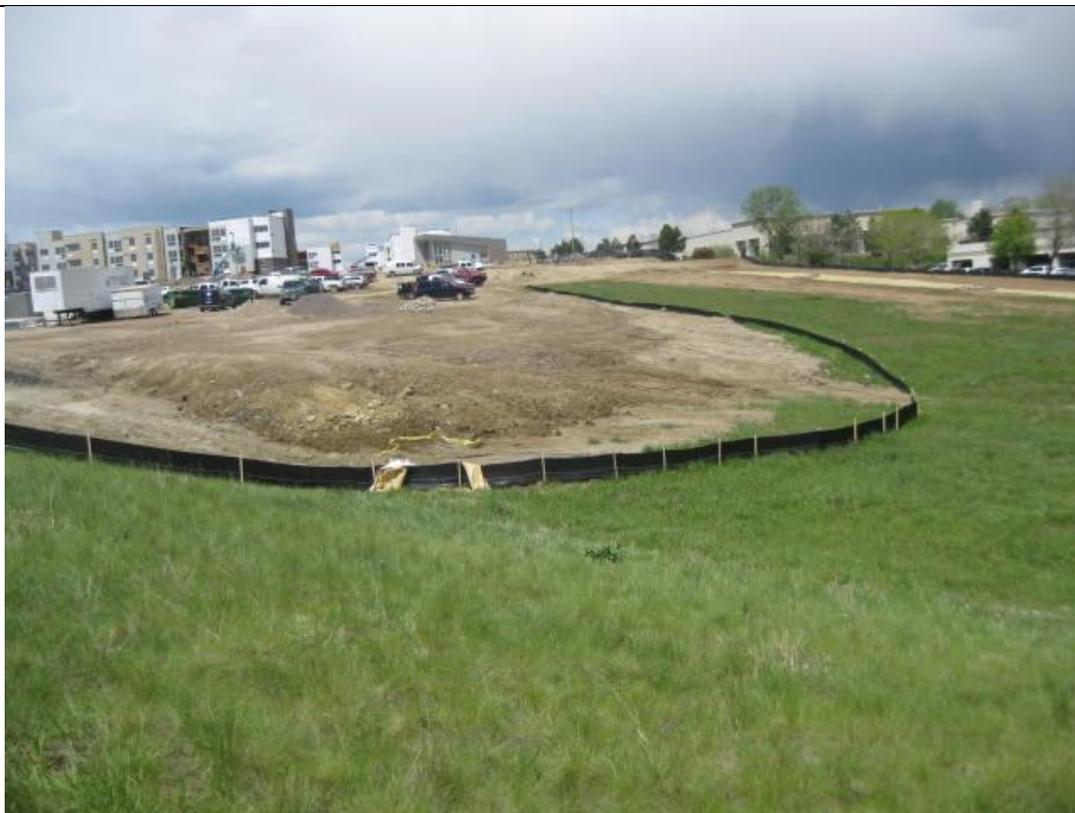
Specifically, silt fence was the only control measure for an approximately 3 acre upslope disturbed area, significantly exceeding its treatment capacity (maximum contributing drainage area of ¼ acre per 100 linear feet of silt fence), and subsequently failed during a runoff event. Note the silt fence was not located on the site map.

**Photograph 19:** Contributing area exceeds treatment capacity of control measure

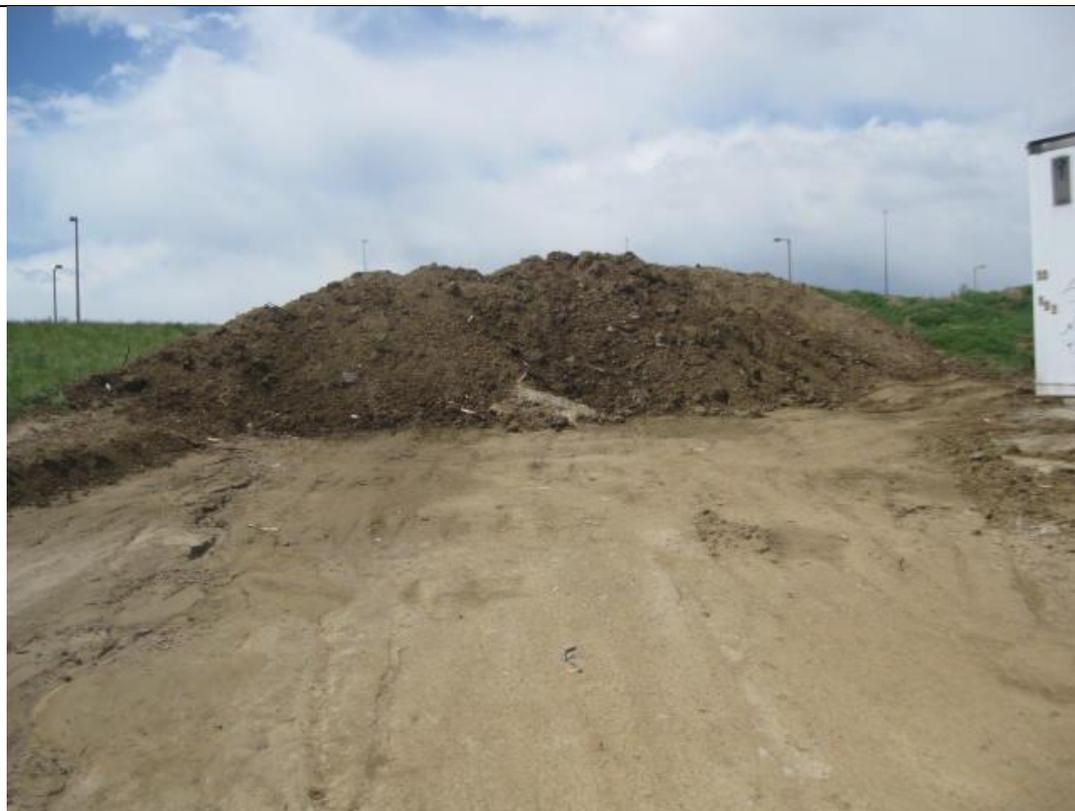
10. It was noted during the inspection that control measures were not implemented to manage pollutant contributions to stormwater runoff from sediment from stockpiles located on Lot 6 (refer to photograph 20).

- Control Measure Observation: Control measures were not observed at the location and for the pollutant source noted above.
- Control Measure Finding: An installation and implementation specification for stockpile management control measures was provided in the SWMP, but was not implemented.

Specifically, No containment control measure was observed downslope at the toe of the stockpile

**Photograph 20:** Stockpile management control measure not installed.

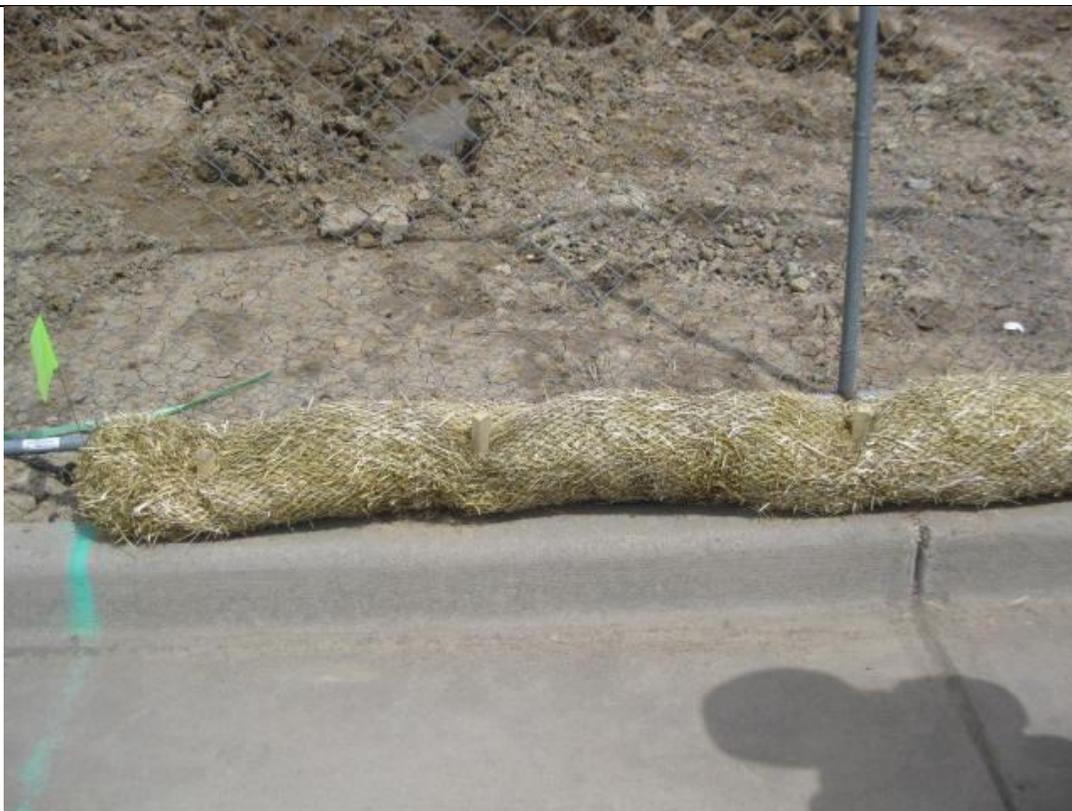
**Photograph 21:** Sediment control log installation not per spec.

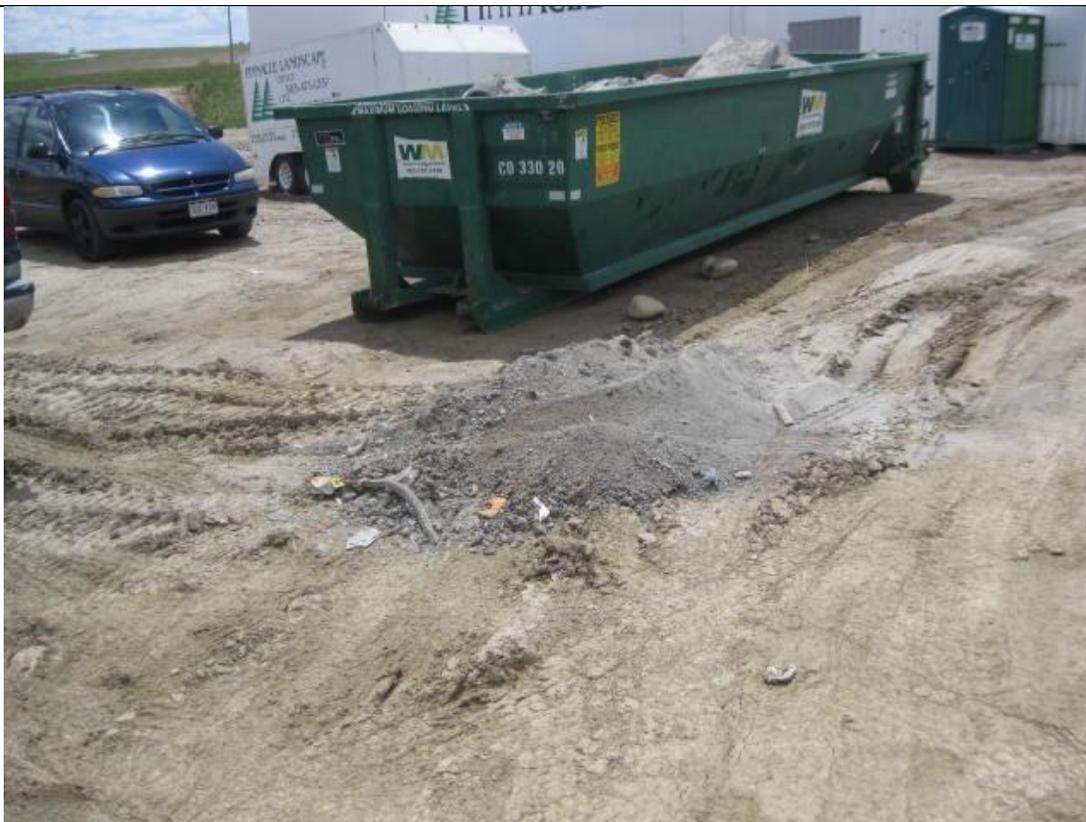
11. It was noted during the inspection that control measures were not implemented to manage pollutant contributions to stormwater runoff from construction materials waste located on Lot 6 (refer to photograph 22).

- Control Measure Observation: A waste management control measure was implemented to manage pollutant contributions to stormwater runoff from the location and pollutant source noted above; however the control measure was inadequate and not consistently implemented.
- Control Measure Finding: An implementation specification for construction waste management was provided in the SWMP, but was not implemented.

Specifically, street sweeping tailings were observed on the ground next to a dumpster not disposed of properly.

**Photograph 22:** Street sweeper tailings dumped on the ground.
