CAPITOL COMPLEX MASTER PLAN
FINDINGS & RECOMMENDATIONS (F & R) NEEDS ASSESSMENT
700 KIPLING BUILDING, 700 KIPLING STREET (LAKEWOOD)

NOVEMBER 2014

FINDINGS & RECOMMENDATIONS (F&R) NEEDS ASSESSMENT

700 KIPLING BUILDING
700 KIPLING STREET (LAKEWOOD)

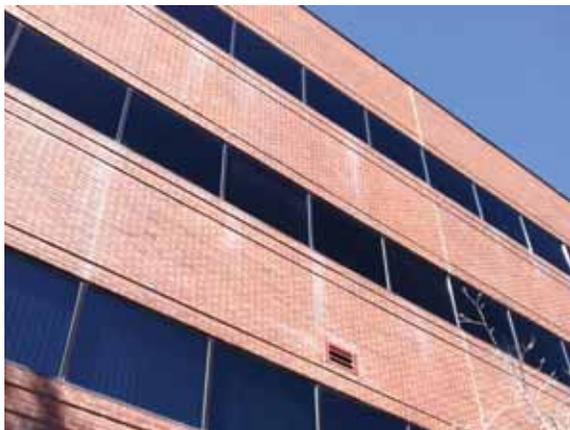
The brick cladding the building is in fair condition overall. Soiling was readily observable and consistent around the perimeter of the building (see Fig. 2.1.A.1). The mortar is deteriorating in spots and there was some damage noted to the brick, especially around the windows and at the corners of the building (see Fig. 2.1.A.2 and Fig. 2.1.A.3). The sealant along the control joints around the perimeter of the building is deteriorating and in generally poor condition (see Fig. 2.1.A.4). The deterioration is creating points where water can penetrate the building envelope and cause damage. There were also areas noted where the mortar is deteriorating along the foundation and creating points where water can penetrate the building envelope and cause damage (see Fig. 2.1.A.5). There was evidence of water damage noted along the brick retaining wall at the West Entrance (see Fig. 2.1.A.6). It was reported that repair of the exterior walls is on the Capitol Complex list of controlled maintenance projects that need to be addressed.

Fig. 2.1.A.1 Typical soiling of the brick observed around the perimeter of the building.

- Clean soiled/stained brick veneer around the building exterior, including the retaining walls.
- Repair or replace cracked or spalling brick veneer around the building exterior.

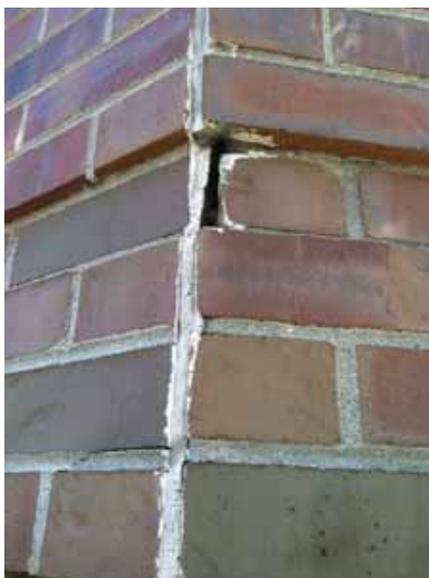
Fig. 2.1.A.2 Damaged brick and deteriorating mortar at the corner of the building.

- Tuck point areas with deteriorated mortar around the exterior of the building, including the brick cladding the walls and along the foundation, paying particular attention above the windows and along the brick reveals.

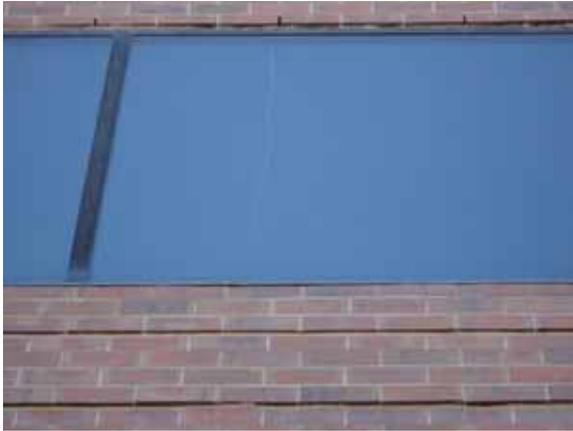
Fig. 2.1.A.3 Deteriorating sealant along the top edge of the windows and deteriorating mortar along the pair of reveals below the windows.

- Remove existing sealant in control joints around the building exterior and replace with new sealant. Sealant, backup materials, and preformed joint fillers should be nonstaining.

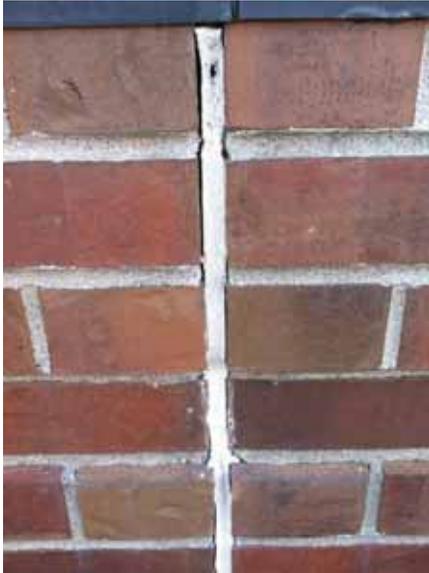
Fig. 2.1.A.4 Typical deteriorating sealant along the building's control joints.

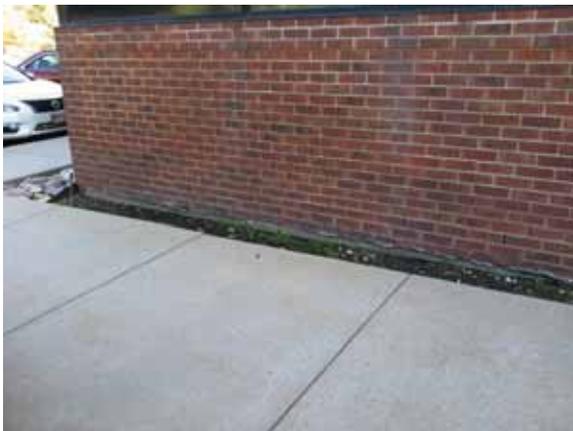
Fig. 2.1.A.5 Typical deterioration of the mortar along the building's foundation.

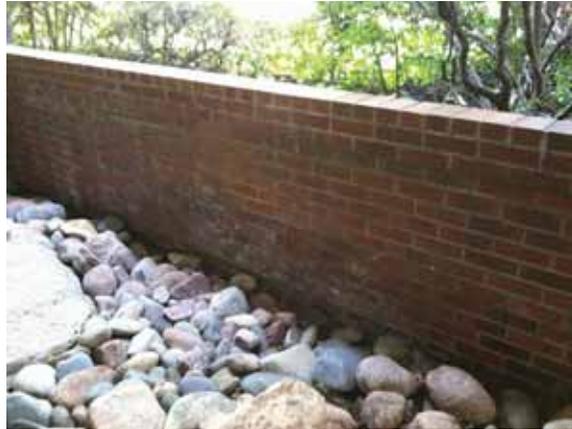
Fig. 2.1.A.6 Evidence of water damage along brick retaining wall at the West Entrance.

- Repair or replace the stucco walls cladding the exterior of the Penthouse.
- Verify the cause of water damage along the brick retaining wall at the West Entrance and repair as necessary.

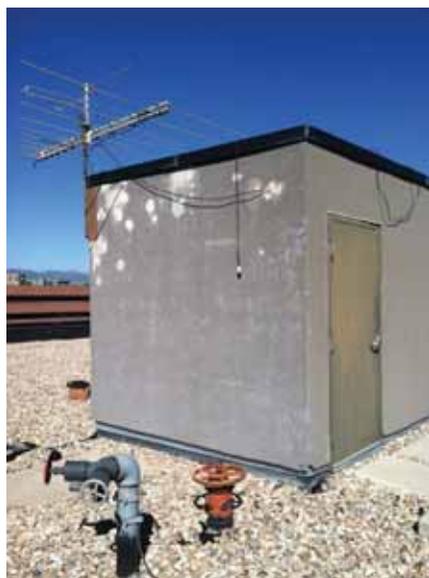
The stucco cladding the exterior of the Penthouse is generally soiled and discolored and appears to have been poorly repaired (see Fig. 2.1.A.7). Some of the worst spalling has been repaired with sealant but it appears that further deterioration is occurring (see Fig. 2.1.A.8).

Fig. 2.1.A.7 Soiled and poorly repaired stucco cladding the Penthouse.

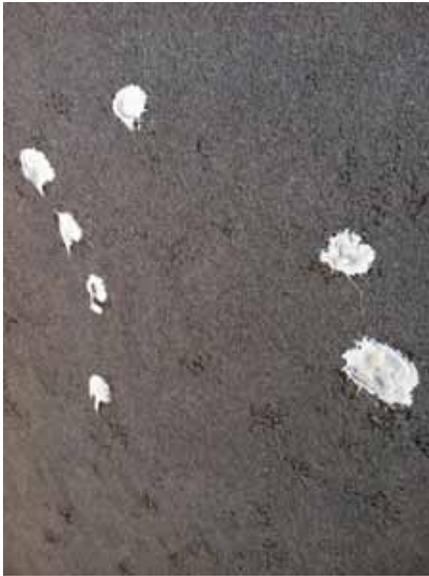
Fig. 2.1.A.8 Poorly repaired areas of spalling at the Penthouse with further deterioration visible.

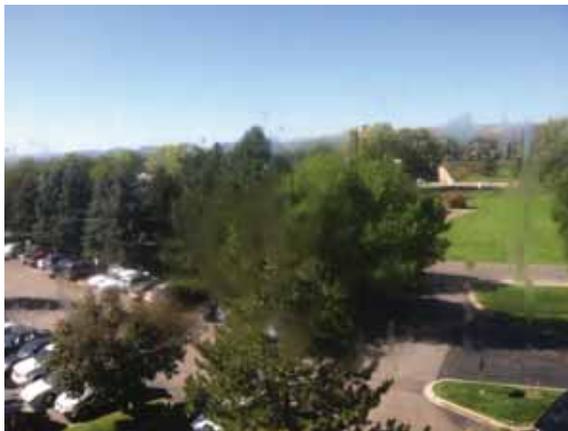
Fig. 2.1.A.10 Window with potential broken seal.

- Replace existing windows with new energy efficient windows and frames.
- Repair or replace the weatherstripping between all exterior doors and their frames to prevent air leakage.
- Repair or replace the corroding door and frame at the Penthouse.
- Remove existing sealant around the door frame at the Penthouse and replace with new sealant. Sealant, backup materials, and preformed joint fillers should be nonstaining.

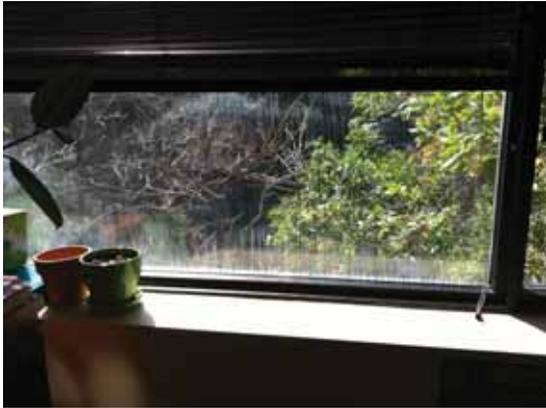
Fig. 2.1.A.11 View of soiled window from the interior of the building.

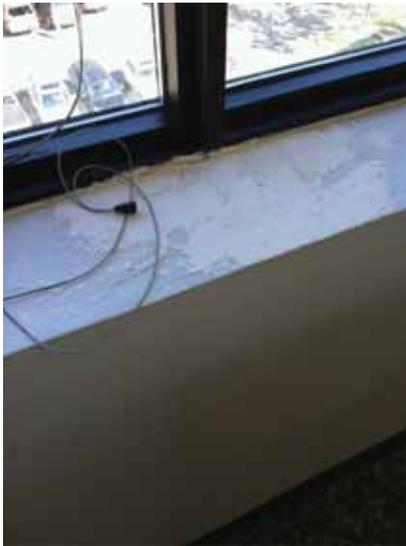
Fig. 2.1.A.12 Evidence of water damage along the base of a window on the Fourth Floor.

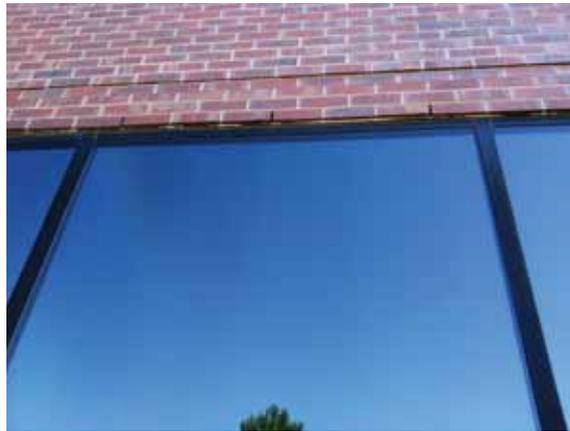
Fig. 2.1.A.14 Deteriorating sealant between the top of the window frames and the brick veneer.

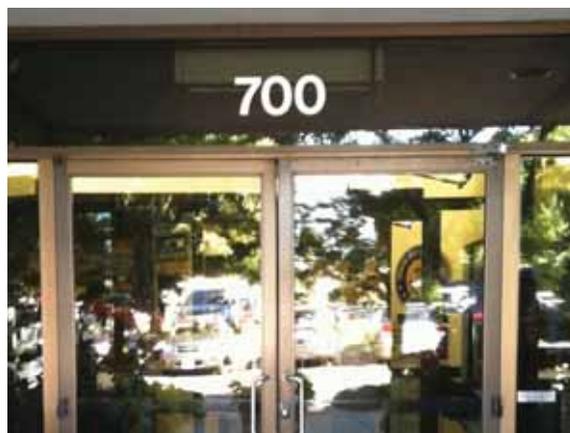
The single sets of glazed entrance doors at the West Entrance and the East Entrance are in fair condition and appear to be original to the building. Air gaps due to deteriorated or missing weatherstripping were noted, allowing air leakage from the building (see Fig. 2.1.A.15). The door and door frame to the Penthouse on the Roof are corroding and the sealant between the frame and the stucco wall is deteriorating (see Fig. 2.1.A.16).

Fig. 2.1.A.15 Missing weatherstripping noted at the West Entrance doors.

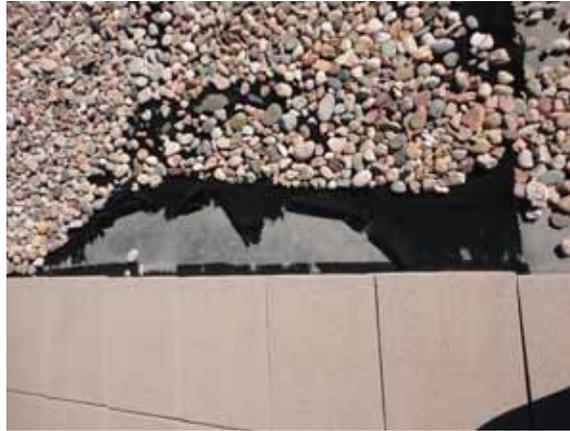
It was reported that the roof of the 700 Kipling Building is fifteen years old. The roof is ballasted and is thin or missing in spots, exposing the roof membrane (see Fig. 2.1.A.17 and Fig. 2.1.A.18). It was further reported that the roof has issues with leaking and steps have been taken inside to protect equipment from water damage (see Fig. 2.1.A.19). Some of the roof drain covers are in good condition and some are showing evidence of corrosion (see Fig. 2.1.A.20). The sealant is deteriorating along the seams of the roofing membrane covering the inside face of the roof parapet (see Fig. 2.1.A.21). The coping of the parapet appears to be flat and there is evidence of pooling water (see Fig. 2.1.A.22) and poor sealant repair along the seams of the coping (see Fig. 2.1.A.23). Some of the concrete pavers have cracked into numerous pieces and are creating a tripping hazard (see Fig. 2.1.A.24). It was reported that replacement of the roof and CCF roof assessments are on the Capitol Complex list of controlled maintenance projects that need to be addressed.

Fig. 2.1.A.17 Typical areas of thin ballast exposing the roof membrane which is deteriorating.

- Replace the existing roof and Penthouse roof with a new roofing system, including a new membrane, ballast, roof drains, and flashing around the perimeter of the Penthouse and the parapet. Ensure that the new coping along the top edge of the parapet slopes to allow drainage of any water.
- Replace damaged concrete pavers with new concrete pavers.

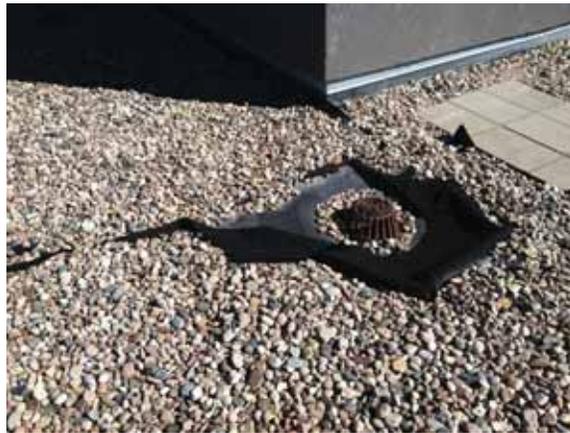
Fig. 2.1.A.18 Typical areas of thin ballast exposing the roof membrane.

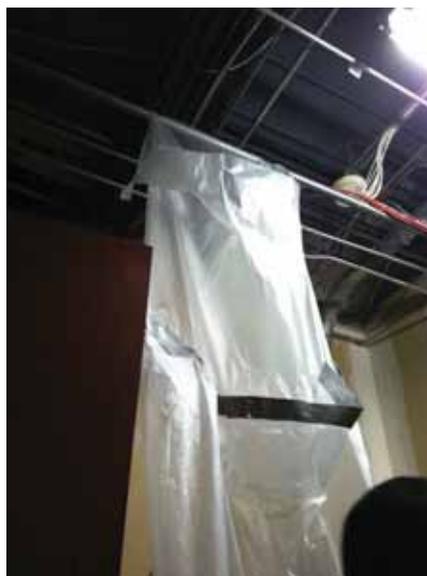
Fig. 2.1.A.19 Plastic used to protect equipment from water leaking from the roof.

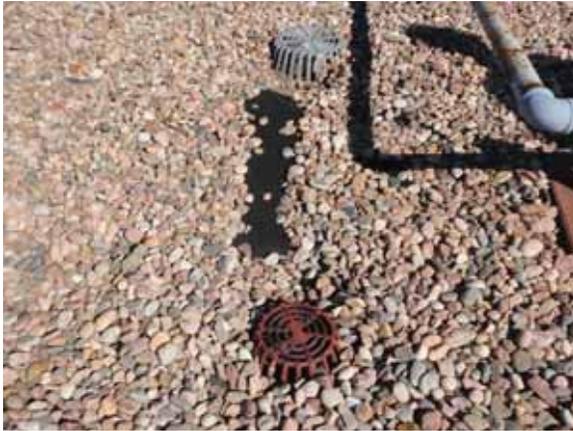
Fig. 2.1.A.20 Roof drain cover in good condition and roof drain cover with evidence of corrosion.

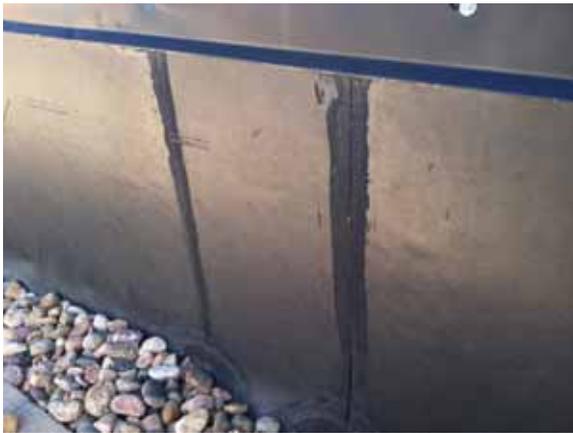
Fig. 2.1.A.21 Deteriorating sealant along the seams of the roof membrane covering the inside face of the parapet.

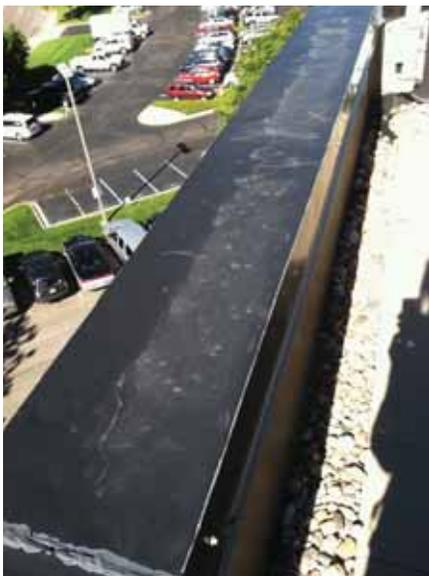
Fig. 2.1.A.22 Evidence of water pooling along the parapet's coping.

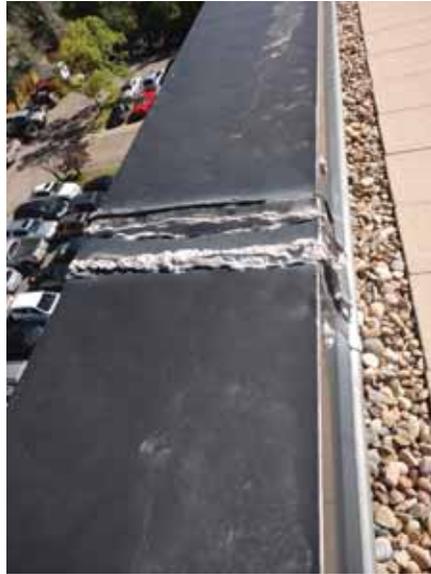
Fig. 2.1.A.23 Poor sealant repair along the seams of the parapet's coping.

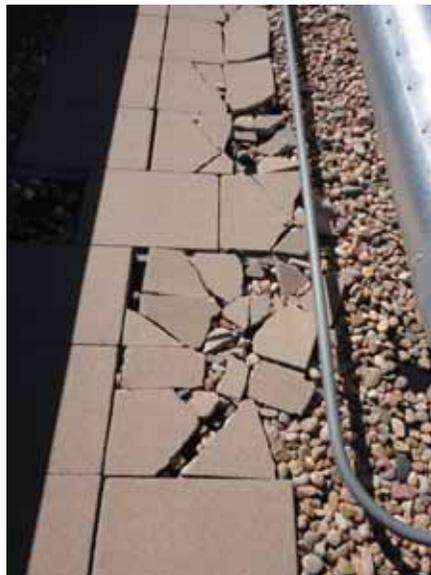
Fig. 2.1.A.24 Cracked concrete pavers creating a tripping hazard on the roof.

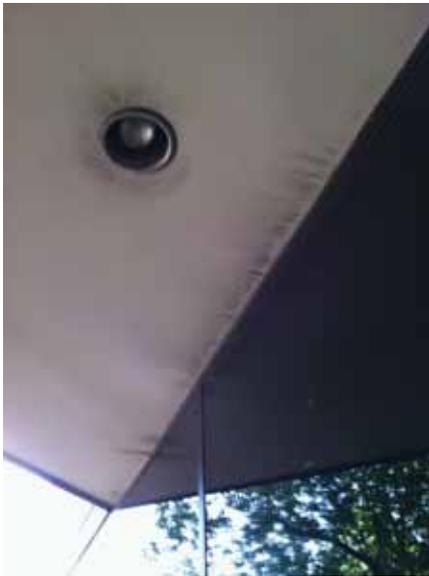
The entrance canopies appear to show evidence of air leakage with soiling along the edge of the building and around the recessed lighting (see Fig. 2.1.A.25 and Fig. 2.1.A.26). There is also evidence of water damage with cracking and previous repairs noted (see Fig. 2.1.A.27).

Fig. 2.1.A.25 Soiling around areas of potential air leakage.

- Verify cause of water damage and air leakage and repair or replace the required elements as necessary.
- Clean and repair areas soiled by air leakage or damaged by water.

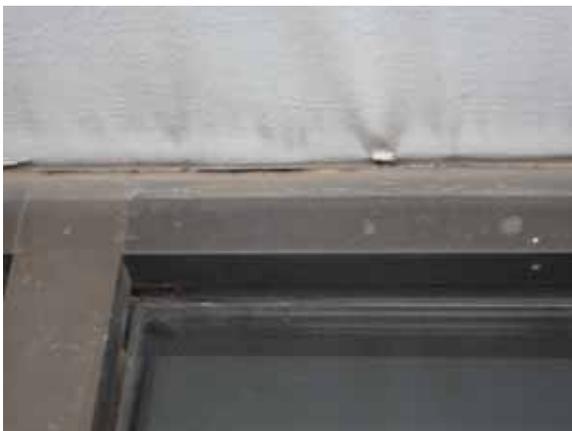
Fig. 2.1.A.26 Soiling around areas of potential air leakage.

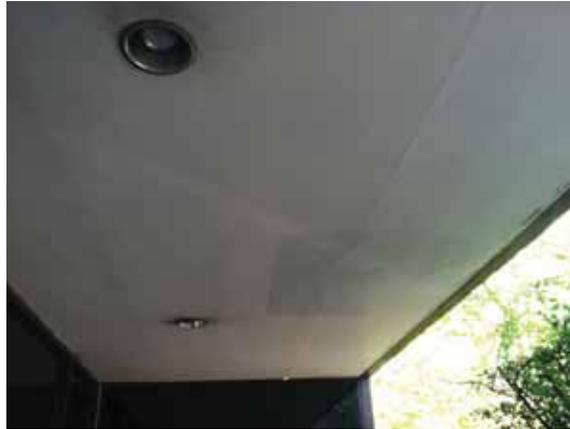
Fig. 2.1.A.27 Evidence of water damage and previous repairs of the entrance canopies.

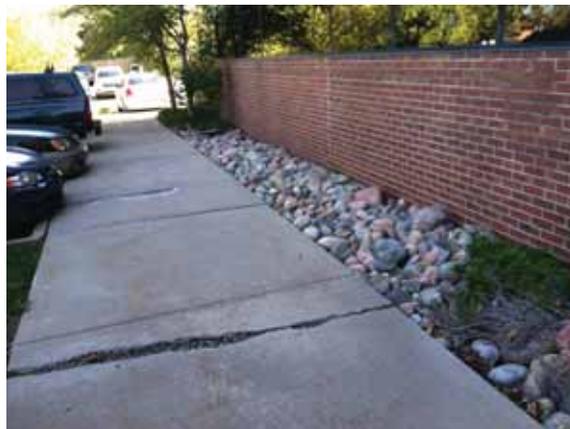
There were a number of potential tripping hazards that were noted around the perimeter of the building. The concrete sidewalk pavers are spalling and cracked (see Fig. 2.1.A.28 and Fig. 2.1.A.29). There was a gap noted between two of the concrete pavers (see Fig. 2.1.A.30). There is a corroding metal cover flush with the concrete pavers that has holes and is creating a tripping hazard (Fig. 2.1.A.31).

Fig. 2.1.A.28 Cracked and spalling concrete pavers are creating a tripping hazard.

- Repair or replace concrete pavers with spalling, cracks, and gaps between the pavers.
- Replace the corroded metal cover flush with the concrete pavers with a new metal cover.

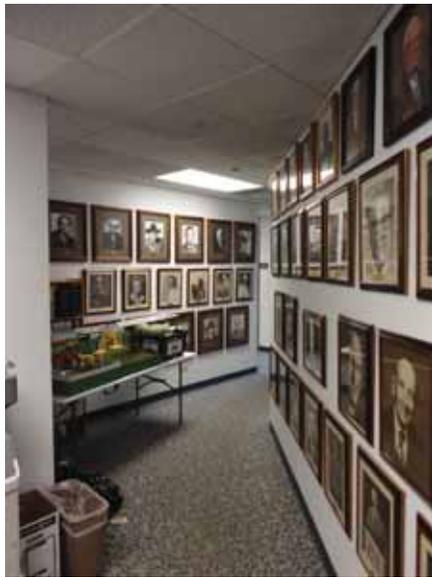
within the Colorado Department of Agriculture's office space on the Fourth Floor (see Fig. 2.1.B.1). The Fourth Floor has an occupancy of more than 50 and therefore, according to Table 1018.2 of the IBC (2012), has a required minimum corridor width of 44 inches. According to Section 1018.3 of the IBC (2012), the required width of corridors shall be unobstructed. It appears that the table is intruding into the minimum required width of the egress corridor and should be addressed immediately and regardless of any future renovation plans. The occupancy loads of each floor should be verified as part of any future renovation plans.

Fig. 2.1.B.1 Furniture possibly intruding into the required minimum width of the egress corridor on the Fourth Floor.

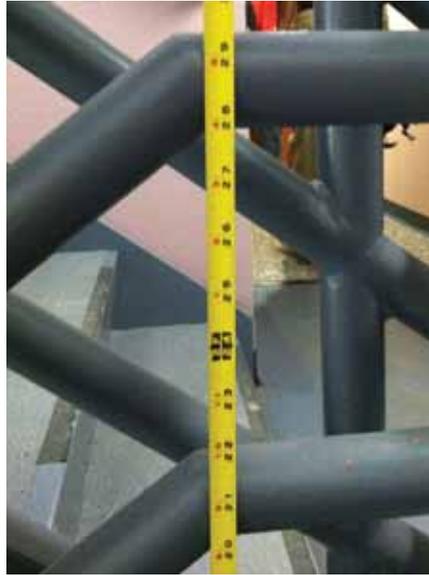
In general, the exit stairs comply with the code requirements for stairs, with the exception of the stairway railing system. The spacing between the guardrails exceeds the code-maximum of four inches (see Fig. 2.1.B.2).

Fig. 2.1.B.2 The spacing between the railings exceeds the code-maximum of four inches.

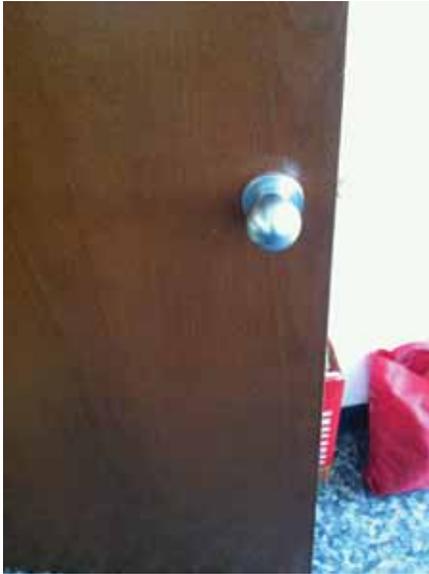
Fig. 2.1.B.3 Typical knob-style door handle found throughout the building.

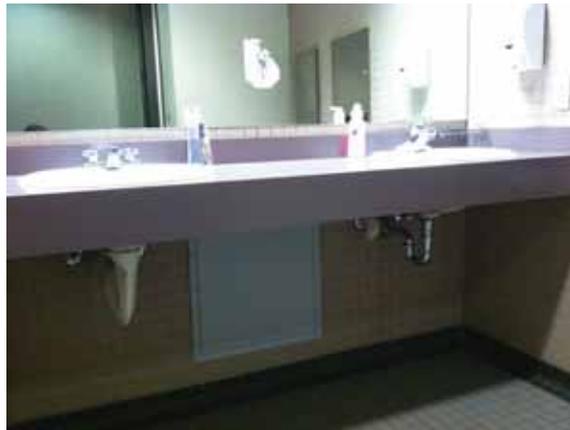
A small number of non-accessible issues were noted during the site survey visit. The non-accessible lavatory with knob-style faucet controls in the Women's Restroom on the Second Floor has insulation wrapped around the lavatory pipes while the pipes of the accessible lavatory with code-compliant lever-style faucet controls are not insulated (see Fig. 2.1.C.1). According to Section 606.6 of ICC/ANSI A117.1-2003, water supply and drainpipes under accessible lavatories and sinks shall be insulated or otherwise configured to protect against contact.

Fig. 2.1.C.1 Insulation is wrapped around the pipes of the non-accessible lavatory with knob-style faucet controls in the Women's Restroom on the Second Floor.

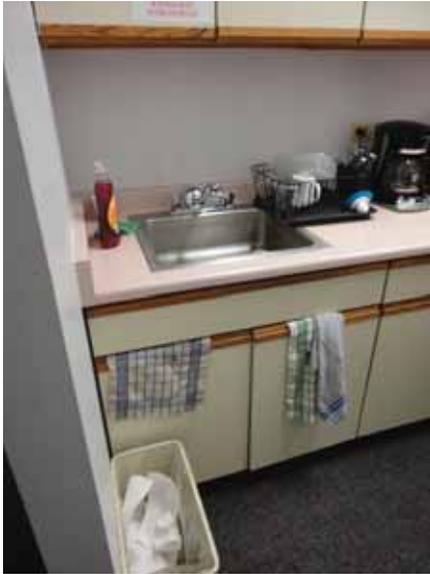
Fig. 2.1.C.2 Typical non-accessible sink found in the Break Rooms throughout.

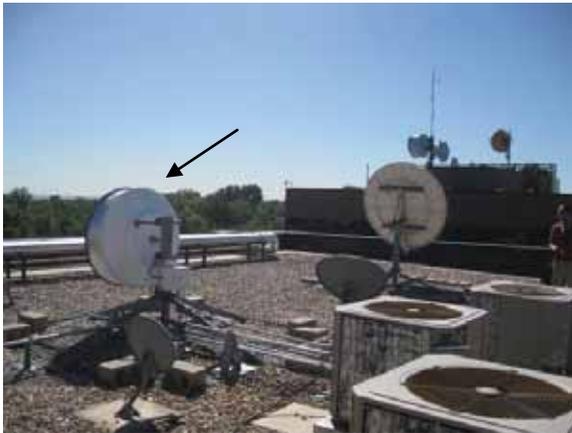
Fig. 2.2.A.1

The building's exterior is in good condition. RF antennas were observed on the roof with no warning signs (Fig. 2.2.A.1). RF antennas can expose people to harmful radiation and cause serious damage. The owner of the antennas should provide signage and safe distance requirements prior to people stepping out on the roof.

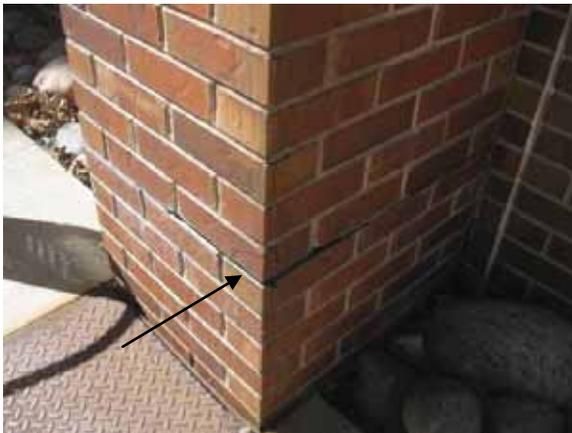
Fig. 2.2.A.2

A deteriorated mortar joint was observed on the brick veneer along the east wall (Fig. 2.2.A.2). The deteriorated mortar joint allows water to penetrate behind the wall and cause additional deterioration.

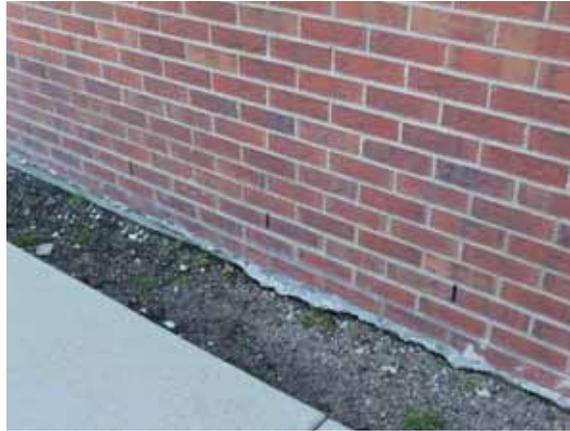
Some subgrade settling was observed around the exterior of the building but it appears to be contained to the landscaped areas around the building rather than the foundation (Fig. 2.3.A.5). The foundation of the building appears to be stable.

Figure 2.3.A.5 – Low Subgrade and Foundation Exposure

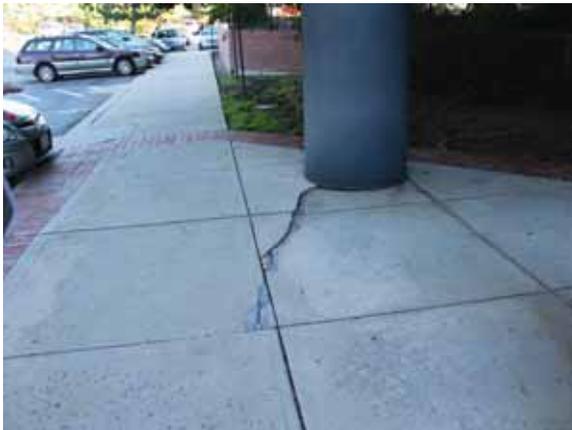
Numerous locations of broken concrete, concrete settling and concrete cracking was observed. Large cracks through walking paths can create tripping hazards. Repair or replace broken or cracked concrete.

Figure 2.3.A.6 – Site Concrete Crack, Recommended for Replacement

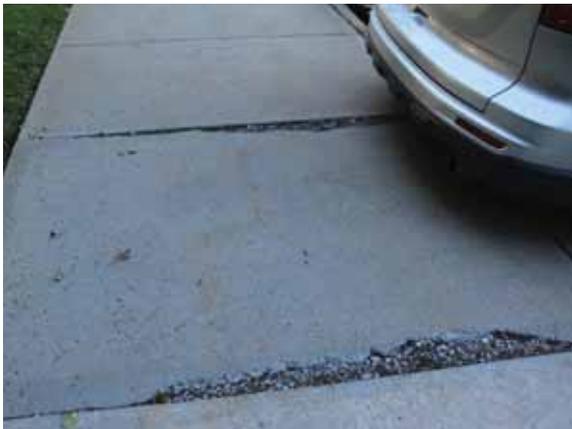
Figure 2.3.A.7 – Broken Site Concrete, Recommended for Replacement

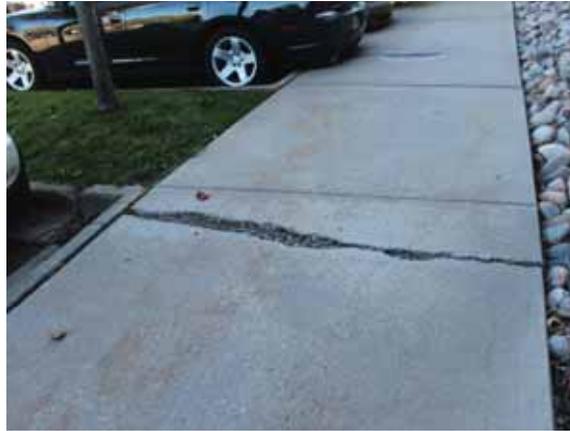
Figure 2.3.A.8 – Broken Site Concrete, Recommended for Replacement

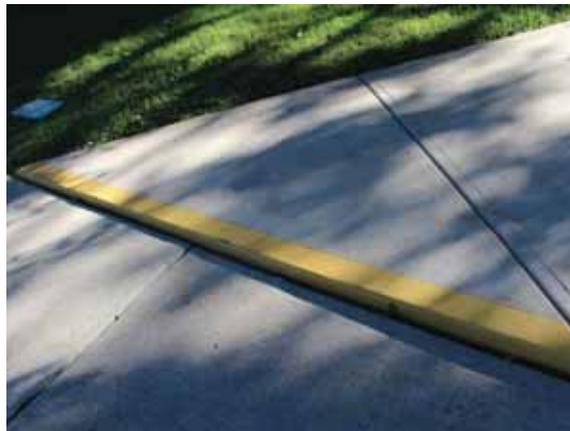
Figure 2.3.A.9 – Settlement in Concrete Along Major Walkway, Recommended for Replacement

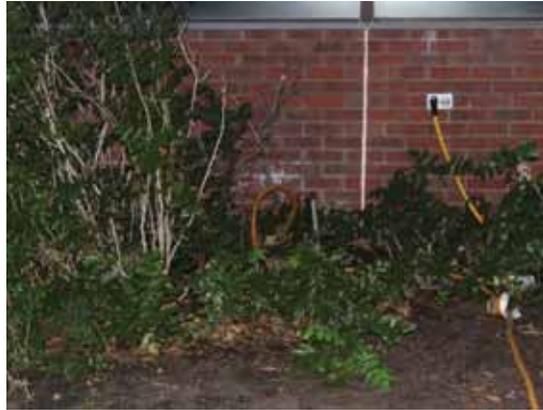
An irrigation line was observed close to the foundation of the building (Fig. 2.3.B.2 and 2.3.B.3). Typical geotechnical recommendations do not allow irrigation within 10 feet of a building perimeter. Irrigation this close may cause wetting of the building foundation, which again could lead to numerous problems including settlement. This irrigation line should be relocated and watering methods re-evaluated.

Figure 2.3.B.2 – Irrigation Near Building Foundation

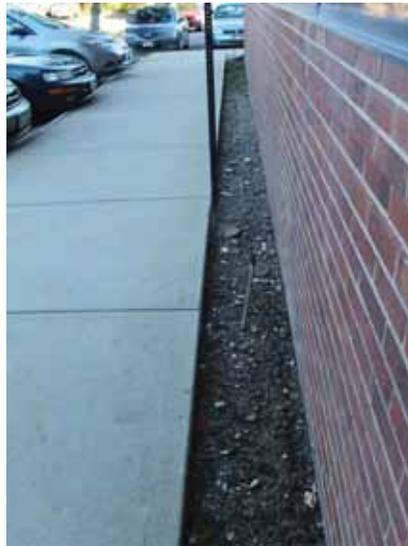
Figure 2.3.B.3 – Irrigation Near Building Foundation

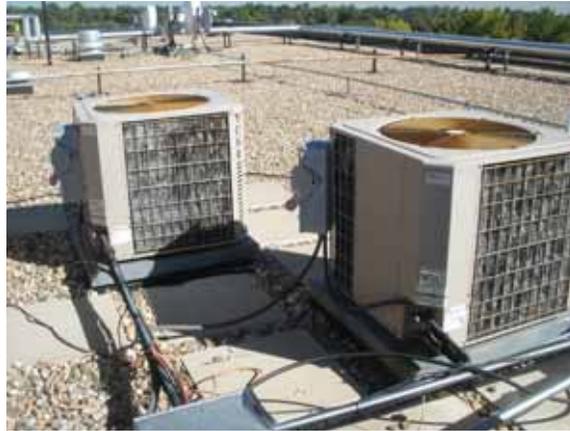
Fig 2.4.A.10 – Damaged fins

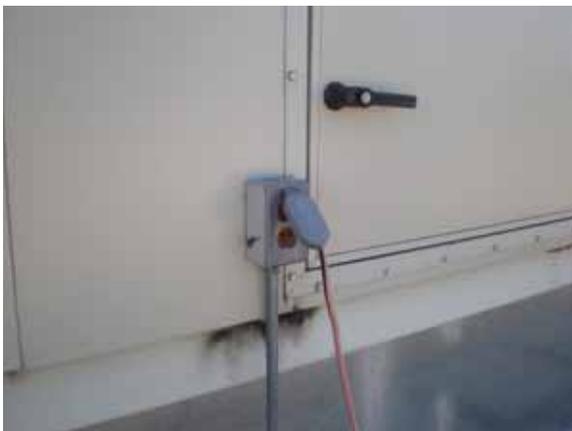
Fig 2.4.B.1 – Satellite plugged into HVAC unit

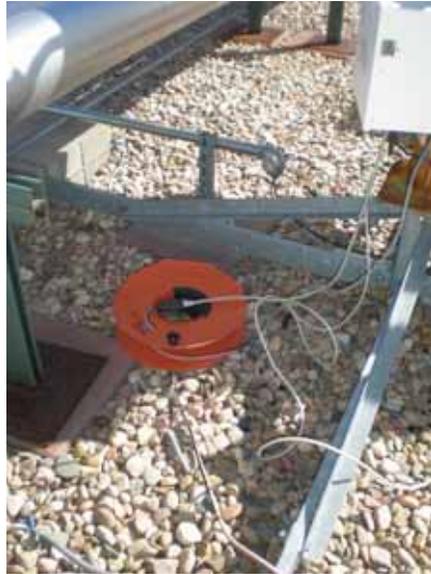
Fig 2.4.B.2 – Extension cord providing power to satellite

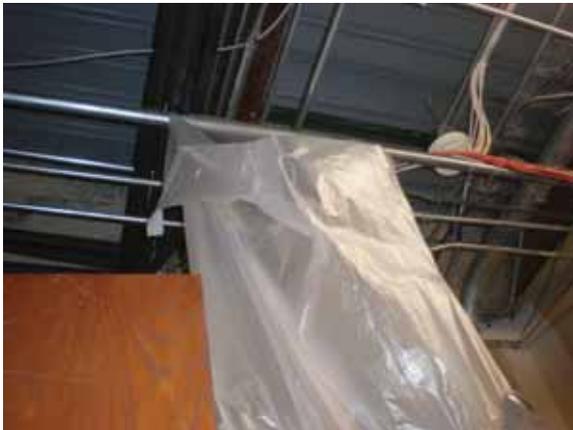
Fig 2.4.B.6 – Plastic for water leak in electrical room

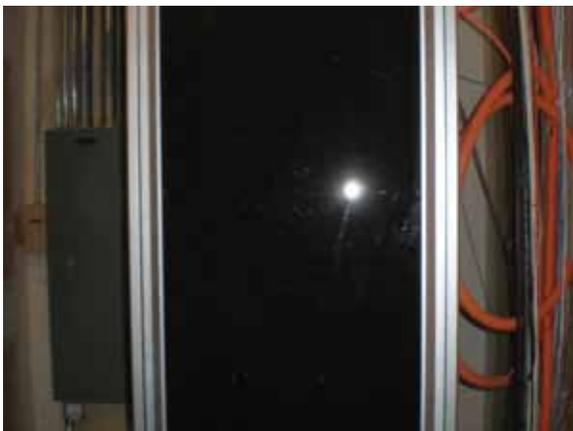
In the electrical rooms on floors two through four, an IT rack is located within the dedicated clearance space of a panelboard (see Fig 2.4.B.7).

Fig 2.4.B.7 – IT rack in front of panelboard

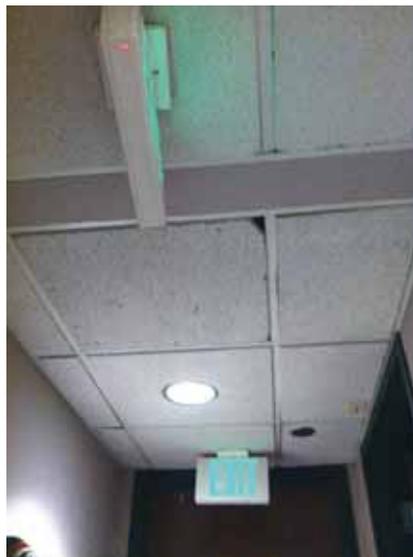
Fig. 3.0.C.1 Typical instance of deteriorated 2x2 acoustic ceiling tiles in generally fair to poor condition throughout.

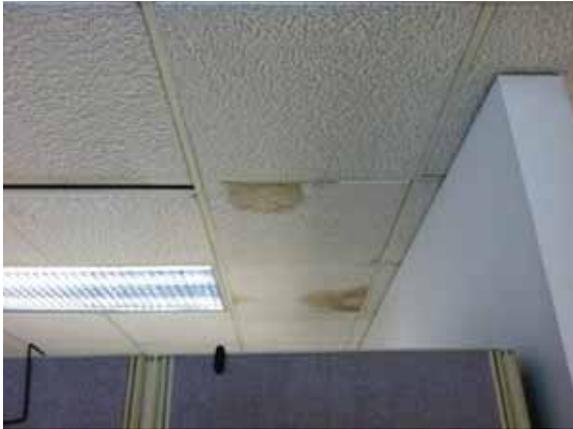
Fig. 3.0.C.2 Typical instance of stained and soiled 2x2 acoustic ceiling tiles noted throughout.

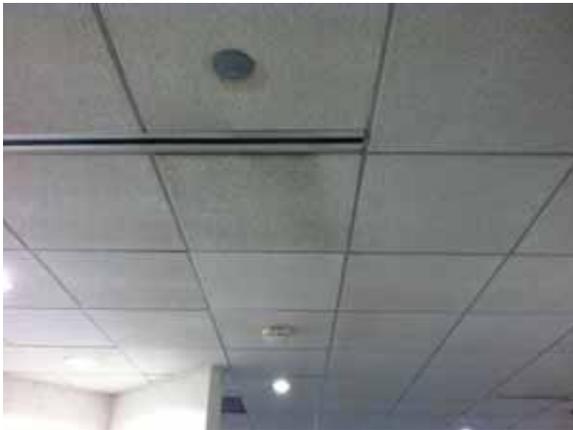
Fig. 3.0.C.3 Typical instance of soiled 2x2 acoustic ceiling tiles at the air diffusers noted throughout.

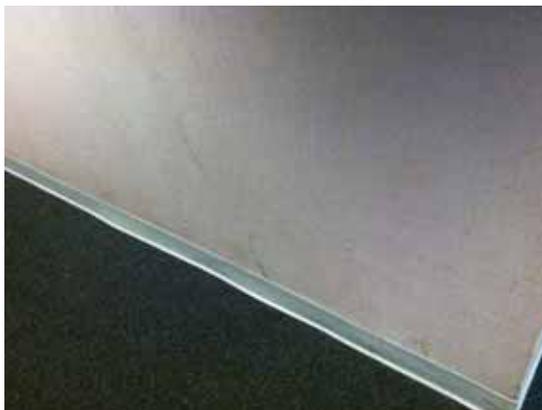
Fig. 3.0.C.6 Typical instance of damaged wallcovering noted throughout.

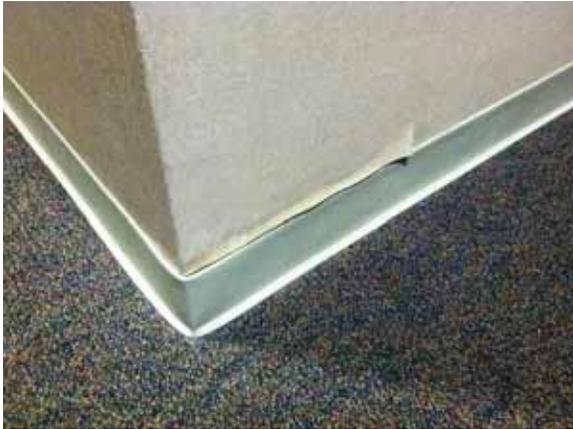
Fig. 3.0.C.7 Typical instance of damaged wallcovering noted throughout.

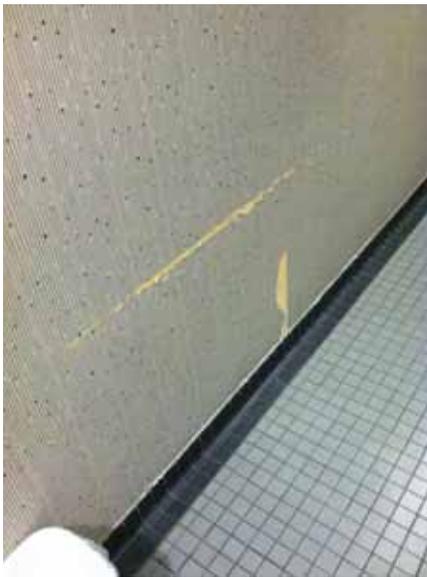
Fig. 3.0.C.8 Typical instance of damaged wallcovering noted throughout the restrooms.

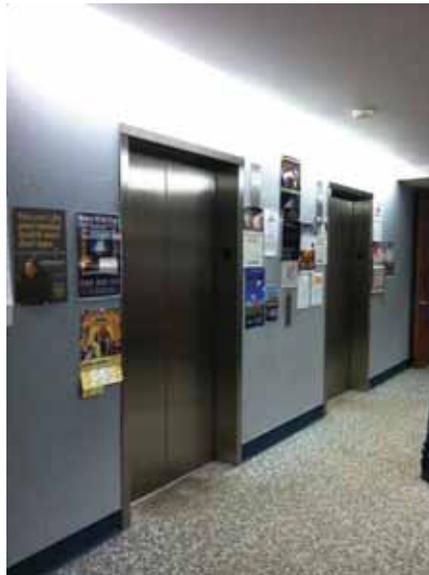
Fig. 3.0.C.9 Typical instance of worn and soiled carpet in the elevator lobbies.

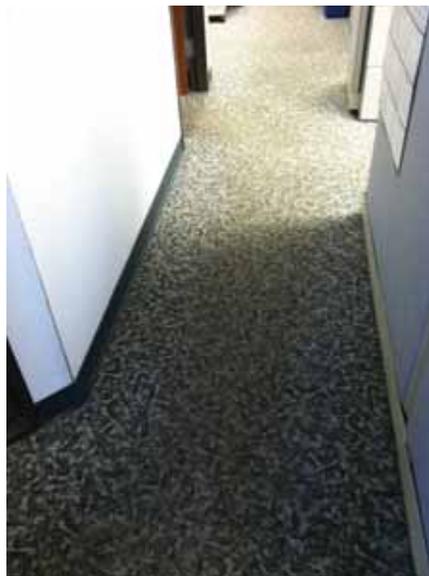
Fig. 3.0.C.10 Typical instance of worn and soiled carpet throughout.

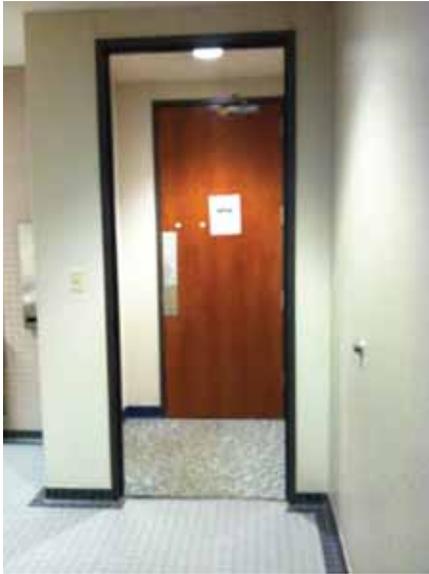
Fig. 3.0.C.11 Typical instance of worn and soiled carpet in the restroom vestibules.

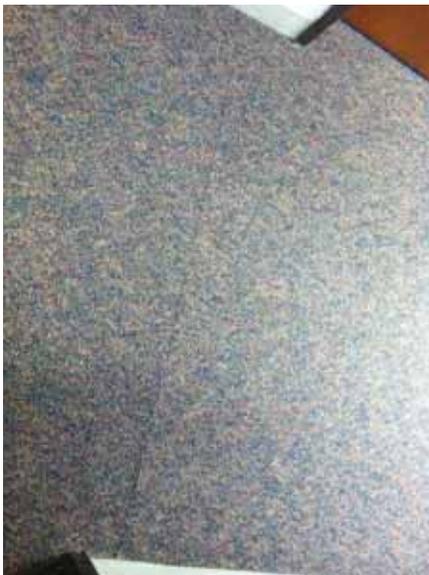
Fig. 3.0.C.12 Typical instance of carpet flooring pulling loose along the seams and creating a potential tripping hazard.

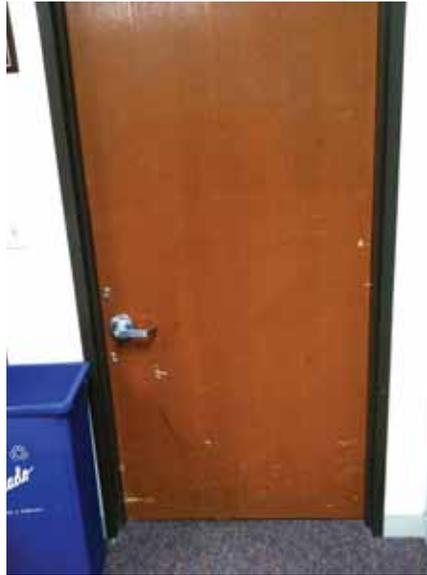
Fig. 3.0.C.13 General wear-and-tear noted at the doors.

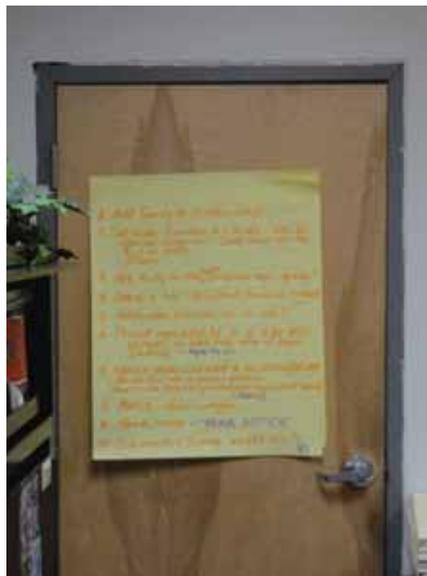
Fig. 3.0.C.14 Unfinished door jamb noted on the Second Floor.

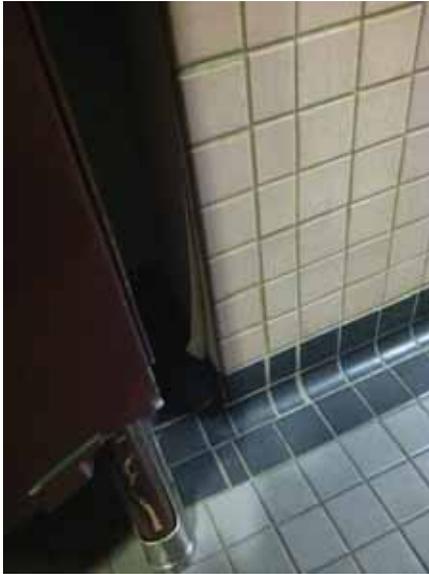
Fig. 3.0.C.15 Damage noted to the toilet stall partitions and to the wallcovering in the Second Floor Women's Restroom.

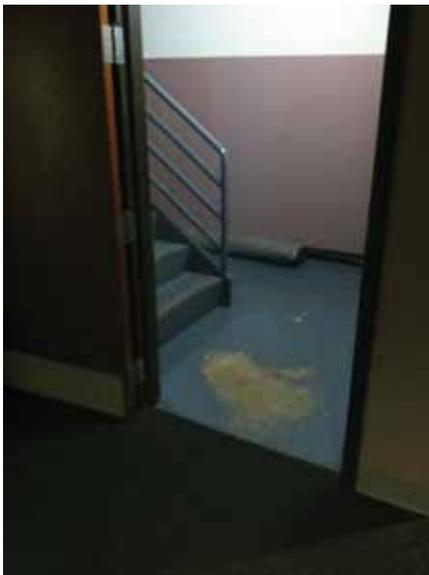
The painted concrete flooring in the stairway was noted to have paint that was worn off at the base of the stairs (see Fig. 3.0.C.16).

Fig. 3.0.C.16 Worn painted concrete flooring at the base of the stairs.
