## Building 444

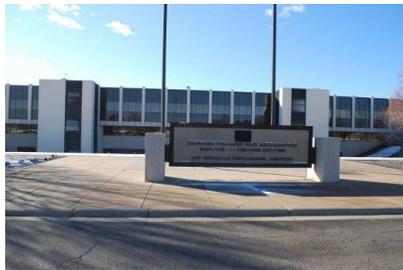
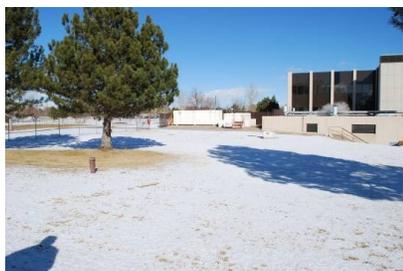
Building 444 was built in 1976 and currently houses the Defense Finance and Accounting Service and other tenants. The primary environmental concern at this building is the estimated 10,500 gallons of fuel oil which leaked from an underground storage tank into soil and groundwater. The tank, located off the southwestern corner of the building, and three additional underground storage tanks were removed in March and April 1992. Approximately 5,400 cubic yards of petroleum contaminated soil were excavated and treated, and a

bioventing system was installed to remediate contaminated soil left in place. Excavated soil was placed in a land farm located in another part the Lowry Air Force Base. Subsequently, the soil was remediated and the land farm closed. Final close out of the underground storage tanks and remediation of the associated contamination has been completed sufficiently for the use of the property at the time, and the Colorado Department of Public Health and Environment concurred in an October 3, 2000 letter with the understanding that soil and groundwater contamination may still be present underneath Building 444 and may need to be addressed when the building is demolished.

Six active diesel above ground storage tanks (ASTs) are associated with Building 444. These tanks are used to store fuel for backup generators within Building 444. One inactive recovered product (fuel oil) above ground storage tank, used to support cleanup activities during the removal of underground storage tanks south of Building 444, was cleaned and scheduled for removal from Buckley Annex.

A total of 82 gallons of free product were collected from the groundwater using five recovery wells within the zone of contamination. These wells were taken out of service in April 1994 because no free product had been observed since the initial months of operation. Monitoring and semiannual sampling at the site indicate corrective actions are working.

Because Building 444 remains an operating facility, the extent of hydrocarbon contamination beneath the building was never determined. The Colorado Department of Public Health and Environment is requesting additional investigations and, if necessary, the cleanup of soil and groundwater beneath the building prior to the clean transfer of the property for redevelopment.

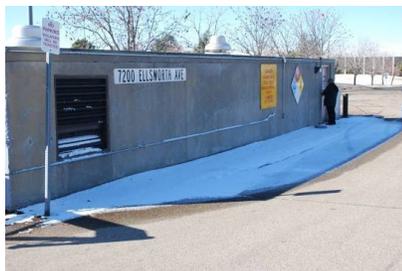
## Building 446

Building 446 was built in 1976 as a sewage detention station for Building 444. At the time, sewage lines in the vicinity of Building 444 were inadequate. Between 1976 and 1993, larger sewage lines were installed and the detention station was decommissioned. In 1993, the building was inspected and identified as a potential solid waste management unit because of a PCB-containing transformer located in the building. The transformer did not appear to be leaking. By 1994, all PCB-containing transformers had been removed.

In 1995, Building 446 was converted to a hazardous waste storage facility. Used oil and mercury-contaminated materials were stored in 55-gallon drums within the facility. Used oil and universal waste continue to be stored in the building.

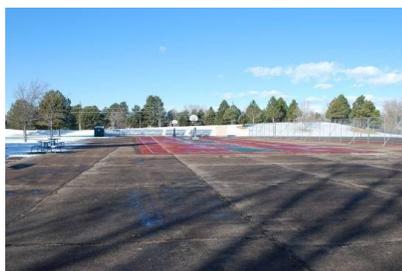
## Runway Apron and Buildings Along First Avenue

Historically, maintenance activities on the runway apron included degreasing aircraft engines and parts. Buildings previously located along 1st Avenue were used for aircraft maintenance, as well. Reportedly, degreasing solvents were allowed to run directly onto the runway apron, and historical aerial photographs show what appears to be an elongated drain on the eastern end of the runway apron. Groundwater samples collected during the Preliminary Assessment / Site Investigation found several volatile organic compounds at concentrations

near the detection limit.

Several structures along the northern edge of the runway apron were demolished. Due to numerous historical discoveries of buried asbestos-containing materials within the boundaries of the former Lowry Air Force Base, the Colorado Department of Public Health and Environment has requested a complete investigation to determine whether asbestos-containing construction debris has been buried onsite.

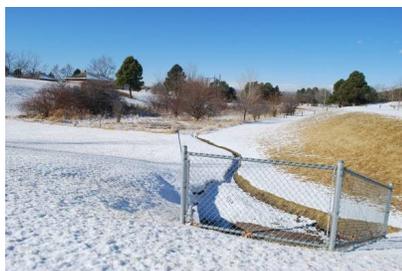
## Wetlands West of Building 444

A storm drainage system developed to drain precipitation from the area surrounding Building 444 consists of an open channel in the southwestern corner of the Buckley Annex parcel. The open drainage is now designated as a wetland and is watered intermittently for aesthetic purposes. No environmental samples have been collected from this area.

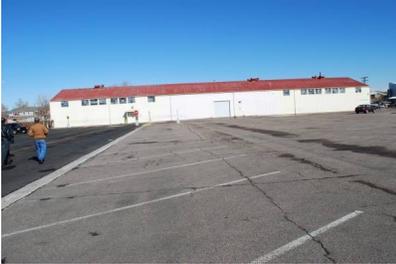
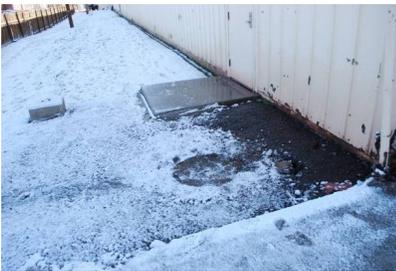
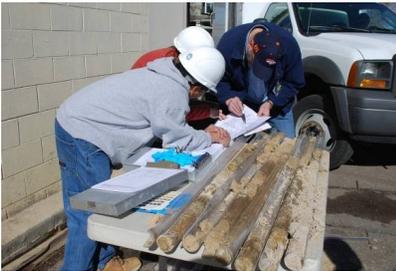
### **Building 409**

Building 409, formerly known as Building 1709, was used as the aerospace ground equipment shop and aircraft maintenance area. The building is currently being used as office space, a maintenance shop, and storage space. Hazardous materials were stored in the building. Two oil water separators were located on the northern side of the building and two above ground storage tanks used for storing magnesium chloride were located on the western end of the building. Stains on the asphalt of the storage yard were

determined to be the result of hydraulic fluid leaking from heavy equipment.

The oil water separator at the eastern end of the facility was removed in April 2004. The oil water separator at the western end of the facility was believed to have been removed earlier. However, during a recent site visit, the Air Force discovered this oil water separator remained. Further work on this oil water separator began in February 2009.

Soil samples collected from beneath the oil water separators in 1999 indicated barium and chromium above laboratory reporting limits. The Colorado Department of Public Health and Environment has not concurred with closure of the oil water separator removal locations, and discussions are on-going to resolve the issues. On November 27, 2008, the Air Force submitted a soil and groundwater investigation work plan to investigate any remaining contamination in the vicinity of the eastern oil water separator. The Colorado

Department of Public Health and Environment approved the work plan on December 19, 2008, recommending additional field screening due to the possibility of fuel-related compounds historically being disposed of in the oil water separators.
