**RE: Expedited Settlement Agreement, Number ES-160317-1  
Star Ranch Filing 2 / CDPS Permit Number: COR03M988**

### EXPEDITED SETTLEMENT AGREEMENT

**Stormwater Inspection Report  
Star Ranch Filing 2**

<b>Permittee:</b> Lorson South Land Corp.	<b>Report Date:</b> July 20, 2015
<b>Legally Responsible Person:</b> Dave Cocolin	<b>Cert#:</b> COR03M988
<b>Facility:</b> Star Ranch Filing 2	<b>Title:</b> VP
<b>Address:</b> Old Star Ranch View & Rocking Tree Grove	<b>Receiving Water:</b> Neal Ranch Creek to Fisher Canyon Creek to Fountain Creek
<b>Persons Present:</b> Jeff Mark/ Lorson South Land Corp; Ron Van Dyke, Trevor Terrill / TNT Landscaping; Steve Kuehster / City of Colorado Springs.	<b>MS4/County:</b> Colorado Springs
<b>Inspector:</b> Rik Gay	
<b>Inspection Began:</b> 6/12/15 1:30 PM	<b>Inspection Completed:</b> 6/12/15 4:00 PM

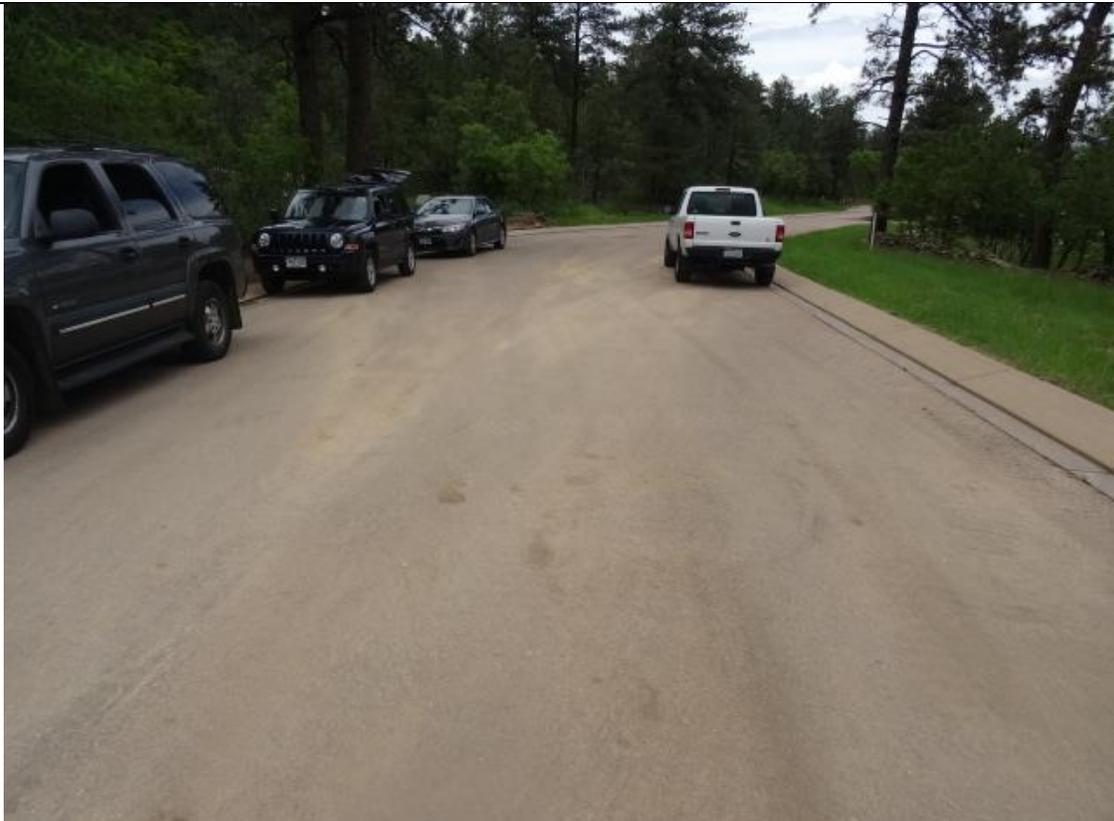
1. It was noted during the inspection that inadequate control measures were implemented to manage stormwater runoff from sediment from vehicle tracking located on Old Star Ranch and Old Timber Grove roads (refer to photographs 1 & 2).

- Significant sediment was observed on the streets beyond the tracking pad.
  - Control Measure Finding: An installation and implementation specification was provided for Vehicle Tracking Control in the SWMP but was not in accordance with good engineering, hydrologic and pollution control practice as required by the permit. Specifically,

- Sediment was deposited on the street surfaces indicating that the control measures, as they were being implemented, were inadequate.
  - Stormwater runoff from this area is discharged as follows: Runoff from the paved surfaces was collected in inlets which discharged to the Colorado Springs MS4 and ultimately to Fountain Creek. Additional control measures were implemented down gradient of this location (rock sock curb checks). However, these down gradient controls were implemented as part of a treatment train and are dependent on the control measure identified as inadequate in this finding. As a result, the overall system of control measures was inadequate to manage pollutant contribution from the pollutant source referenced above.

**Photograph 1:** Old Star Ranch Road looking east - Vehicle tracking on road

- Maintain all erosion and sediment control practices and other protective practices in good and effective operating condition.
    - Practices must be implemented for all areas of potential vehicle tracking, and can include: minimizing site access; street sweeping or scraping; tracking pads; graveled parking areas; requiring that vehicles stay on paved areas on-site; wash racks; contractor education; and/or sediment control measures, etc.

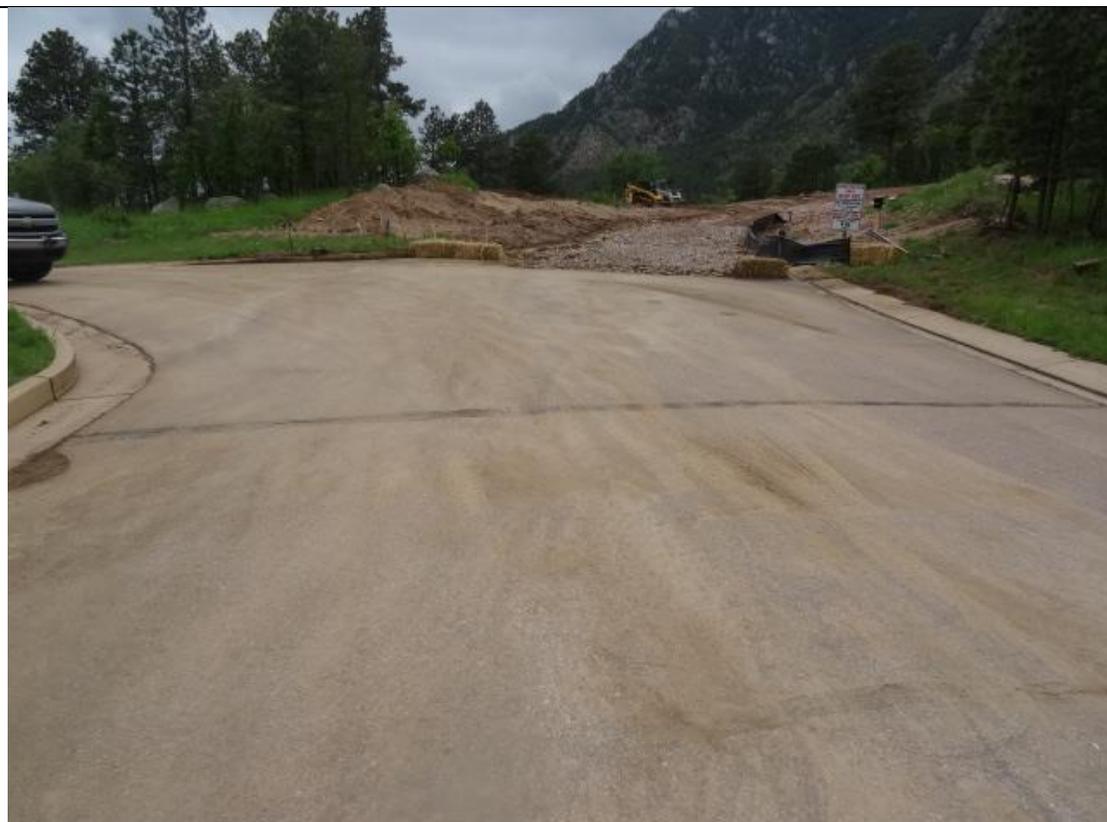
**Photograph 2:** Looking west from Photograph 1 toward construction entrance - Vehicles Tracking

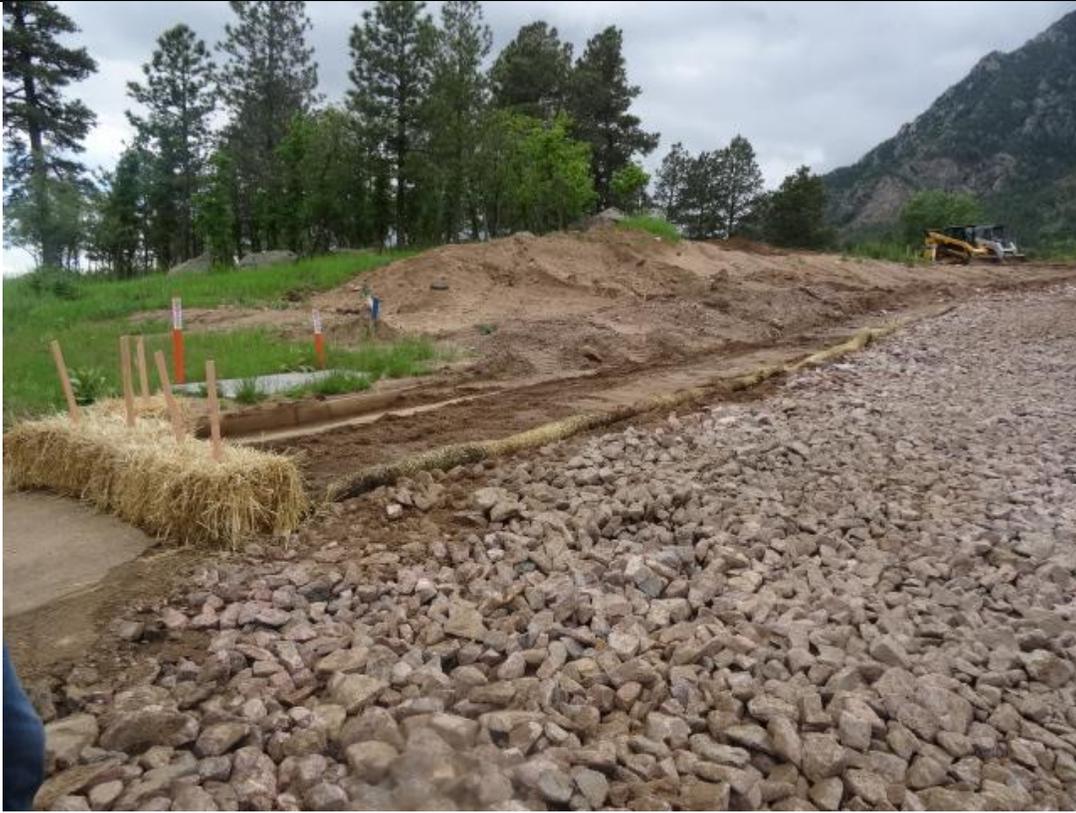
3. It was noted during the inspection that inadequate control measures were implemented to manage stormwater runoff from sediment from disturbed areas located upgradient and south of the vehicle tracking pad (refer to photograph 3).

- Wattle was not secured to the ground.
  - Control Measure Finding: An installation and implementation specification for straw wattle observed in the field during the inspection was not provided in the SWMP as required by the permit. Specifically,

- The straw wattle was not staked to the ground as according to common industry installation standards.
  - Stormwater runoff from this area is discharged as follows: Runoff from the paved surfaces was collected in inlets which discharged to the Colorado Springs MS4 and ultimately to Fountain Creek. Additional control measures were implemented down gradient of this location (rock sock curb checks). However, these down gradient controls were implemented as part of a treatment train and are dependent on the control measure identified as inadequate in this finding. As a result, the overall system of control measures was inadequate to manage pollutant contribution from the pollutant source referenced above.

Photograph 3: Construction entrance - Straw wattle not staked.

- Maintain all erosion and sediment control practices and other protective practices in good and effective operating condition.
    - Facilities must select, install, implement, and maintain appropriate control measures, following good engineering, hydrologic and pollution control practices.

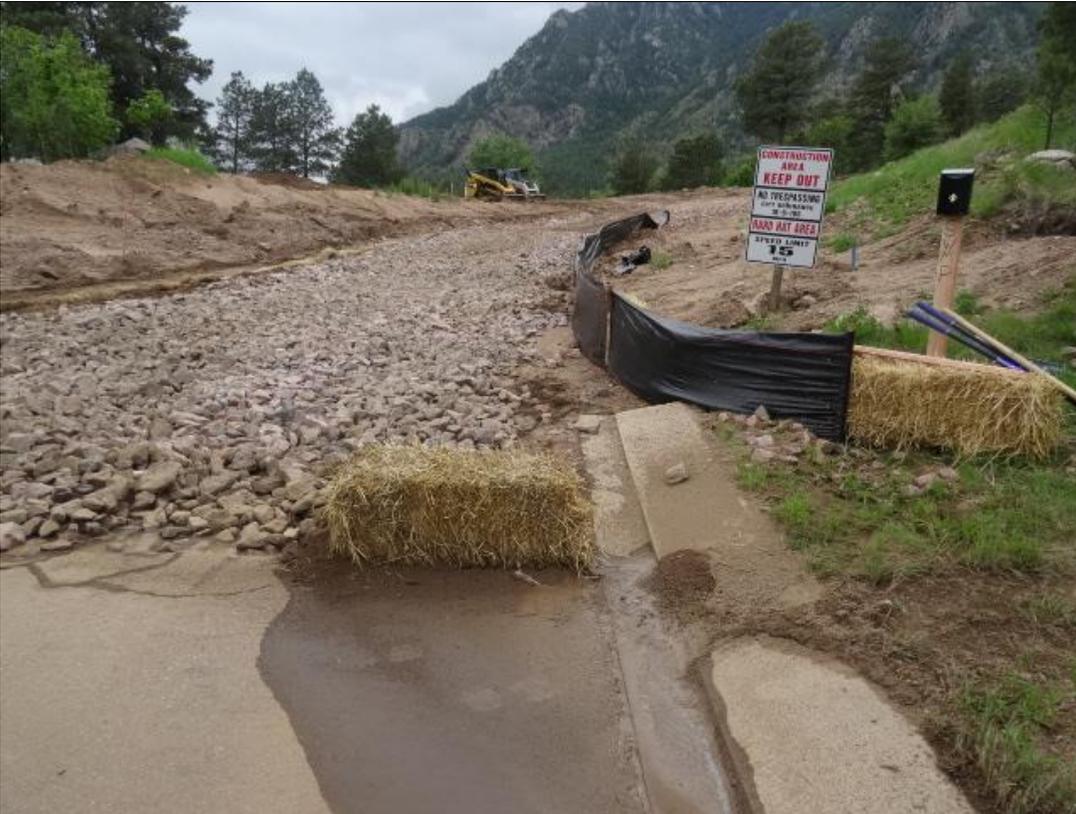
2. It was noted during the inspection that inadequate control measures were implemented to manage stormwater runoff from sediment from disturbed areas located upgradient of the project access (refer to photographs 4 & 6).

- Sediment was observed to have bypassed the control measure and had deposited in the curb line.
  - Control Measure Finding: An installation and implementation specification for straw bales observed in the field during the inspection was not provided in the SWMP as required by the permit. Specifically,

- The straw bales were not secured to the ground as per common industry installation standards.
  - Stormwater runoff from this area is discharged as follows: Runoff from the paved surfaces was collected in inlets which discharged to the Colorado Springs MS4 and ultimately to Fountain Creek. Additional control measures were implemented down gradient of this location (rock sock curb checks). However, these down gradient controls were implemented as part of a treatment train and are dependent on the control measure identified as inadequate in this finding. As a result, the overall system of control measures was inadequate to manage pollutant contribution from the pollutant source referenced above.

Photograph 4: Construction entrance - Straw bales not staked, sediment in flow line

- Maintain all erosion and sediment control practices and other protective practices in good and effective operating condition.
  - Facilities must select, install, implement, and maintain appropriate control measures, following good engineering, hydrologic and pollution control practices.

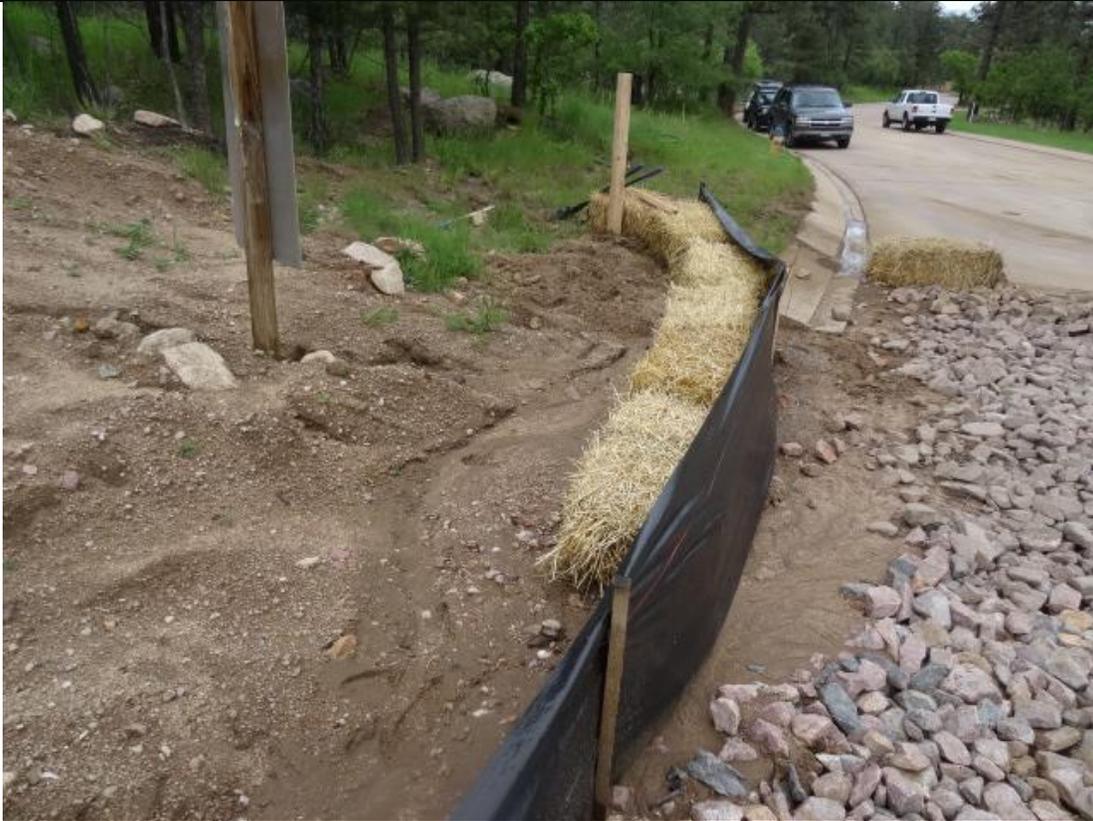
Photograph 6: See photograph #4

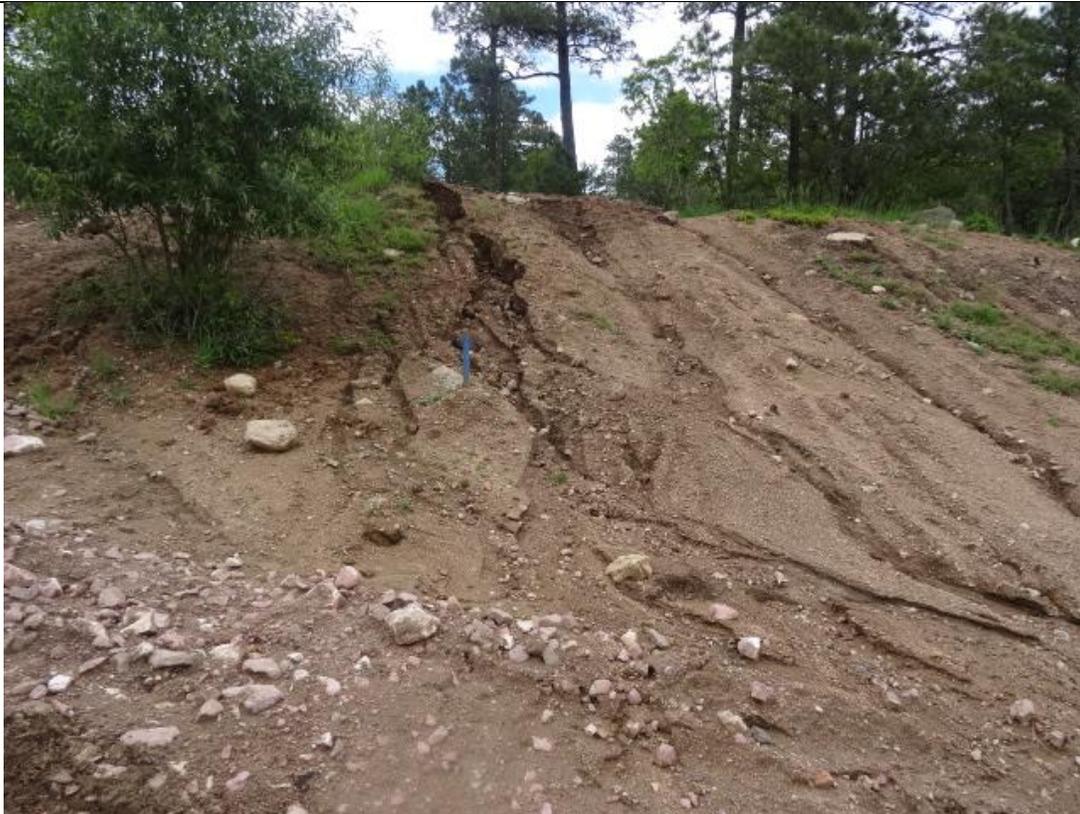
Photograph 7: Unstable slope down gradient of an impoundment.

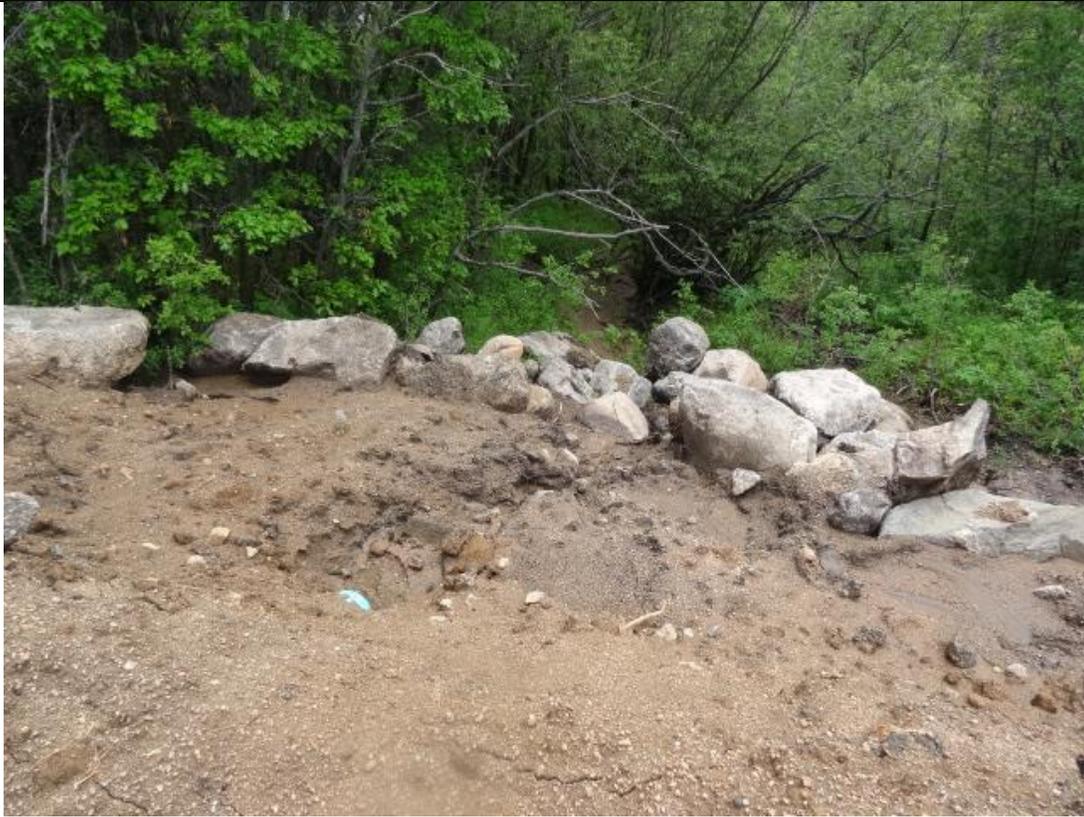
**Photograph 8:** South end of unnamed road. Inadequate control measures at edge of disturbance.

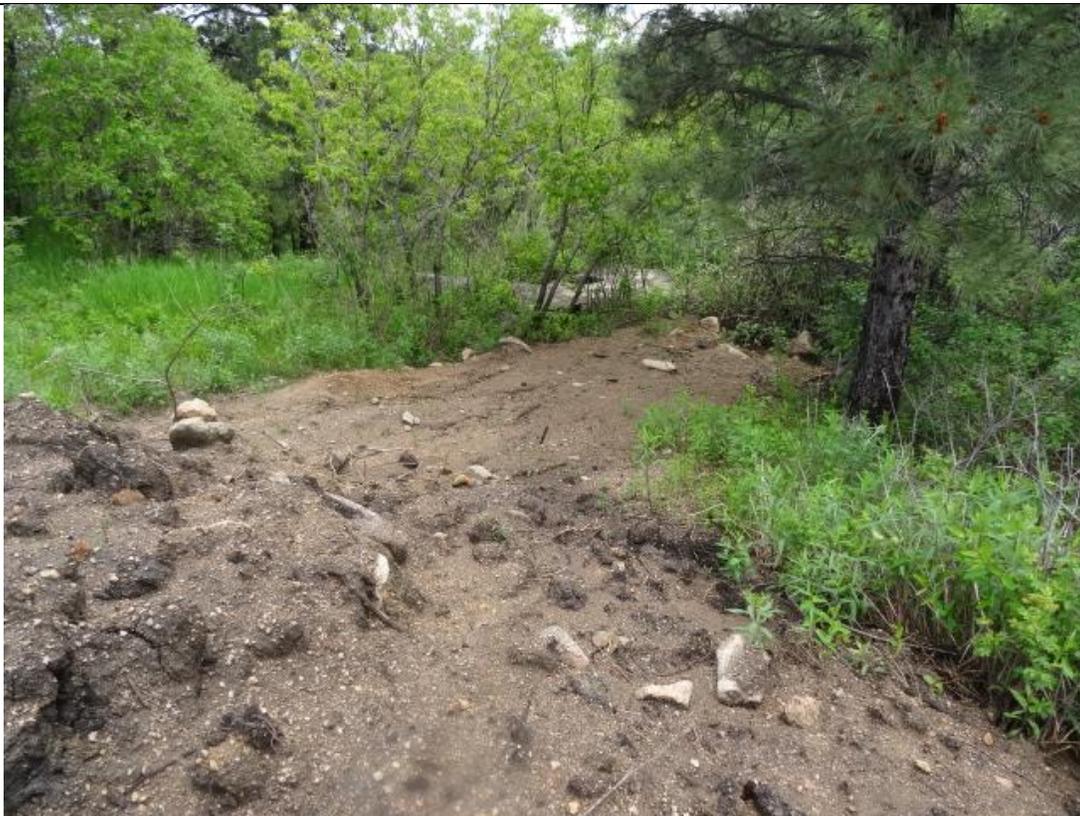
4. It was noted during the inspection that control measures were not implemented to manage stormwater runoff from sediment from disturbed areas located project wide (with the exception of the entrance) (refer to photographs 11, 12, 14, 18, 21, 24 - 30, 32 - 36, 39, 40, 46 - 49).

**Photograph 11:** South end of unnamed road. No control measures at perimeter of disturbance.

- Control measures must be implemented to manage stormwater runoff from all potential pollutant sources.
5. It was noted during the inspection that inadequate control measures were implemented to manage stormwater runoff from run-on flows originating in the west side of the project and conveyed to the east approximately through the center of the project area (refer to photographs 15, 16, 19, 37 & 38).

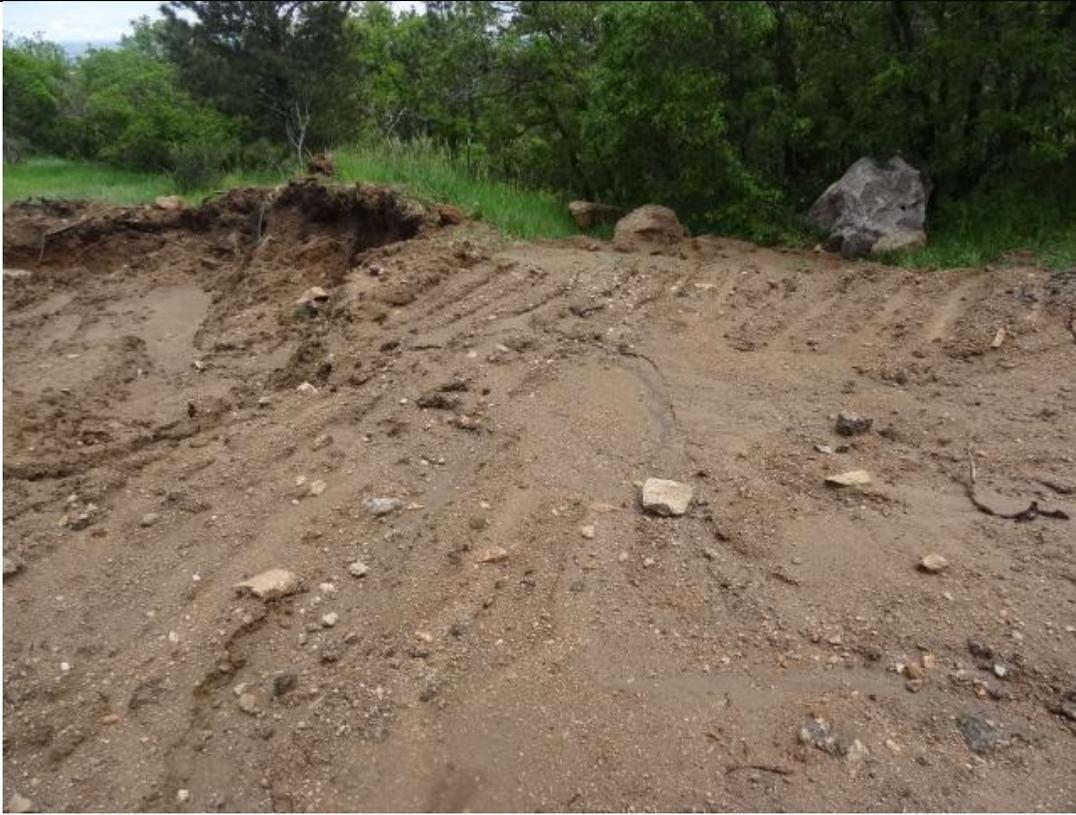
**Photograph 12:** South end of unnamed road. No control measures at perimeter of disturbance.

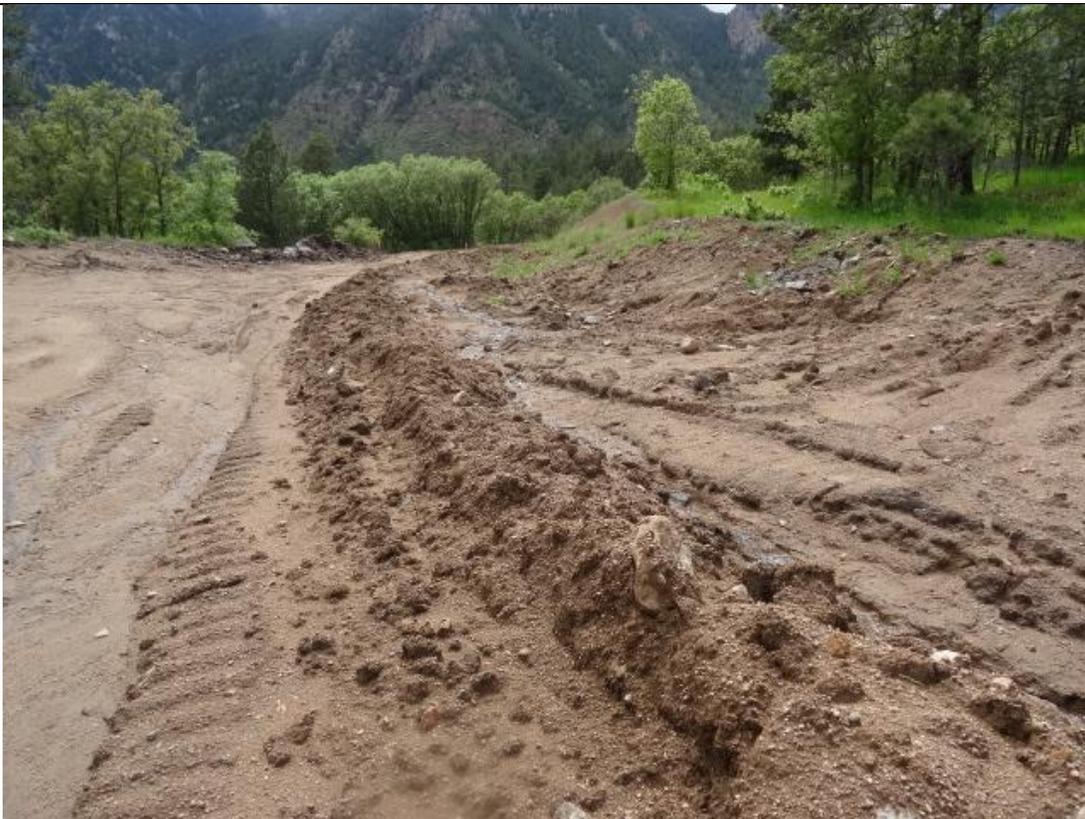
**Photograph 13:** Unnamed road looking north. Disturbed area contributing to photographs 8 - 11.

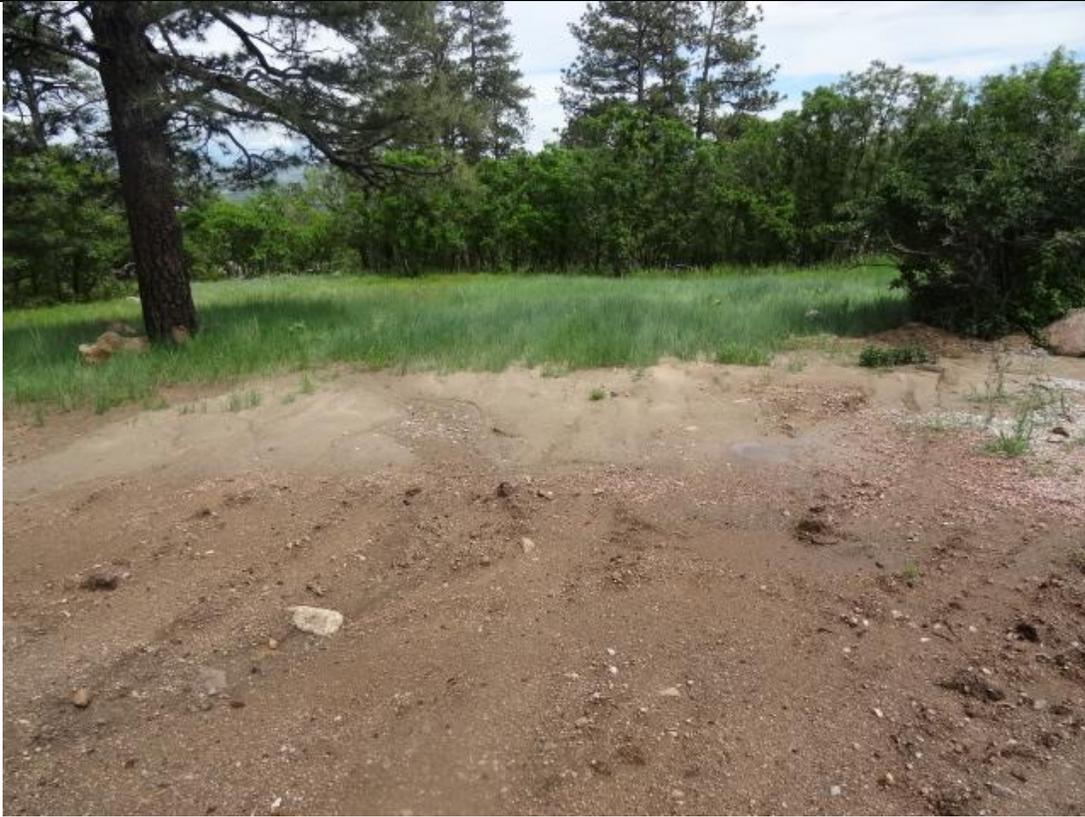
**Photograph 14:** Unnamed road southwest of Star Ranch Road. No control measures at perimeter of disturbance.

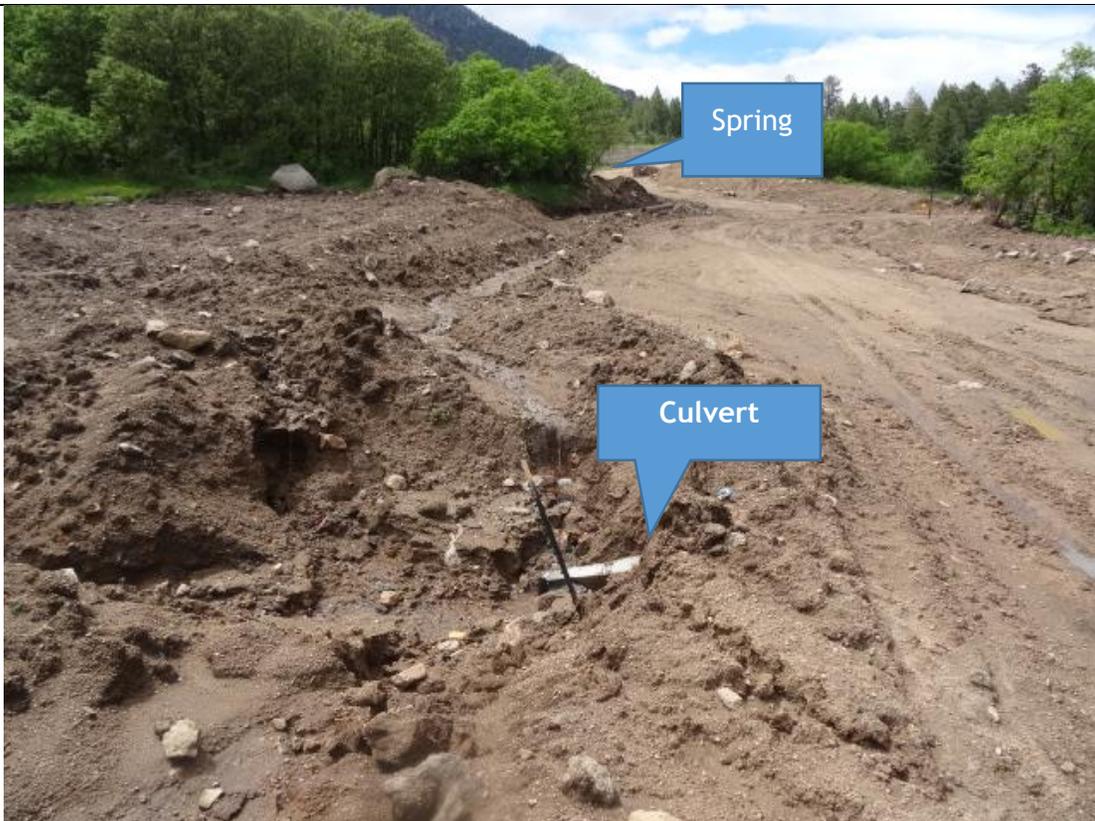
- Run-on flows comingled with surface runoff were of sufficient volume and force to cause significant erosion of the channel.
- Control Measure Finding: Control measures were not implemented to manage stormwater runoff from the above listed pollutant source as required by the permit. Specifically,

**Photograph 15:** Disturbed contributing area at intersection unnamed road looking northwest on Star Ranch Rd.

- Control measures must be implemented to manage stormwater runoff from all potential pollutant sources.
  - Control measures implemented at the site must be adequately designed to provide control for all potential pollutant sources associated with construction activity to prevent pollution or degradation of State waters.

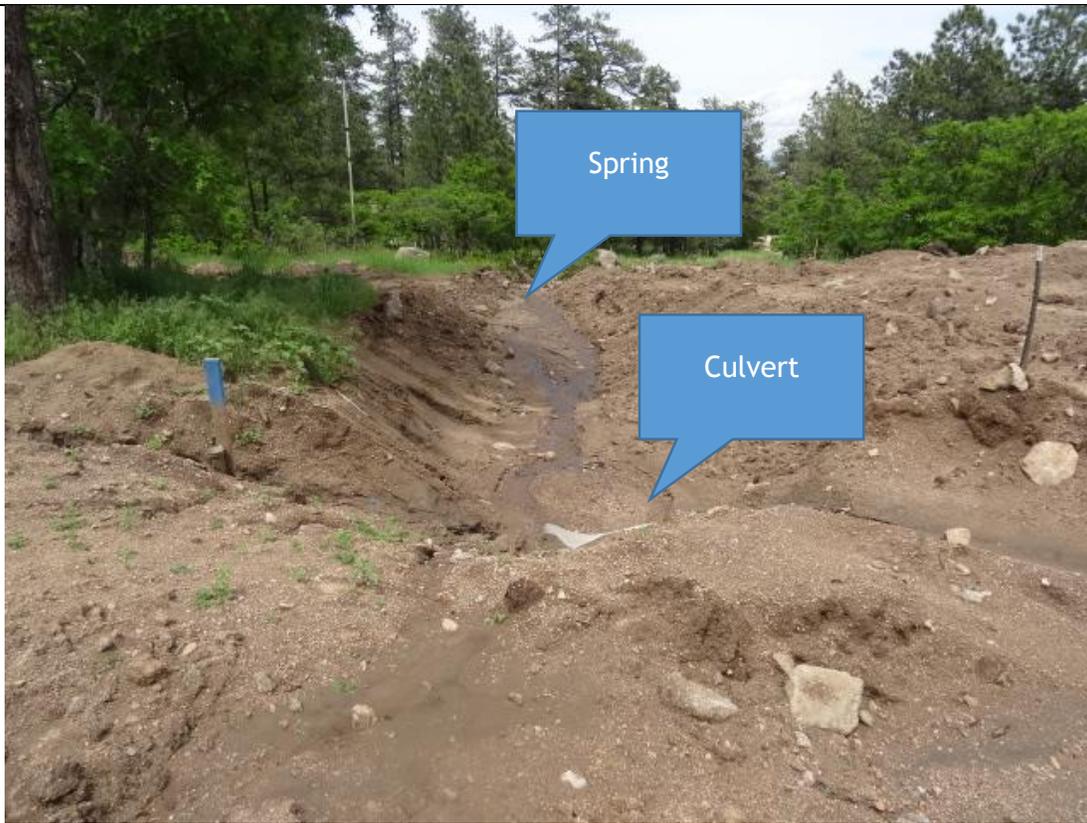
**Photograph 16:** Culvert and drainage ditch. No control measures.

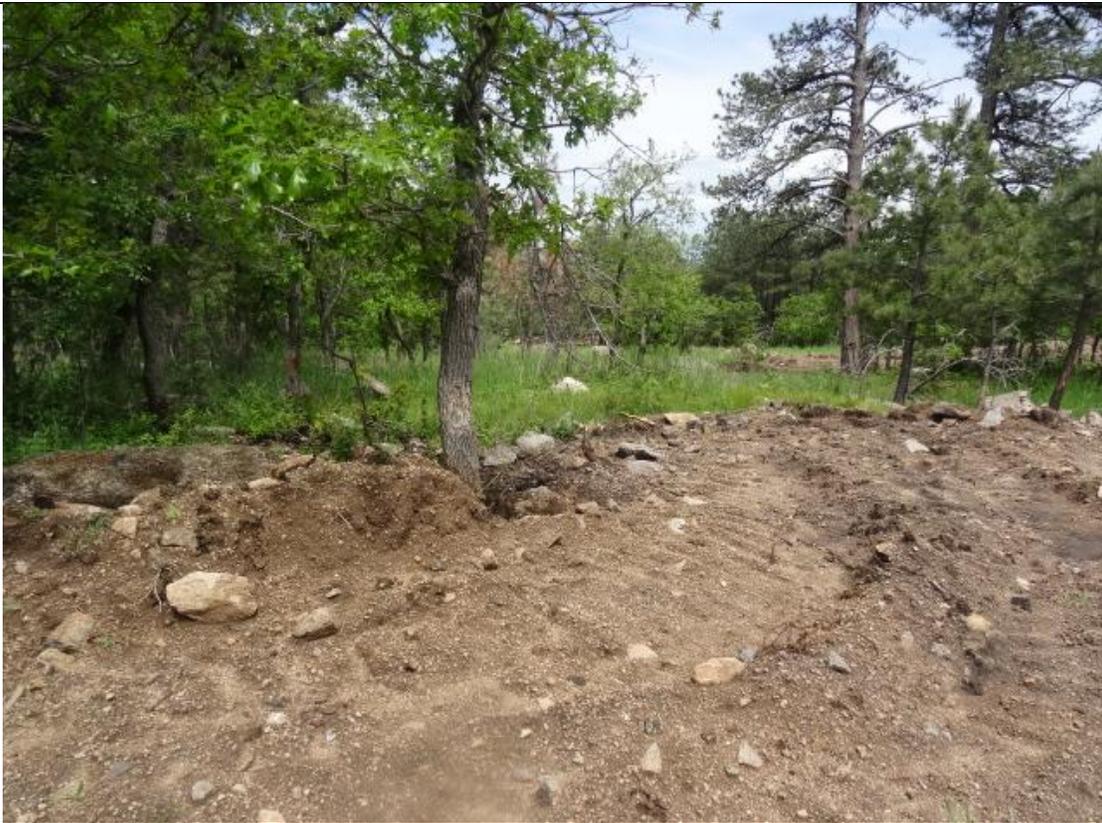
**Photograph 18:** No perimeter control measures on downslope side of disturbance.

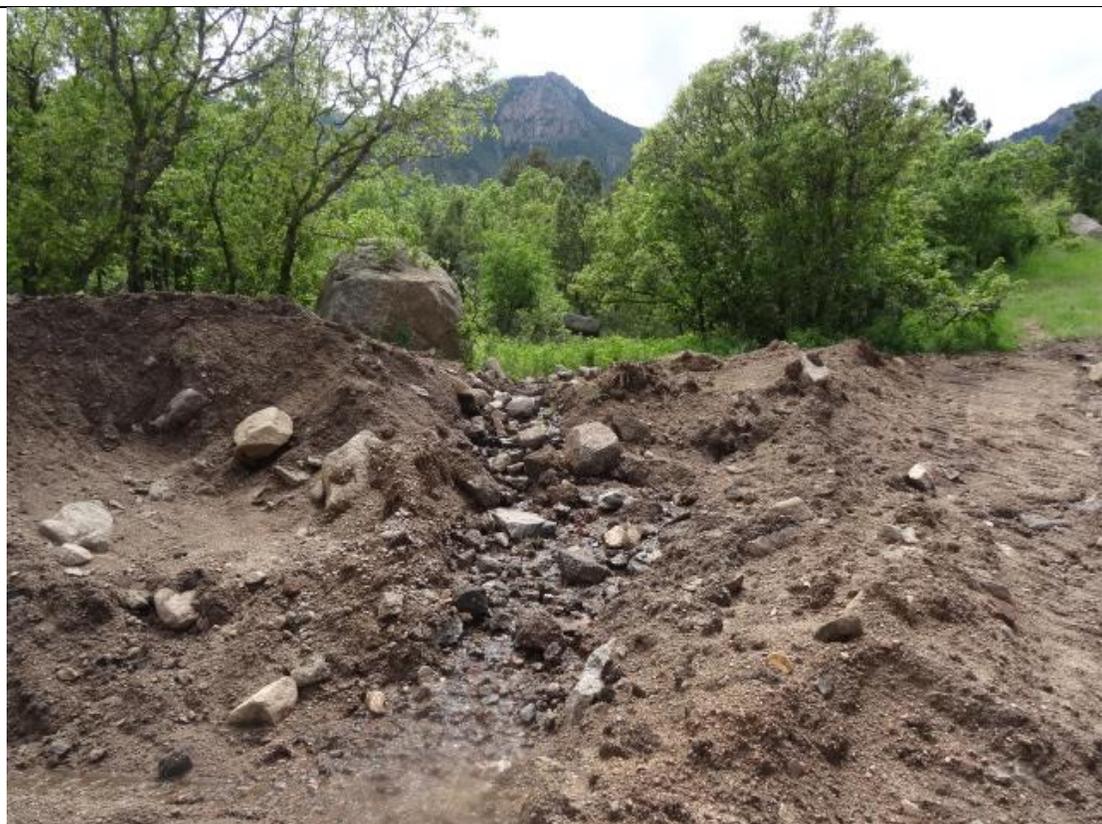
**Photograph 19:** Spring flowing into the project directed to culvert in photograph 15.

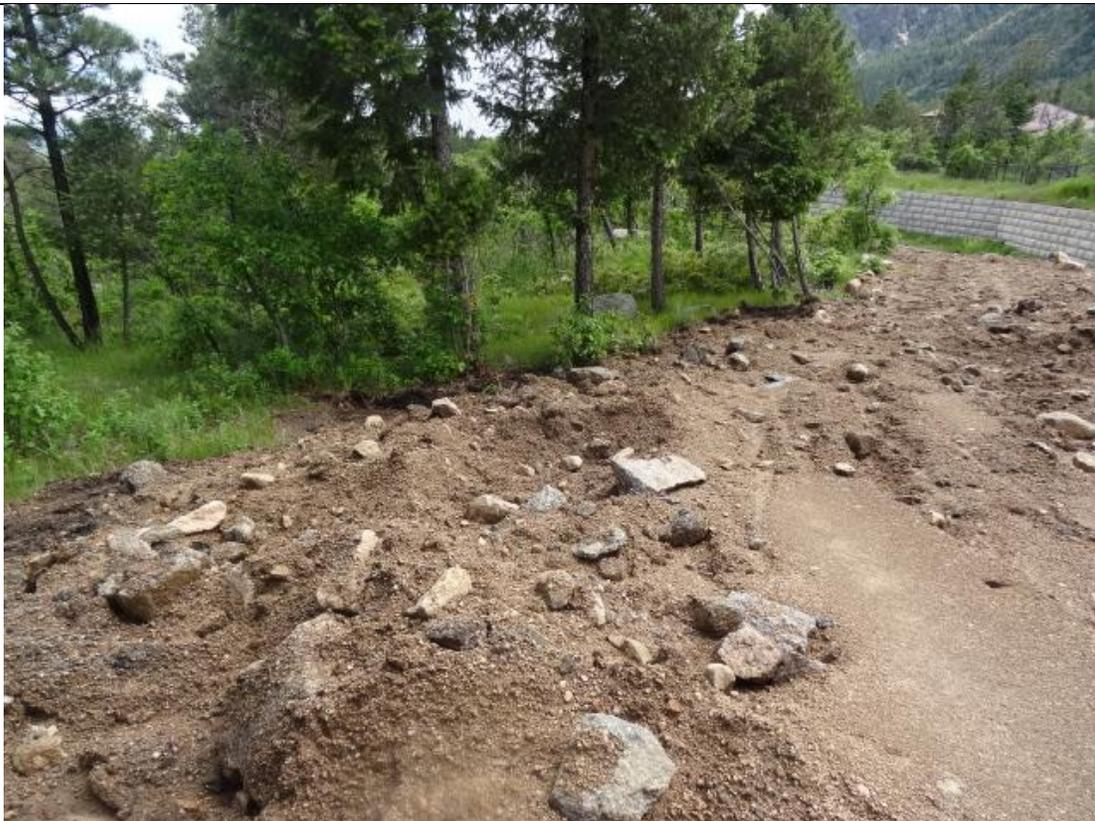
**Photograph 21:** No perimeter control measures on downslope side of disturbance.

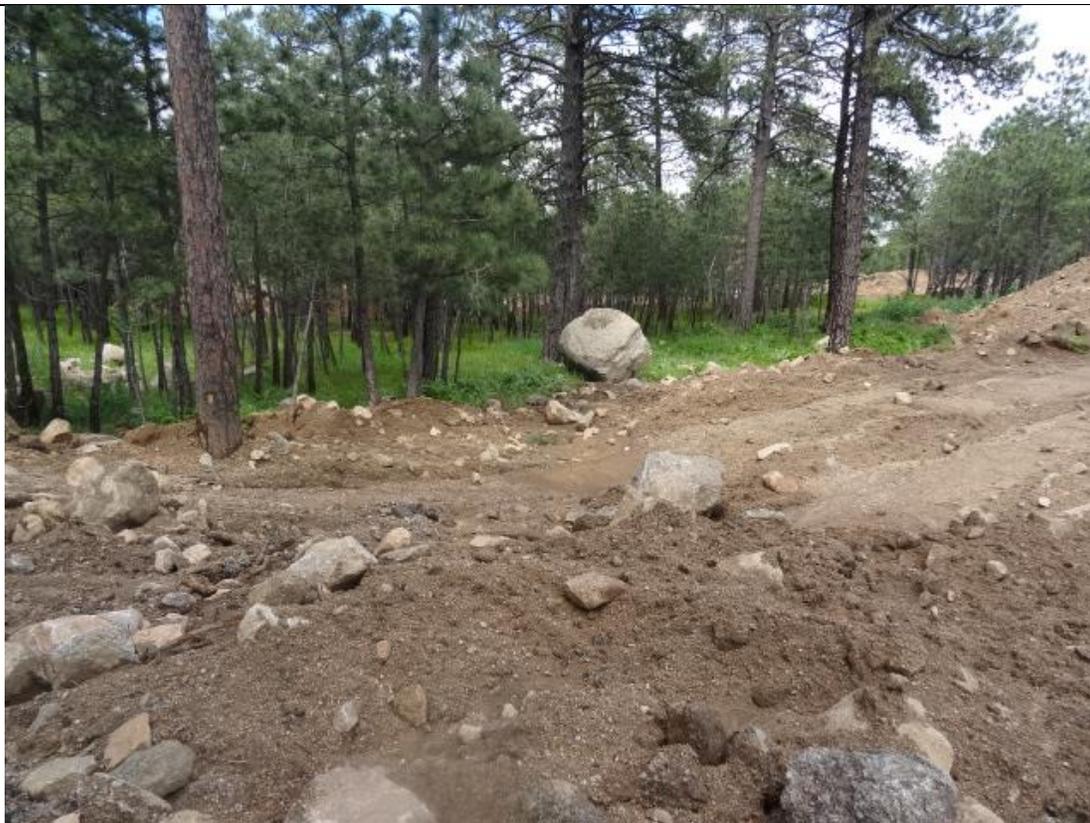
**Photograph 24:** High Lonesome View Rd. No perimeter control measures downslope of the disturbance.

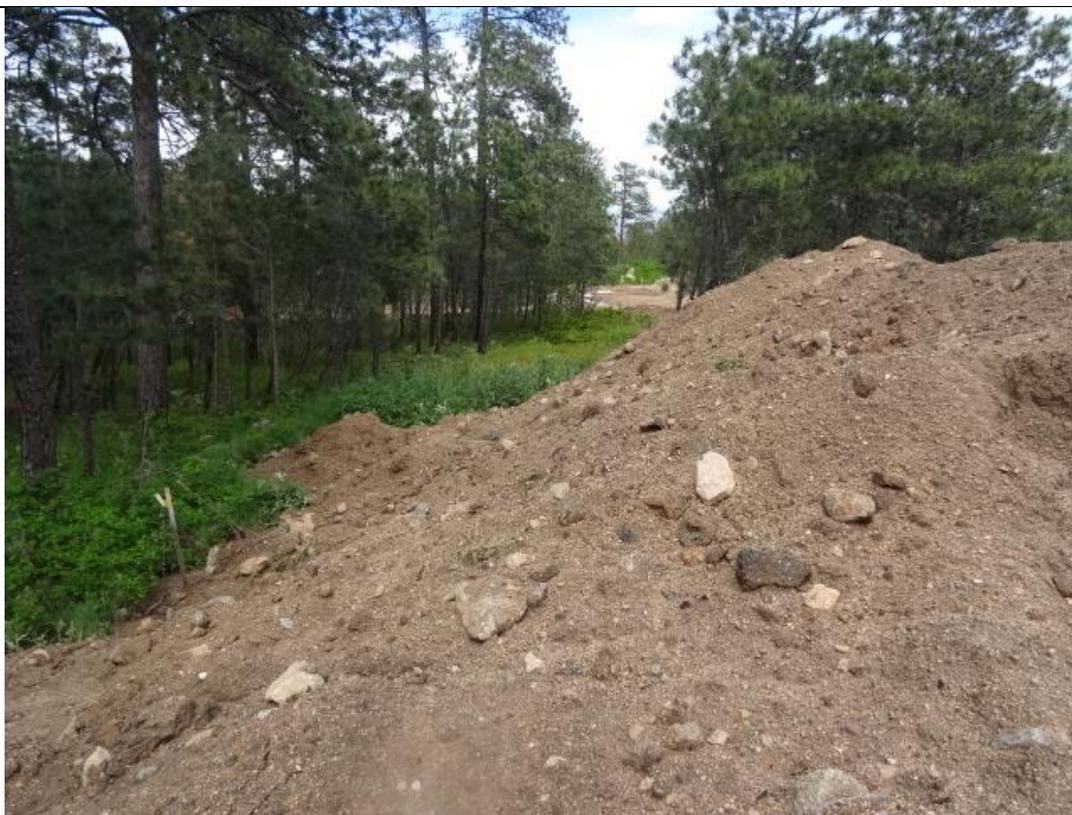
**Photograph 25:** High Lonesome View Rd. No perimeter control measures downslope of the disturbance.

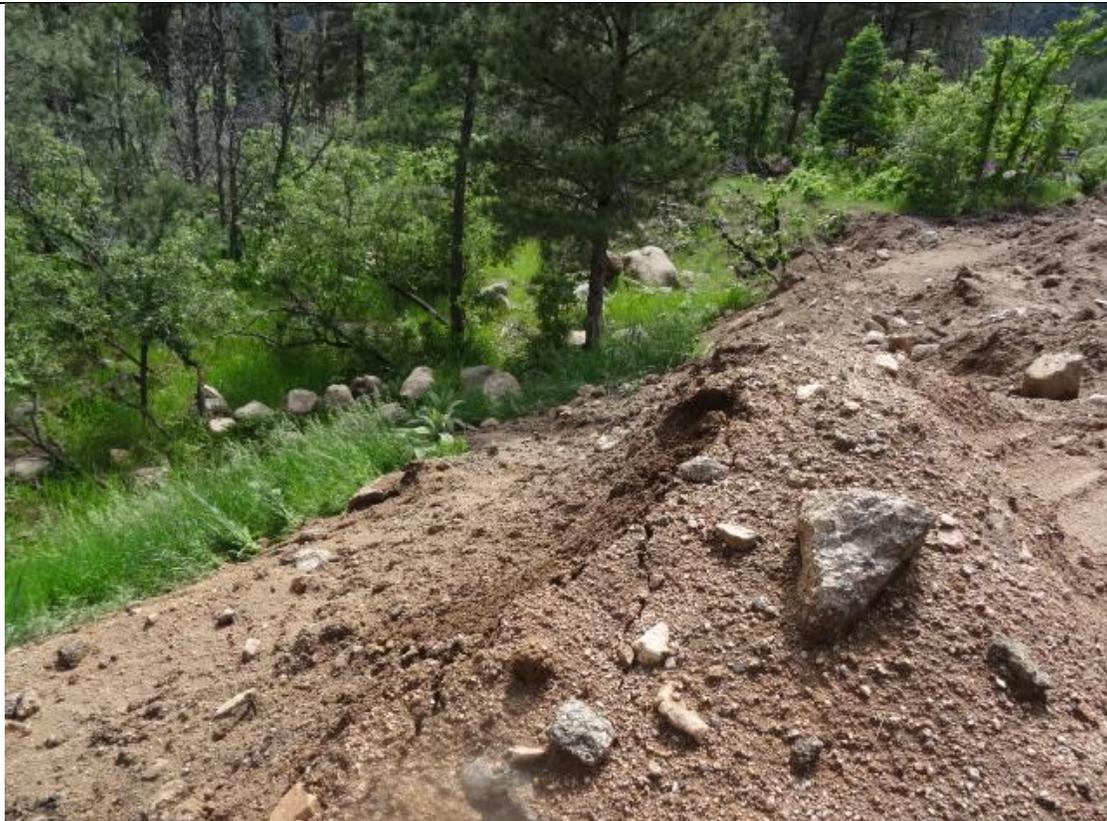
**Photograph 26:** High Lonesome View Rd. No perimeter control measures downslope of the disturbance.

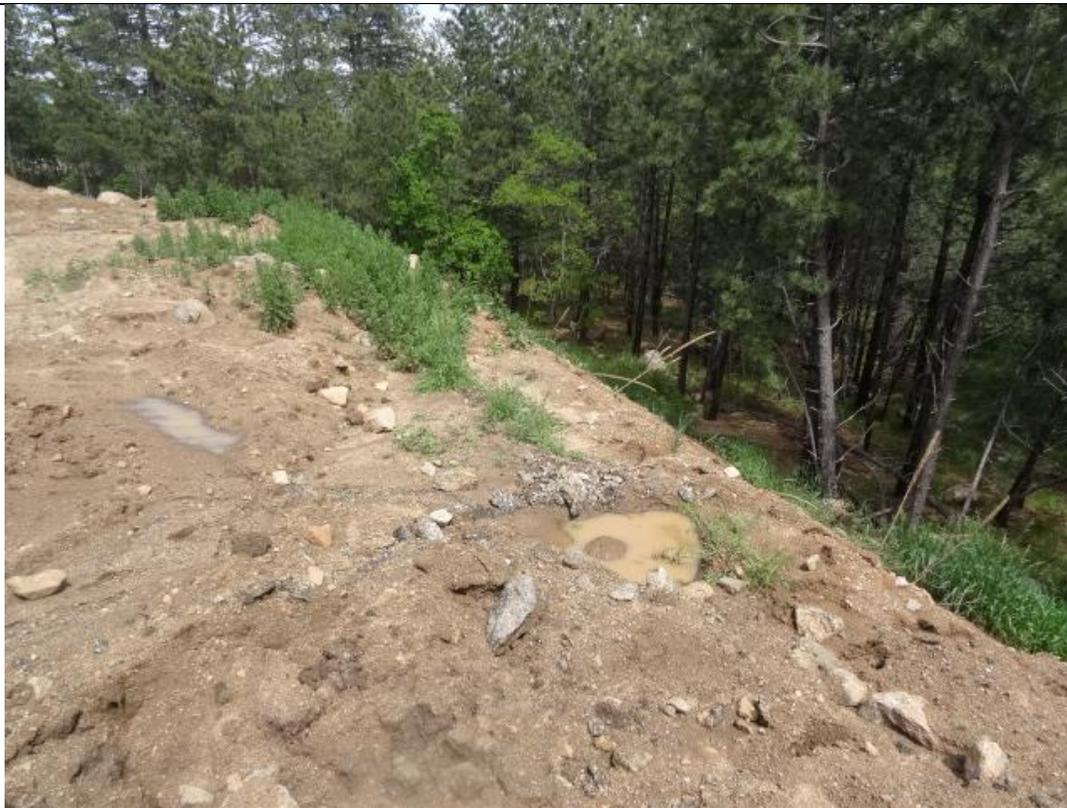
**Photograph 27:** High Lonesome View Rd. No perimeter control measures downslope of the disturbance.

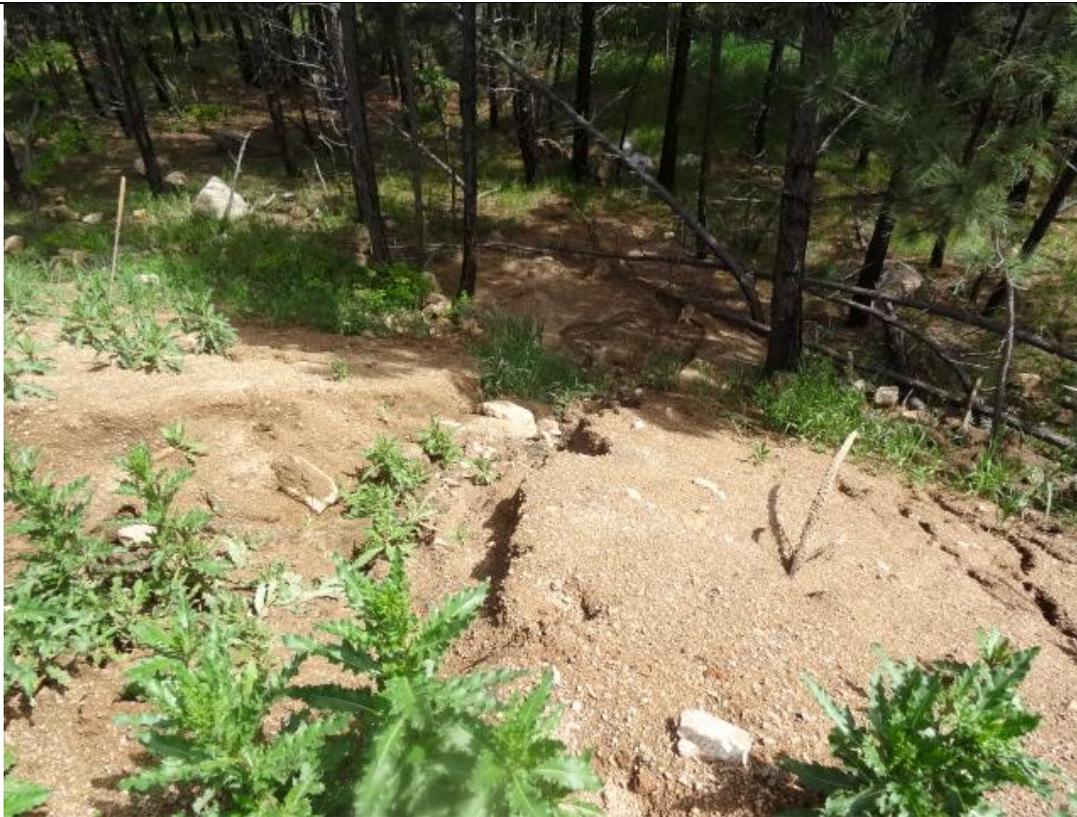
**Photograph 28:** High Lonesome View, discharge of sediment from disturbed area in photographs 29 & 30.

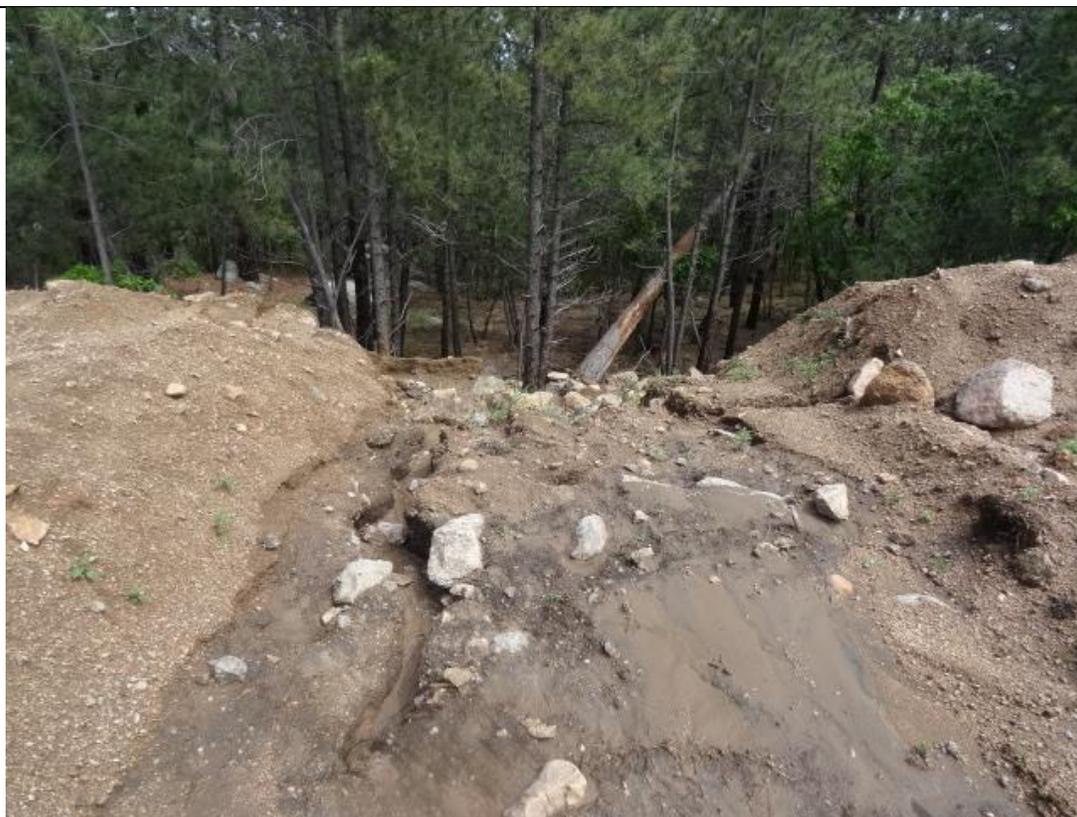
**Photograph 29:** High Lonesome View, discharge of sediment from disturbed area in photograph 30.

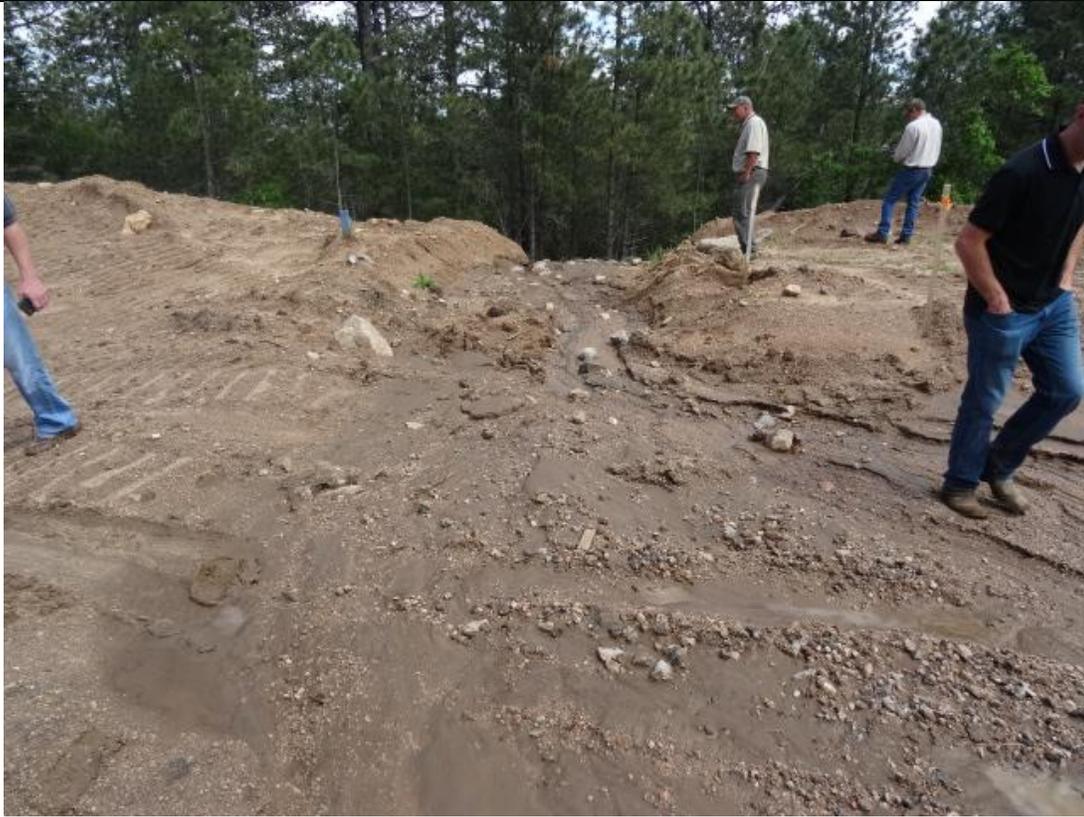
**Photograph 30:** High Lonesome View, no control measures at top of slope.
