**RE: Expedited Settlement Agreement, Number ES-160317-1  
Star Ranch Filing 2 / CDPS Permit Number: COR03M988**

### EXPEDITED SETTLEMENT AGREEMENT

**Stormwater Inspection Report  
Star Ranch Filing 2**

<b>Permittee:</b> Lorson South Land Corp.	<b>Report Date:</b> July 20, 2015
<b>Legally Responsible Person:</b> Dave Cocolin	<b>Cert#:</b> COR03M988
<b>Facility:</b> Star Ranch Filing 2	<b>Title:</b> VP
<b>Address:</b> Old Star Ranch View & Rocking Tree Grove	<b>Receiving Water:</b> Neal Ranch Creek to Fisher Canyon Creek to Fountain Creek
<b>Persons Present:</b> Jeff Mark/ Lorson South Land Corp; Ron Van Dyke, Trevor Terrill / TNT Landscaping; Steve Kuehster / City of Colorado Springs.	<b>MS4/County:</b> Colorado Springs
<b>Inspector:</b> Rik Gay	
<b>Inspection Began:</b> 6/12/15 1:30 PM	<b>Inspection Completed:</b> 6/12/15 4:00 PM

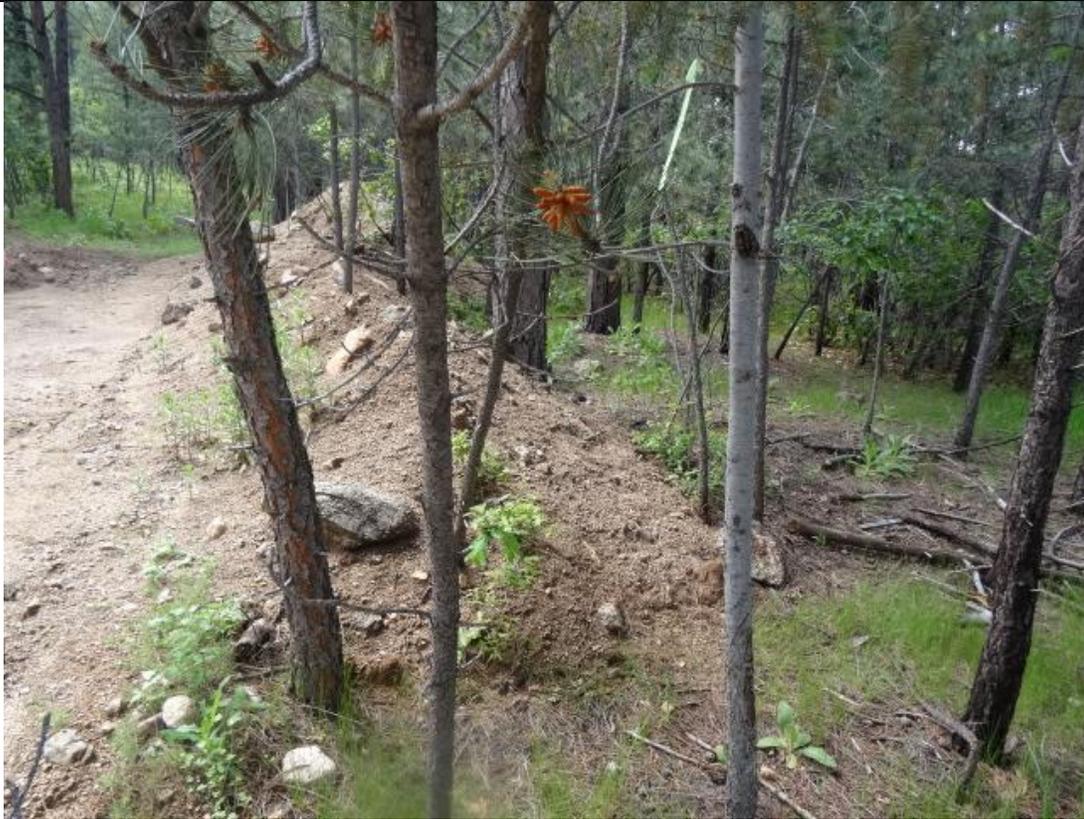
4. It was noted during the inspection that control measures were not implemented to manage stormwater runoff from sediment from disturbed areas located project wide (with the exception of the entrance) (refer to photographs 11, 12, 14, 18, 21, 24 - 30, 32 - 36, 39, 40, 46 - 49).

**Photograph 32:** East end High Lonesome View. No control measures at downslope edge of disturbance.

- Control measures must be implemented to manage stormwater runoff from all potential pollutant sources.
5. It was noted during the inspection that inadequate control measures were implemented to manage stormwater runoff from run-on flows originating in the west side of the project and conveyed to the east approximately through the center of the project area (refer to photographs 15, 16, 19, 37 & 38).

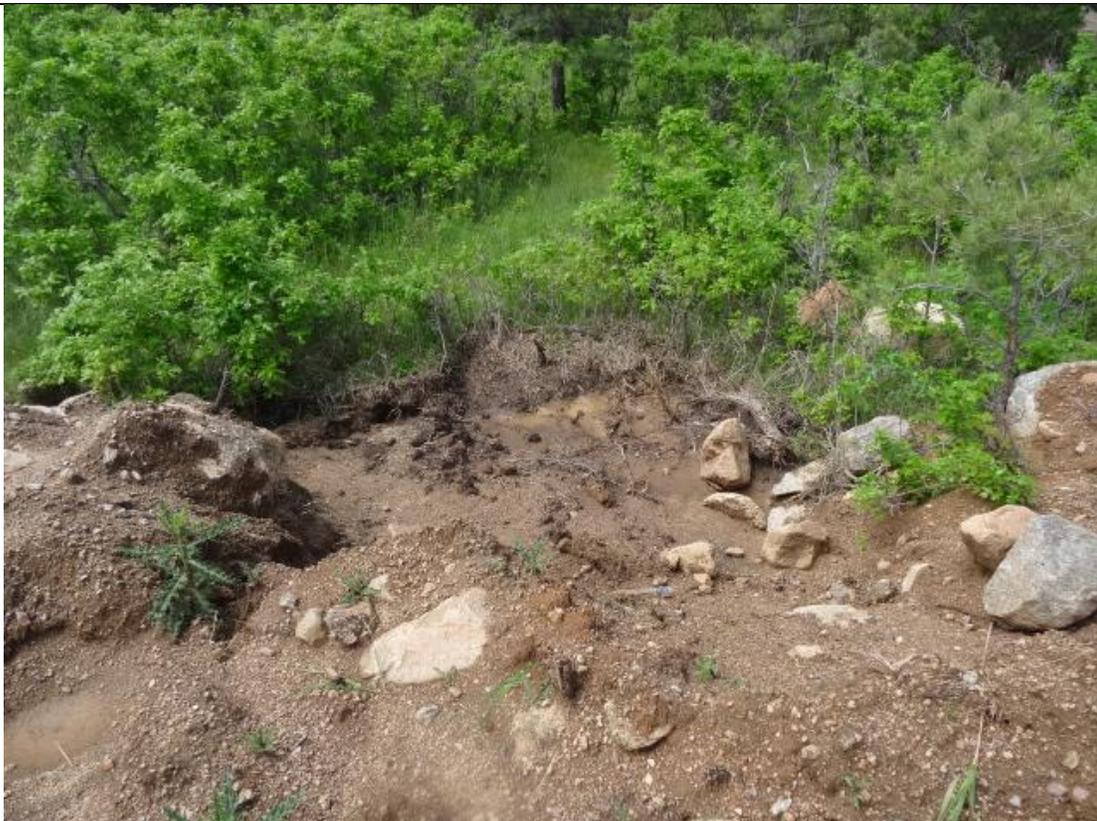
**Photograph 33:** East end High Lonesome View. No control measures at downslope edge of disturbance.

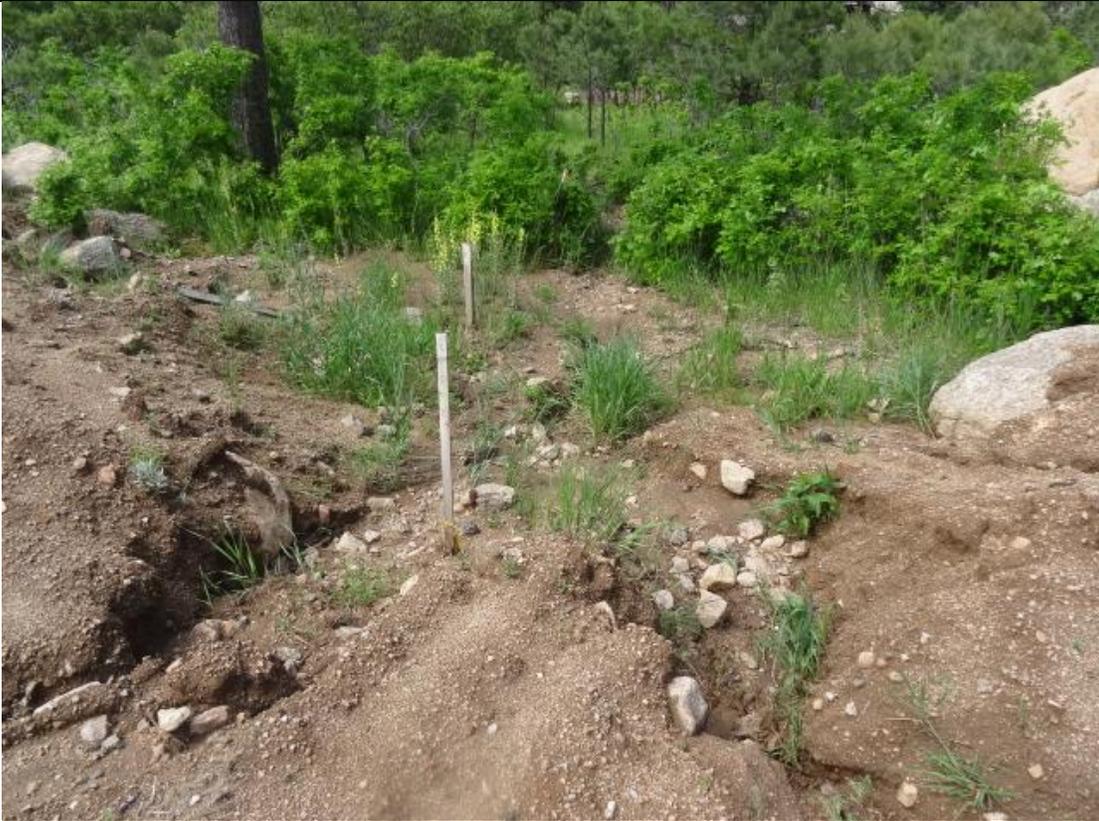
**Photograph 34:** East end High Lonesome View. No control measures at downslope edge of disturbance.

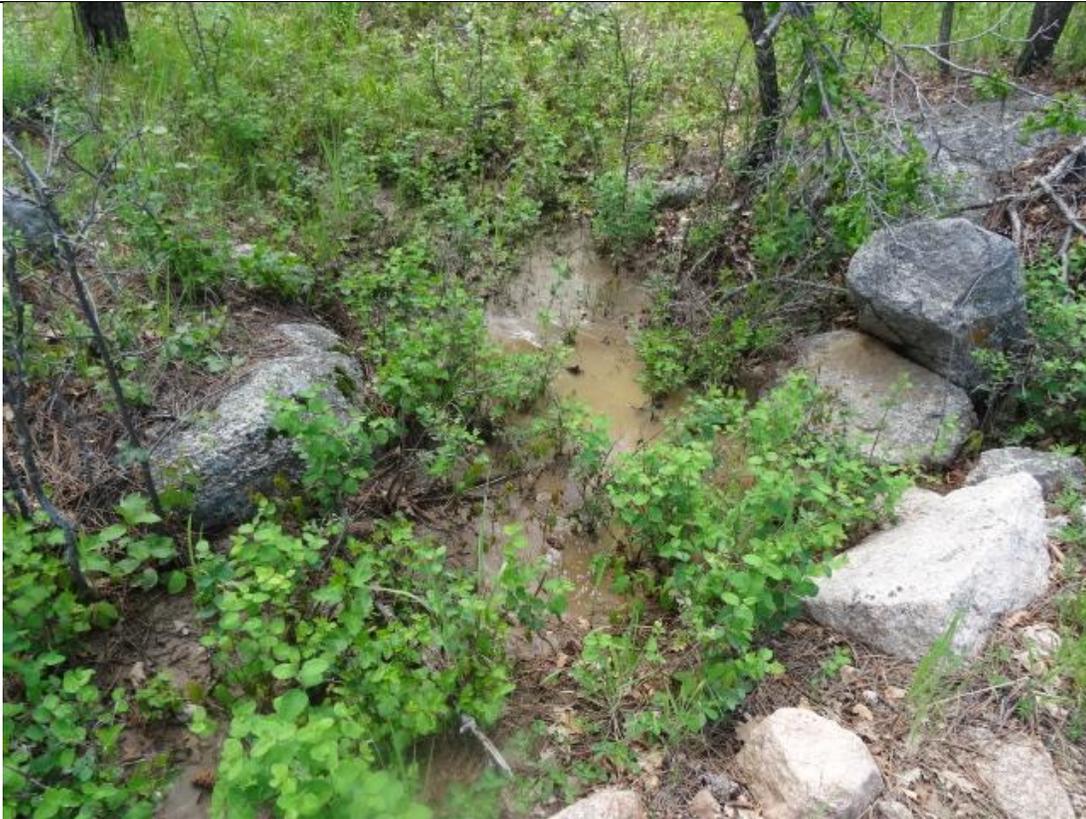
**Photograph 35:** West end High Lonesome View. No control measures at downslope edge of disturbance.

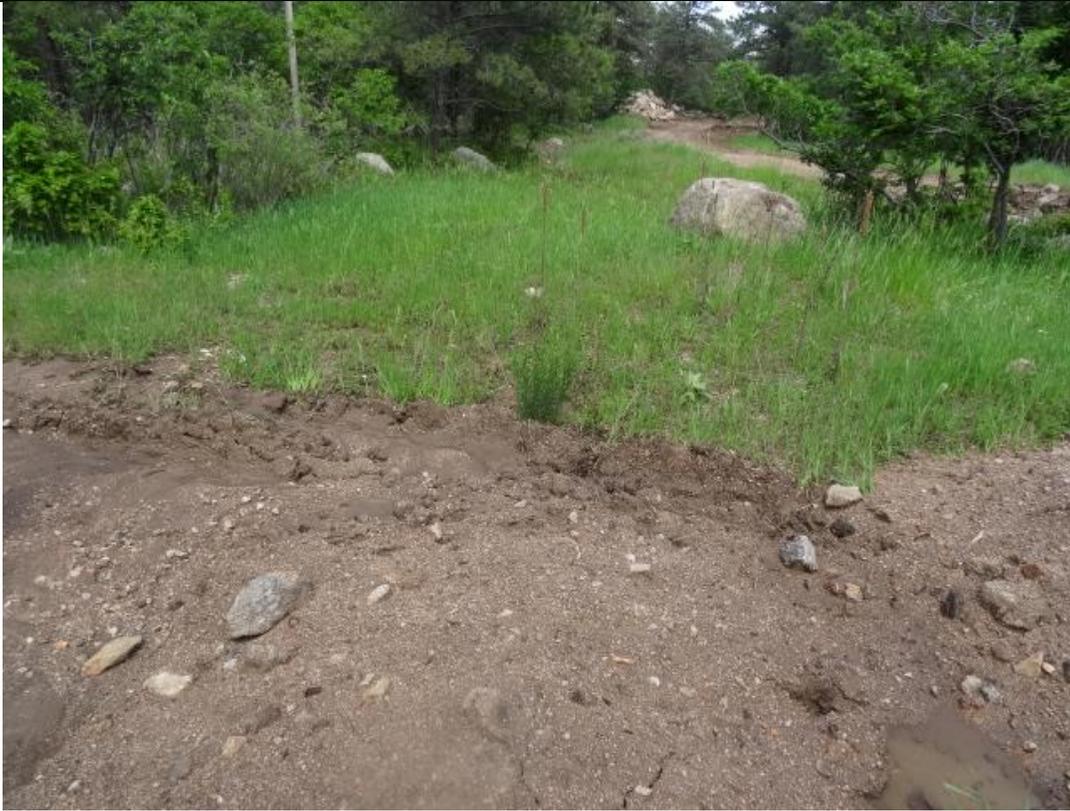
**Photograph 36:** West end High Lonesome View. No control measures at downslope edge of disturbance.

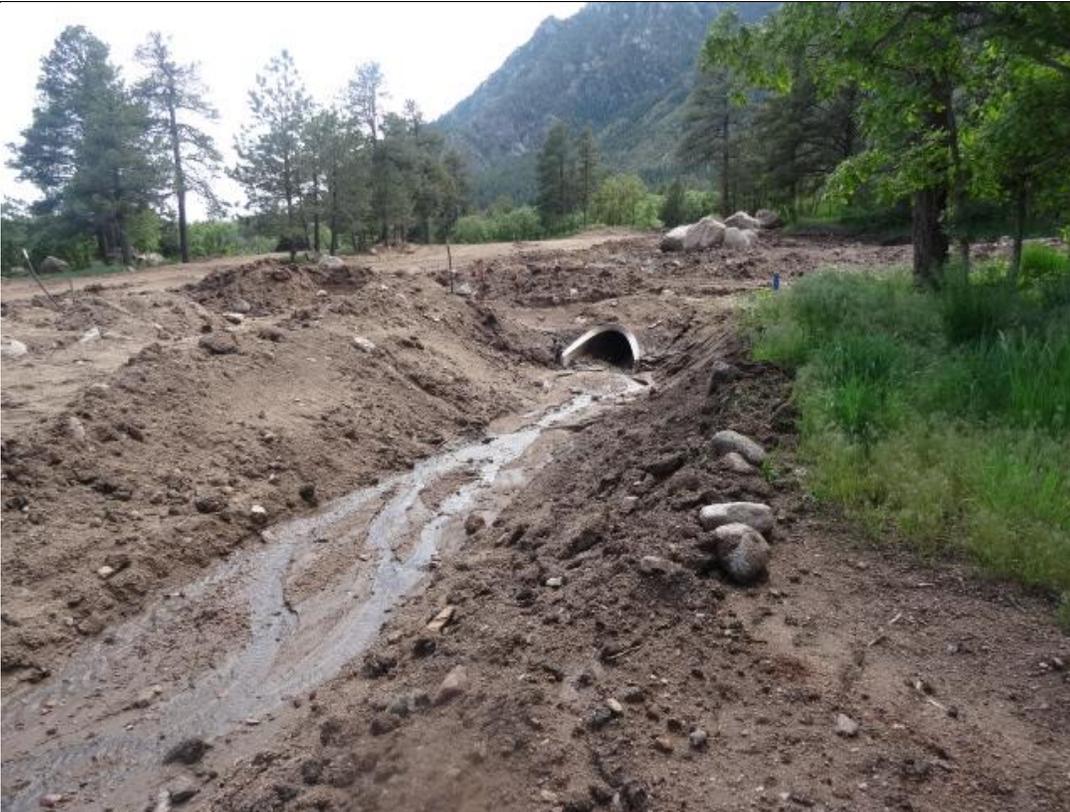
- Run-on flows comingled with surface runoff were of sufficient volume and force to cause significant erosion of the channel.
- Control Measure Finding: Control measures were not implemented to manage stormwater runoff from the above listed pollutant source as required by the permit. Specifically,

**Photograph 37:** Star Ranch Rd. drainage ditch looking northwest. No control measures.

- Control measures must be implemented to manage stormwater runoff from all potential pollutant sources.
  - Control measures implemented at the site must be adequately designed to provide control for all potential pollutant sources associated with construction activity to prevent pollution or degradation of State waters.

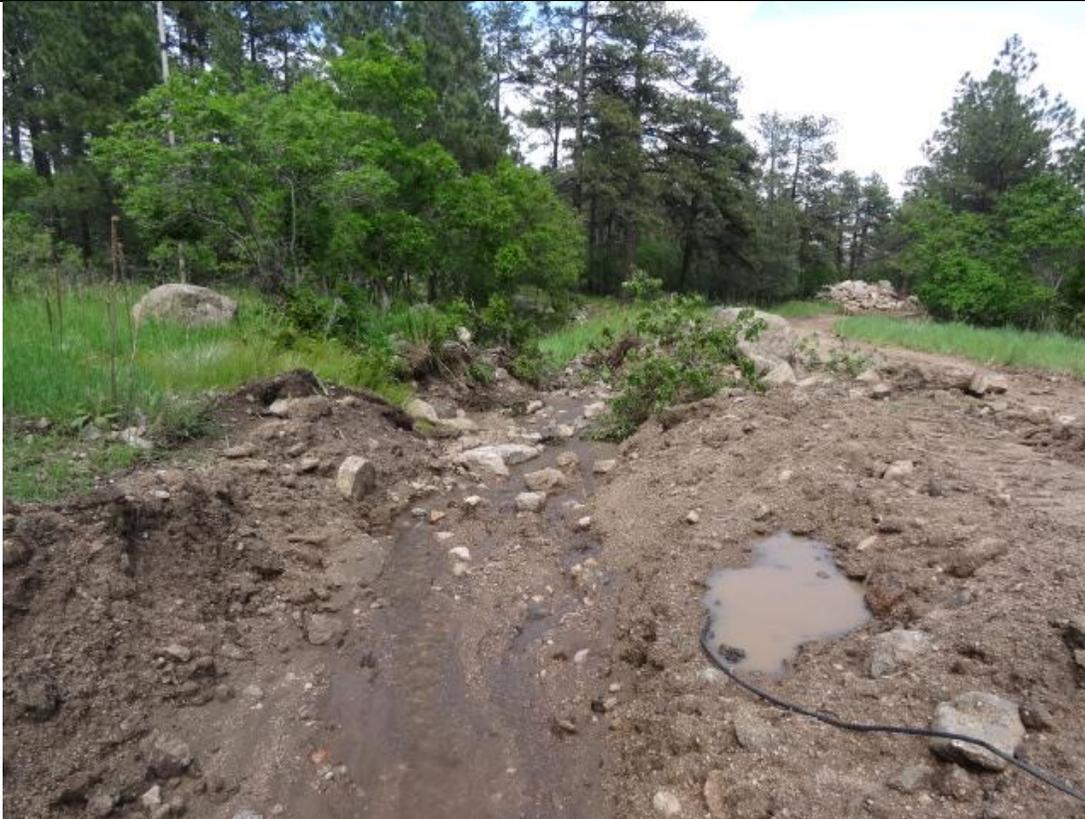
**Photograph 38:** Star Ranch Rd. drainage ditch looking southeast. No control measures.

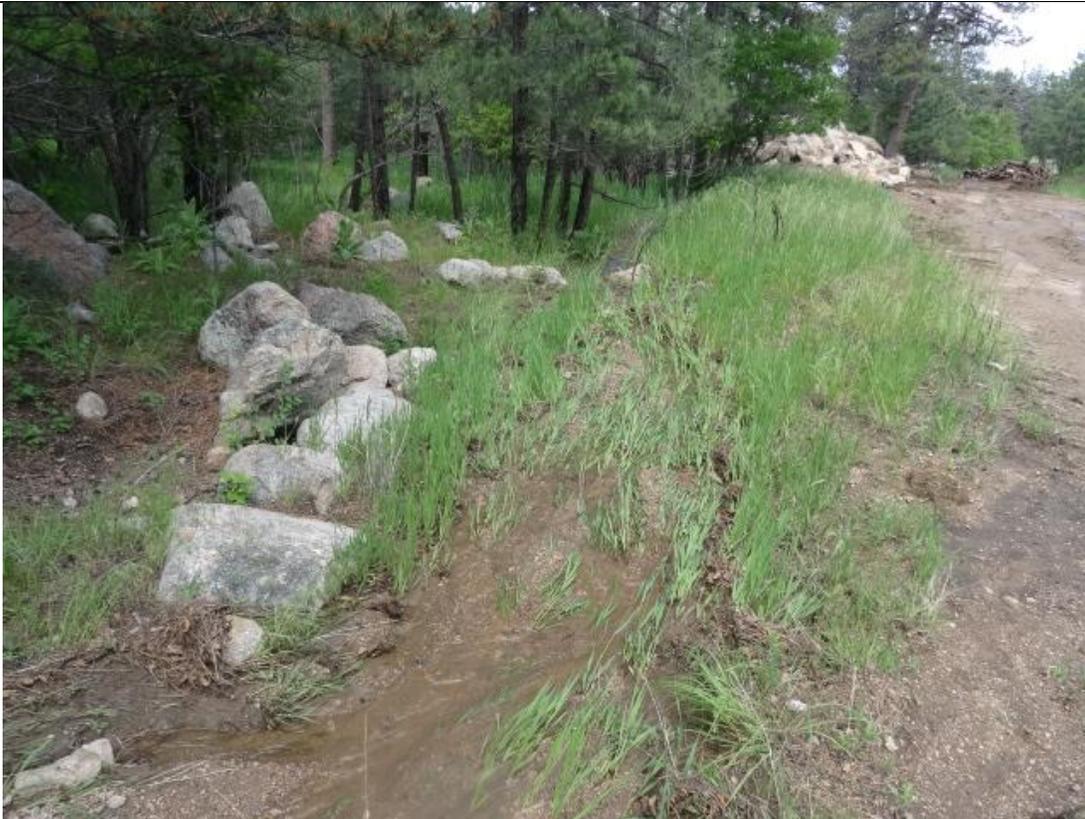
**Photograph 39:** Unnamed road between Star Ranch and High Lonesome Rds. No control measures.

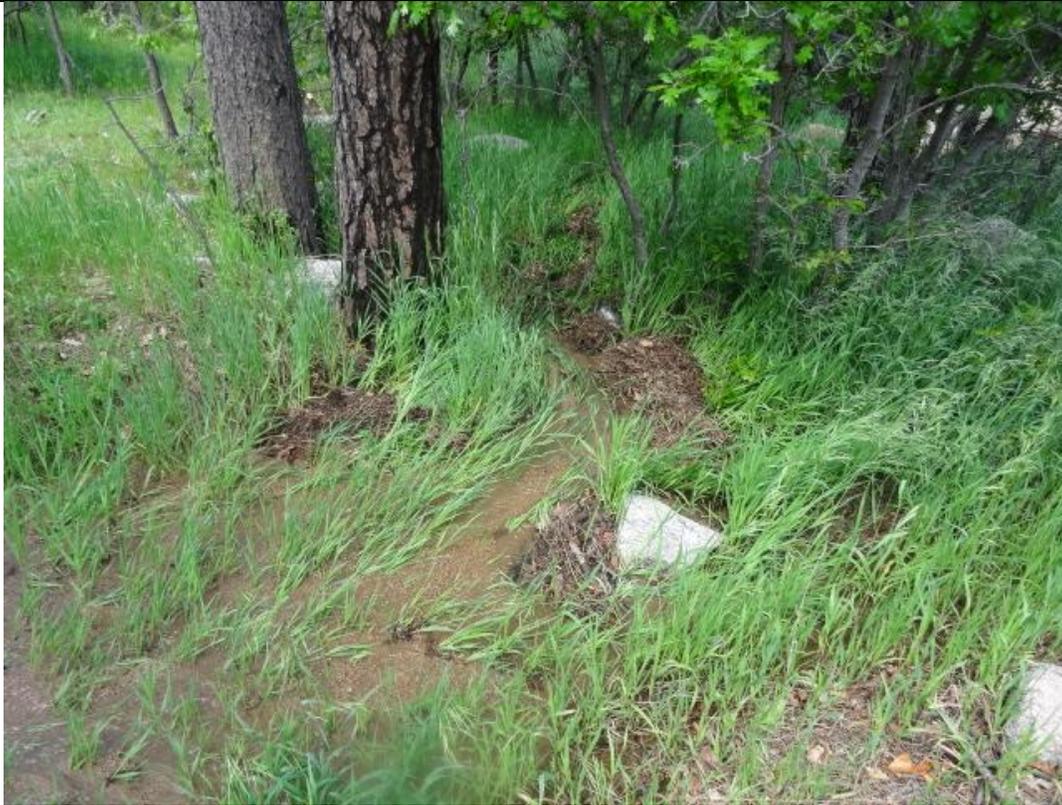
**Photograph 40:** Unnamed road between Star Ranch and High Lonesome Rds. Flow path from photograph 39.

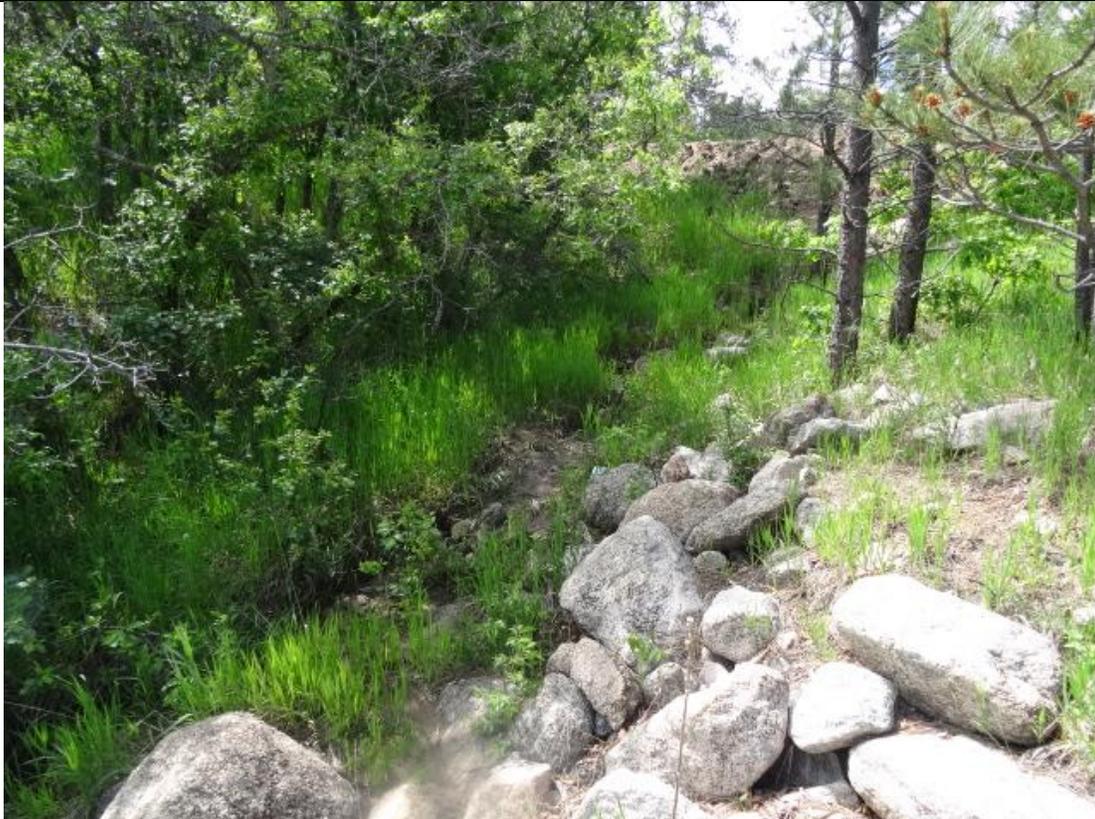
**Photograph 5:** Discharge of sediment down gradient (south) of Old Star Ranch Rd. (Photograph 45)

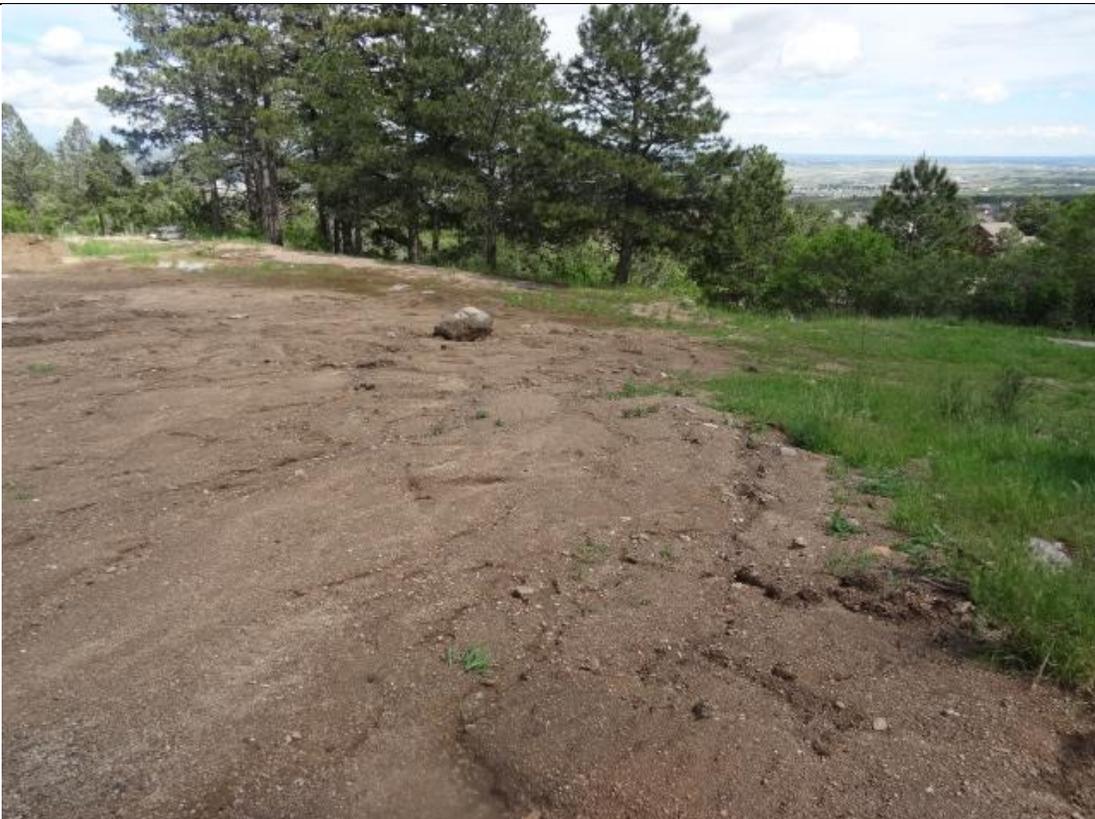
**Photograph 46:** South side of Star Ranch Rd. No control measures downslope of disturbed area.

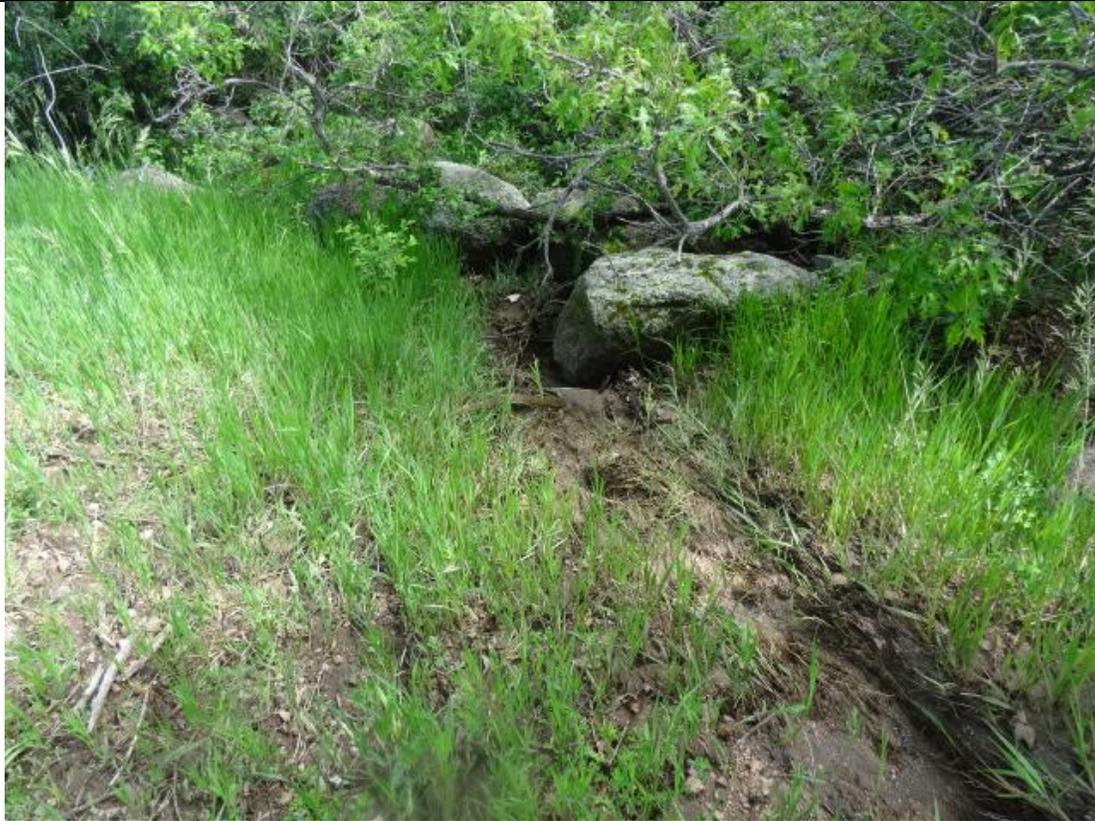
**Photograph 47:** South side of Star Ranch Rd. Discharge from photograph 46.

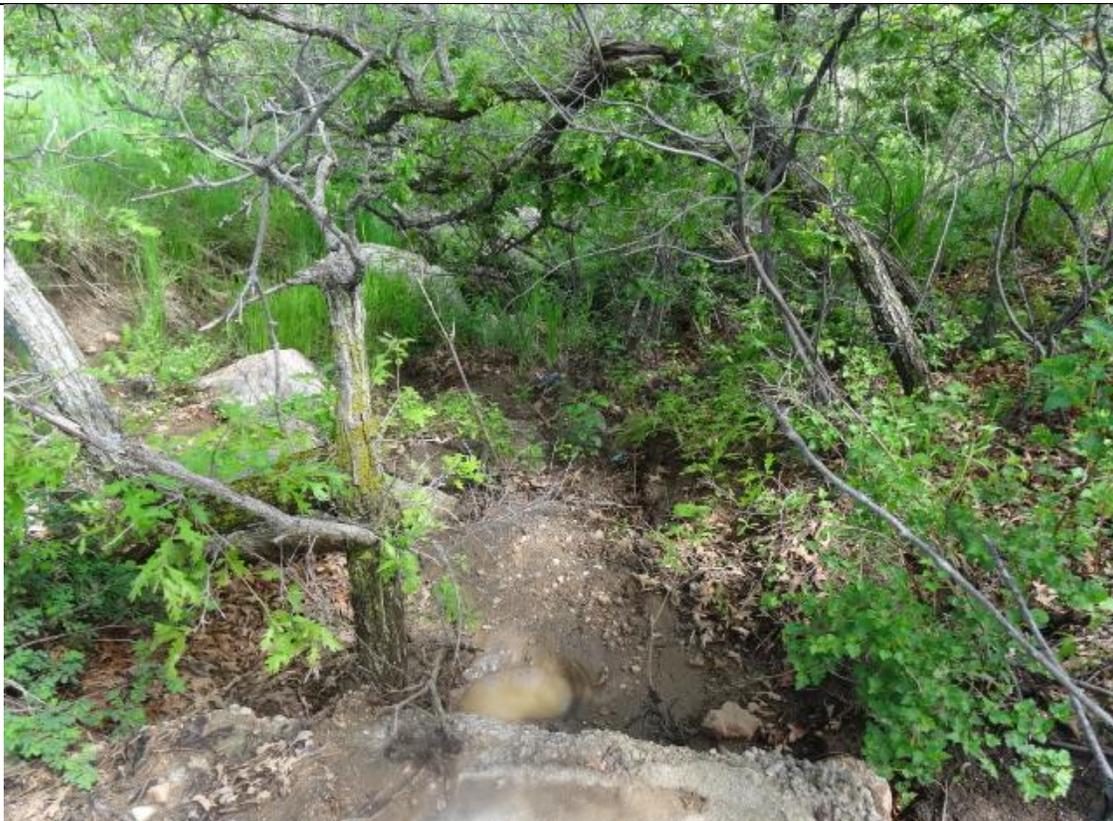
**Photograph 48:** South side of Star Ranch Rd. Discharge from photograph 46.

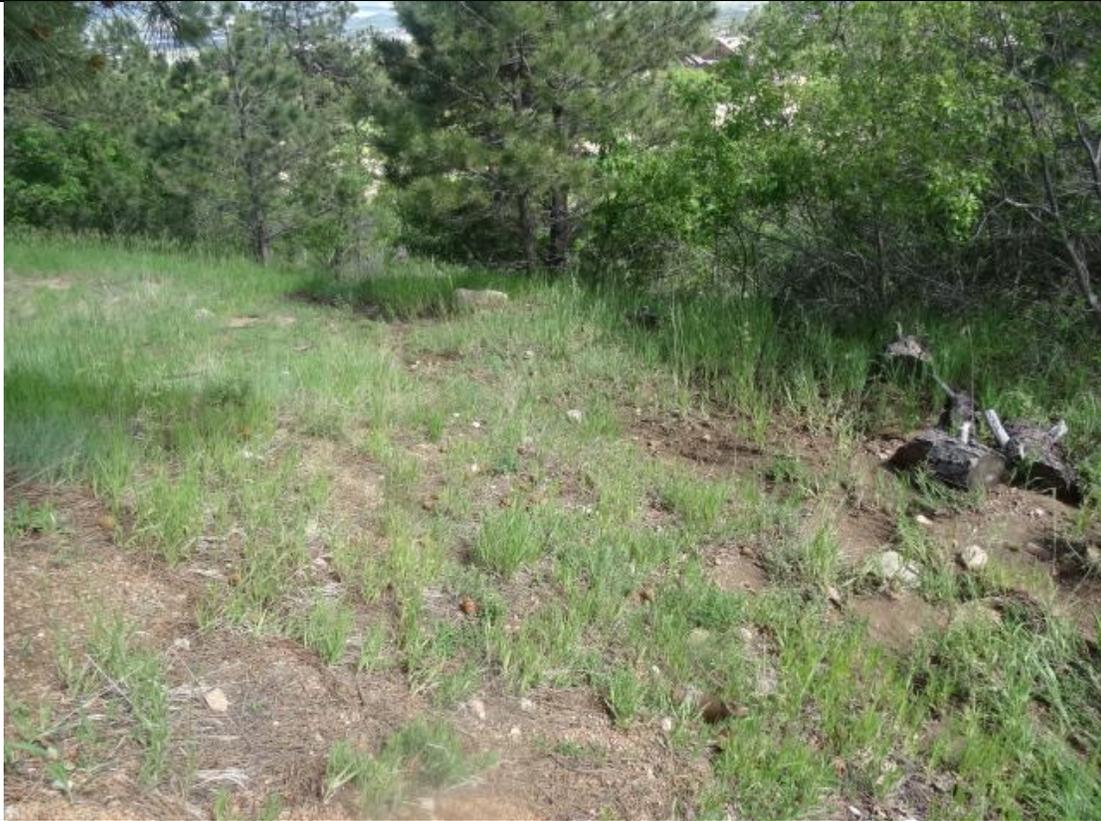
**Photograph 49:** South side of Star Ranch Rd. Discharge from photograph 46.
