Department of Public
Health & Environment

RE: Service of Notice of Violation/Cease and Desist Order, Number: SO-151007-1

NOTICE OF VIOLATION / CEASE AND DESIST ORDER

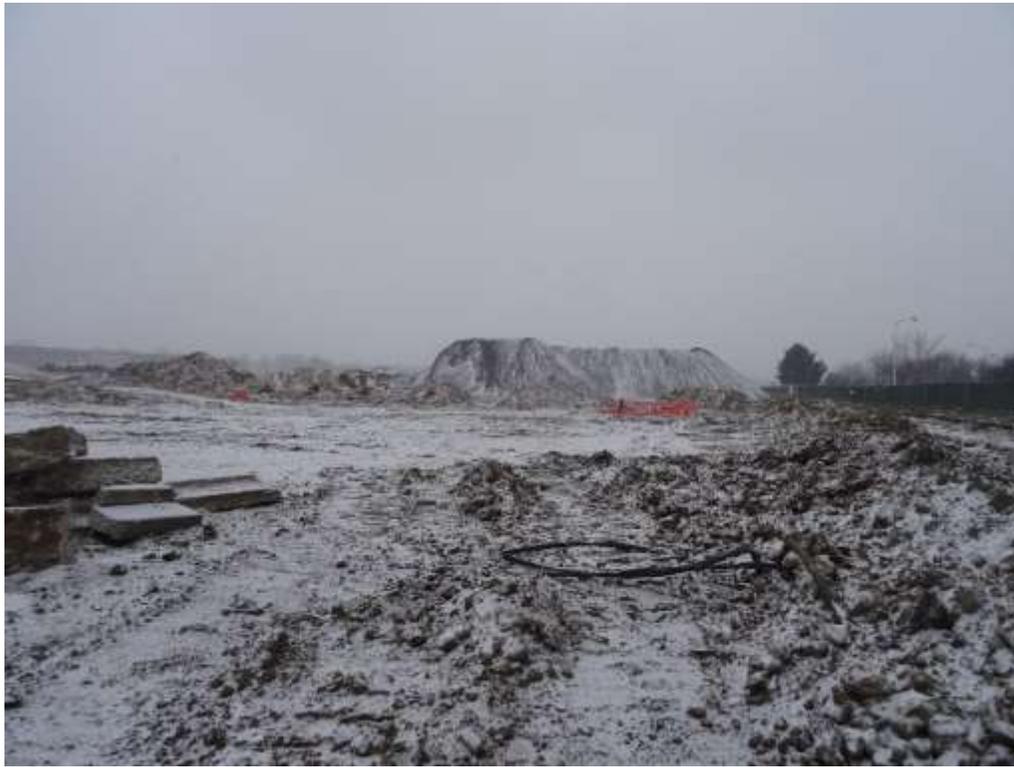
Photograph 1: Crushed asphalt stockpiles looking south, not identified in the SWMP or the map

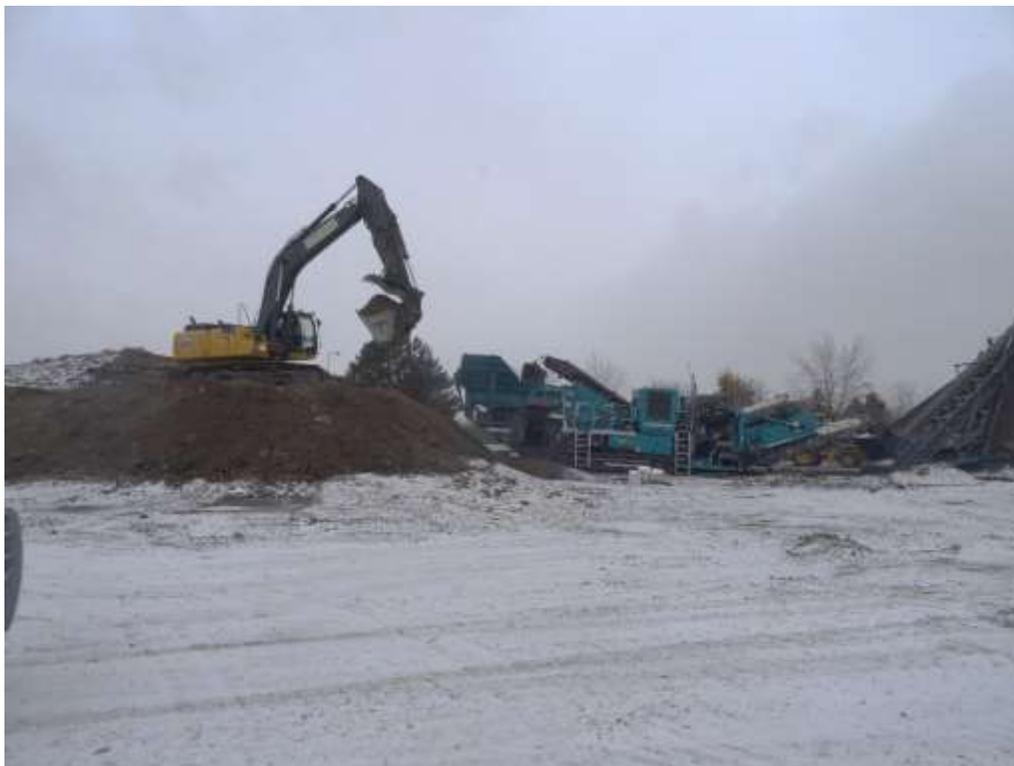
Photograph 2: Asphalt crushing operations looking west, control measures and source not identified in SWMP

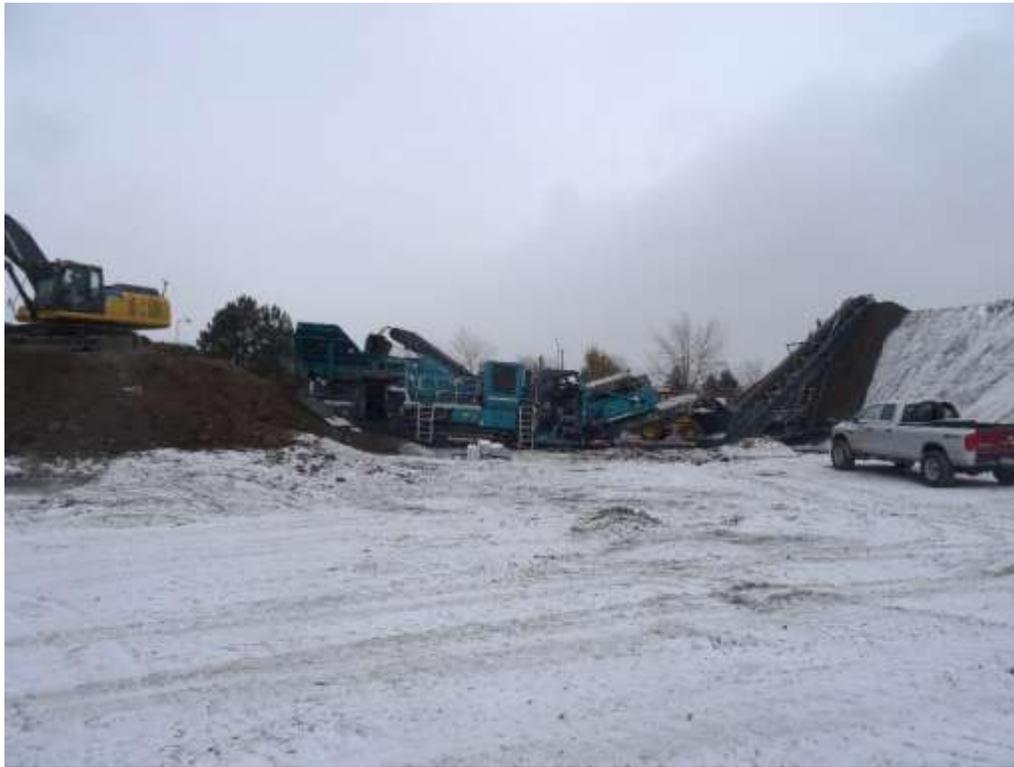
Photograph 3: Asphalt crushing operations looking west, control measures and pollutant source not identified in SWMP

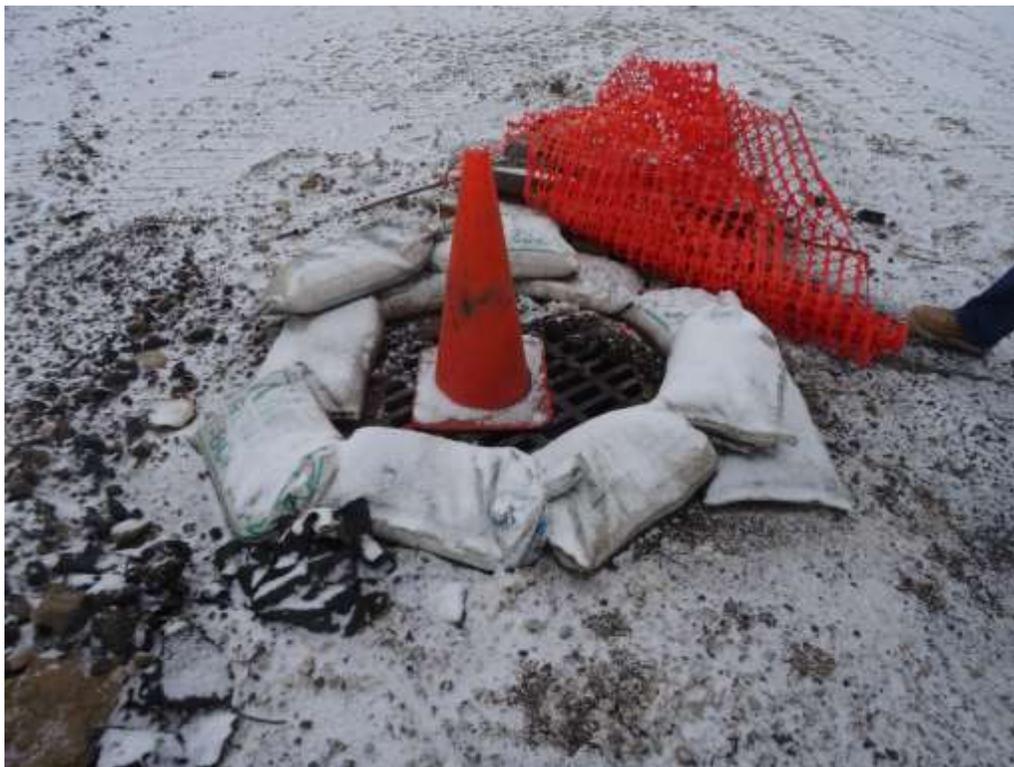
Photograph 4: Inlet protection using sandbags; not in accordance with good engineering, hydrologic, and pollution control practices.

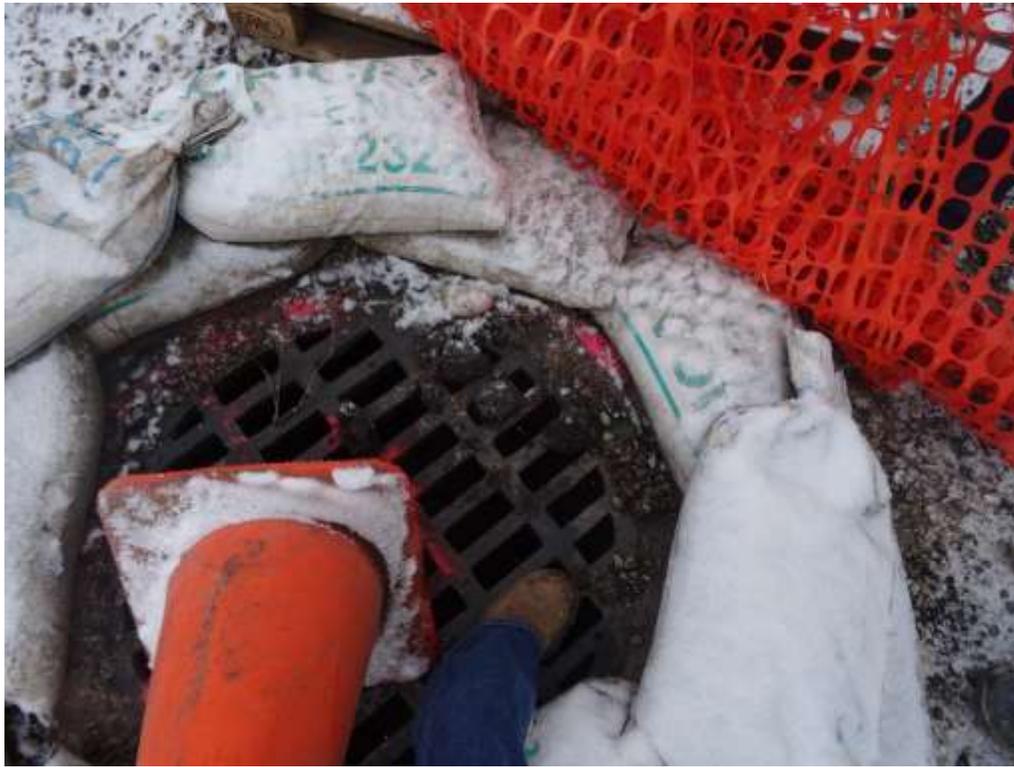
Photograph 5: Sandbags not properly overlapped or placed, potential for bypass

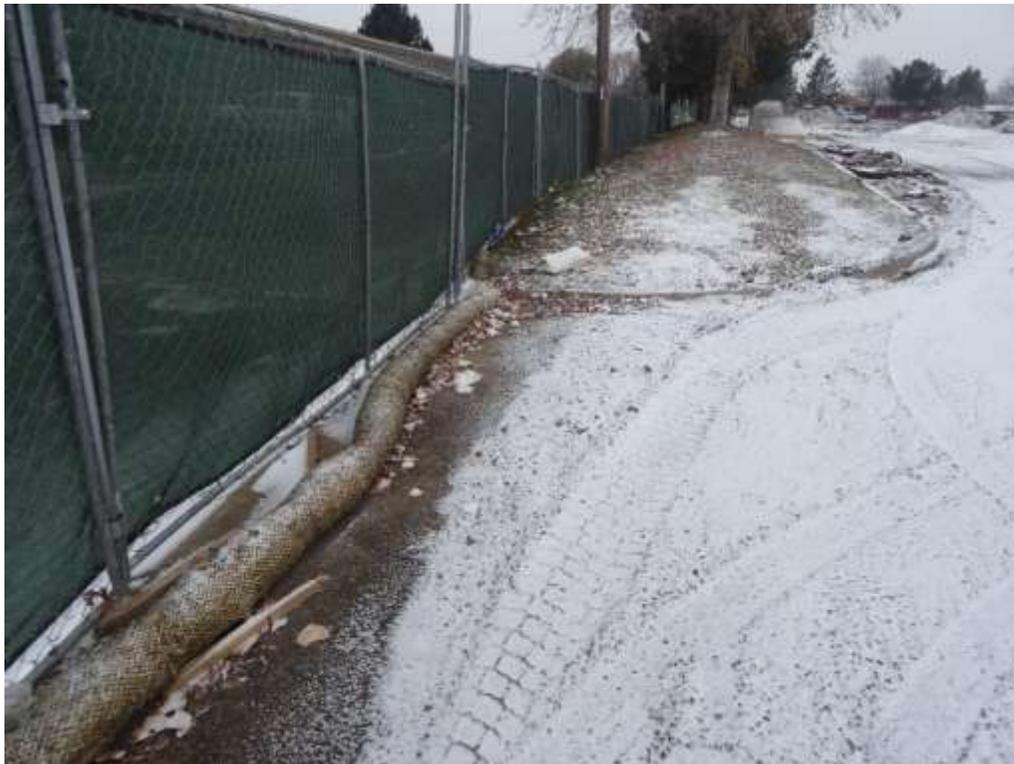
Photograph 6: Straw wattle at emergency exit not trenched or staked into the ground

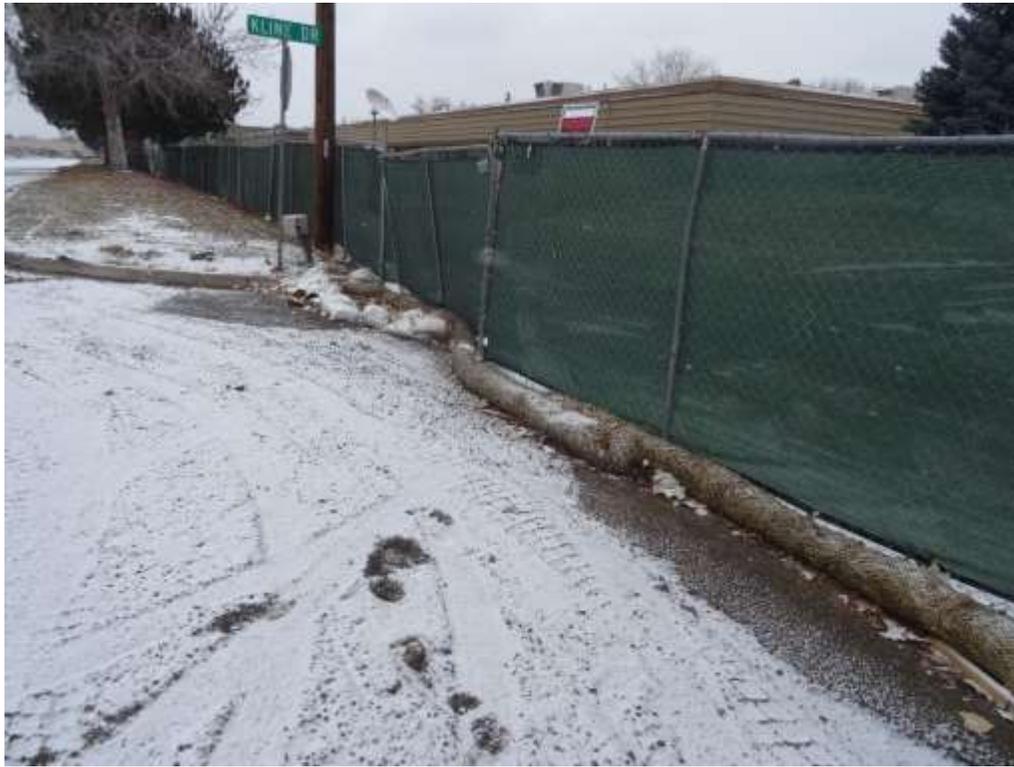
Photograph 7: Straw wattle at emergency exit not trenched or staked into the ground

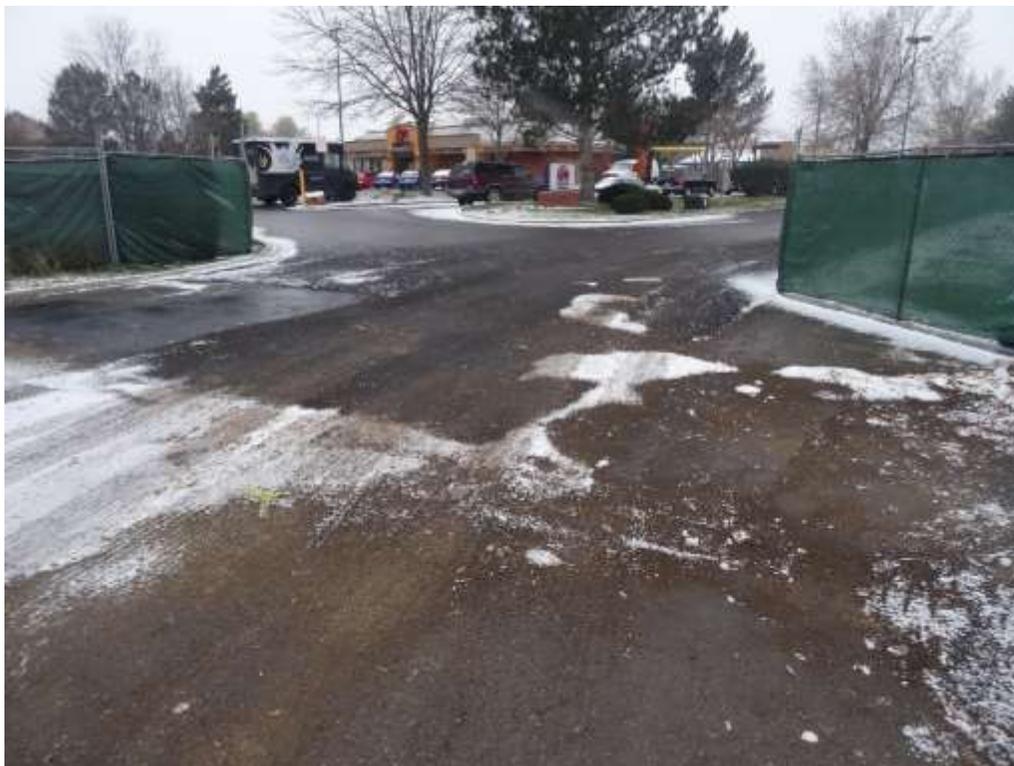
Photograph 8: Access point without tracking controls implemented, looking from jobsite out

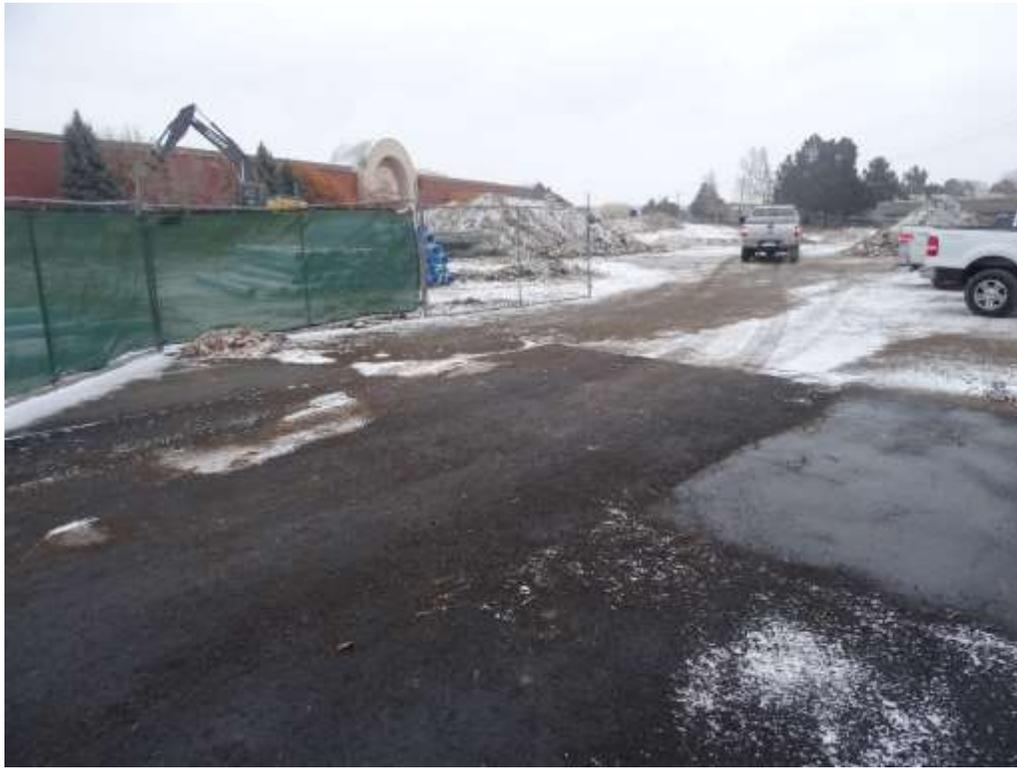
Photograph 9: Access point without tracking controls implemented, looking from outside to jobsite

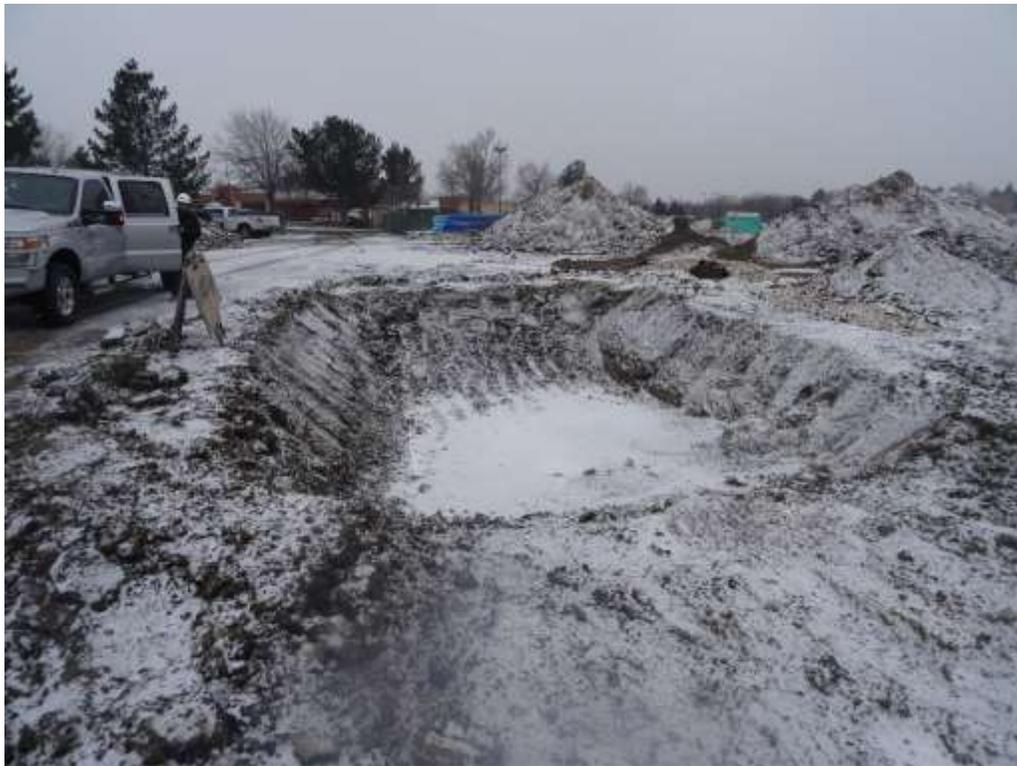
Photograph 10: Concrete washout not installed per the specification provided in the SWMP

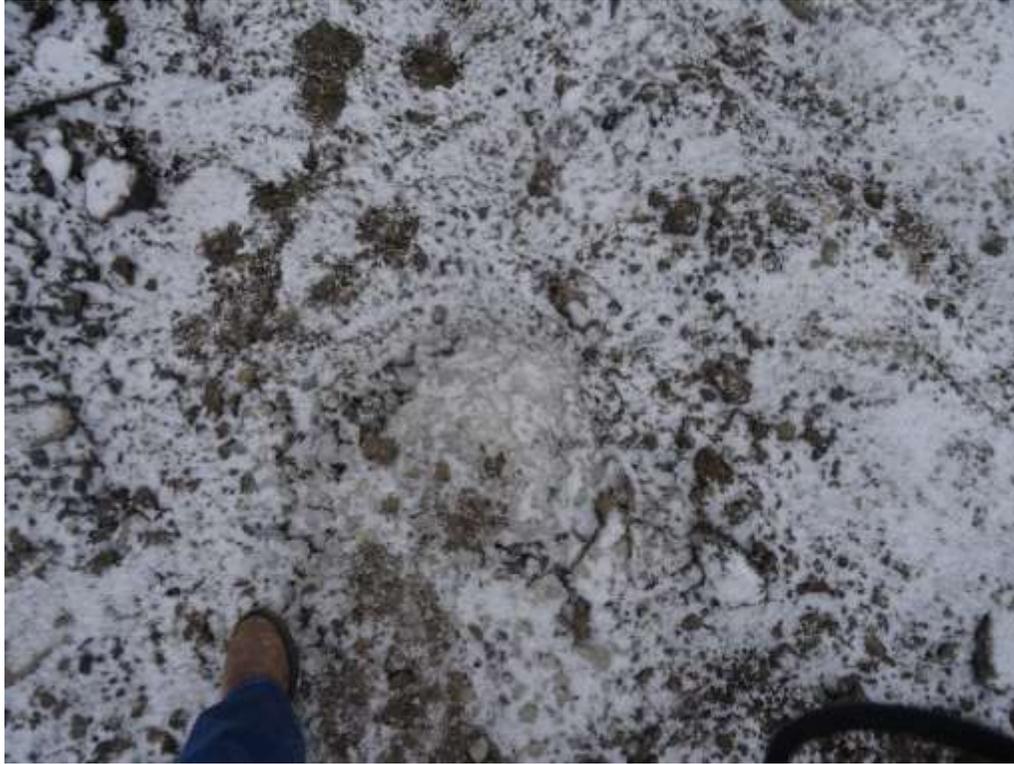
Photograph 11: Concrete waste observed around the washout area and not deposited inside the control

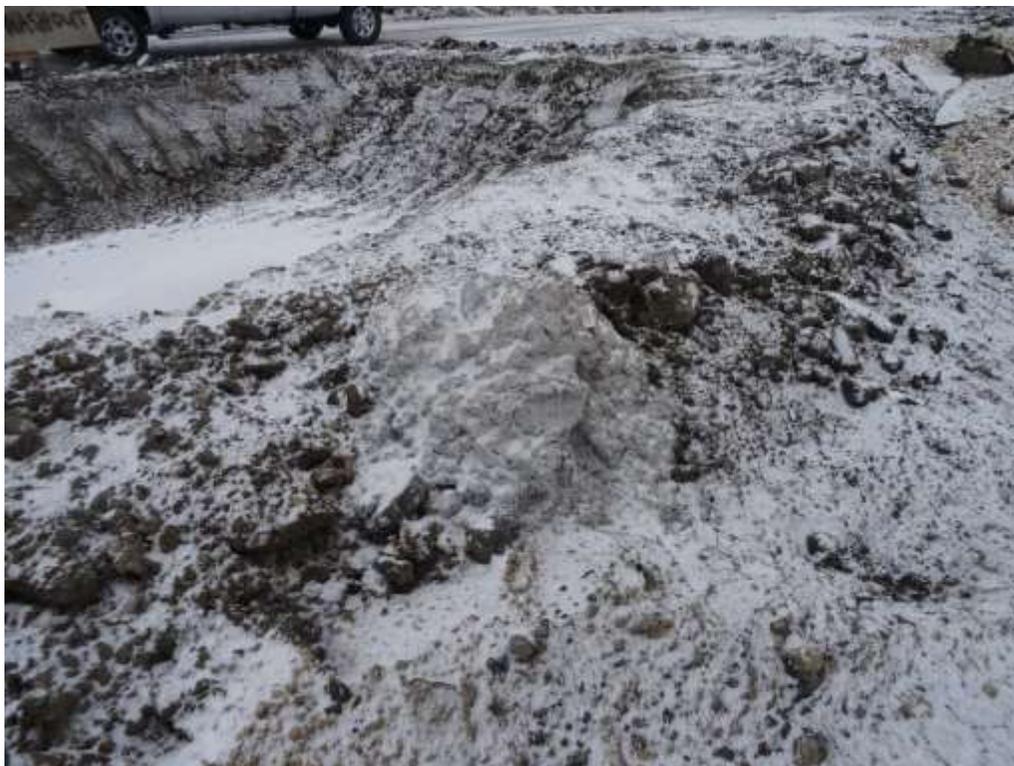
Photograph 12: Concrete waste observed around the washout area and not deposited inside the control

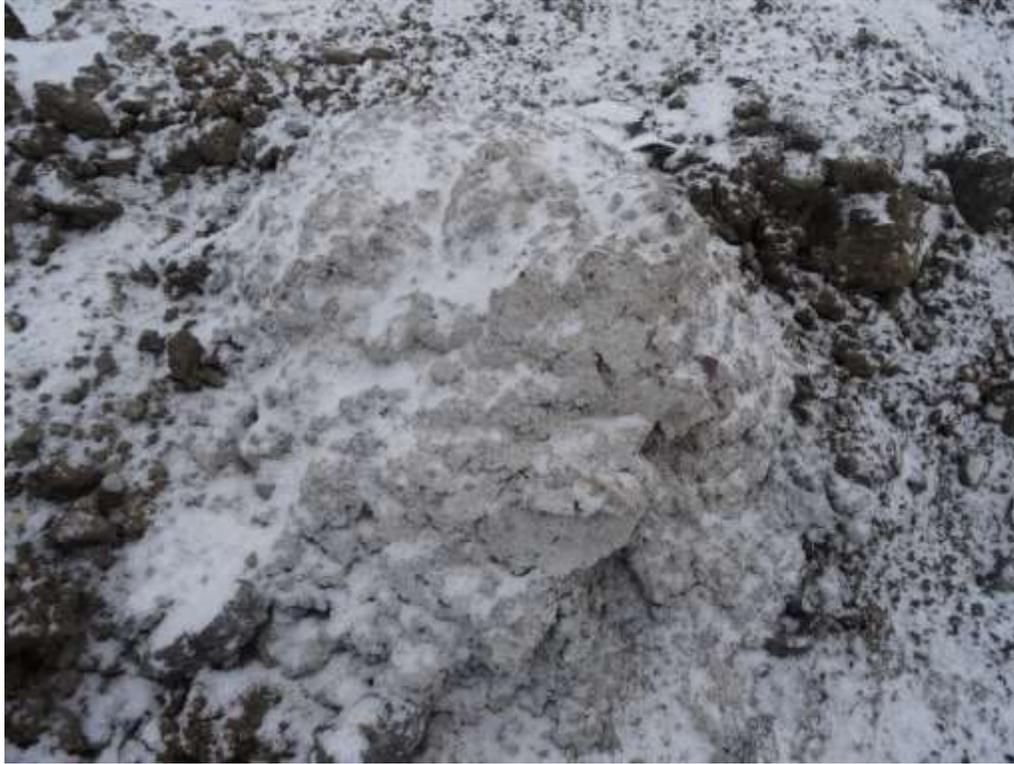
Photograph 13: Concrete waste observed around the washout area and not deposited inside the control

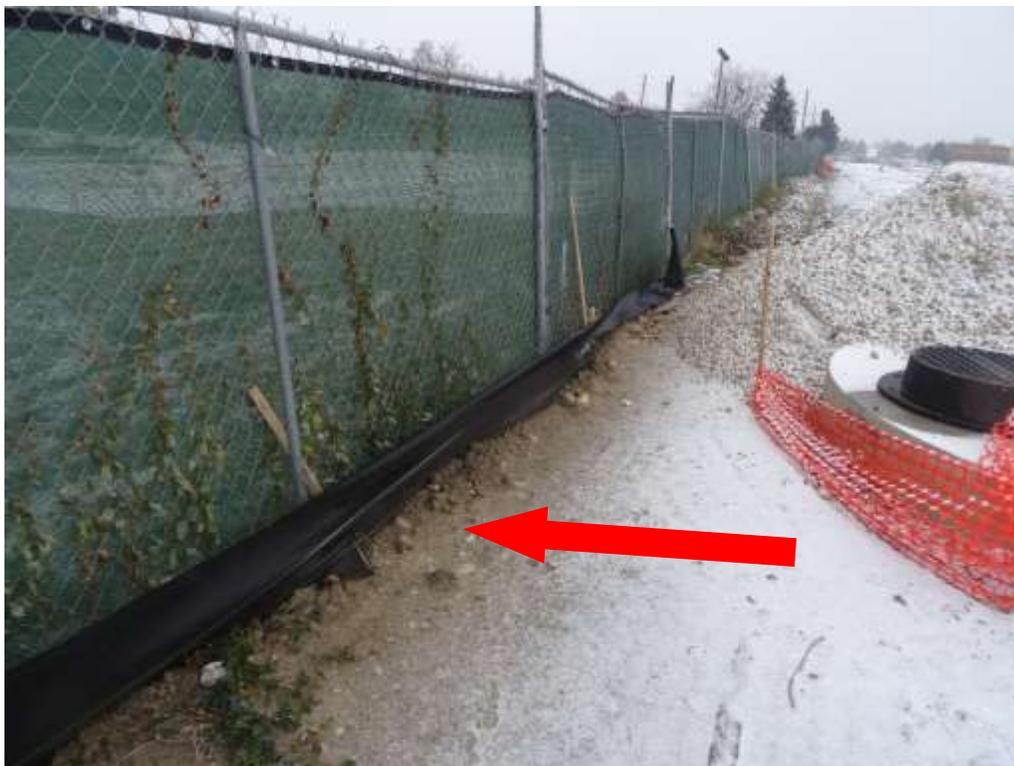
Photograph 14: Silt fence not trenched in and material pulling away from stakes, slumping conditions

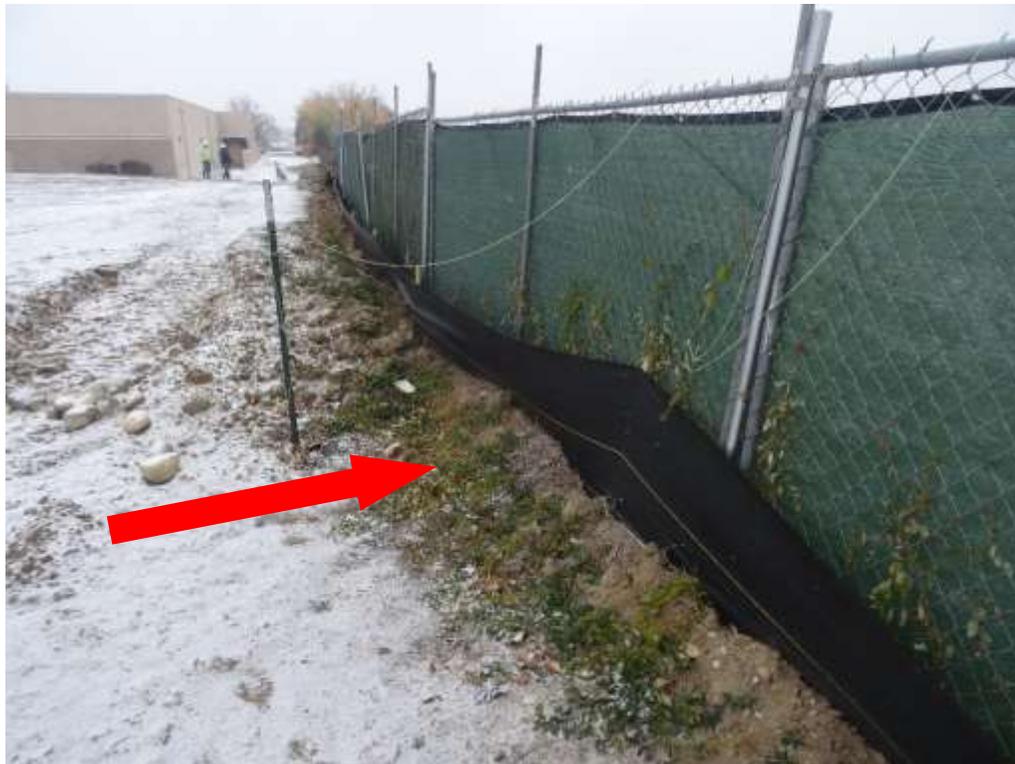
Photograph 15: Geotextile not consistently trenched in, sediment build-up greater than six inches

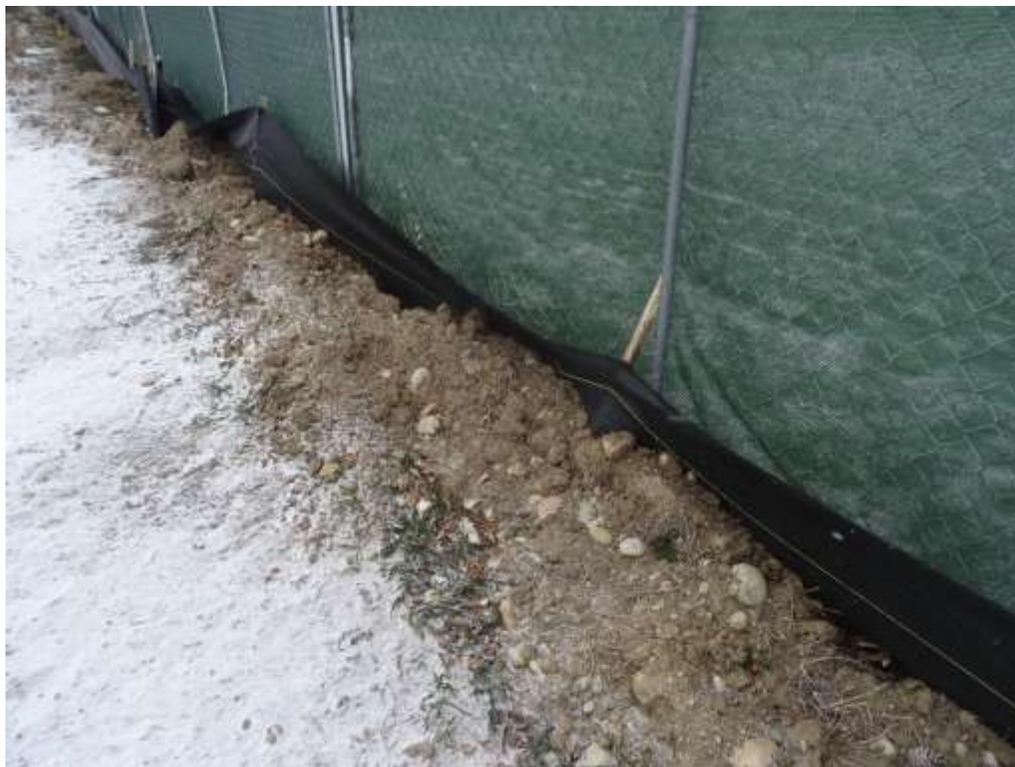
Photograph 16: Sediment build-up against silt fence greater than six inches, fence is being pushed over

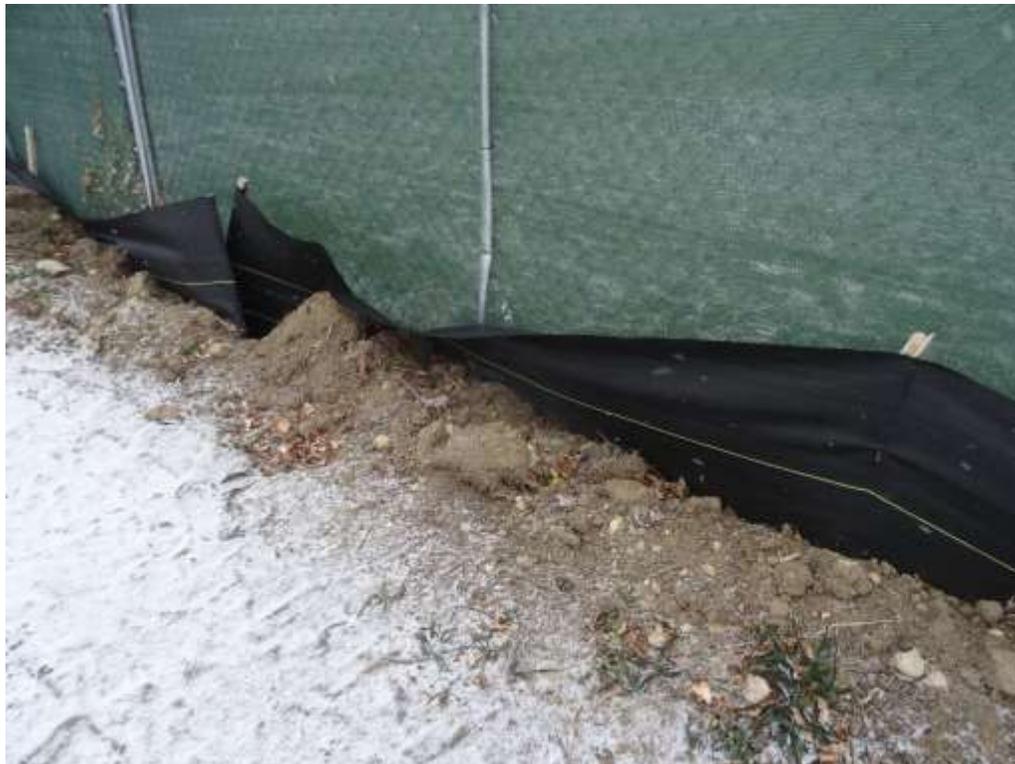
Photograph 17: Sediment built up greater than six inches along silt fence, joints not wrapped properly

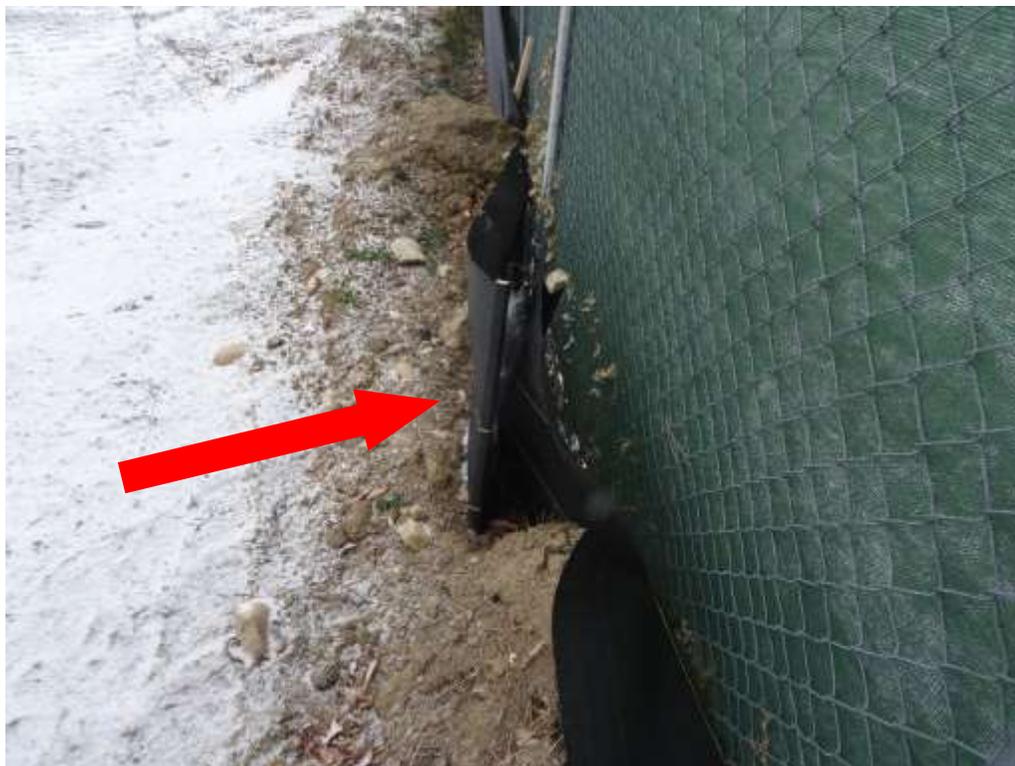
Photograph 18: Joints in silt fence not wrapped properly, silt fence not consistently trenched in and staked

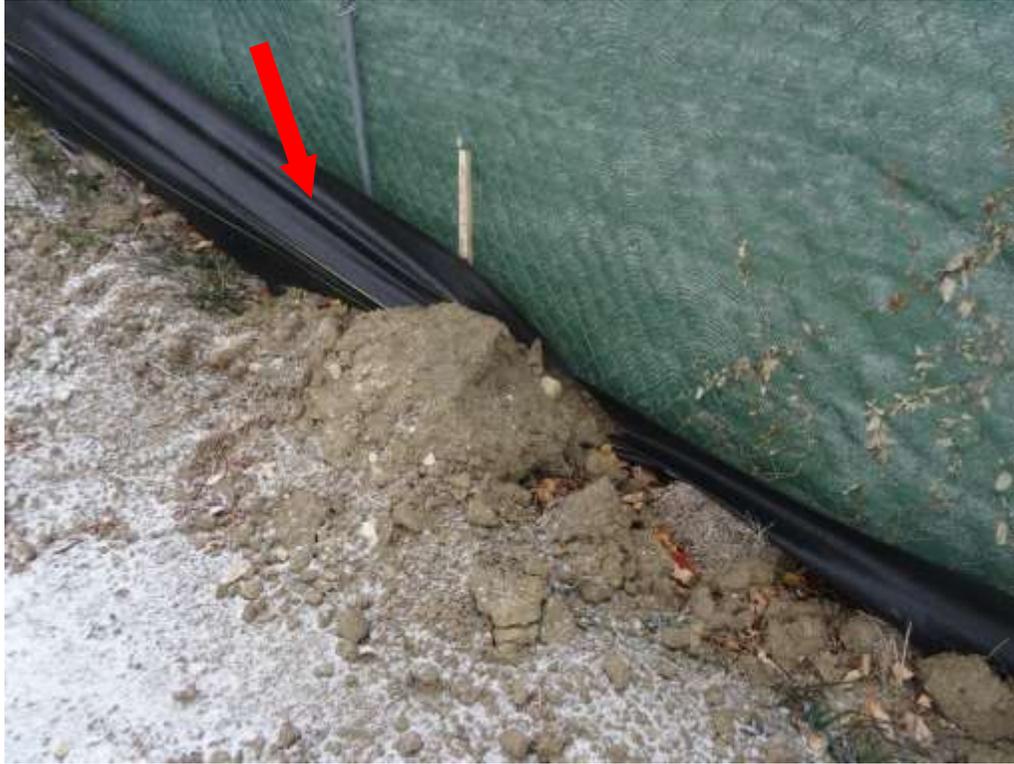
Photograph 19: Sediment build-up against silt fence greater than six inches, fence is being pushed over

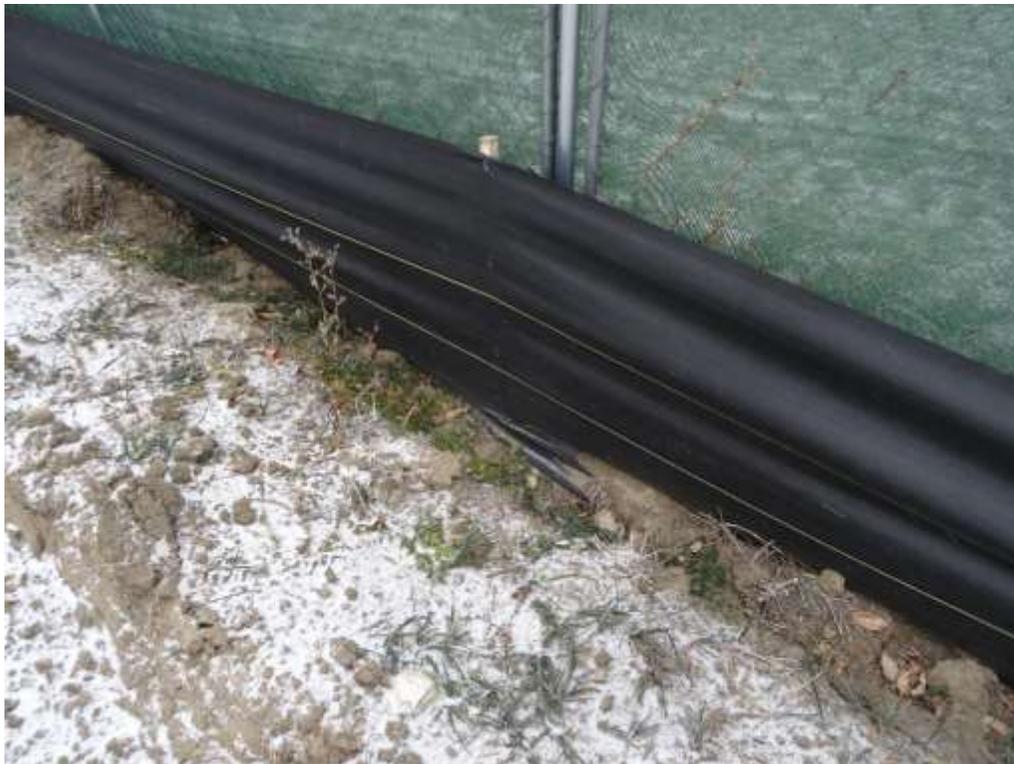
Photograph 20: Silt fence not buried in a six inch by four inch trench and then compacted to secure the fence to the ground.

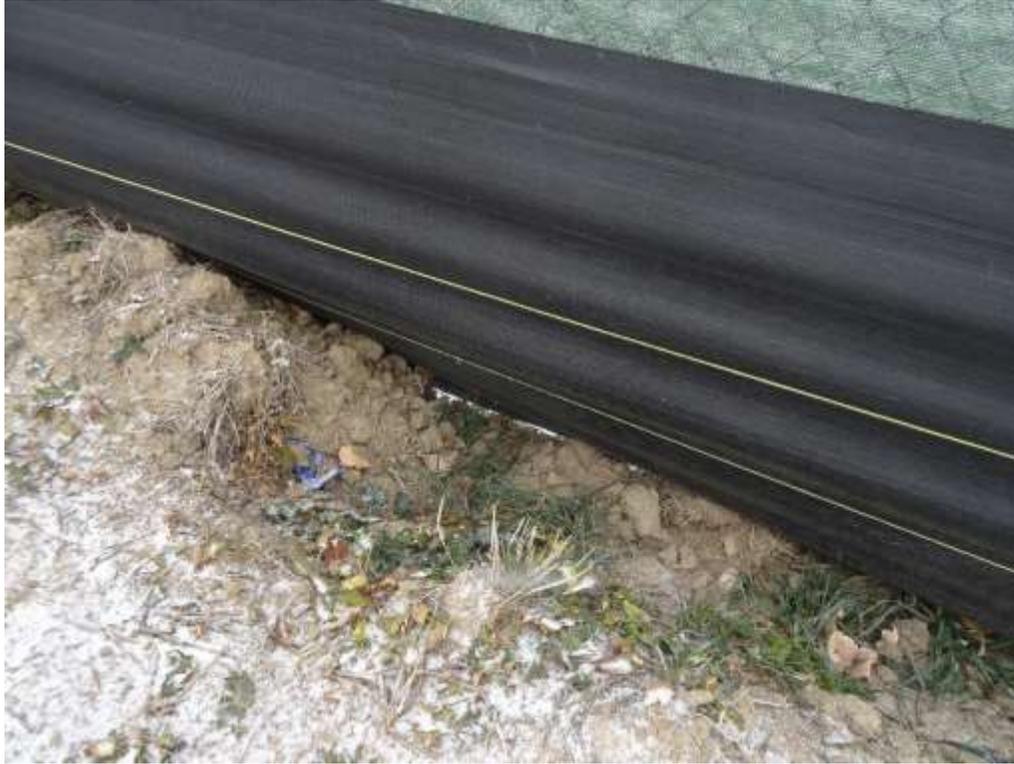
Photograph 21: Silt fence not properly buried in a six inch by four inch trench and then compacted to secure the fence to the ground.

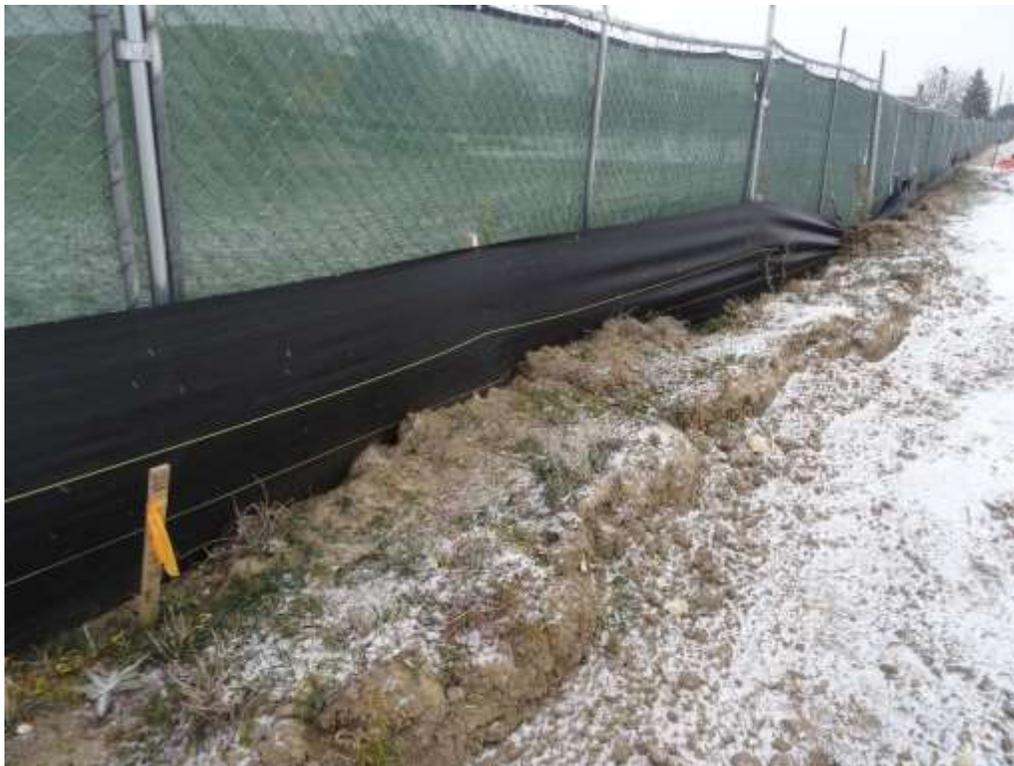
Photograph 22: Sediment built up greater than six inches, not buried in a trench consistently

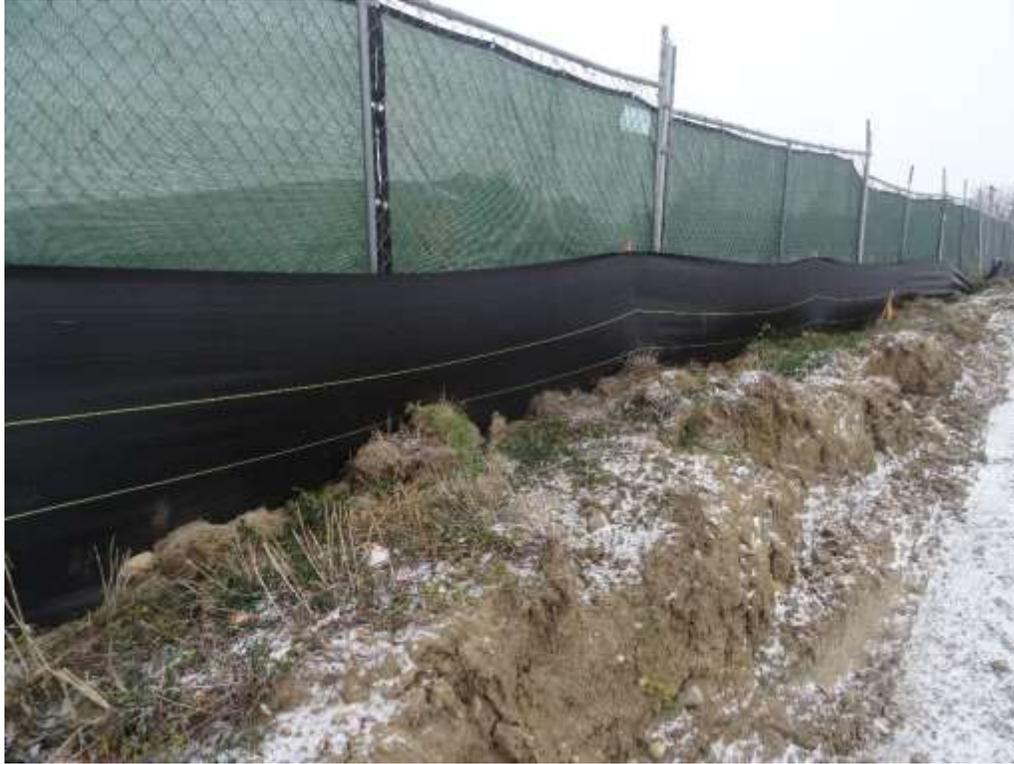
Photograph 23: Sediment built up greater than six inches, not buried in a trench consistently

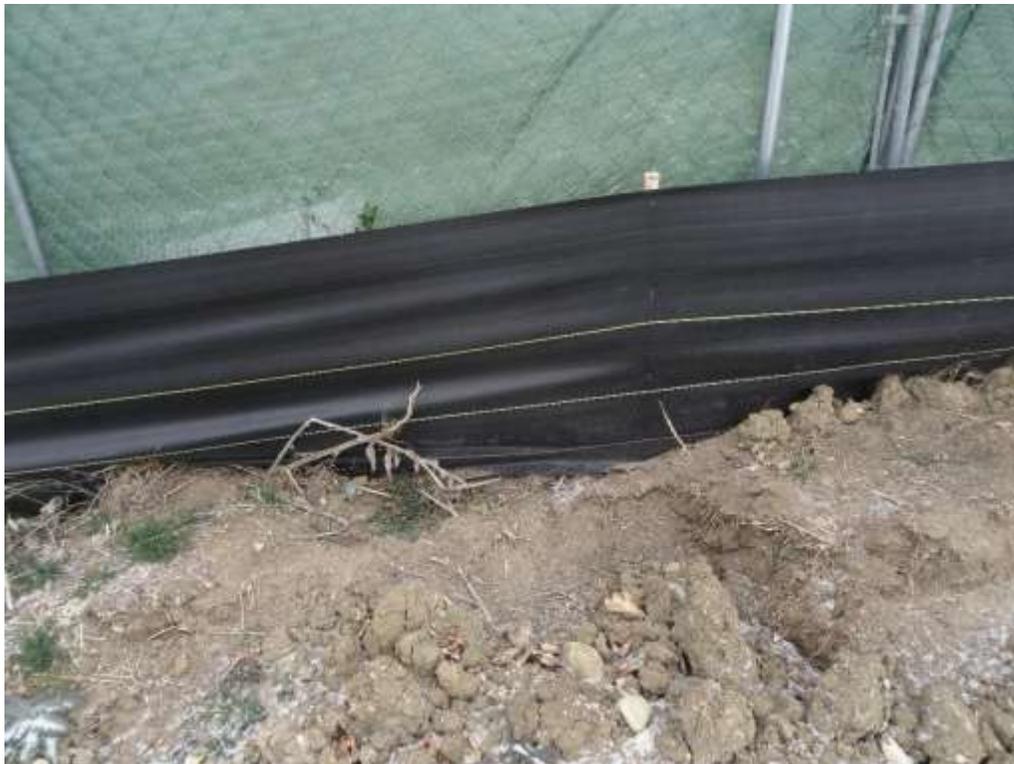
Photograph 24: Sediment built up greater than six inches, not buried in a trench consistently

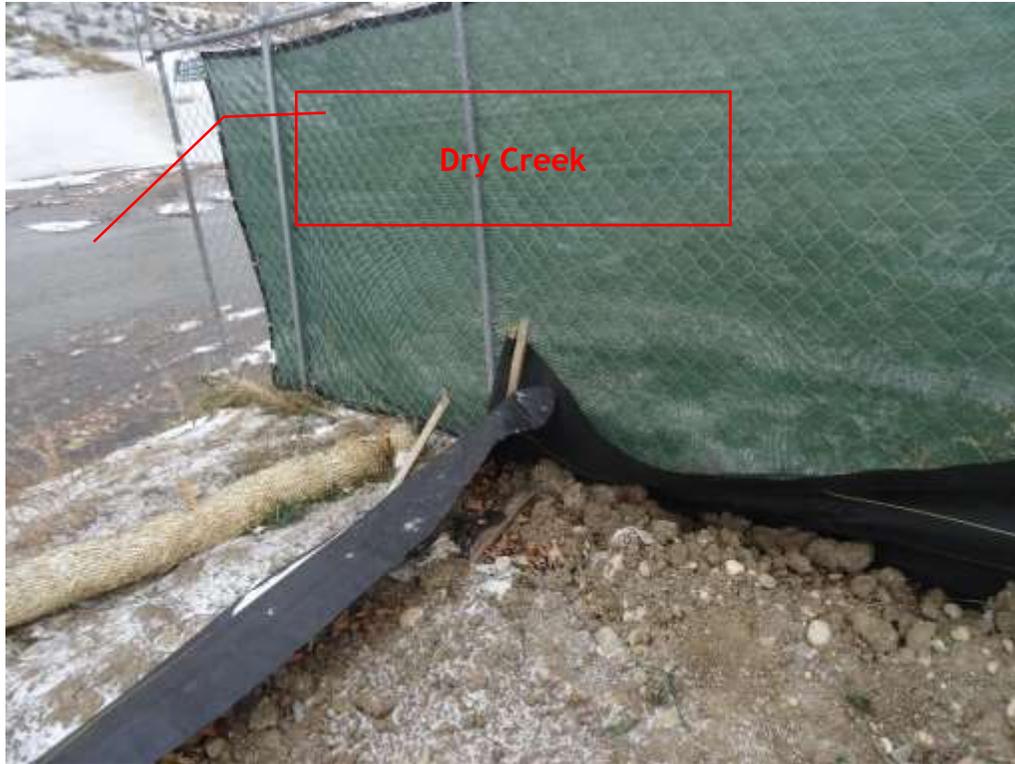
Photograph 25: Silt fence not maintained, joints not wrapped properly to prevent bypass

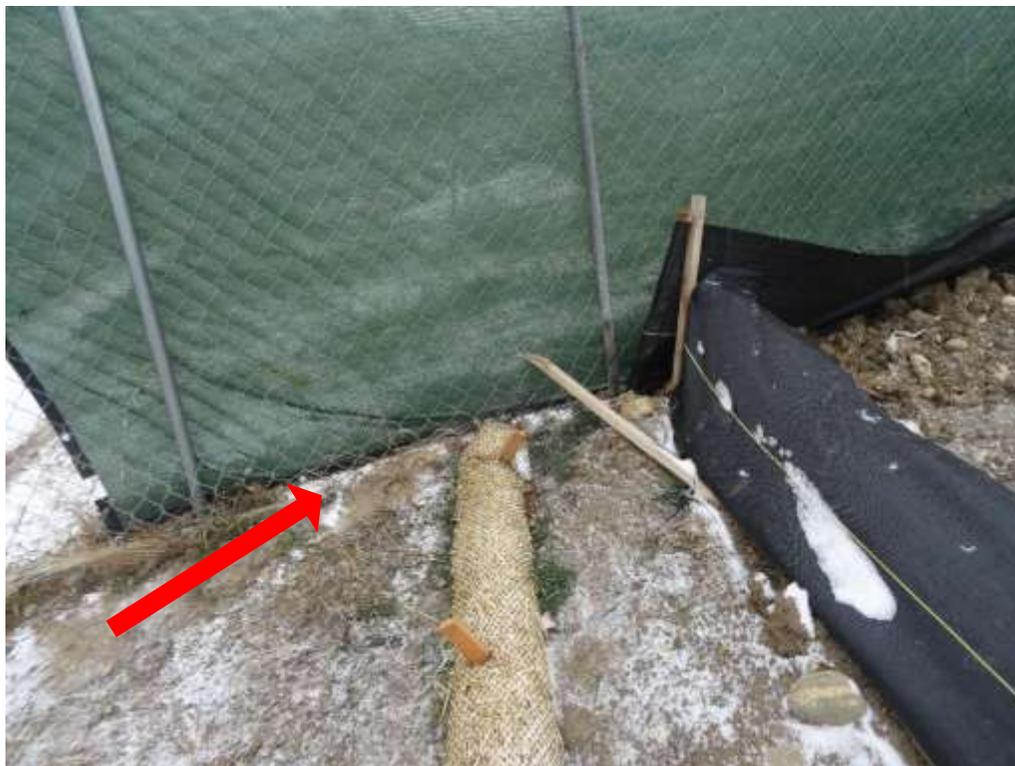
Photograph 26: Potential bypass through silt fence and straw wattle

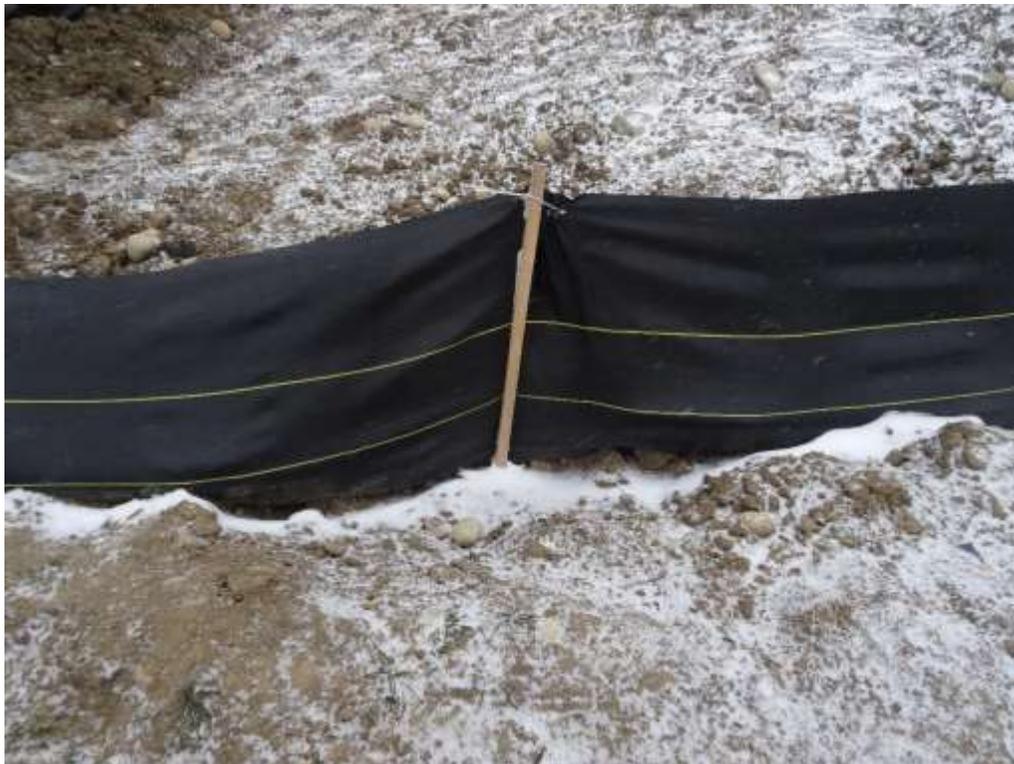
Photograph 28: Silt fence not buried in a six inch by four inch trench and then compacted to secure the fence to the ground and prevent bypass of pollutants

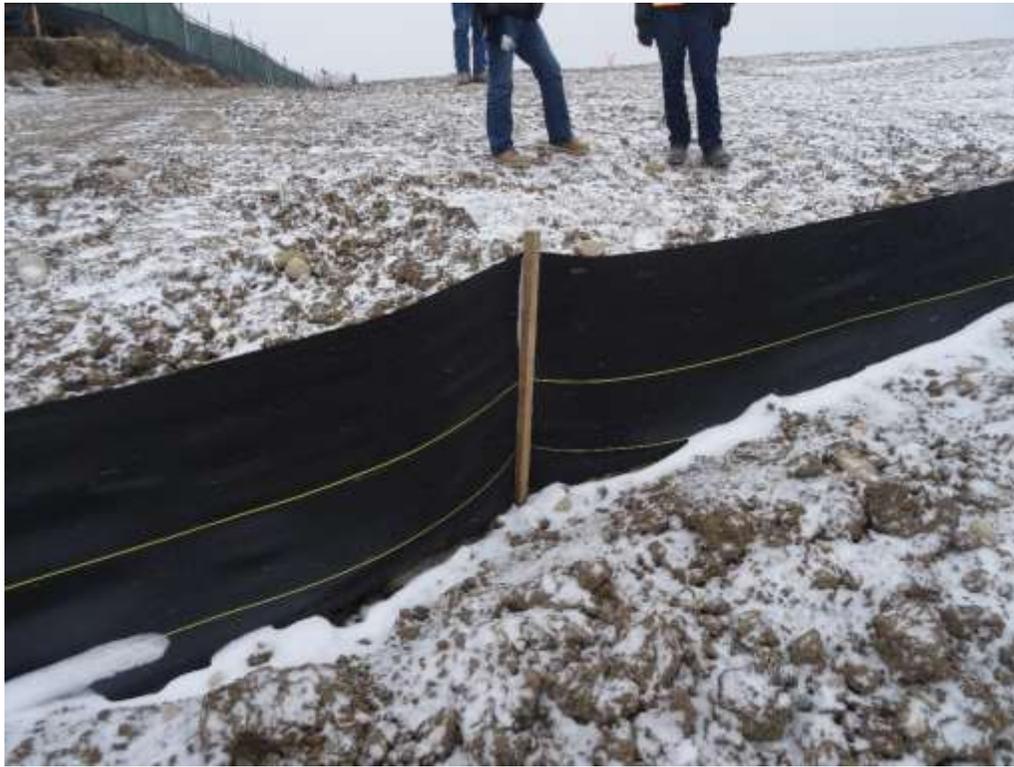
Photograph 29: Silt fence not buried in a six inch by four inch trench and then compacted to secure the fence to the ground and prevent bypass of pollutants
