Department of Public
Health & Environment

RE: Service of Notice of Violation/Cease and Desist Order, Number: SO-151007-1

NOTICE OF VIOLATION / CEASE AND DESIST ORDER

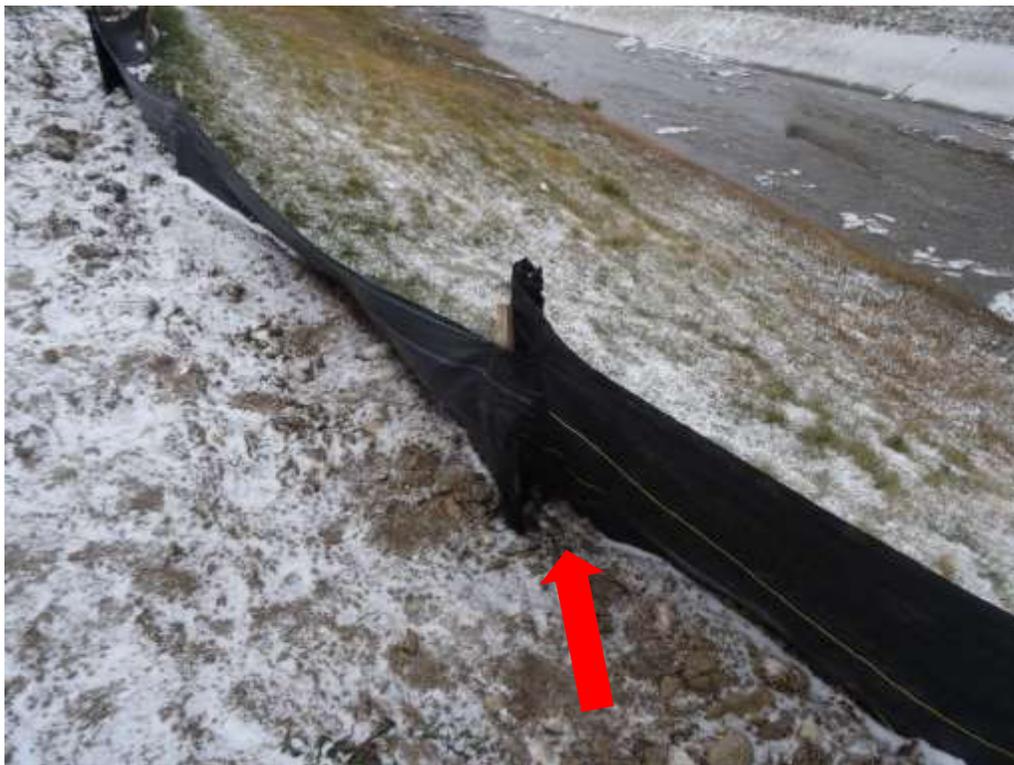
Photograph 32: Silt fence joint not wrapped as required to prevent bypass, large gap where arrow points

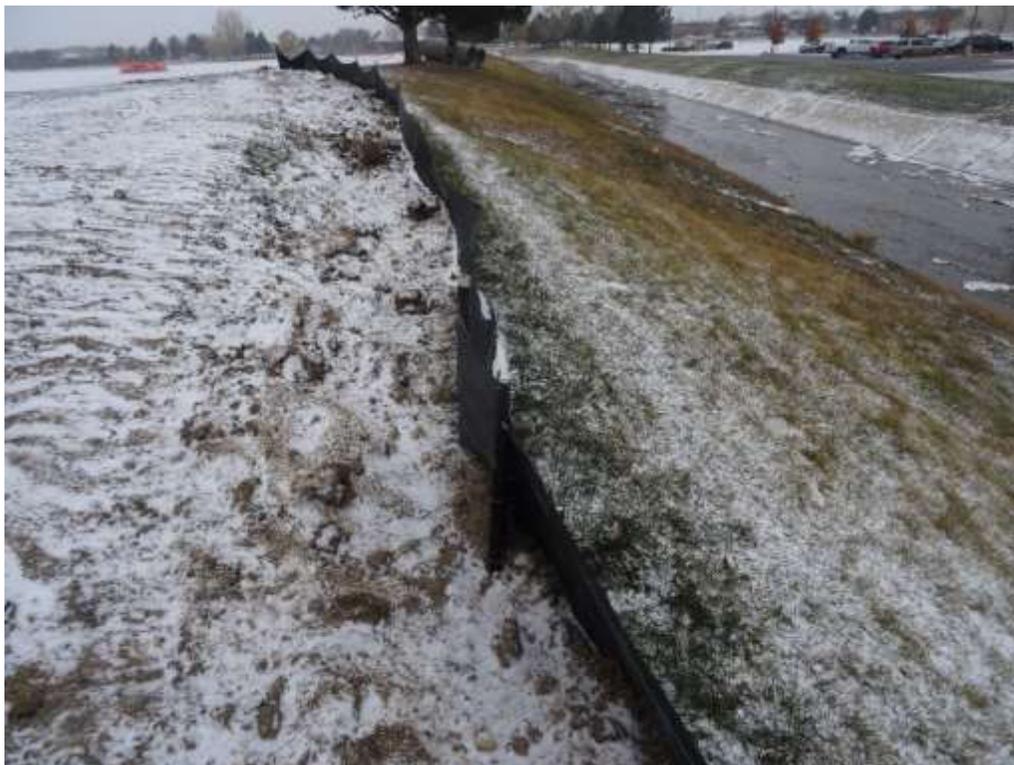
Photograph 34: Silt fence looking west, not consistently trenched or installed as required

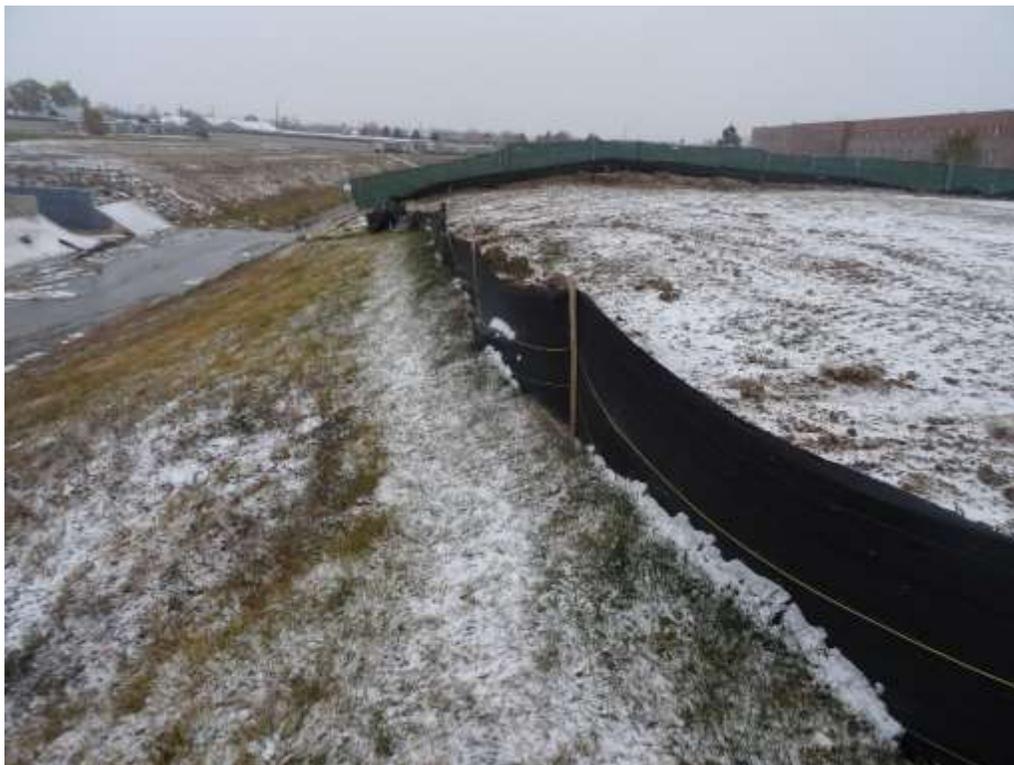
Photograph 36: Sediment built up along fence, bulging along the back from sediment build-up

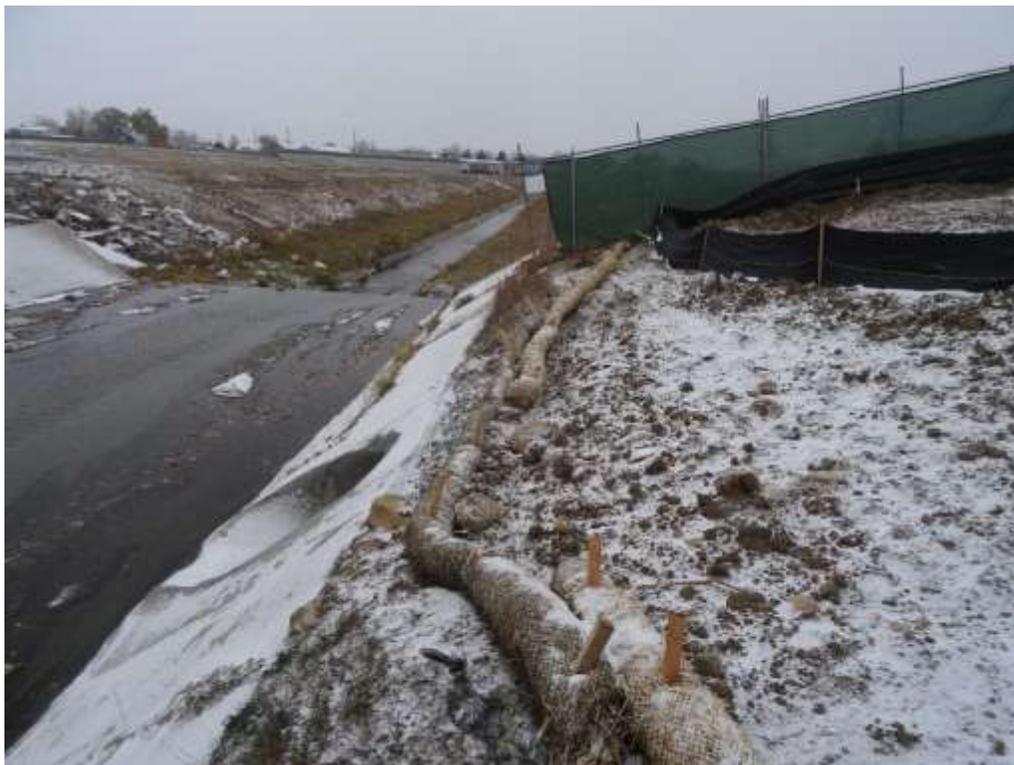
Photograph 38: Straw wattle not installed per specification, not trenched and overlapped properly

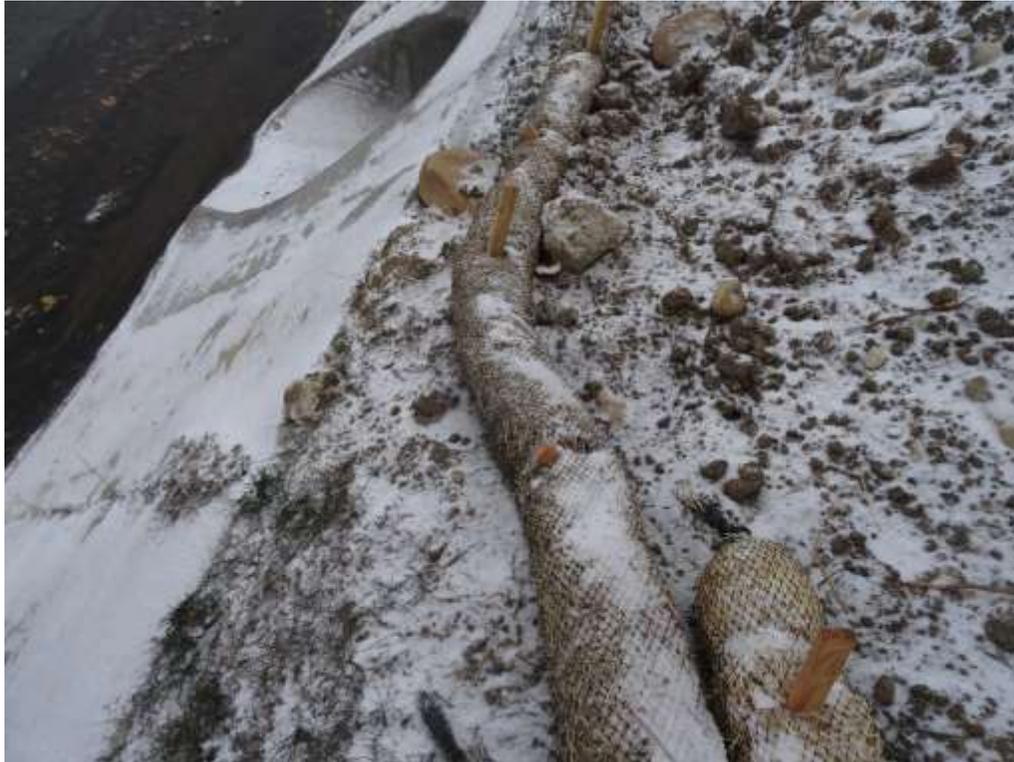
Photograph 39: Straw wattle not trenched in, rocks pushing on wattle and pulling it loose

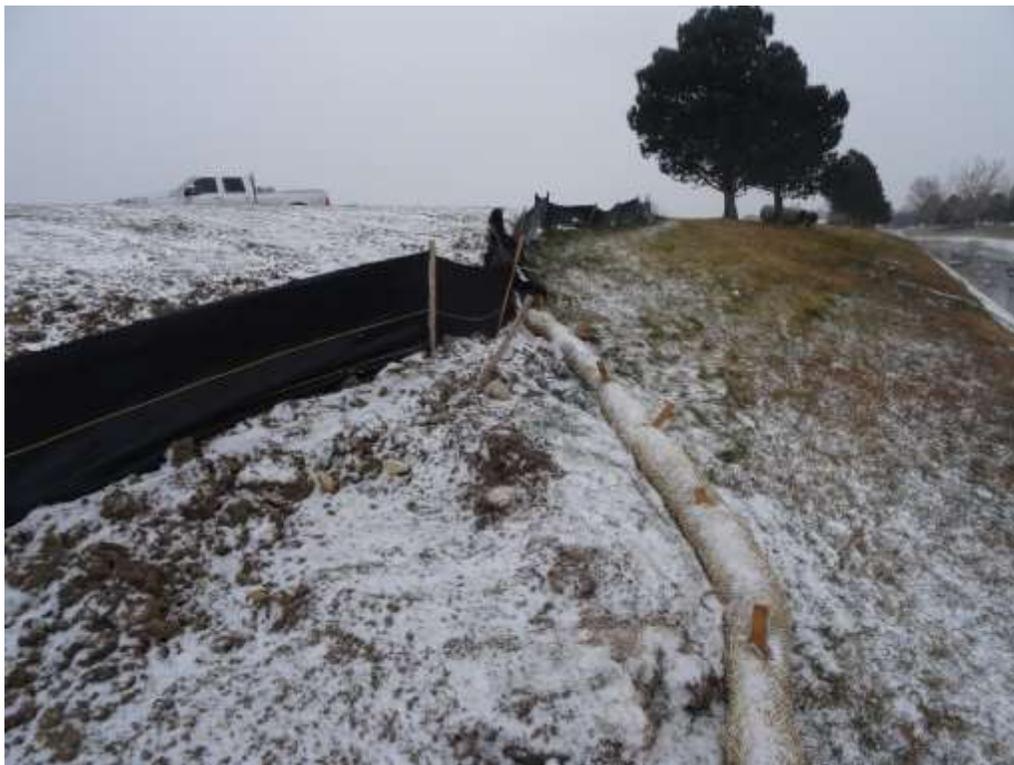
Photograph 40: Straw wattle not trenched in as required per specification

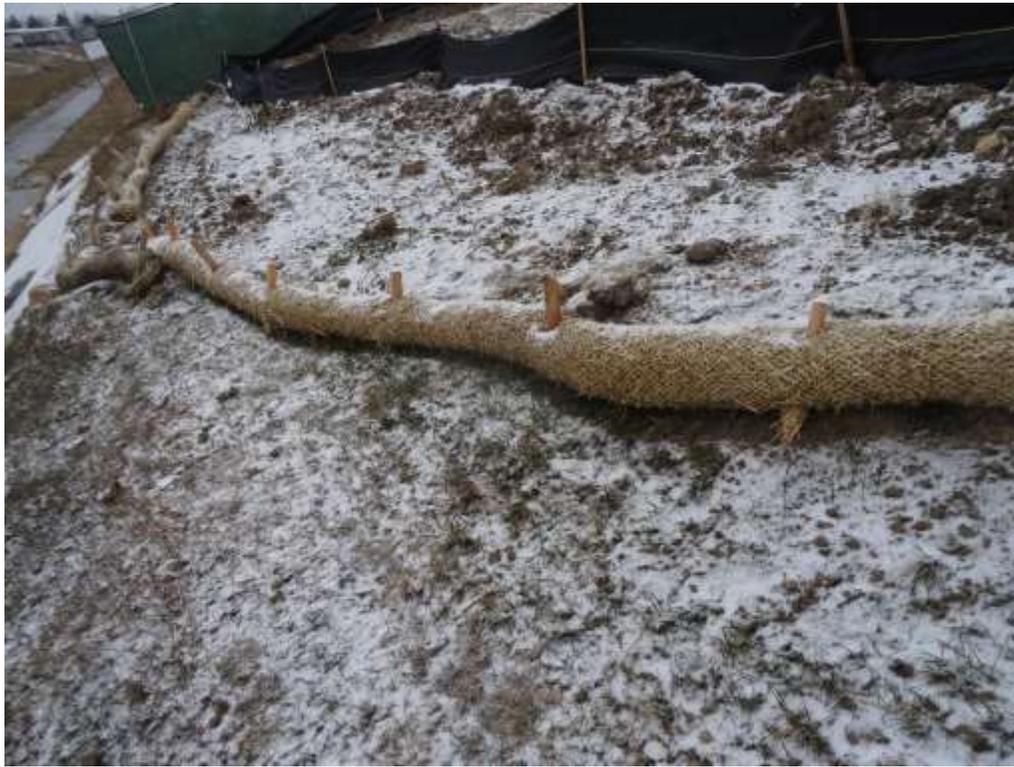
Photograph 41: Straw wattle not trenched in per spec, stakes not in ground at depth required

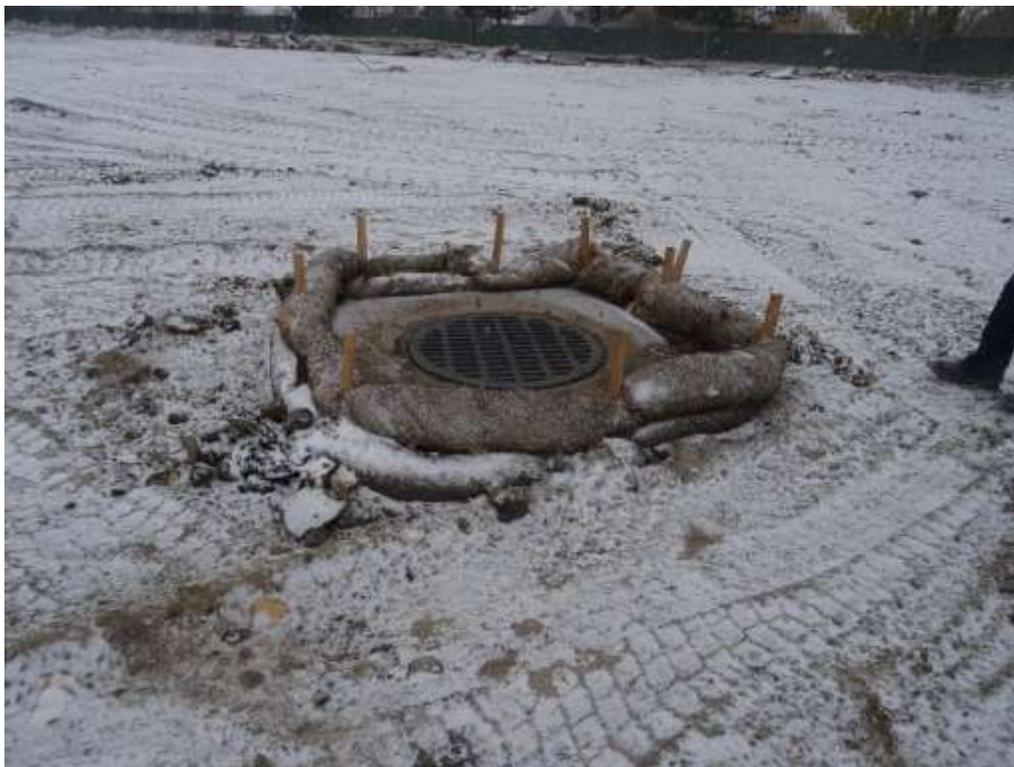
Photograph 44: Wattle not consistently staked and trenched as required per specification

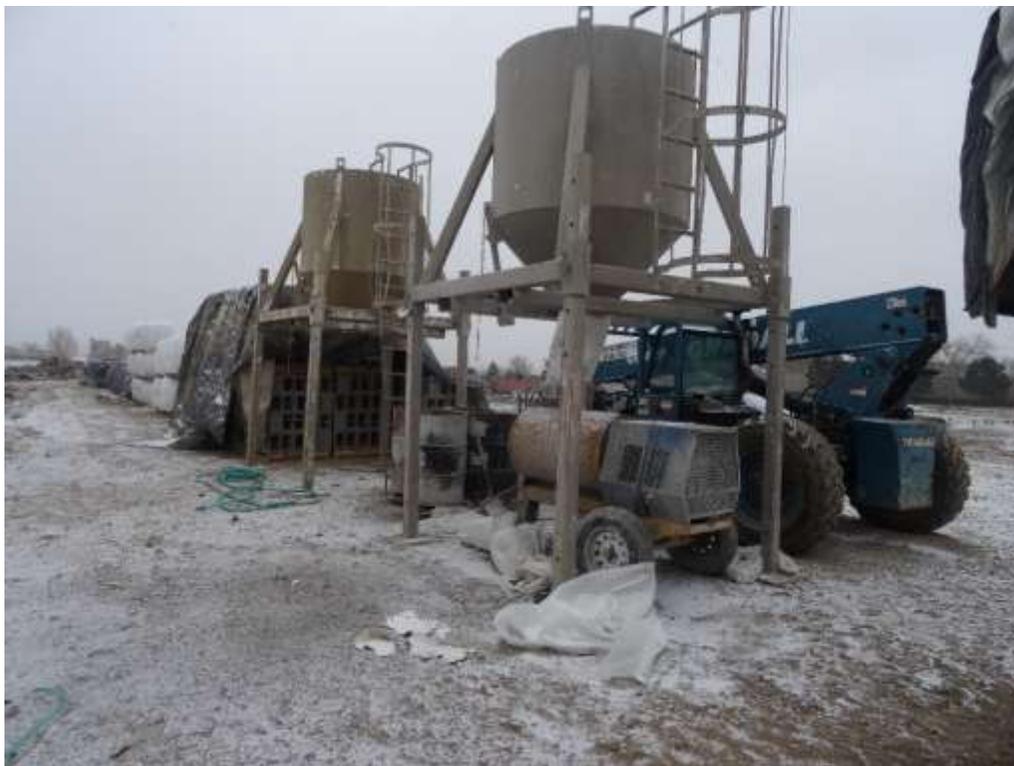
Photograph 52: Grout mixing station without containment, waste materials present on the ground

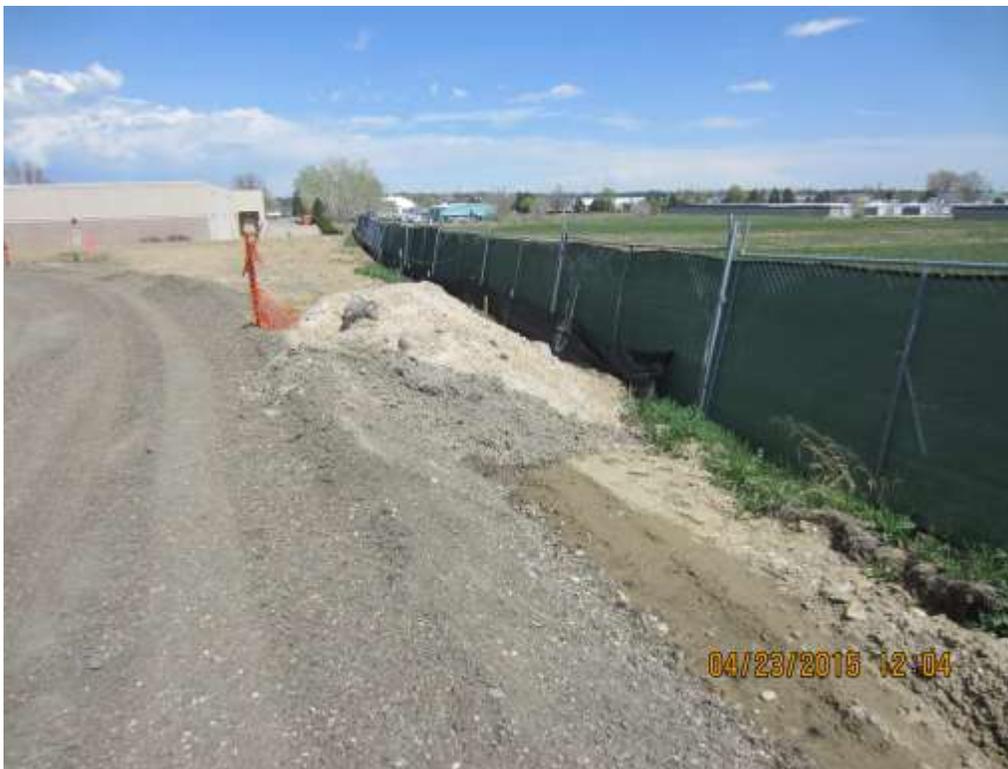
Photograph 24: Silt fence not installed or maintained per the specification provided in the SMWP

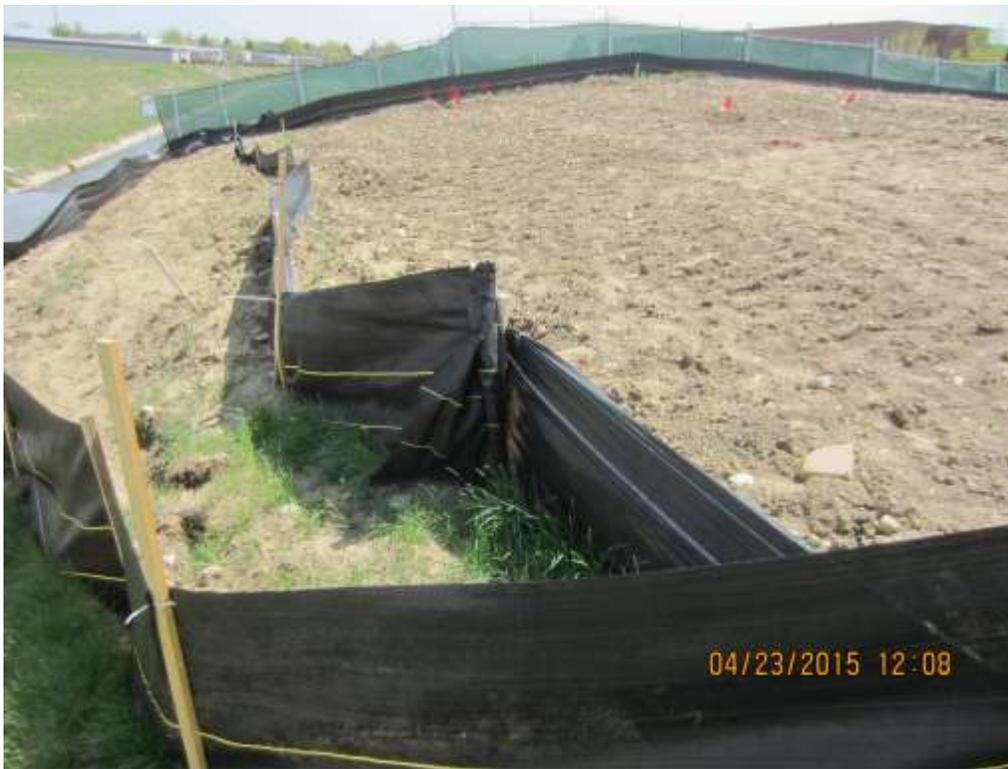
Photograph 31: Silt fence not installed or maintained per the specification provided in the SMWP

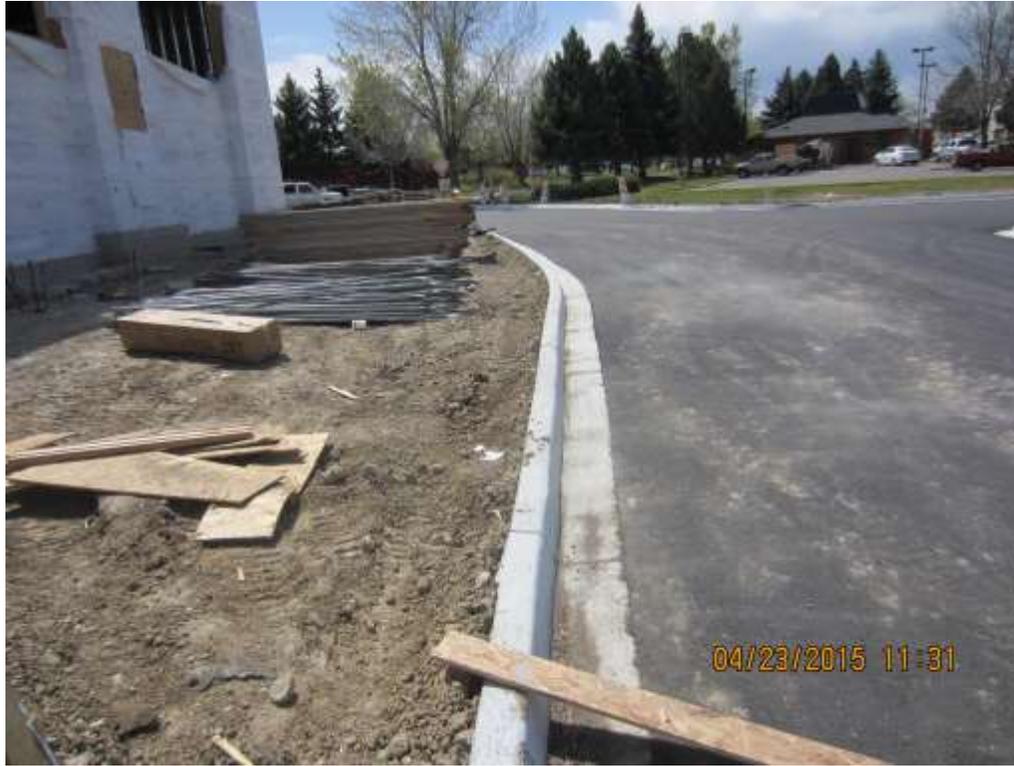
Photograph 42: Grade cut perimeter control not installed or maintained in accordance with good engineering, hydrologic, and pollution control practices

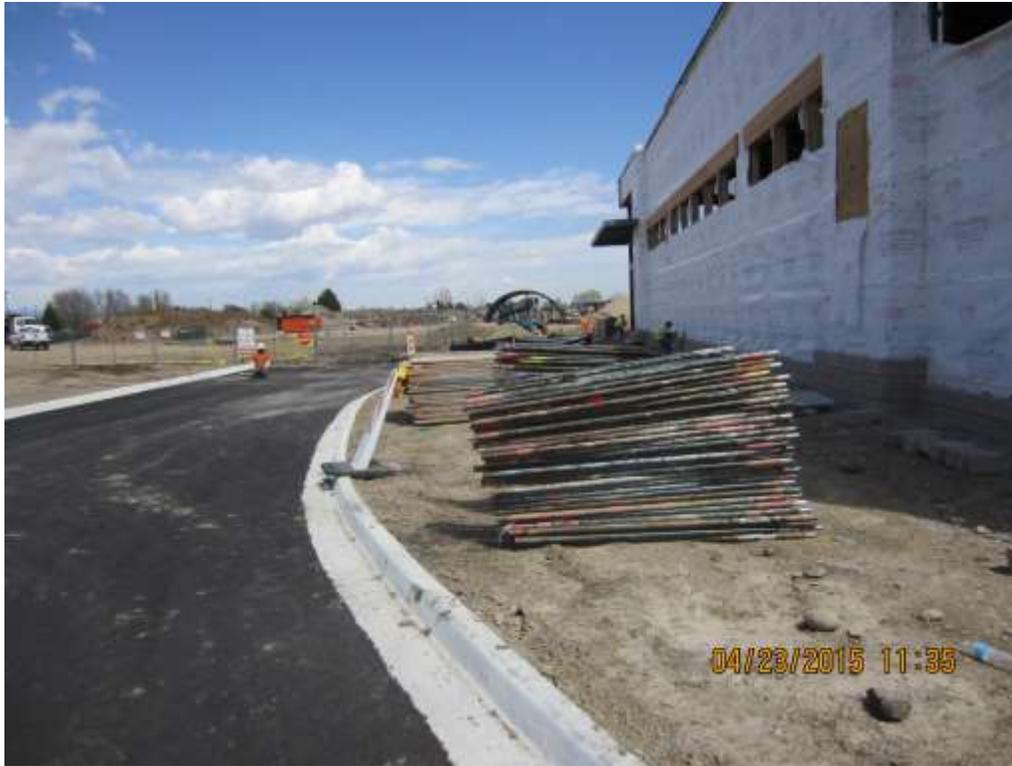
Photograph 46: Grade cut perimeter control not installed or maintained in accordance with good engineering, hydrologic, and pollution control practices

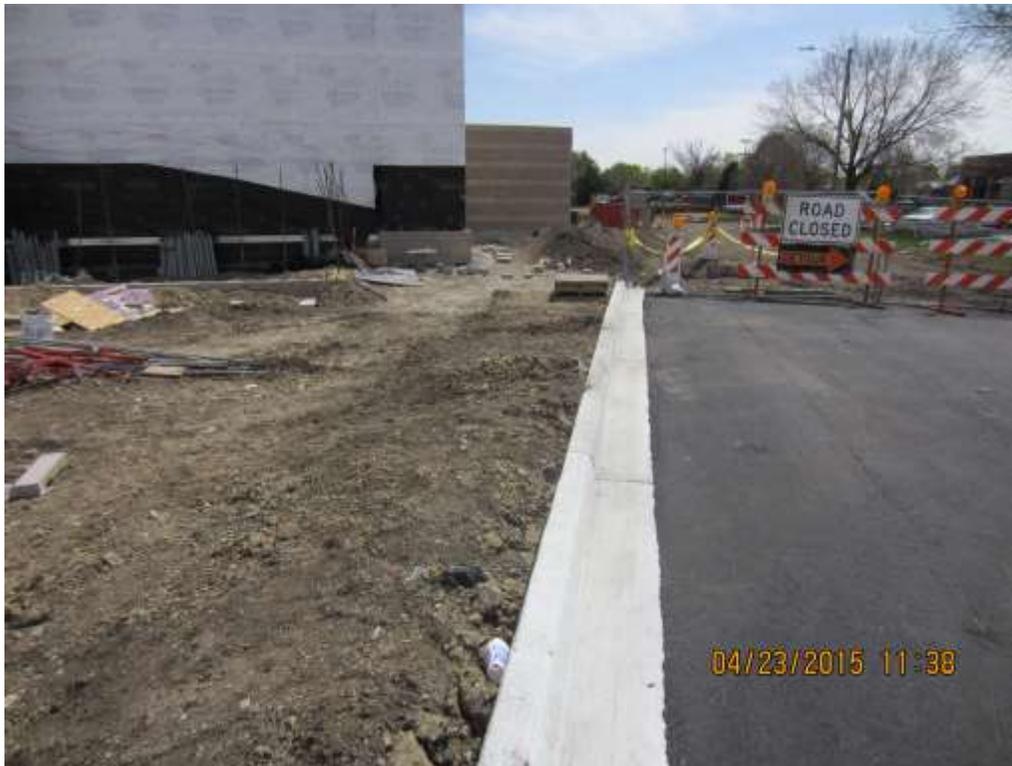
Photograph 47: Grade cut perimeter control not installed or maintained in accordance with good engineering, hydrologic, and pollution control practices

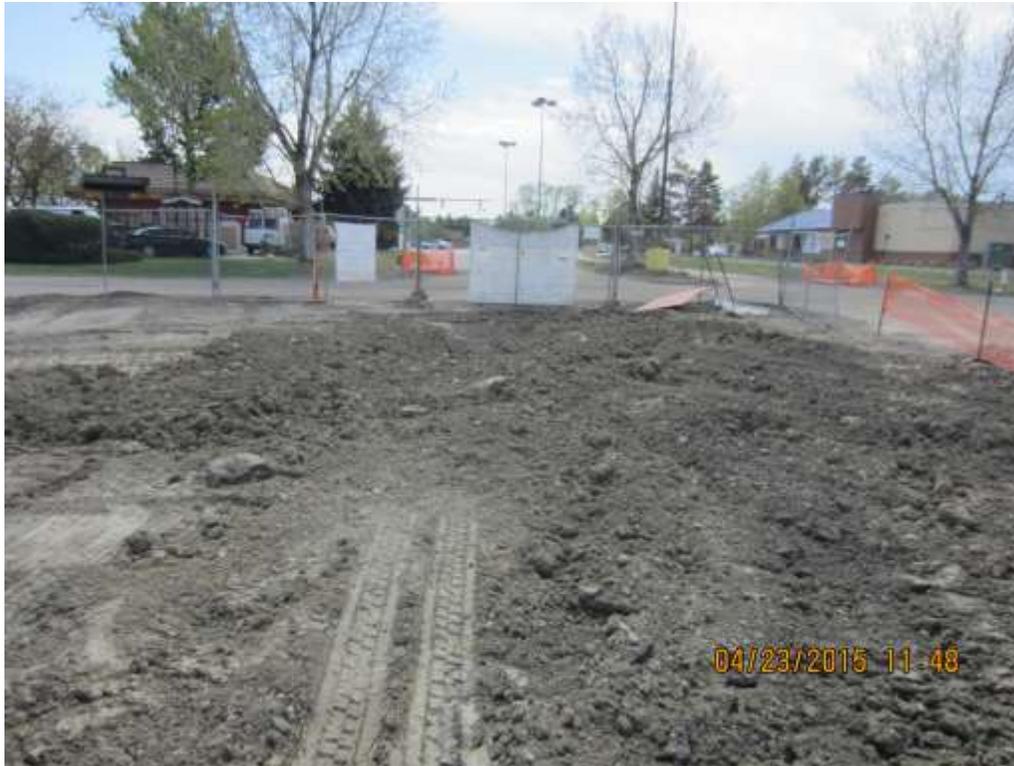
Photograph 50: Grade cut perimeter control not installed or maintained in accordance with good engineering, hydrologic, and pollution control practices

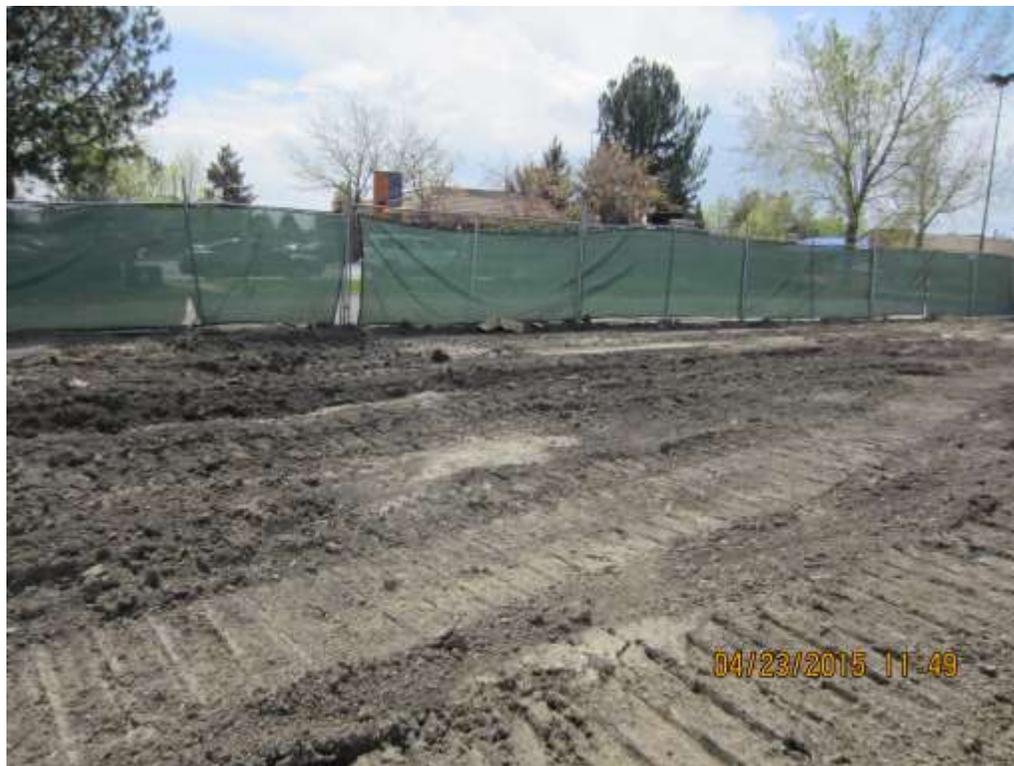
Photograph 51: Grade cut perimeter control not installed or maintained in accordance with good engineering, hydrologic, and pollution control practices

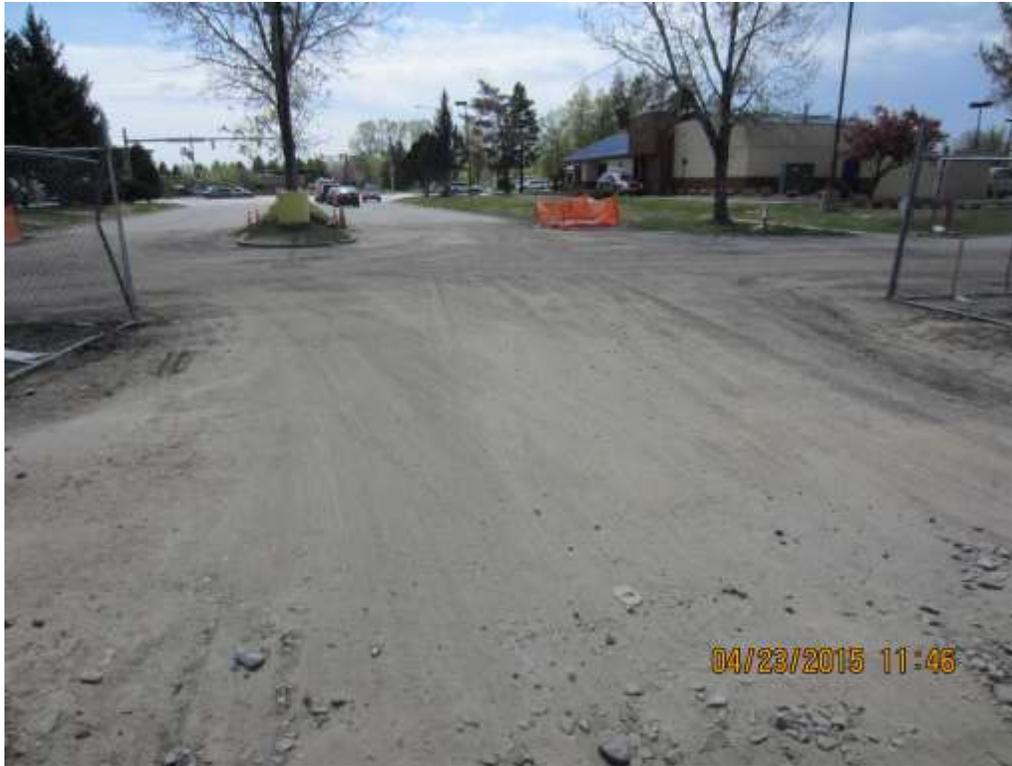
Photograph 52: Tracking observed exiting the site onto public roadway

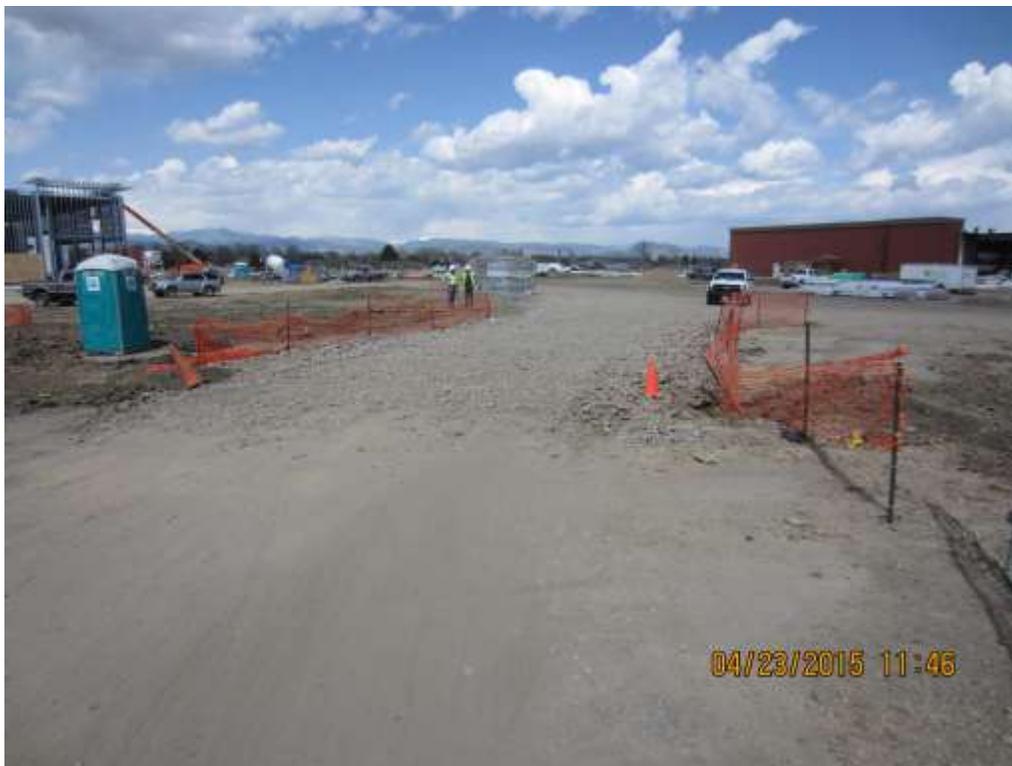
Photograph 53: Tracking pad in need of maintenance per the specification provided in the SMWP

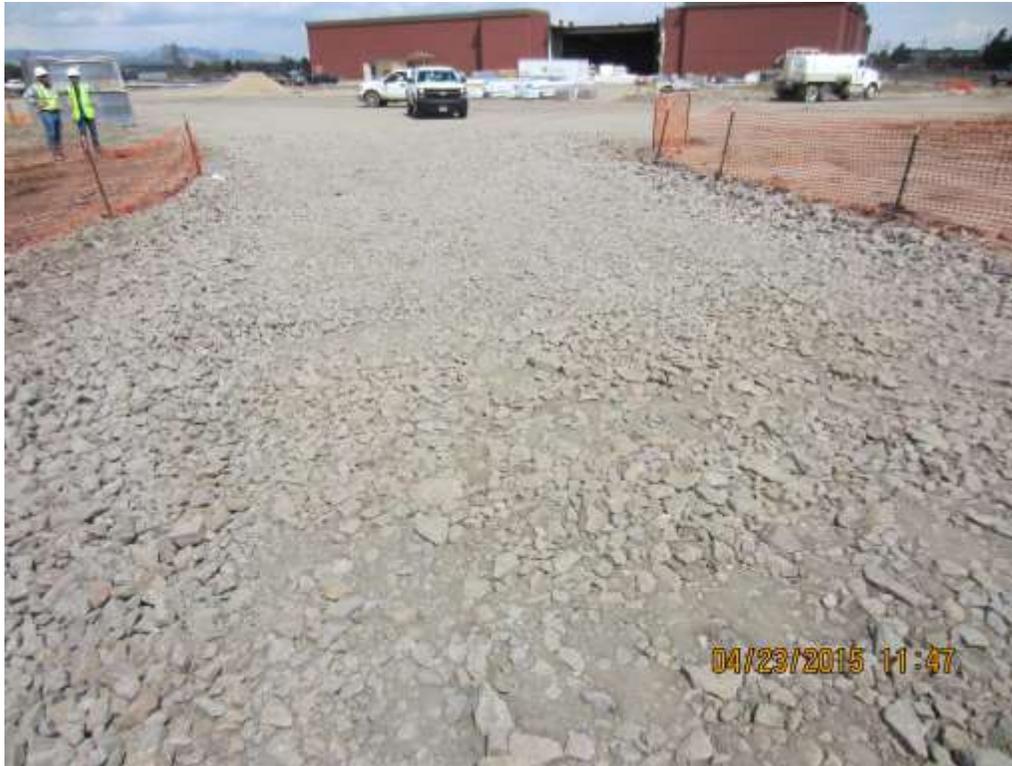
Photograph 54: Tracking pad in need of maintenance per the specification provided in the SMWP

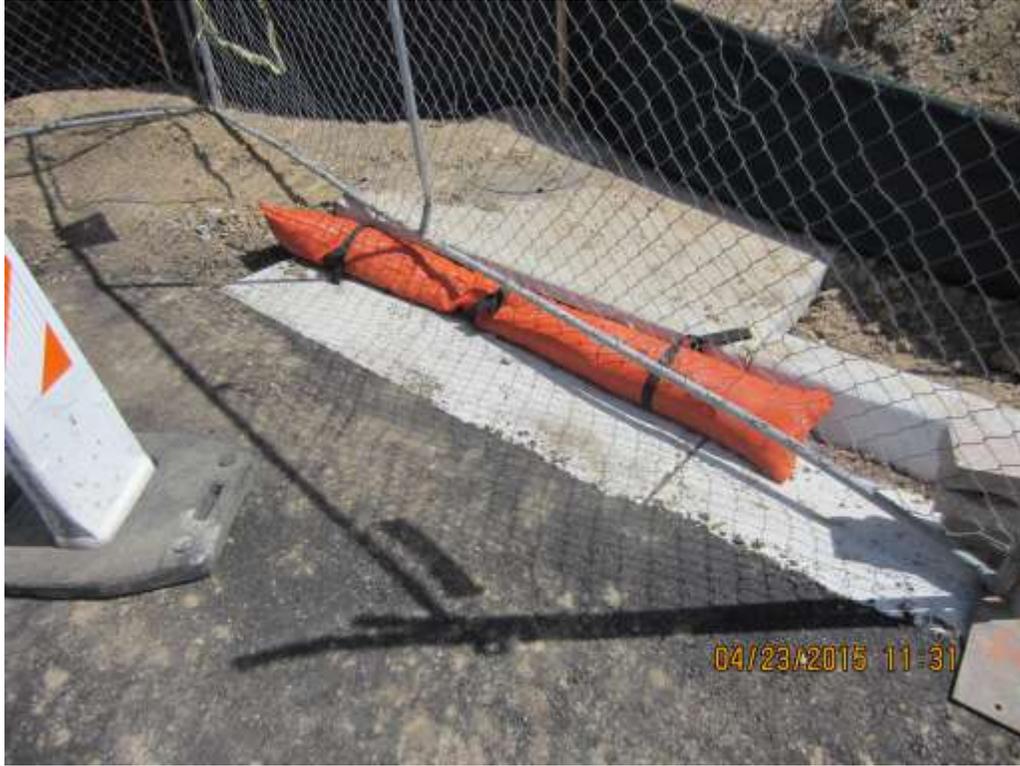
Photograph 56: No control at the back of inlet box for overtopped soils

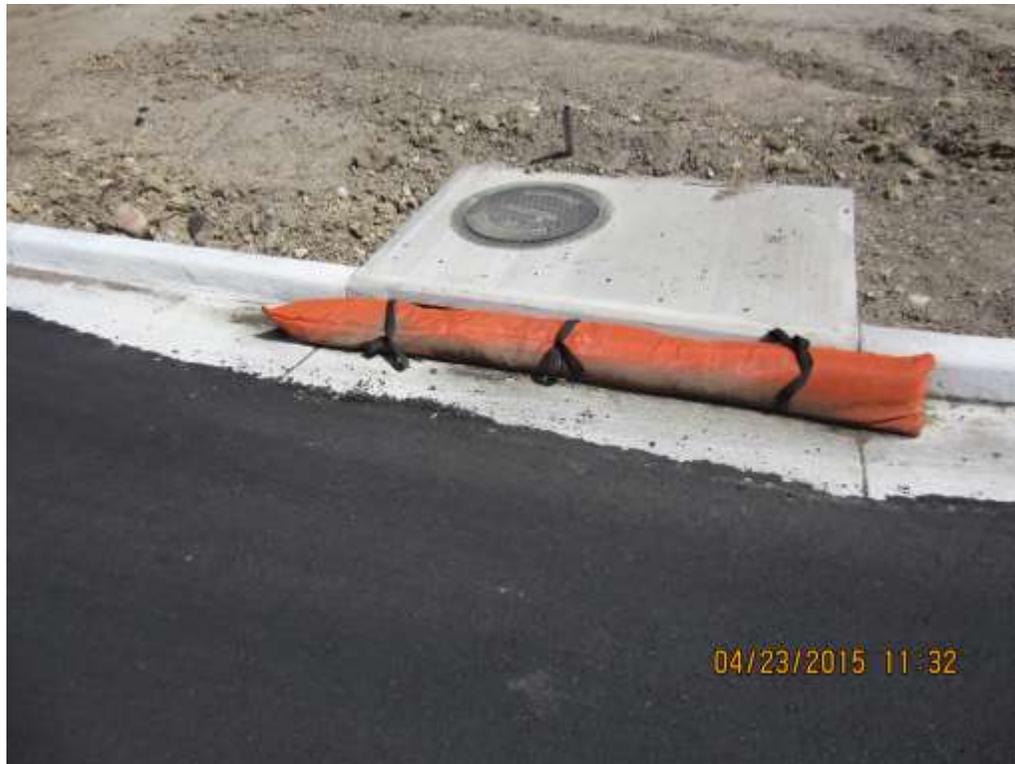
Photograph 57: No control at the back of inlet box for overtopped soils

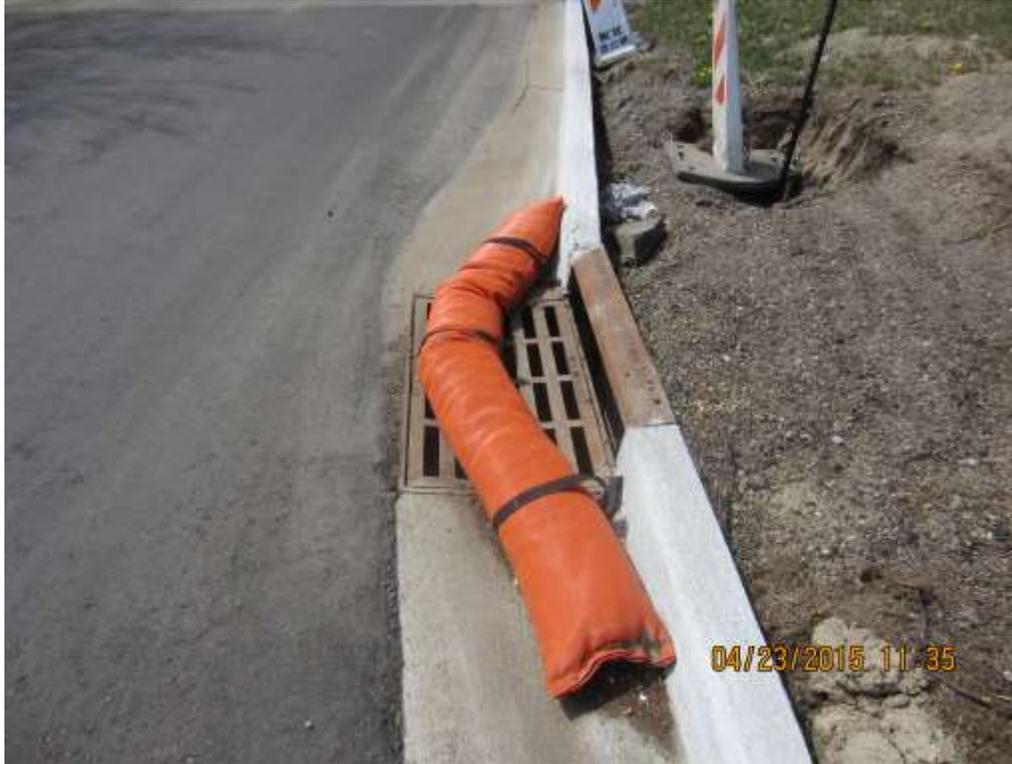
Photograph 58: Rubber wattle inadequate for application

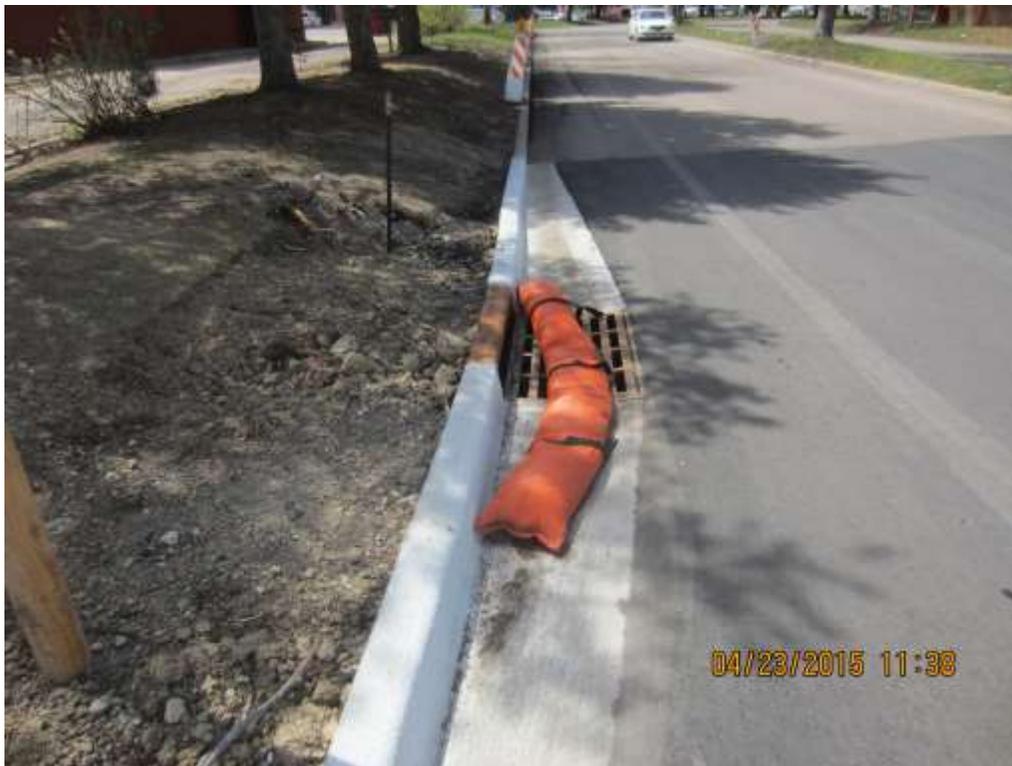
Photograph 59: Rubber wattle inadequate for application

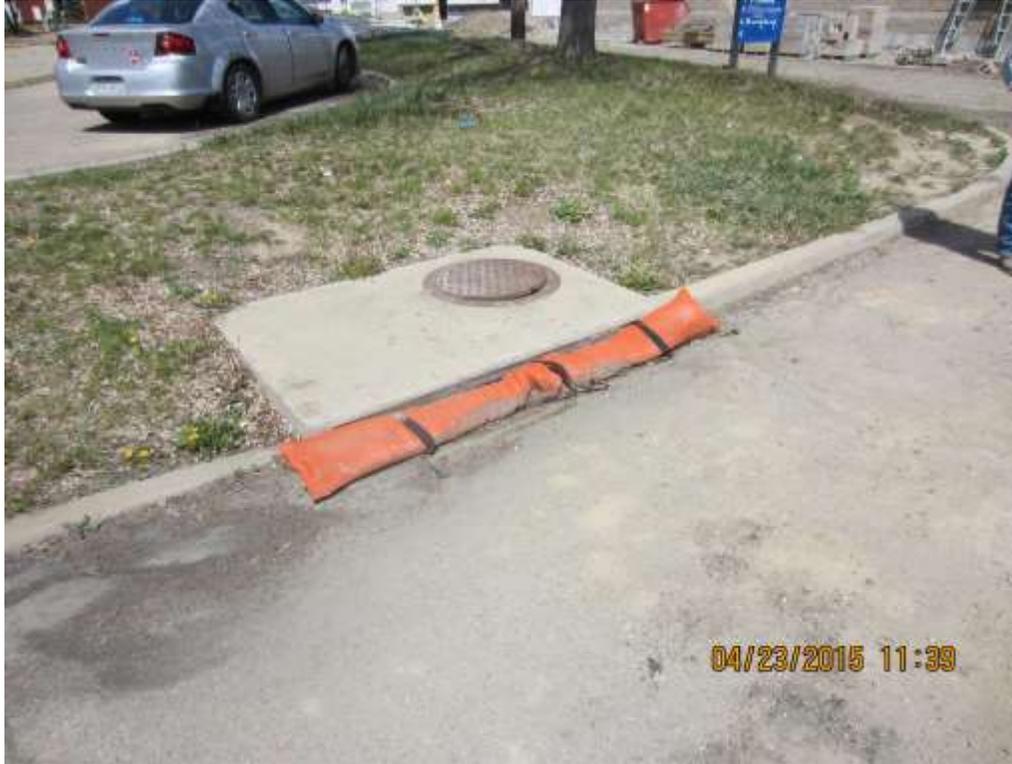
Photograph 60: Rubber wattle not maintained, sediment and debris accumulation should be removed

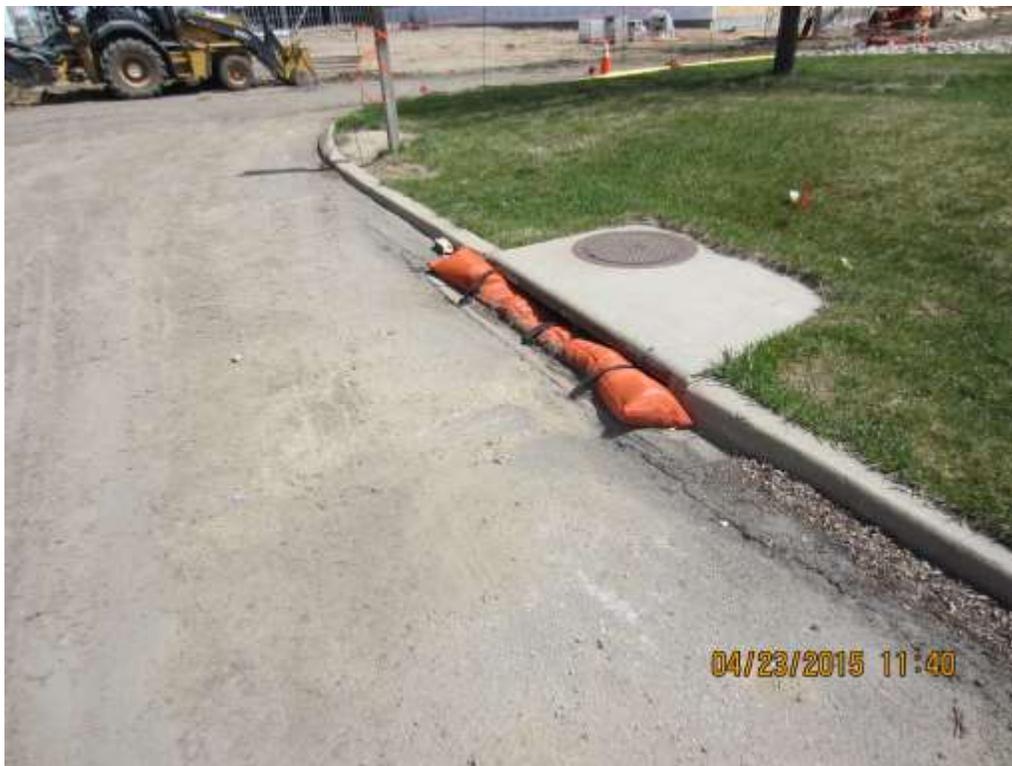
Photograph 61: Rubber wattle not maintained, sediment and debris accumulation should be removed

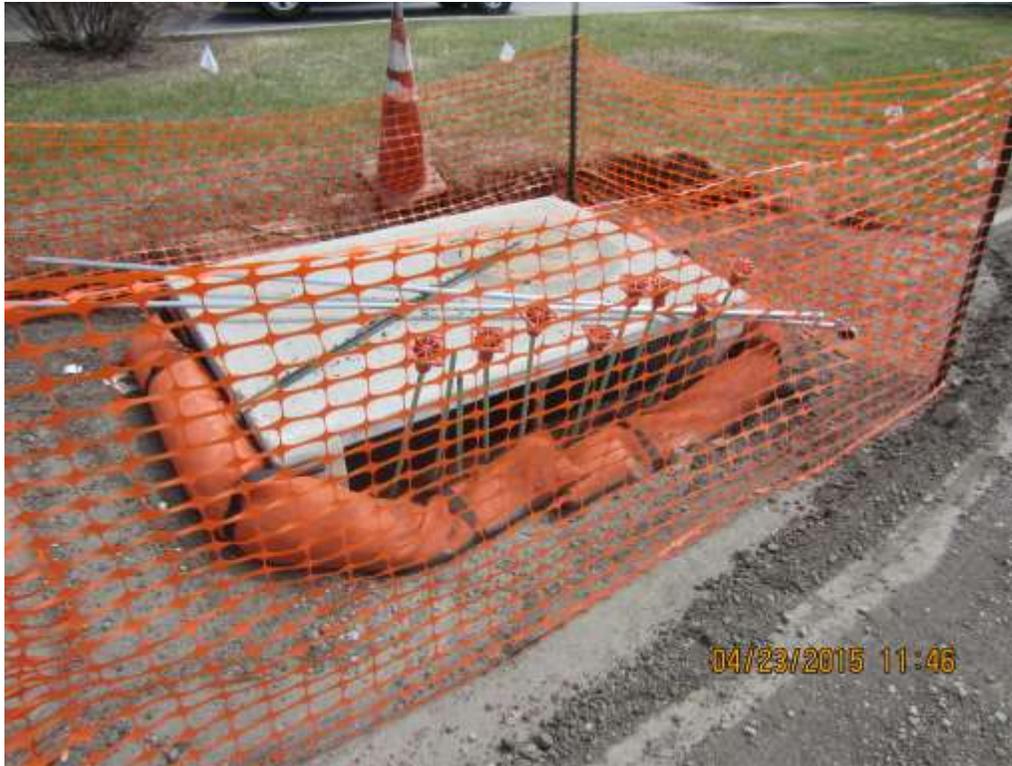
Photograph 62: Rubber wattle not maintained, sediment and debris accumulation should be removed

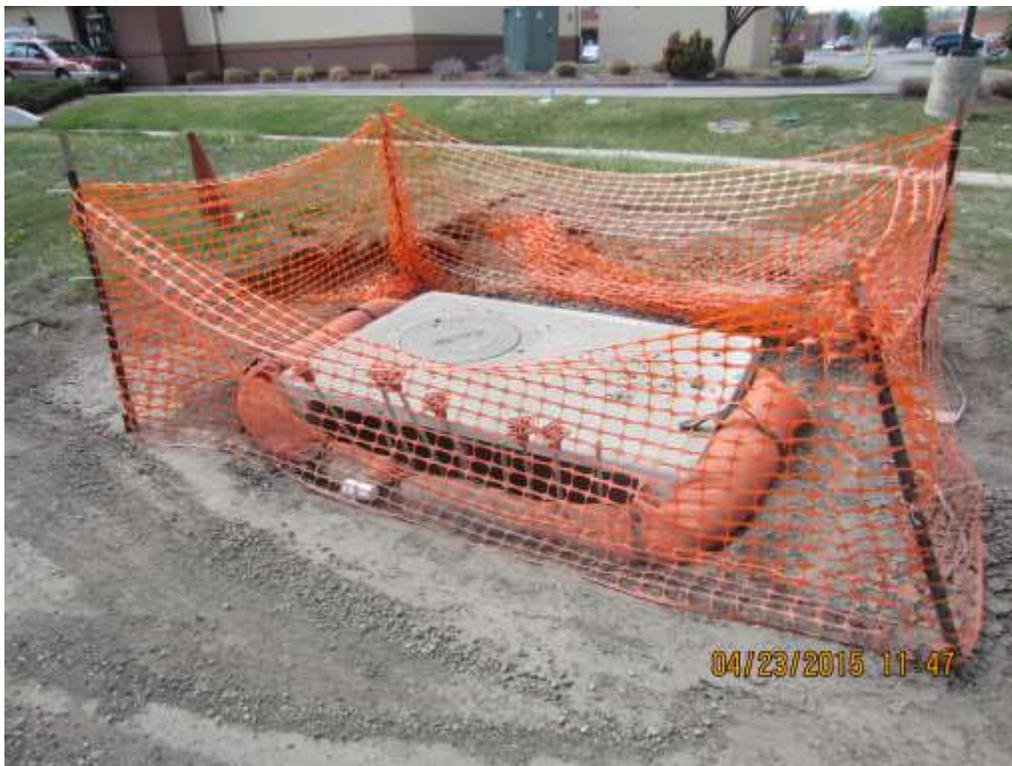
Photograph 63: Rubber wattle not maintained, sediment and debris accumulation should be removed

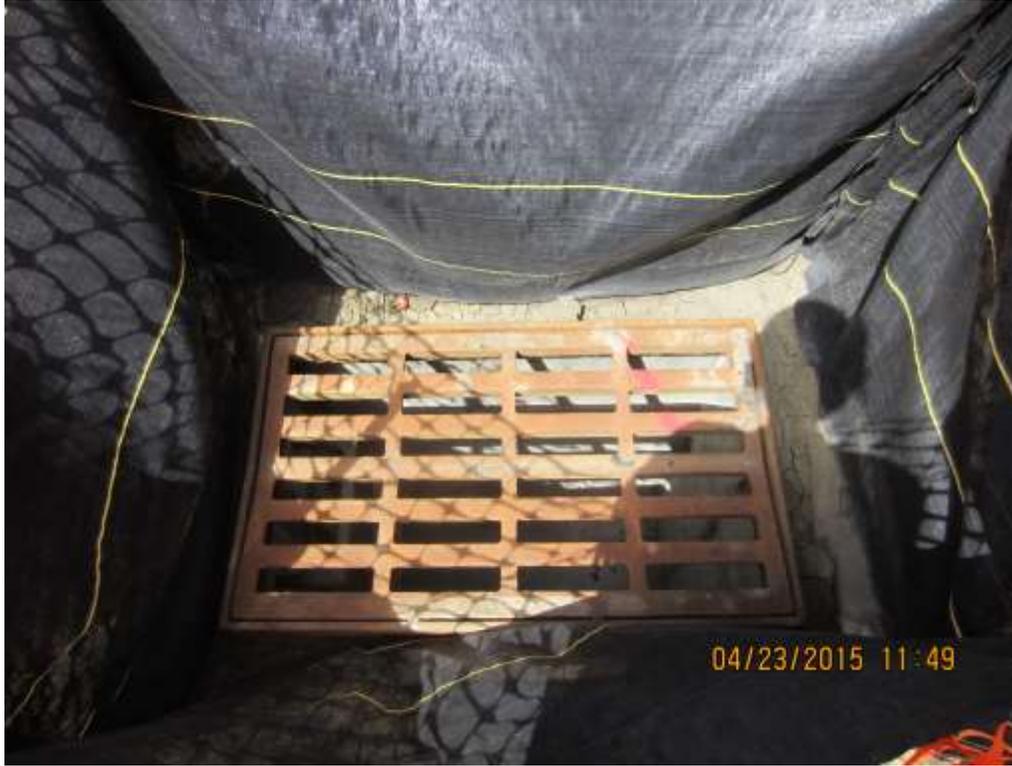
Photograph 64: Silt fence inlet protection not installed or maintained per the specification provided in the SWMP

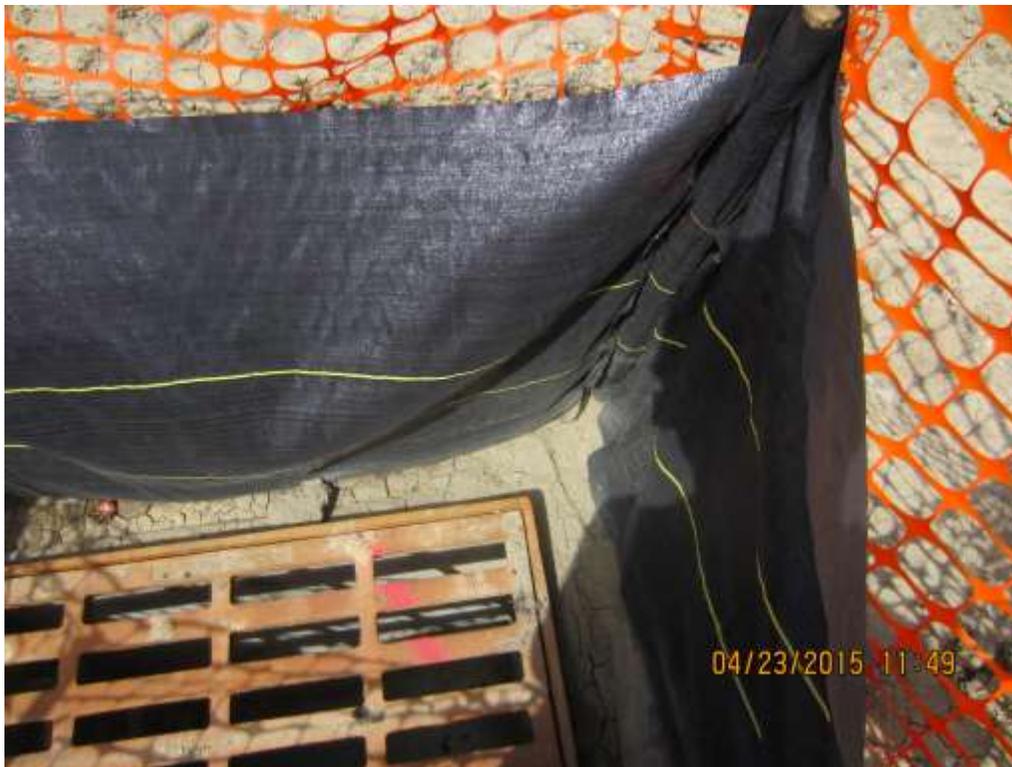
Photograph 65: Silt fence inlet protection not installed or maintained per the specification provided in the SWMP
