Department of Public
Health & Environment

RE: Service of Notice of Violation/Cease and Desist Order, Number: SO-151007-1

NOTICE OF VIOLATION / CEASE AND DESIST ORDER

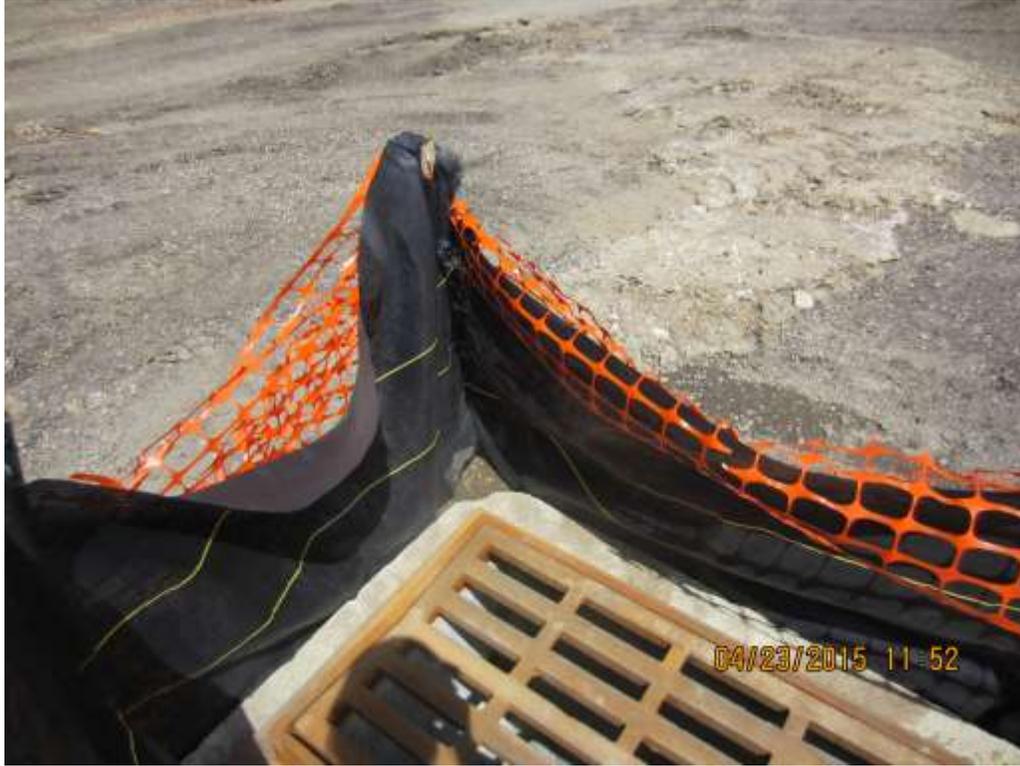
Photograph 66: Silt fence inlet protection not installed or maintained per the specification provided in the SWMP

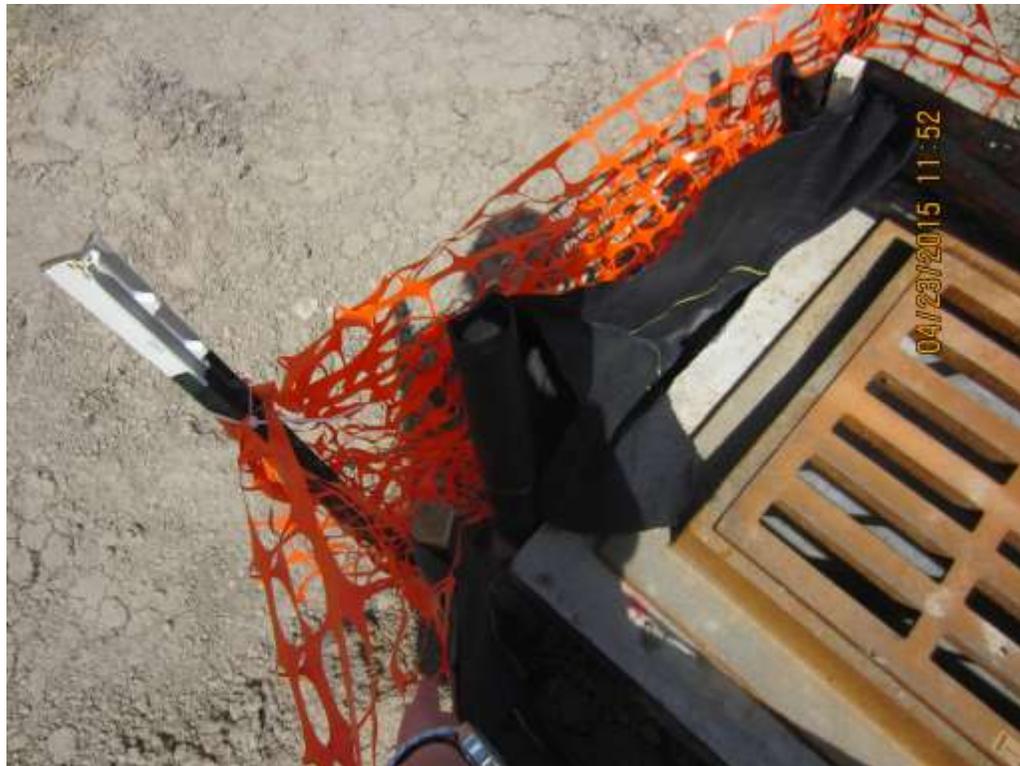
Photograph 67: Silt fence inlet protection not installed or maintained per the specification provided in the SWMP

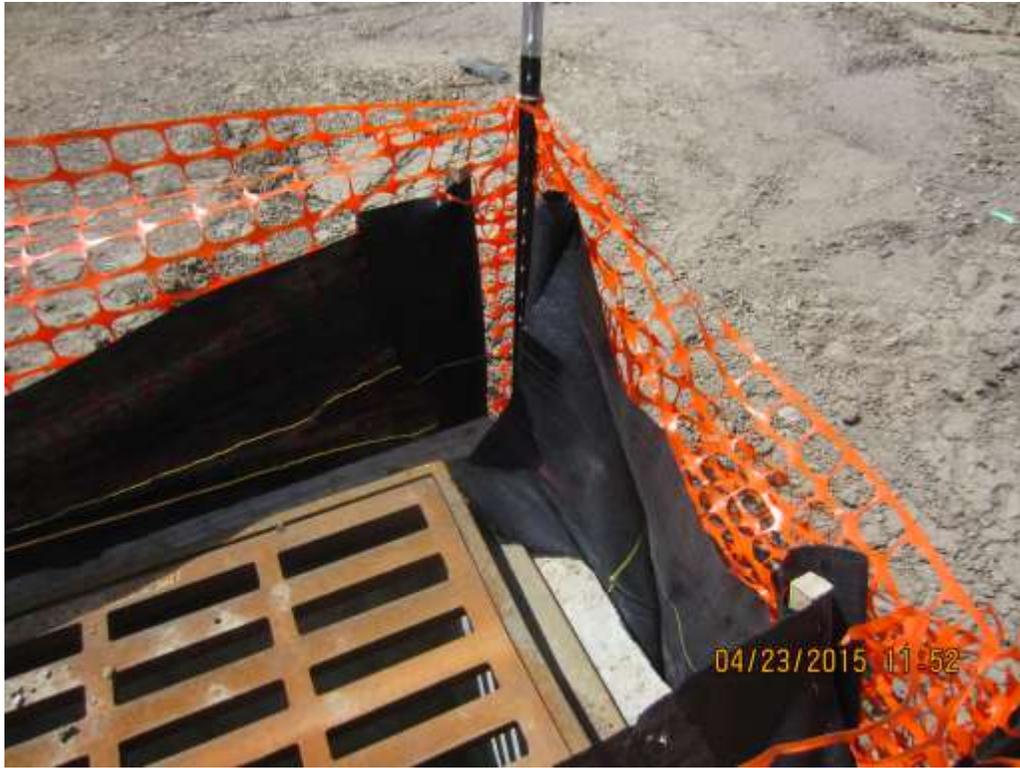
Photograph 68: Silt fence inlet protection not installed or maintained per the specification provided in the SWMP

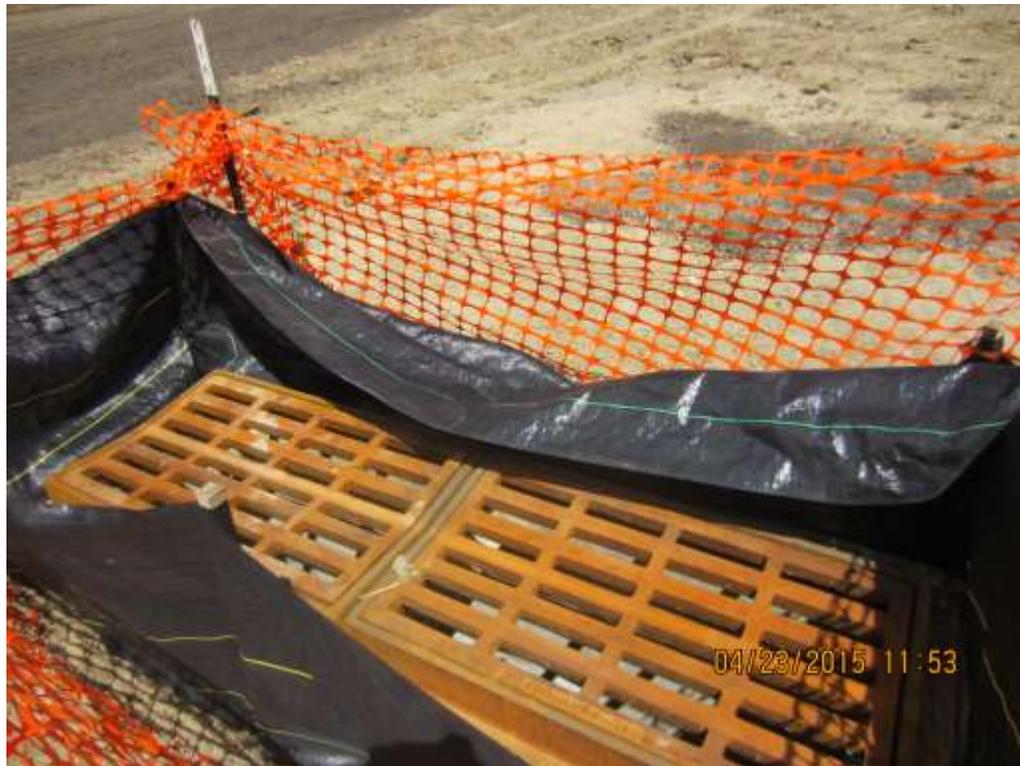
Photograph 69: Silt fence inlet protection not installed or maintained per the specification provided in the SWMP

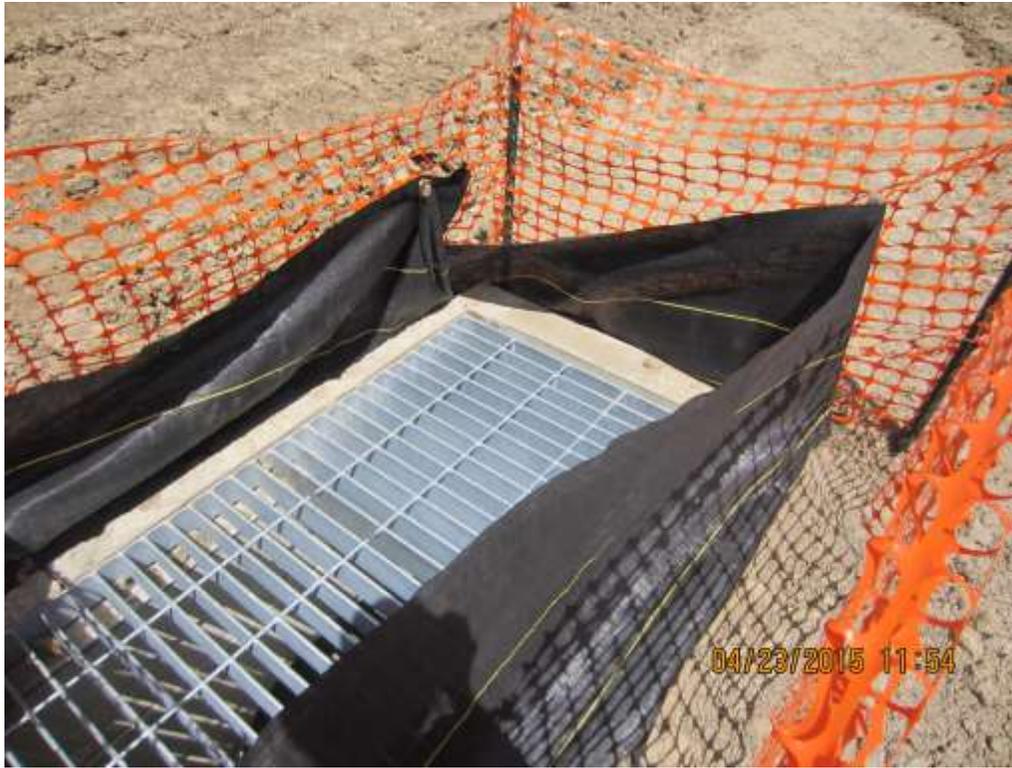
Photograph 70: Silt fence inlet protection not installed or maintained per the specification provided in the SWMP

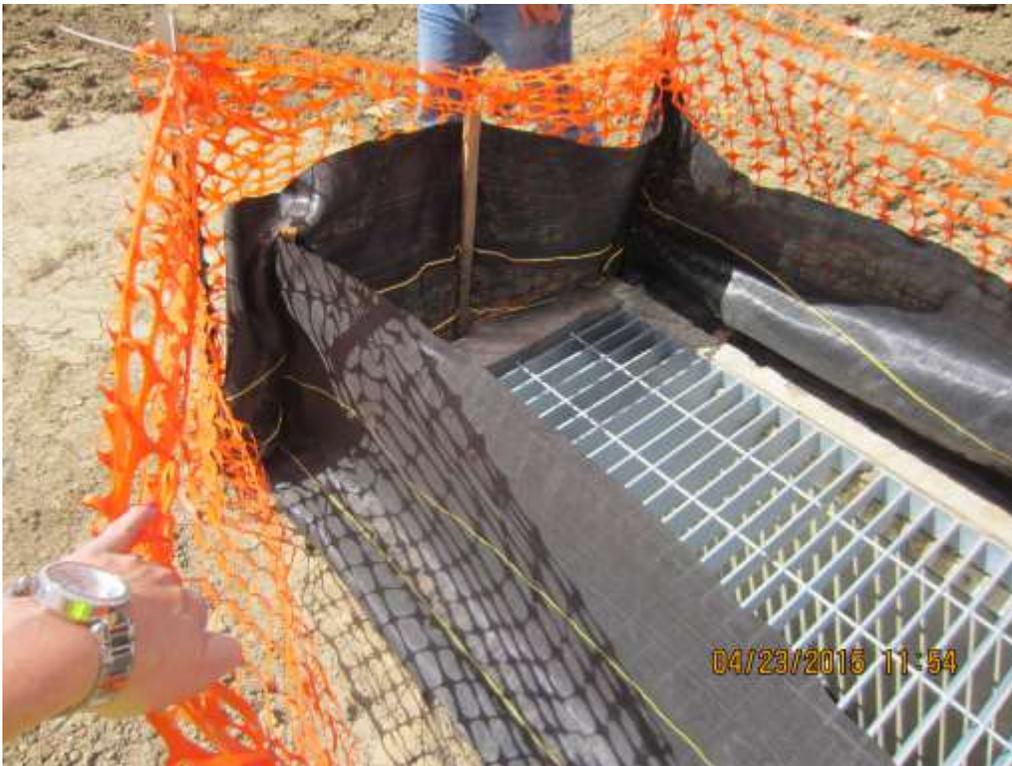
Photograph 71: Silt fence inlet protection not installed or maintained per the specification provided in the SWMP

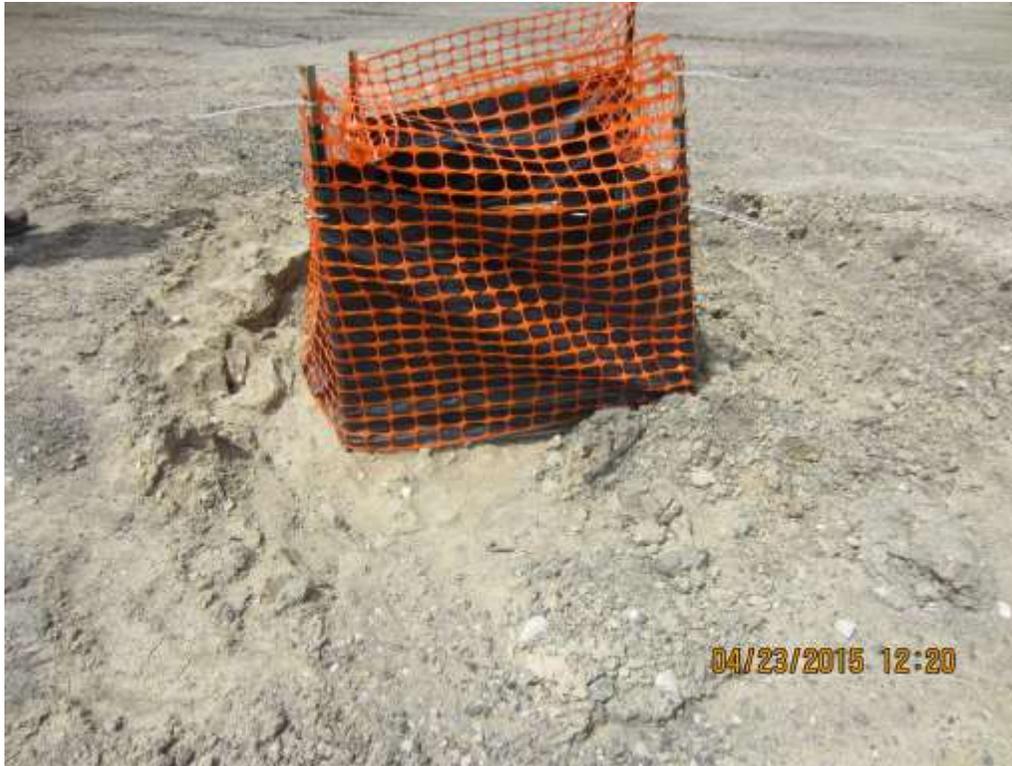
Photograph 72: Silt fence inlet protection not installed or maintained per the specification provided in the SWMP

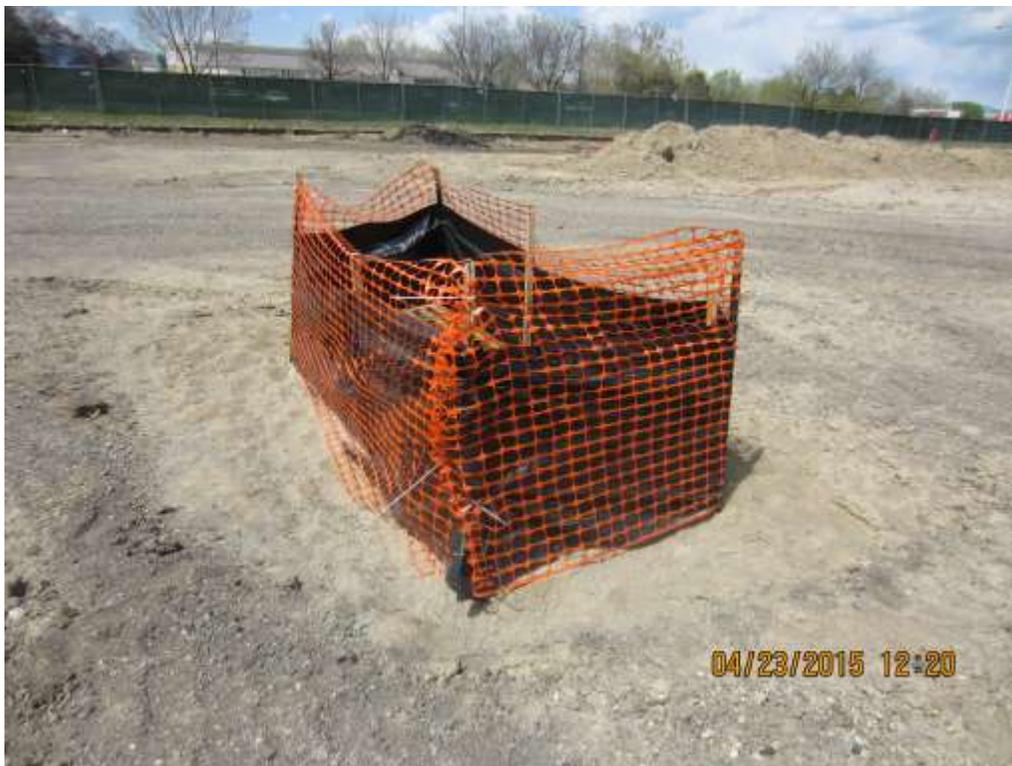
Photograph 73: Silt fence inlet protection not installed or maintained per the specification provided in the SWMP

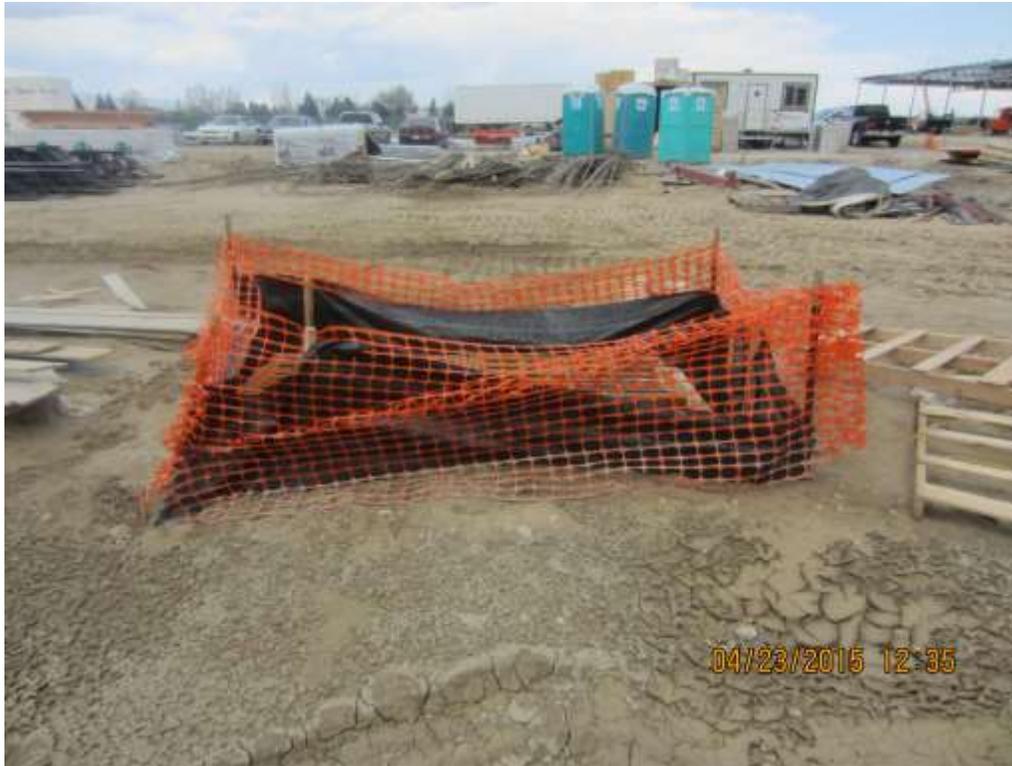
Photograph 74: Silt fence inlet protection not installed or maintained per the specification provided in the SWMP

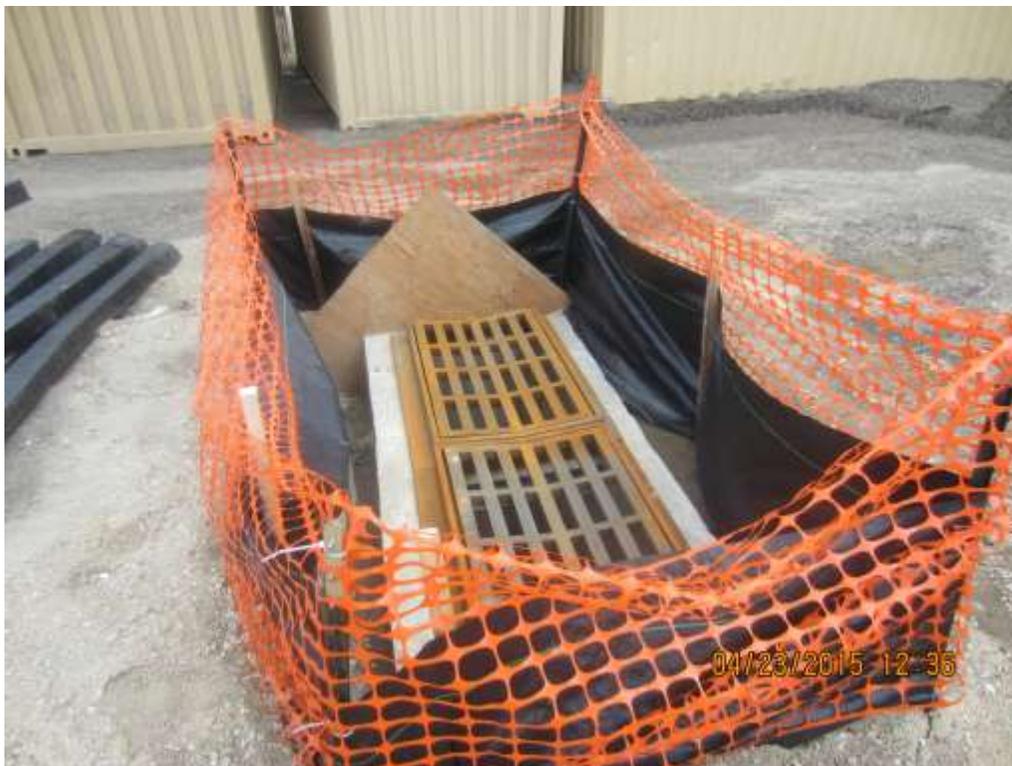
Photograph 75: Silt fence inlet protection not installed or maintained per the specification provided in the SWMP

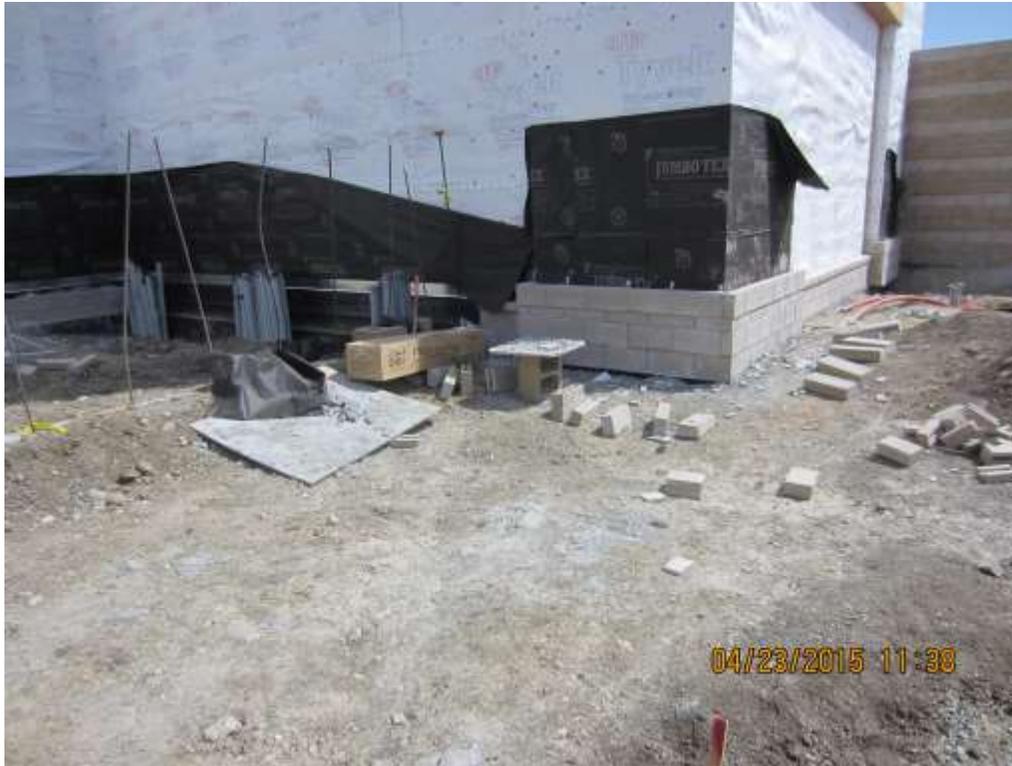
Photograph 78: Concrete waste not managed in accordance with the requirements in the SWMP

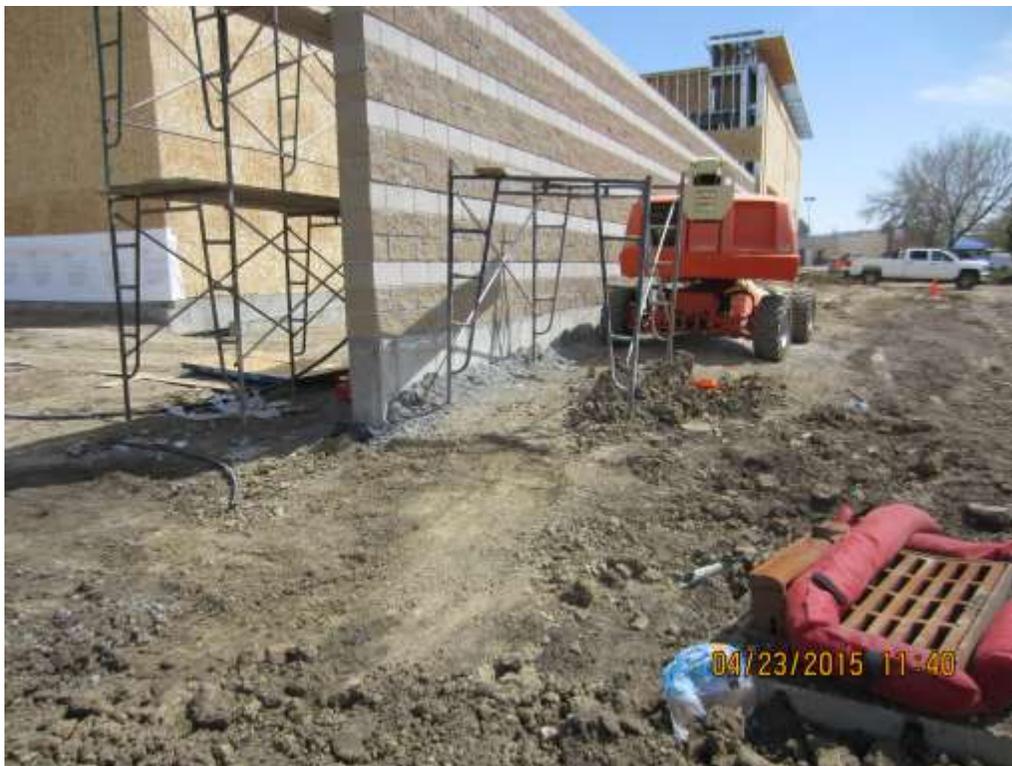
Photograph 79: Concrete waste not managed in accordance with the requirements in the SWMP

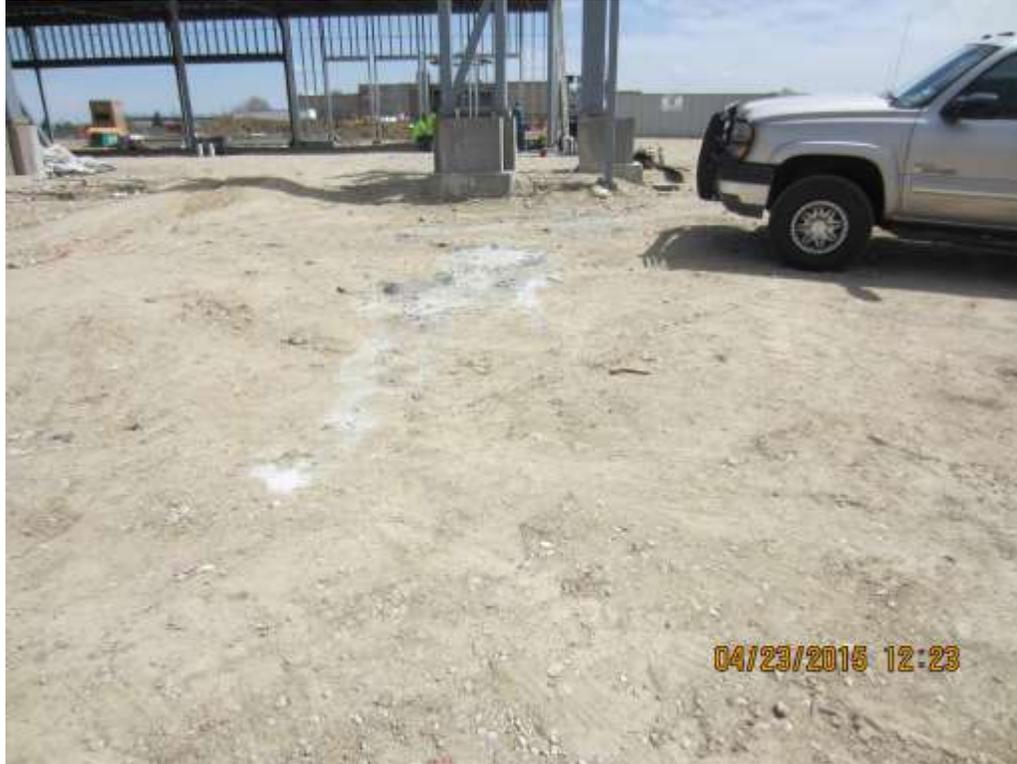
Photograph 80: Concrete washout waste not managed in accordance with the requirements in the SWMP
