**RE: Expedited Settlement Agreement Offer
River Trail Subdivision / CDPS Permit Certification # COR-03D372**

Stormwater Inspection Report

Permittee: River Trail Investment LLC **Cert#** COR03D327 **Report Date:** November 12, 2014

Facility: River Trail Subdivision **Rec. Water(s)** Beswick Drain - Colorado River

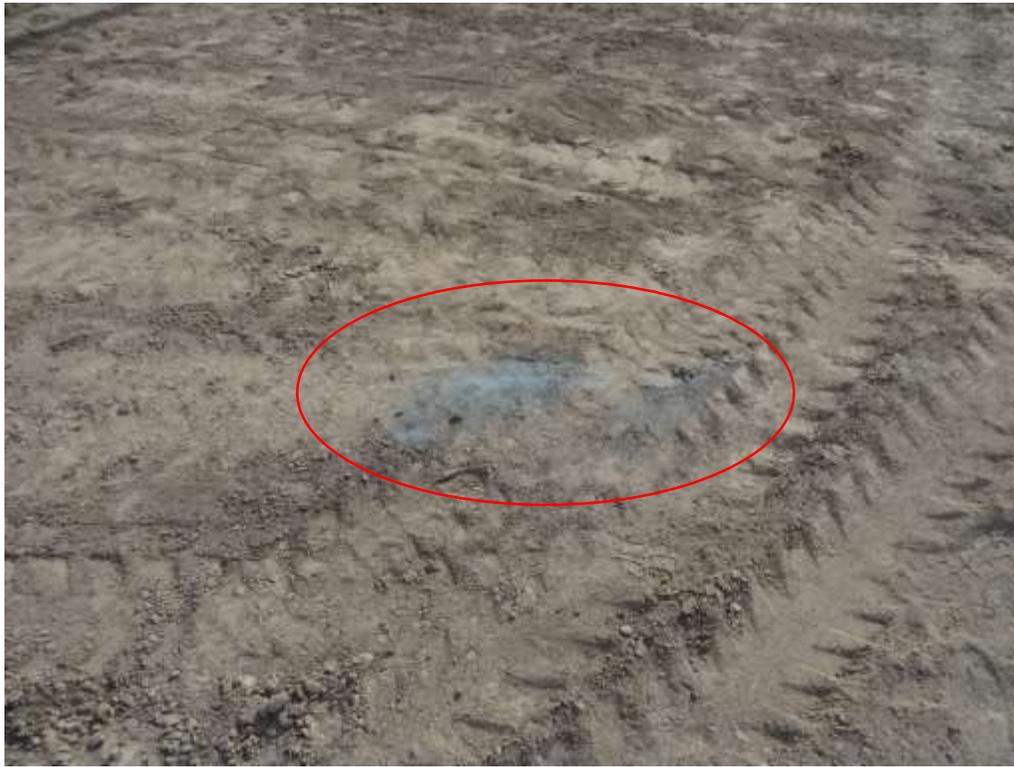
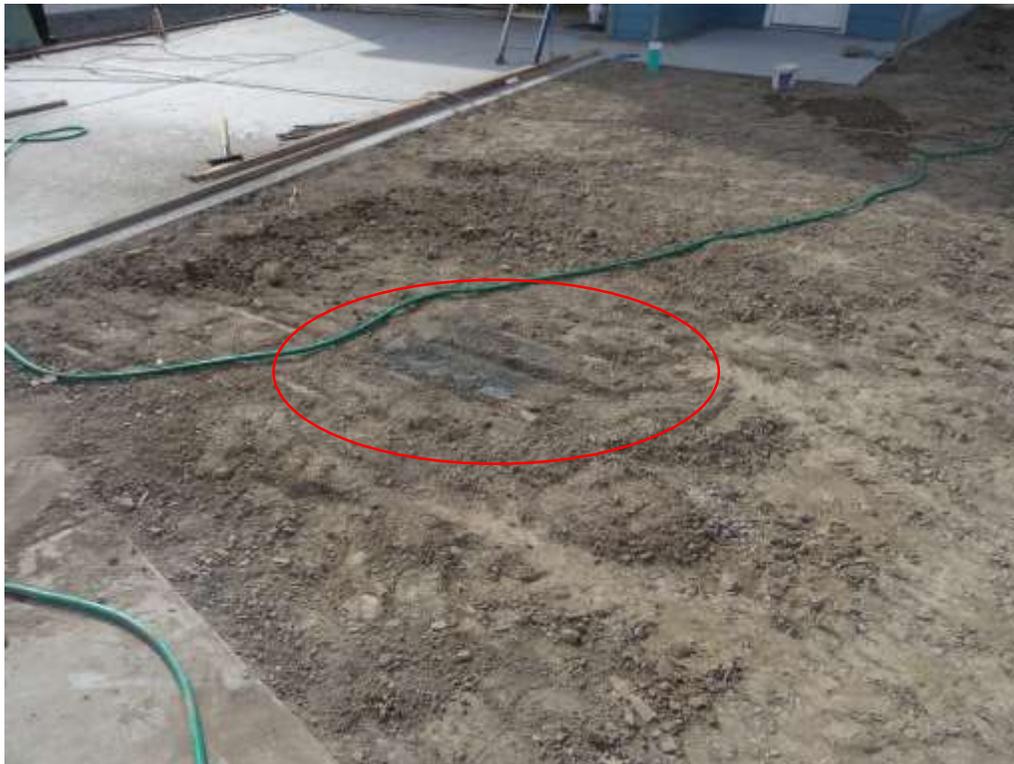
1. It was noted during the inspection that control measures were not implemented to manage pollutant contributions to stormwater runoff from construction materials waste located west of Green River Drive on lot 57 (refer to photograph(s) 01 - 02).

- Control Measure Observation: Control measures were not implemented to control stormwater runoff from the location and pollutant source noted above.
 - Paint spills were observed around a house that was undergoing finishing activities on lot 57.

Photograph 1: Paint spilled on sediment on lot 57, not managed as required in the SWMP

Photograph 2: Paint spilled on sediment on lot 57, not managed as required in the SWMP

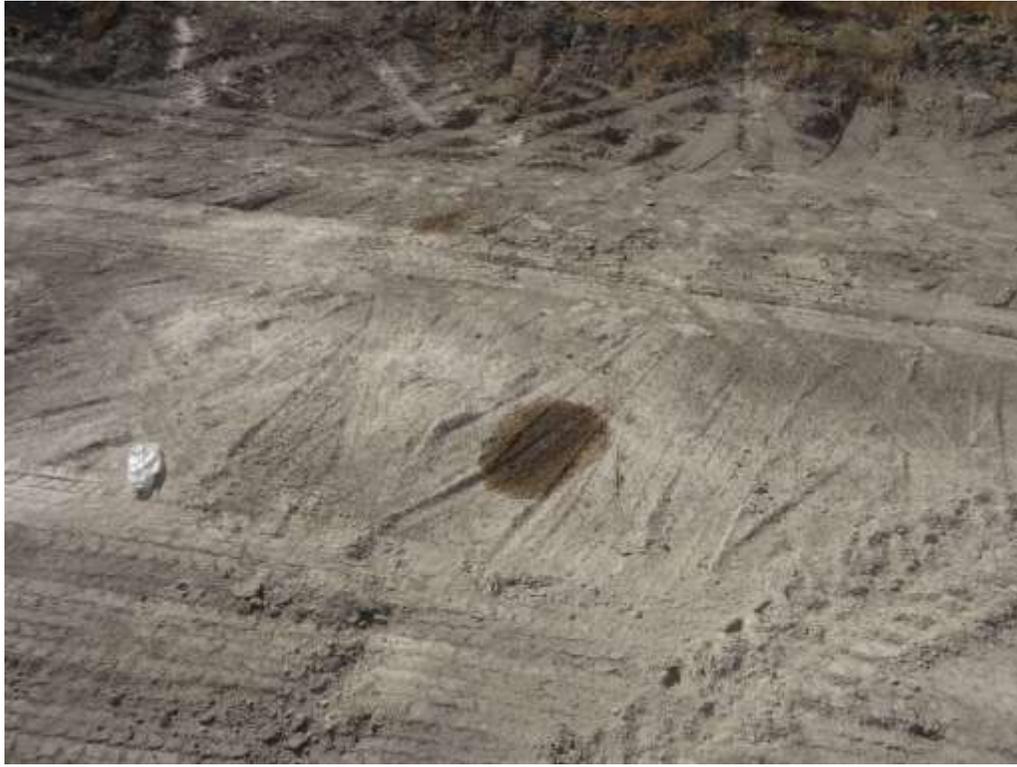
2. It was noted during the inspection that inadequate control measures were implemented to manage pollutant contributions to stormwater from construction materials waste located west of Green River Drive on the west side of lot 52 (refer to photograph(s) 03).

- Control Measure Observation: Control measures were not implemented to control stormwater runoff from the location and pollutant source noted above.
 - A vehicle fluid spill was observed on the sediment and had not been cleaned-up and properly disposed of.

Photograph 3: Vehicle fluid spill on lot 52, not managed as required in the SWMP

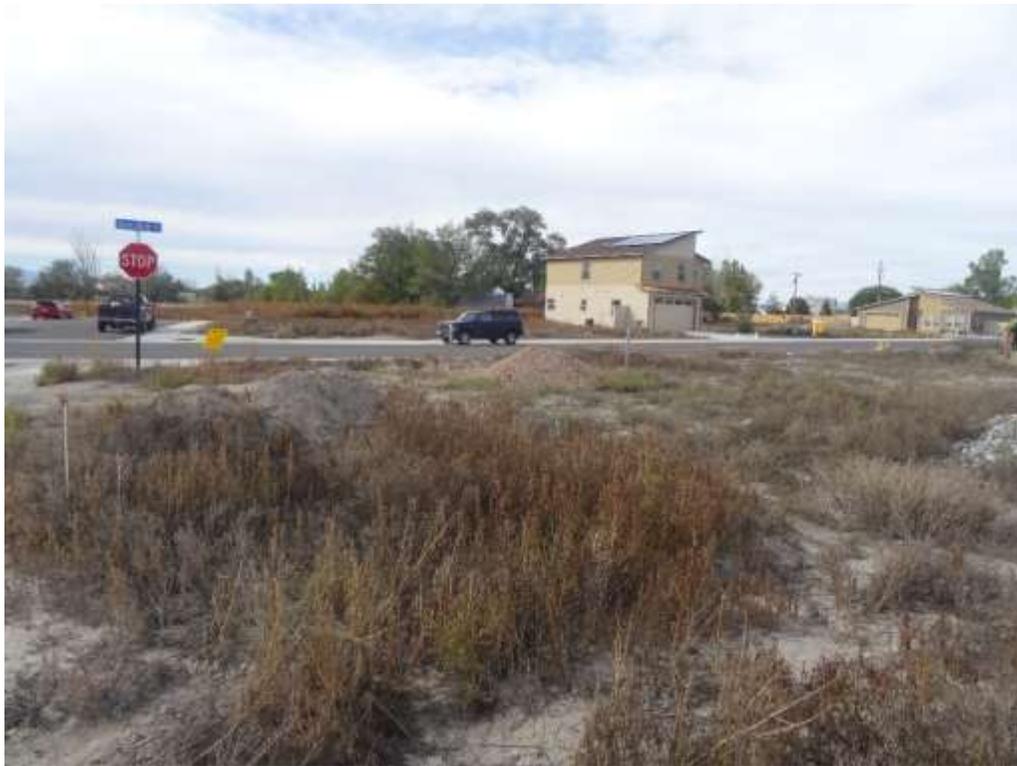
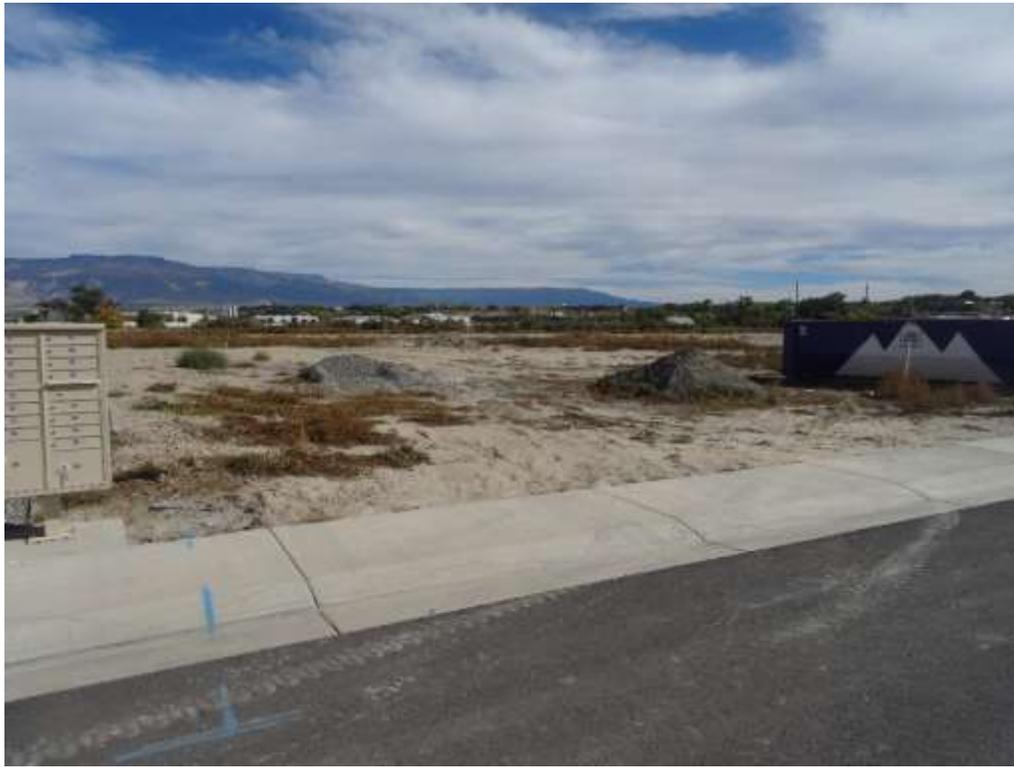
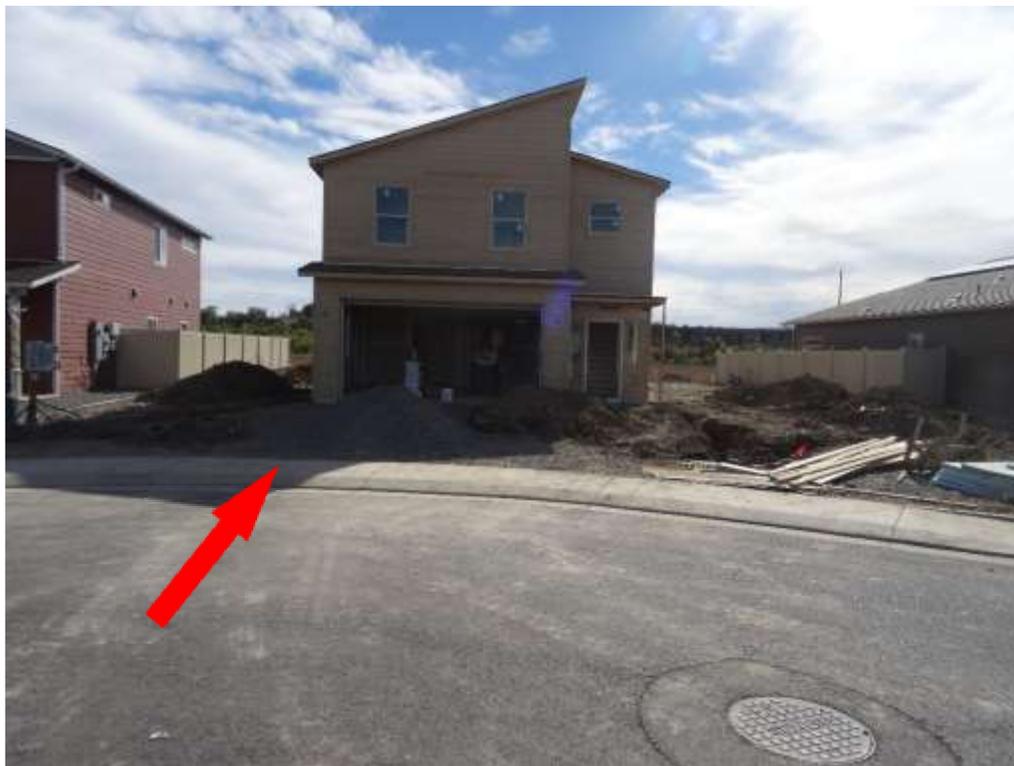
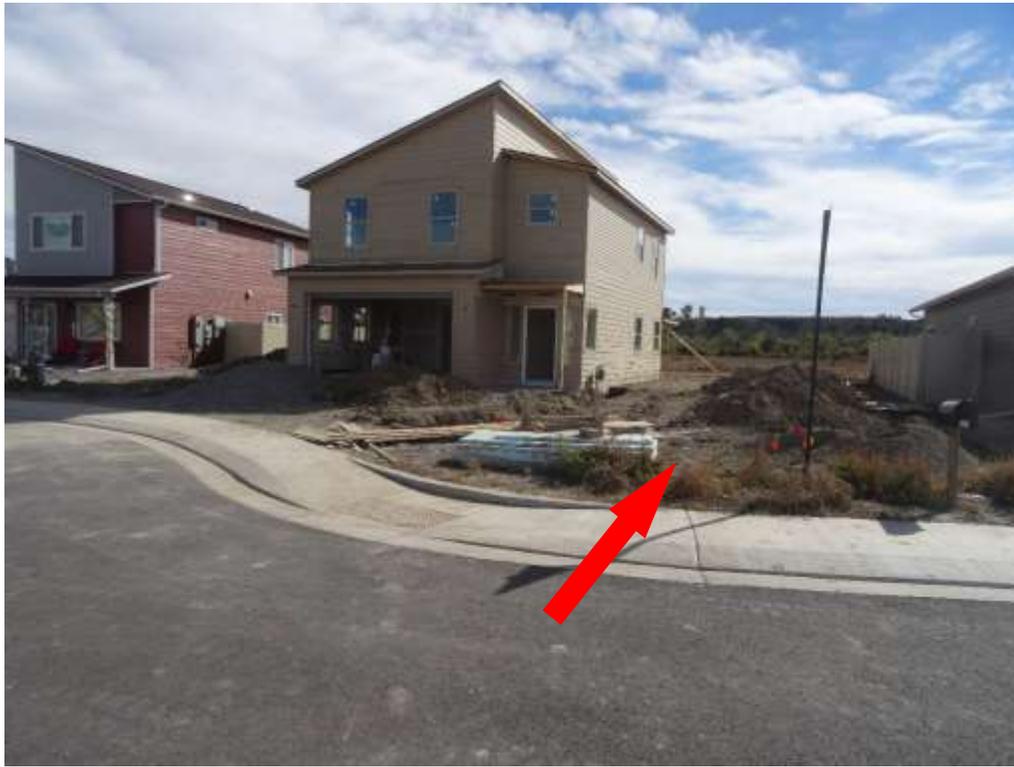
3. It was noted during the inspection that control measures were not implemented to manage pollutant contributions to stormwater from sediment from stockpiles located on disturbed lots on both sides of Green River Drive (refer to photograph(s) 04 - 07).

- Soil stockpiles were observed on the jobsite and no control measures were present.
 - Control Measure Finding: Control measures were not implemented to manage stormwater runoff from the above listed pollutant source as required by the permit. Specifically,

Photograph 4: Stockpiles without control measures, not managed as required in the SWMP

Photograph 5: Stockpiles without control measures, not managed as required in the SWMP

Photograph 6: Stockpiles without control measures, not managed as required in the SWMP

Photograph 7: Stockpiles without control measures, not managed as required in the SWMP

- Control measures must be implemented to manage stormwater runoff from all potential pollutant sources.
 - Control measures implemented at the site must be adequately designed to provide control for all potential pollutant sources associated with construction activity to prevent pollution or degradation of State waters.

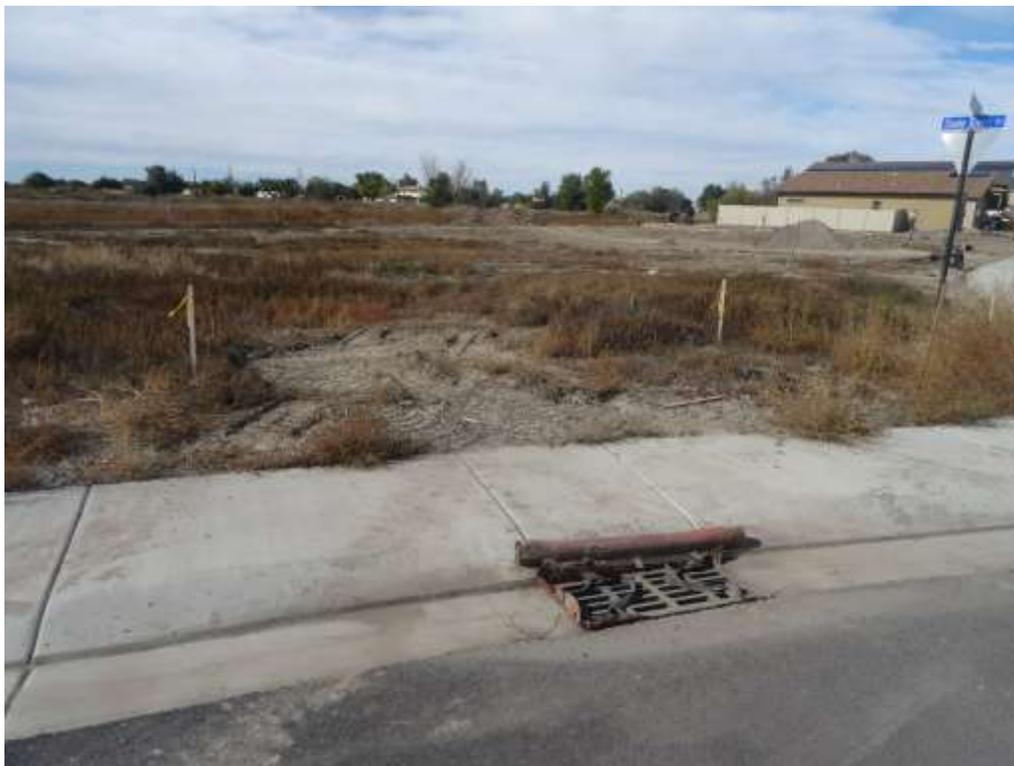
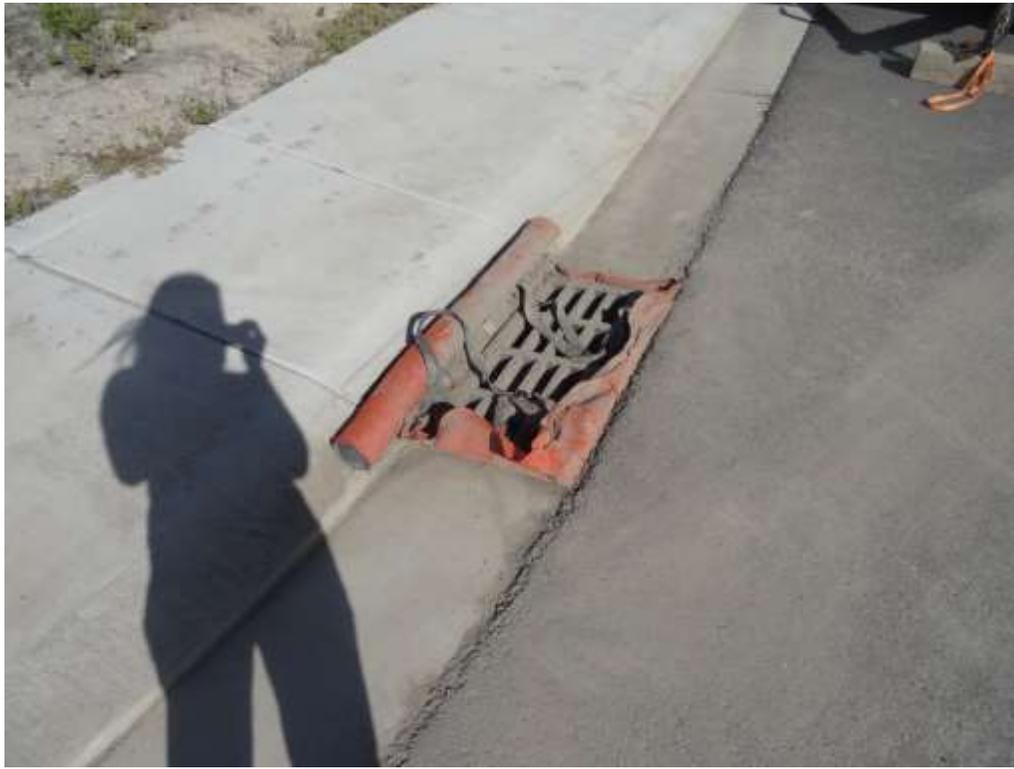
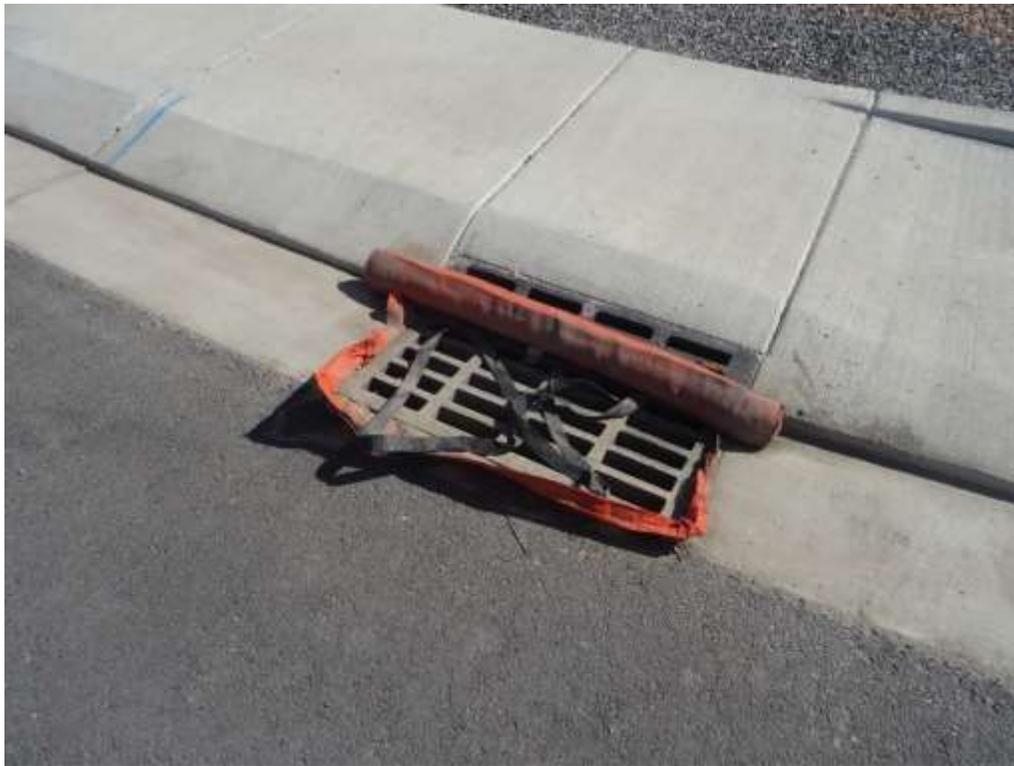
- Control Measure Observation: A dandy bag inlet protection control measure was implemented to manage stormwater runoff from the location and pollutant source noted above; however the control measure was inadequate.

- The areas of disturbance and expected sediment transport exceed the capacity of the inlet protection control measure.
 - Control Measure Finding: An installation and implementation specification for Dandy Bag inlet protections observed in the field during the inspection was not provided in the SWMP as required by the permit. Specifically,

Photograph 8: Inlet with a dandy sack, southeast of lot 51

Photograph 9: Inlet with dandy sack south of lot 63

Photograph 10: Inlet with dandy sack north of lot 73

- Control measures implemented at the site must be adequately designed to provide control for all potential pollutant sources associated with construction activity to prevent pollution or degradation of State waters.

- Design control measures following good engineering, hydrologic and pollution control practices to prevent pollution or degradation of state waters and document in the SWMP.

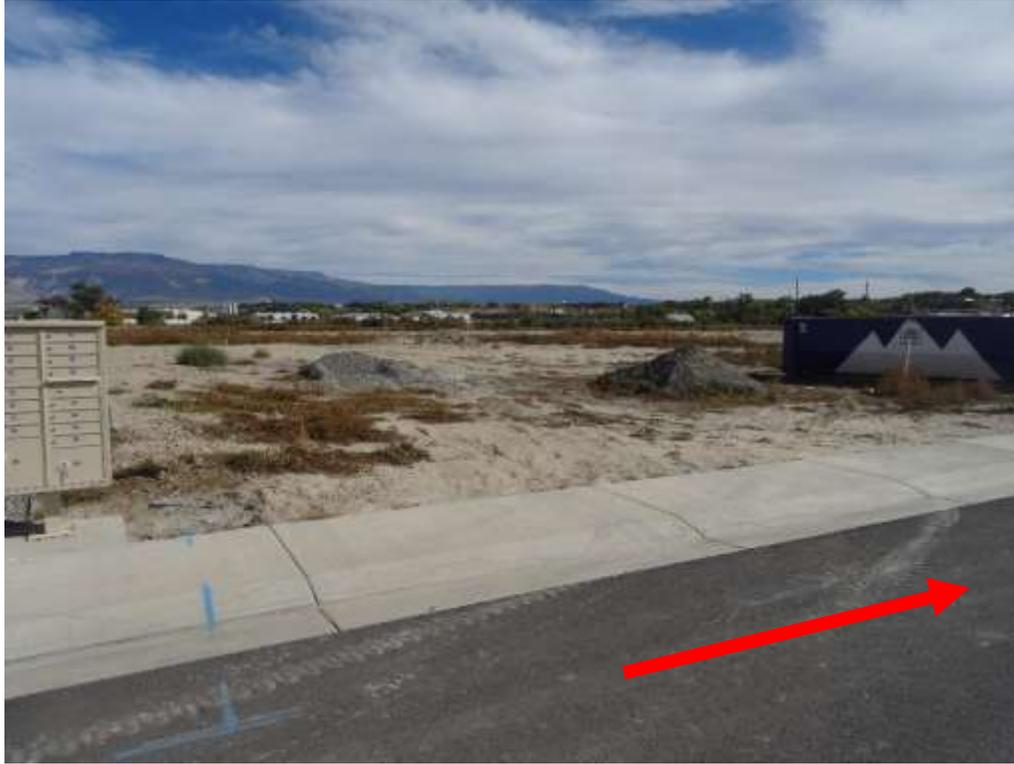
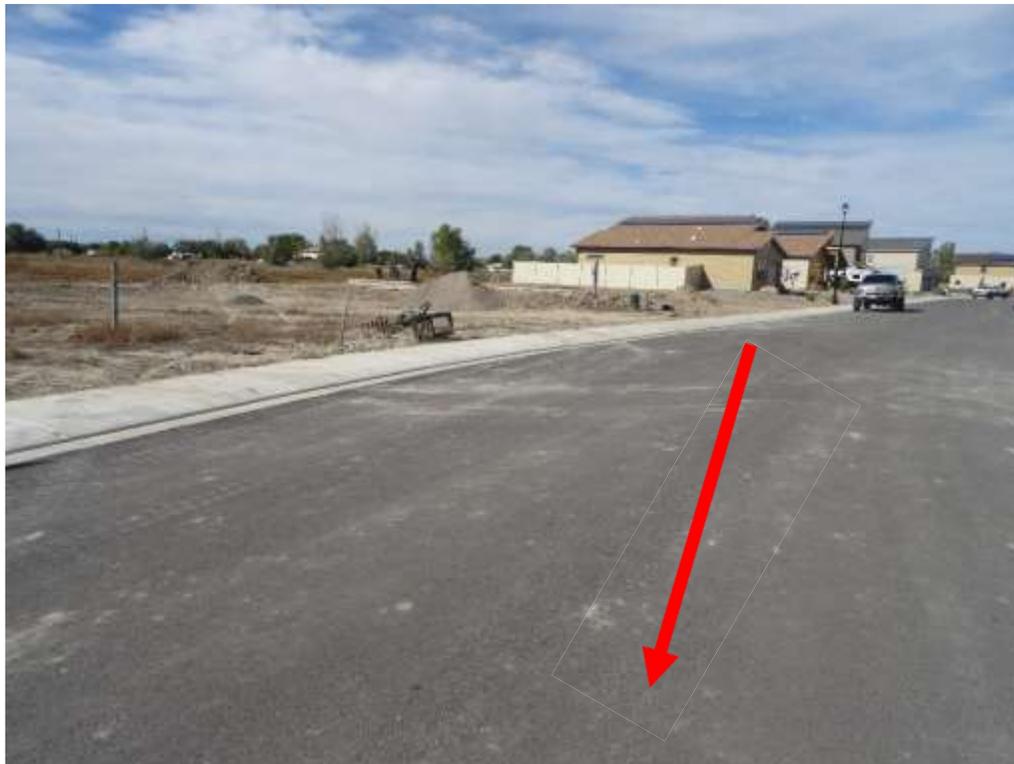
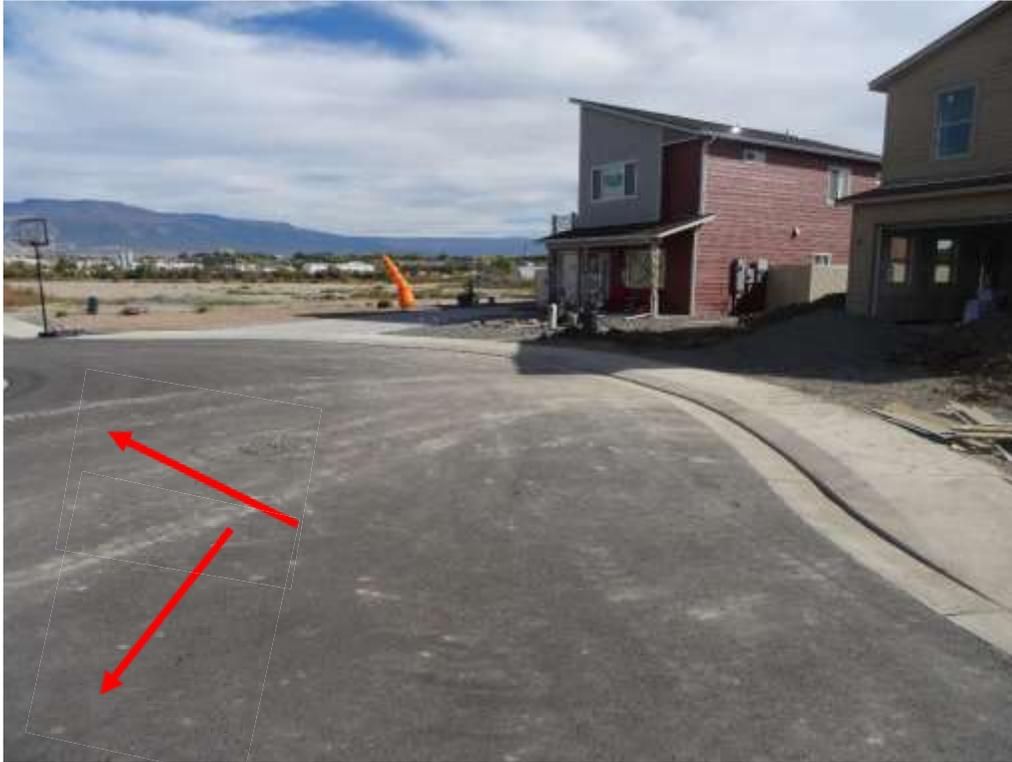
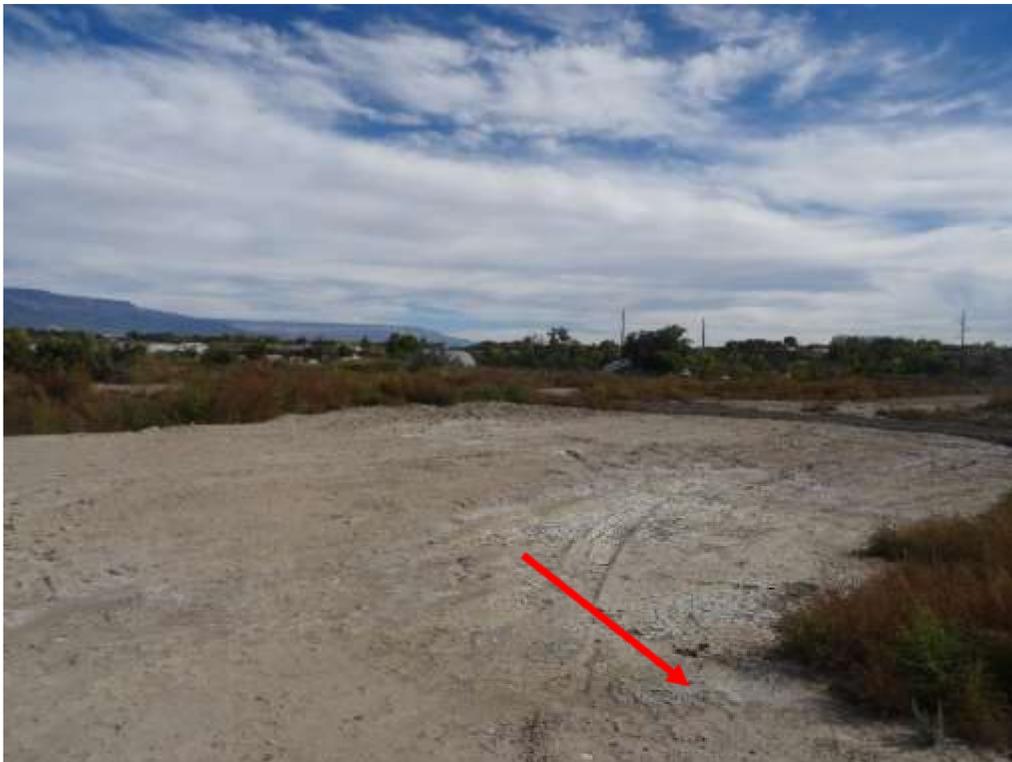
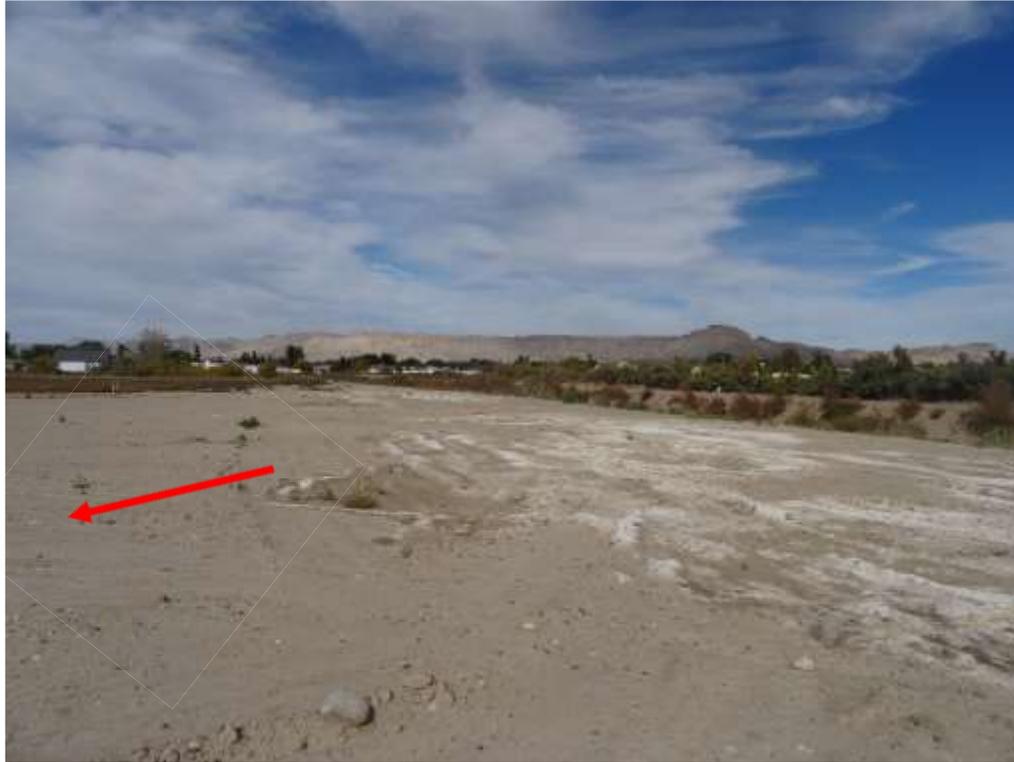
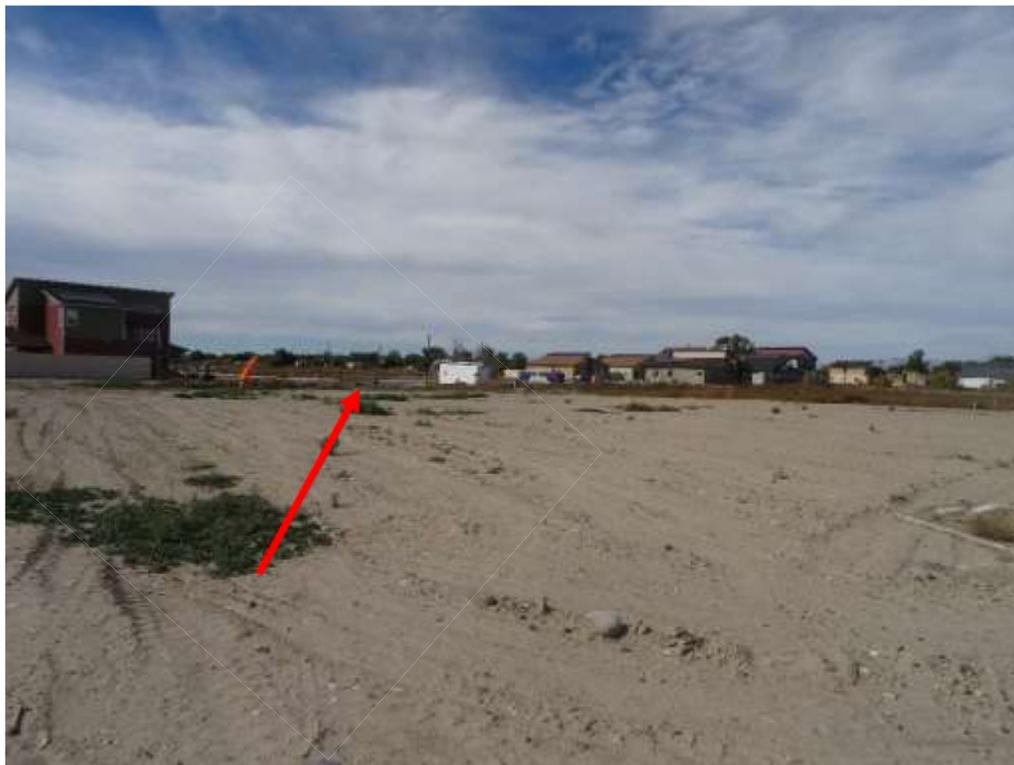
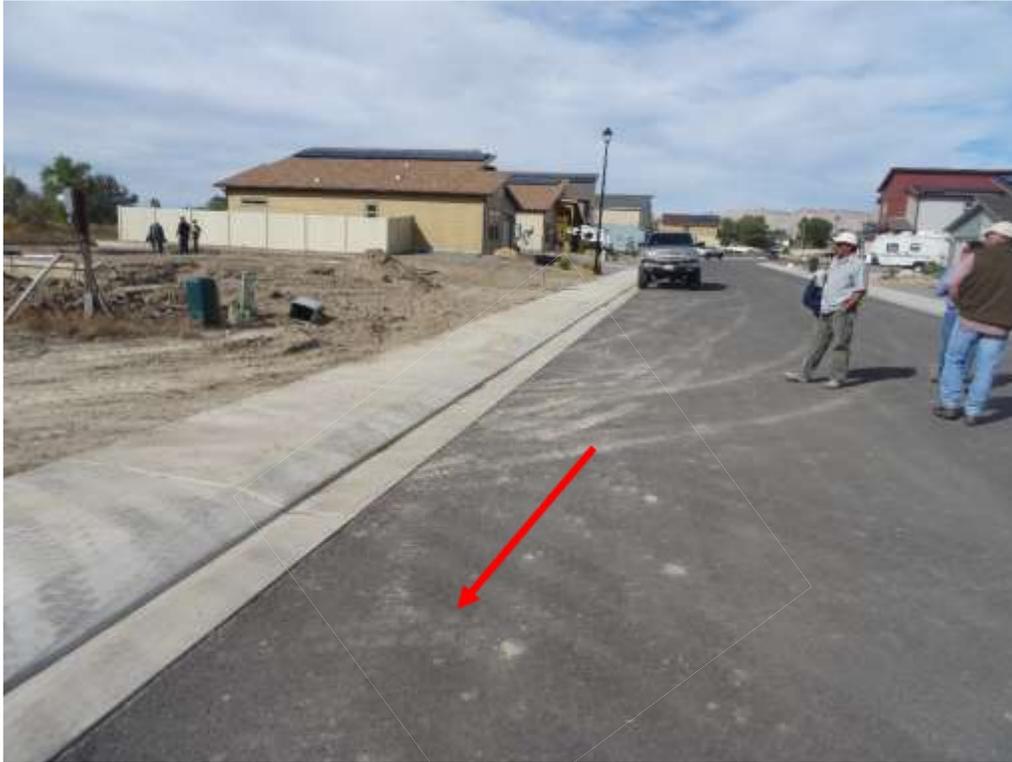
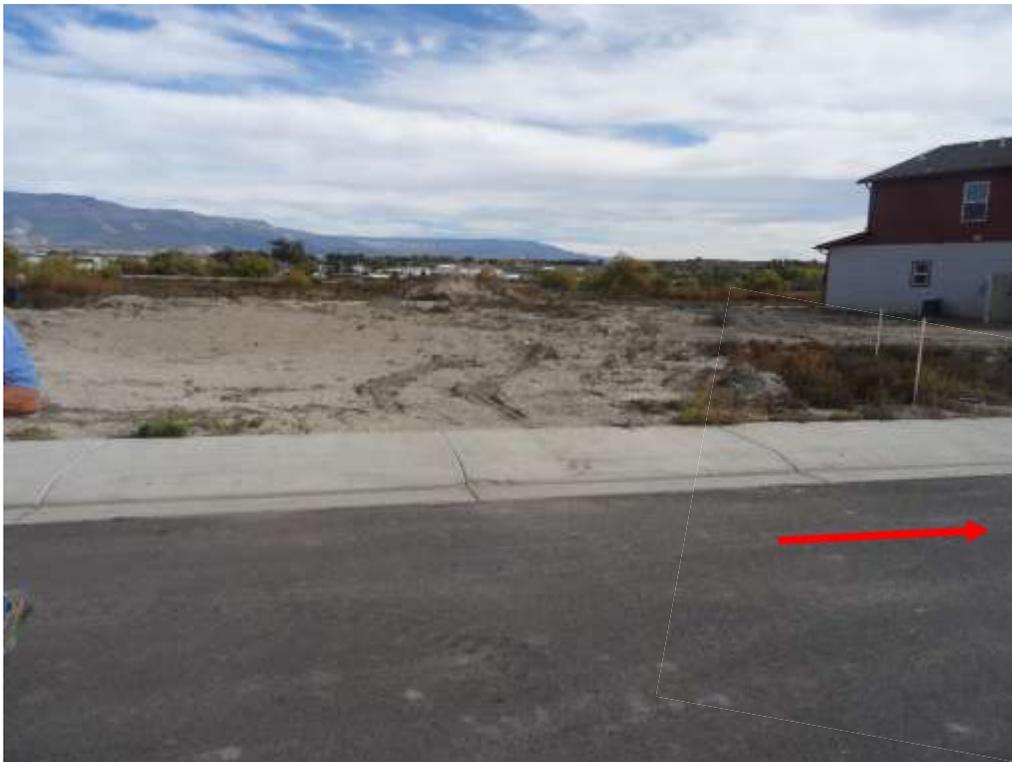
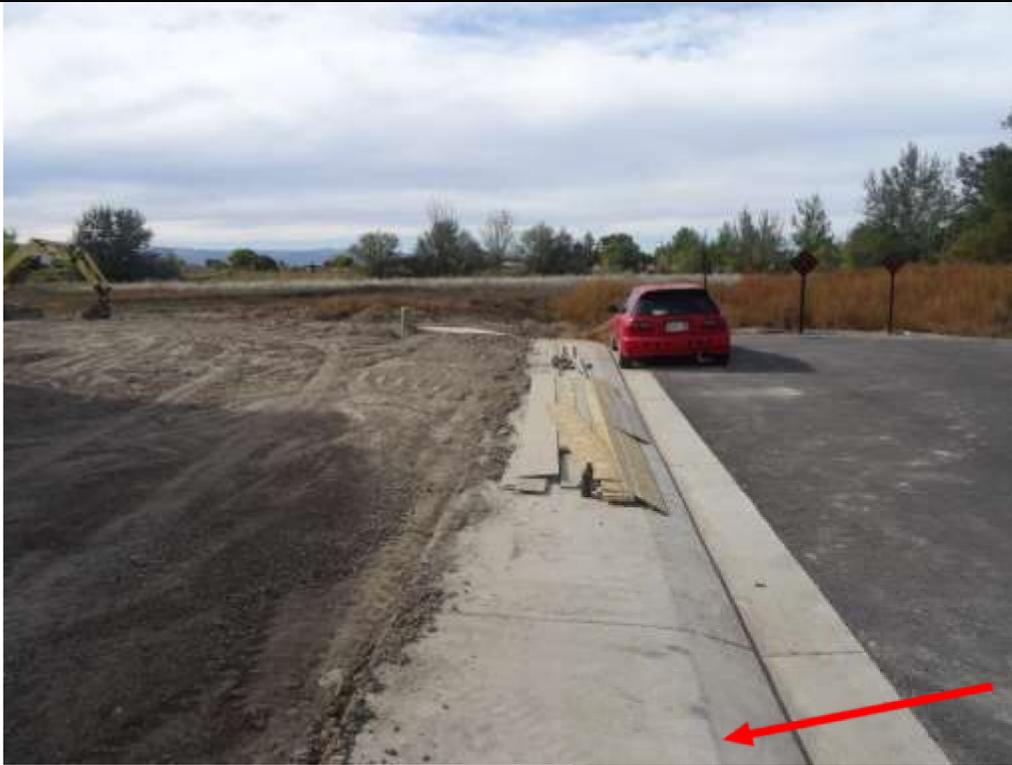
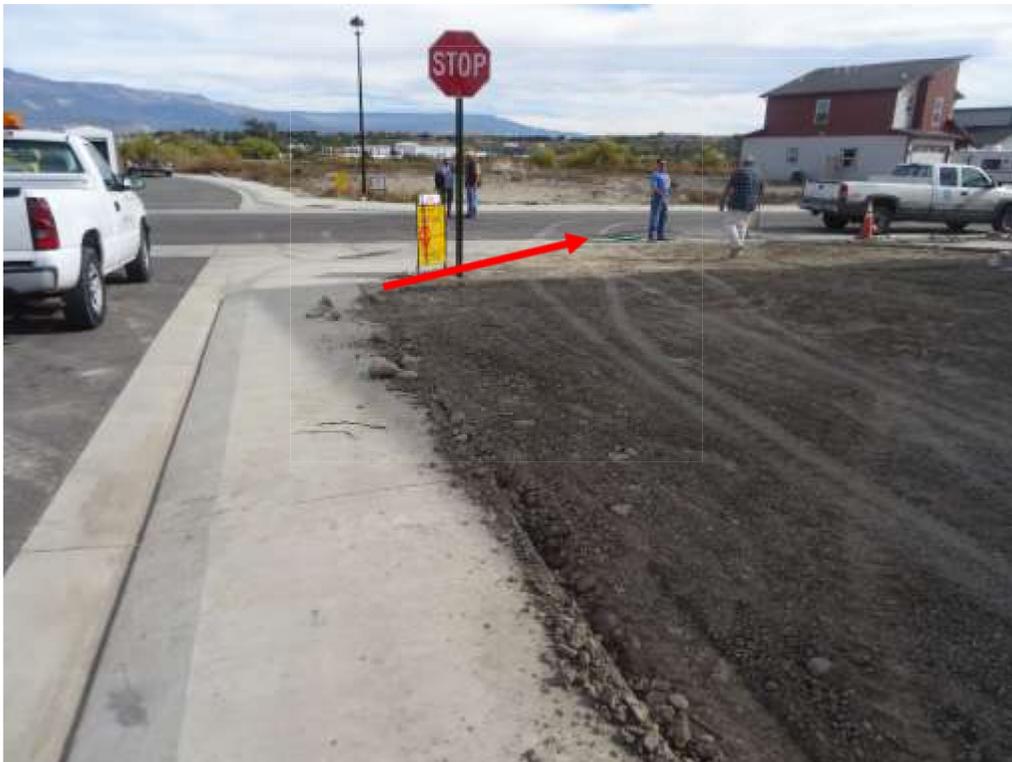
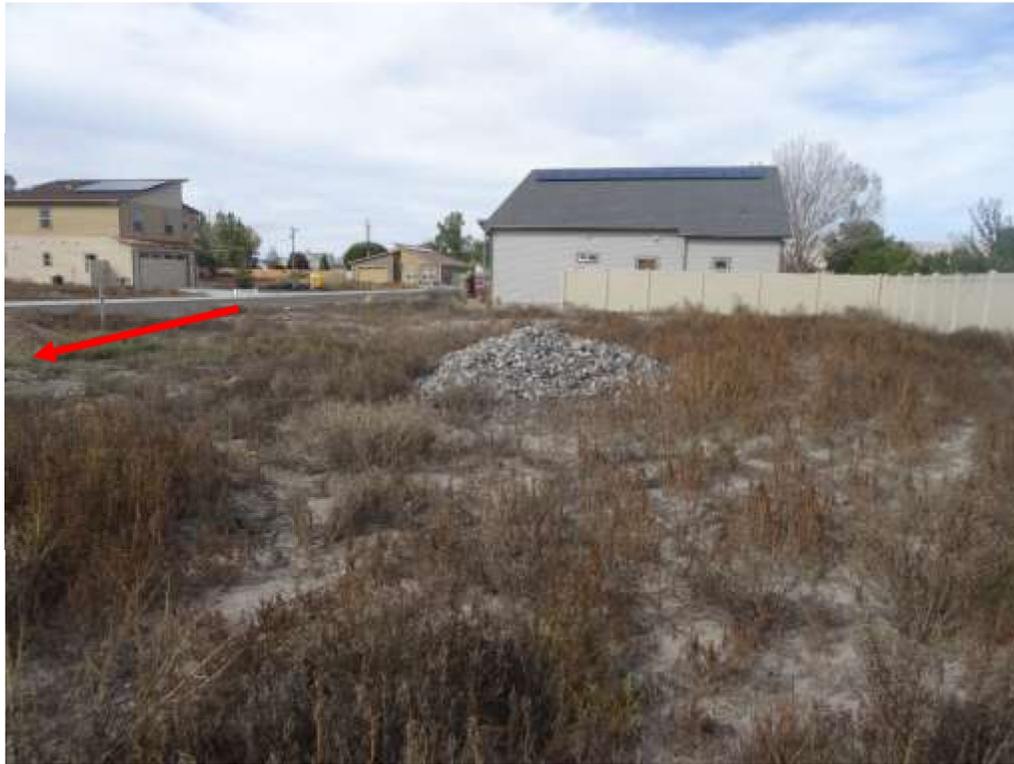
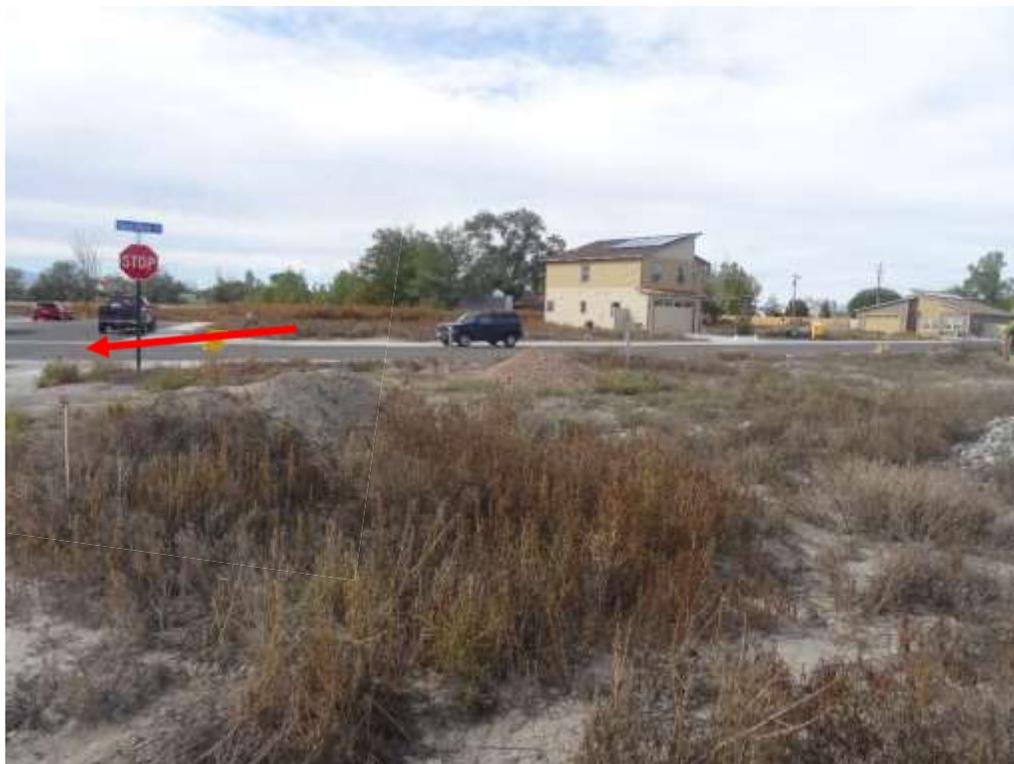
4. It was noted during the inspection that inadequate control measures were implemented to manage stormwater runoff from sediment from disturbed areas located at all disturbed lots on the east and west sides of Green River Drive (refer to photograph(s) 08 - 22).

- Sediment was observed overtopping the sidewalk from disturbed areas.
 - Several disturbed lots were observed with no additional, up-gradient control measures implemented.

Photograph 11: Disturbed area to the northeast of the curb inlets, arrow indicates location of inlets

Photograph 12: Disturbed area to the northwest of the curb inlets, arrow indicates location of inlets

Photograph 13: Disturbed area to the south of the curb inlets, arrow indicates location of inlets

Photograph 14: Disturbed area to the south of the curb inlets, arrow indicates location of inlets

Photograph 15: Disturbed area to the east of the curb inlets, arrow indicates location of inlets

Photograph 16: Disturbed area to the east of the curb inlets, arrow indicates location of inlets

Photograph 17: Disturbed area to the north of the curb inlets, arrow indicates location of inlets

Photograph 18: Disturbed area to the northeast of the curb inlets, arrow indicates location of inlets

Photograph 19: Disturbed area to the northwest of the curb inlets, arrow indicates location of inlets

Photograph 20: Disturbed area to the northwest of the curb inlets, arrow indicates location of inlets

Photograph 21: Disturbed area to the northeast of the curb inlets, arrow indicates location of inlets

Photograph 22: Disturbed area to the northeast of the curb inlets, arrow indicates location of inlets
