**RE: Expedited Settlement Agreement Offer
River Trail Subdivision / CDPS Permit Certification # COR-03D372**

Stormwater Inspection Report

Permittee: River Trail Investment LLC **Cert#** COR03D327 **Report Date:** November 12, 2014

Facility: River Trail Subdivision **Rec. Water(s)** Beswick Drain - Colorado River

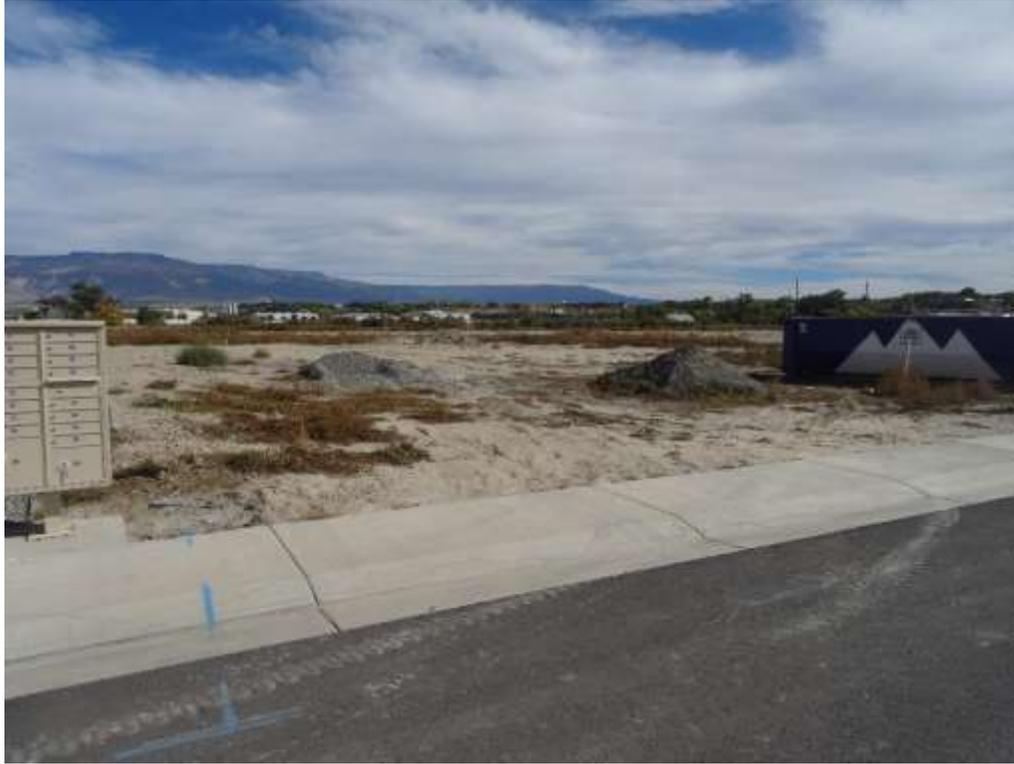
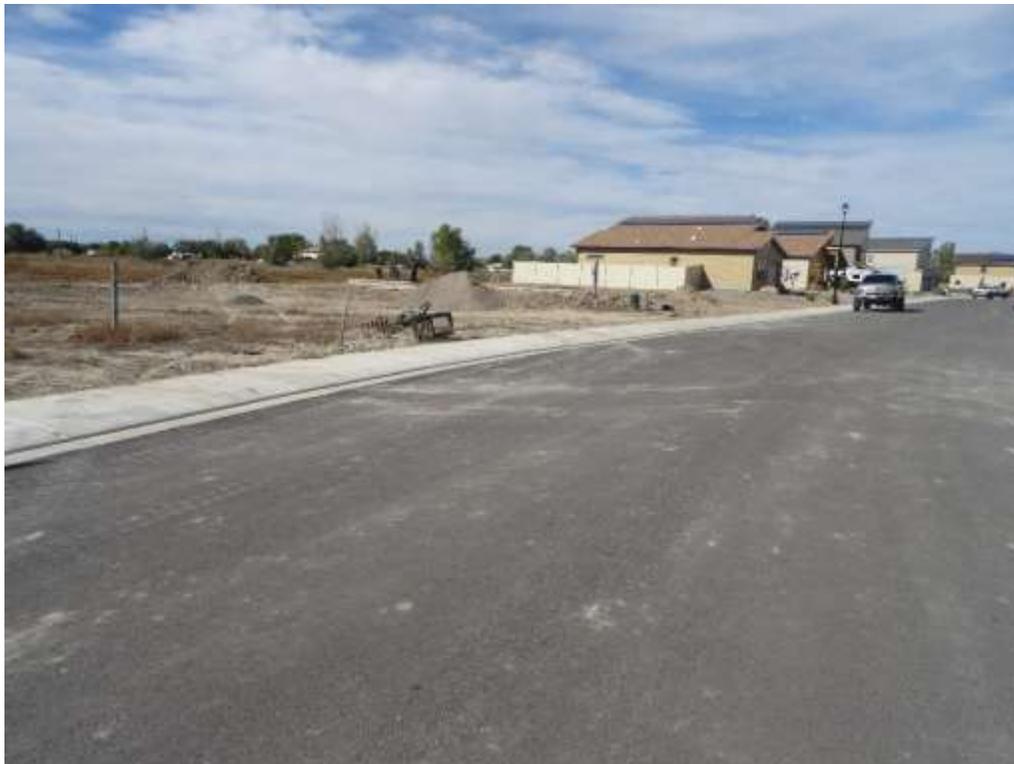
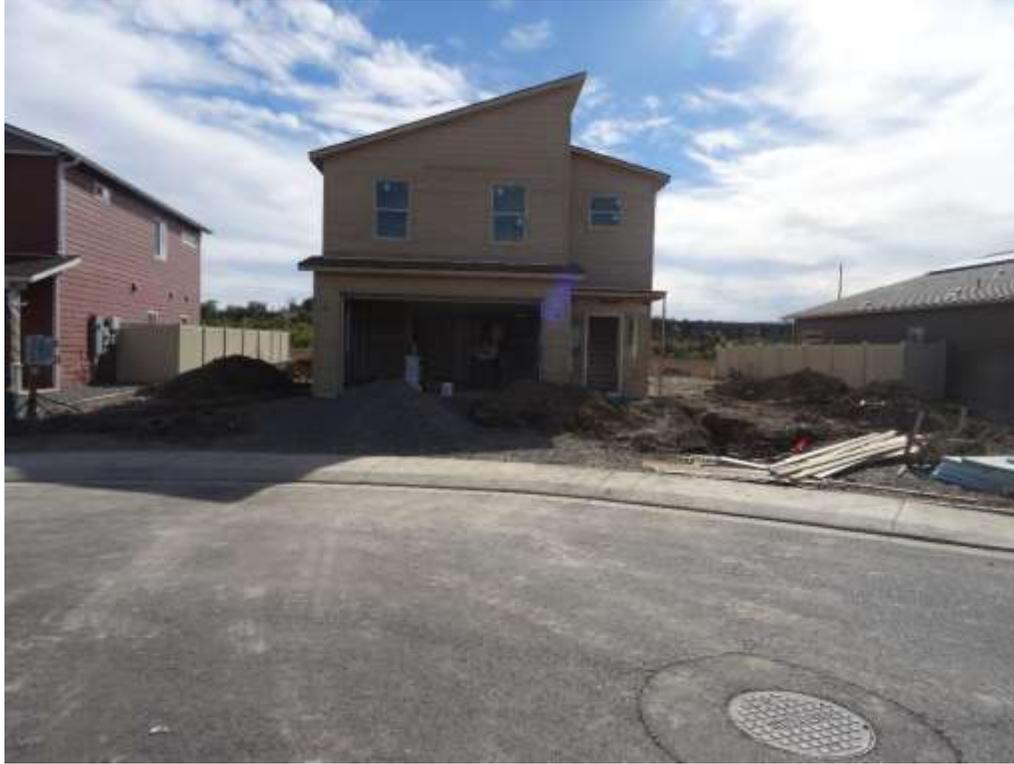
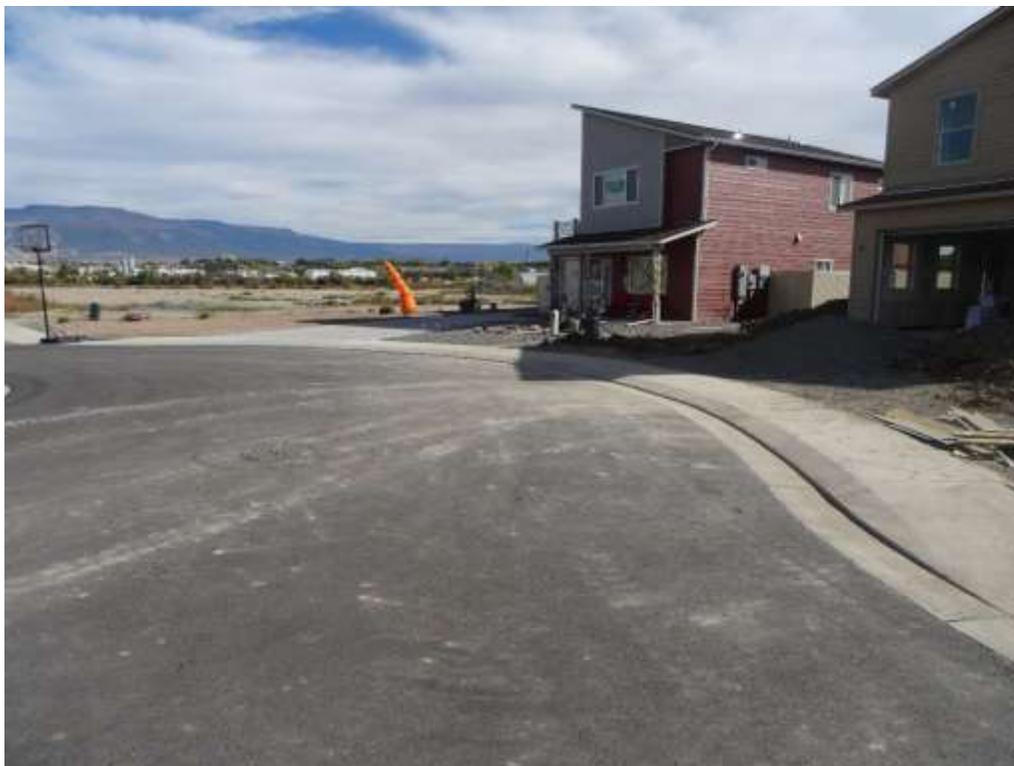
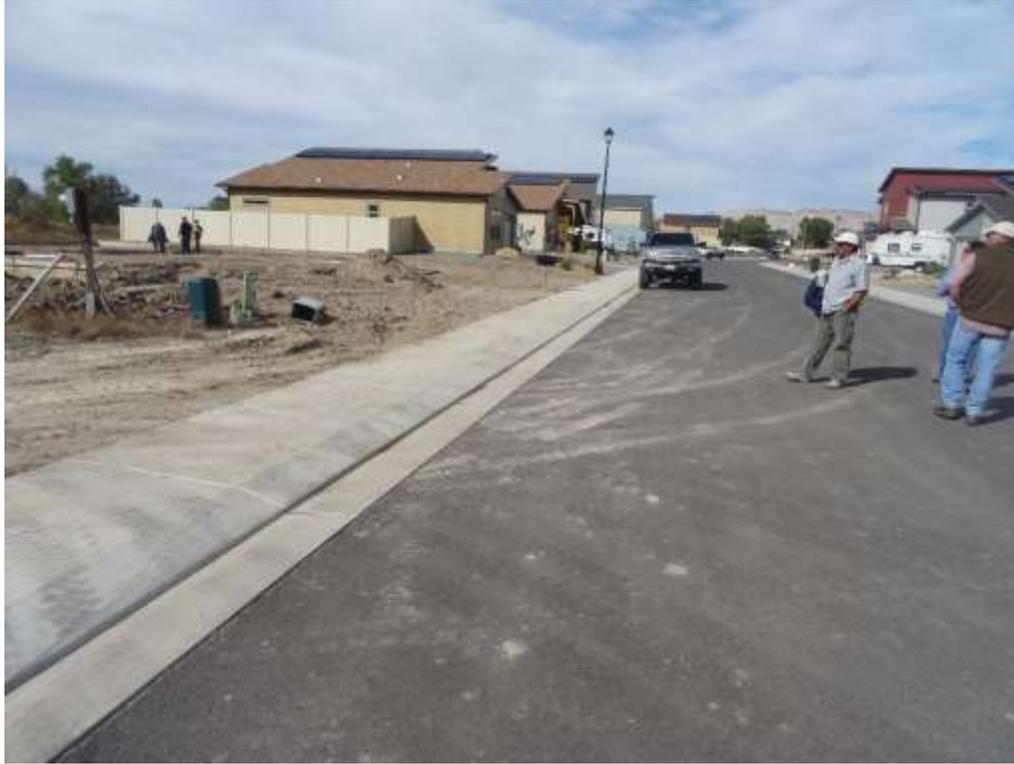
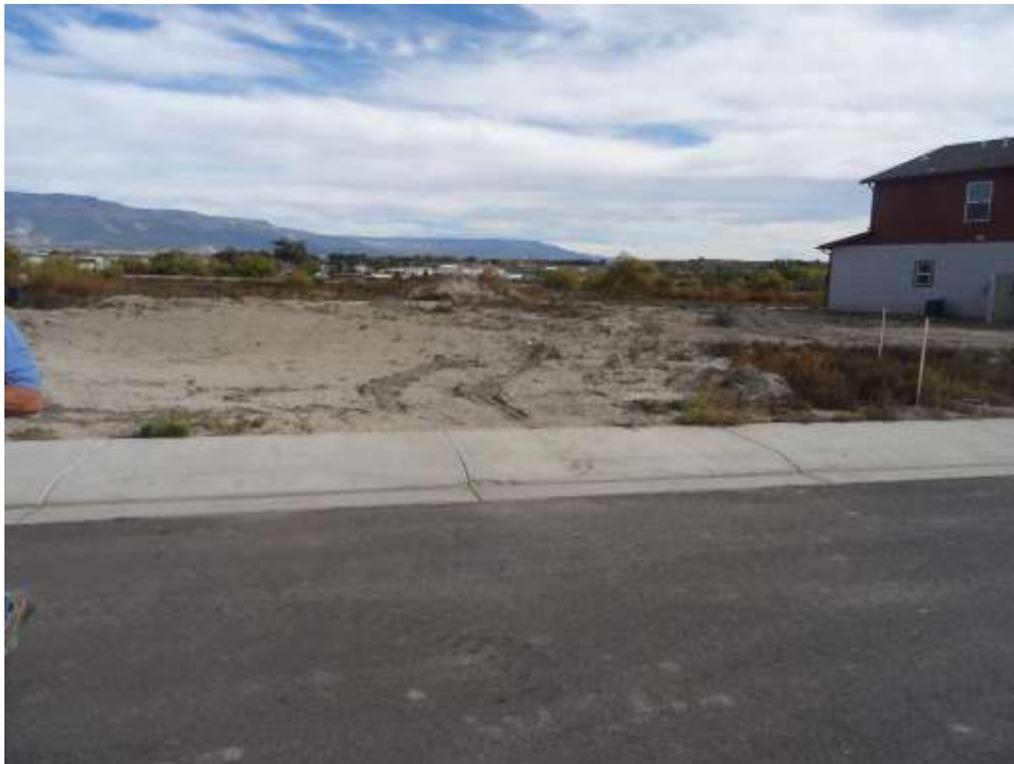
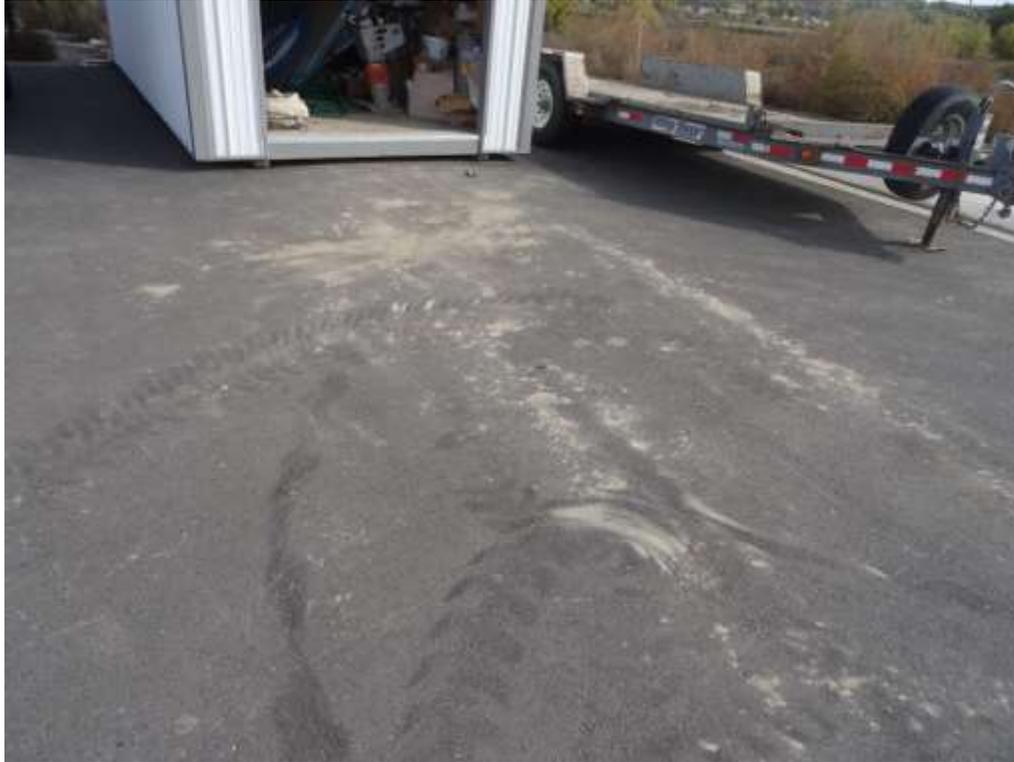
5. It was noted during the inspection that inadequate control measures were implemented to manage pollutant contributions to stormwater from sediment from disturbed areas located on paved surfaces along Green River Drive, Crystal River Drive, and Snake River Drive (refer to photograph(s) 23 - 29).
 - Control Measure Observation: The SWMP identified a vehicle tracking pad control measure for the location and pollutant source noted above; however the control measure had not been implemented.
 - Tracking of sediment onto impervious surfaces was observed during the inspection.
 - No control measures to manage tracking were present as required by the SWMP.
 - Control Measure Finding: An installation and implementation specification for a vehicle tracking pad was provided in the SWMP, but was not implemented. Specifically,

Photograph 23: Tracking from lot 63 onto Green River Drive

Photograph 24: Tracking from Lot 51-52 onto Green River Drive

Photograph 25: Tracking from lot 74 onto Snake River Drive

Photograph 26: Tracking from lot 73 onto Snake River Drive

Photograph 27: Tracking from lot 52 onto Green River Drive

Photograph 28: Vehicle tracking marks without a vehicle tracking pad as required in the SWMP

Photograph 29: Tracking onto Crystal River Drive

- Facilities must implement the provisions of the SWMP as written and updated, from commencement of construction activity until final stabilization is complete, as a condition of this permit.

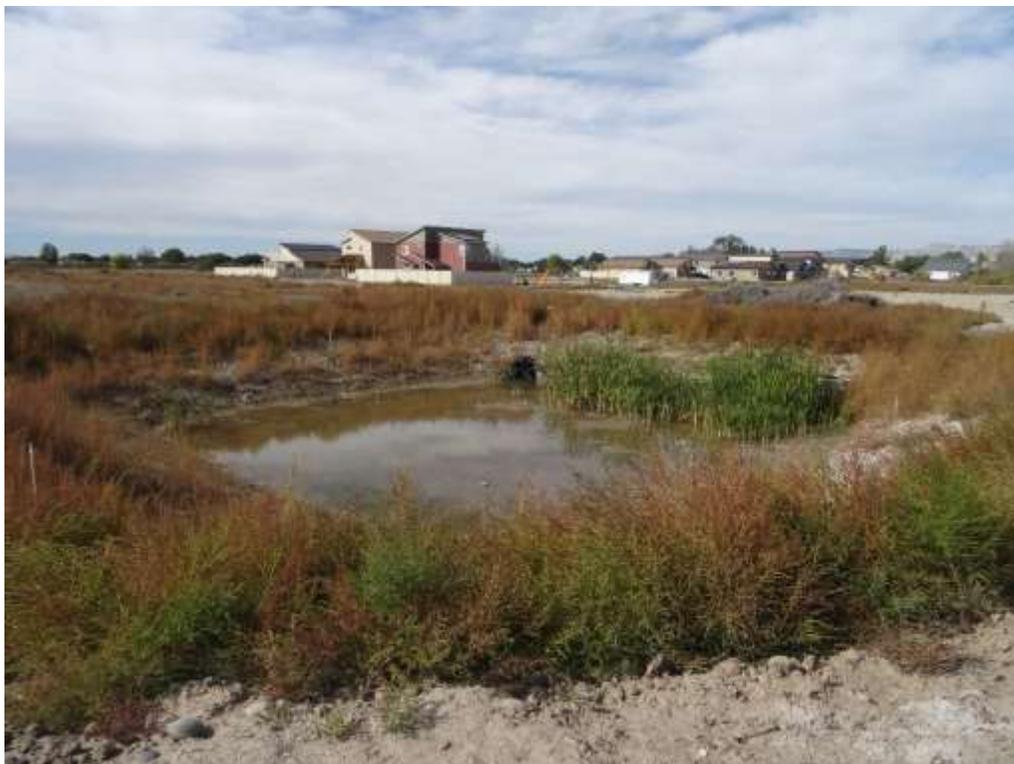
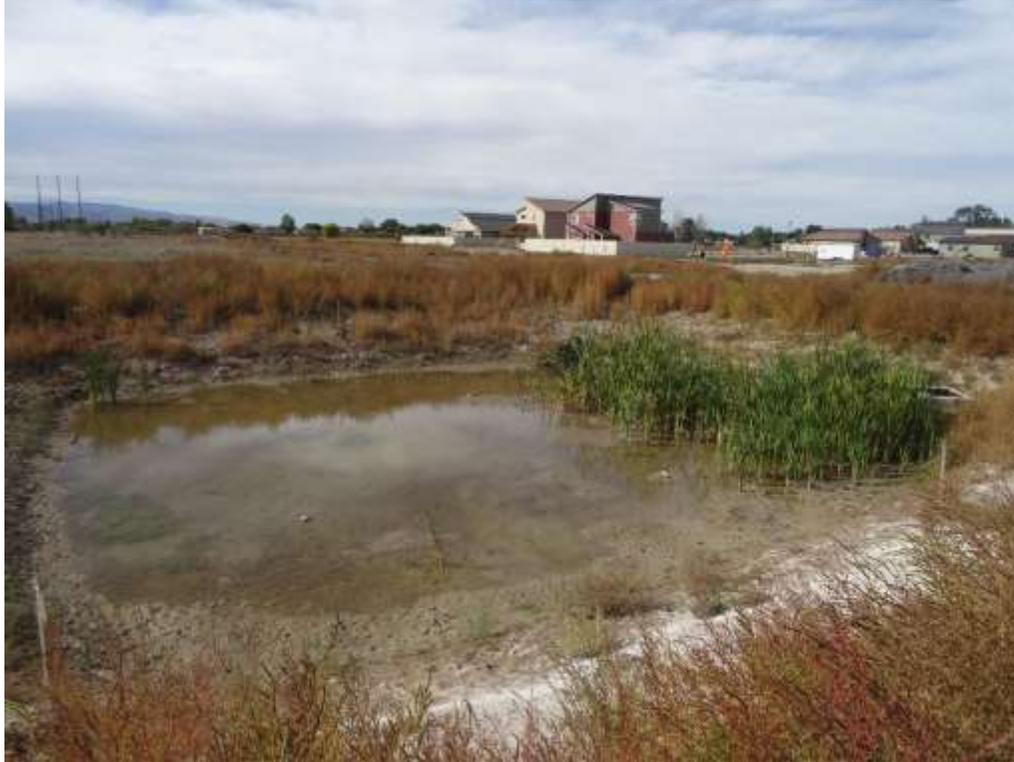
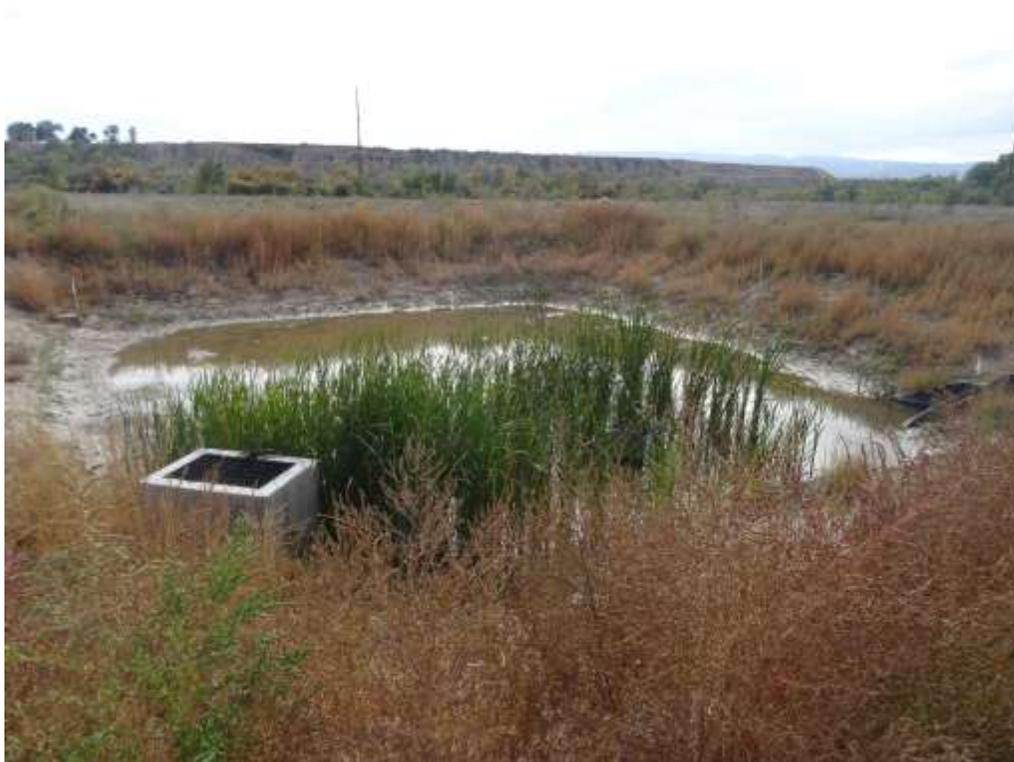
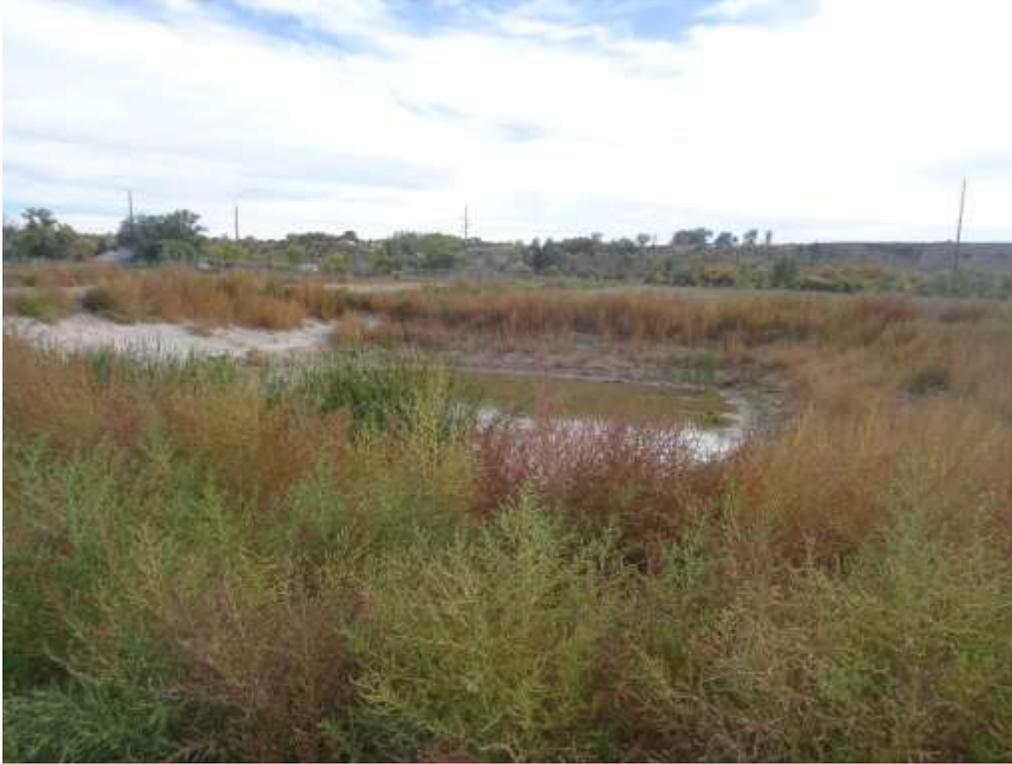
6. It was noted during the inspection that inadequate control measures were implemented to manage pollutant contributions to stormwater from sediment from disturbed areas located at the detention pond adjacent to the development area off of the southeast corner of the property (refer to photograph(s) 30 - 33).

- Control Measure Observation: A detention pond control measure was implemented to manage stormwater runoff from the location and pollutant source noted above; however the control measure was inadequate.

- The detention pond for the subdivision was not identified on the site map or in the SWMP.
 - Control measures were not observed at the outfall of the detention pond, therefore the pond did not contain a mechanism for pollutant removal.

Photograph 30: Detention pond southeast of the subdivision, looking northwest, groundwater present

Photograph 31: Detention pond southeast of the subdivision, looking northwest, groundwater present

Photograph 32: Detention pond southeast of the subdivision, looking south, no control measures at outfall, looking towards the Colorado River along the trees in the background

Photograph 33: Detention pond southeast of the subdivision, looking southeast towards Preston Drain

- Control measures implemented at the site must be adequately designed to provide control for all potential pollutant sources associated with construction activity to prevent pollution or degradation of State waters.

- Design control measures following good engineering, hydrologic and pollution control practices to prevent pollution or degradation of state waters and document in the SWMP.

- Update the SWMP when new control measures are installed or control measures are replaced.
