RE: Expedited Settlement Agreement, Number ES-160908-1
Dove Hill Estates Ph II / CDPS Permit Certification No. COR03N464

EXPEDITED SETTLEMENT AGREEMENT

Number: ES-160908-1

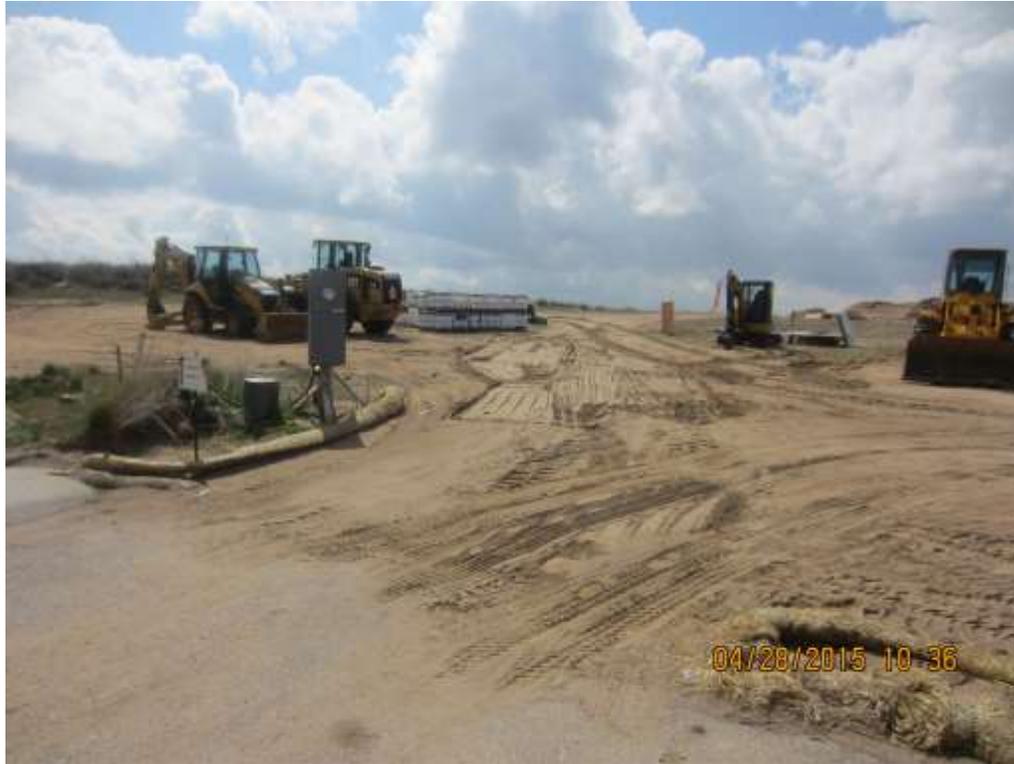
- a. Along Sunset Drive (refer to photograph(s) 01, 06).
 - b. Along Dove Hill Road (refer to photograph(s) 02-05, 07-09).
- Control Measure Observation: Control measures were not implemented to control stormwater runoff from the locations and pollutant source noted above. Specifically,

- Sediment tracking was observed along the paved street and significant amounts of sediment had accumulated within the curb flowlines.
 - Hauling activities were observed during the inspection on and off of disturbed areas without tracking controls.

Photograph 1: Tracking from staging area on the south side of site onto Sunset Drive

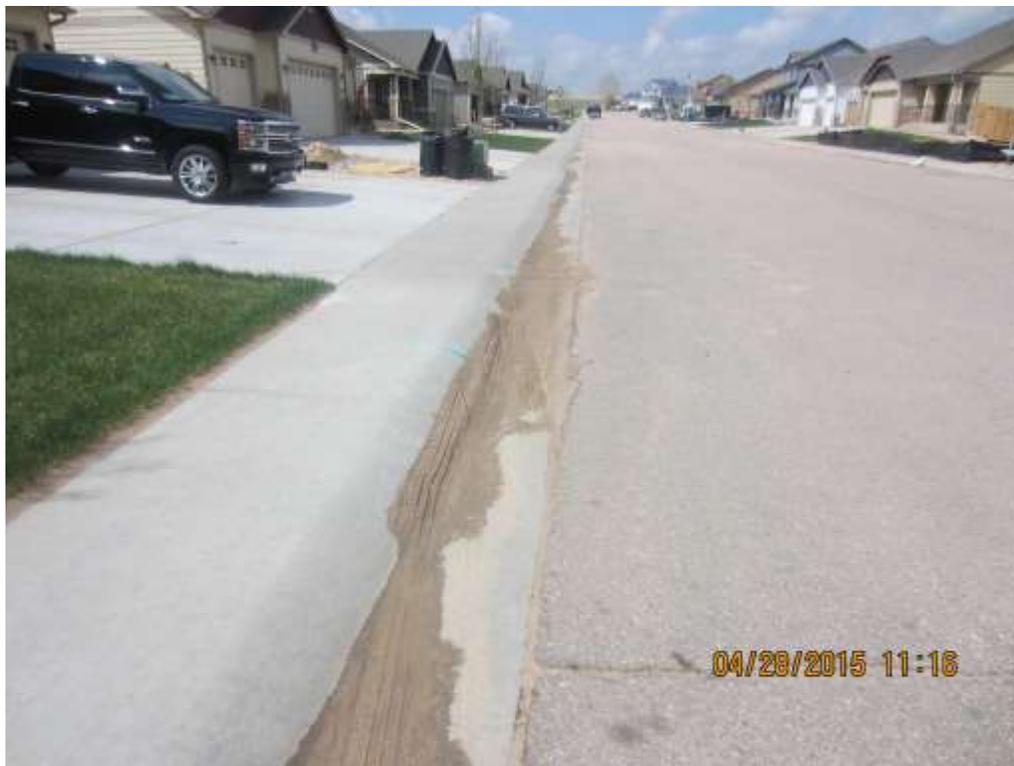
Photograph 2: Sediment in curblines along Dove Hill Road

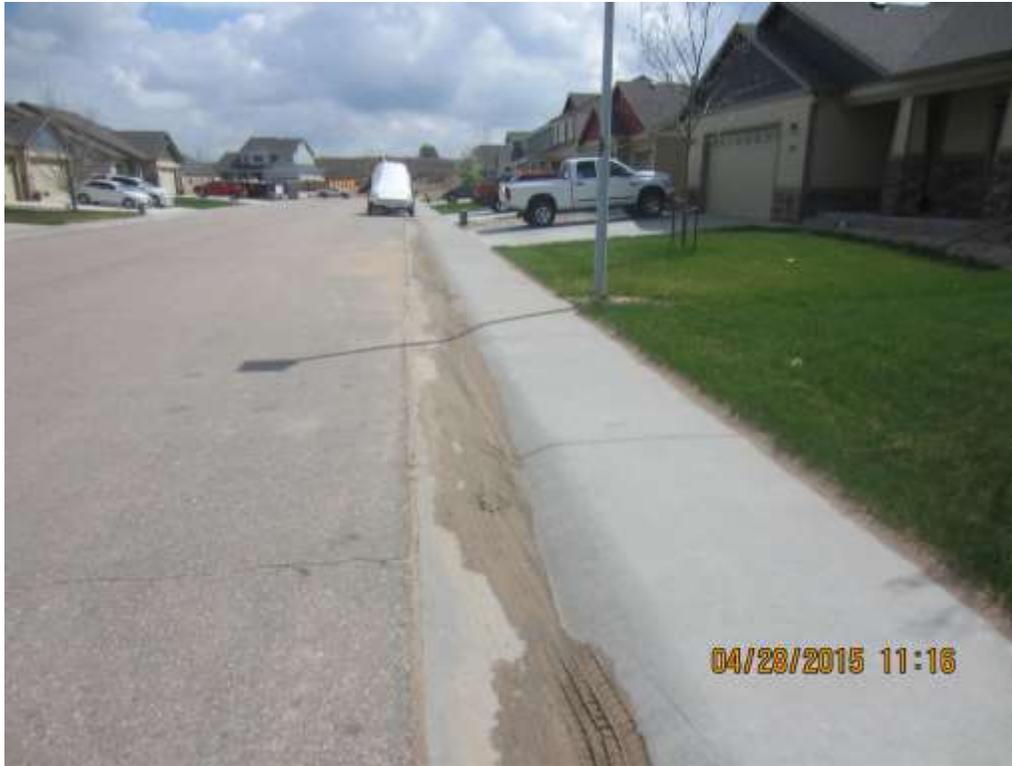
Photograph 3: Sediment in curblin along Dove Hill Road

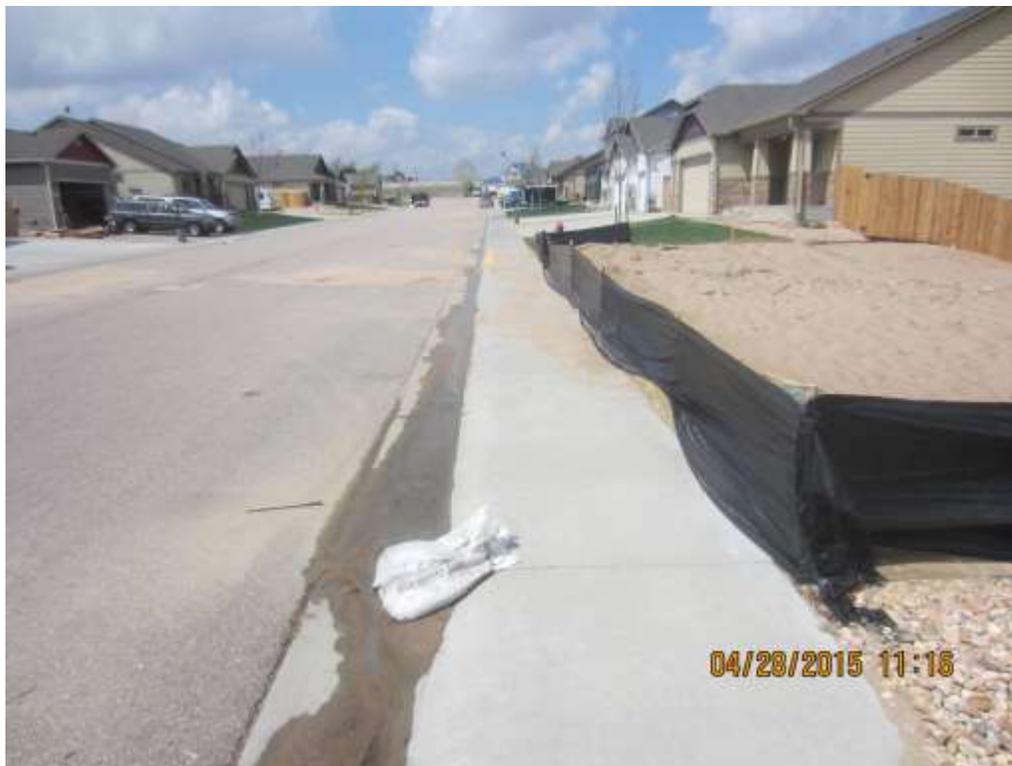
Photograph 4: Sediment in curblin along Dove Hill Road

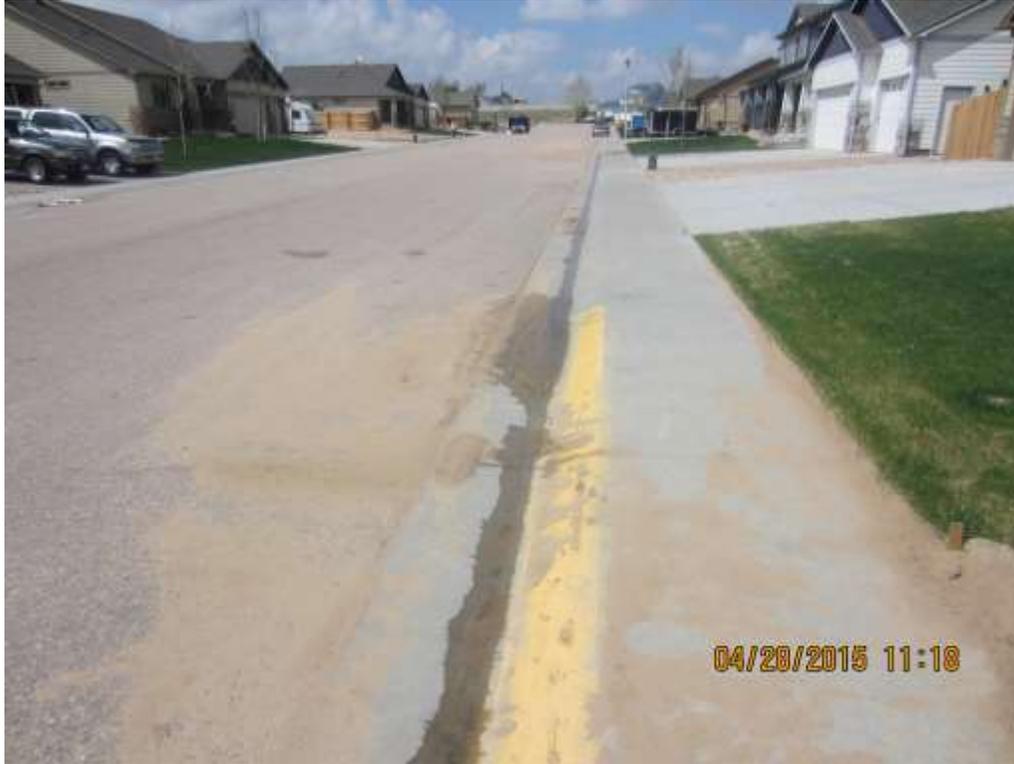
Photograph 5: Sediment in curblines along Dove Hill Road

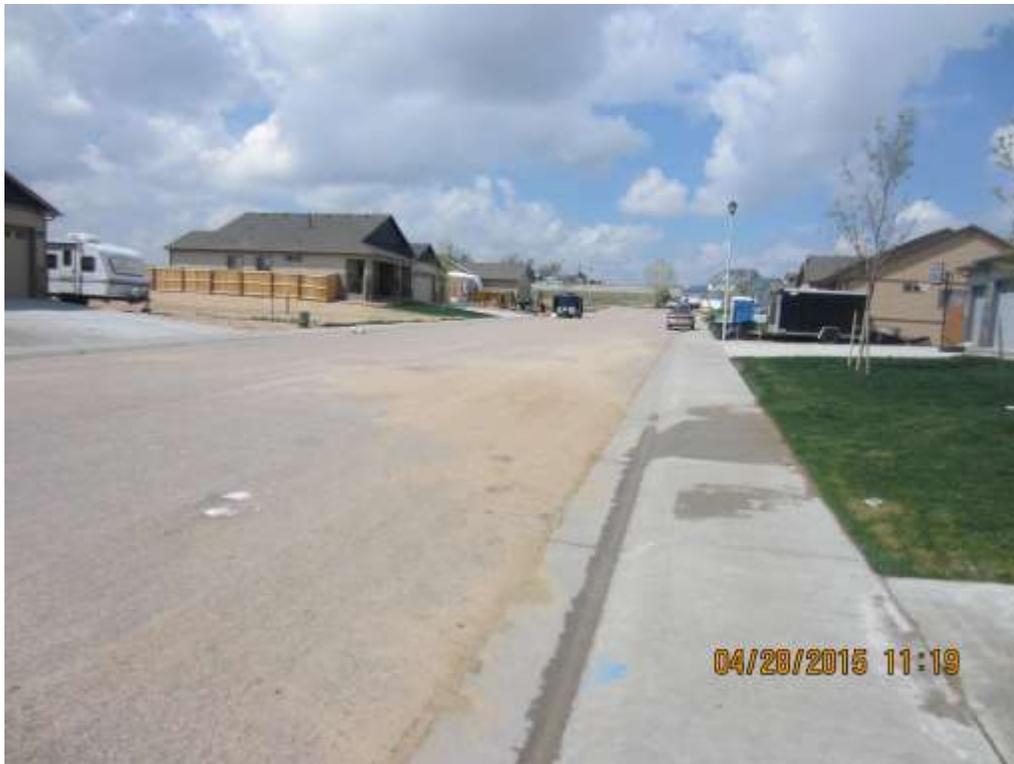
Photograph 6: Sediment in curblines along Sunset Drive

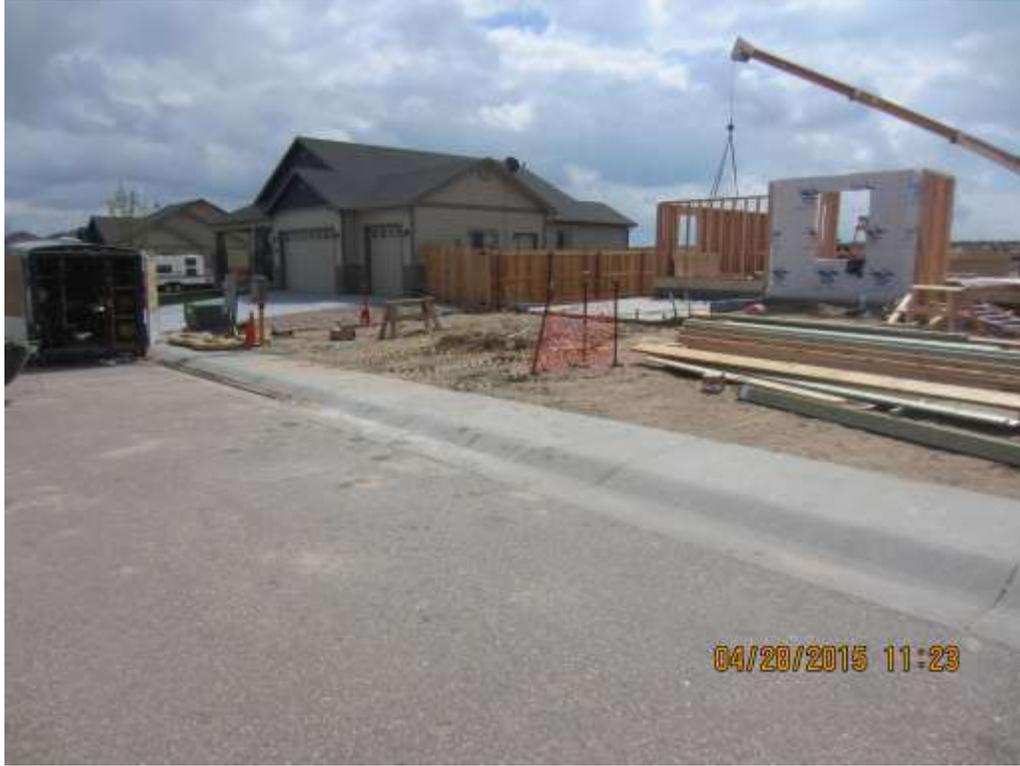
Photograph 7: Tracking off of disturbed site onto Dove Hill Road

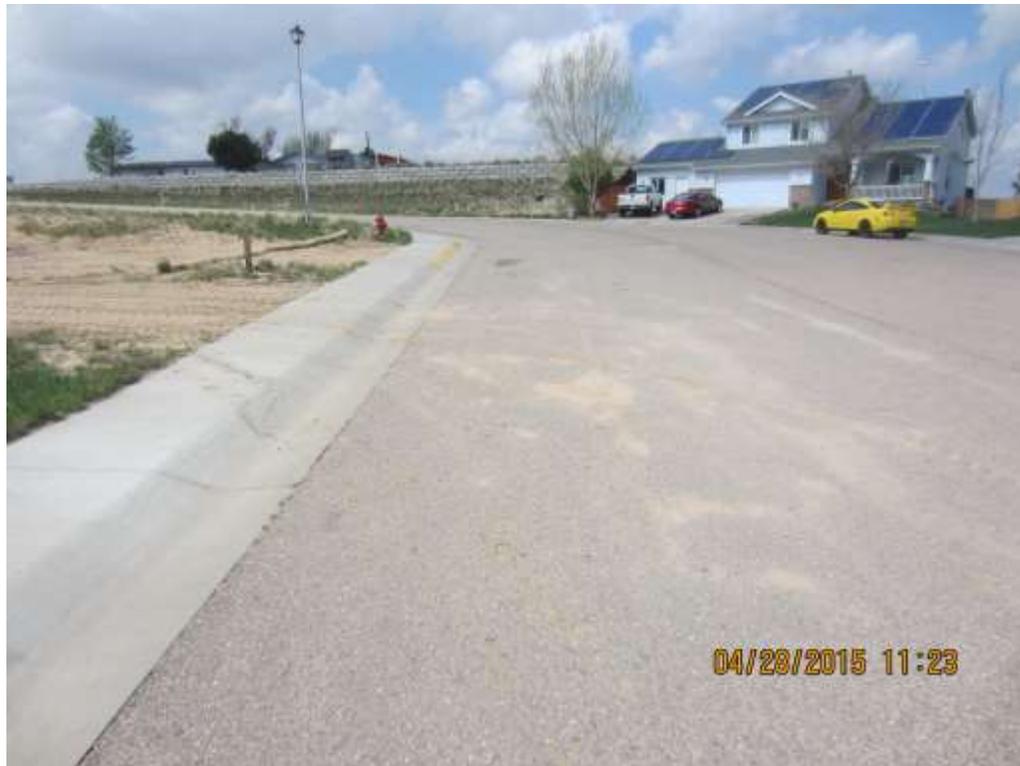
Photograph 8: Tracking off of disturbed site onto Dove Hill Road

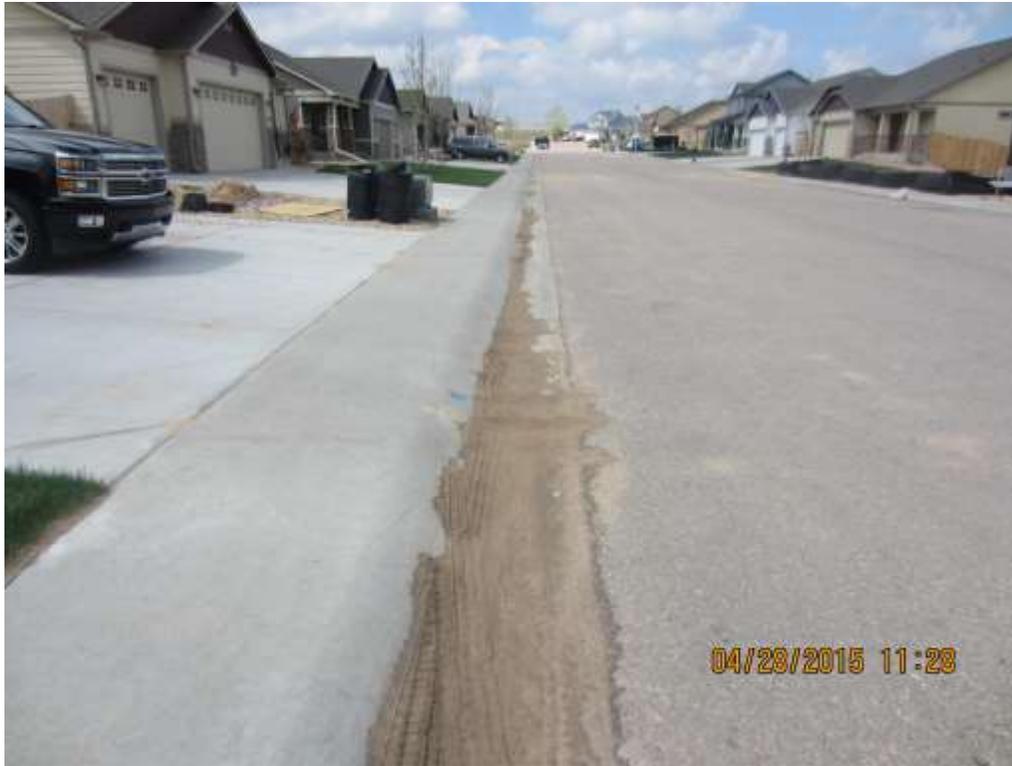
Photograph 9: Sediment in curblin along Dove Hill Road

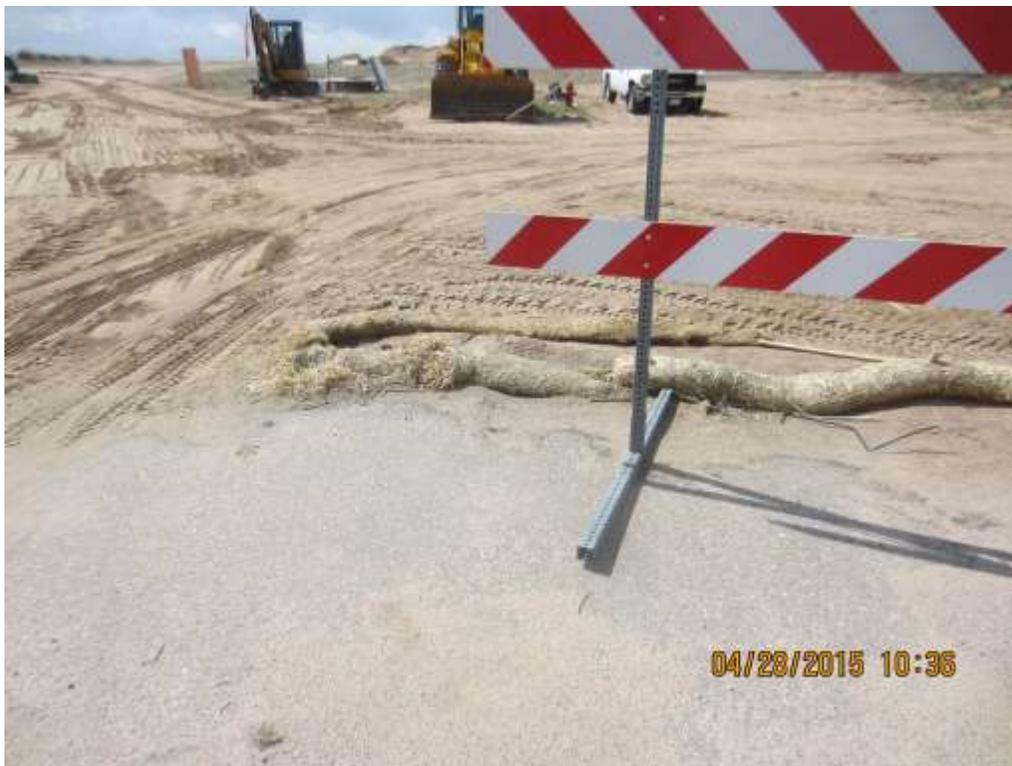
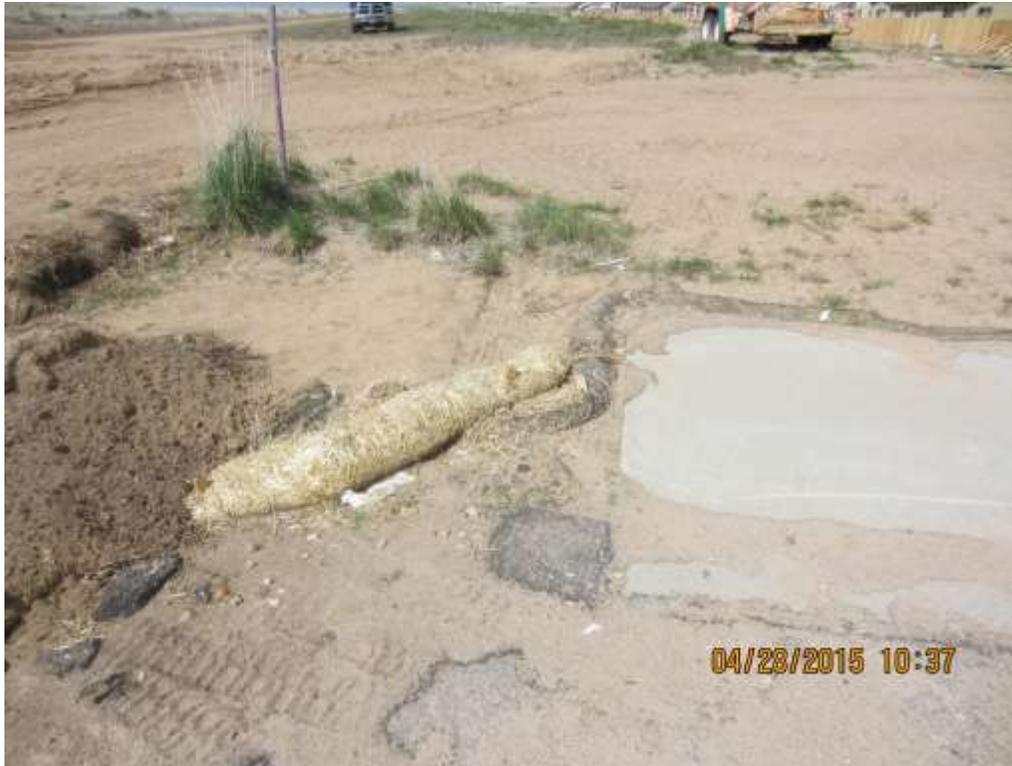
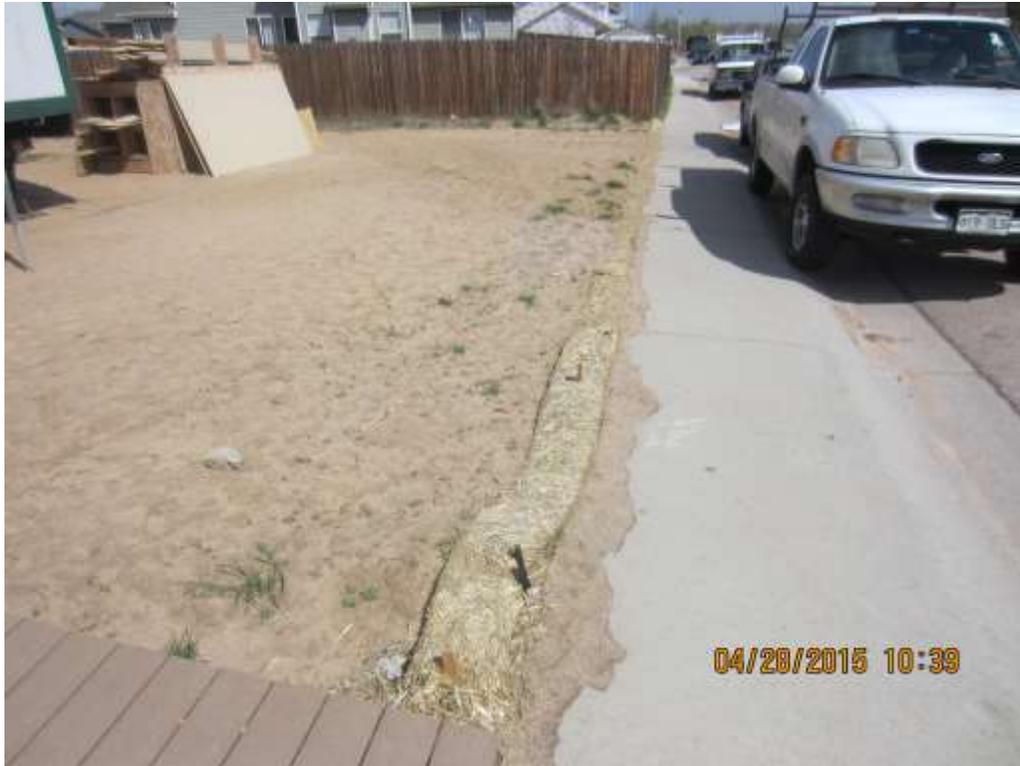
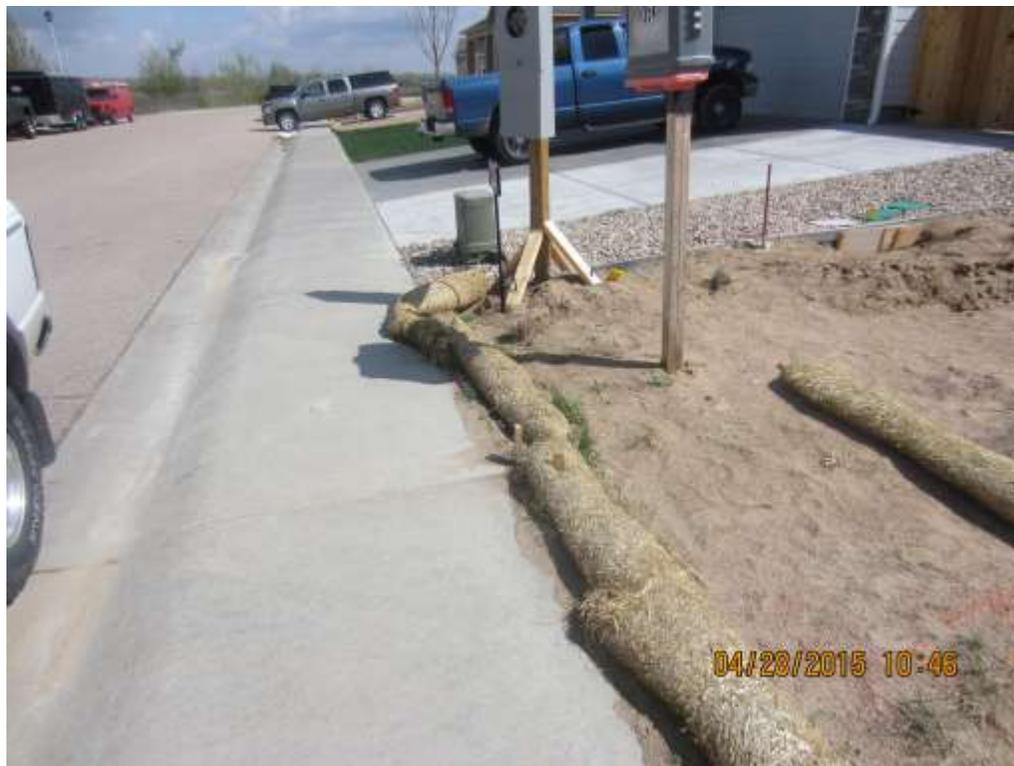
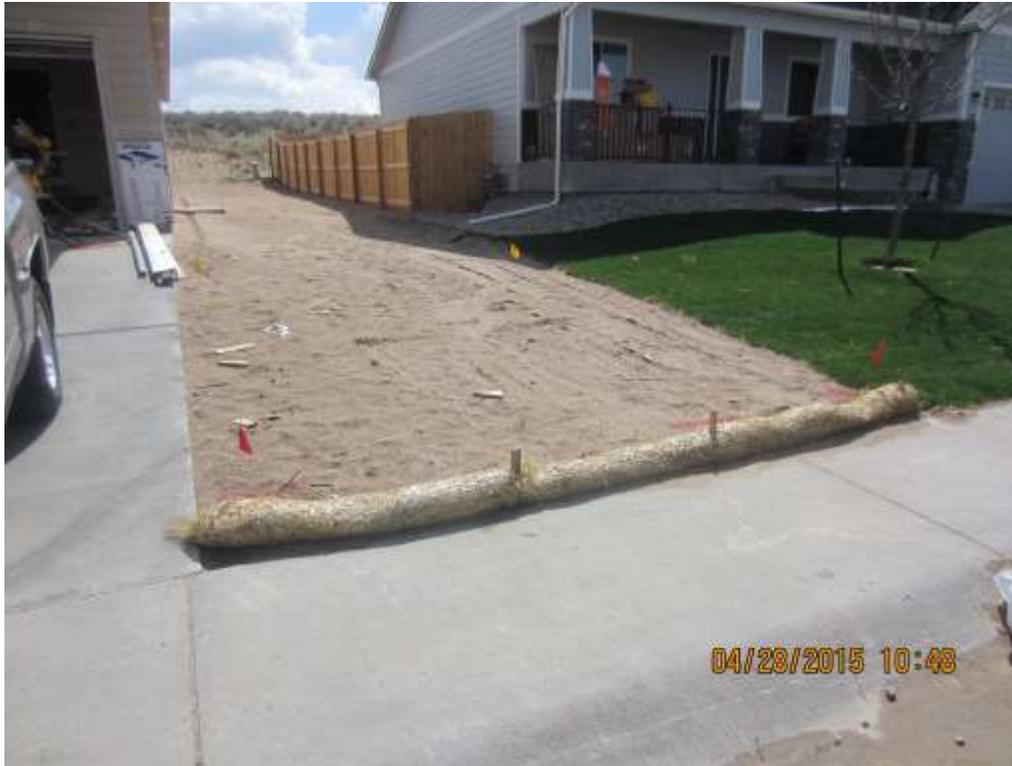
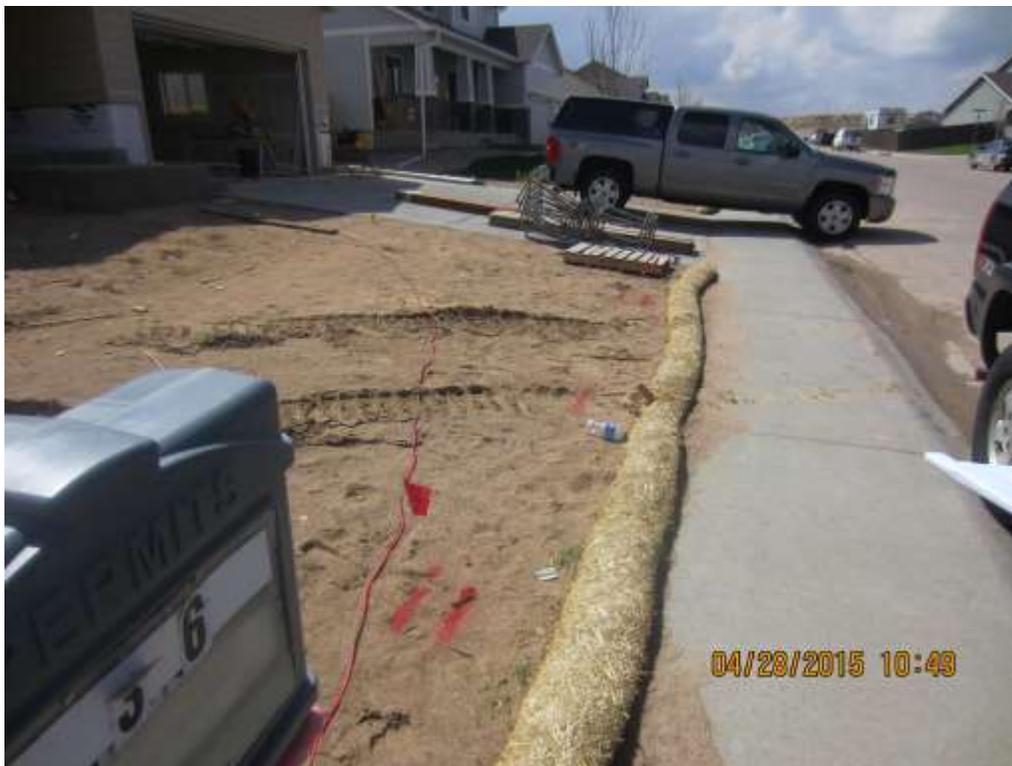
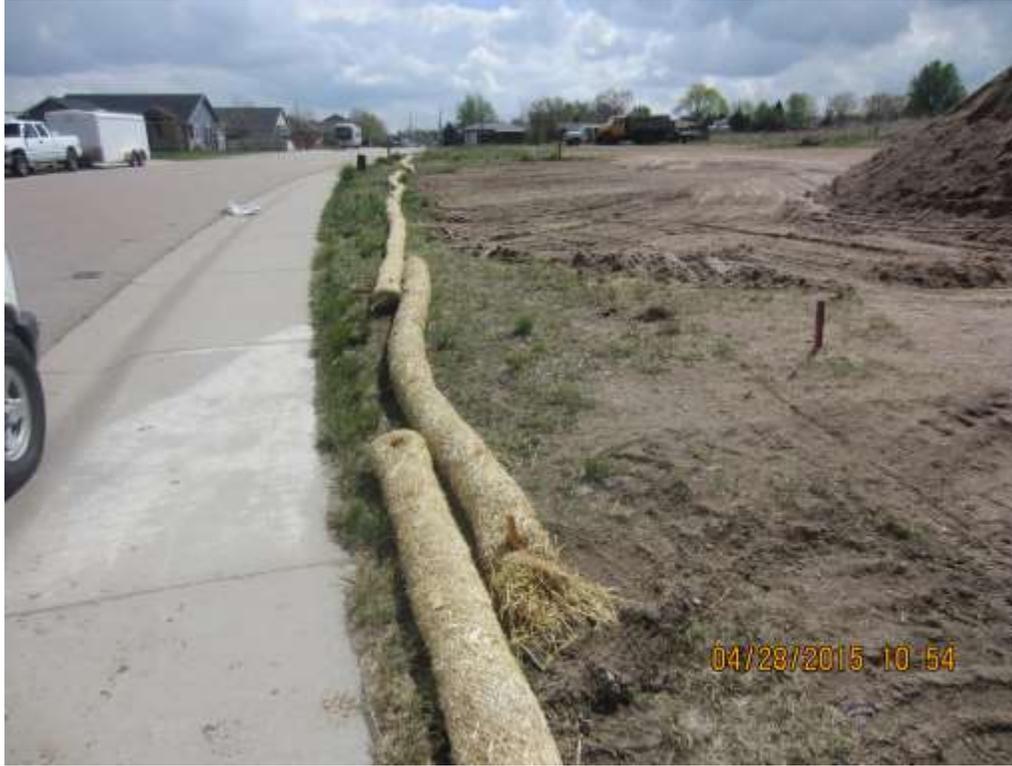
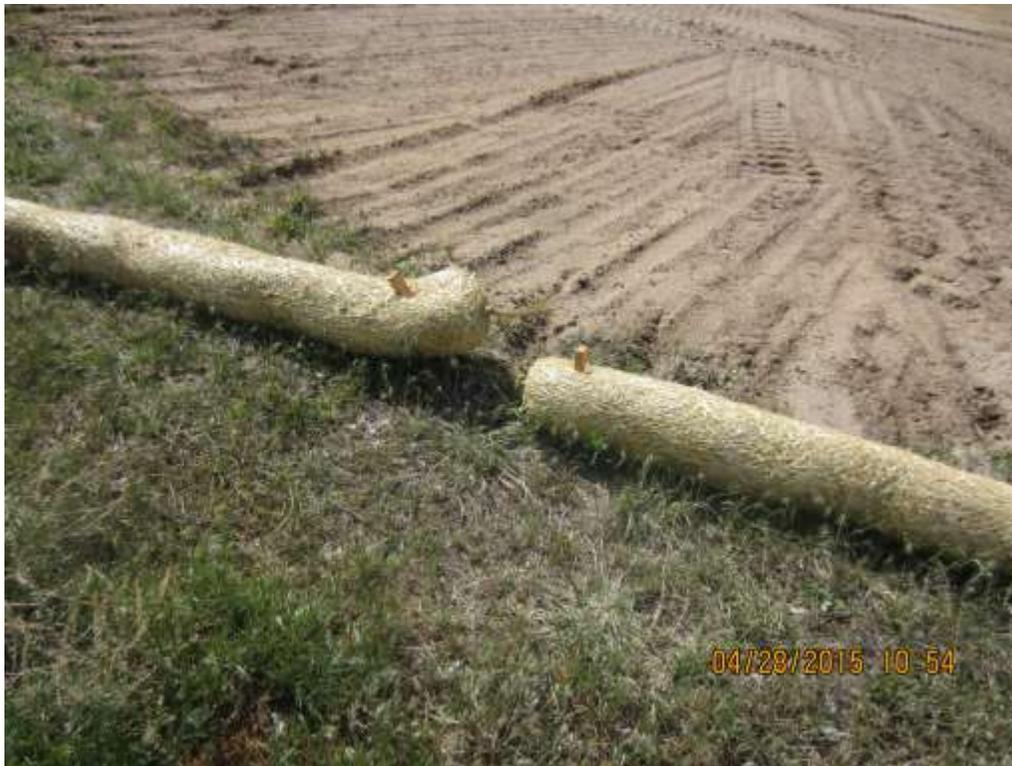
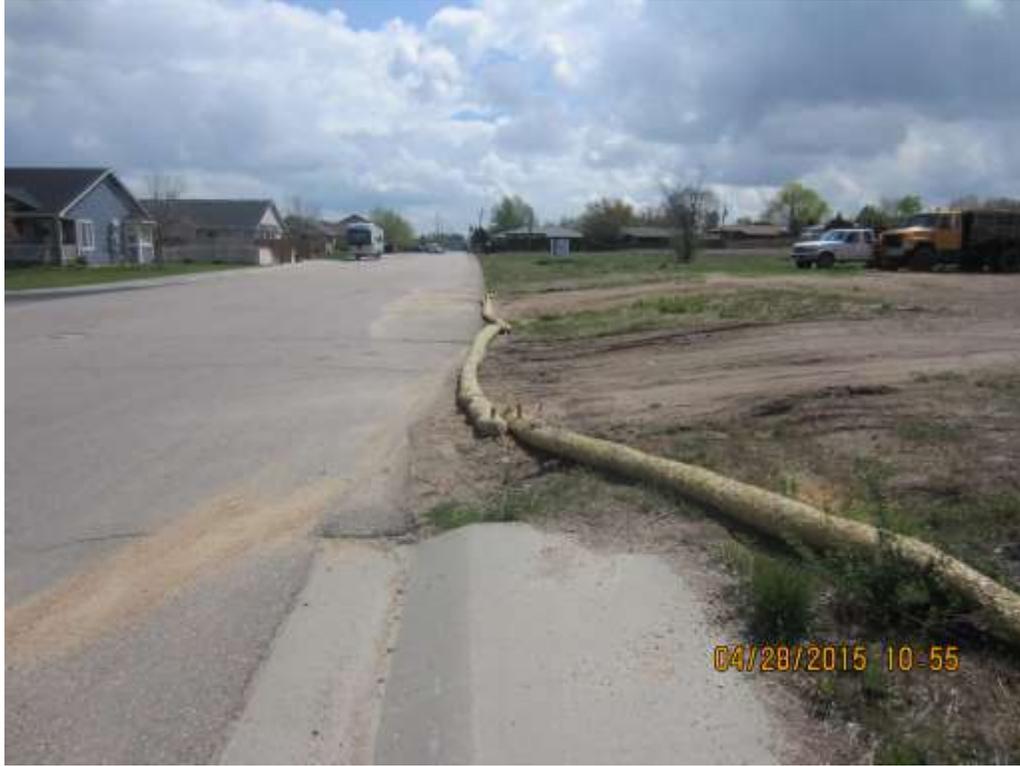
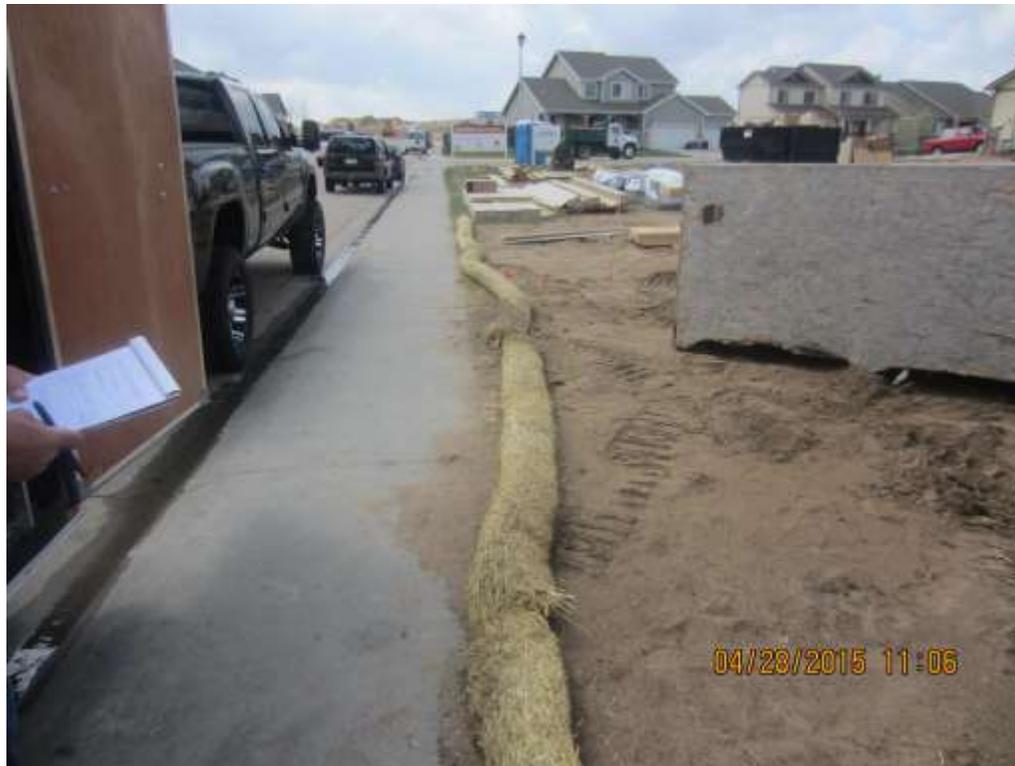
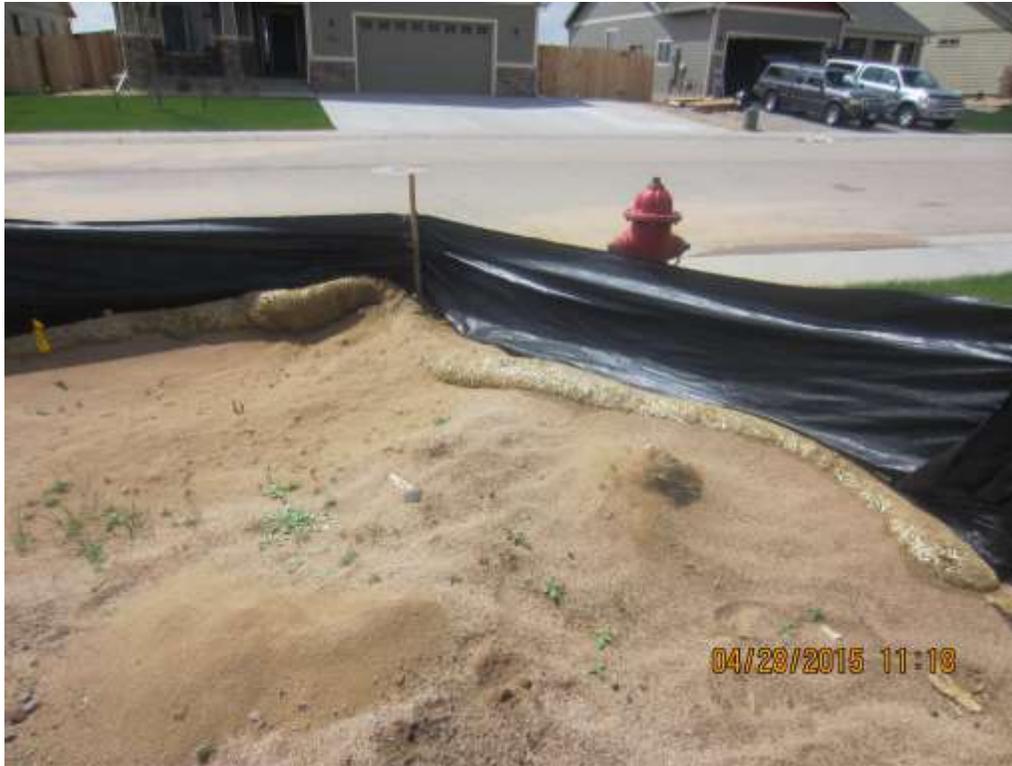
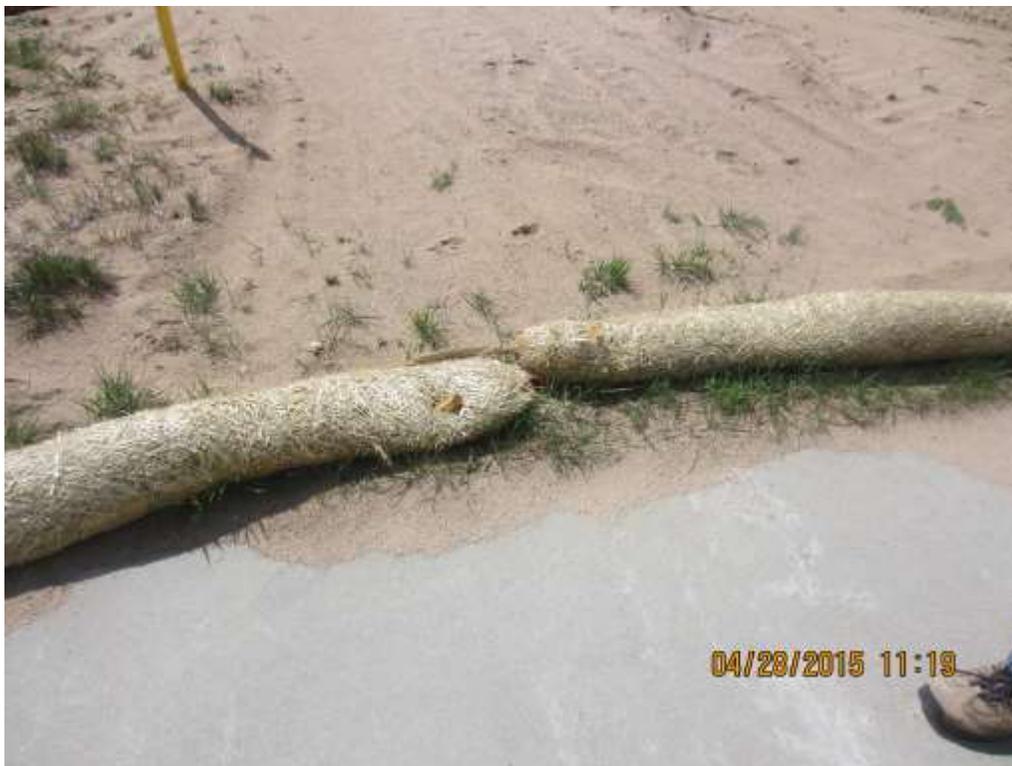
- The straw wattles observed during the inspection were not consistently installed per the specification provided in the SWMP.
 - The wattles were not correctly entrenched, staked, or abutted/overlapped to prevent bypass of sediment laden stormwater.

- Straw wattles were observed along the above described locations to be in need of maintenance to repair or replace damaged sections that had tears or holes.

- Maintenance was needed to remove accumulated sediment from the down-gradient sides of the wattle. This sediment resulted from stormwater bypassing the control measure from failure to install it as required, as stated above.

Photograph 10: Straw wattle not installed or maintained as required in the SWMP

- Damaged straw wattles shall be replaced or repaired and accumulated sediment removed to maintain functionality of the control measure at its intended capacity.

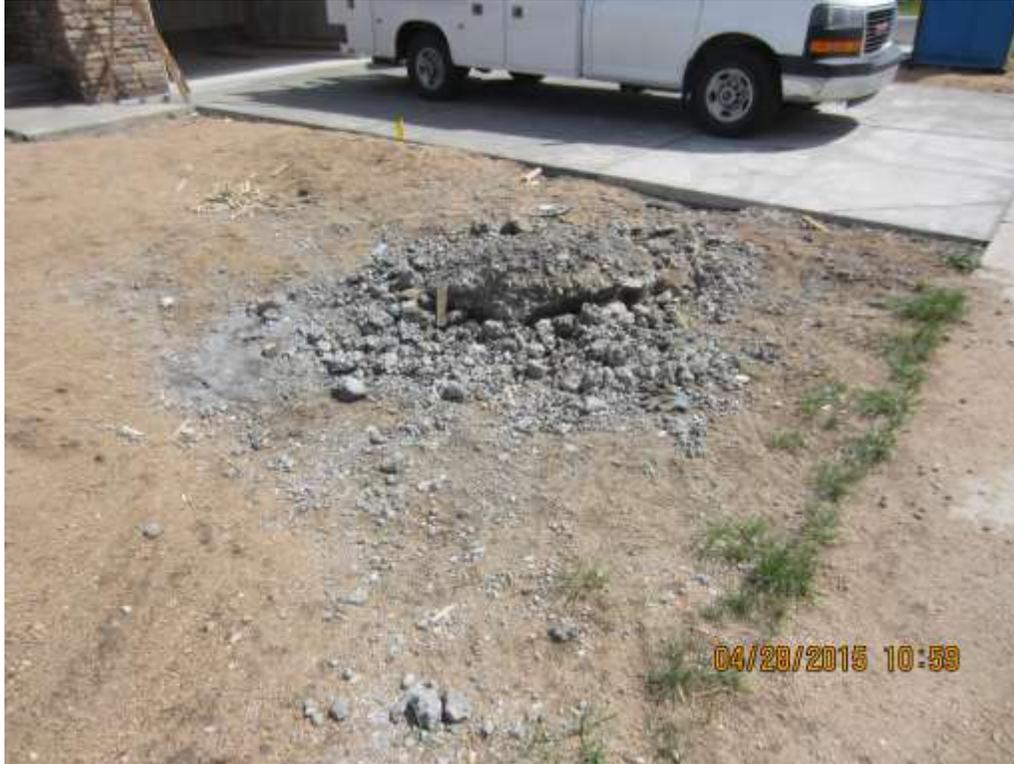
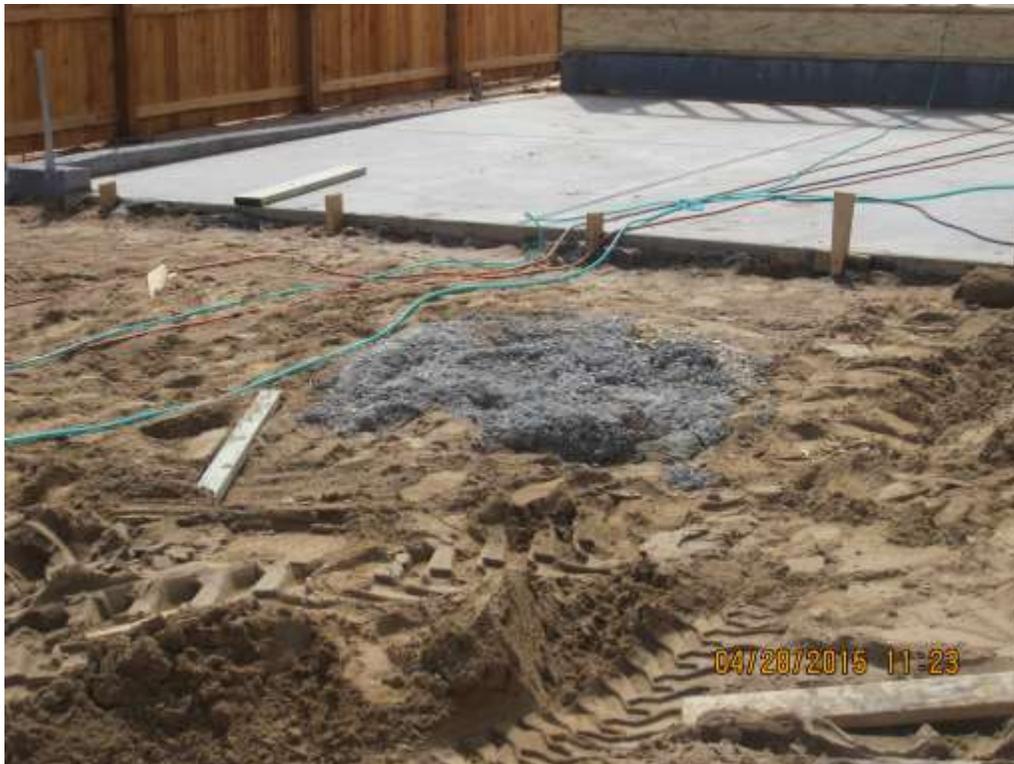
- Concrete waste was observed deposited on the ground and not properly disposed of as required in the SWMP.
 - Control Measure Finding: An installation and implementation specification for a concrete washout area was provided in the SWMP, but was not consistently implemented.

Photograph 29: Concrete waste disposed to ground, waste management controls not implemented

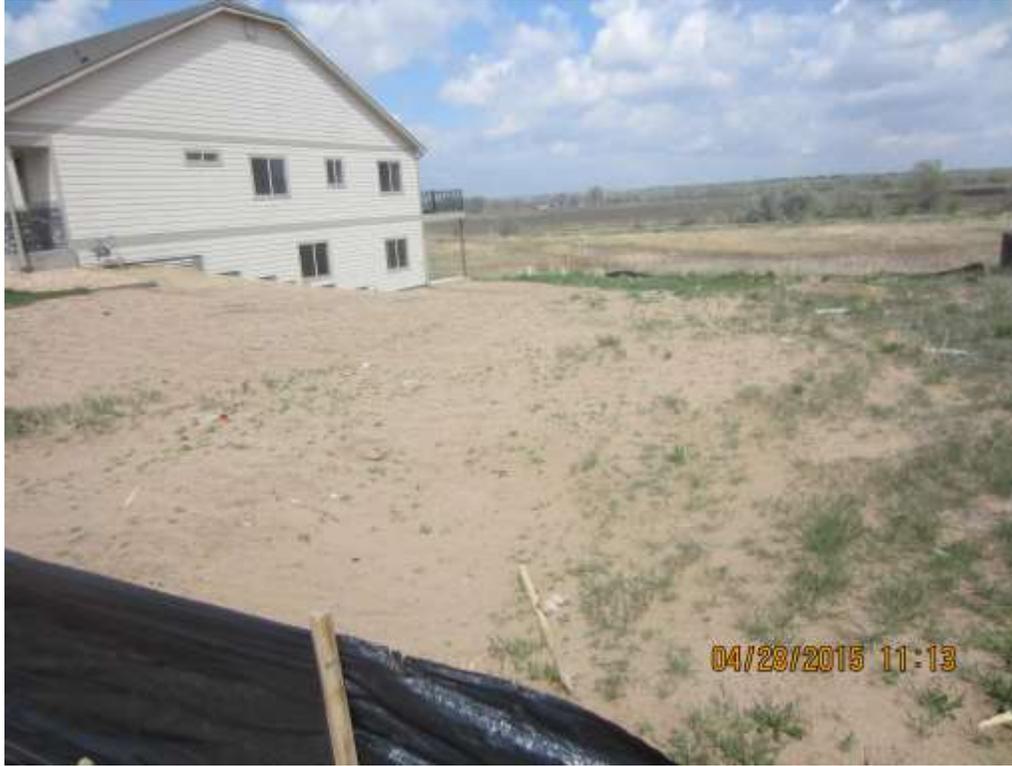
- All site wastes must be properly managed to prevent potential pollution of state waters. This permit does not authorize on-site waste disposal.
5. It was noted during the inspection that control measures were not implemented to manage stormwater runoff from sediment from disturbed areas located on the north side of Dove Hill Road (refer to photograph(s) 31-32).

Photograph 31: Surface roughening not implemented as required in the SWMP

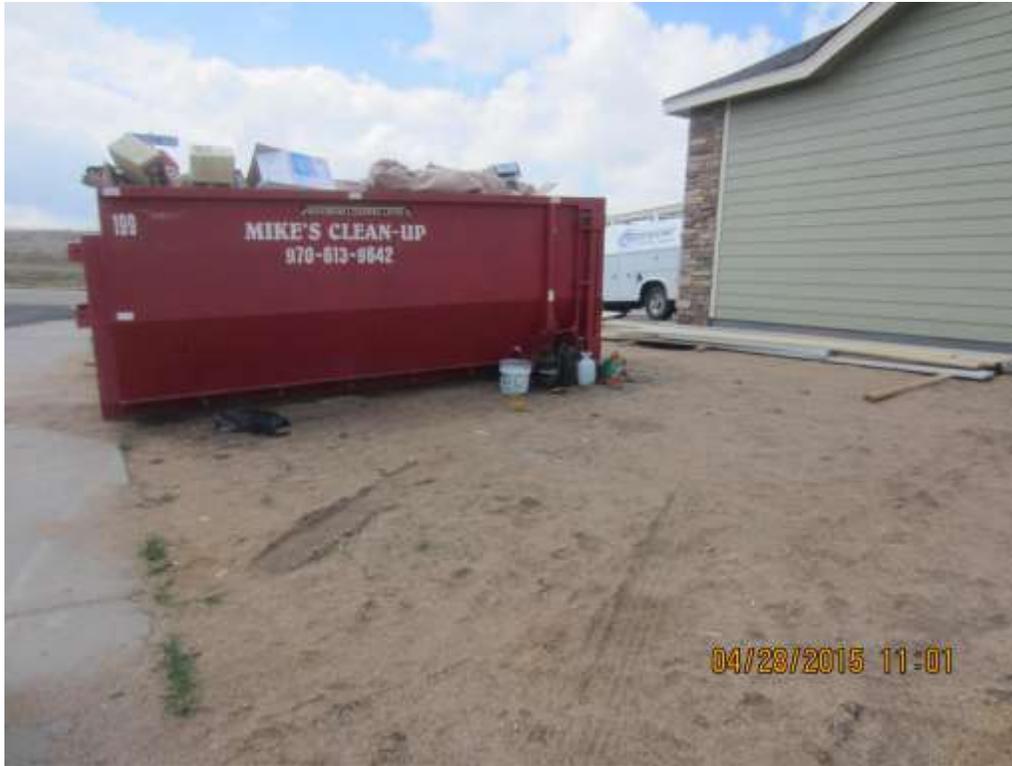
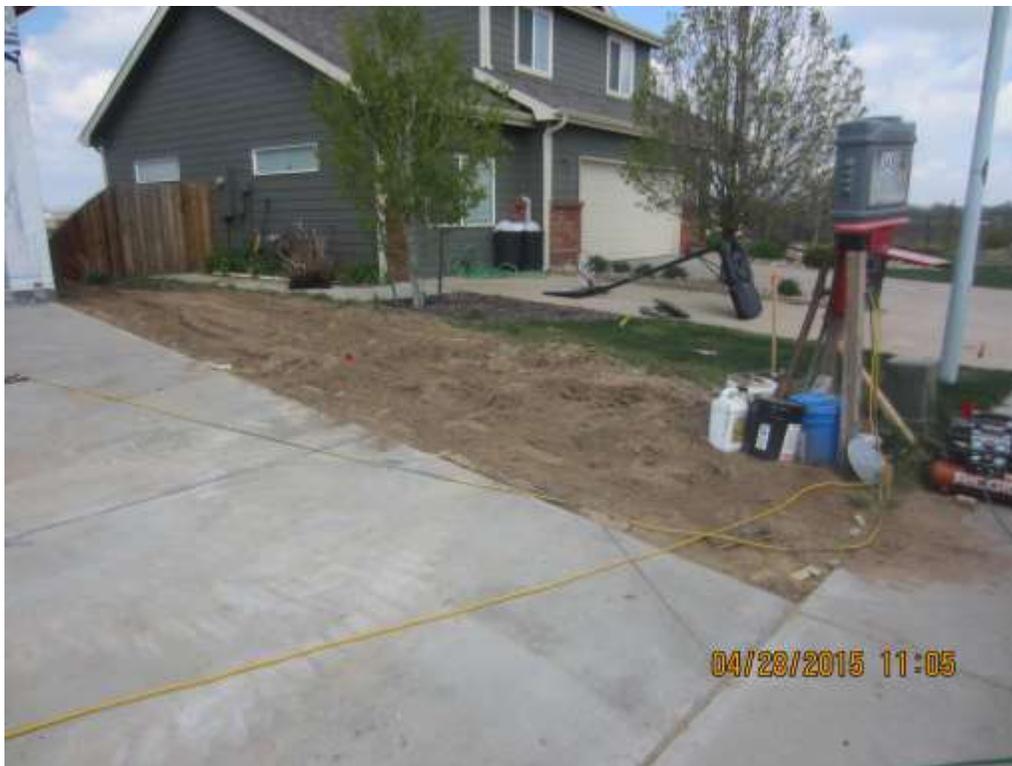
Photograph 33: Materials not managed to prevent pollution of stormwater

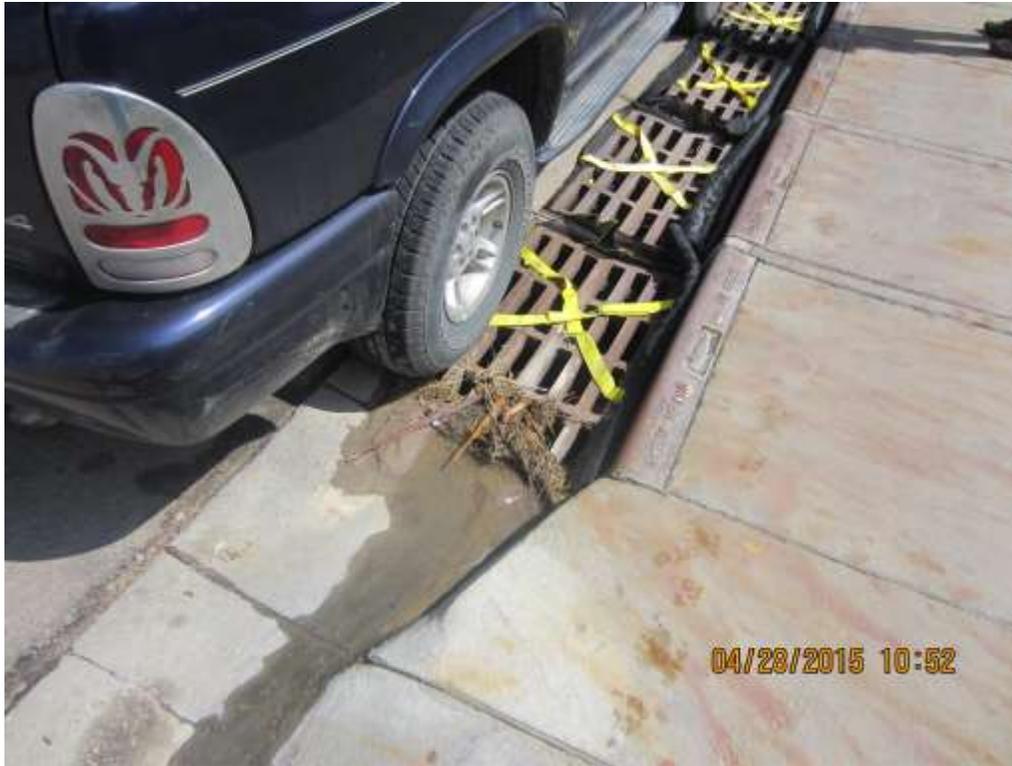
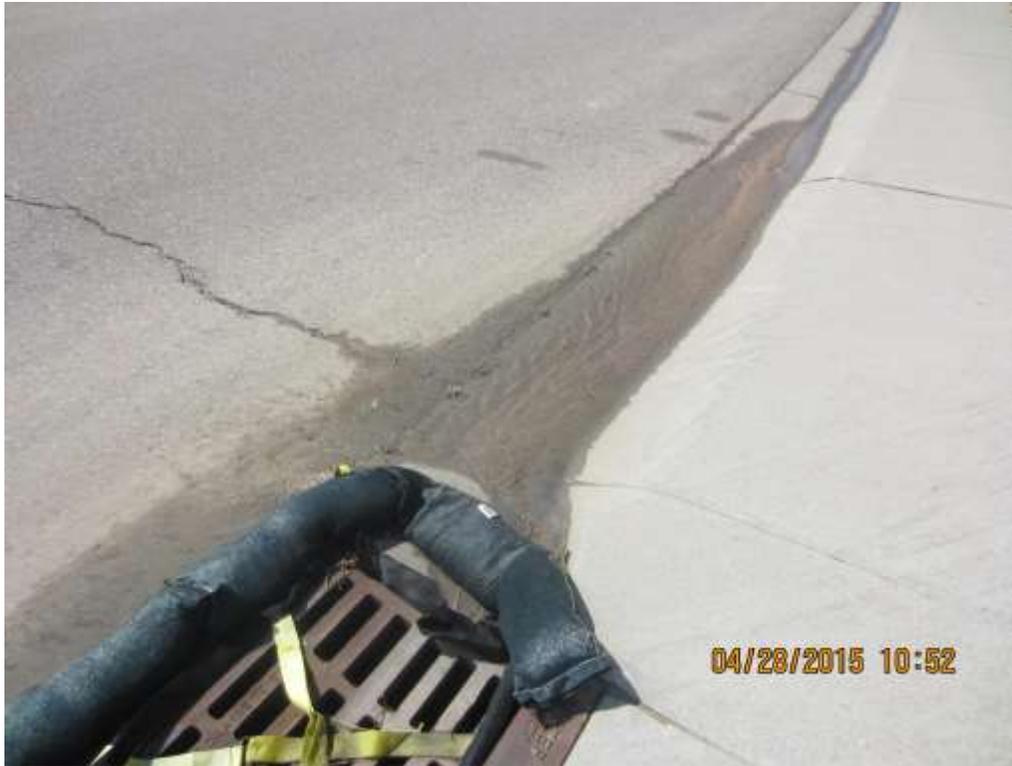
Photograph 35: Inlet protection in need of maintenance to remove accumulated sediment
