RE: Expedited Settlement Agreement, Number ES-160908-1
Dove Hill Estates Ph II / CDPS Permit Certification No. COR03N464

EXPEDITED SETTLEMENT AGREEMENT

Number: ES-160908-1

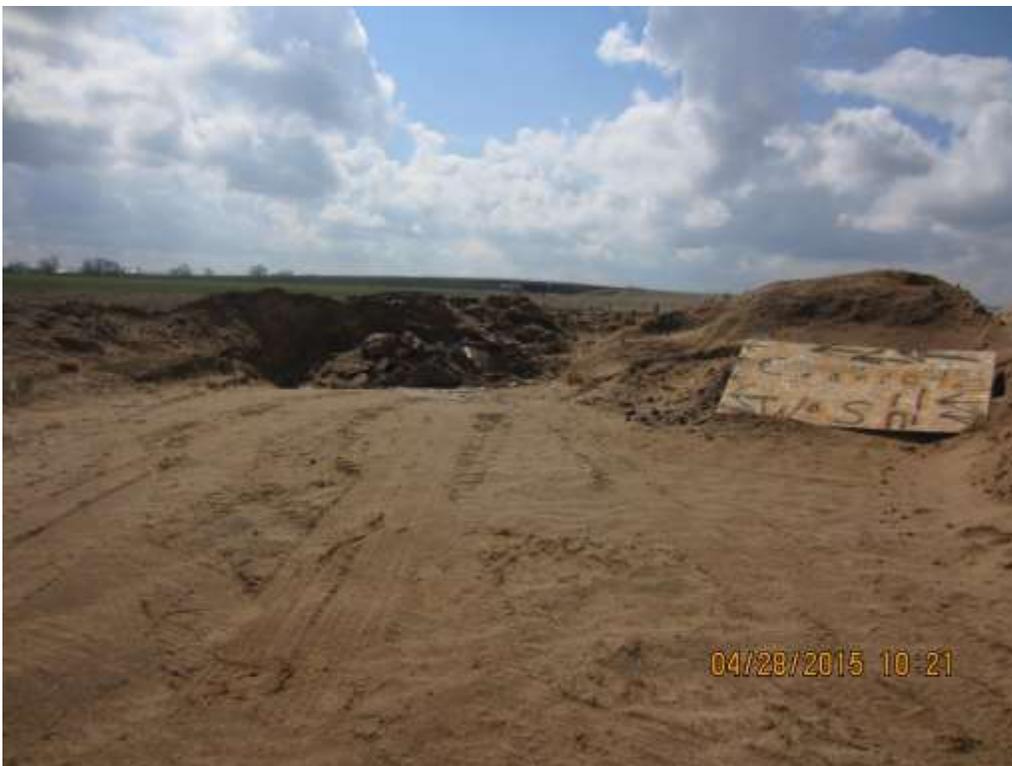
Photograph 38: Concrete washout area not installed per the specification provided in the SWMP

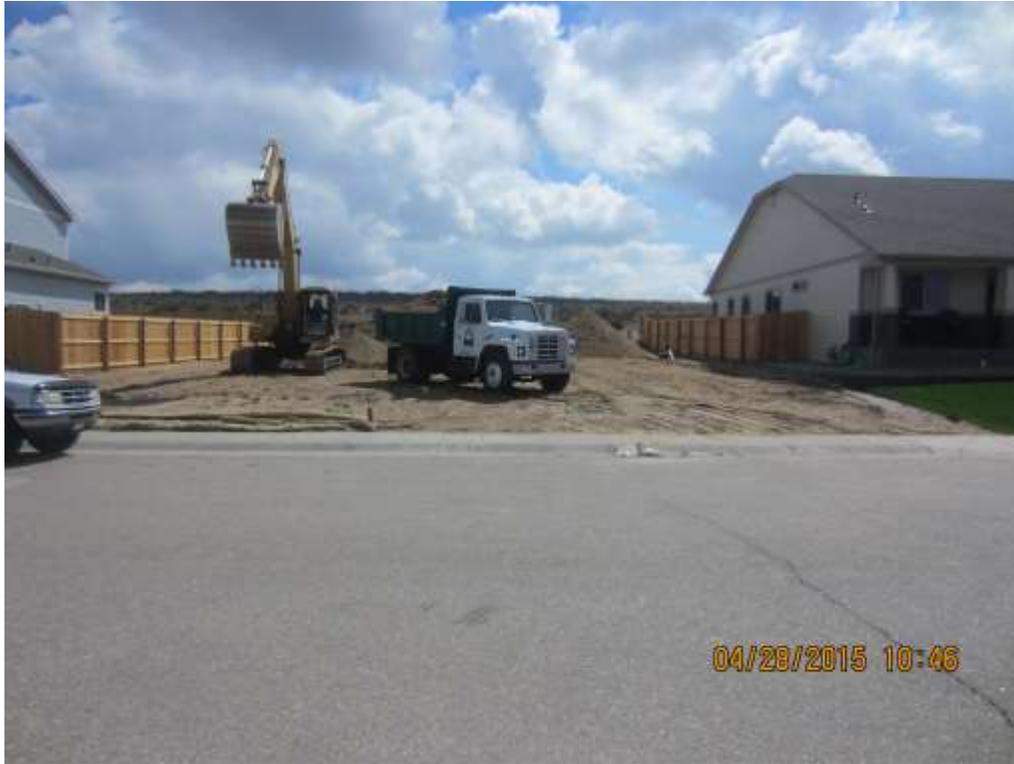
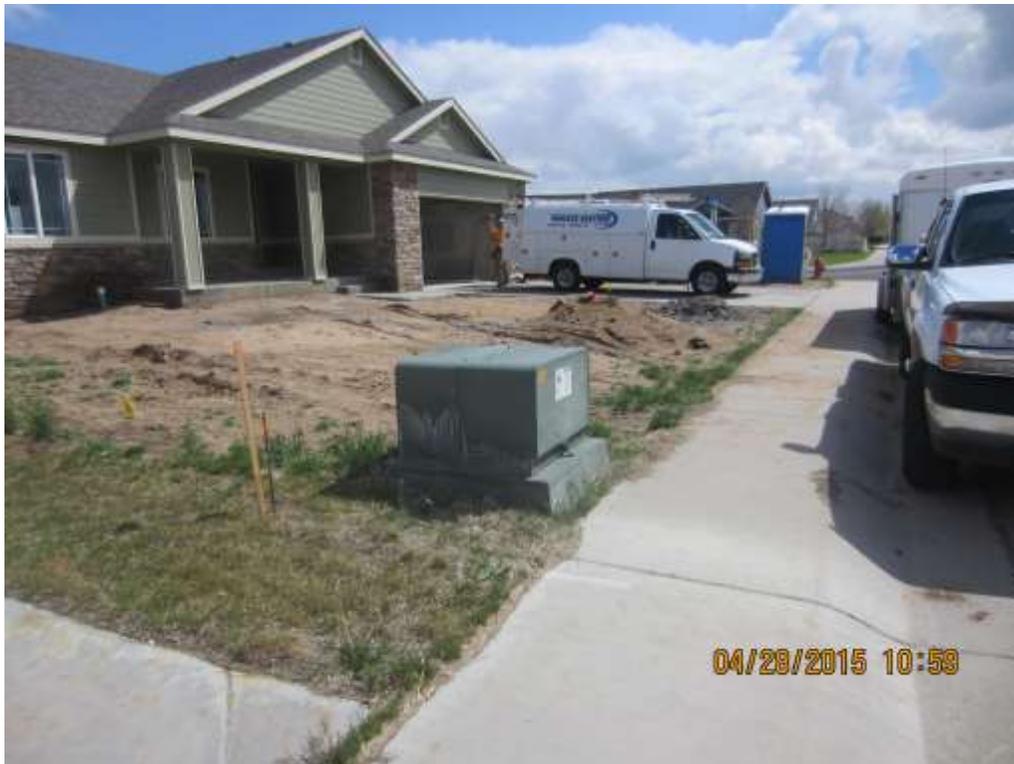
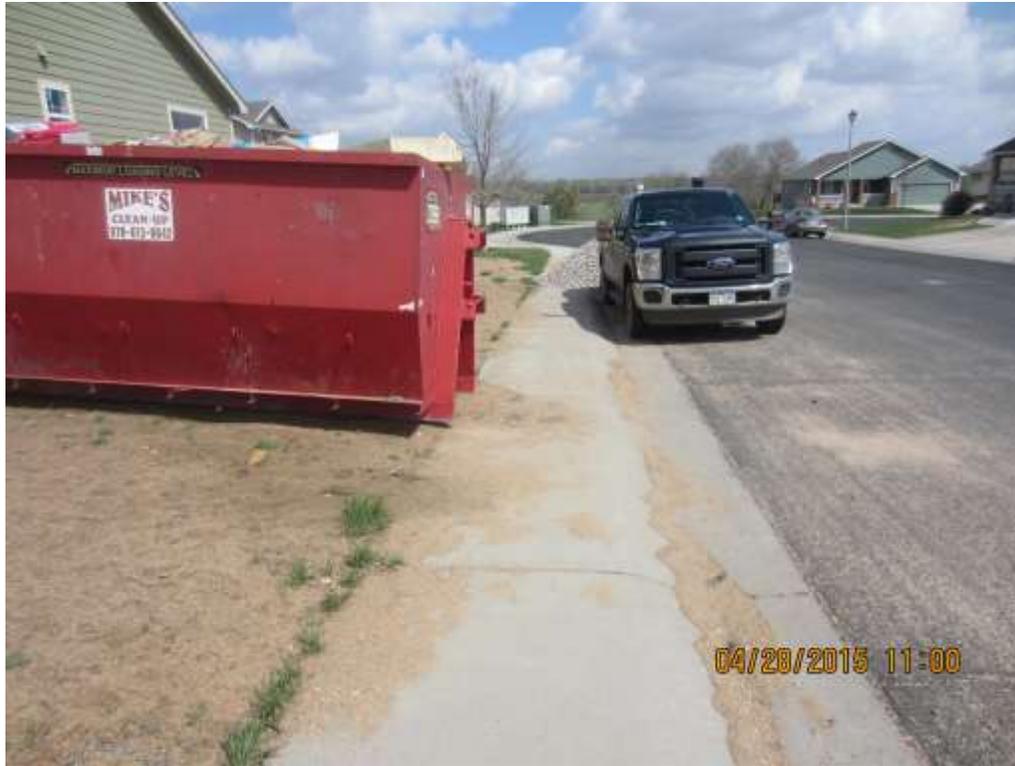
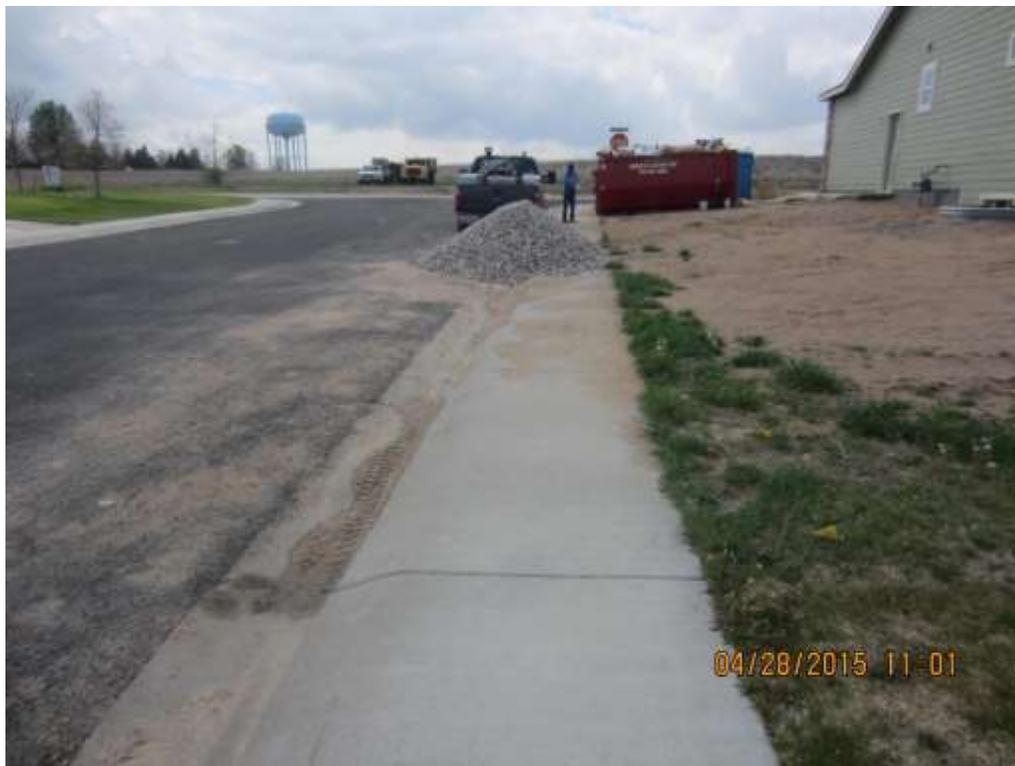
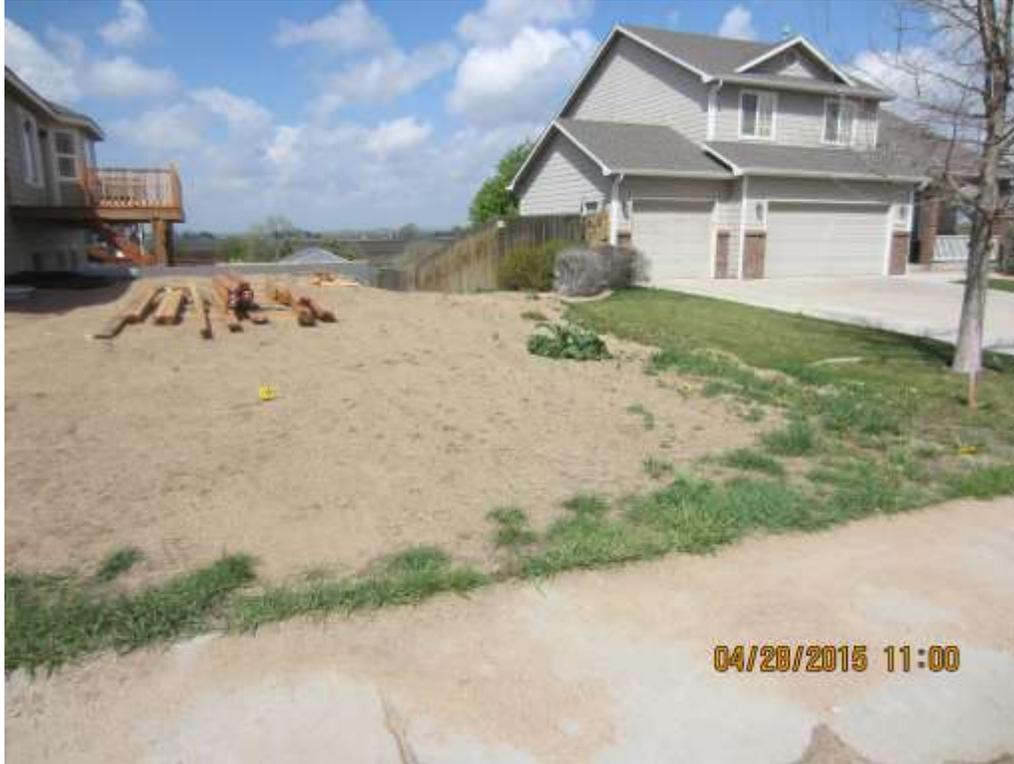
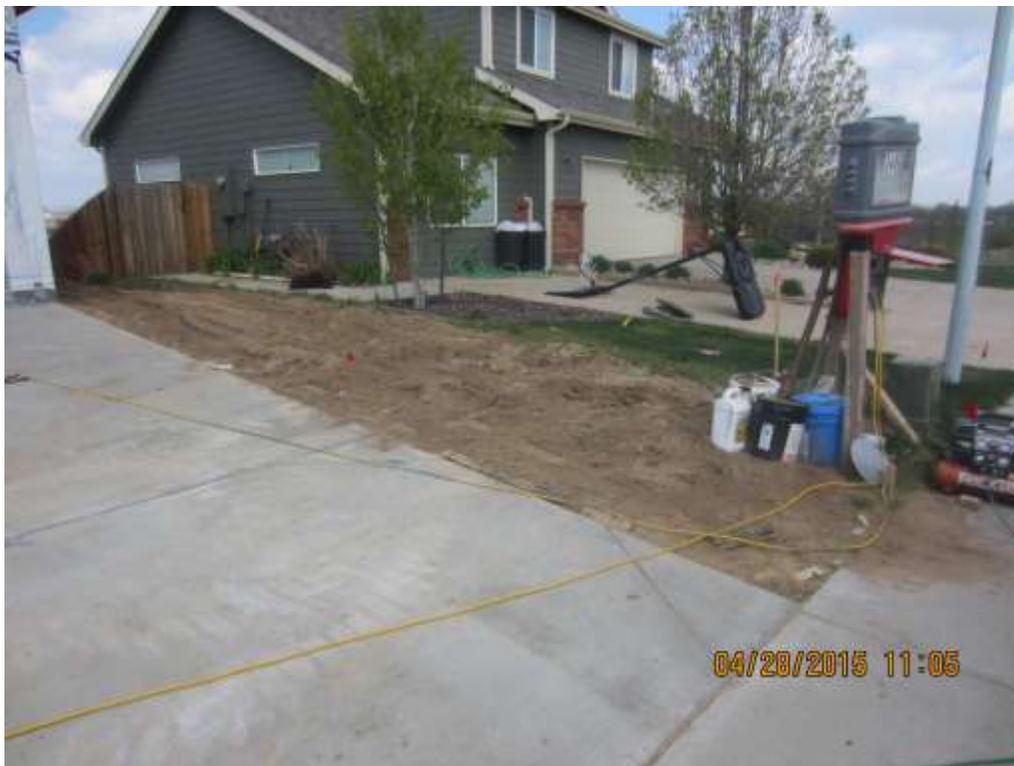
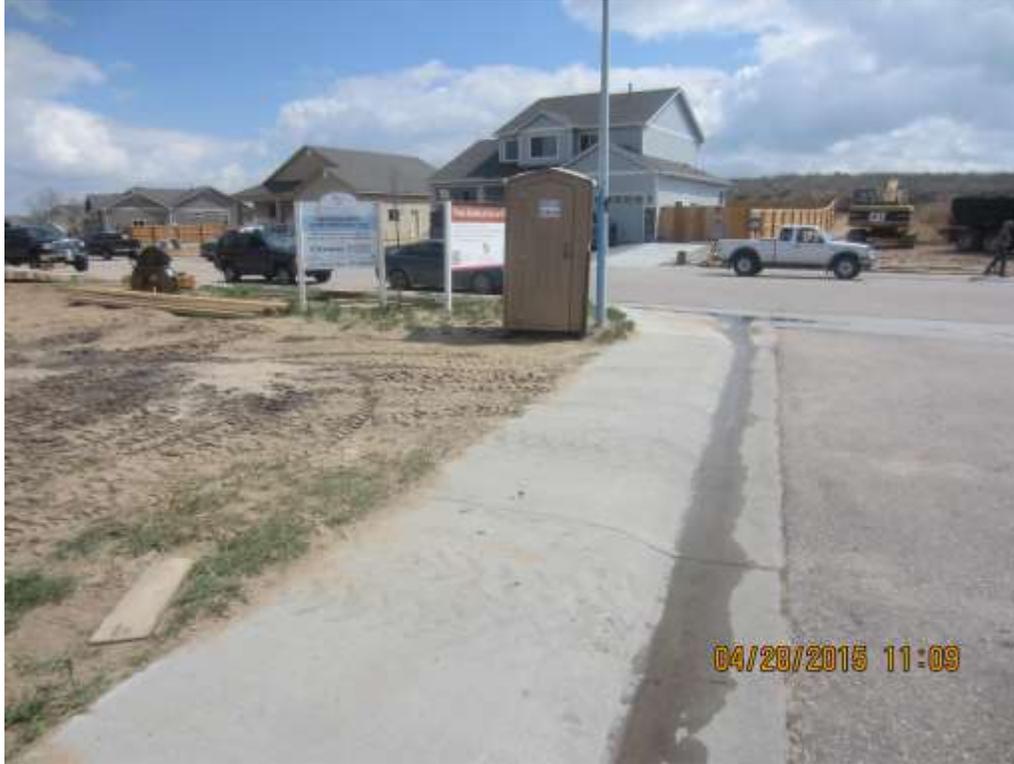
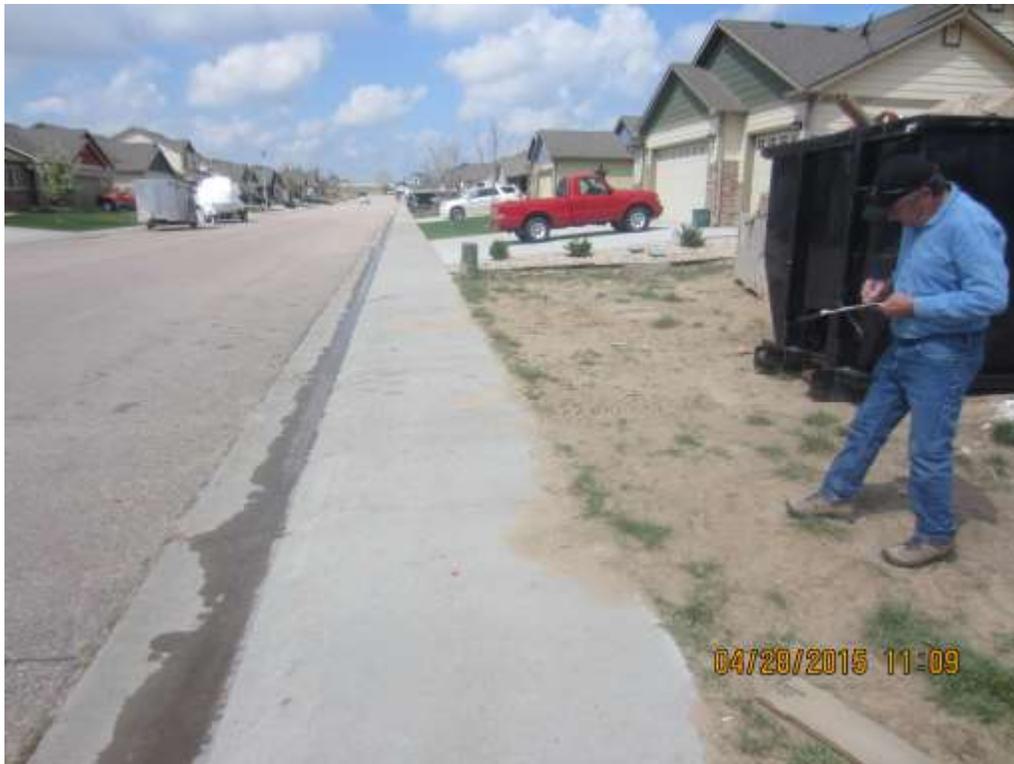
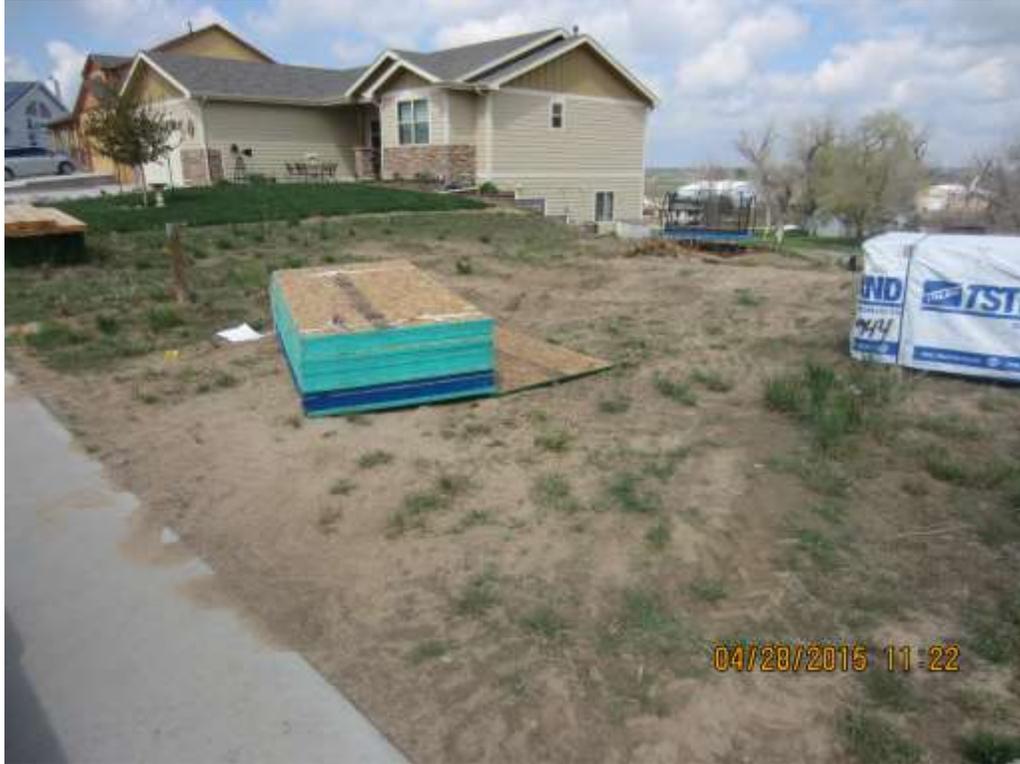
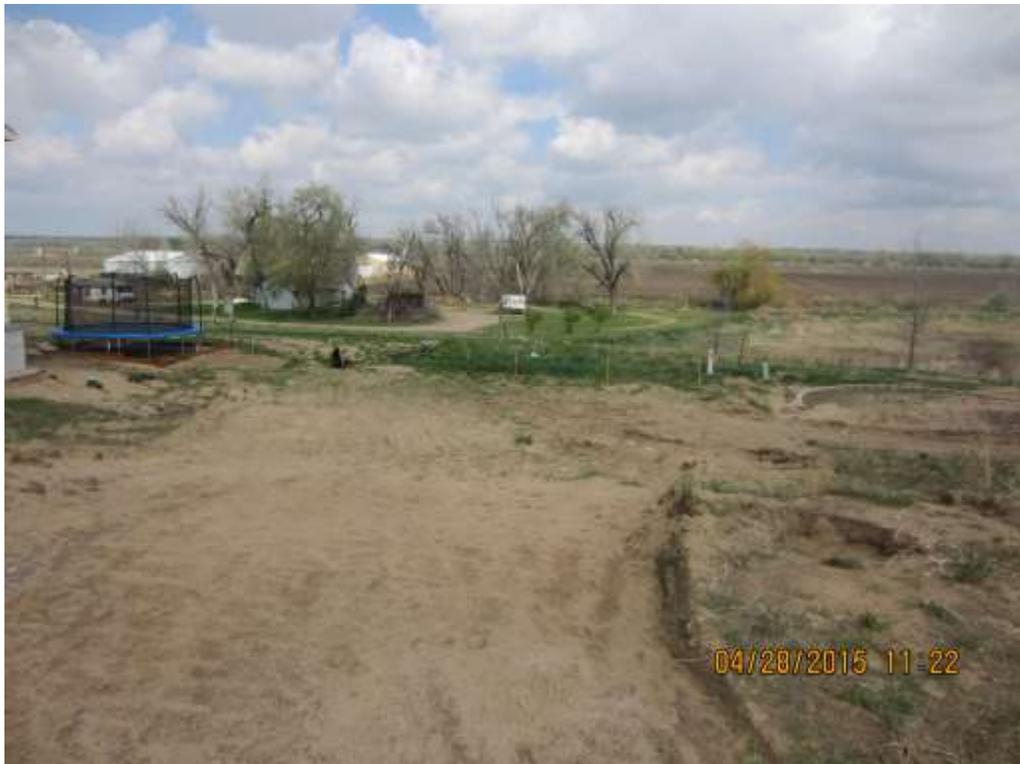
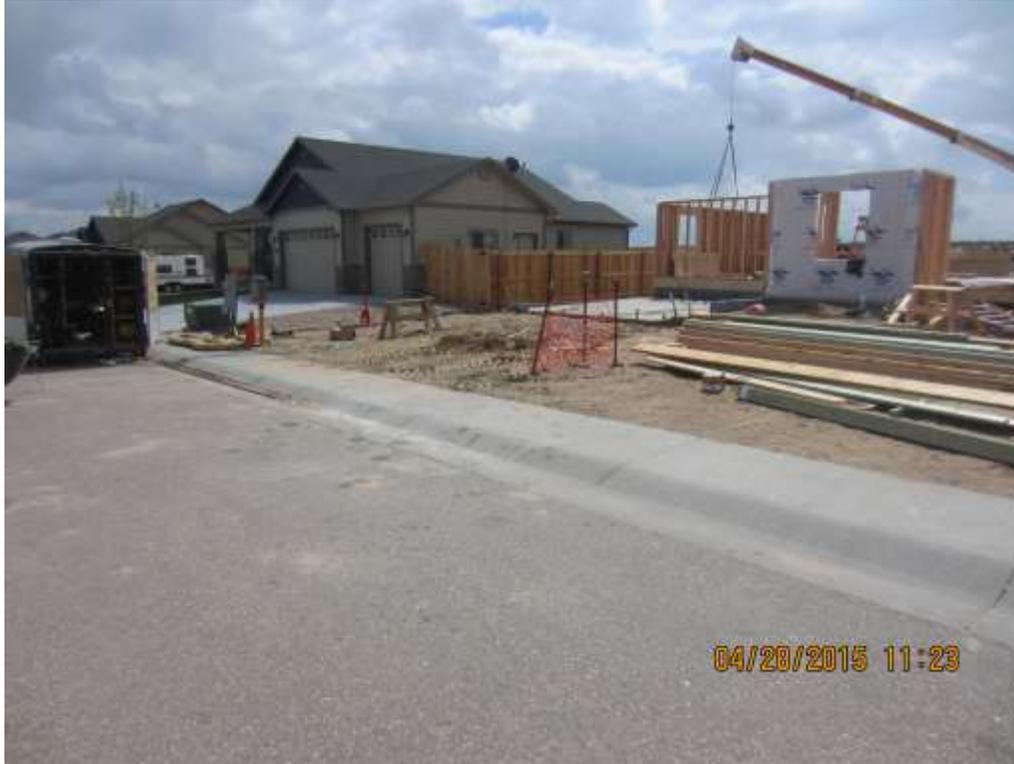
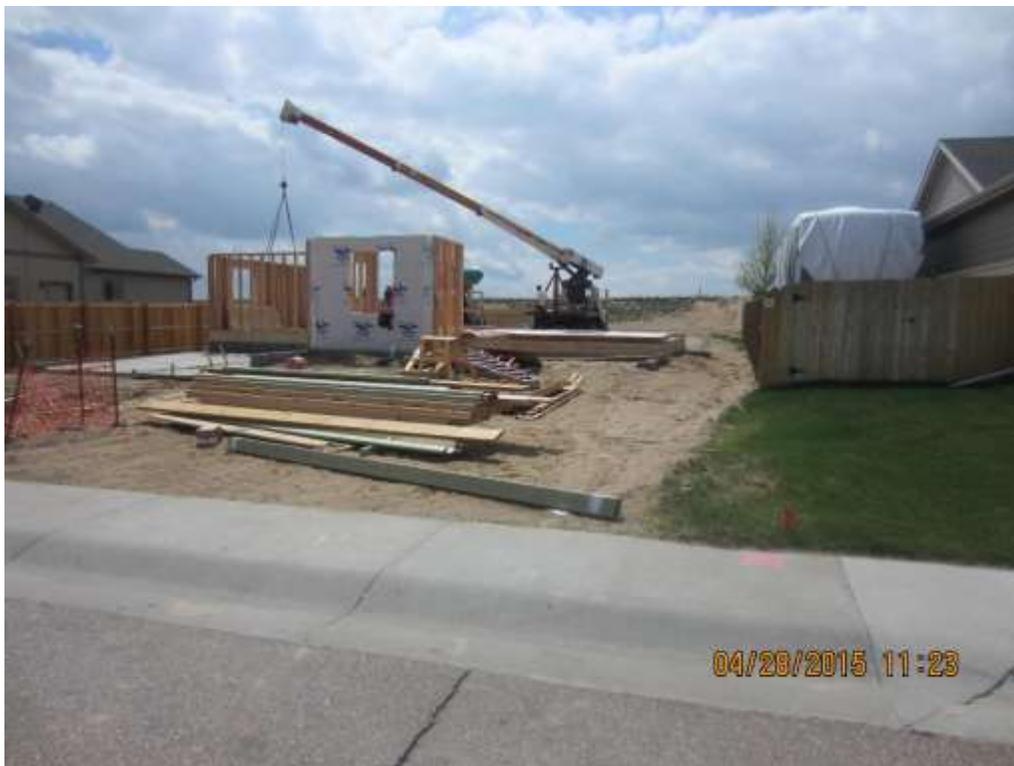
- Several lots in the above described locations were observed during the inspection to be without control measures implemented to manage sediment from the disturbed areas.

Photograph 41: Control measures not implemented to manage pollutants for disturbed lots

- Control measures must be implemented to manage stormwater runoff from all potential pollutant sources.
 - Control measures implemented at the site must be adequately designed to provide control for all potential pollutant sources associated with construction activity to prevent pollution or degradation of State waters.

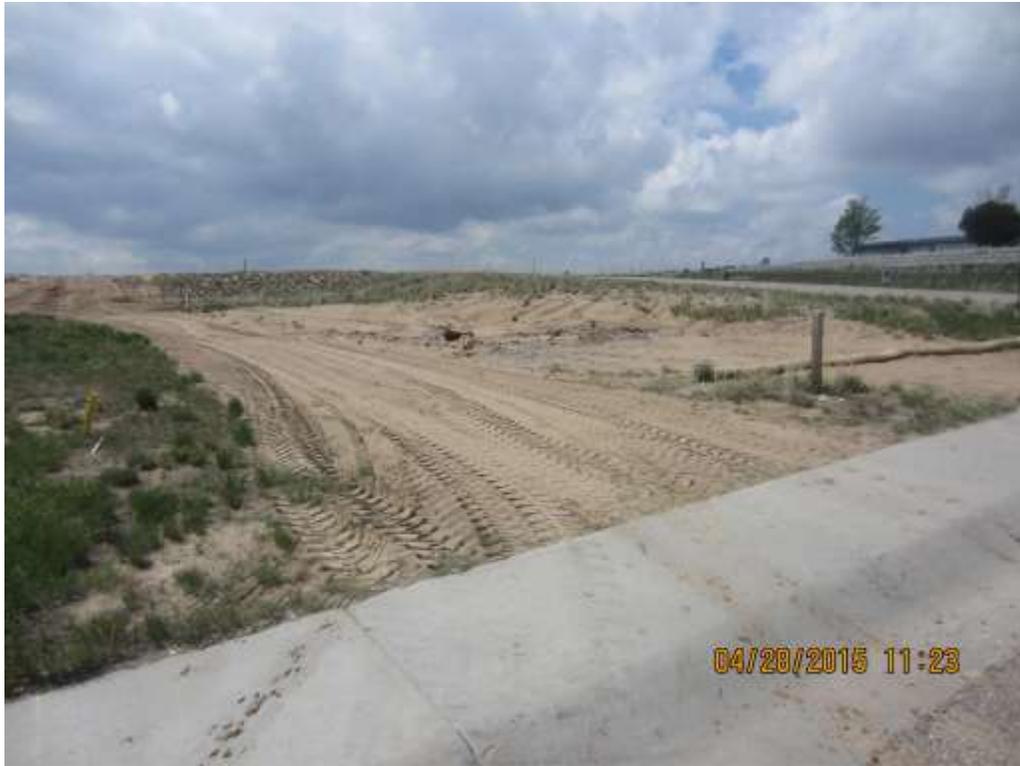
- f. On the south side of Dove Hill Road (refer to photograph(s) 53).
- Control Measure Observation: Control measures were not implemented to control stormwater runoff from the locations and pollutant source noted above. Specifically,

Photograph 53: Control measures not implemented to manage pollutants for disturbed lots
