RE: Expedited Settlement Agreement, Number ES-160908-1
Dove Hill Estates Ph II / CDPS Permit Certification No. COR03N464

EXPEDITED SETTLEMENT AGREEMENT

Number: ES-160908-1

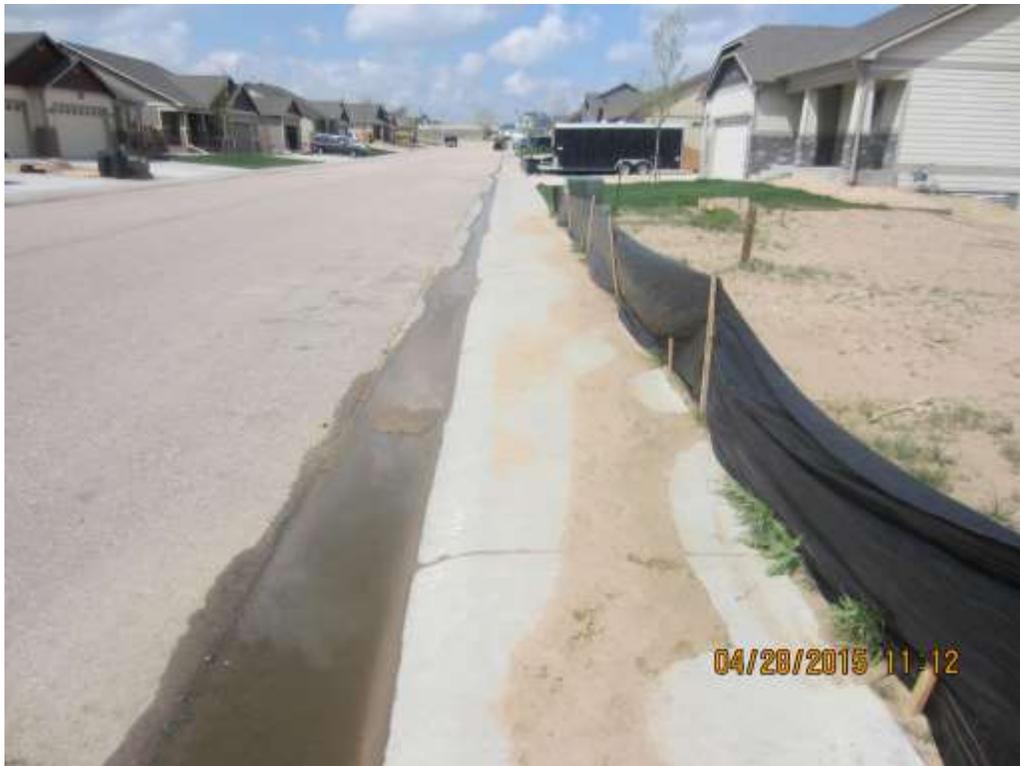
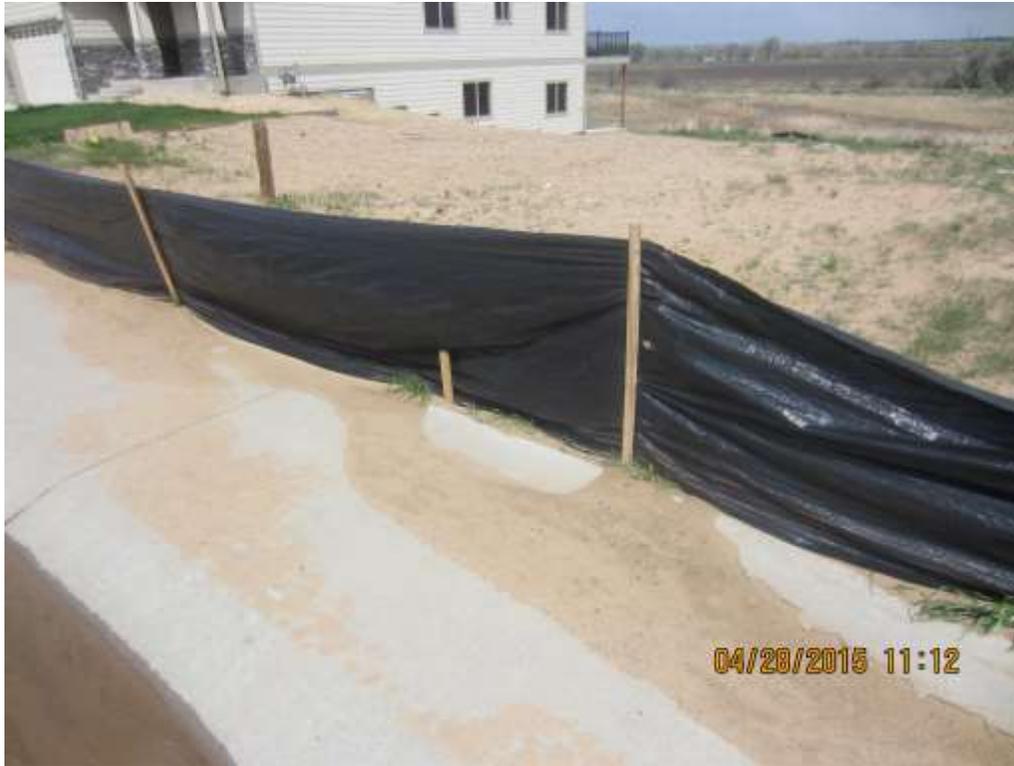
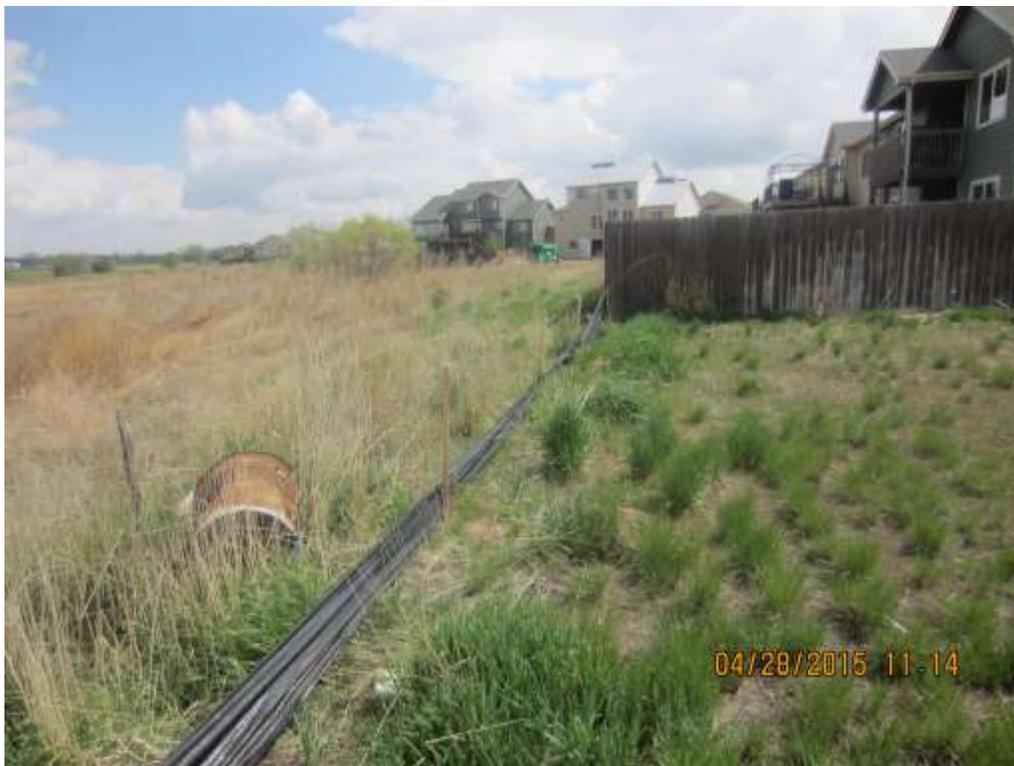
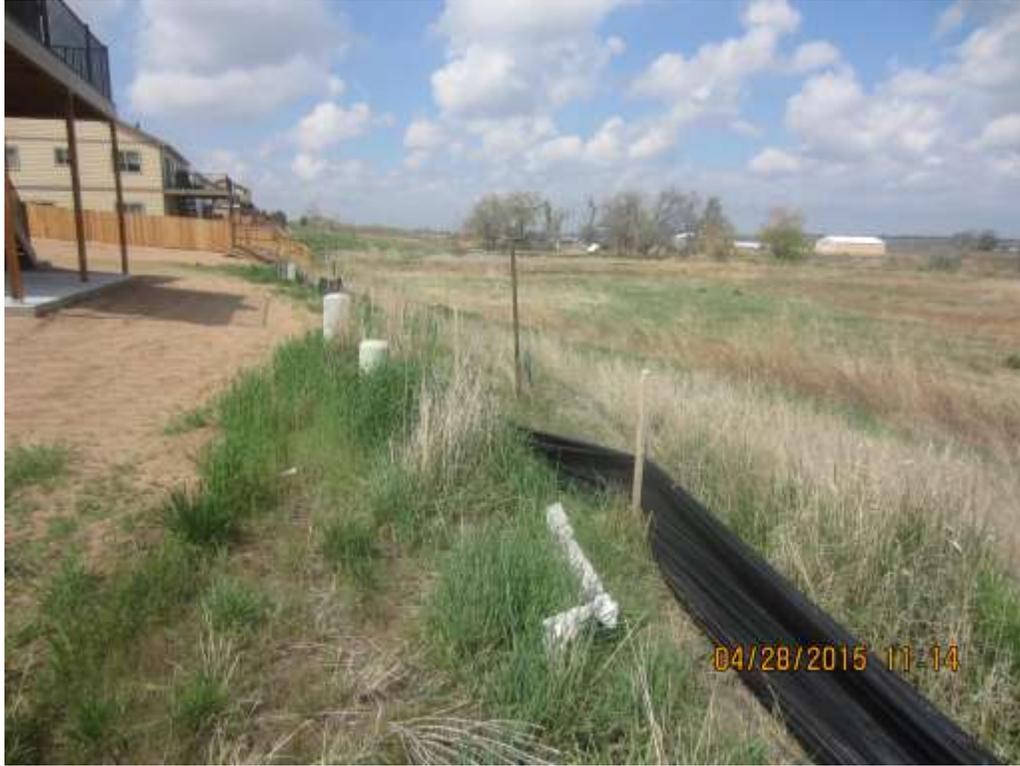
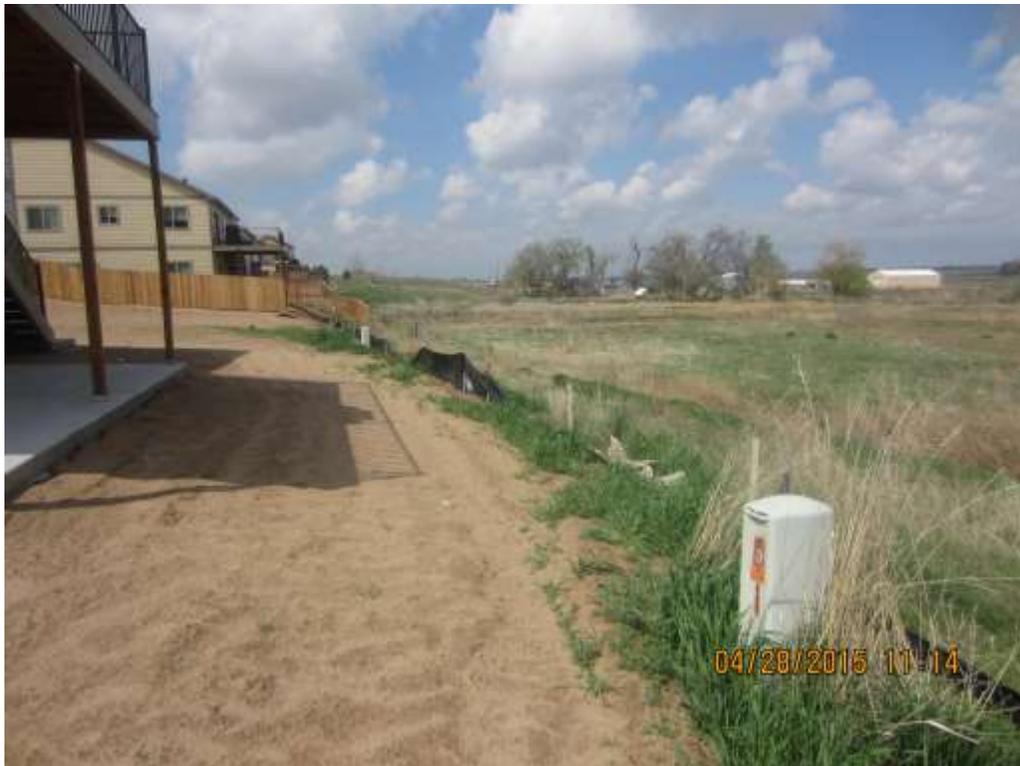
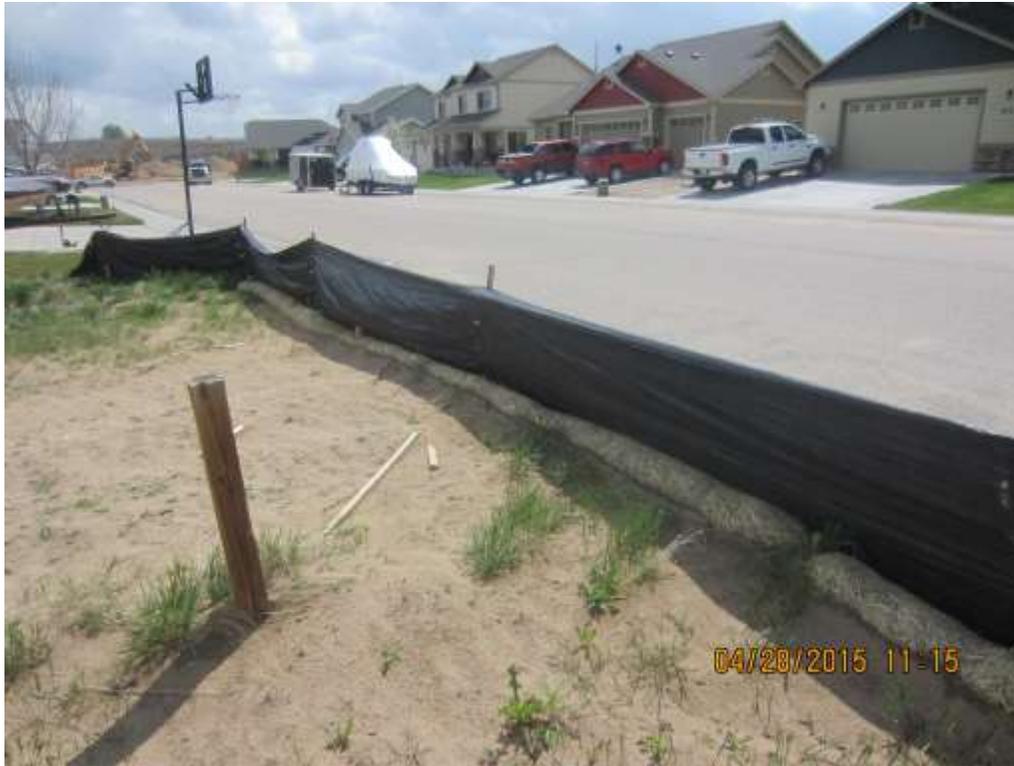
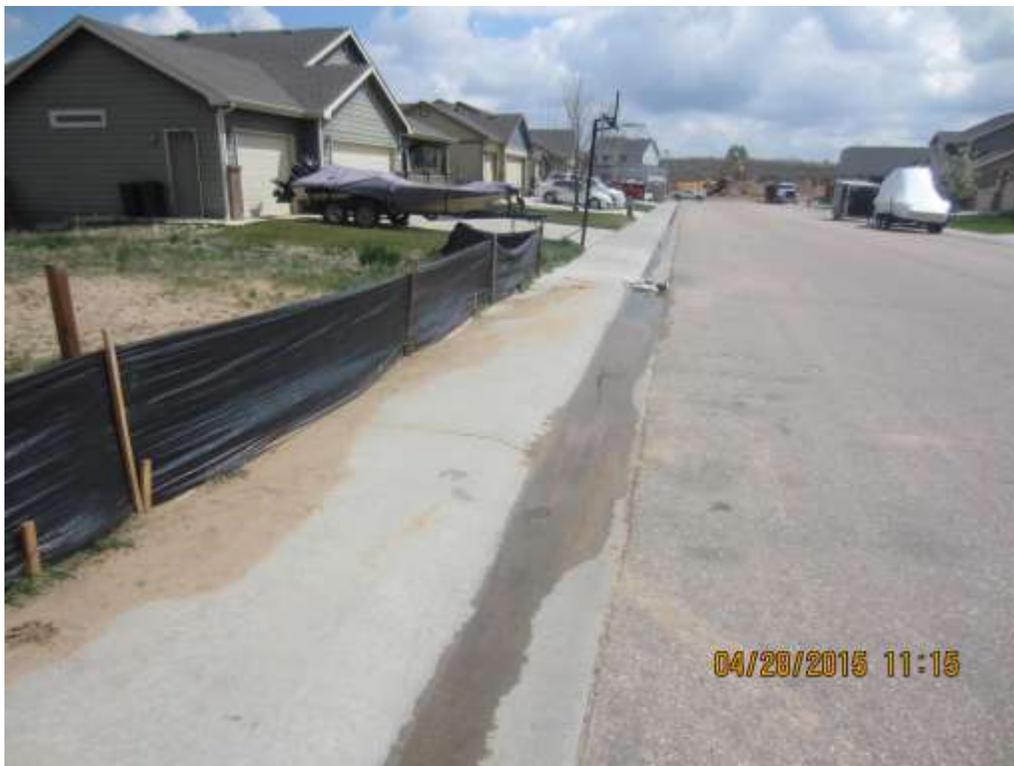
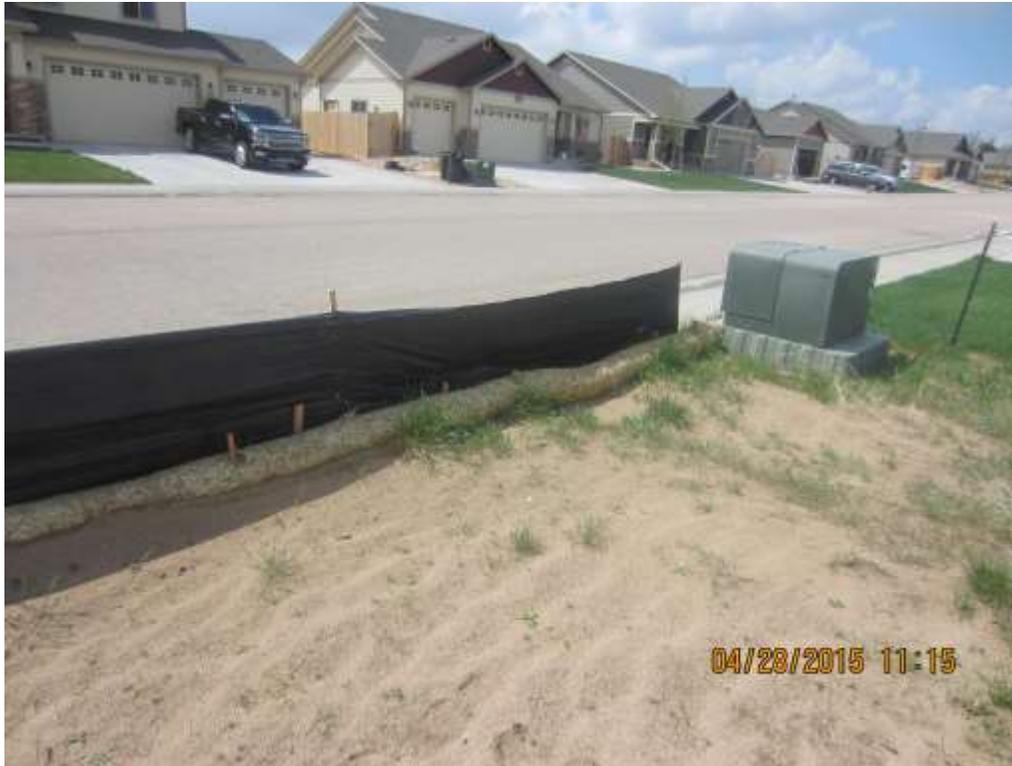
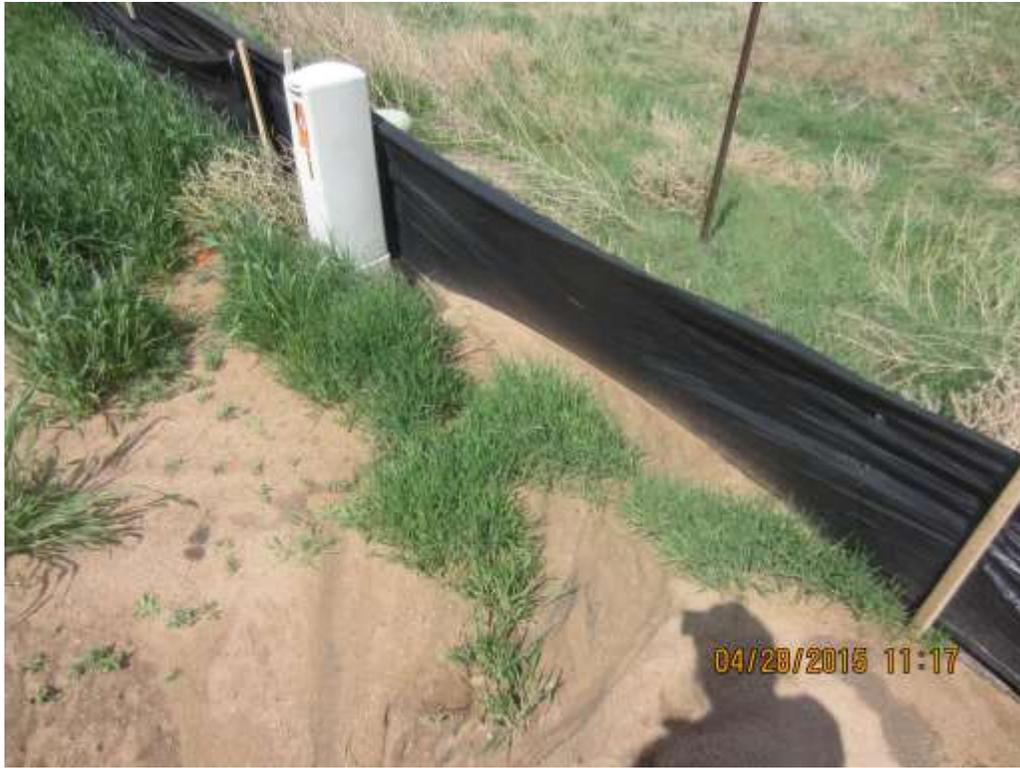
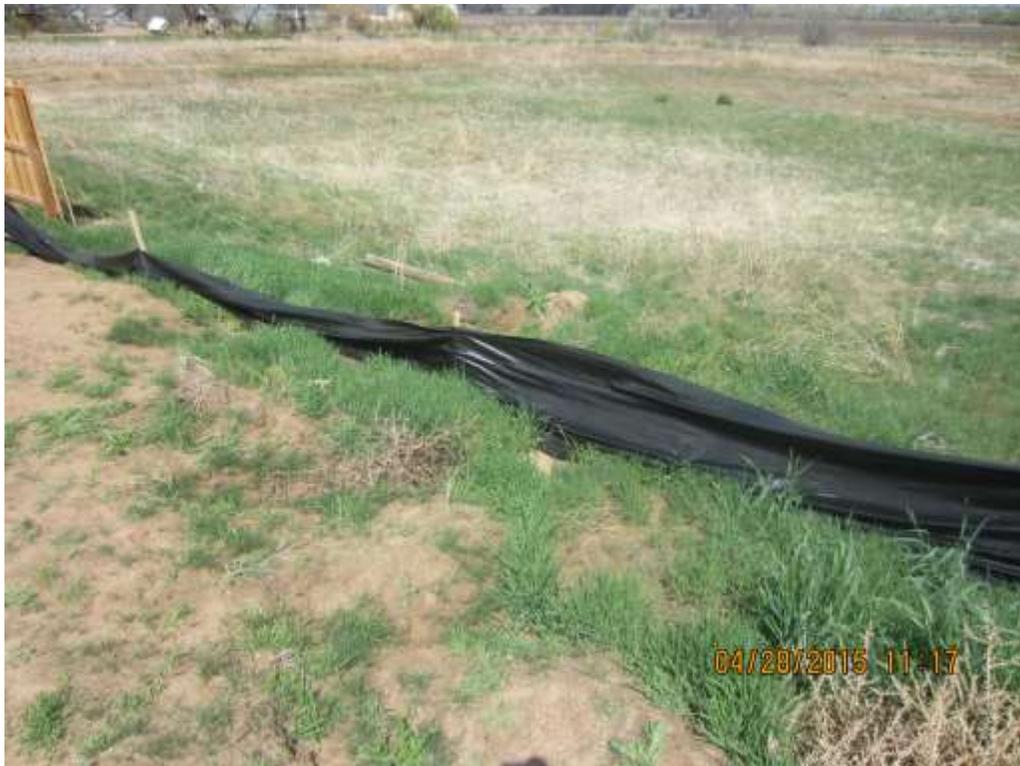
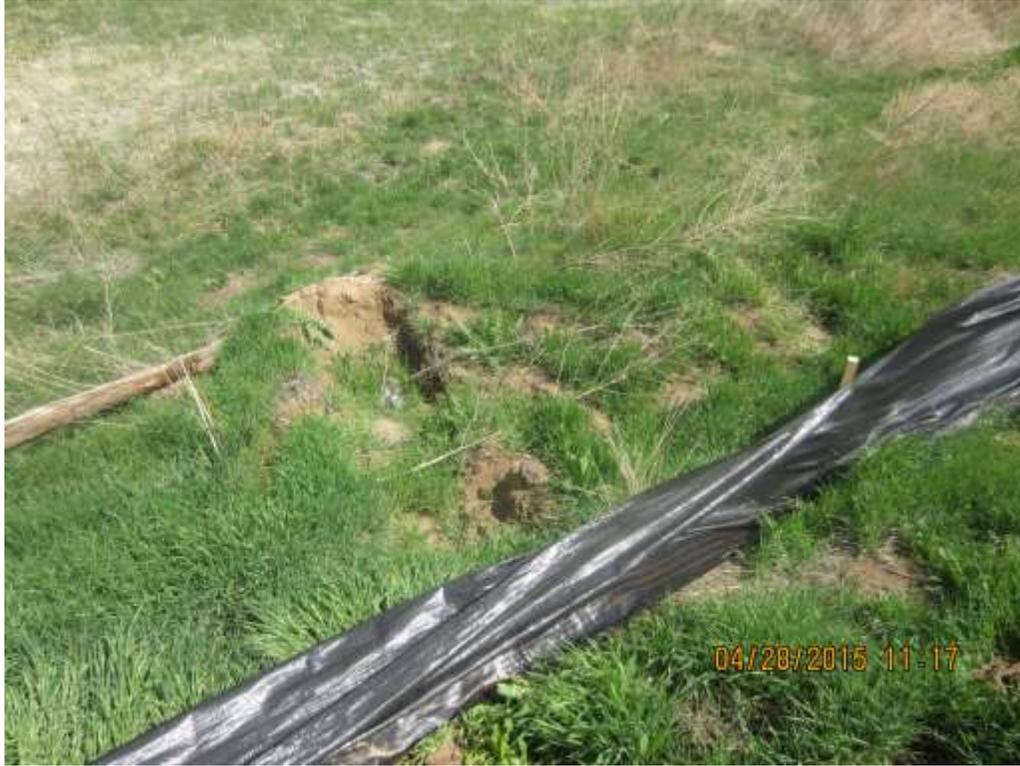
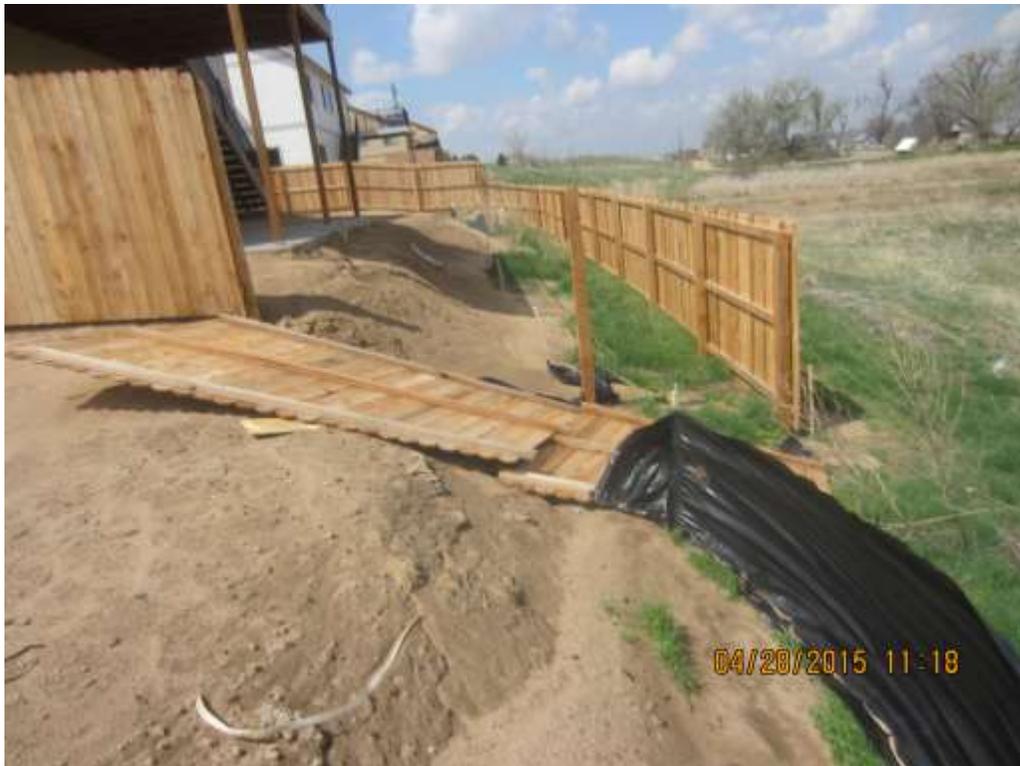
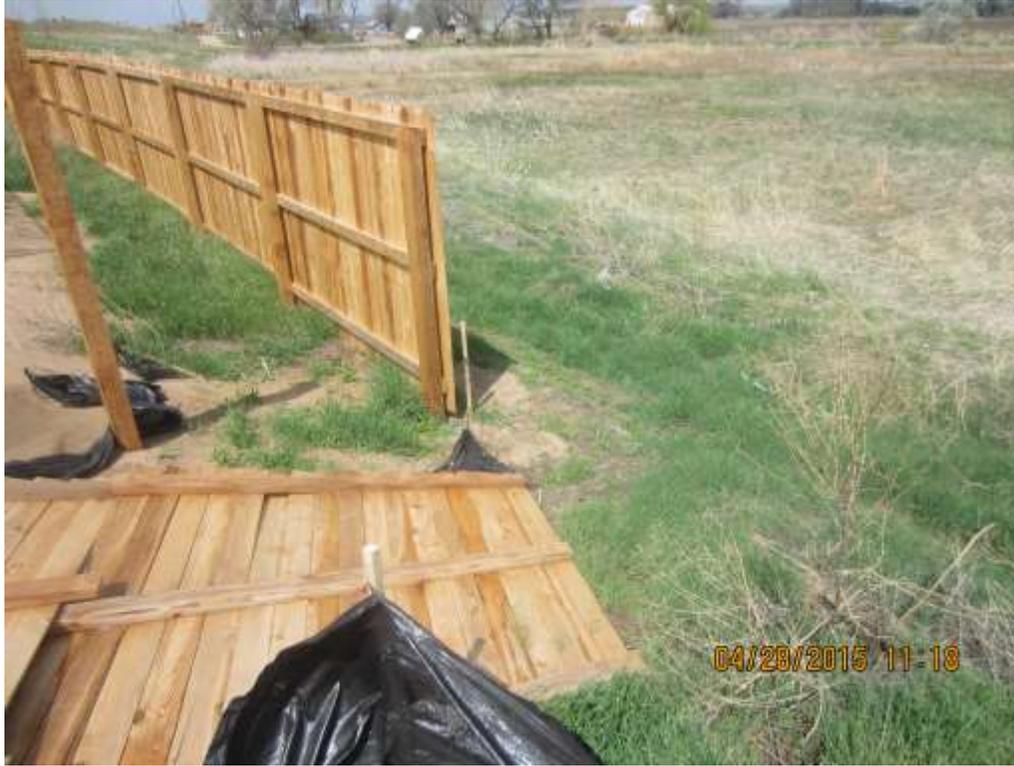
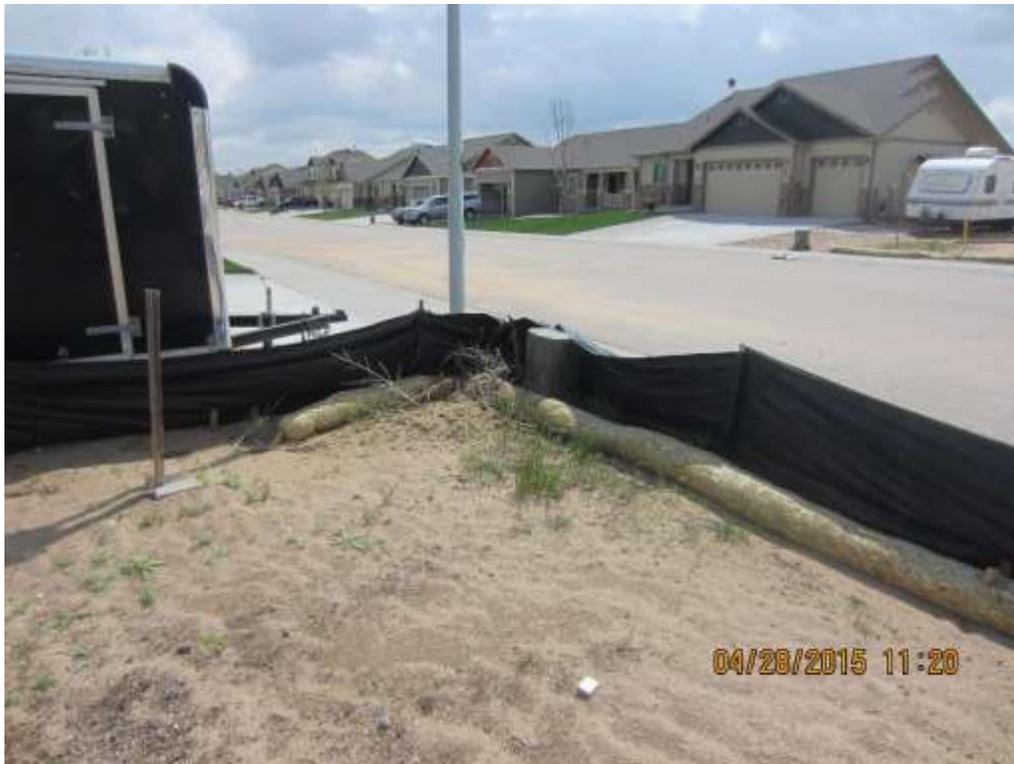
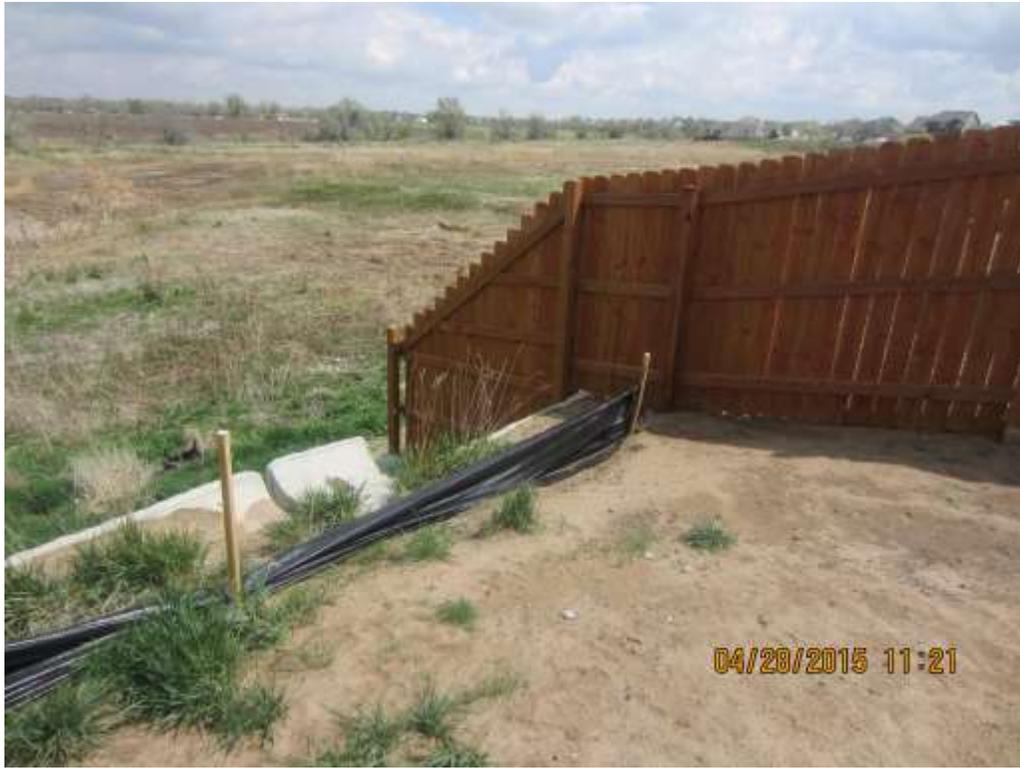
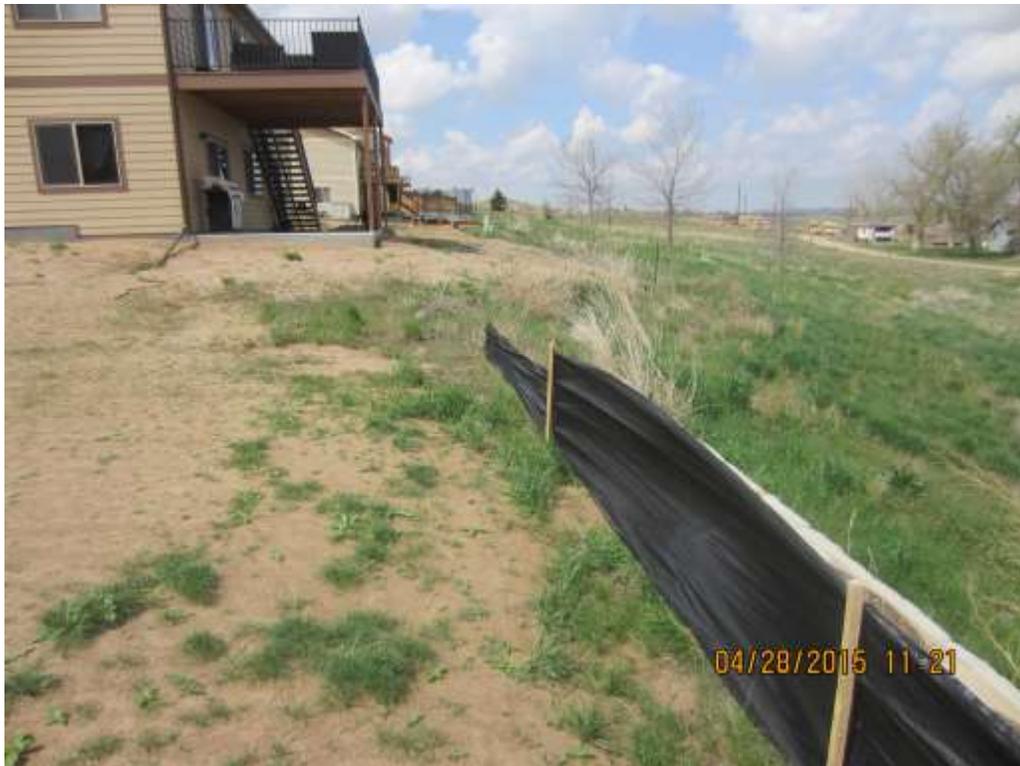
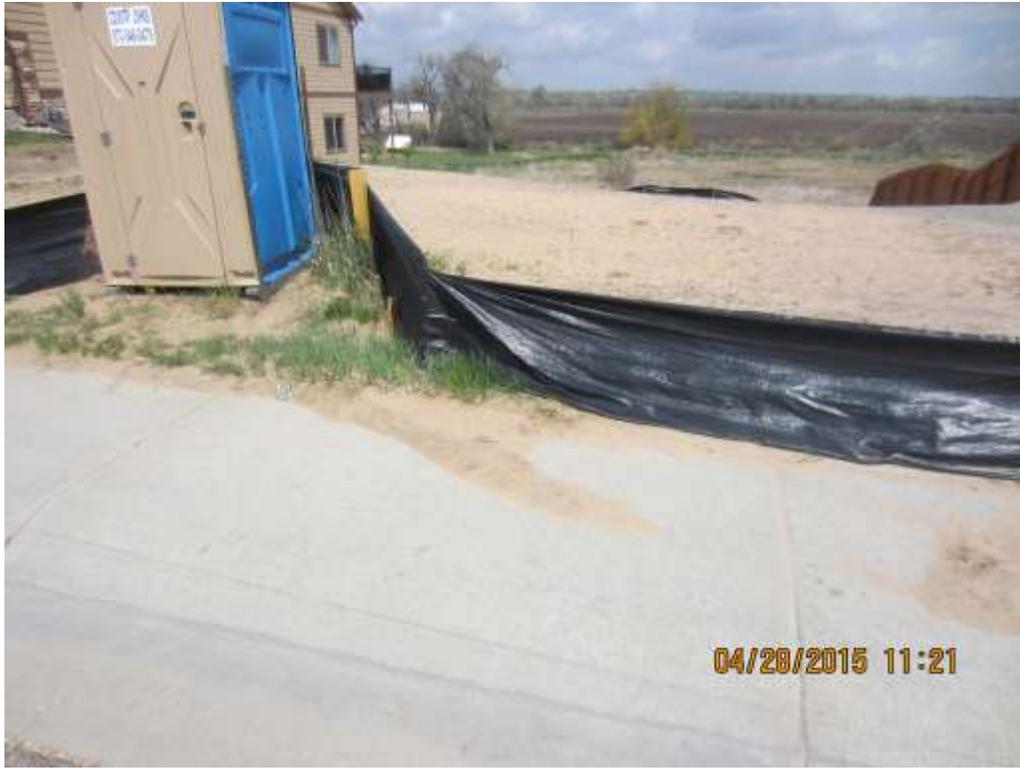
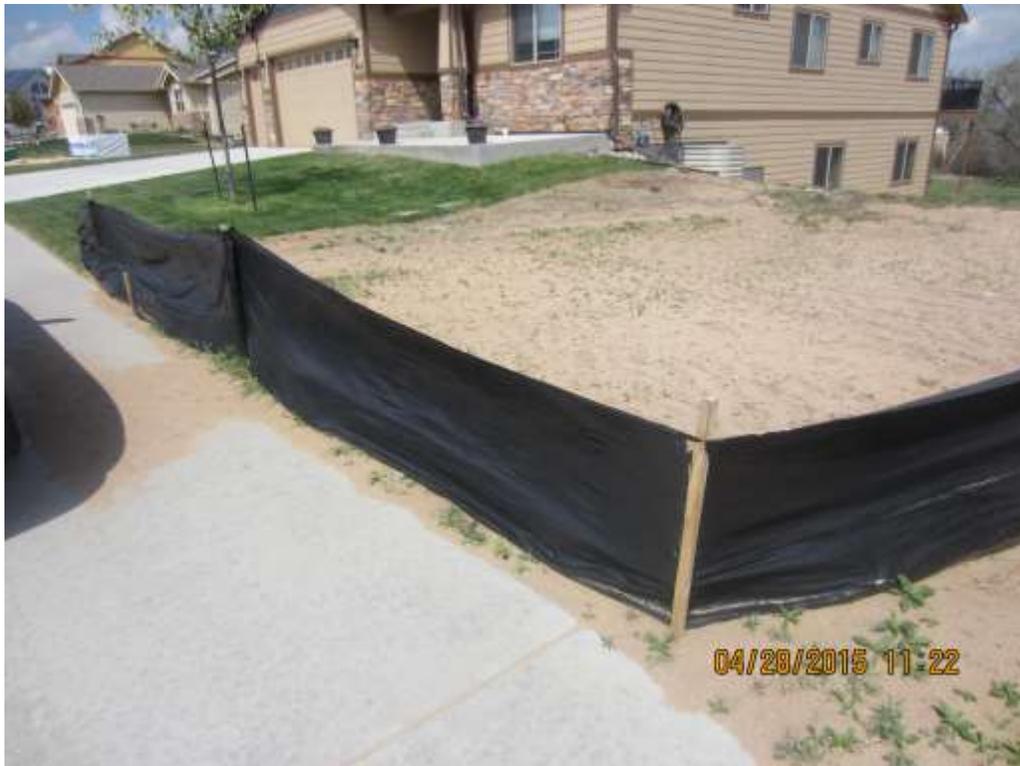
Photograph 54: Silt fence not installed or maintained per specification

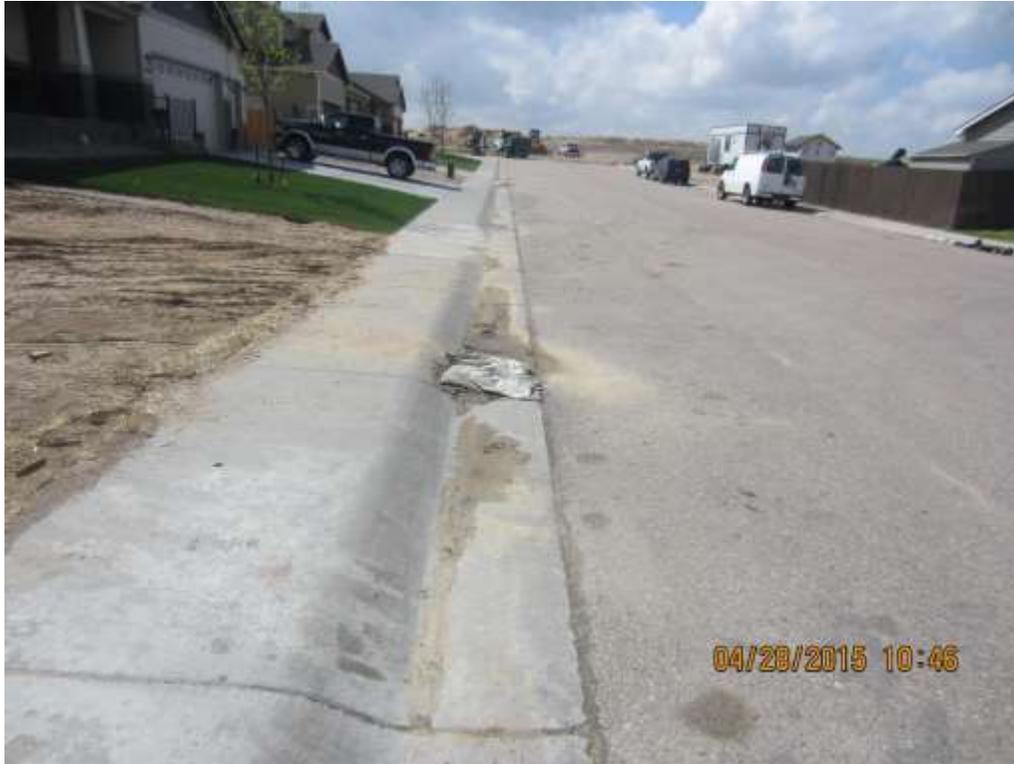
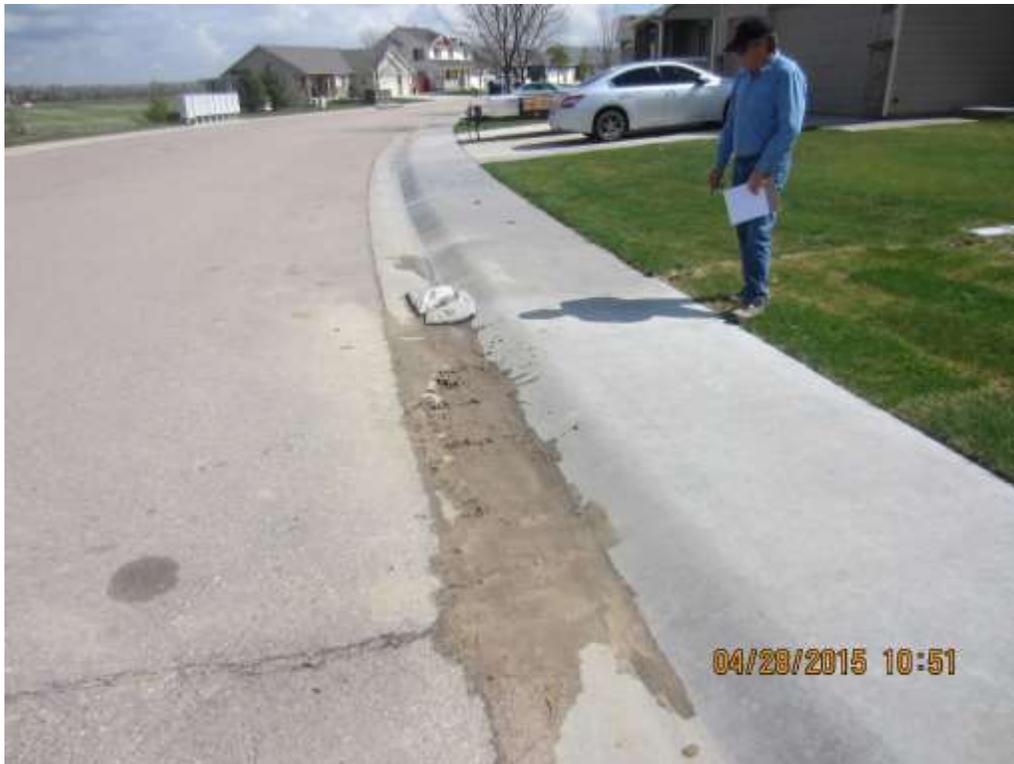
Photograph 73: Sand bag curb checks in need of maintenance

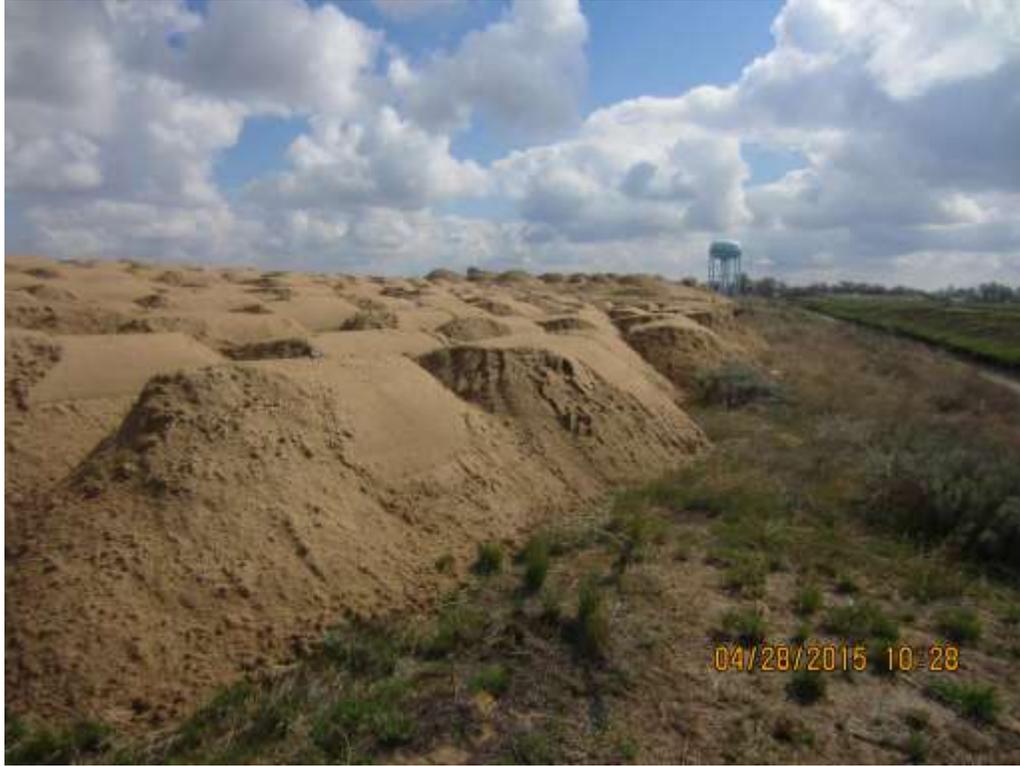
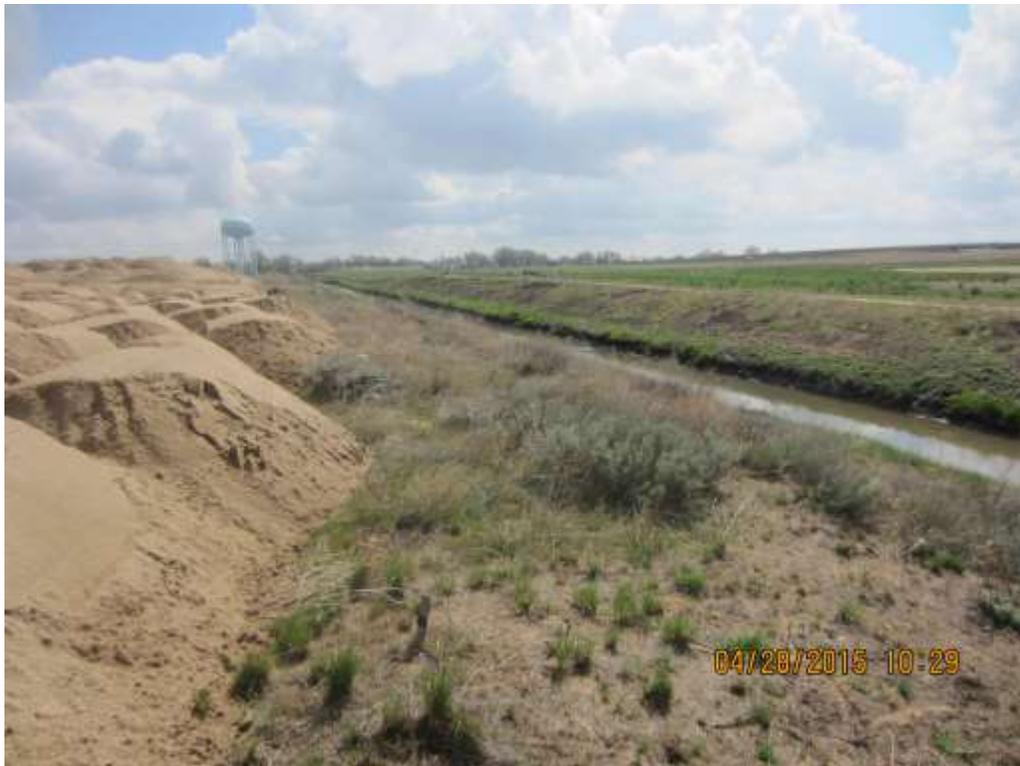
Photograph 77: Soil stockpiles without control measures, Union Ditch to the right in the photo

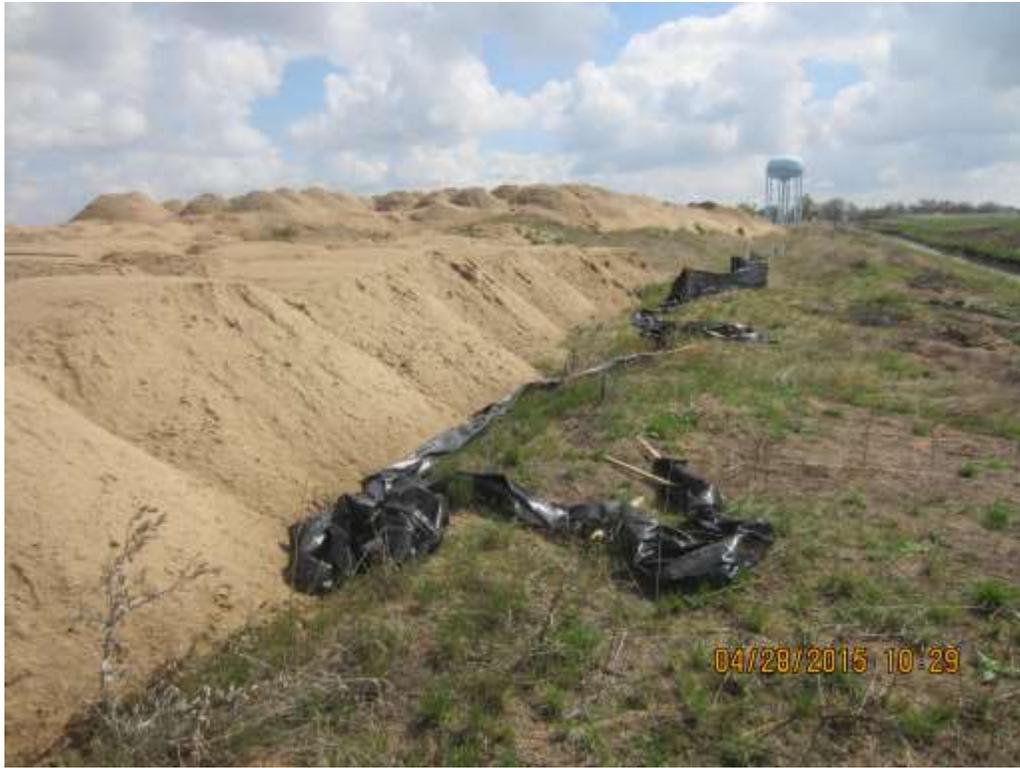
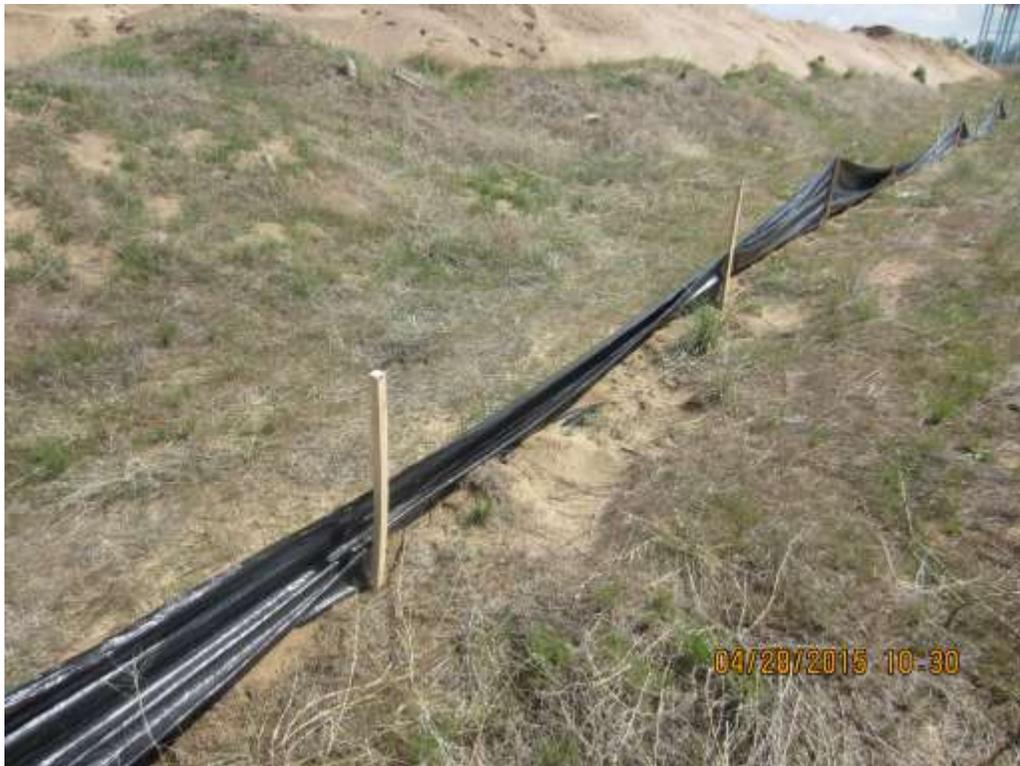
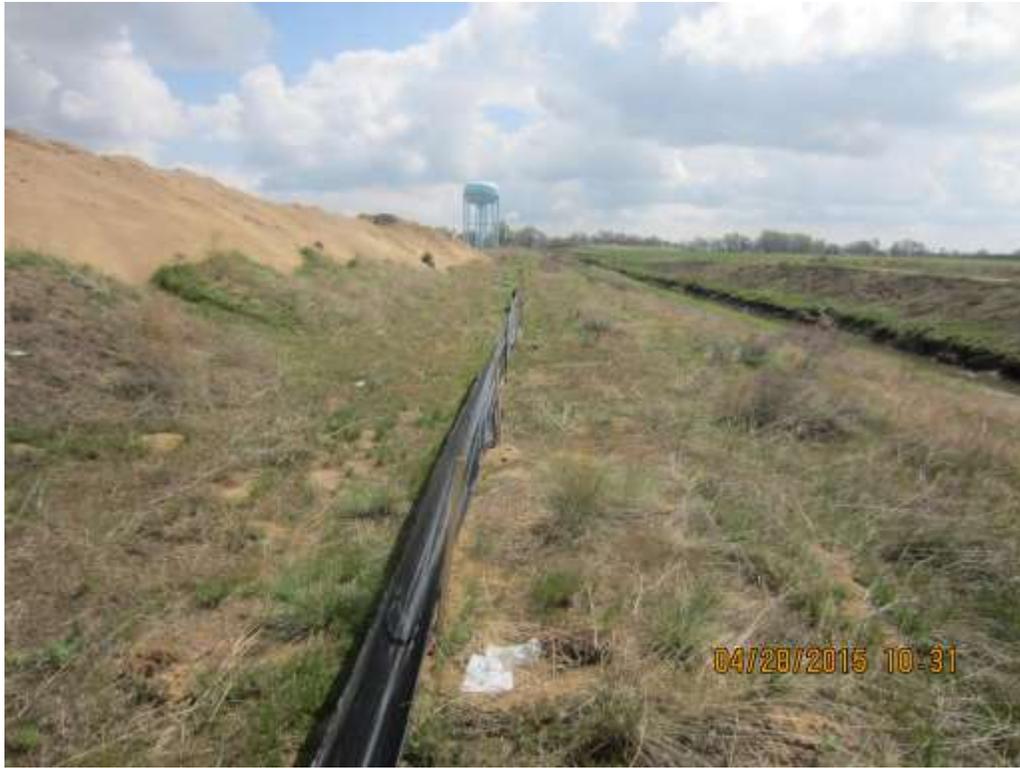
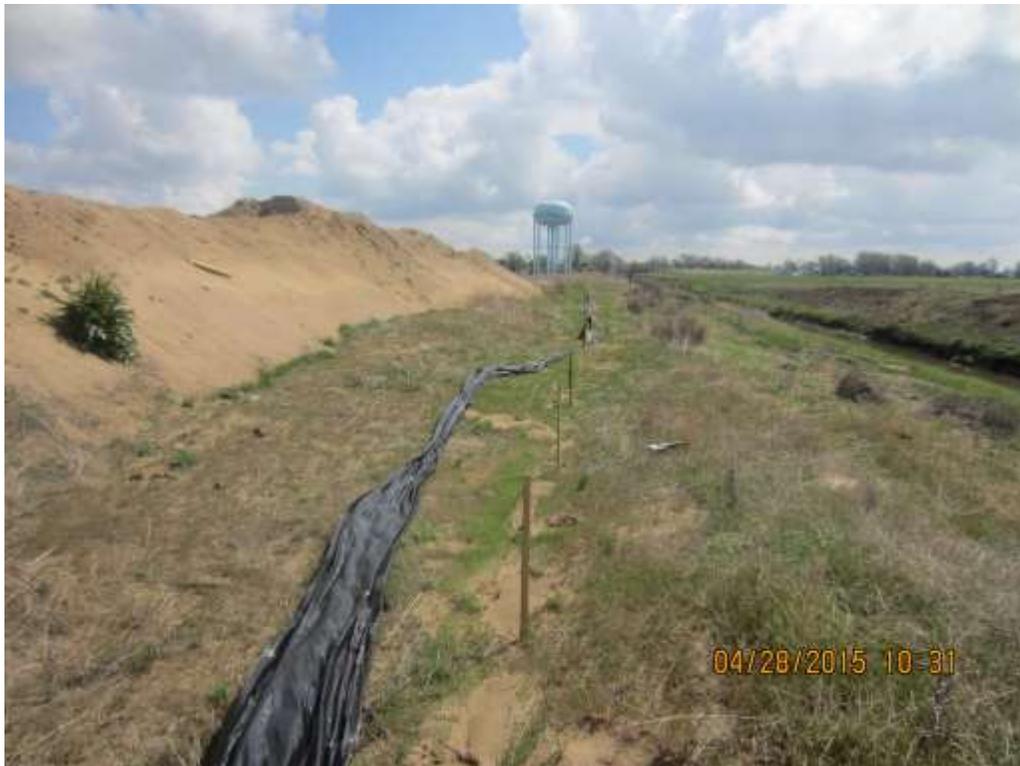
Photograph 79: Silt fence stockpile control not installed or maintained per specification

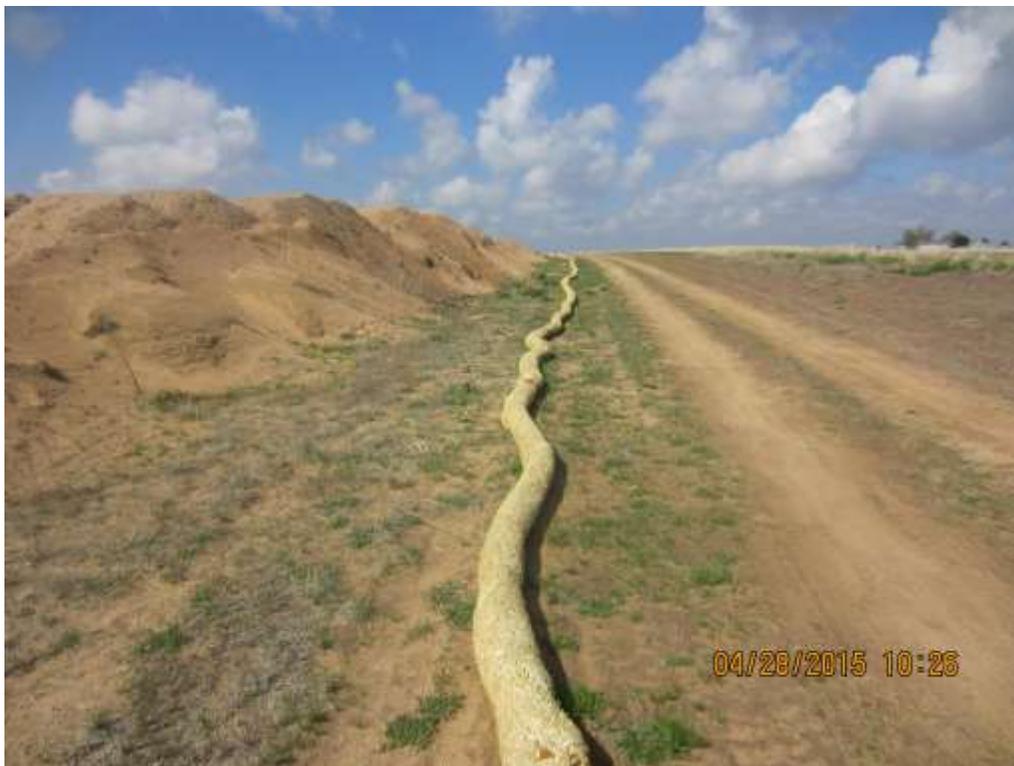
Photograph 88: Straw wattle around stockpiles, not installed or maintained per specification
