## EXPEDITED SETTLEMENT AGREEMENT

Number: ES-110524-1

## Stormwater Inspection Report

<b>Permittee:</b> Weaver General Construction Co.	<b>Cert. No.</b> COR03F048	<b>Date(s):</b> September 2, 2010
<b>Facility:</b> Edwards WWTP Solids Processing Facilities Improvements	<b>Industrial Type:</b> Construction	<b>Receiving Water:</b> Eagle River
<b>Facility Address:</b> 3101 Lake Creek Village Drive, Edwards, CO		
<b>Persons present:</b> Joshua Greene (Project Superintendent, Weaver General Construction Co.) and Randy Bruggeman (Assistant Superintendent, Weaver General Construction)		
<b>Legally Responsible Person(s)/Title(s):</b> Tom Baughman (Project Manager, Weaver General Construction)	<b>Inspector(s):</b> Matt Czahor (WQCD) and Nicole Rolfe (WQCD)

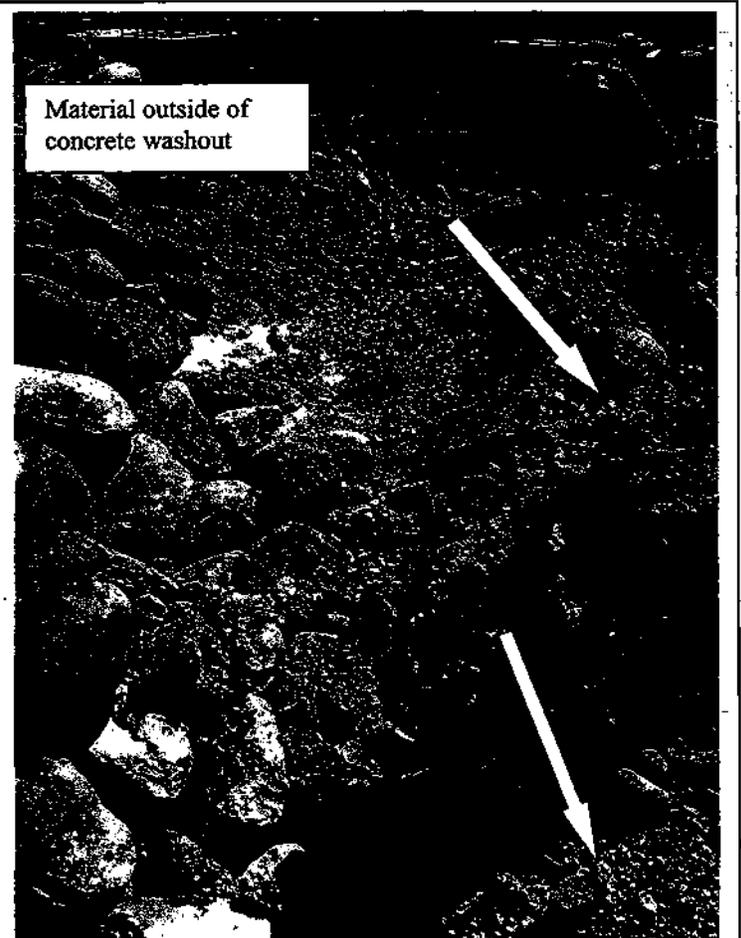
Photo 16—Concrete washout area located east of scum room

9. It was noted during the inspection that inadequate BMPs were implemented to ensure that concrete washout activities do not result in the contribution of pollutants to stormwater runoff. It was noted during the inspection that concrete washout waste was discharged to the ground east of the scum room. The SWMP did not identify installation and implementation specifications for the concrete washout. The concrete washout was not installed following good engineering, hydrologic and pollution control practices. There was evidence that concrete washout waste as discharged to the ground outside of the concrete washout area (see photo 16). As a result there was potential to contribute pollutants from the concrete washout waste to stormwater runoff that discharges to the south and east and eventually to the Eagle River. All BMPs must be implemented according to installation and implementation specifications outlined in the SWMP. All installation and implementation specifications outlined in the SWMP must follow good engineering, hydrologic and pollution control practices.

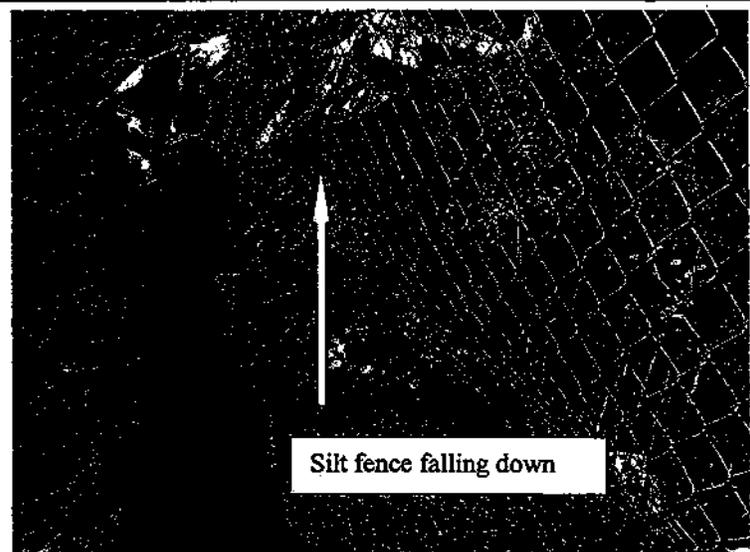
8. It was noted during the inspection that inadequate BMPs were implemented to manage stormwater runoff from the areas of disturbance located along the northeastern section of the project boundary. Silt fence was installed down gradient of this area along the northeast side of the project boundary. The silt fence was not installed according to the installation and an implementation specification outlined in the SWMP and was not maintained in good and effective operating condition. The silt fence was not trenched, material was placed on the silt fence, the silt fence was falling over, the silt fence was not installed on the contour, the silt fence was installed in an area of concentrated flow, and the silt fence was not properly joined (see photos 11, 12, 13, 14, and 15). As a result, there was potential to discharge sediment to the north and northeast to adjacent wetlands. All BMPs must be implemented according to installation and implementation specifications outlined in the SWMP, and must be inspected and maintained in good and effective operating condition.

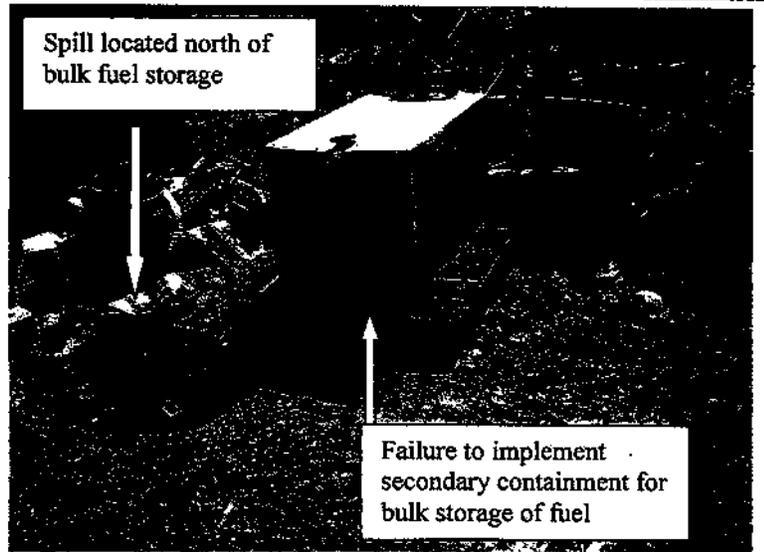
Photo 6—Area north of construction trailer

- 5. It was noted during the inspection that a spill occurred in the area north of the job trailer (see photo 5) and in the area north of the bulk storage of fuel area (see photo 6). There was potential for the spill to discharge to the south and southeast and eventually to the Eagle River. The SWMP did not identify spill response procedures. The SWMP must identify spill response procedures for all areas or procedures where potential spills can occur. All spills must be cleaned up in accordance with the spill response procedures identified in the SWMP.

- 6. It was noted during the inspection that the bulk storage of fuel did not have secondary containment (see photo 6) as required by Part I. D.1.c of the permit. The SWMP states the fuel will be stored within a secondary containment vessel of equal and/or greater capacity. A different section of the SWMP states an earthen dike will be constructed around the perimeter of the fuel storage area. However, it was noted during the inspection that the fuel was not stored in secondary containment, nor was an earthen dike was not constructed around the fuel storage area. As a result, there was potential to discharge pollutants to the south and southeast and eventually to the Eagle River. All provisions of the SWMP must be implemented. Bulk storage structures for petroleum products and any other chemicals shall have secondary containment or equivalent adequate protection so as to contain all spills and prevent any spilled material from entering State waters.
