EAGLE MINE SUPERFUND SITE EAGLE MINE NEWS

Spring 2012

CBS, ENVIRON complete pipeline work from audit

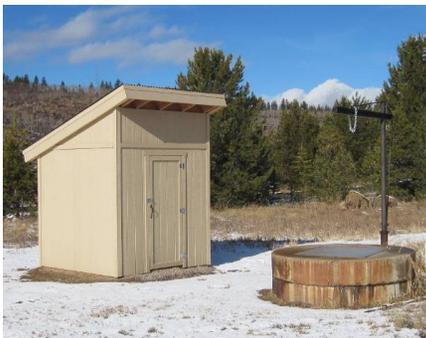
The electrical distribution equipment was enclosed in a shed.

Lockable enclosures now protect sensitive equipment such as electrical distribution systems.
