**Preliminary Report
Engineering Geology and Surface Fault Rupture Hazard Evaluation
Energy Fuels Resources Corporation
Piñon Ridge Mill Site, Montrose County, Colorado**

**PRELIMINARY REPORT
ENGINEERING GEOLOGY AND
SURFACE FAULT RUPTURE HAZARD
EVALUATION
ENERGY FUELS RESOURCES CORPORATION
PIÑON RIDGE MILL
MONTROSE COUNTY, COLORADO
KLEINFELDER PROJECT NO. 83088**

April 4, 2008

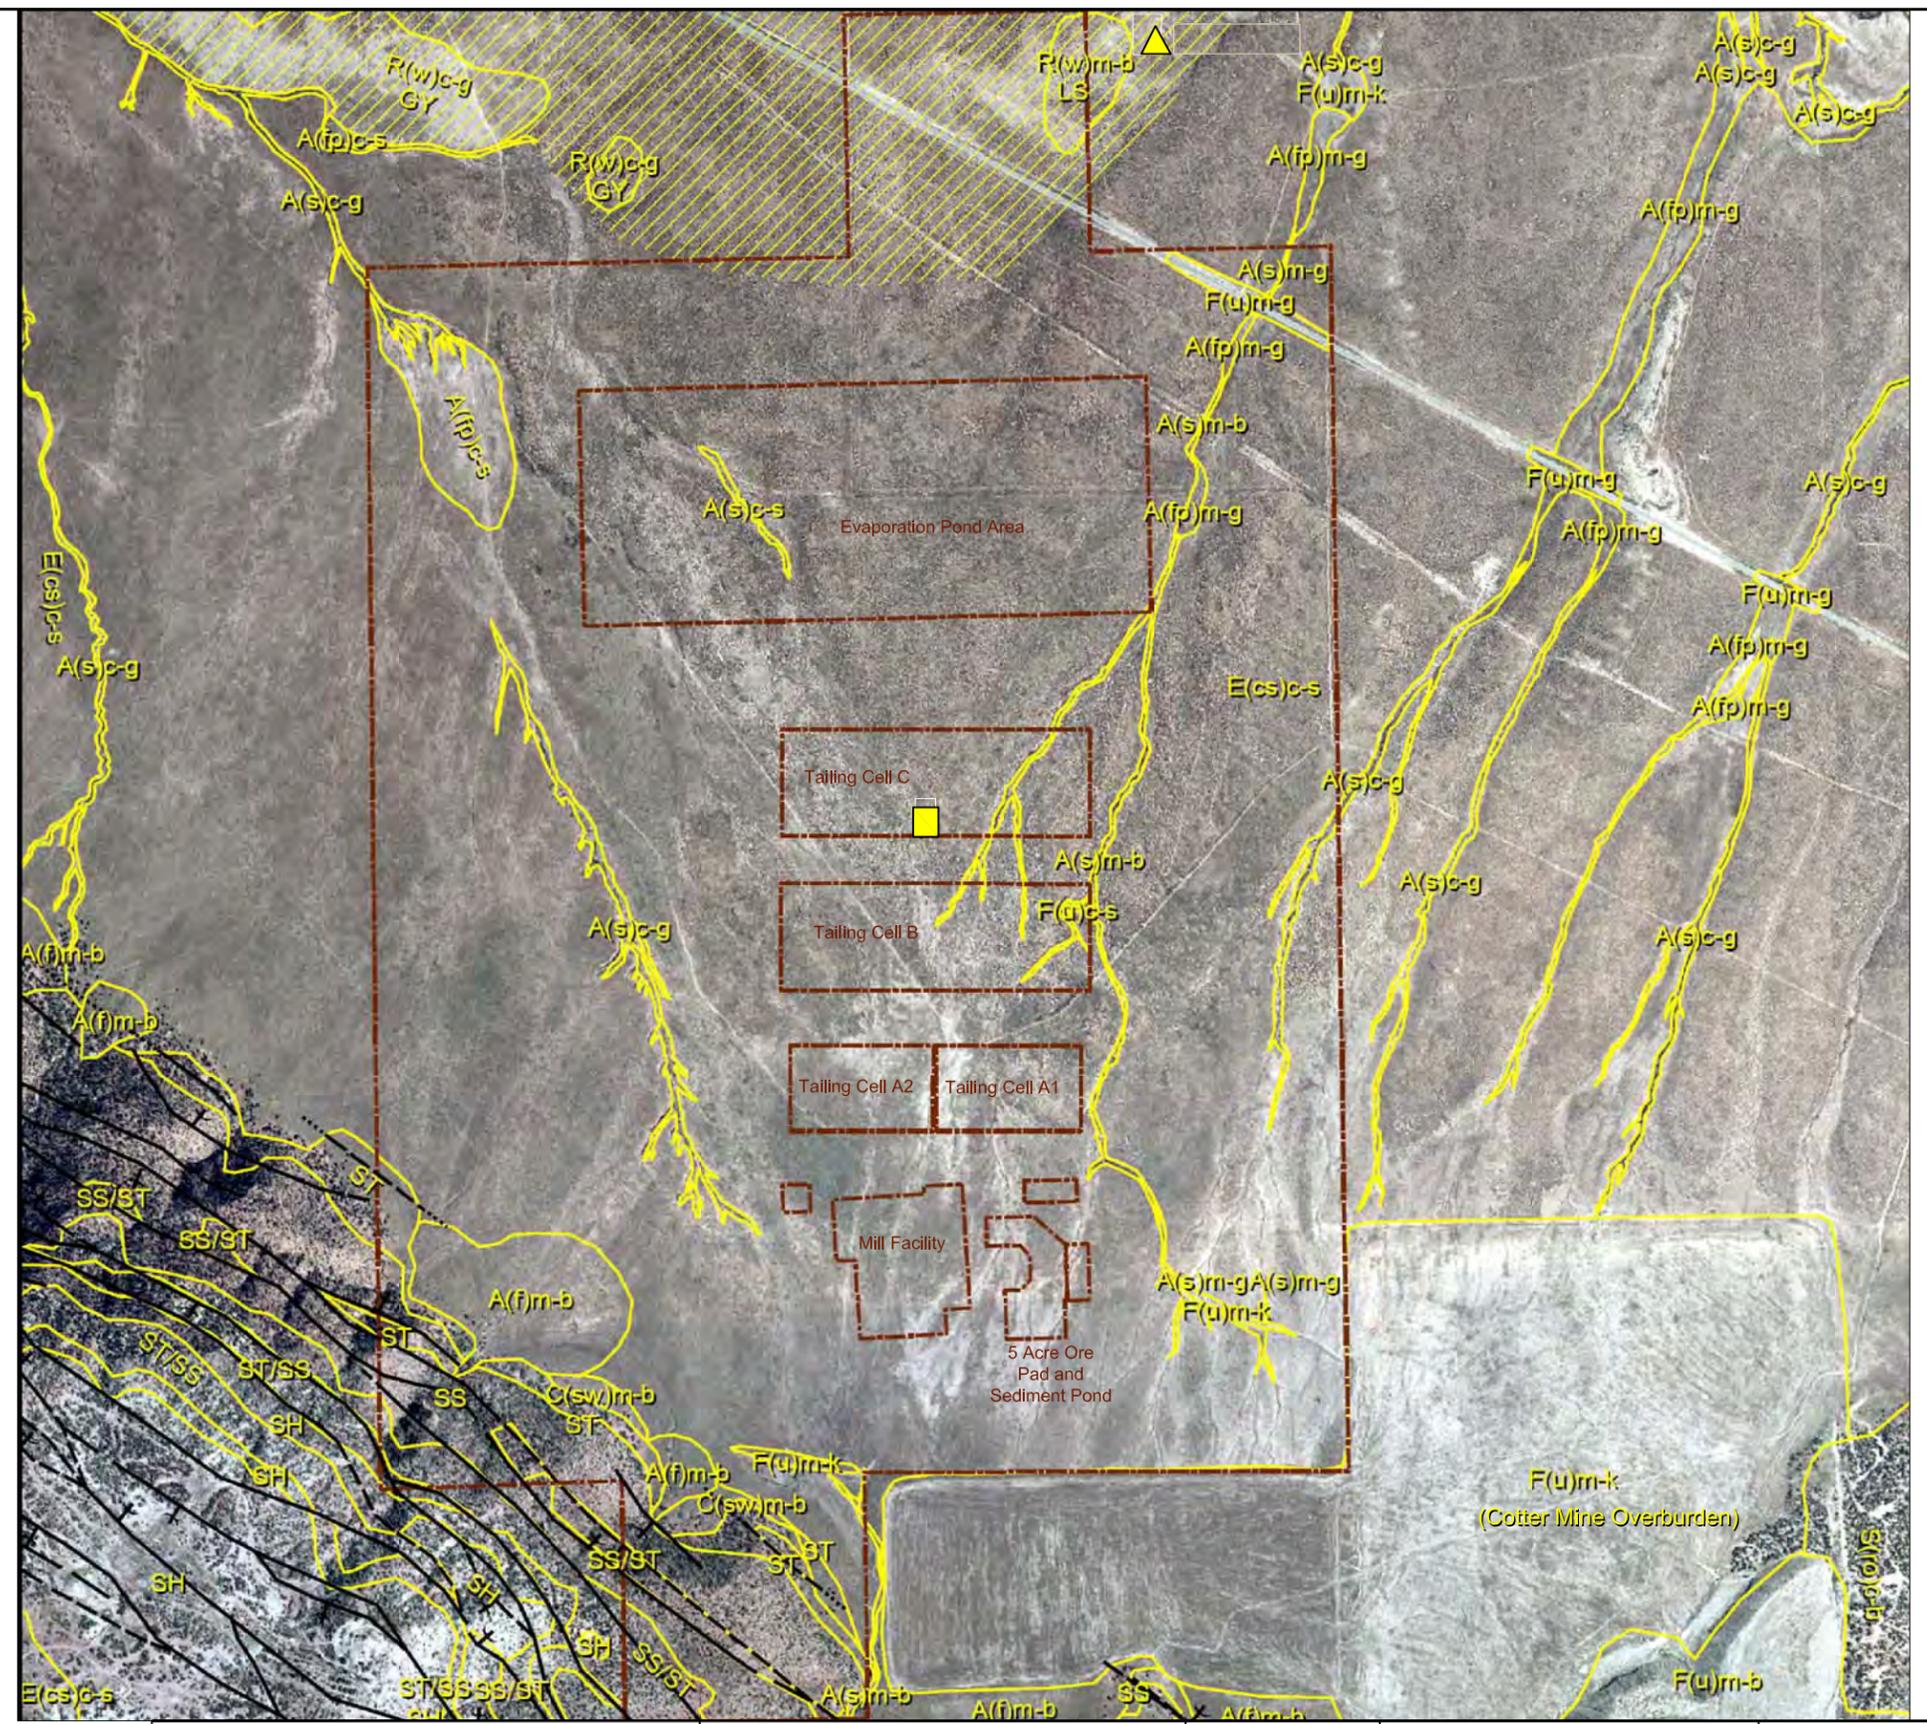
Several areas of active gully erosion were observed and are presented in Figure 2 as alluvial stream deposits, including A(s)c-s, A(s)c-g, A(s)m-g and A(s)m-b. The gullies were in many cases more than 10 feet in depth and showed indications of active erosion processes including active sediment deposition in stream beds and bank failures due to erosion and undercutting.

Clear-water flood hazards may result from the small drainages on the southwest corner of the Site, where the alluvial fan deposits, A(f)m-b are present, as shown in Figure 2. However because these are small head water streams, it is unlikely the long sustained periods of flooding will occur in these streams.

Alluvial fan deposits (A(f)m-b) on the very southwest corner of the Site indicate past debris flow deposition as the stream drain from Davis Mesa. They are localized and are characterized by relatively small areally extensive headwaters. Engineering controls are readily available to mitigate any potential damage caused by debris flows and flooding associated with the alluvial fan deposits.

Several active gullies were observed on Site. If uncontrolled, future head-cutting of the gullies could impact the proposed facilities.

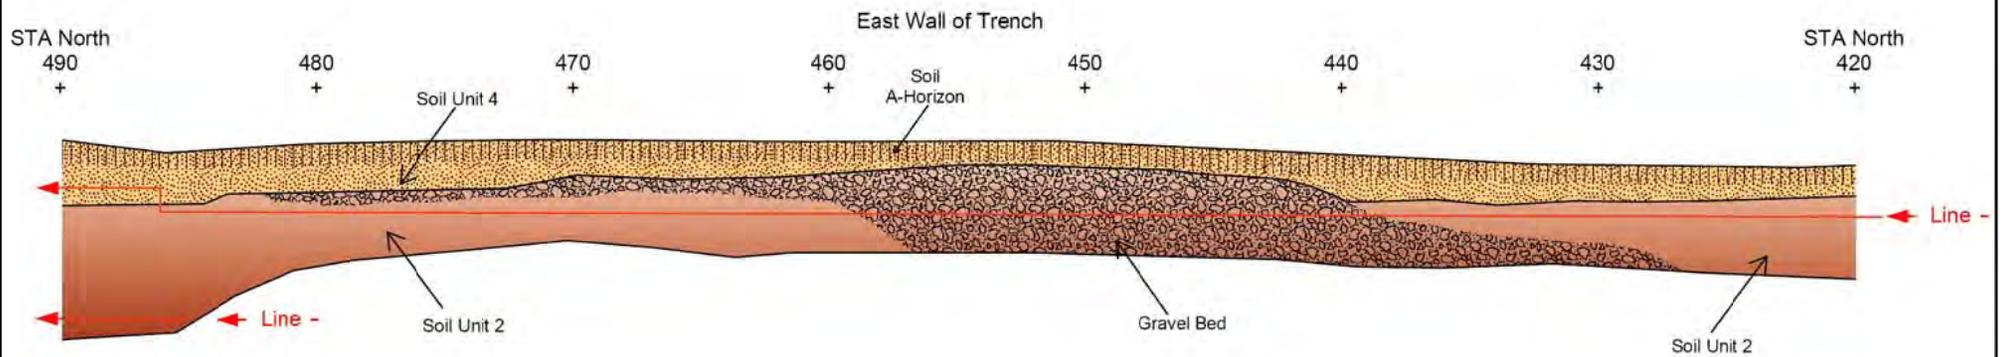
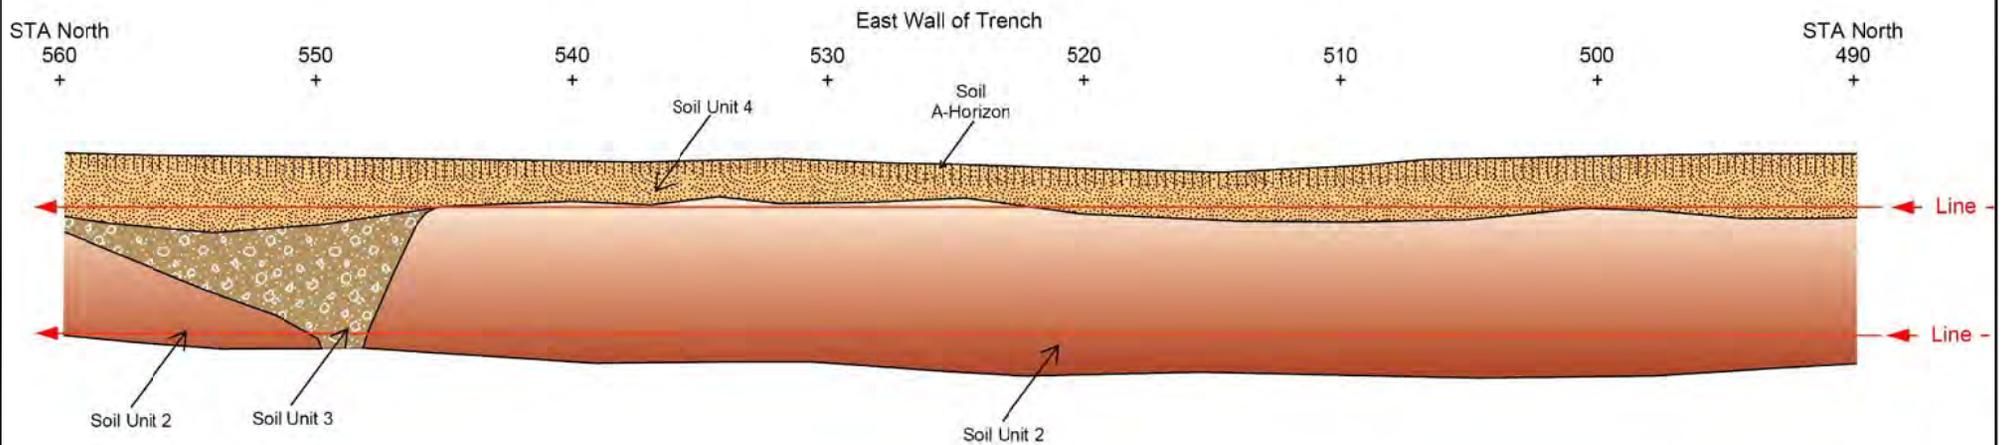
APPROVED BY:	AK
DRAWN BY:	PD
CHECKED BY:	RM
DATE:	FEB 2009
SCALE:	NOT TO SCALE
FIGURE	18

Soil Unit 3: Silty fine sand, brown, with traces of angular gravel and broken carbonate soil aggregates; dry, medium-dense, massive colluvial collapse deposit. Surface of Soil Unit 3 is unconformably overlain by Soil Unit 4. Observed in Trench 2 only at a maximum thickness of 5 feet. In the north end of Trench 2, Soil Unit 3, displayed what appears to be a slump or subsidence feature. This is depicted in Figure 18.

Because a soil discontinuity, possibly indicative of sinkhole infilling (undetectable at the surface), was observed in Trench 2, geophysical surveys and additional trenching to evaluate the presence or absence of potentially karst-sinkhole processes beneath the proposed facilities should be conducted prior to final site selection.
