**Capital Development Committee**  
State Capitol Building, Room 029  
Denver, Colorado 80203-1784  
(303) 866-3521

September 6, 2012

**OFFICE OF THE STATE ARCHITECT ANNUAL REPORT  
STATEWIDE PRIORITIZED CONTROLLED MAINTENANCE  
PROJECT REQUEST DESCRIPTIONS FOR FY2012/2013**

December 2011

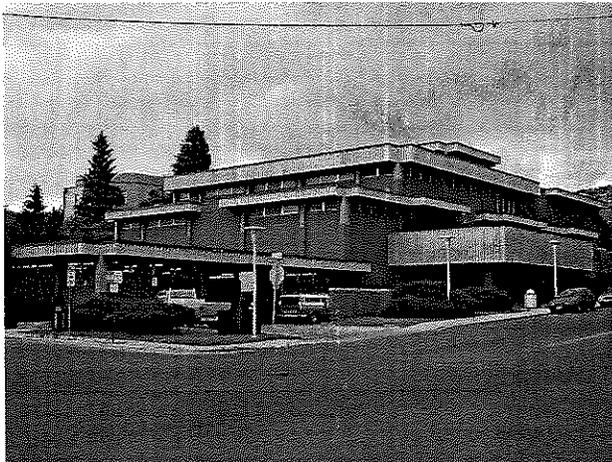
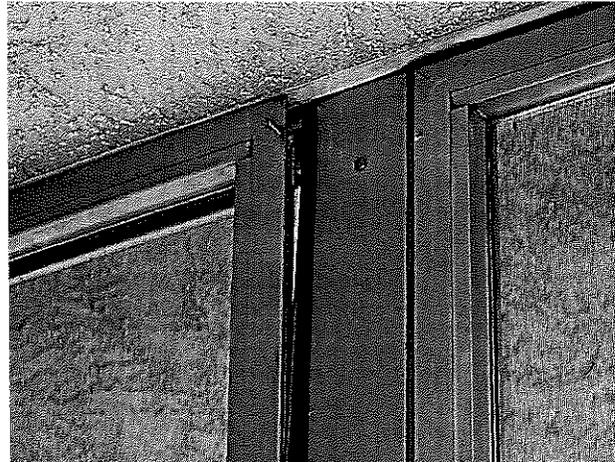
**Banta Building, Critical Air Quality Improvements and Replace the Windows and Boilers, Ph 2 of 2**

The boilers and windows in the Banta building (RM #200) are original equipment dating back to the mid 1960's. The air quality in this building is a critical problem since the auto and welding shops return air system are connected to the supply air system for the office and classroom spaces. Therefore, the classrooms and office smell of diesel and welding fumes. The windows are old and failing and replacing them will increase the energy efficiency of the building and improve comfort. The ADA access to the third floor is through the building trades shop which is a major hazard. There is space in the main entrance for a small ADA compliant elevator. Phase 1 of this project designed and replaced the boiler and upgraded the duct system. Phase 2 will replace the windows and install the new elevator.

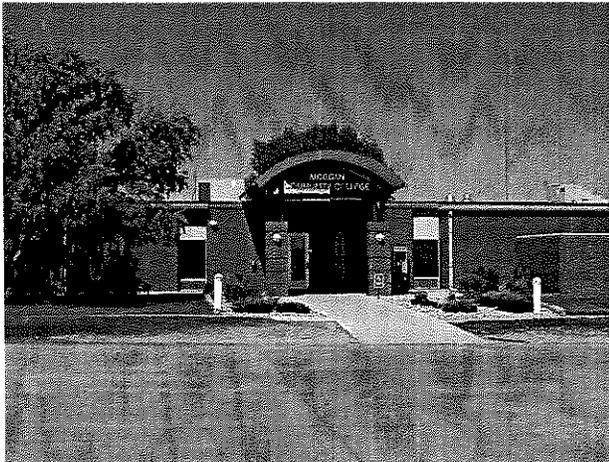
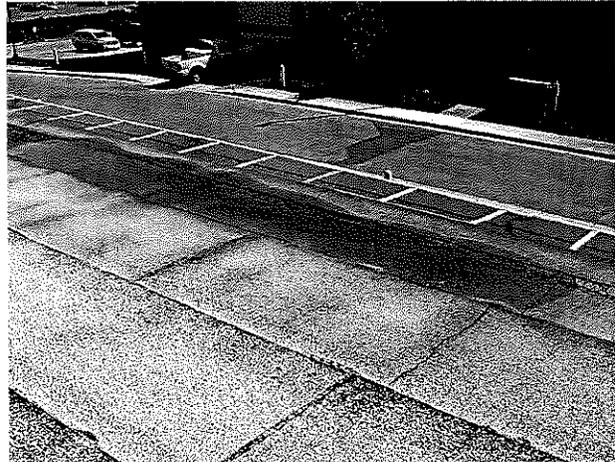
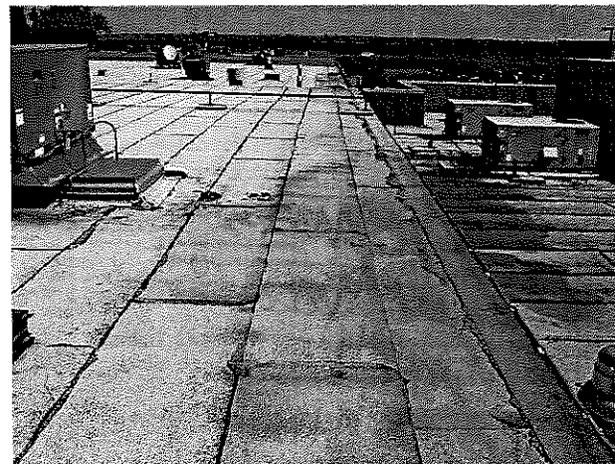
**Roof Repairs, Main Campus, Ph 1 of 1**

The Cottonwood (RM #739), Aspen (RM #740), and Spruce (RM #741) Halls are joined and the roofs on the buildings are 29 years and 23 years old respectively. The roofs have shown continual deterioration, including bubbling, and have been repeatedly patched as needed through the years. Because of the heavy rain and hailstorms during the summer of 2009, the protective gravel has been washed off and shortened the life of the roofs. The roofs are at the end of their life cycle and need to be replaced.

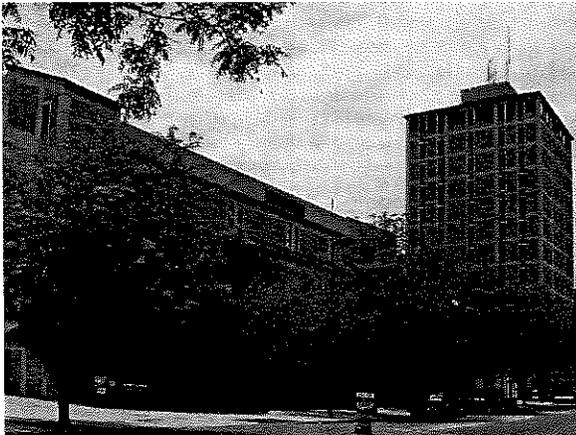
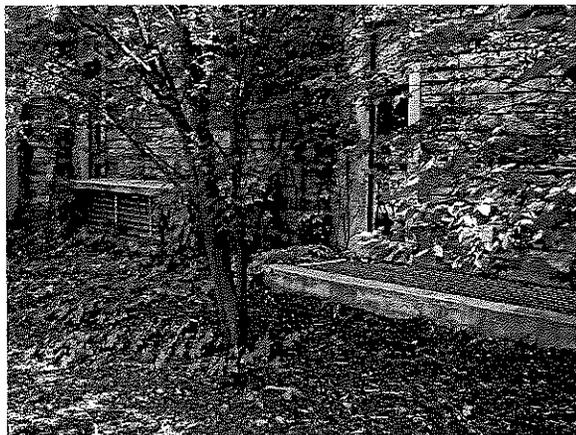
**Roof Repair/Replacement and Waterproofing, Ph 1 of 2**

Phase 1 Duane (UCB #359) (pictured) requires waterproofing of building exterior at underground classrooms and labs. These areas have leaked for years. The concrete underground roof deck over the classrooms is showing signs of deterioration and needs to be repaired requiring extensive excavation of the site. Water is being collected in drip pans, which hang from the ceiling. Phase 2 includes repairing/replacing roofs and waterproofing at Macky Auditorium (UCB #243), Center for Astrophysics and Science Astronomy (UCB #553), and Dennison Arts and Sciences (UCB #207).

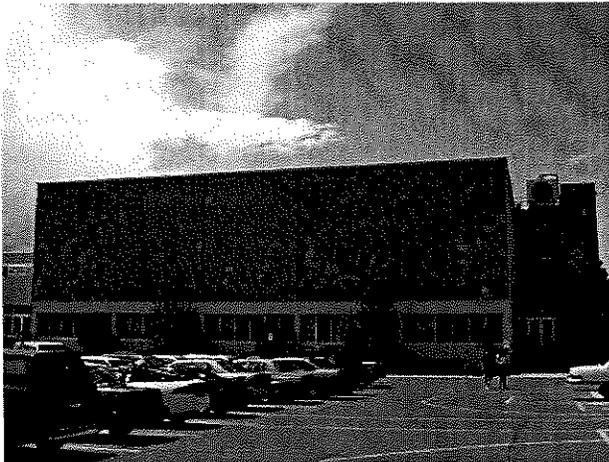
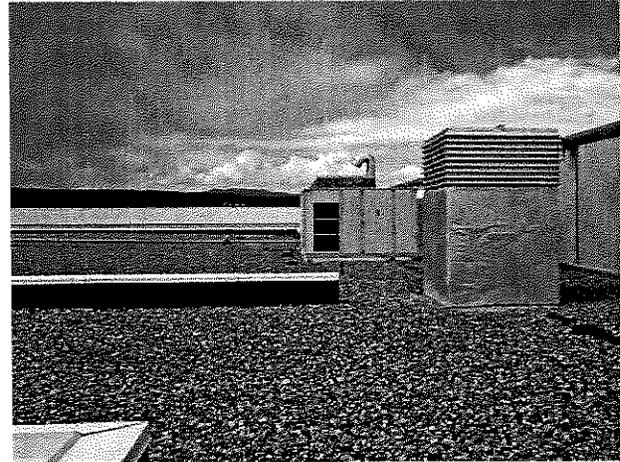
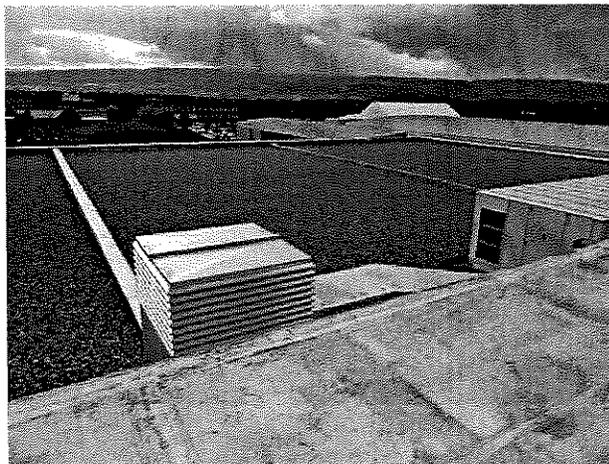
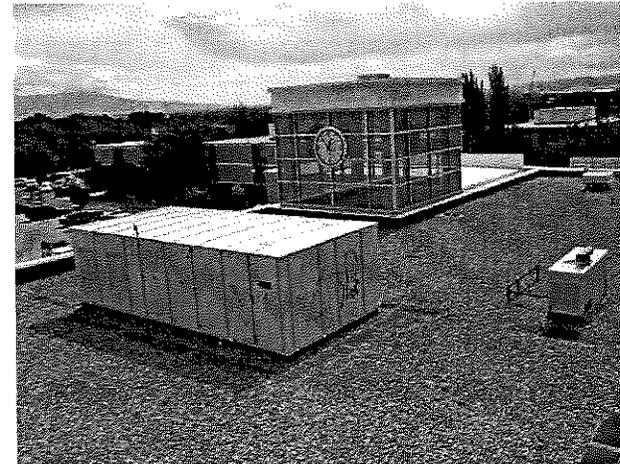
**Repair Roof, Saunders Multi-Use Facility, Ph 1 of 1**

The roof(s) over Saunders Multi-Use building (RM #0215) vary in age with the oldest roof installed in 1981 (30 year life) and the newer roof 15 years later in 1996 (15 year life). Both roofs are ballasted membrane roofs. The majority of leaks occur around roof penetrations and adjacent to the parapet walls along the exterior of both roofs. The old roofing material has continued to crack and has been patched many different times to try to extend the roof's life expectancy. Colorado Mesa experienced two significant rainstorms in July 2011, both of which caused extensive damage to the NW stair tower and a significant portion of the upper floor of the new addition that connects into stair tower and the locker rooms below. The impacts of not funding this project range from having to reschedule a basketball or volleyball game to moving gym classes to another facility.

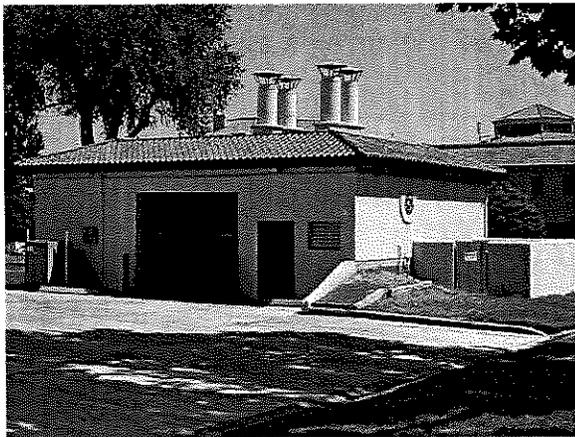
**Repair Steam/Power/Communication Tunnel at San Juan Building, Pueblo Campus, Ph 1 of 1**

The underground chase/tunnel system between the San Juan Building (RM #65) and the Boiler House (RM #73) at Pueblo Community College is in very poor condition. Approximately 60 feet of the 200 feet tunnel is non-accessible due to asbestos contamination. The piping hangers used for support are failing and placing excess stress on the main hot water boiler feed to the southern portion of the campus. The condition of approximately 120 feet of the south chase was verified as experiencing extreme corrosion in October of 2008 when another portion of the northern chase piping failed. Emergency funding under EM423 was required to make immediate repairs. Additionally, portions of the remaining south chase reviewed in May of 2009 showed extreme corrosion of supporting ladders within the chase. Other various infrastructure systems run in the same chase including potable water, power, phone, and fiber systems. Failure of any one of the systems located within the chase area will result in catastrophic loss throughout the campus. This CM request is to clean and refurbish or seal and replace the 200 feet of chase between the San Juan Building and Boiler House and install new support devices for infrastructure items within the area. Boiler House pictured.

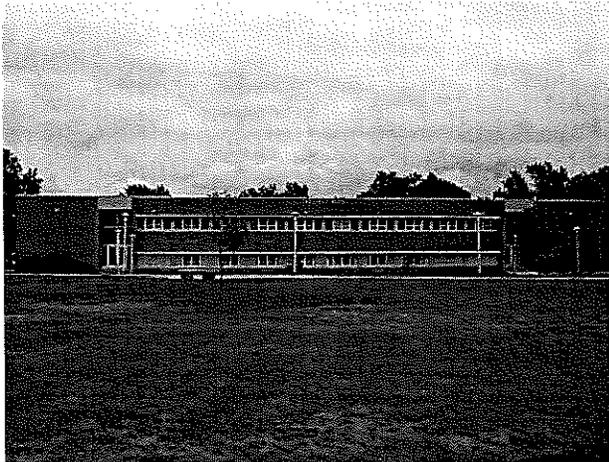
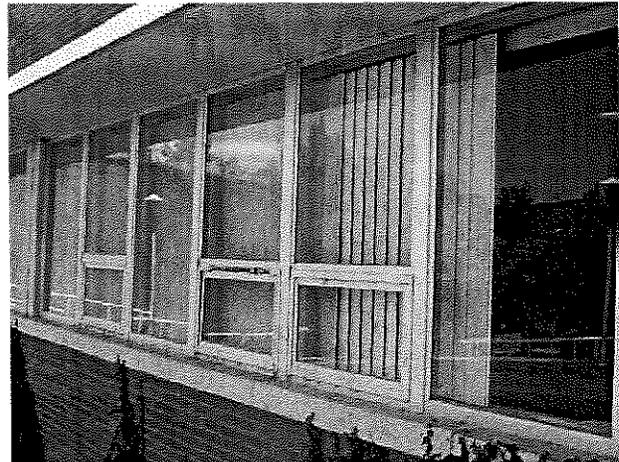
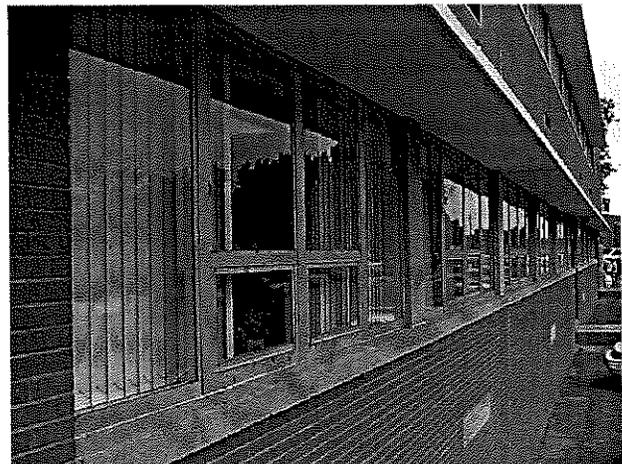
**Window Replacement and Exterior Wall Repair, Bowman/Trustees Buildings, Ph 1 of 1**

Windows in both Bowman (RM #2773) and in the Trustees Buildings (RM #1774) are original. The caulking and sealing components of the frames and windows have deteriorated and are now leaking outside air into the classrooms. In some weather conditions, the areas next to the windows are so uncomfortable that all the students sit next to the inside walls. The extreme hot/cold weather has been very disruptive to teaching in the classrooms. The glazing is single pane with no insulation capacity. Upgrading glazed areas to double glazed, low E type glass will not only protect against heat loss but will also cut down on solar gain loads in the summer thereby reducing utility costs. Through a controlled maintenance project, the HVAC system is being repair/replaced. The upgraded HVAC system was designed based upon the replacement of the windows. This project will replace the windows in the Bowman and in the Trustees Buildings (pictured).

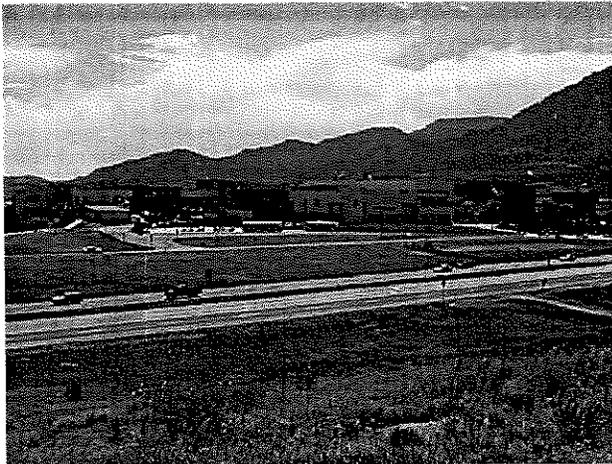
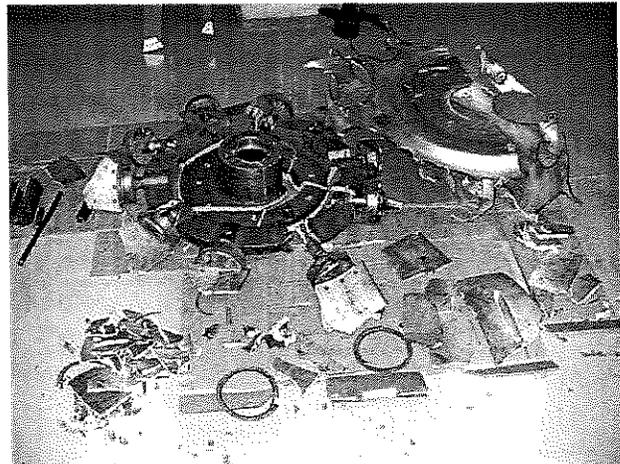
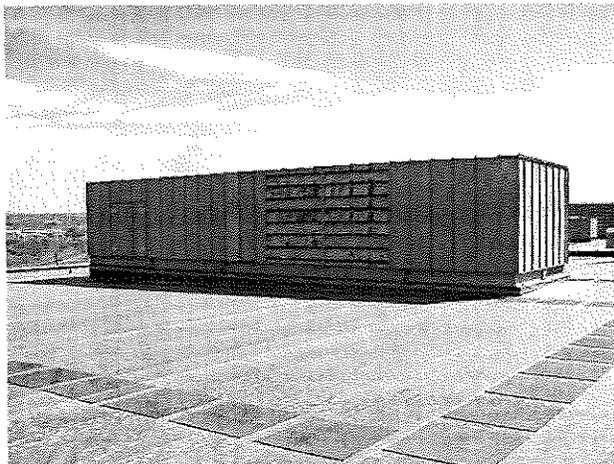
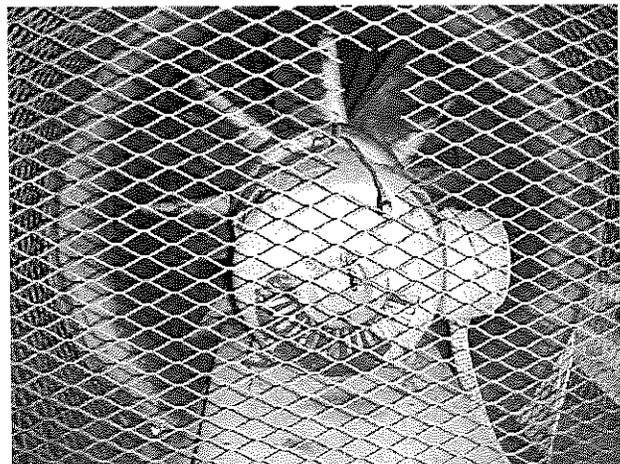
**HVAC Rooftop AHU's and Control System Replacement, Aspen and Breckenridge Buildings, Centennial Campus, Ph 2 of 3**

The air-handling units (AHU's) for the Aspen (RM #57) and Breckenridge (RM #58) buildings are over 30 years old and are the original units. There are currently 19 units with four large and six small units on the Aspen Building and one large and eight small units on the Breckenridge Building. These units are at least five years past the manufacturer's recommended life cycle. Repair parts are becoming difficult to locate when the units fail. The fans are dangerous for college personnel to work on. The school has put additional safety conditions in place when personnel perform maintenance on the equipment. The pneumatic control system was installed in 1993, is not energy efficient, and needs to be converted to a DDC system. This request is for a three-phase project with engineering and some of the Aspen Building's AHU's and control system being replaced in Phase 1 (funded). Phase 2 will consist of the balance of AHU's for Aspen Building as well as some of the Breckenridge Building AHU's. Phase 3 would complete the installation of AHU's for the Breckenridge Building and the control system. The estimate includes crane service to remove and place units, labor, adapter curbs for the new units, chilled and hot water piping modifications as well as electrical modifications.

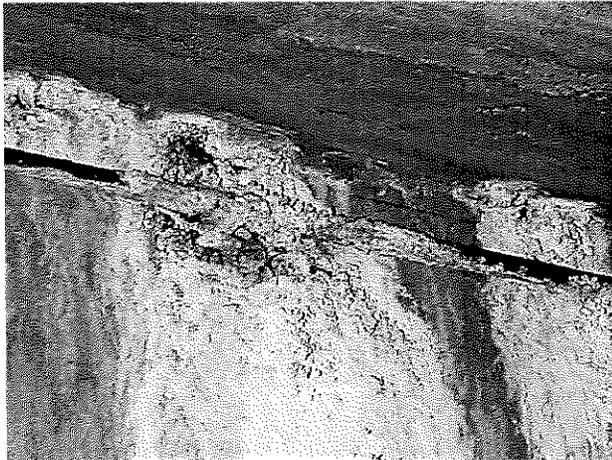
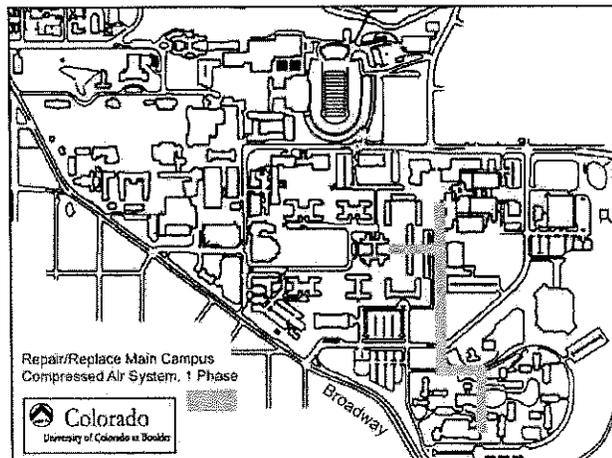
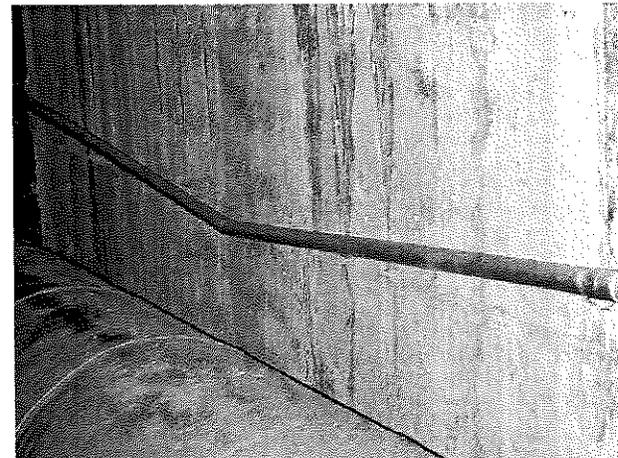
**Repair/Replace Main Campus Compressed Air System, Ph 1 of 1**

Compressed air supply piping is old and deteriorated, improperly sized and has many leaks. It is subject to failure at any time. Parts of this piping system contains old copper-coated steel pipe; this pipe is a legacy from World War II when solid copper pipe was not available. The solution is to replace existing piping with larger copper piping and valves and drainage devices, and to install supplementary air compressors to the Power House in the east part of the main campus. A previous CM project, M07012, funded the replacement of piping from the Power House in tunnel #'s 1N, 1S, 5 and 6. This new request will install the compressor and the associated power and cooling equipment, controls, and replaces the remaining tunnel piping in tunnels 7 and 8.

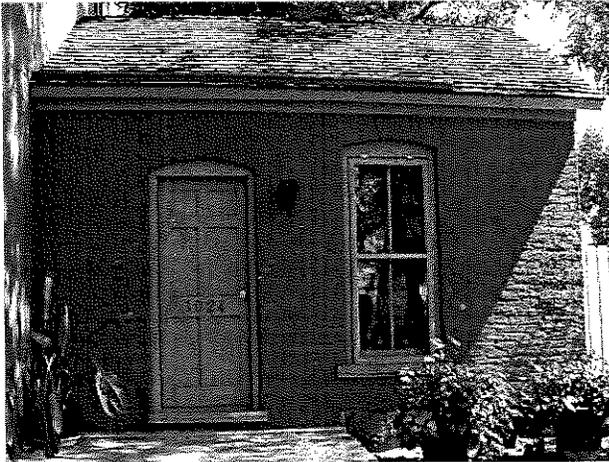
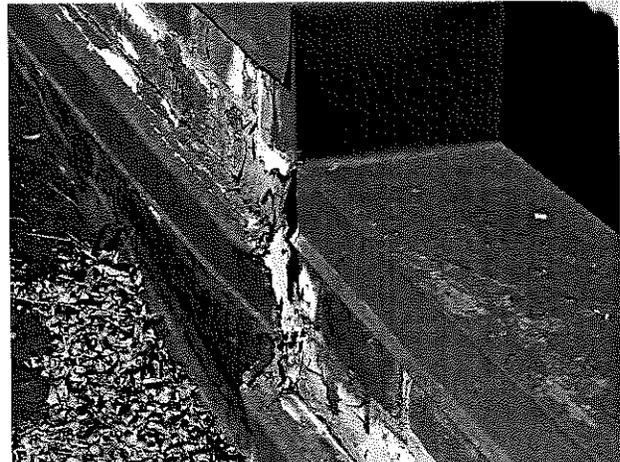
**Campus Roofing, Access Ladder Repairs and Replacement, Ph 1 of 1**

Several buildings (Arts, North Chiller Plant, Technology, Children's College) have roof ladders and similar access equipment that do not meet building safety standards. The Utility Building (RM #8180) and several of the Ninth Street Historical Park office buildings 1024 (RM #1224), 1041 (RM #1227), and 1045/74 (RM #1228) have roofs that have deteriorated, are leaking into the structure and causing structural and interior damage. Two of the roofs are beginning to exhibit sagging. This single-phase project would repair and replace the roof ladders and roof replacements noted above. Buildings 1024 and 1041 pictured.
