Memorandum - Results of Additional Trenching May 27 to May 29, 2008

Subject: Results of Additional Trenching May 27 to May 29, 2008

Regarding results of the additional trenching at the Piñon Mill Site.

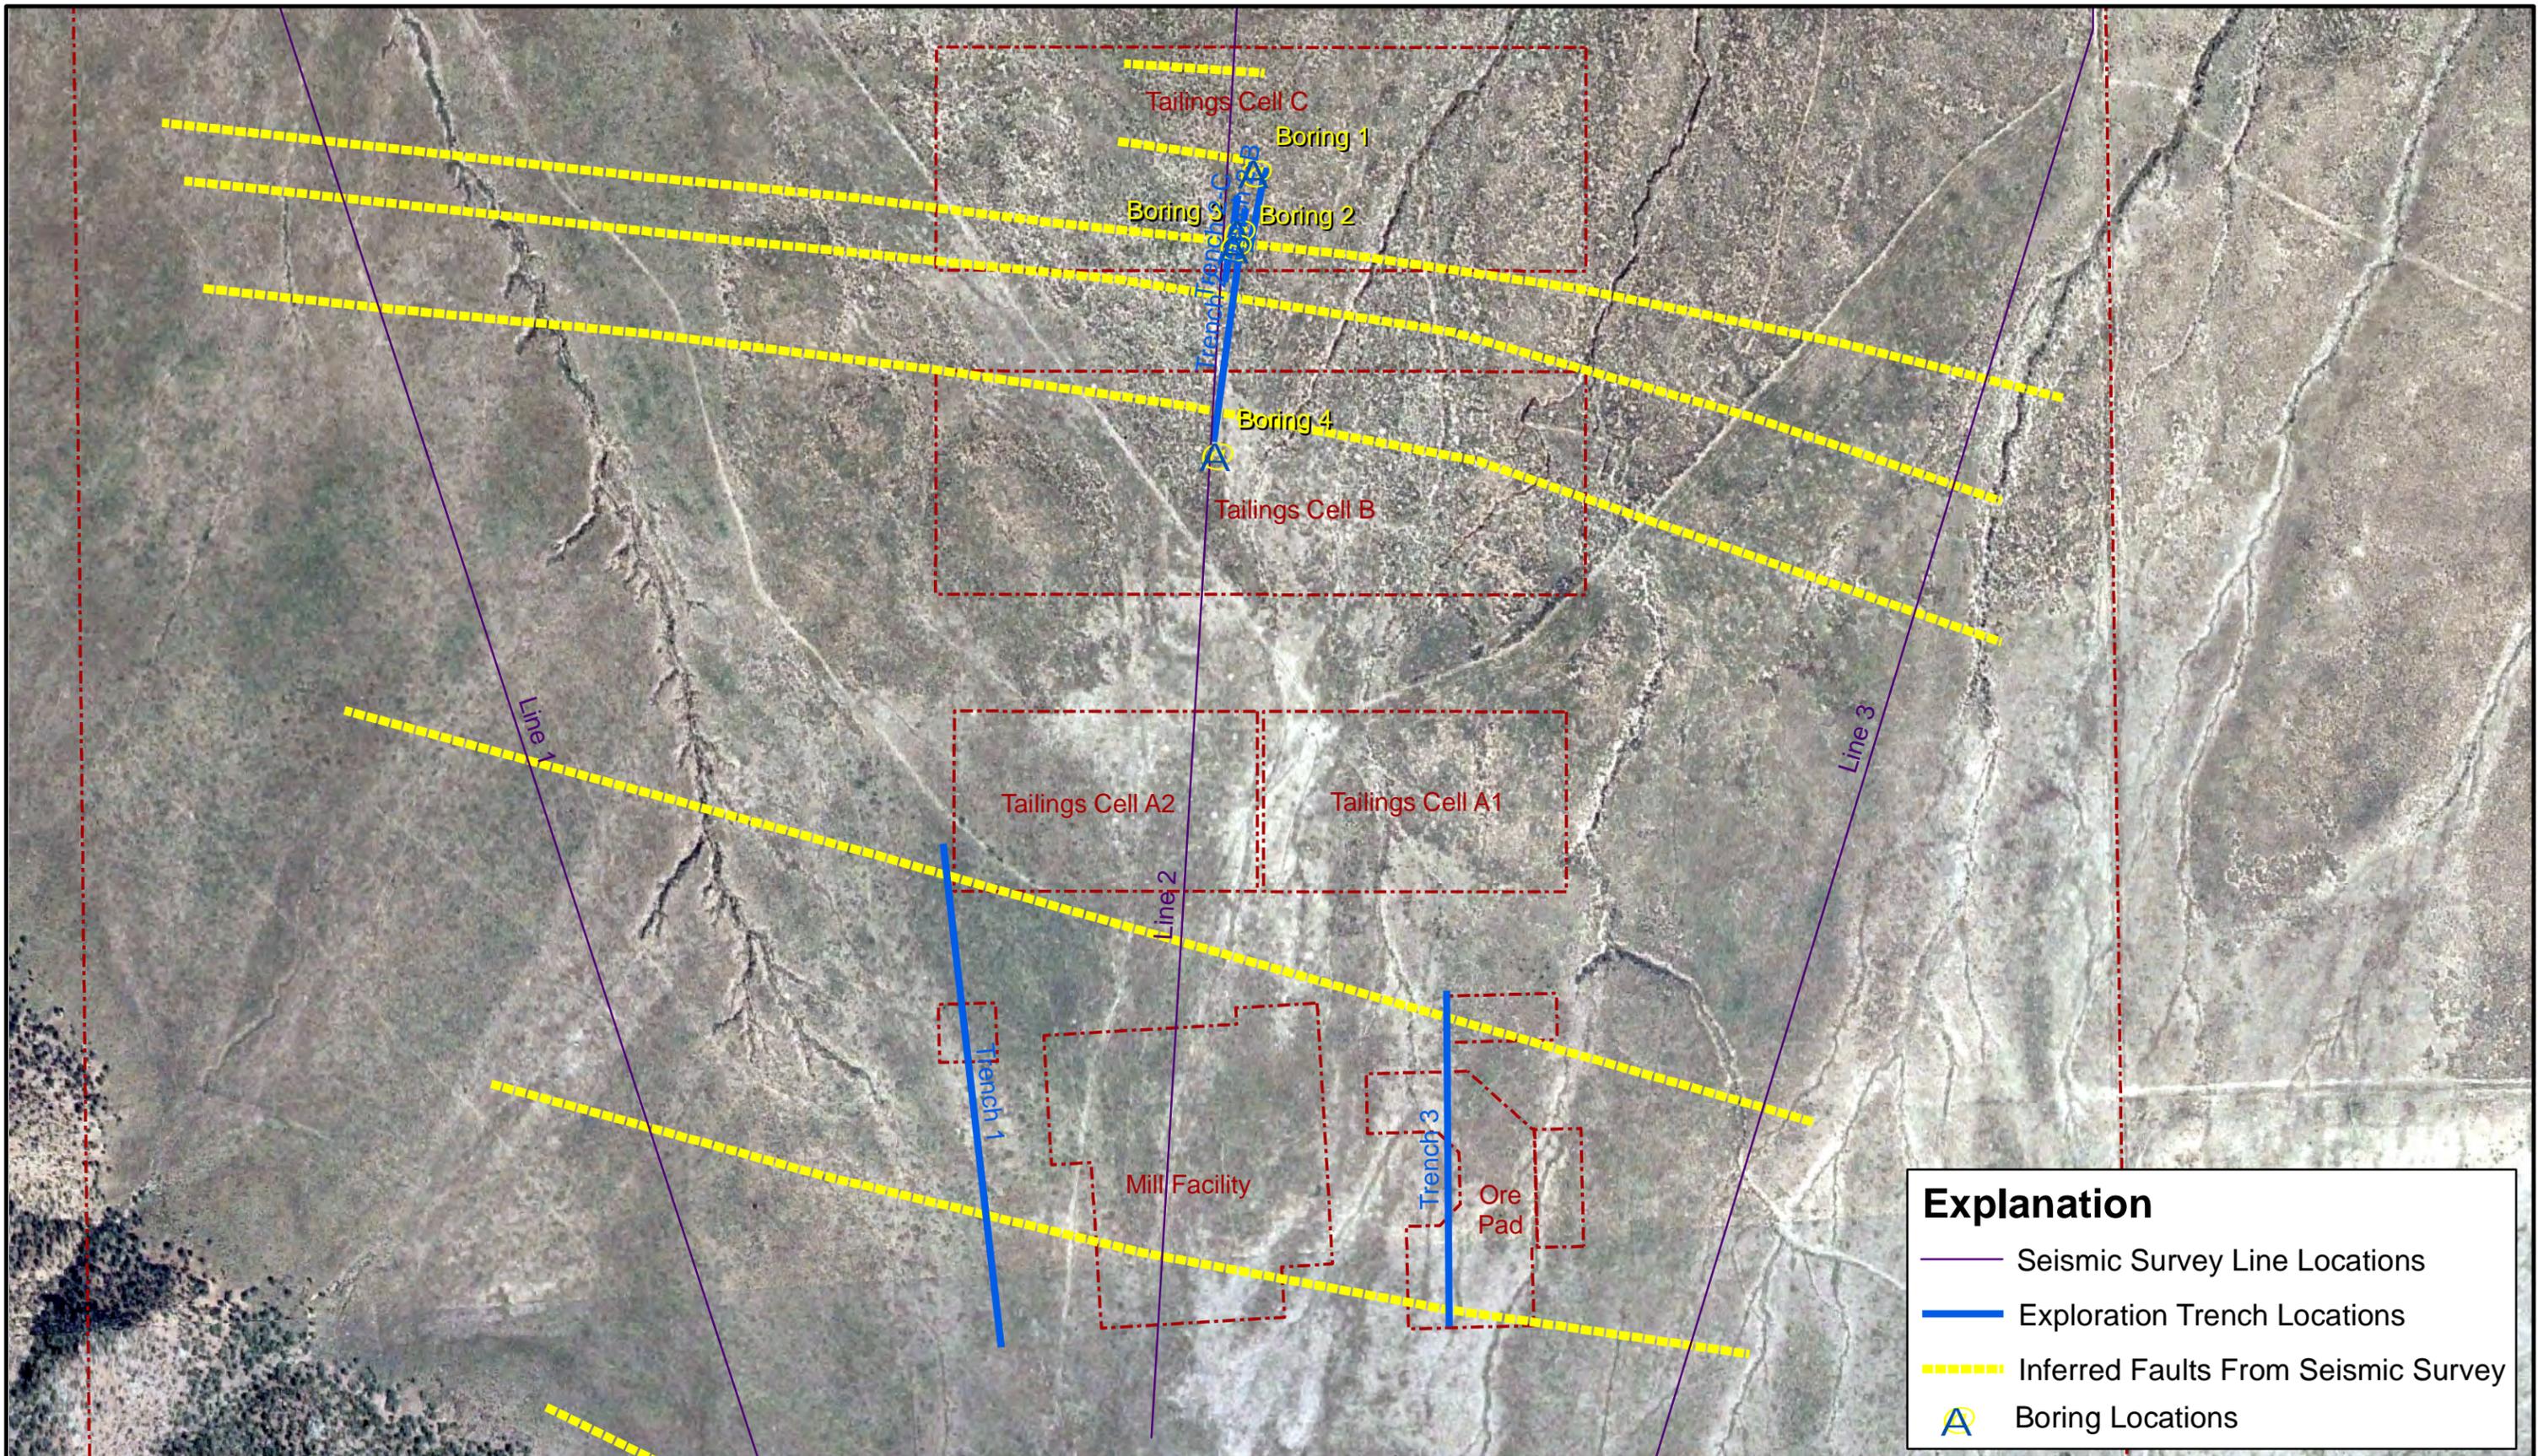
FIGURE
1

Our exploration trenches were constructed on the site as shown on attached Figure 1. The trenches were constructed generally north to south on the east and west side of Trench 2 which was constructed and backfilled during our December 2007 field program. The trenches were constructed to the east and west of Station 545-feet North and Station 560-feet North of Trench 2 where we observed an apparent soil subsidence during our December 2007 field program. The additional trenches are labeled Trench 2-B and Trench 2-C on Figure 1. The purpose of the additional trenches were to evaluate the lateral extent of the possible soil subsidence feature along the axis of the inferred faults interpreted at depth from seismic refraction and reflection surveys previously conducted on the site, and to further investigate the origin or genesis of the apparent subsidence feature.

Seismic Survey Line, Exploration Trench Locations and Geologic Boring Locations Piñon Ridge Mill Site, Montrose County, Colorado		
Originator: G. Schlenker	Drawn By: G.Schlenker	Date: February 2009
Checked By:	Project No: 83088	Drawing No: 83088_1.4.1-TBA
Approved By:	Scale: 1" = 400'	Drawing Category: TBA

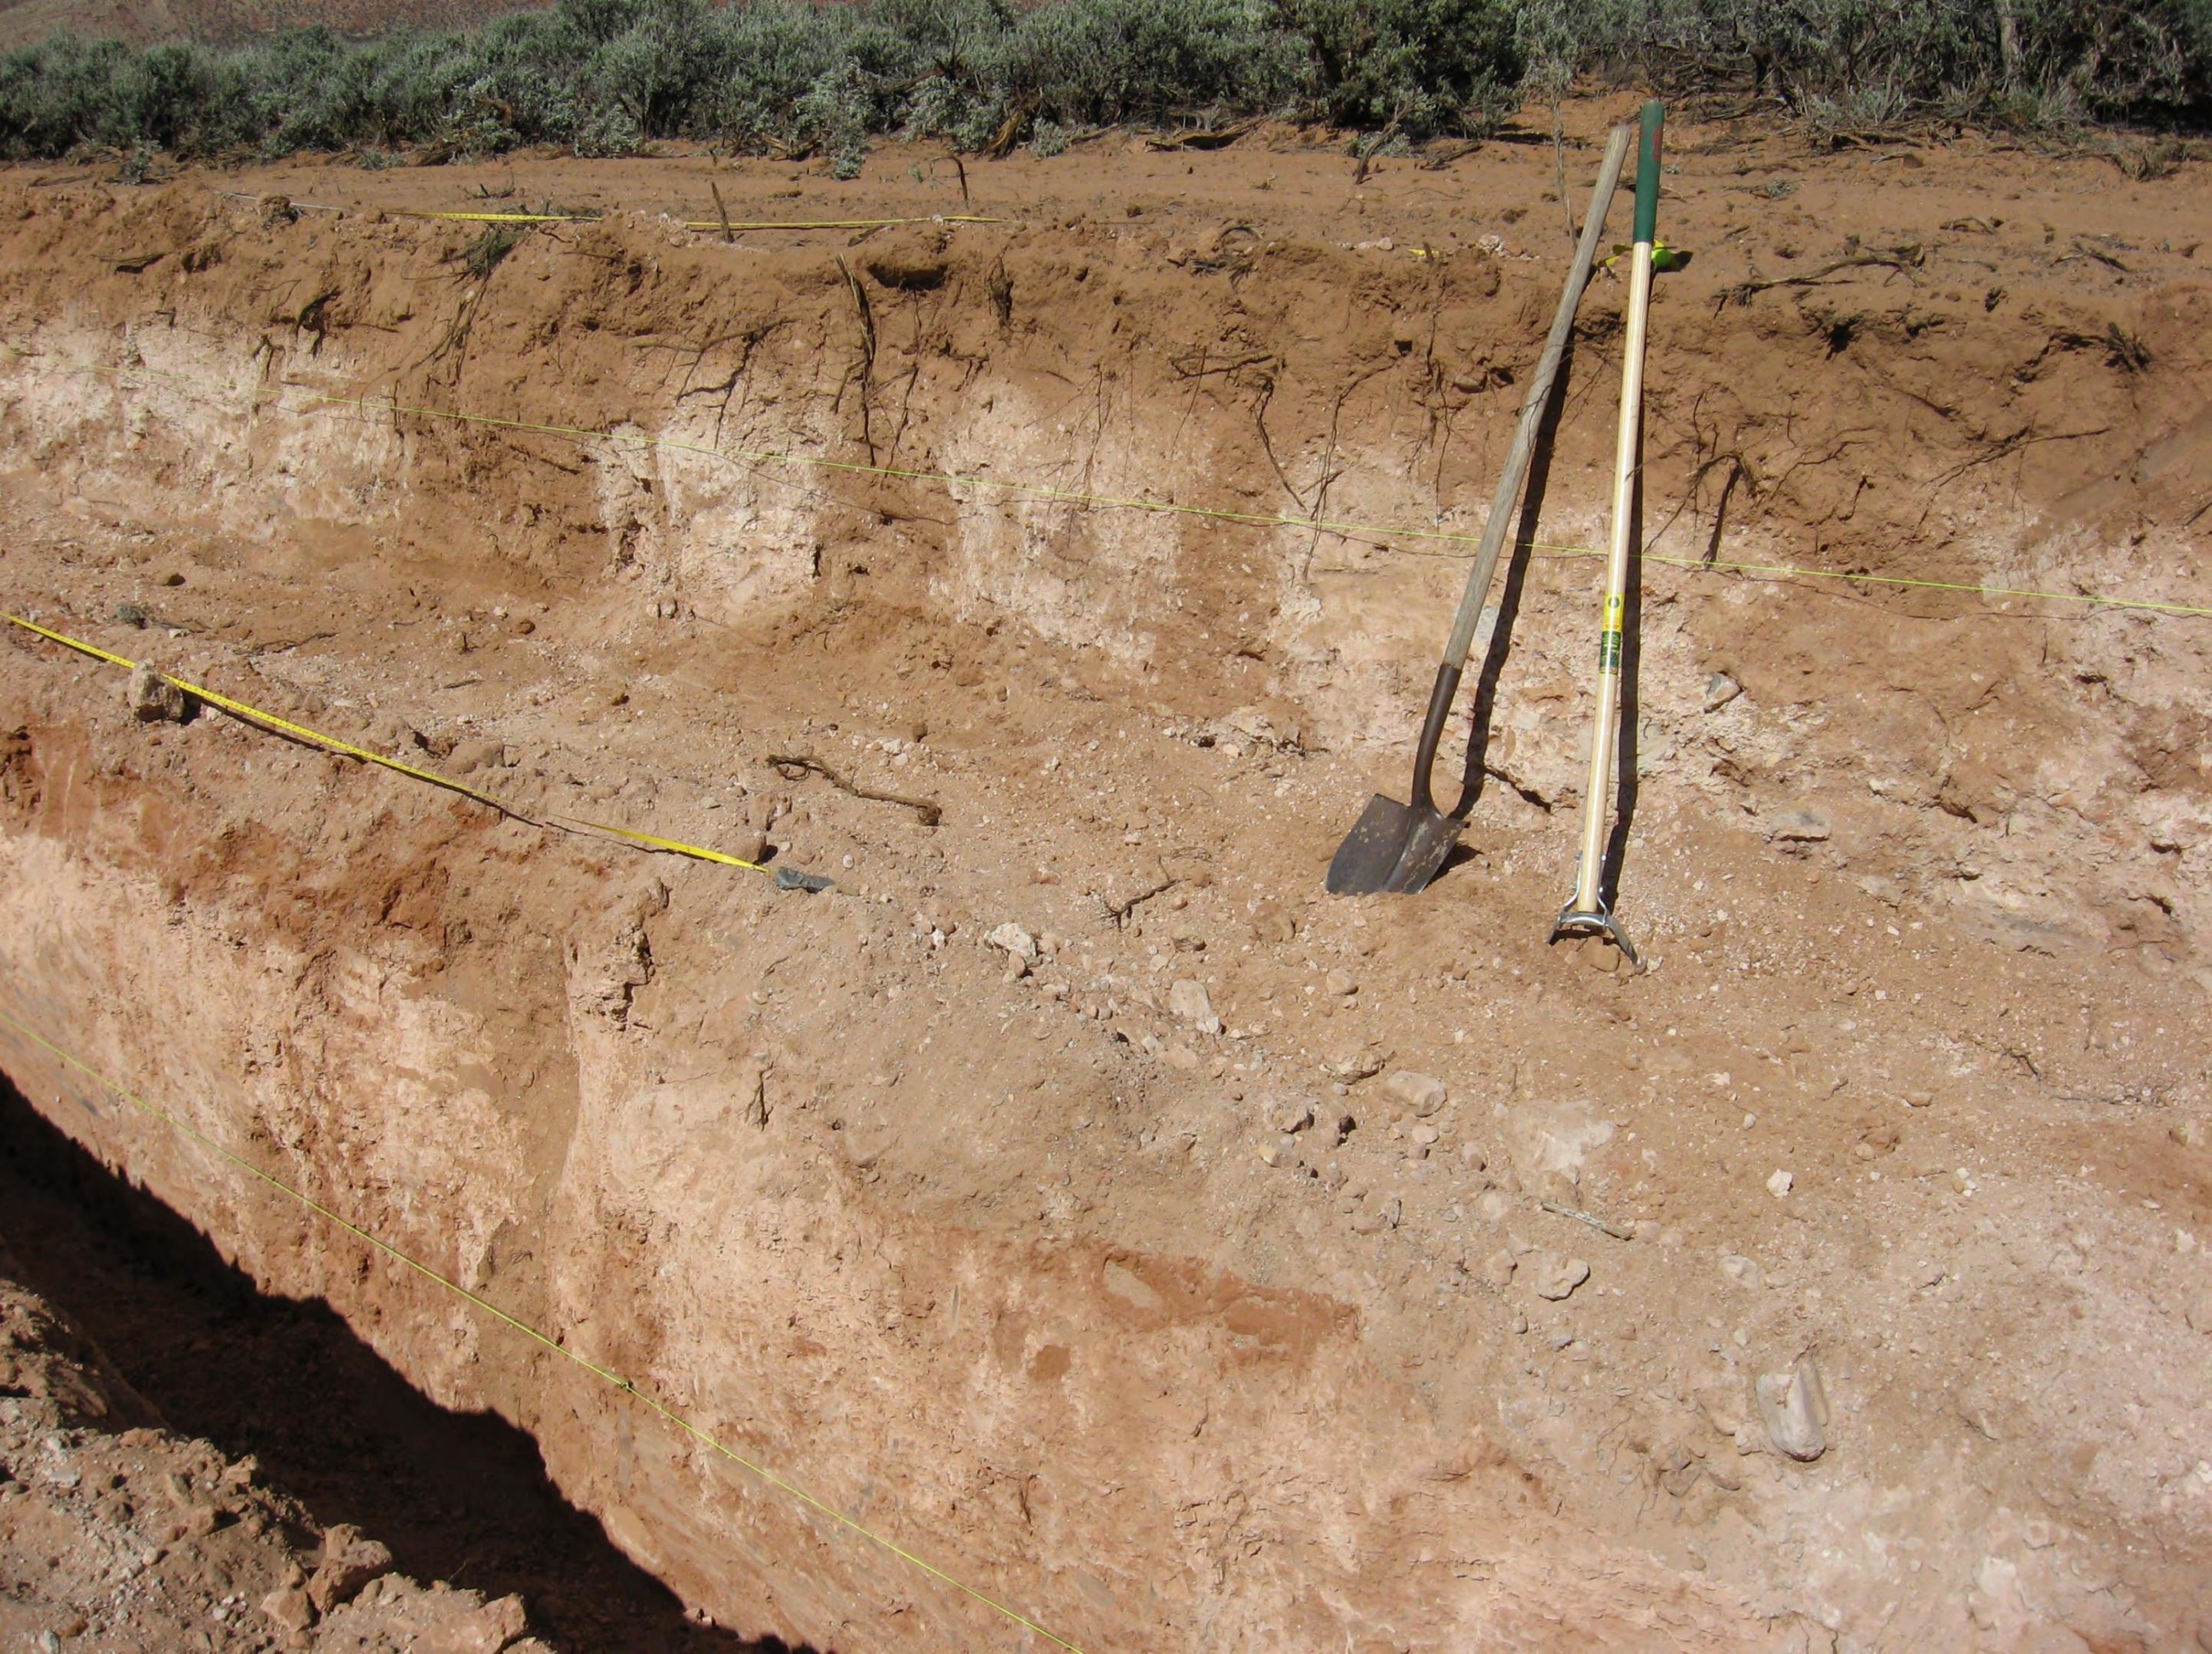
Photo IMG_0394

We observed zones in Trench 2-B where younger soils had penetrated downward through the upper Soil S-2 carbonate horizon into the lower Soil S-1 carbonate horizon similar to the soils observed as the apparent subsidence feature (see attached photo IMG_0394). Our trench was deepened to 12 feet in this zone to reveal that the younger soil features did not fully penetrate the Soil S-1 carbonate horizon. Based on this observation, we believe that the occurrence of the younger soils penetrating the carbonate horizons is not the results of bottom-up phenomenon such as karst subsidence or fault rupture, but is likely related to surficial processes such as erosion or bioturbation.
