## EXPEDITED SETTLEMENT AGREEMENT

## Stormwater Inspection Report

<b>Permittee:</b> Lawrence Construction Company	<b>Cert. No.</b> not permitted (previously covered under COR03F280)	<b>Date(s):</b> 12/20/2011
<b>Facility:</b> S Academy Blvd Improvements Phase 4	<b>Industrial Type:</b> Construction	<b>Receiving Water:</b> unnamed tributary to Fountain Creek
<b>Facility Address:</b> South Academy Blvd. & B St., Colorado Springs Colorado		
<b>Persons present:</b> Keith Mondal (Project Manager, Lawrence Construction Company), John Chavez (Inspector, El Paso County), Scott Holzer (Field Safety Manager, Lawrence Construction Company)		
<b>Legally Responsible Person(s)/Title(s):</b> Bill Lawrence (Vice President, Lawrence Construction Company)		<b>Inspector(s)</b> Matt Czahor (WQCD)

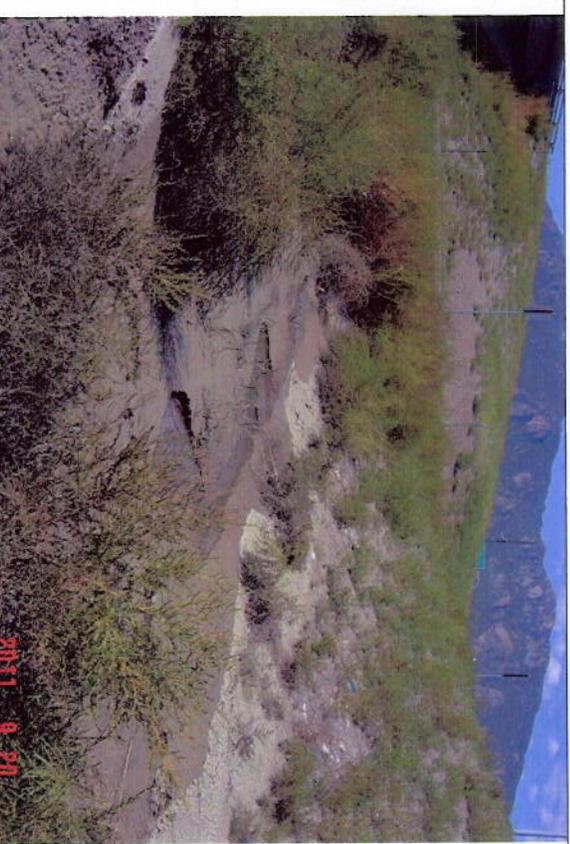
**Photograph 1** – Photo taken 9/20/2011 by John Chavez. Inlet side of water quality pond, silted in. Looking SW.

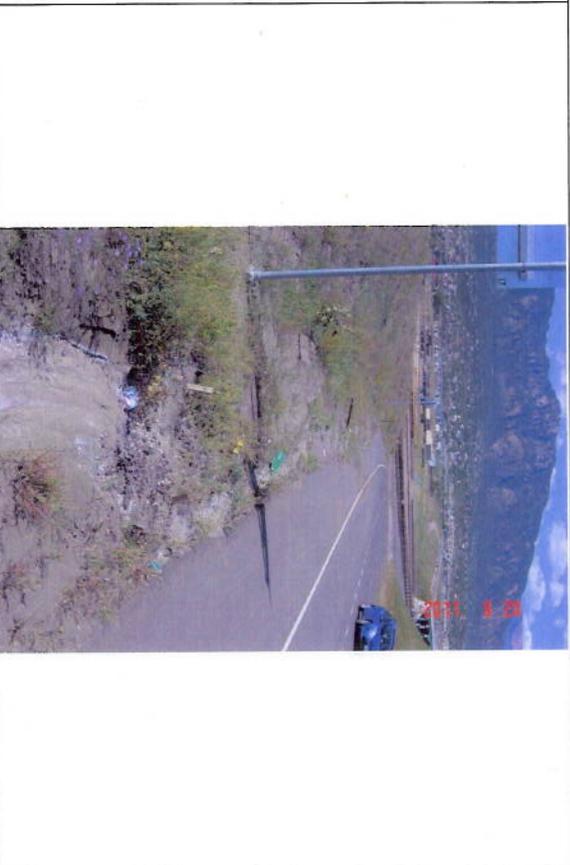
**Photograph 2** – Photo taken 9/20/2011 by John Chavez. On ramp to east bound S. Academy Blvd., erosion and sediment transport occurring. Looking W.

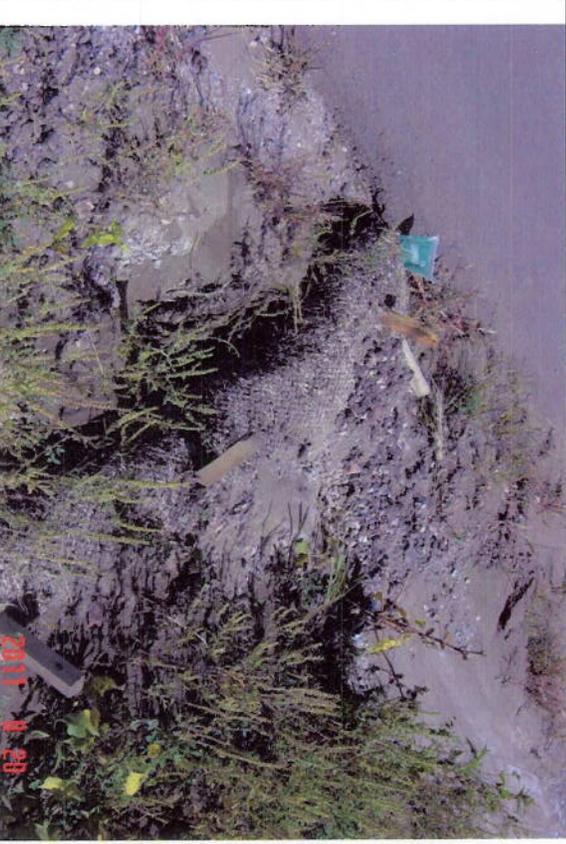
**Photograph 3** – Photo taken 9/20/2011 by John Chavez. Close up of ground in photo 2, straw wattle check dam completely silted in.

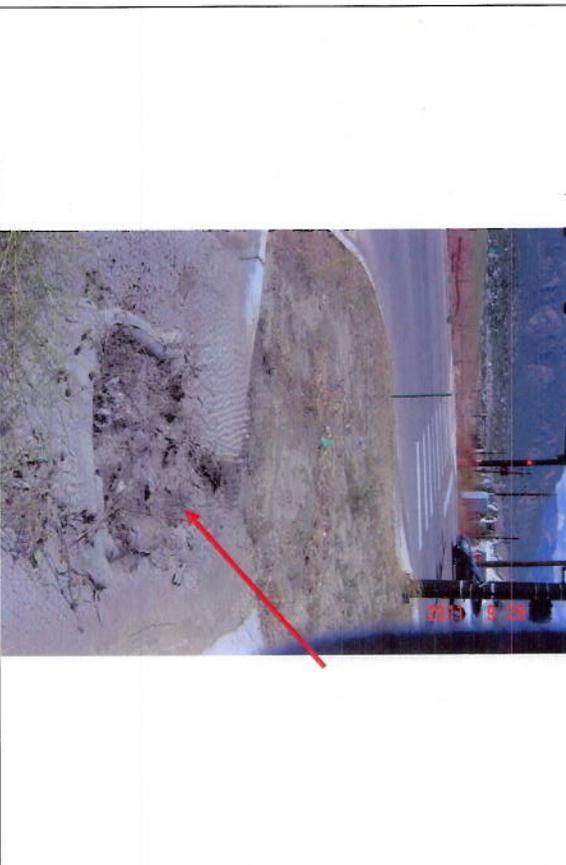
**Photograph 4** – Photo taken 9/20/2011 by John Chavez. Red arrow points to drop inlet at west bound off-ramp at B St. Inlet silted in and clogged with sediment.

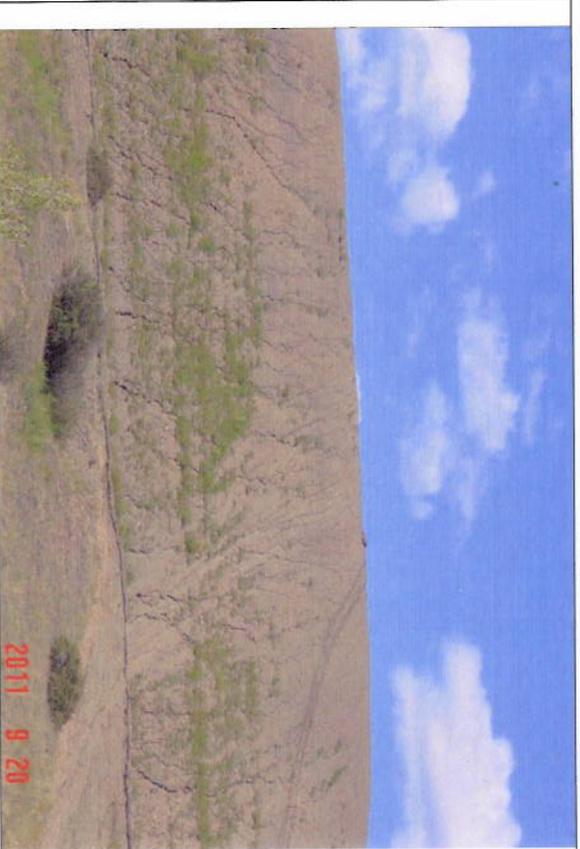
1. It was noted during an inspection conducted by John Chavez (Inspector for El Paso County) on 9/20/2011 that Lawrence Construction Company had not achieved final stabilization in accordance with the Permit. A uniform vegetative cover had not been established for the disturbed areas adjacent to S Academy Blvd. As a result, erosion and sediment transport was occurring on these disturbed areas adjacent to S Academy Blvd (see photos 1-3). So much sediment was being transported during storm events that the sediment was clogging the down gradient storm sewer system (see photo 4). A uniform vegetative cover had not been established for the disturbed slopes and fill areas associated with the fill grading export site. Numerous bare dirt areas that were void of vegetation were observed on the disturbed slope. As result,

erosion rills were evident across the slope and sediment transport was observed at the toe of the slope (see photos 5 and 6).

**Photograph 5** – Photo taken 9/20/2011 by John Chavez. Fill slope in fill grading export site. Looking up at slope to the NW. Note the erosion rills and areas of bare dirt.

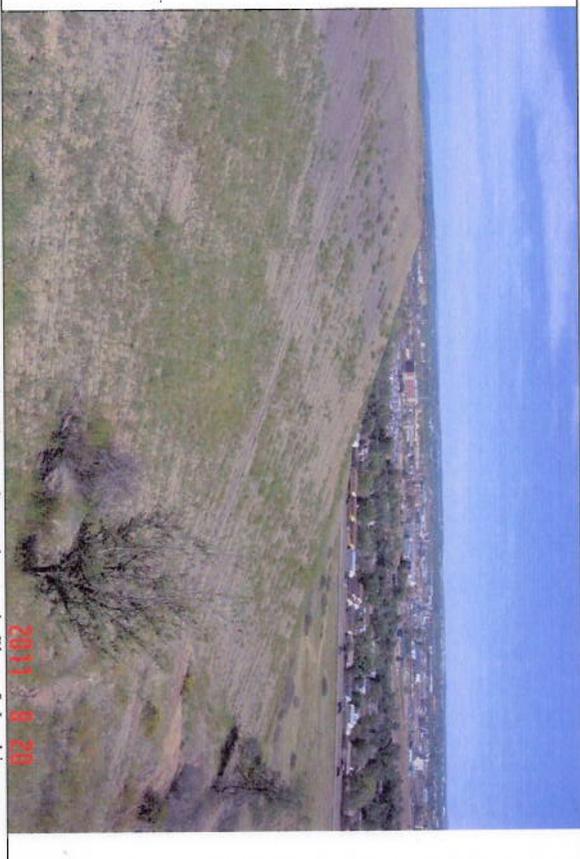
**Photograph 6** – Photo taken 9/20/2011 by John Chavez. Same slope as in Photo 5. Looking across mid-slope to the NE. Note the erosion rills and areas of bare dirt.

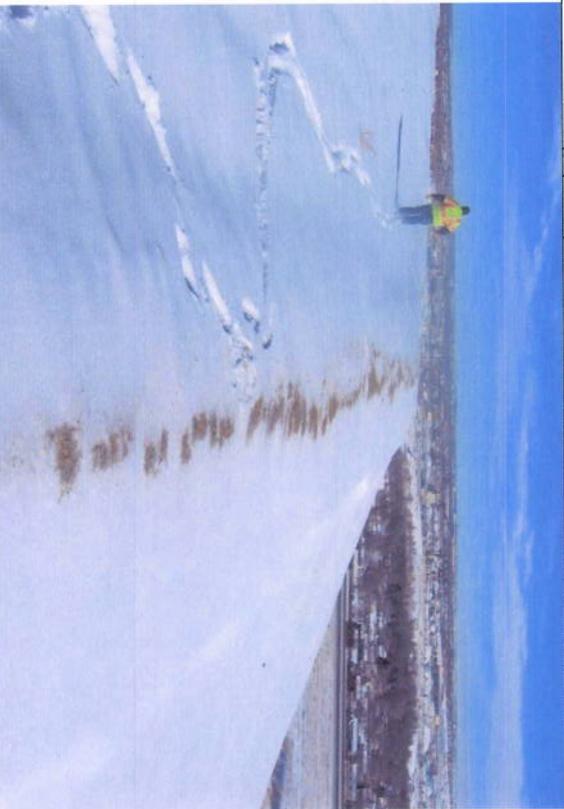
2. It was noted during the inspection conducted by the Division on 12/20/2011 that Lawrence Construction Company had not achieved final stabilization in accordance with the Permit. A uniform vegetative cover had not been established for the disturbed areas adjacent to S Academy Blvd. The exposed areas were discovered to be void of vegetation and were comprised of bare loose dirt (see photos 17-19). A uniform vegetative cover had not been established for the disturbed slopes and fill areas associated with the fill grading export site. The exposed areas were discovered to be void of vegetation and were comprised of either bare loose dirt or bare loose dirt covered by erosion control blankets. (see photos 7-16).

**Photograph 7** – Photo taken 12/20/2011 by Matt Czahor. Same slope as in photo 5. At the top of slope looking E. Note the exposed ECBS along the ridge. Dirt under ECBS.

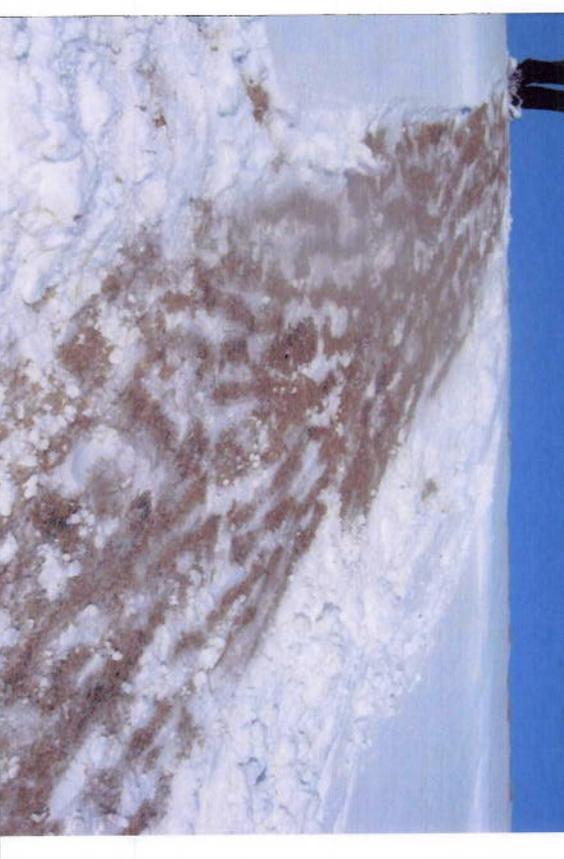
**Photograph 8** – Photo taken 12/20/2011 by Matt Czahor. Approximately same location as in photo 7. Looking at the face of the slope extending down from the top. ECBS, with dirt below.

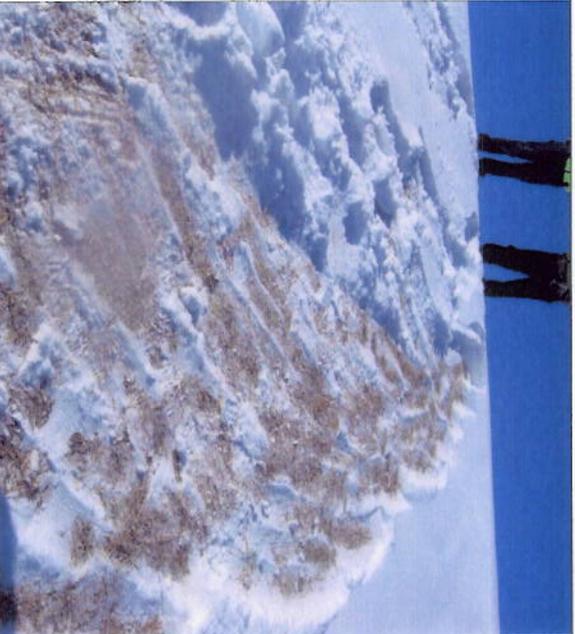
**Photograph 9** – Photo taken 12/20/2011 by Matt Czahor. Approximately 50 yards NE of location in photo 8. Looking at the face of the fill slope extending down from the top. ECBs, dirt below.

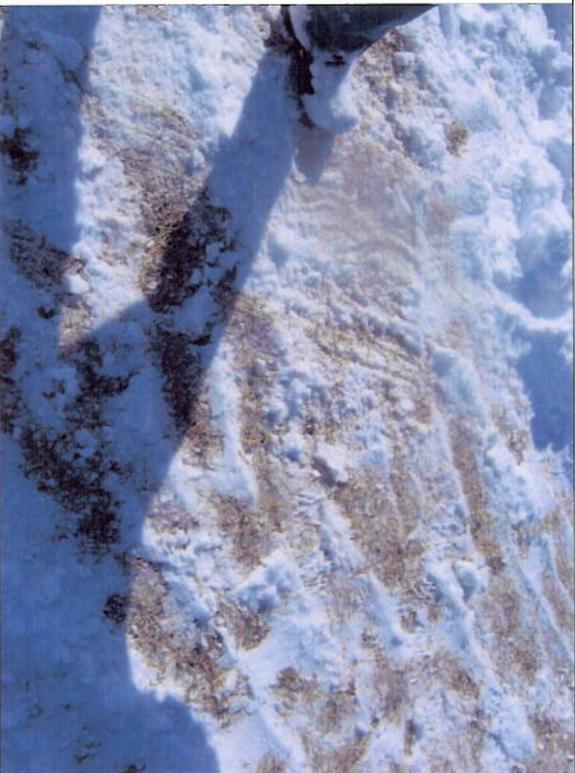
**Photograph 10** – Photo taken 12/20/2011 by Matt Czahor. Close up of photo 9. ECBs with dirt below.

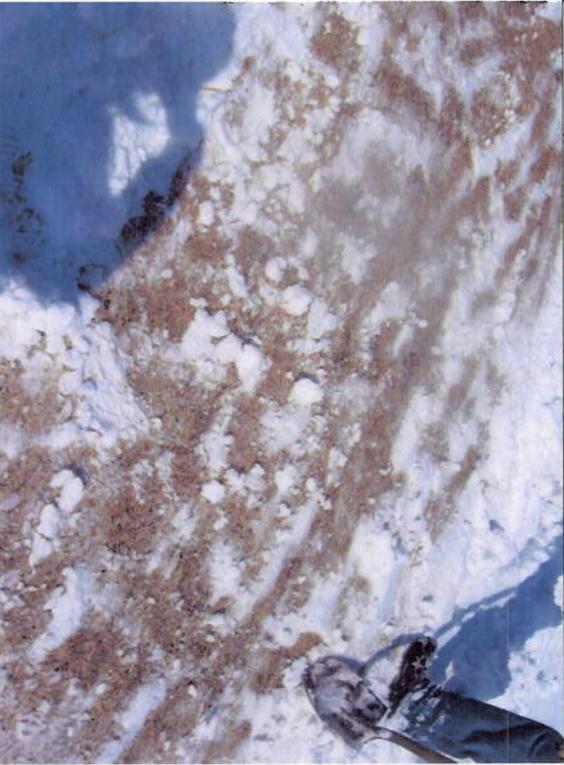
**Photograph 11** – Photo taken 12/20/2011 by Matt Czahor. Close up of photo 9. ECBs with dirt below.

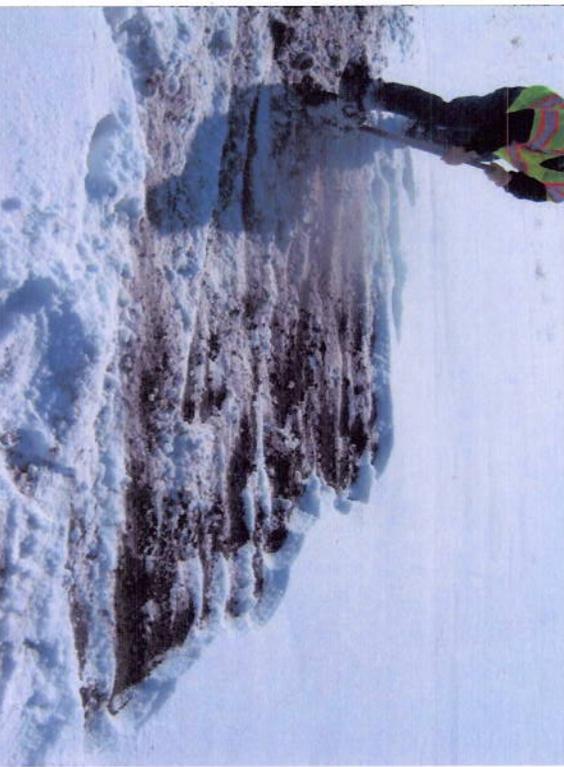
**Photograph 12** – Photo taken 12/20/2011 by Matt Czahor. Approximately 20 yards NW of location in photo 9 and mid-way down fill slope. Just loose bare dirt.

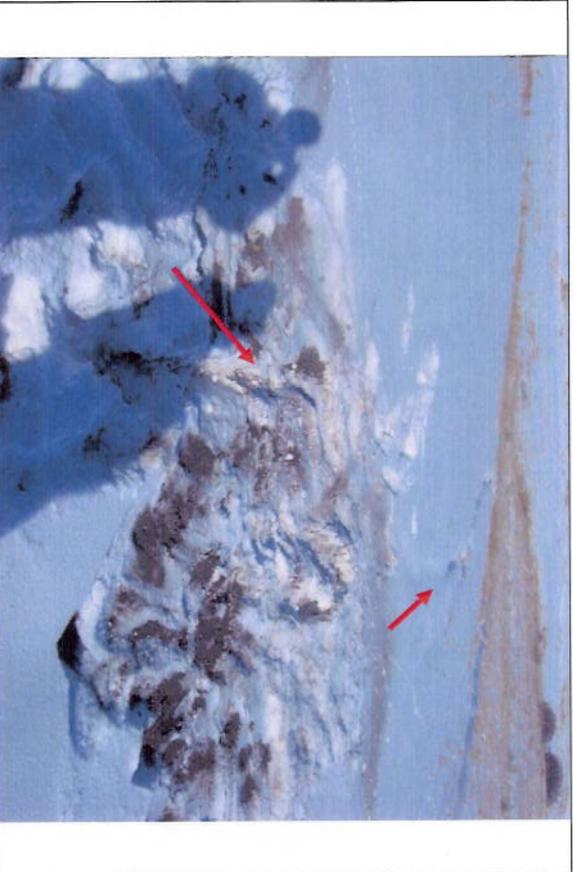
**Photograph 13** – Photo taken 12/20/2011 by Matt Czahor. NW of location in photo12. Disturbed slope with loose bare dirt and erosion gully. Red arrows point to erosion gully.

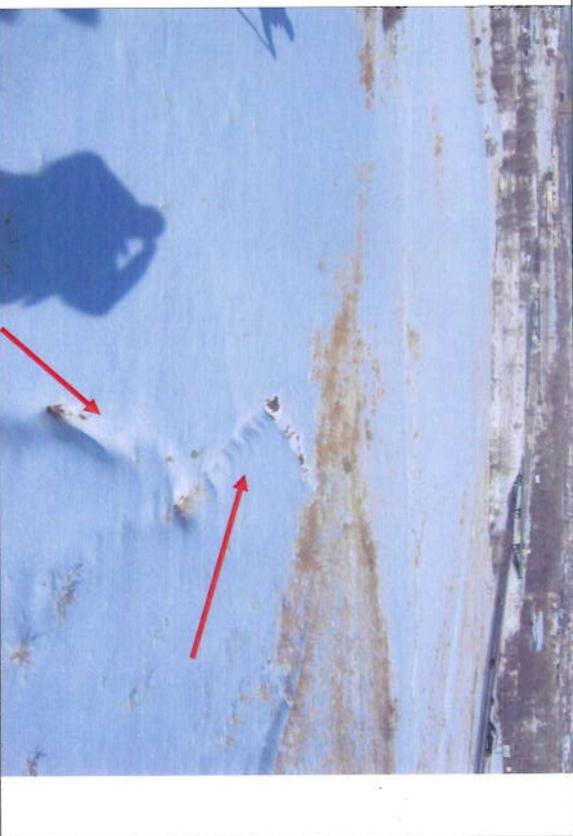
**Photograph 14** – Photo taken 12/20/2011 by Matt Czahor. Same location as photo 13, view of erosion gully. Red arrows point to erosion gully

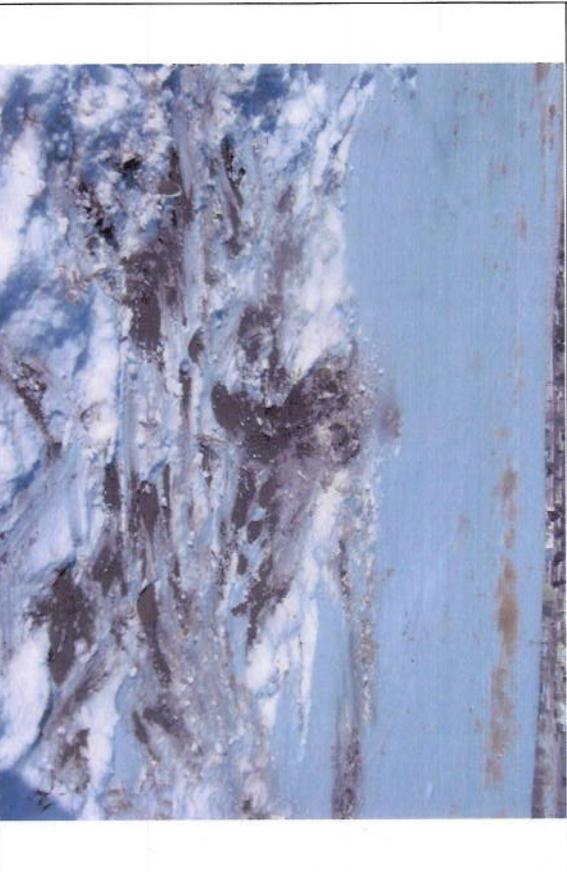
**Photograph 15** – Photo taken 12/20/2011 by Matt Czahor. Down gradient and to the W of the location in Photo13. Just loose bare dirt.

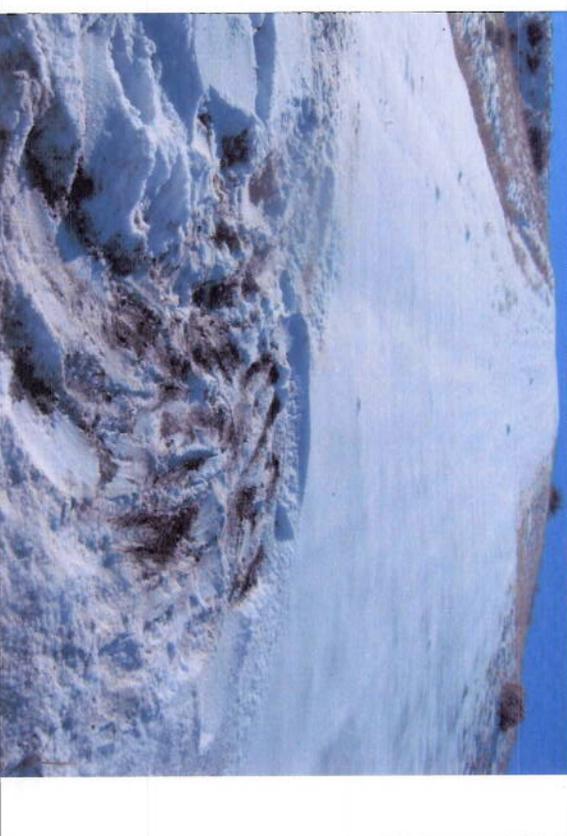
**Photograph 16** – Photo taken 12/20/2011 by Matt Czahor. W of the location in photo 15. Looking up the face of a disturbed slope. Just loose bare dirt with some erosion rills.

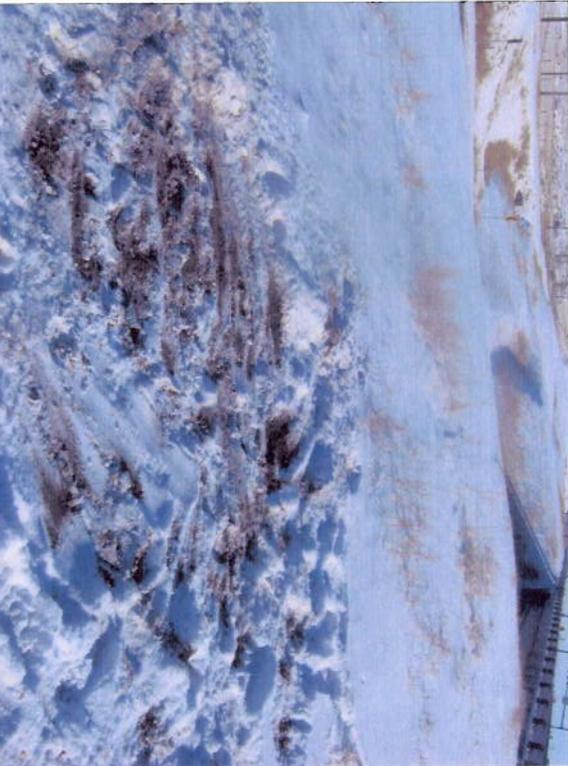
**Photograph 17** – Photo taken 12/20/2011 by Matt Czahor. Disturbed slope W of B St. and N of E bound S. Academy Blvd. Loose bare dirt with sparse weeds.

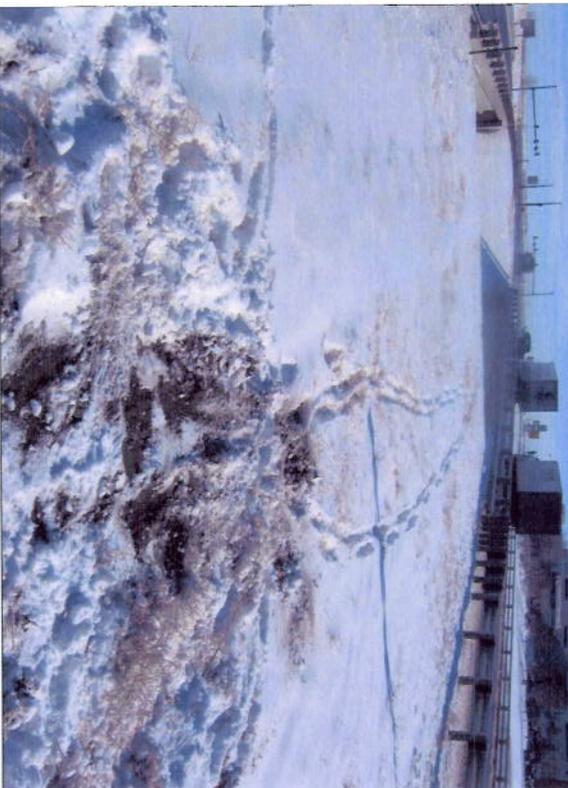
**Photograph 18** – Photo taken 12/20/2011 by Matt Czahor. Disturbed area W of B St. and in between E and W bound S. Academy Blvd. Looking E. Loose bare dirt with sparse weeds.

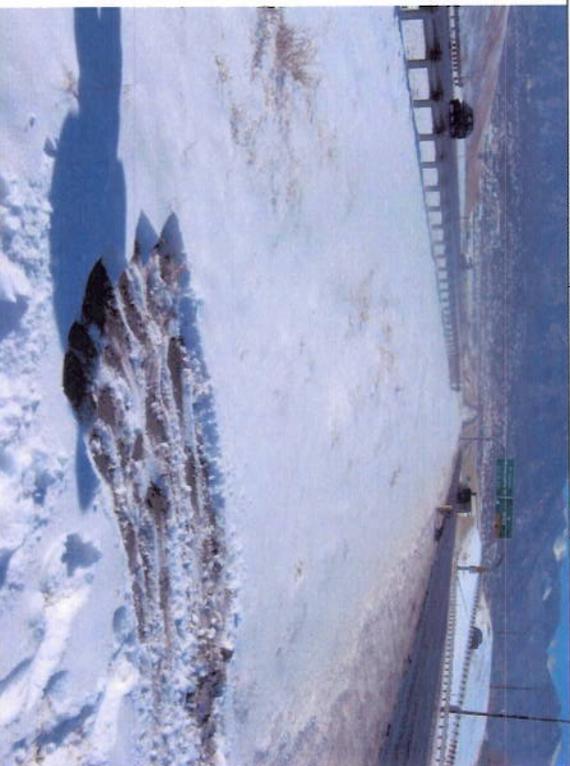
**Photograph 19** – Photo taken 12/20/2011 by Matt Czahor. Disturbed area W of B St. and in between E and W bound S. Academy Blvd. Looking W. Loose bare dirt with sparse weeds.

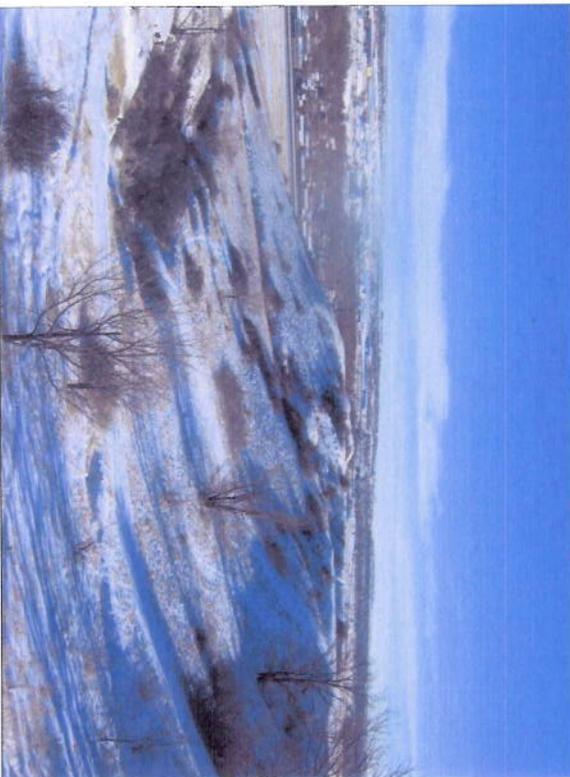
Note: Photographs 20-22 were taken to document the surrounding landscape and undisturbed vegetative cover adjacent to the fill grading export site. The vegetative cover that was left undisturbed comprised of a thick layer of established grasses, occasional shrubs, and occasional small trees.

**Photograph 20** – Photo taken 12/20/2011 by Matt Czahor. Overview of the surrounding landscape adjacent to the fill grading export site. Looking E.

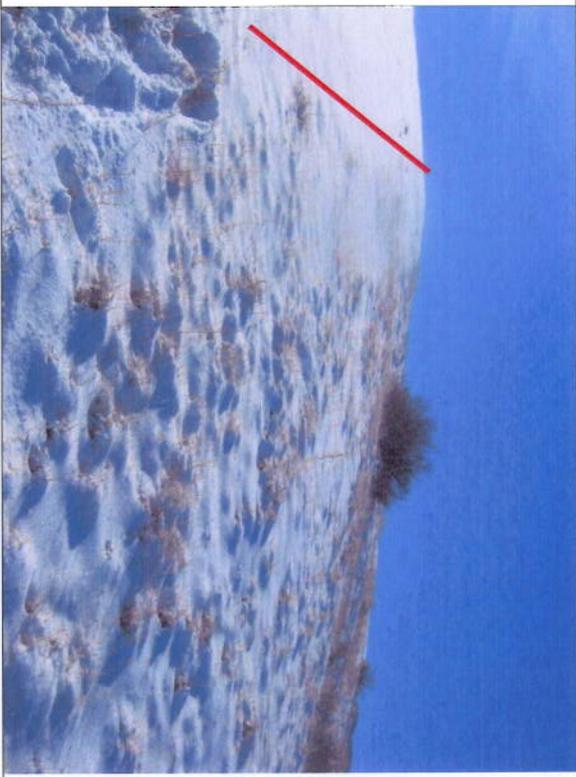
**Photograph 21** – Photo taken 12/20/2011 by Matt Czahor. Looking up the slope in photo 16. To the left of the red line is the disturbed area and to the right is the existing vegetation undisturbed.

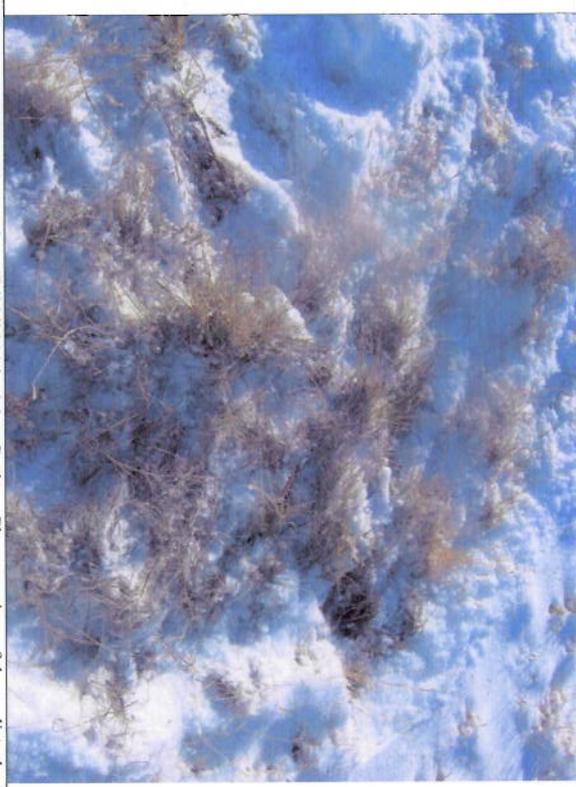
**Photograph 22** – Photo taken 12/20/2011 by Matt Czahor. Close up view of the undisturbed vegetative cover in photo 21. The undisturbed vegetative cover was thick and well established.
