# **2015 PIPELINE MAINTENANCE AND REPAIR**

## **EAGLE MINE SITE MINTURN, COLORADO**

*Prepared for:*  
**CBS Operations Inc.**

**March, 2016**

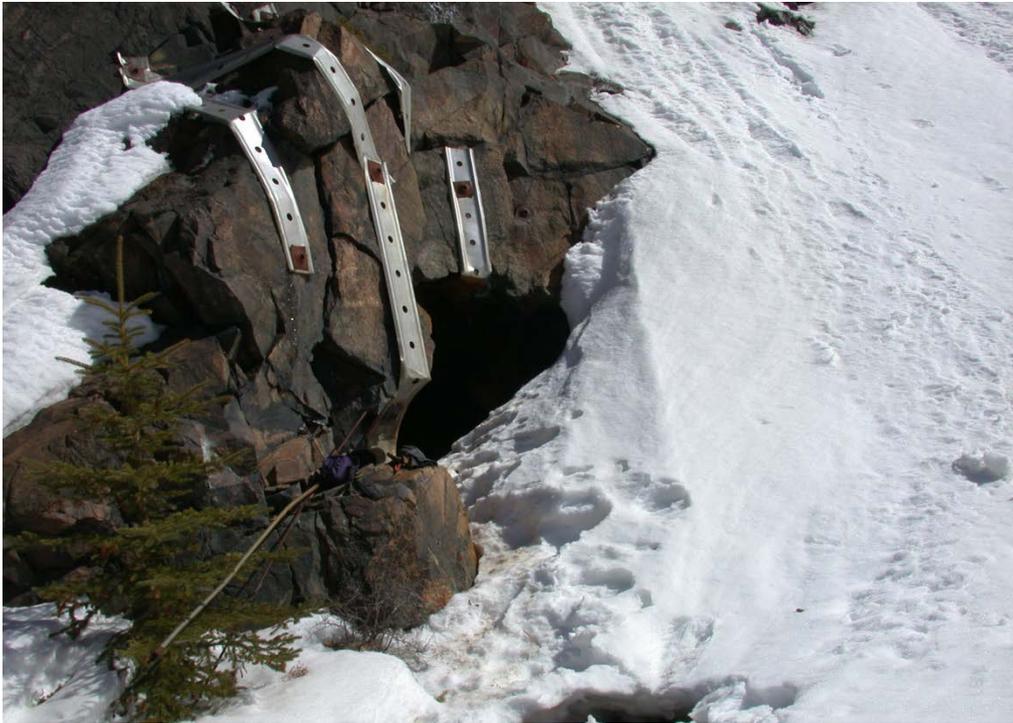
Figure 1 Tip Top mine portal

The Tip Top mine (Figure 1) is the most upstream seepage collection point on the main pipeline. Two pipes drain the Tip Top mine portal at elevation 8411 feet. One 3-inch diameter HDPE line drains groundwater that seeps from the rock around the Tip Top bulkhead (seep line) into the tunnel. This bulkhead is located 300 feet inboard from the portal. Another 3-inch diameter HDPE line drains the water that collects in the mine behind the mine bulkhead (pressure line). The two lines exit the portal area separately but join at a wye connection about 20 feet outside the portal. The joined flows are conveyed in a 3-inch diameter HDPE line to the Tip Top manhole located along the Crib Wall next to the railroad.

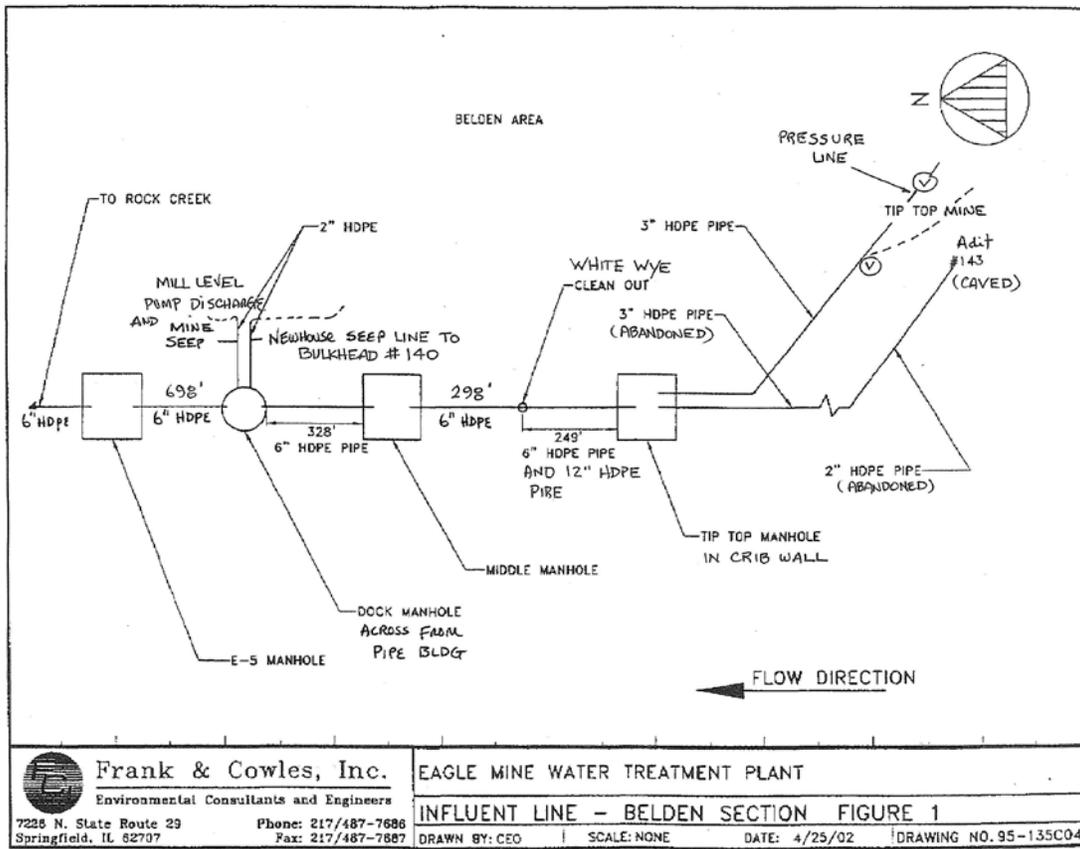
Figure 2 Tip Top and Belden Pipeline Layout

Drainage from the Tip Top mine flows 875 feet from the Tip Top manhole in the Crib Wall to the Dock manhole in Belden in buried 6-inch and 12-inch diameter HDPE lines as diagrammed in Figure 2. The portion of the pipeline from Tip Top manhole to the White Wye, buried at the base of the Crib Wall, is shown in Figure 4.

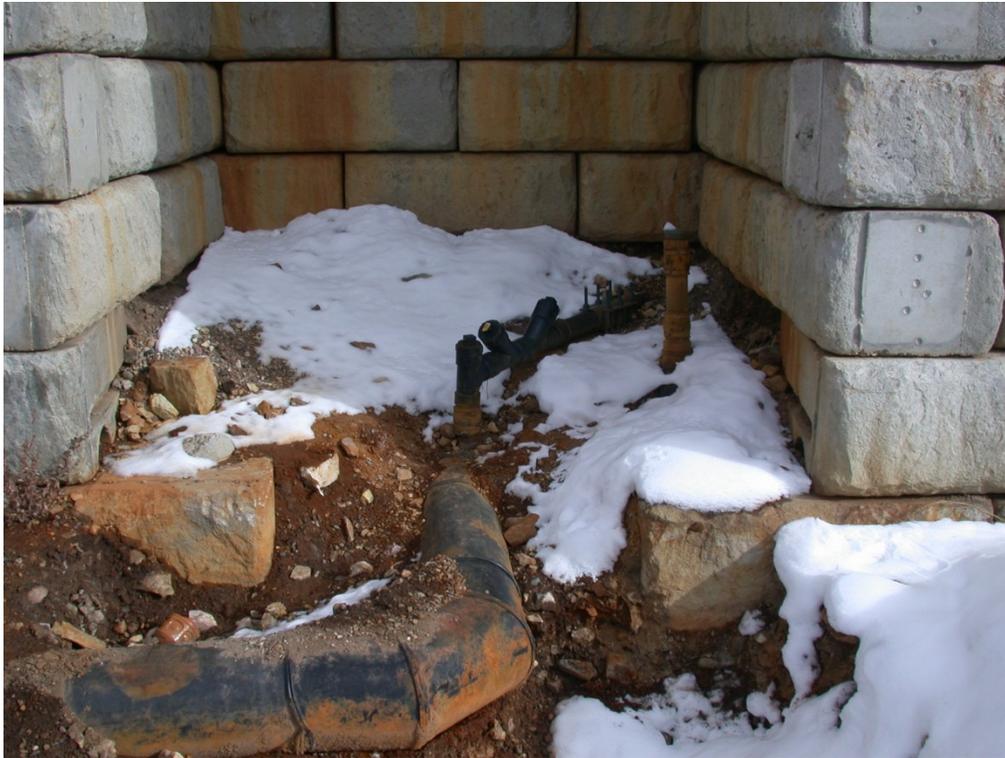
**Figure 3 Tip Top manhole in crib wall and 12-inch diameter HDPE pipe**

- Pipe flow at the Tip Top manhole in the crib wall (Figure 3) was viewed daily and recorded on inspection forms.
- The gauge pressure on the pressure line in the portal was measured periodically.
- On November 5, the pressure line from the Tip Top manhole uphill to the main valve in the portal was jetted.

- Inspect the pipe flow at the Tip Top manhole in the crib wall (Figure 3) daily.
- Measure the gauge pressure on the pressure line in the portal periodically.
- Run flow tests and jet pipelines as needed to maintain flow.
- Adjust flow with the gate valve on the pressure line as needed to maintain mine pool pressure at approximately 6 psi.

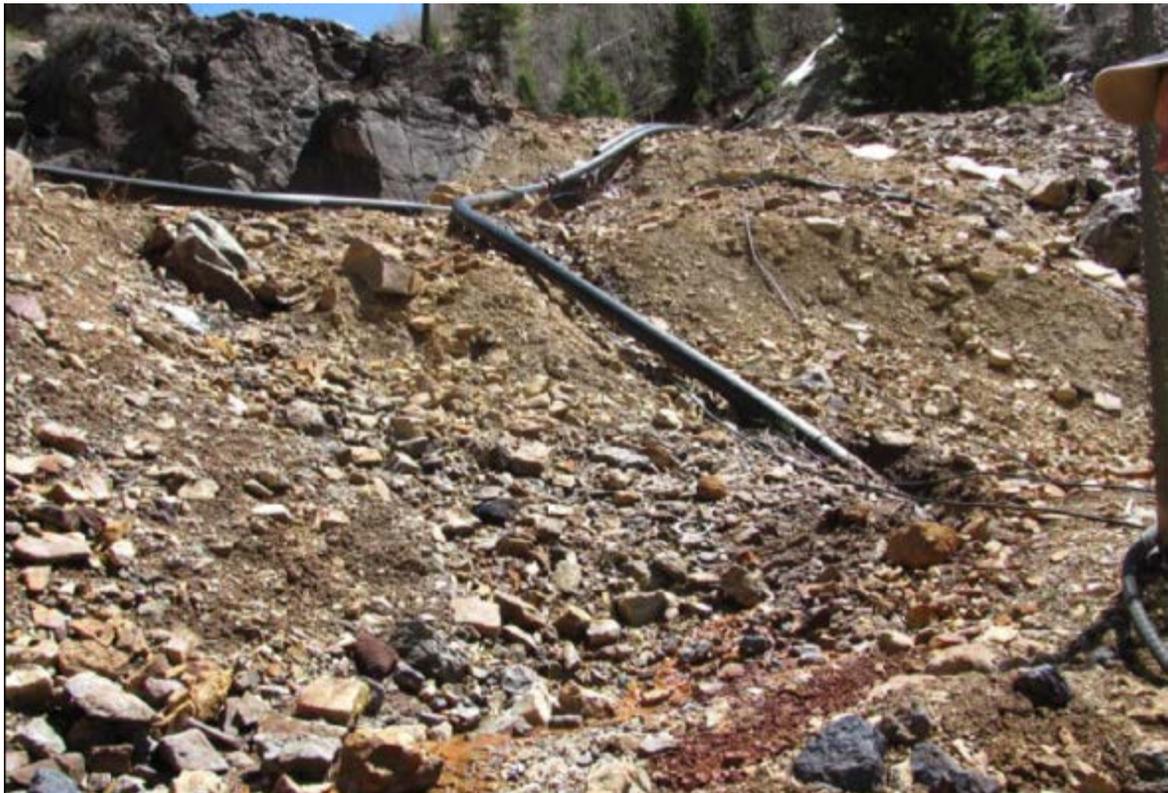
Figure 5 Lowermost portion of 6-inch diameter MDD pipeline

The 6-inch diameter MDD line drains water by gravity from the Eagle Mine pool through the bulkhead in Adit 5 (elev. 8436 feet) to the MDD vault (Figure 5), a steep drop of about 130 feet. The velocity of the water in the MDD line is high, the pH is approximately 6.0, and the oxygen content is near 7 mg/L. Taken together, these parameters indicate that the MDD water is not conducive to the generation of iron scale. No maintenance issues were identified in 2015.

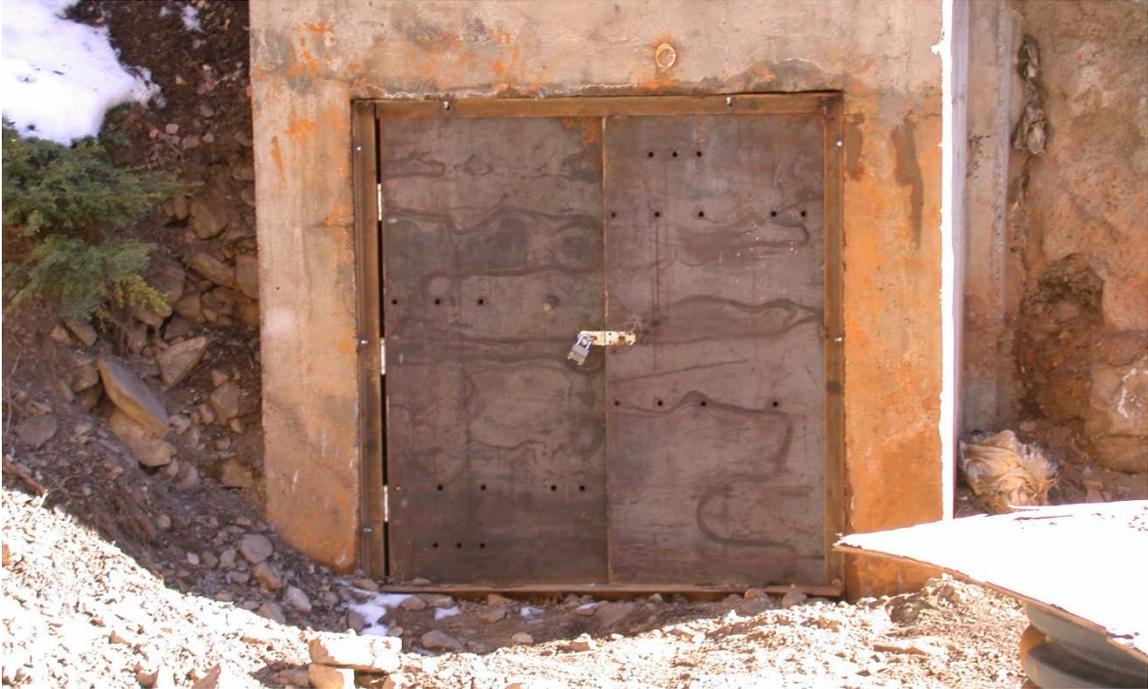
**Figure 6 Adit 5 Portal Door**

- The S-5 seep line plugs frequently with iron and other debris from the Adit 5 floor. Weekly visits to the sediment basin in the portal of Adit 5 were made to clear debris that may clog the S-5 seep line. Snow depth and avalanche danger limit winter inspections.
- Leaves in the S-7 and lower Waste Rock Pile 8 collection basins frequently clog the drain pipes. Weekly visits to the basins, weather permitting, were made to clear the leaves that prevent flow into these two seep lines.
- Daily inspections of flow from S-5 and S-7 were made at the New Manhole.

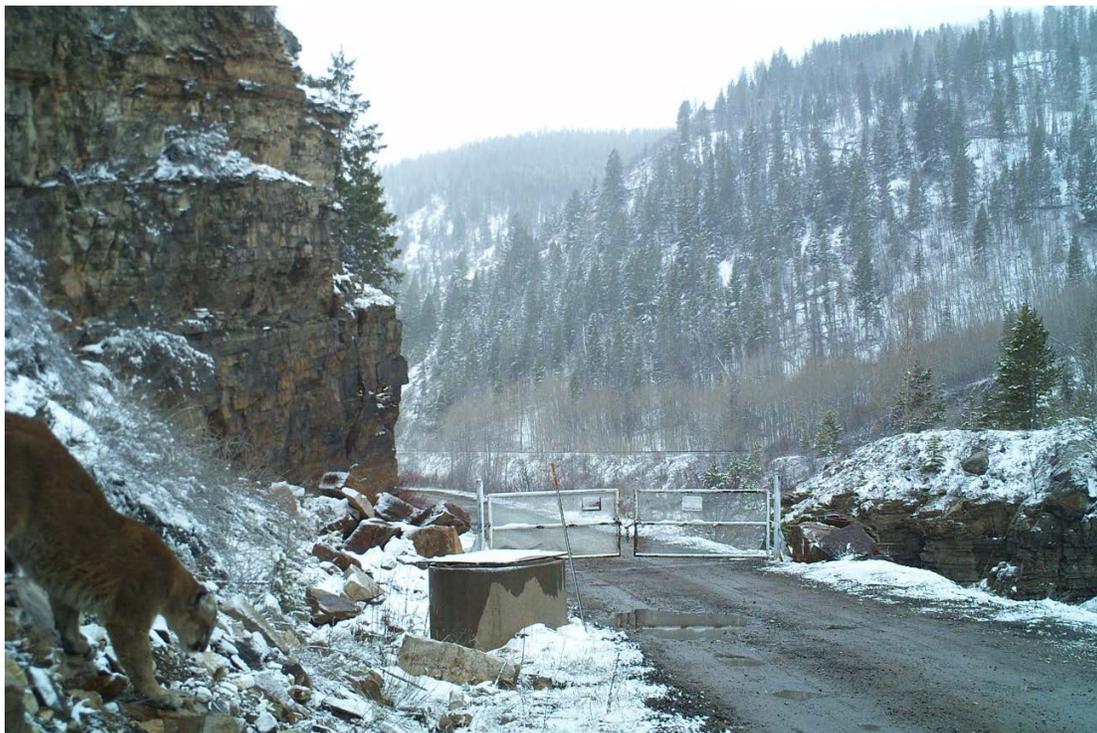
**Figure 8 MH-0 looking upstream to Gate #2**

At the bottom of Rock Creek, flow from the Belden segment joins MDD flow at the 6-foot diameter Structure Box and moves downstream in a buried pipeline to MH-0 (Figure 8). The line consists of 5,760 feet of 10-inch diameter HDPE with access ports and manholes at roughly 300 foot intervals. The upstream portion, 1783 feet long, ends at the Mud Slide manhole or Coffin Box as shown on the diagram in Appendix A. The lower segment extends 3980 feet from the Coffin Box to MH-0; the HDPE pipe is contained within the original 16 – inch diameter concrete bell-and-spigot tailings pipe.

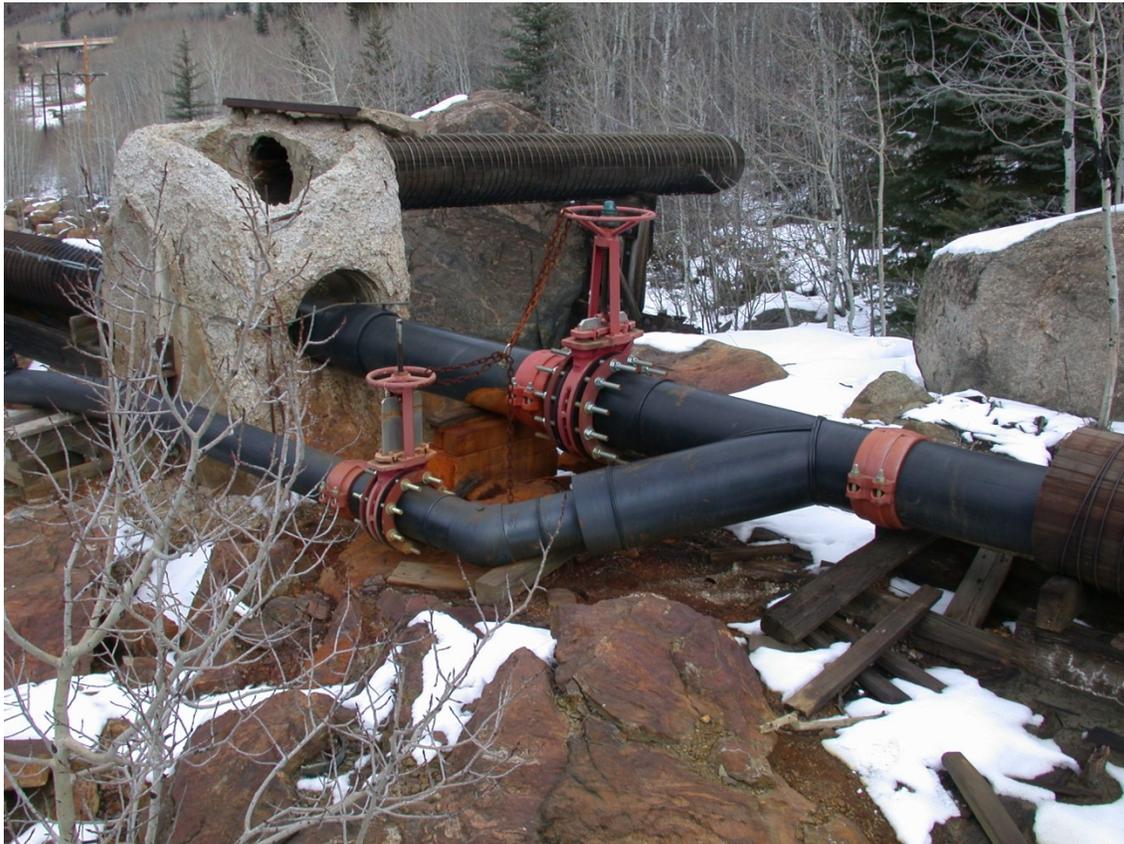
**Figure 9 Junction of 8-inch diameter bypass pipeline and 12-inch diameter trestle pipeline, upper Rex Flats**

A 100-foot-long segment of deeply buried 10-inch diameter pipeline turns sharply at MH-0 to the west under the railroad, surfacing at a concrete junction box called South Rex. From South Rex Flats the old 18-inch diameter wood stave pipeline is slip-lined with 12-inch diameter HDPE pipe, all of which is suspended on a 2-foot to 10-foot high wooden trestle extending 200 feet from the junction box downstream to the junction of the 8-inch diameter bypass and 12-inch diameter HDPE lines (Figure 9).

- In January 2015, two new ports were installed to provide access to accumulations of scale lodged upstream of the wye junction (Figure 9).
- The above segment was jetted on January 7 and 13, 2015.
- On November 5, 2015, the segment was jetted from the concrete vault upstream past MH- 0 to manhole #28.
- On December 10, 2015, the 12-inch diameter valve (Figure 9) was sealed off with a bolt-on steel blind flange. This flange effectively stopped flow across the trestle at Rex Flats.

- A leak from a Dresser coupling above the main underpass in Rex Flats was repaired on April 6, 2015.
- Two Dresser couplings covering older access ports were tightened on November 13, 2015.
- On December 10, 2015, flow over the trestle was eliminated when the 12 – inch diameter valve (Figure 9) was sealed off with a bolt-on steel blind flange.

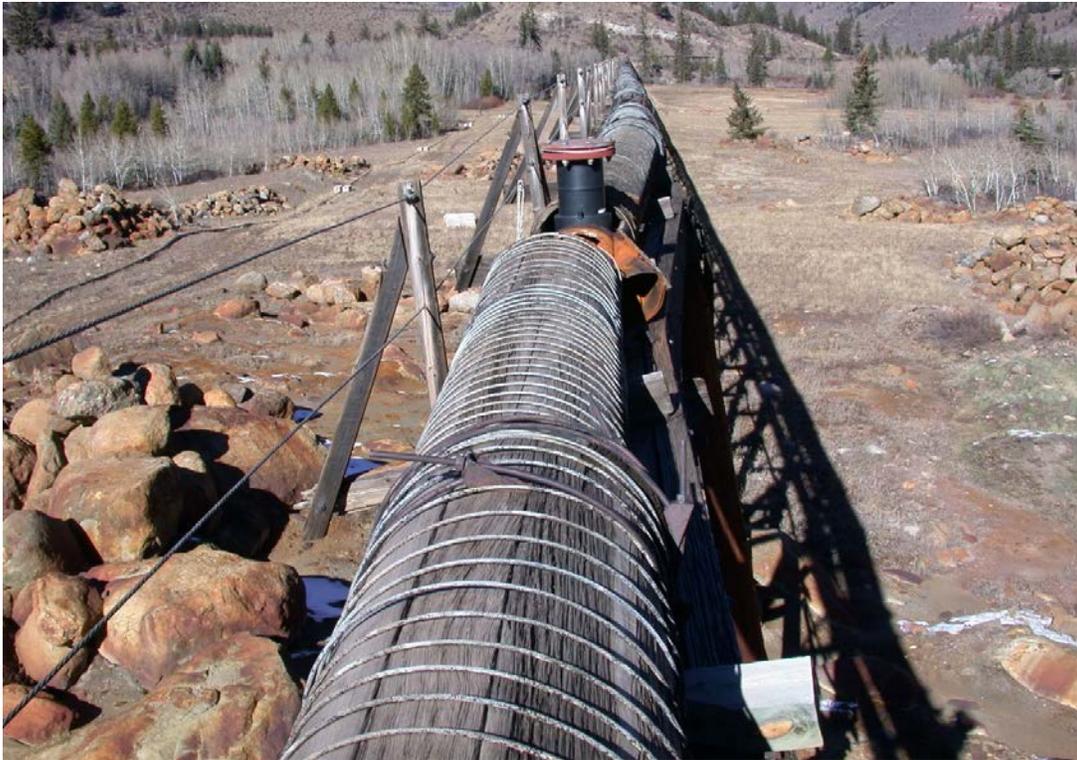
**Figure 10** Wooden trestle crossing Rex Flats and typical T port on the 12-inch diameter HDPE pipe inside the wood stave pipe.

The 2,000-foot long wooden trestle across Rex Flats supports an 18-inch diameter wood-stave pipeline that is slip-lined with 12-inch diameter HDPE pipe (Figure 10). The trestle was taken out of service in 2010 when the 8-inch diameter HDPE bypass was constructed as described in Section 6. The wooden trestle line was activated from April 6 – November 13, 2015.

- Replace a cross brace on the west side of the Tigwon bridge.
- Replace or tighten Dresser couplings as needed to prevent leaks.
- If no leaks are found, switch flow from the bypass to the trestle line from March to October 2016. .

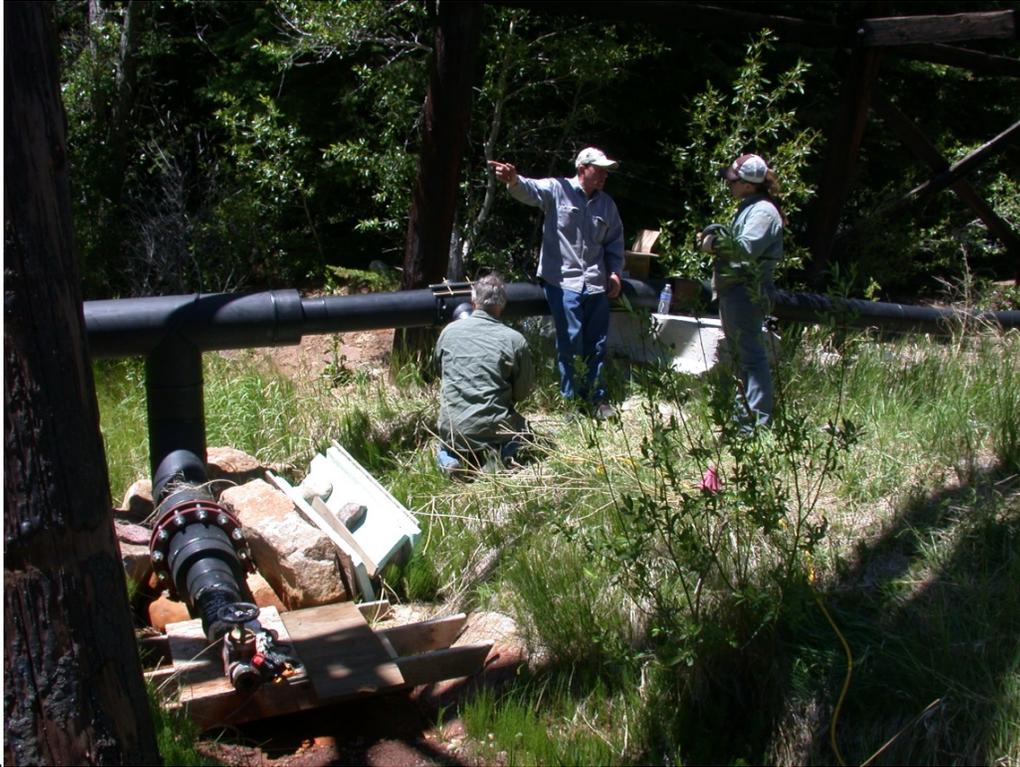
**Figure 12 Rock Box (left) and auxiliary cleanout being installed on bypass**

Approximately 2,000 feet of 8-inch diameter HDPE pipe was installed in 2010 on the ground from the south end of Rex Flats to the steel overpass at the river. On the downstream end of the bypass, a 45-foot-high riser pipe extends from ground level to the trestle level and crosses the river and Tigwon Road on a steel-frame bridge (Figure 11). This segment ends at a concrete manhole on the west side of the river, the OTP manhole. A Rock Box and auxiliary cleanout (Figure 12) near the bottom of the riser collect rock chips and allow access for jetting.

- The 4-inch diameter gate valve at the Rock Box was replaced in March 2015.
- On September 22, 2015, a 4-inch diameter hole was cut into the bypass to allow jetting to relieve a partial blockage of flow.
- On November 12, 2015, timber blocks were used to raise low spots in the bypass in an effort to increase flow velocity and decrease scaling.
- On November 18, 2015, a second 4-inch diameter hole was cut into the bypass to allow jetting to relieve a partial blockage of flow.

- Install a third 4-inch diameter hole into the bypass to allow additional jetting in the segment above the Rock Box. Place a third Dresser coupling over the new access port.
- Drain and jet the bypass as needed to maintain flow.
- Replace the 8-inch diameter gate valves at the wye (Figure 9) and riser with fully sealing butterfly valves.
- Construct an insulated shed that contains the Rock Box valve to provide the opportunity to drain the line in winter.

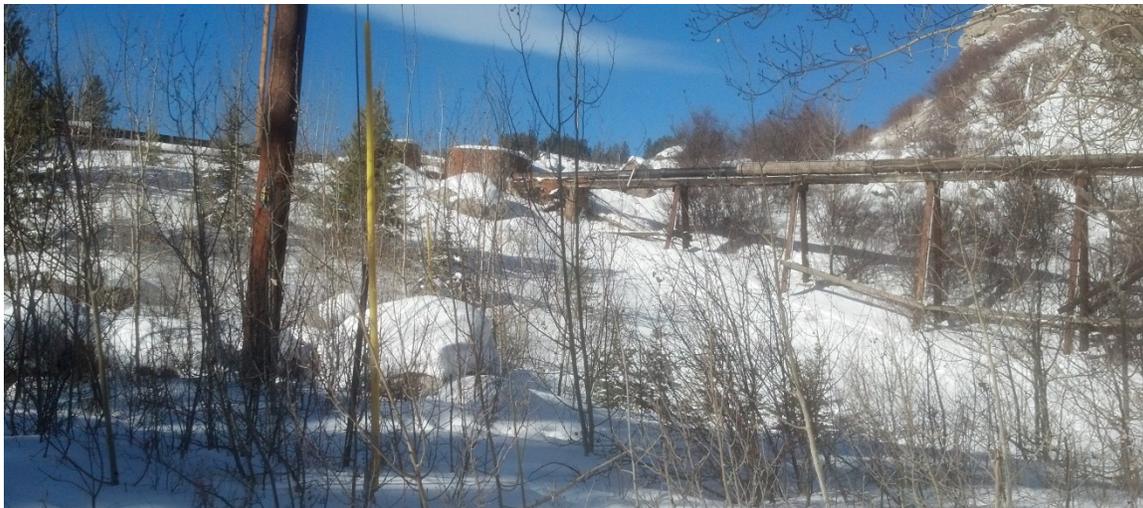
**Figure 13 OTP manhole, downstream is to the right**

Once across the river and Tigwon Road, the 12-inch diameter HDPE line extends from the concrete OTP manhole (Figure 13), through the concrete Garage manhole (Figure 14) to a concrete vault near the Upper Surge Pond at the WTP. While some of the line is at ground level, the greater portion is slip-lined in the old wood stave pipe supported by a wooden trestle identical to the trestle across Rex Flats (Section 7). Figure 15 shows the river crossing and Tigwon Road, and the upstream end of the OTP manhole to WTP segment. The total length of this segment is approximately 3200 feet. A pipeline diagram is included in Appendix A.
