**DRINKING WATER WATERBORNE
DISEASE OUTBREAK
PRINTERS PARK MEDICAL PLAZA
COLORADO SPRINGS, CO**

OCTOBER 26, 2012-NOVEMBER 7, 2012

Water Quality Control Division
Colorado Safe Drinking Water Program

FINAL REPORT

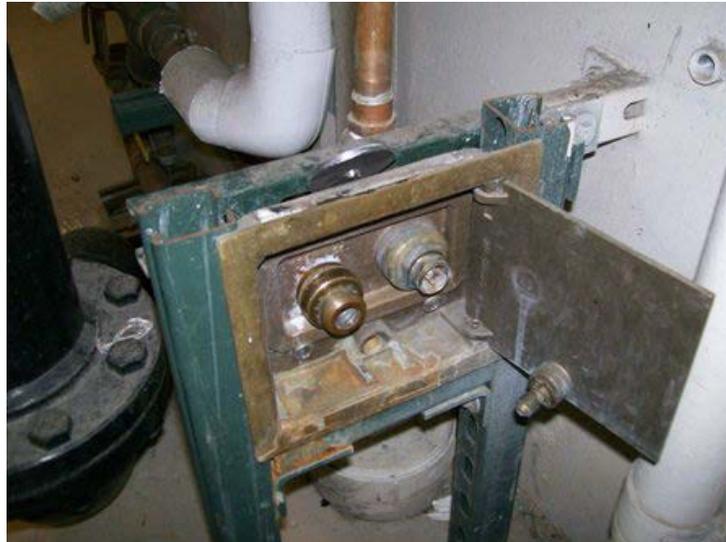
Figure 4. Potable Water Supply Spigot in Plaza Mechanical Room

- On October 29, 2012 NexCore’s maintenance staff, contractors and consultants performed an inspection of the Plaza’s plumbing system. It was determined that the contamination was likely chemical in nature and originated from the HVAC system in the Plaza’s mechanical room. This determination was based on an identified hose that connected the potable water supply (Figure 4. Potable water supply spigot connection) to a nonpotable HVAC system (Figure 5. HVAC spigot connection). The hose was disconnected from the potable system and from the HVAC system on October 29, 2012. Based on historical information it was assumed by NexCore’s consultants that the primary chemical contained in the HVAC system was propylene glycol. In years previous it was suspected that the HVAC system contained ethylene glycol. NexCore’s consultants determined that the Plaza’s potable supply system should be sampled for propylene glycol and ethylene glycol. NexCore’s consultants collected ten samples. Eight samples were collected throughout the Plaza’s potable supply system while two samples were collected directly from the HVAC system (Appendix B, Note the HVAC samples were incorrectly labeled Boiler #1 and Boiler #3 but after speaking with the NexCore’s consultants who collected the samples it was determined that the samples were collected from the HVAC system). The samples were analyzed October 30, 2012. Results were submitted to EPCPH and CDPHE on October 31, 2012. Analysis showed that two

samples collected from the Plaza's potable supply system contained propylene glycol at concentrations of 540 mg/L and 13 mg/L, while the other six samples were determined to be non-detect for propylene glycol. The two HVAC system samples contained propylene glycol at concentrations of 31,000 mg/L and 25,000 mg/L. All samples collected and analyzed for ethylene glycol were determined to be non-detect for that substance. Additionally, ammonia levels in the boiler and potable water were analyzed. Results indicated a concentration of 45 mg/L in the boiler water while levels in the potable water indicated a concentration of 0.03 mg/L, which is consistent with the potable water within the CSU distribution system, i.e. the supply. NexCore believed that the potential contamination did not originate from the boiler.

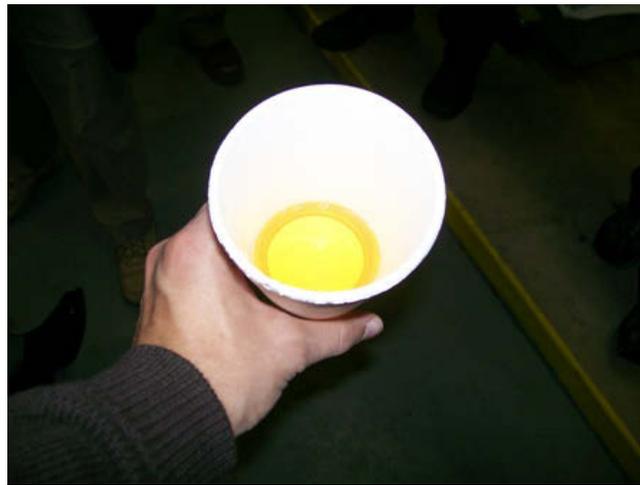
Figure 7. HVAC Liquid in Styrofoam Cup drawn from Spigot in Figure 5

- An investigation was performed on-site on October 31, 2012 by the EPCPH and CDPHE. The EPCPH and CDPHE met with representatives from NexCore, Hayden Mechanical Systems, Calcium Control Inc., Jeff Pohast and Associates, and Environ International Corp., at the Plaza. The investigation was focused on maintenance activities performed at the Plaza and the activities performed in association with flushing and sampling the Plaza's potable supply system. The investigation also focused on the Plaza's mechanical room including the boiler and the HVAC system (Figure 6. HVAC system) and various other areas of the Plaza where chemicals could have been introduced into the potable supply system, such as a scope sterilizer and/or a chemical sterilant. A water sample of the HVAC system water was collected and observed. The liquid was yellow and had a sweet odor that gave some people when they smelled the liquid nausea (Figure 7 HVAC liquid in Styrofoam cup). It was also noted that on October 29, 2012 the hot water had a stronger chemical odor than the cold water.

- The liquid in the HVAC system indicated a concentration of propylene glycol at approximately 25,000-31,000 mg/L.
- After performing the site visit and interviewing maintenance personnel it was determined that a conveyance (hose connecting the potable water supply system to the HVAC system) was created which could allow the liquid from the HVAC system to backflow into the potable supply system.

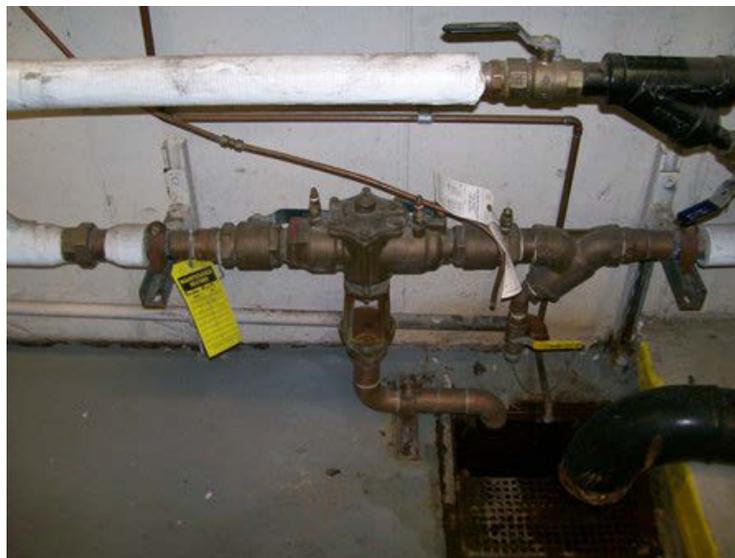
Figure 8. Reduced Pressure Backflow Prevention Assembly in the Plaza's Mechanical Room

- The potable water supply spigot in the mechanical room was upstream of a reduced pressure backflow prevention assembly which had been tested July 2012 (Figure 8. reduced backflow pressure assembly). Had the spigot been installed downstream of the backflow prevention assembly the chemical most likely would not have entered the potable supply system.
- Voluntary closure of the Plaza on October, 29, 2012 appeared to stop public exposure to the contaminated water and ended reported symptoms of the outbreak.

- Public water systems should have an emergency response plan for situations where a building that they serve has been determined to be contaminated. The plan should include backflow assembly performance verification, retesting of devices when necessary, and upstream and downstream chemical analysis. If appropriate backflow protection conditions are determined to be deficient (no device, or device has not been adequately tested) the public water system may need to consider potable water shutoff to the affected area until an appropriate backflow prevention assembly has been installed and performance has been verified through a test.
