**RE: Service of Notice of Violation/Cease and Desist Order, Number: SO-150817-1**

NOTICE OF VIOLATION / CEASE AND DESIST

### Thompson Crossing II - Photo Points

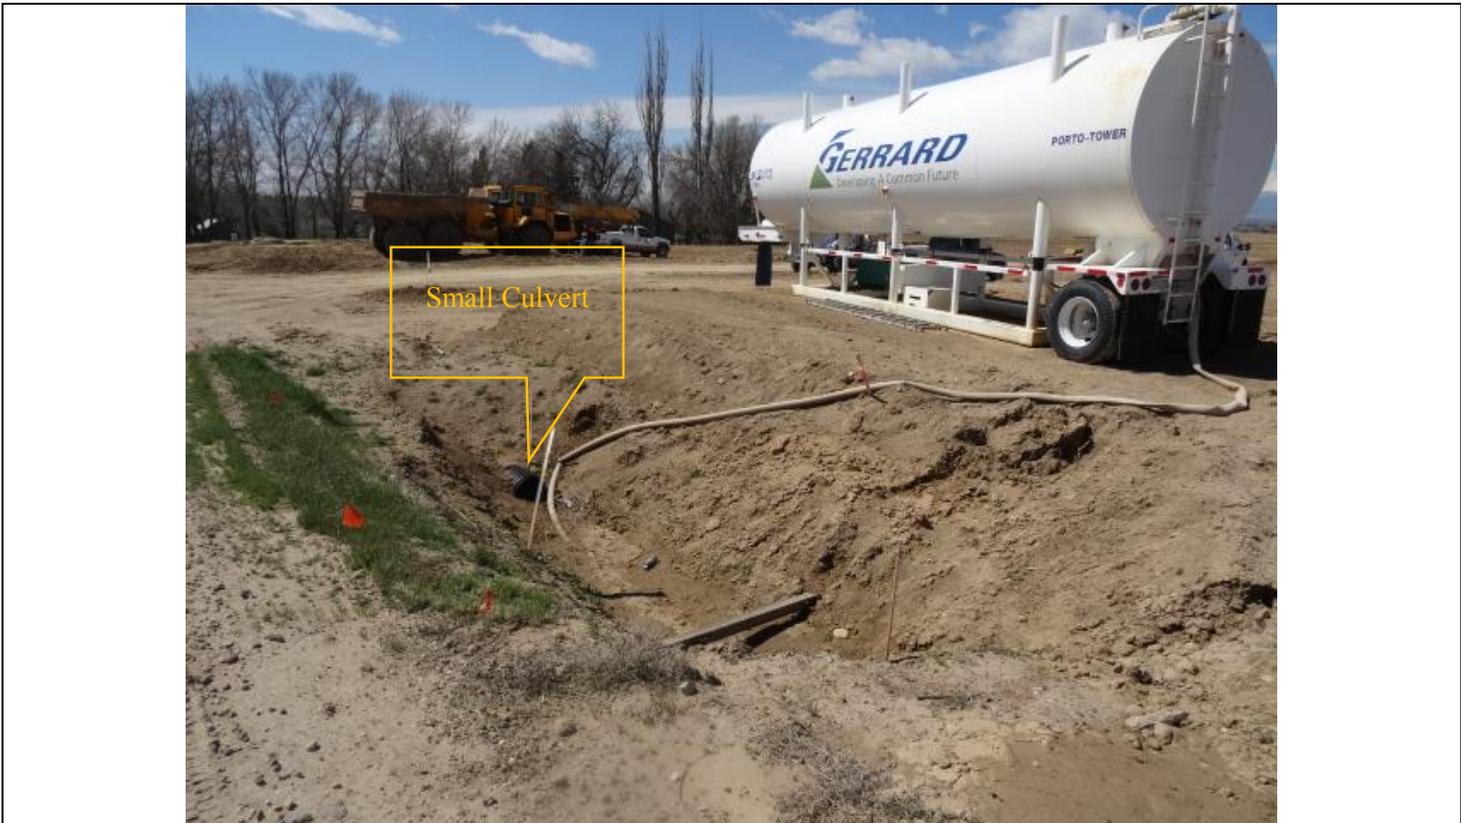
- a. The Inspector observed that control measures were not implemented to prevent stormwater runoff from entering the culvert basin and roadside ditch, located at the northeast corner of the site and identified in Inspection Report Photograph 1 (see Exhibit A). No additional control measures were implemented down gradient of this area. Stormwater from this area of the Project flows through the roadside ditch and discharges to the Big Thompson River.

Photograph 1: CR3 Roadside ditch, NE corner of project, no control measures.

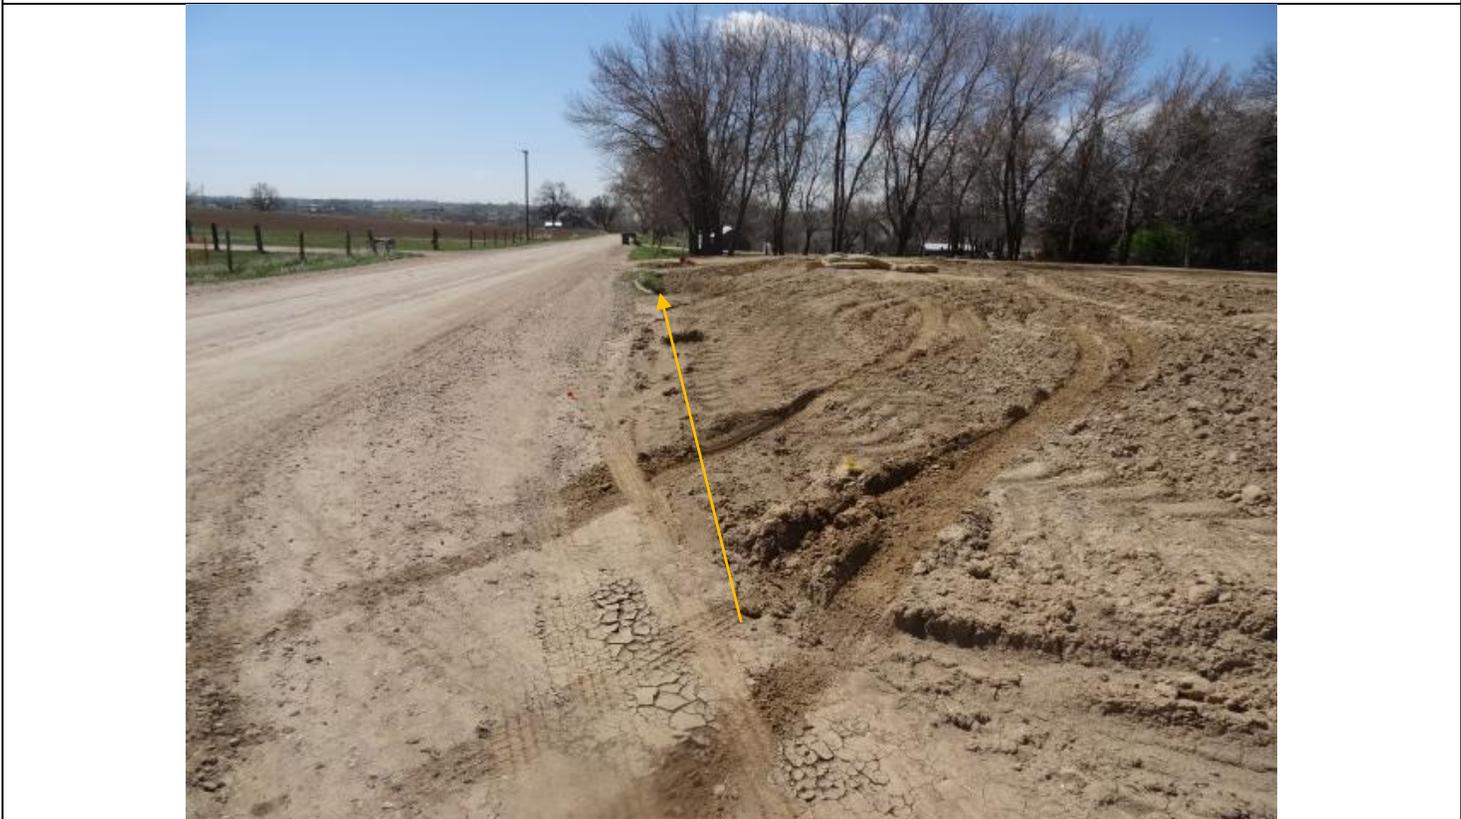
Photograph 2: CR3 Roadside ditch, NE corner of project, flow path to the south (yellow arrow).

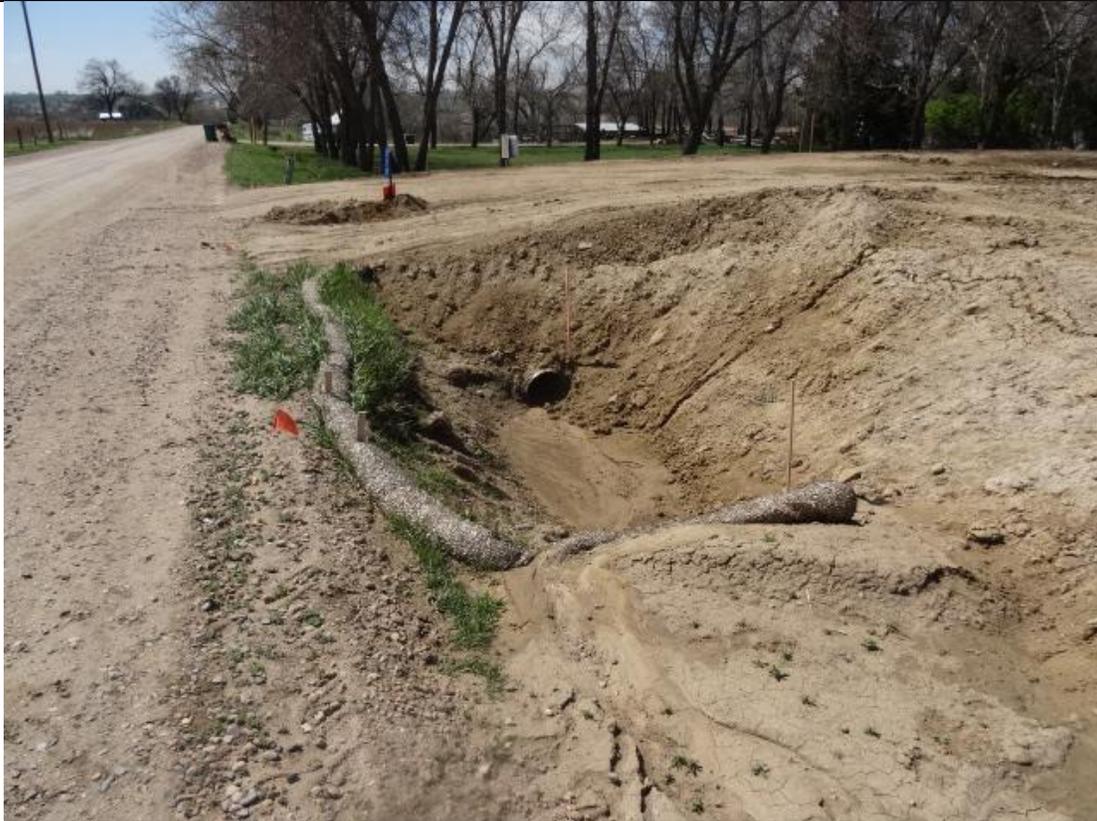
- b. The Inspector observed that inadequate control measures were implemented to prevent stormwater runoff from entering the culvert basin and roadside ditch, located along County Road 3 and identified in Inspection Report Photographs 3 and 4 (see Exhibit A). No additional control measures were implemented down gradient of this area. Stormwater from this area of the Project flows through the roadside ditch and discharges to the Big Thompson River.

Photograph 3: CR3 Roadside ditch, culvert outlet basin from photograph 1, inadequate/no control measures.

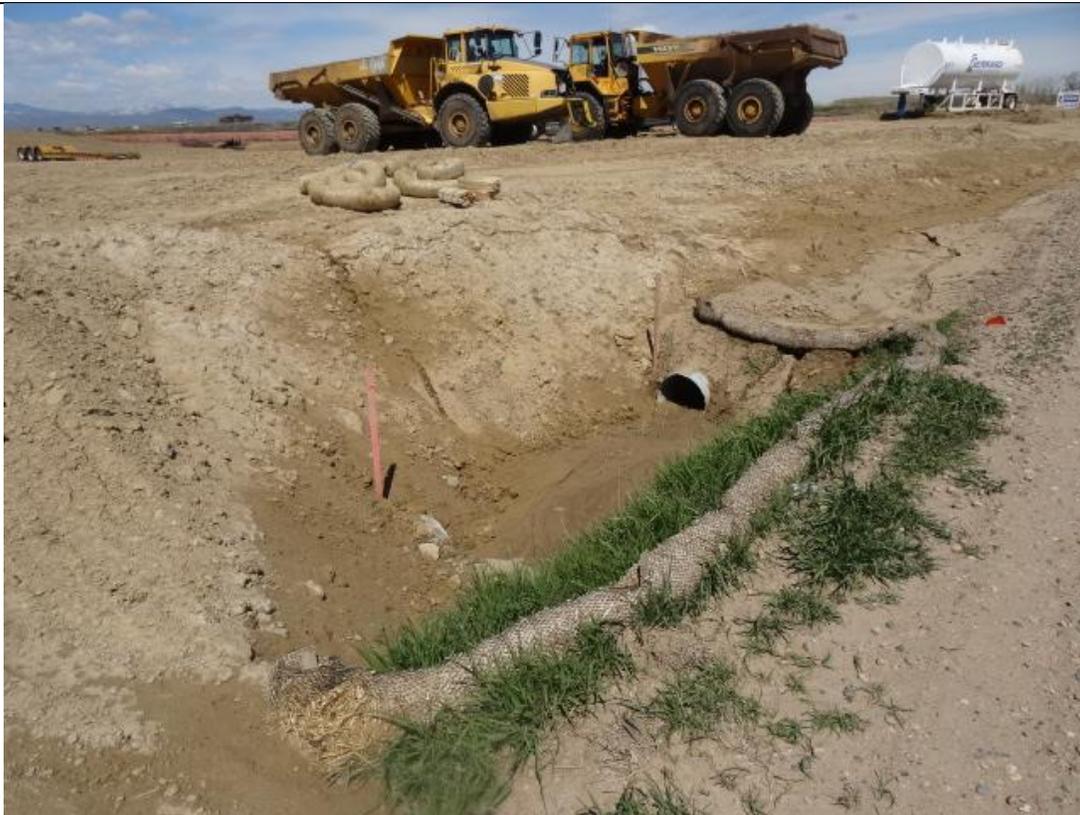
Photograph 4: See photograph 3, reverse view.

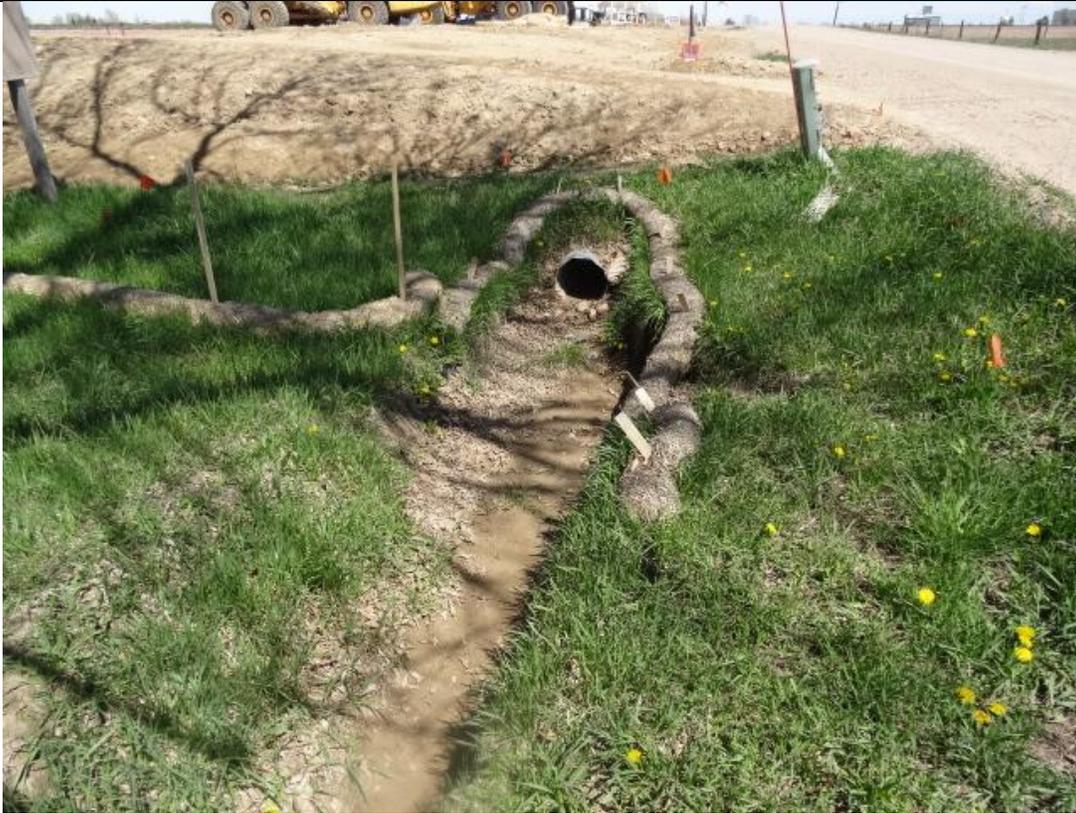
- c. The Inspector observed that control measures were not implemented to reduce erosion and/or the flow velocity of stormwater runoff from the bottom culvert outlet, located along County Road 3 and identified in Inspection Report Photograph 5 (see Exhibit A). No additional control measures were implemented down gradient of this area. Stormwater from this area of the Project flows through the roadside ditch and discharges to the Big Thompson River.

Photograph 5: CR3 Roadside ditch, bottom culvert outlet, minimal sediment deposition.

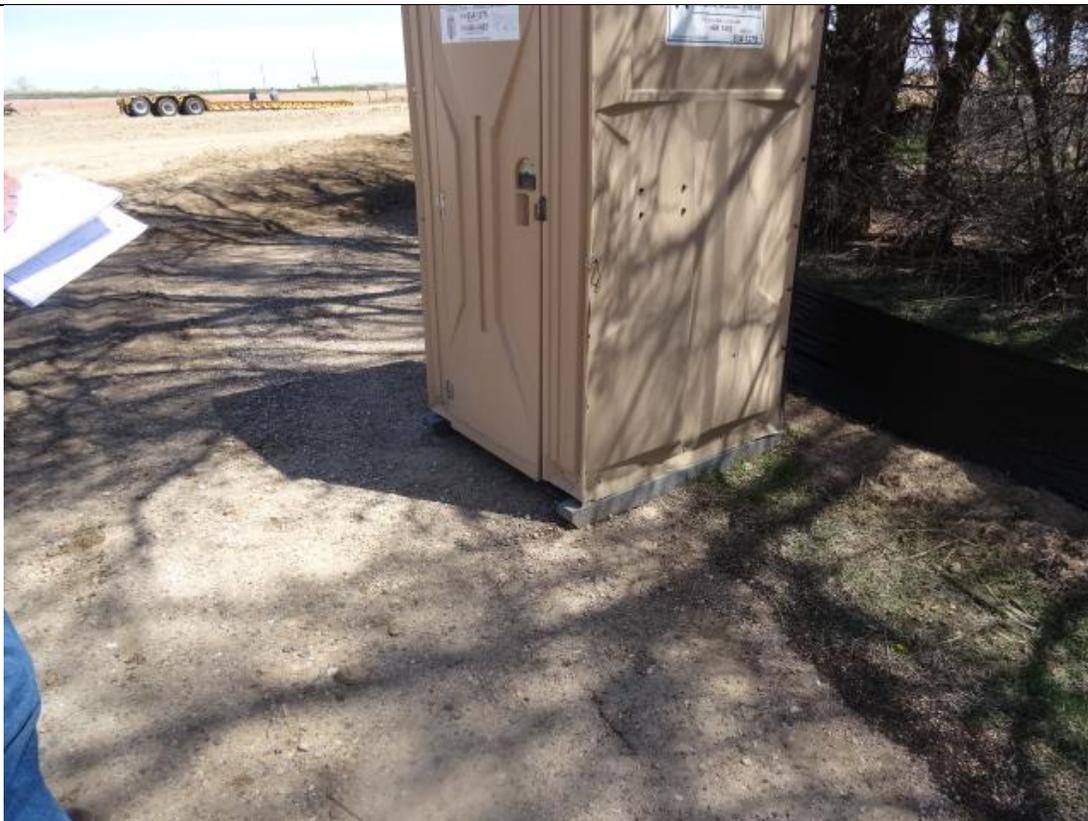
- e. The Inspector observed that control measures were not implemented to manage pollutant contributions from chemical waste from the portable toilets located behind the house in the northeast section of the project. Specifically, the portable toilet was not secured to the ground in order to prevent tipping, per common industry standards. An additional silt fence control measure was implemented down gradient of the portable toilet but this control measure was inadequate to manage pollutant contributions from the portable toilet. Stormwater from this area of the Project flows south to the Big Thompson River.

Photograph 6: Northeast area of project behind house, portable toilet not secured to the ground.

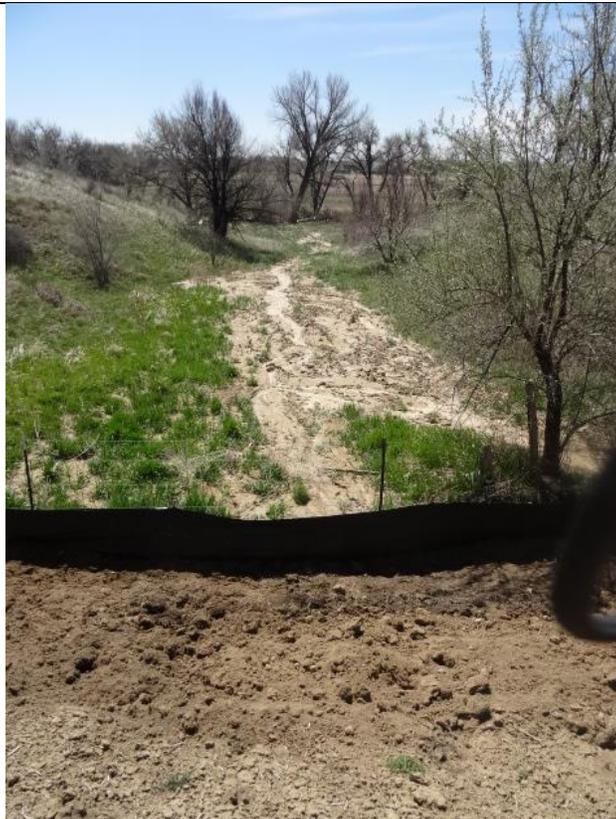
Photograph 8: See photograph 7.

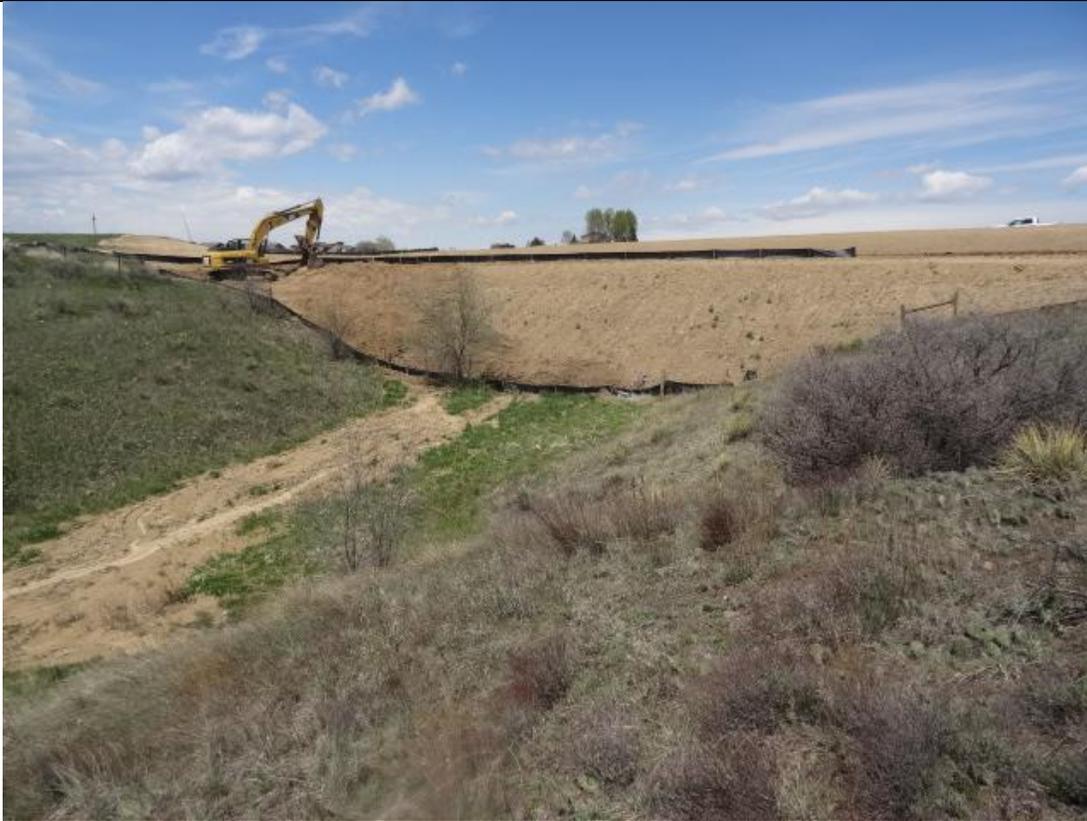
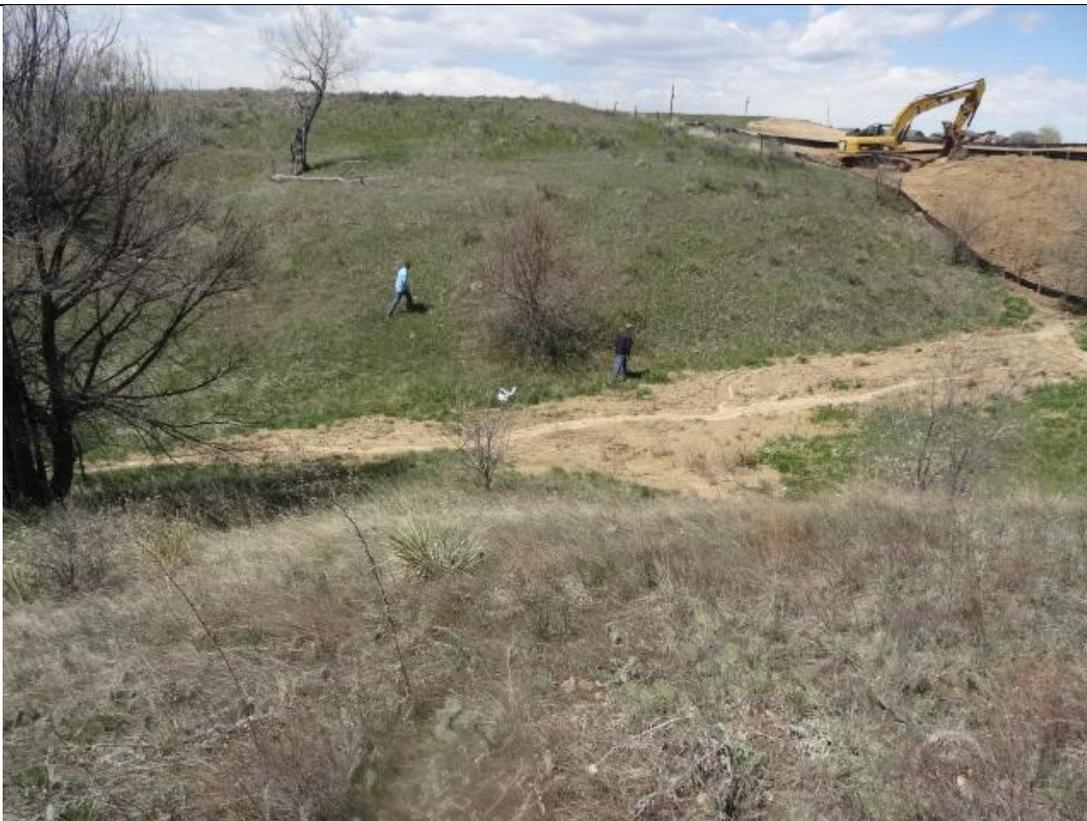
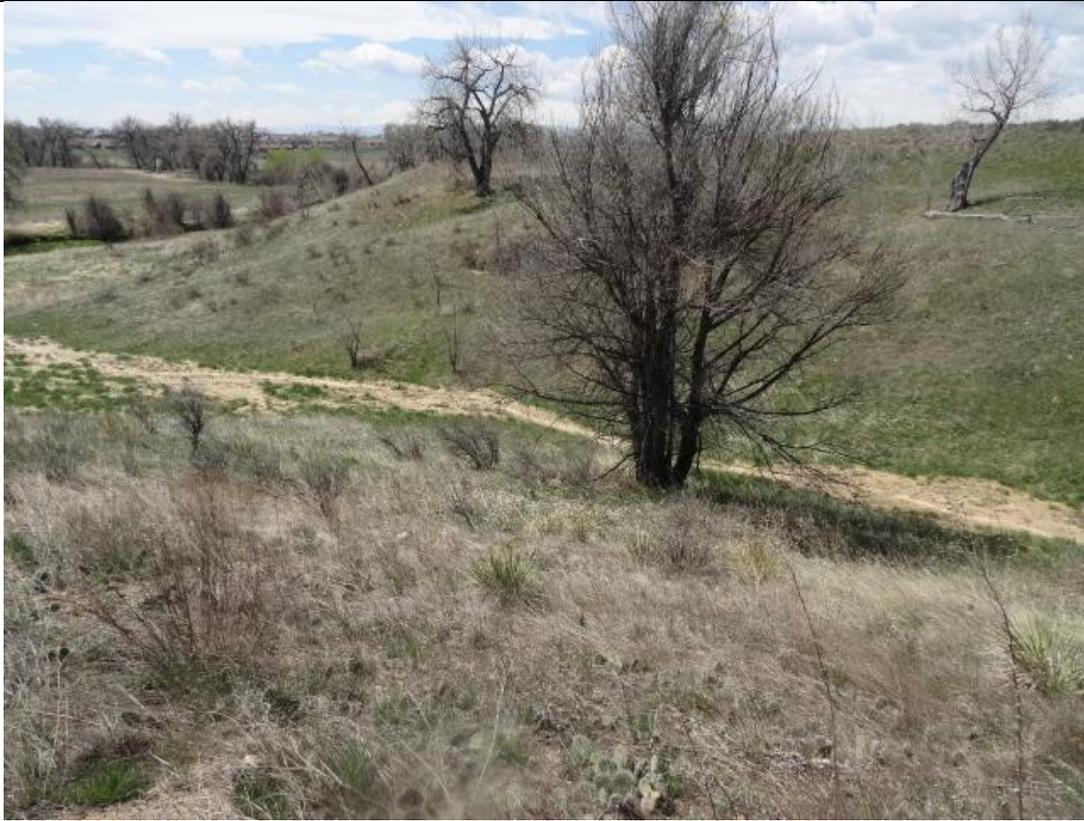
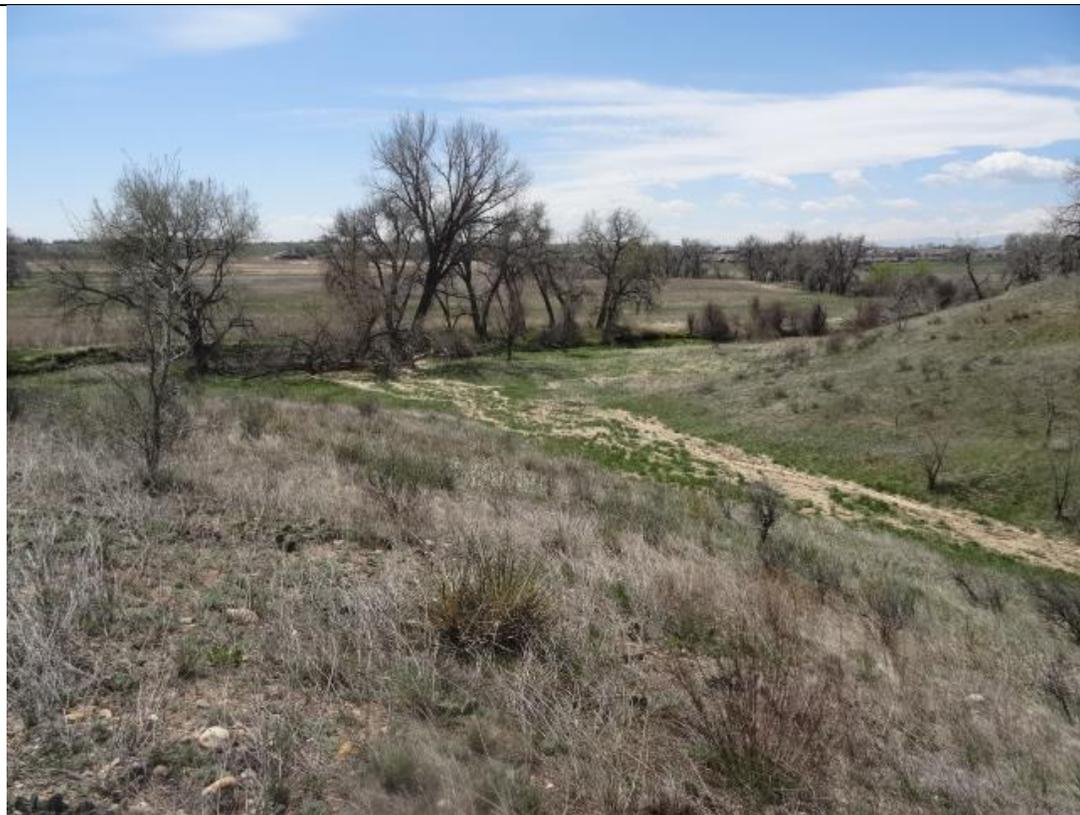
Photograph 9: Photo 1 of 4, sediment flow path from project lower limit to the Big Thompson River.

Photograph 10: Photo 2 of 4, sediment flow path from project lower limit to the Big Thompson River.

Photograph 11: Photo 3 of 4, sediment flow path from project lower limit to the Big Thompson River.

Photograph 12: Photo 4 of 4, sediment flow path from project lower limit to the Big Thompson River.

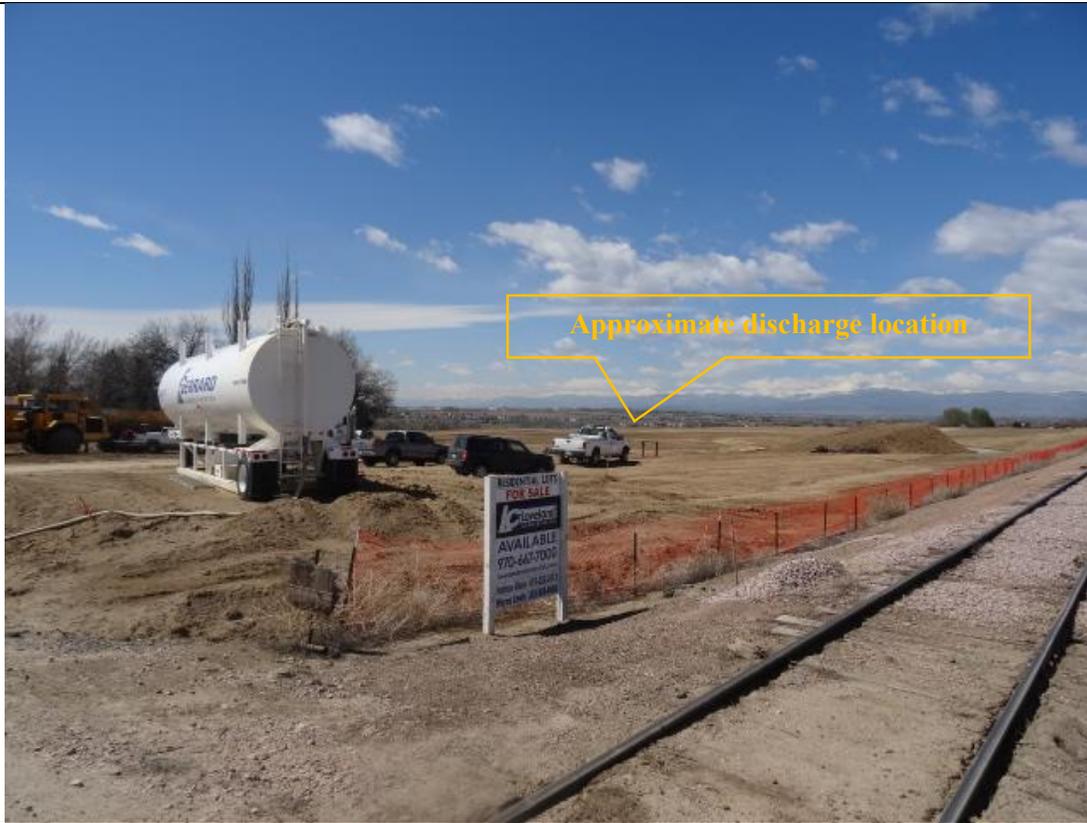
Photograph 21: NE corner of project looking southwest, upper contributing area to discharge point.

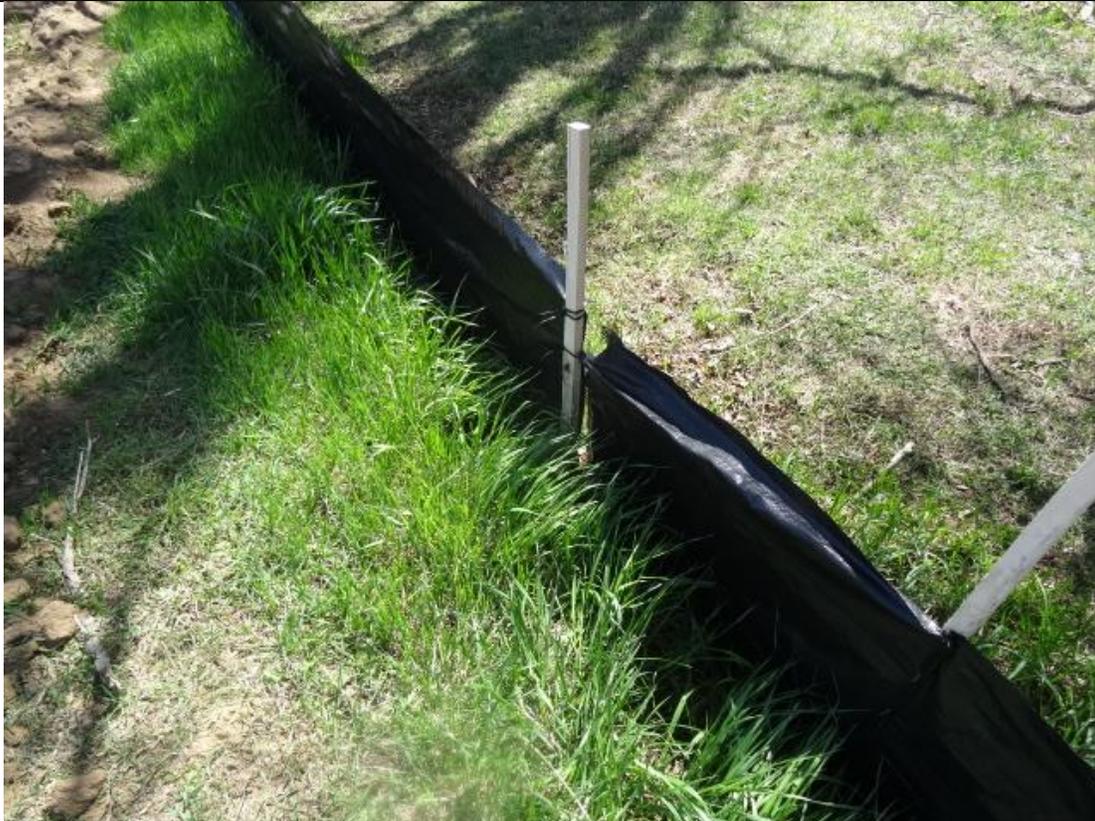
- f. The Inspector observed a silt fence control measure located at the northeast corner of the site and identified in Inspection Report Photograph 27 (see Exhibit A). The silt fence was not implemented and maintained according to the SWMP or common industry standards. The silt fence control measure contained holes or tears, and was not joined at the posts and rotated 180 degrees so no gaps existed. These deficiencies impaired the ability of the silt fence to provide an effective mechanism to manage stormwater runoff. No additional control measures were implemented down gradient of this area. Stormwater from this area of the Project flows east and south to the Big Thompson River.

Photograph 27: Silt fence not installed per specification (joint). Refer to photo point map for location.

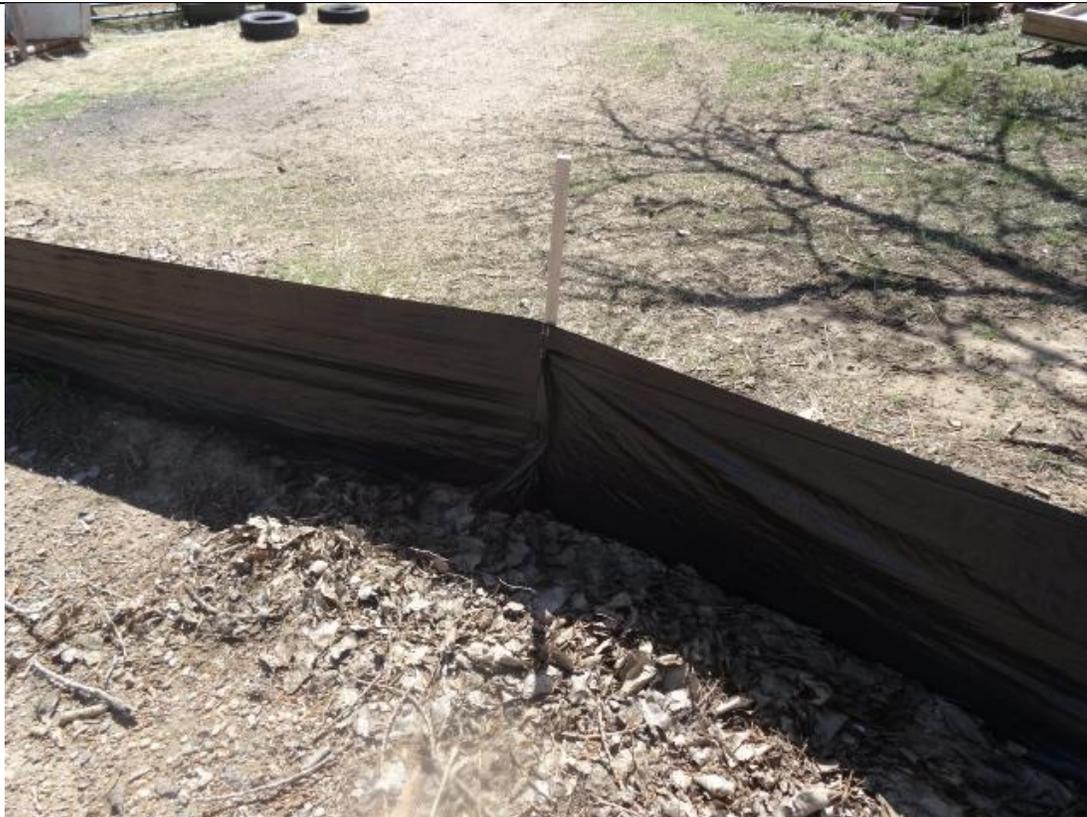
Photograph 28: Silt fence not installed per specification (joint). Refer to photo point map for location.

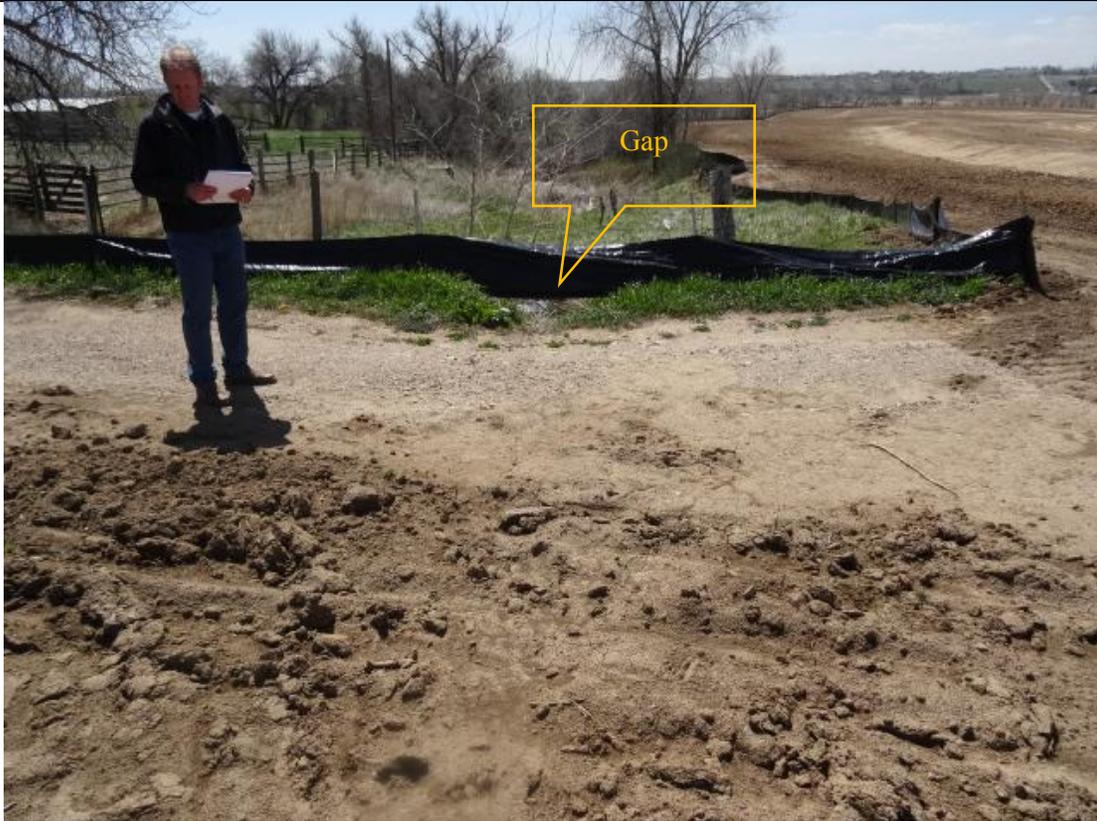
- g. The Inspector observed a silt fence control measure located at the northeast portion of the site and identified in Inspection Report Photograph 29 (see Exhibit A). The silt fence was not implemented and/or maintained according to the SWMP or common industry standards. The silt fence control measure was not properly anchored in a trench, which produced a gap between the ground and the silt fence. This deficiency impaired the ability of the silt fence to provide an effective mechanism to manage stormwater runoff. No additional control measures were implemented down gradient of this area. Stormwater from this area of the Project flows east and south to the Big Thompson River.

Photograph 29: Silt fence not installed per specification (gap under fence). Refer to photo point map for location.

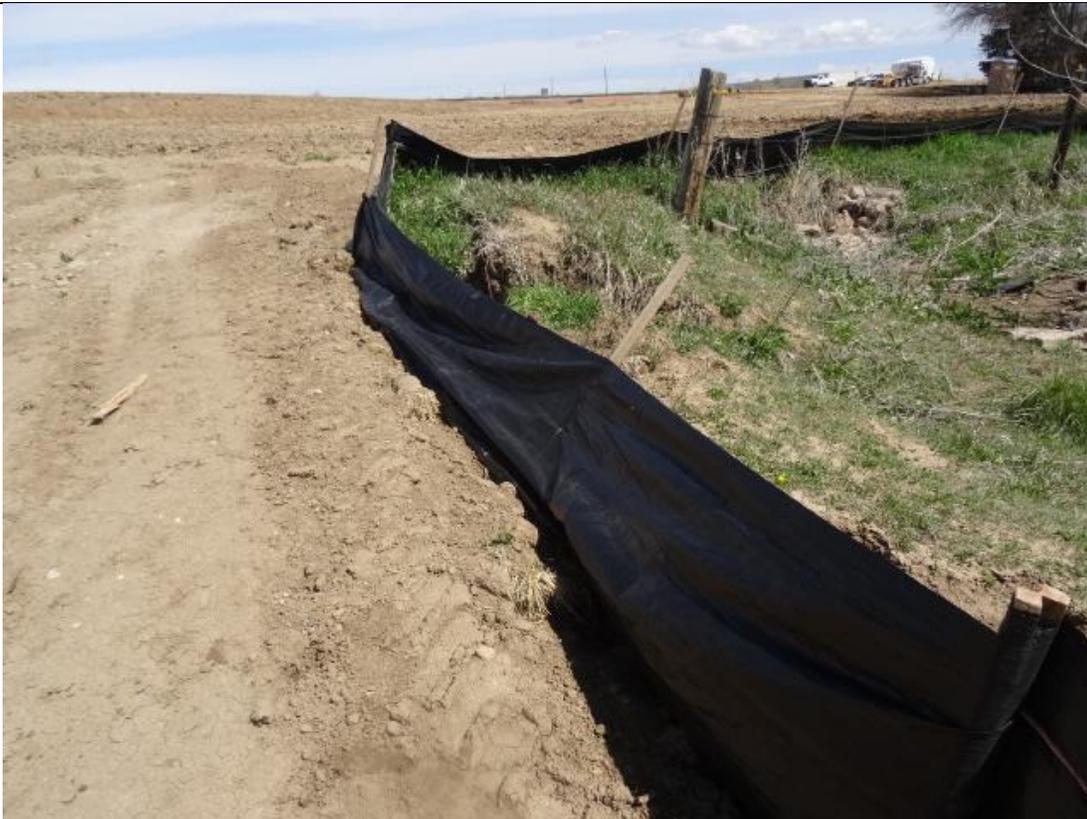
- h. The Inspector observed a silt fence control measure located at the northeast portion of the site and identified in Inspection Report Photograph 30 (see Exhibit A). The silt fence was not implemented and/or maintained according to the SWMP or common industry standards. The silt fence control measure was not properly staked allowing the silt fence to sag. This deficiency impaired the ability of the silt fence to provide an effective mechanism to manage stormwater runoff. No additional control measures were implemented down gradient of this area. Stormwater from this area of the Project flows east and south to the Big Thompson River.

Photograph 30: Silt fence not maintained per specification (staking). Refer to photo point map for location.

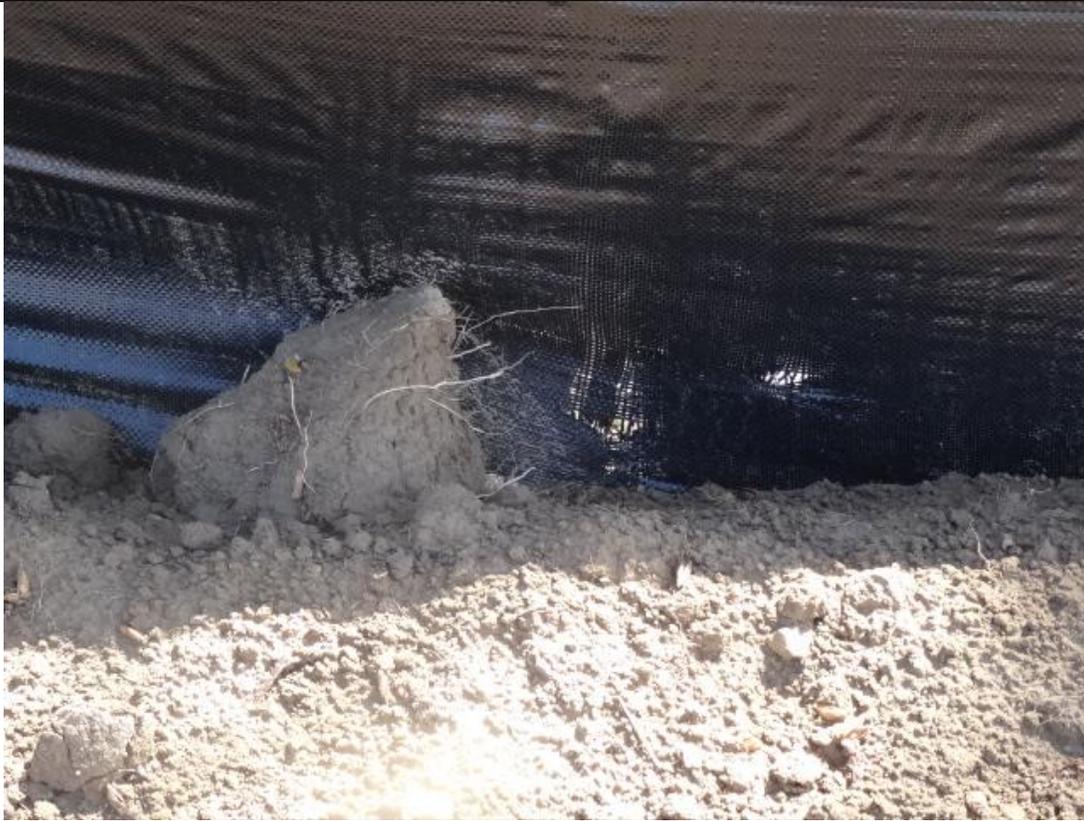
- i. The Inspector observed a silt fence control measure located at the east side of the site and identified in Inspection Report Photograph 31 (see Exhibit A). The silt fence was not maintained according to common industry standards. The silt fence control measure contained holes or tears. These deficiencies impaired the ability of the silt fence to provide an effective mechanism to manage stormwater runoff. No additional control measures were implemented down gradient of this area. Stormwater from this area of the Project flows east and south to the Big Thompson River.

**Photograph 31:** Silt fence not maintained per specification (holes). Refer to photo point map for location.

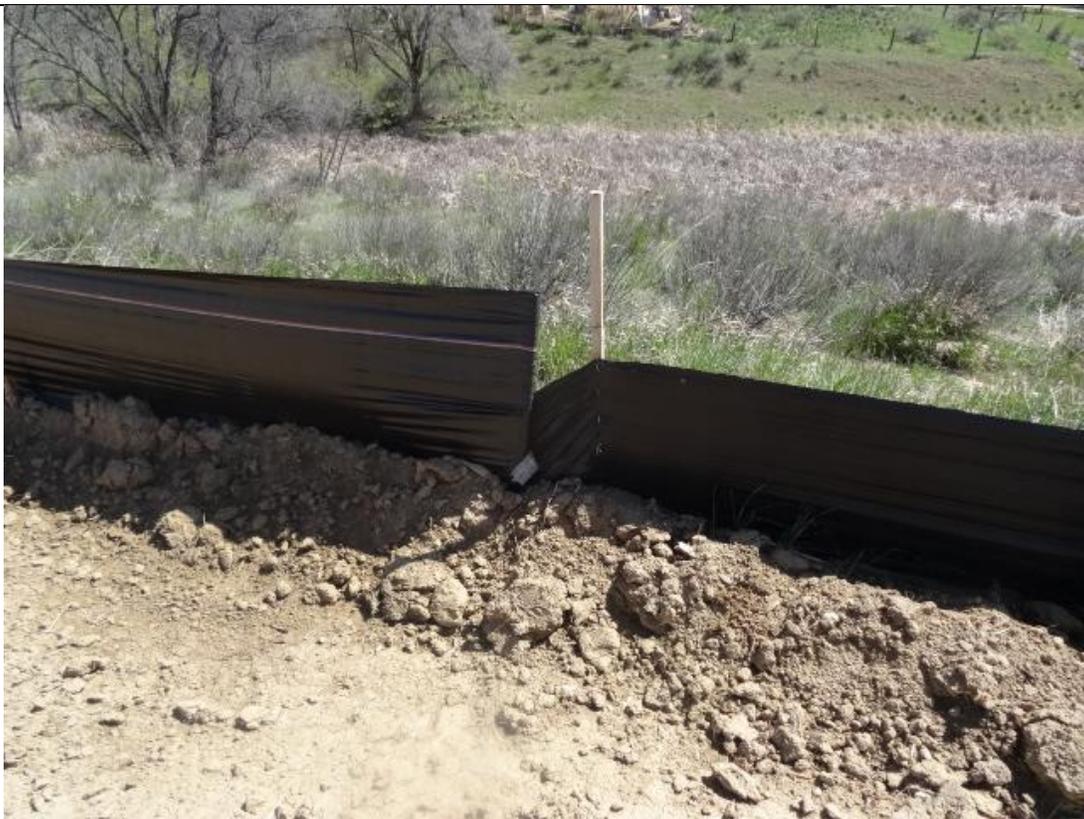
- j. The Inspector observed a silt fence control measure located at the east side of the site and identified in Inspection Report Photograph 32 (see Exhibit A). The silt fence was not implemented and/or maintained according to common industry standards. The silt fence control measure contained a gap in the joint. This deficiency impaired the ability of the silt fence to provide an effective mechanism to manage stormwater runoff. No additional control measures were implemented down gradient of this area. Stormwater from this area of the Project flows east and south to the Big Thompson River.

**Photograph 32:** Silt fence not installed per specification (joint). Refer to photo point map for location.

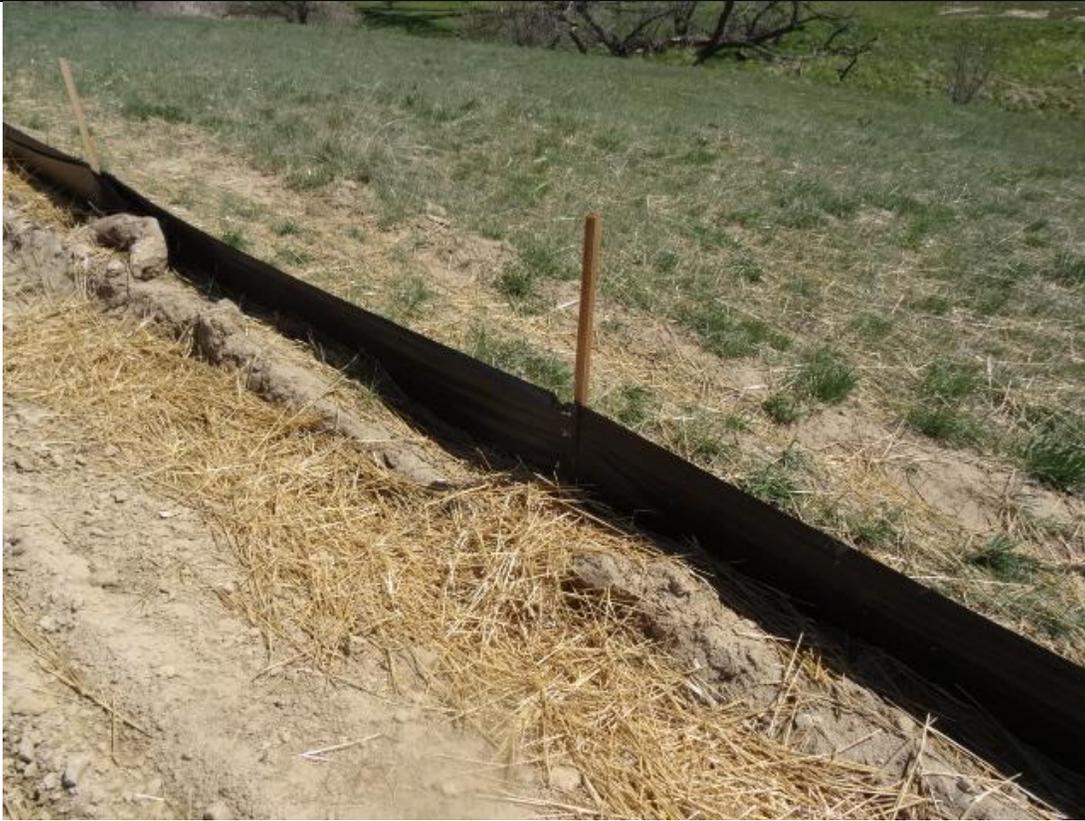
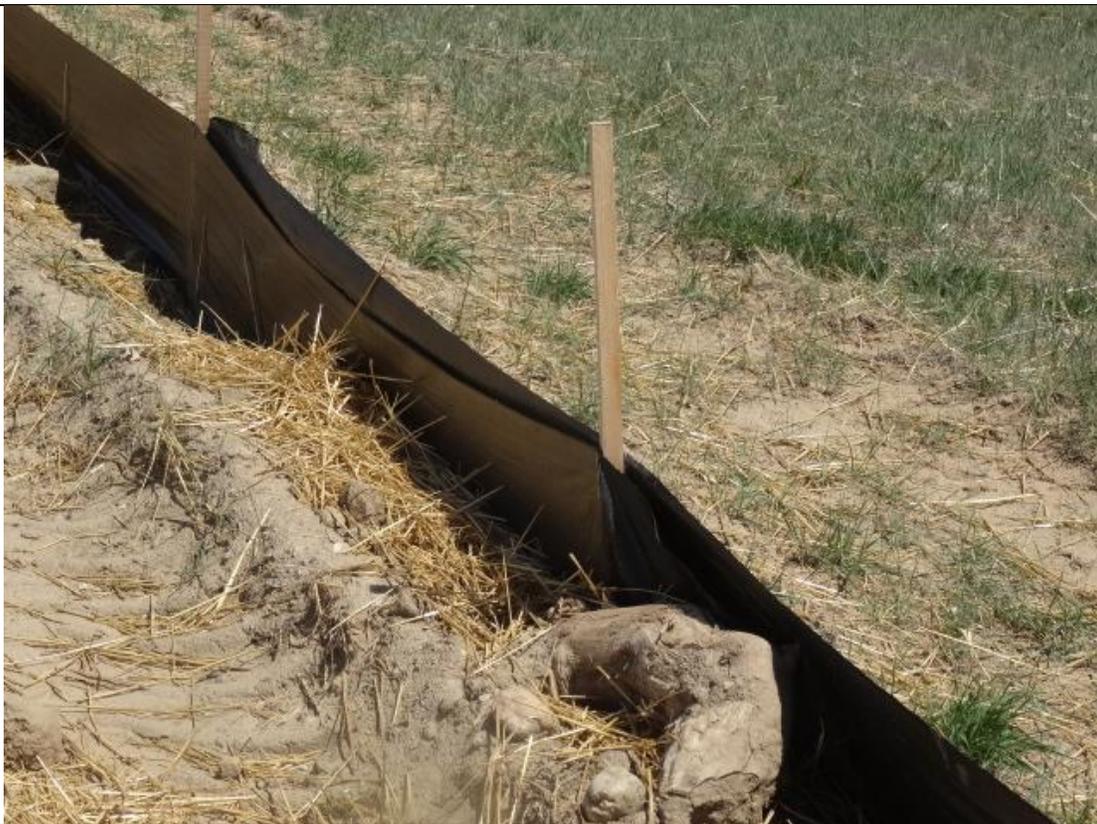
- k. The Inspector observed a silt fence control measure located at the east side of the site and identified in Inspection Report Photographs 33 and 34 (see Exhibit A). The silt fence was not implemented and maintained according to common industry standards. The silt fence control measure contained holes or tears, and was not joined at the posts and rotated 180 degrees so no gaps existed. These deficiencies impaired the ability of the silt fence to provide an effective mechanism to manage stormwater runoff. No additional control measures were implemented down gradient of this area. Stormwater from this area of the Project flows east and south to the Big Thompson River.

**Photograph 33:** Silt fence not maintained per specification (holes, staking). Refer to photo point map for location.

**Photograph 34:** Silt fence not installed per specification (joint). Refer to photo point map for location.

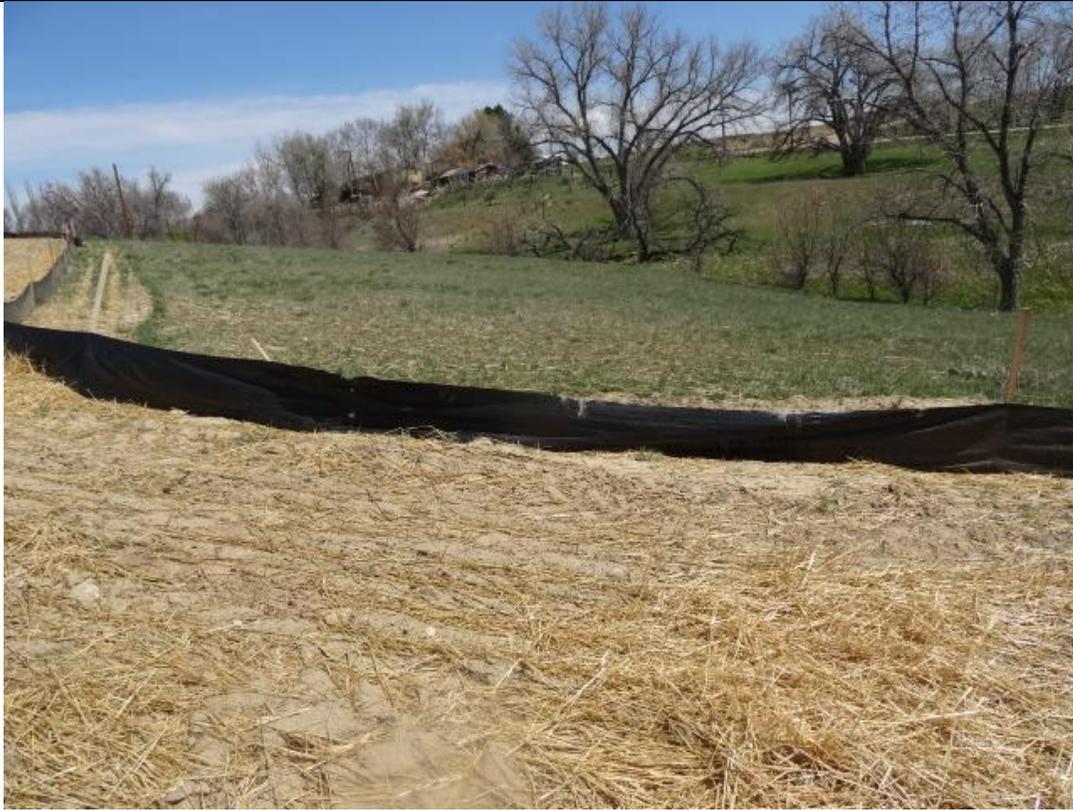
**Photograph 35:** Silt fence not maintained per specification (holes, staking). Refer to photo point map for location.
