**RE: Service of Notice of Violation/Cease and Desist Order, Number: SO-150817-1**

NOTICE OF VIOLATION / CEASE AND DESIST

### Thompson Crossing II - Photo Points

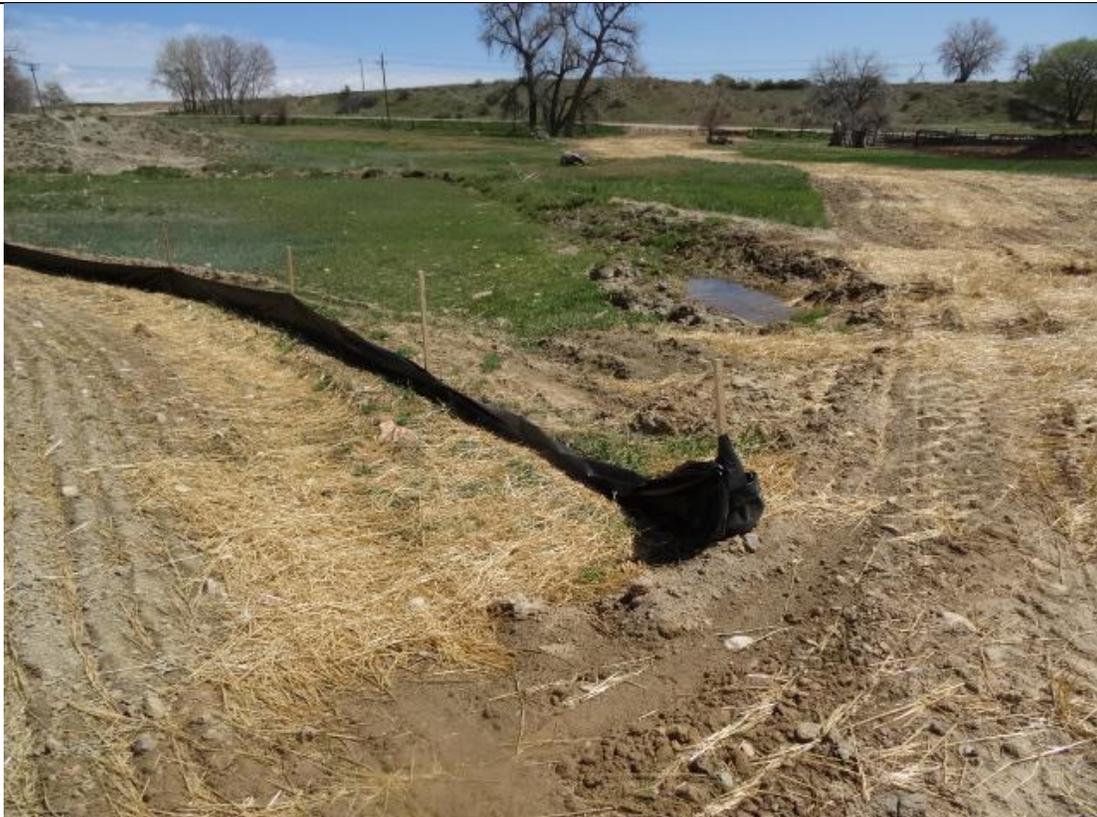
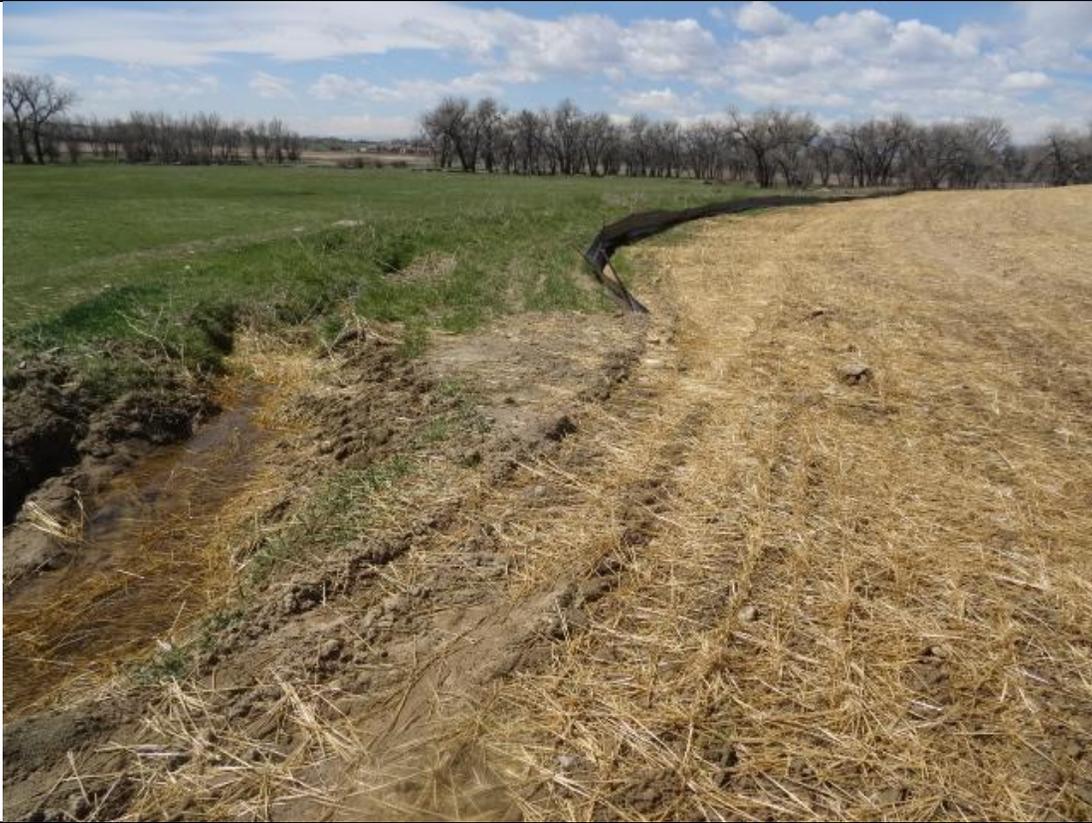
- l. The Inspector observed a silt fence control measure located at the southeast corner of the site and identified in Inspection Report Photographs 36 and 37 (see Exhibit A). The silt fence was not implemented and/or maintained according to the SWMP or common industry standards. The silt fence control measure was not properly staked allowing the silt fence to sag. This deficiency impaired the ability of the silt fence to provide an effective mechanism to manage stormwater runoff. No additional control measures were implemented down gradient of this area. Stormwater from this area of the Project flows east and south to the Big Thompson River.

**Photograph 36:** Silt fence not maintained per specification (staking). Refer to photo point map for location.

**Photograph 37:** Silt fence not maintained per specification (staking). Refer to photo point map for location.

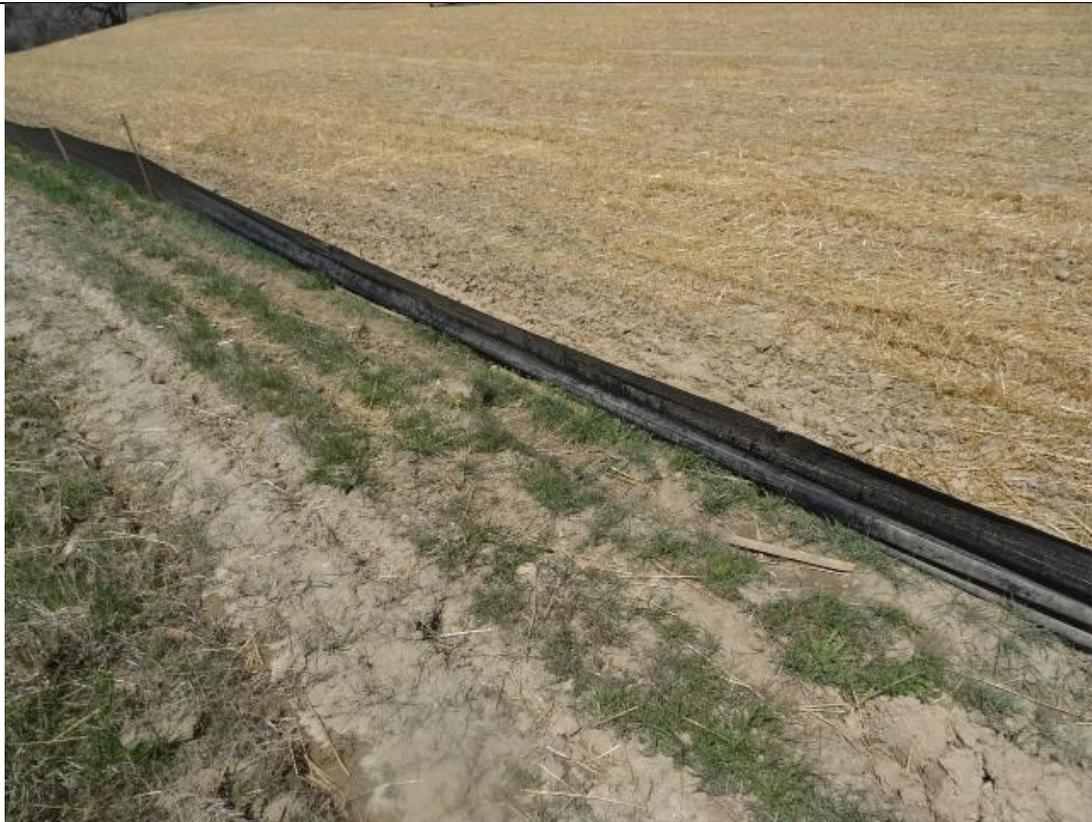
- m. The Inspector observed a silt fence control measure located at the southeast portion of the site and identified in Inspection Report Photograph 38 (see Exhibit A). The silt fence was not implemented and/or maintained according to the SWMP or common industry standards. The silt fence control measure was not properly staked allowing the silt fence to sag. This deficiency impaired the ability of the silt fence to provide an effective mechanism to manage stormwater runoff. No additional control measures were implemented down gradient of this area. Stormwater from this area of the Project flows south to the Big Thompson River.

**Photograph 38:** Silt fence not maintained per specification (staking). Refer to photo point map for location.

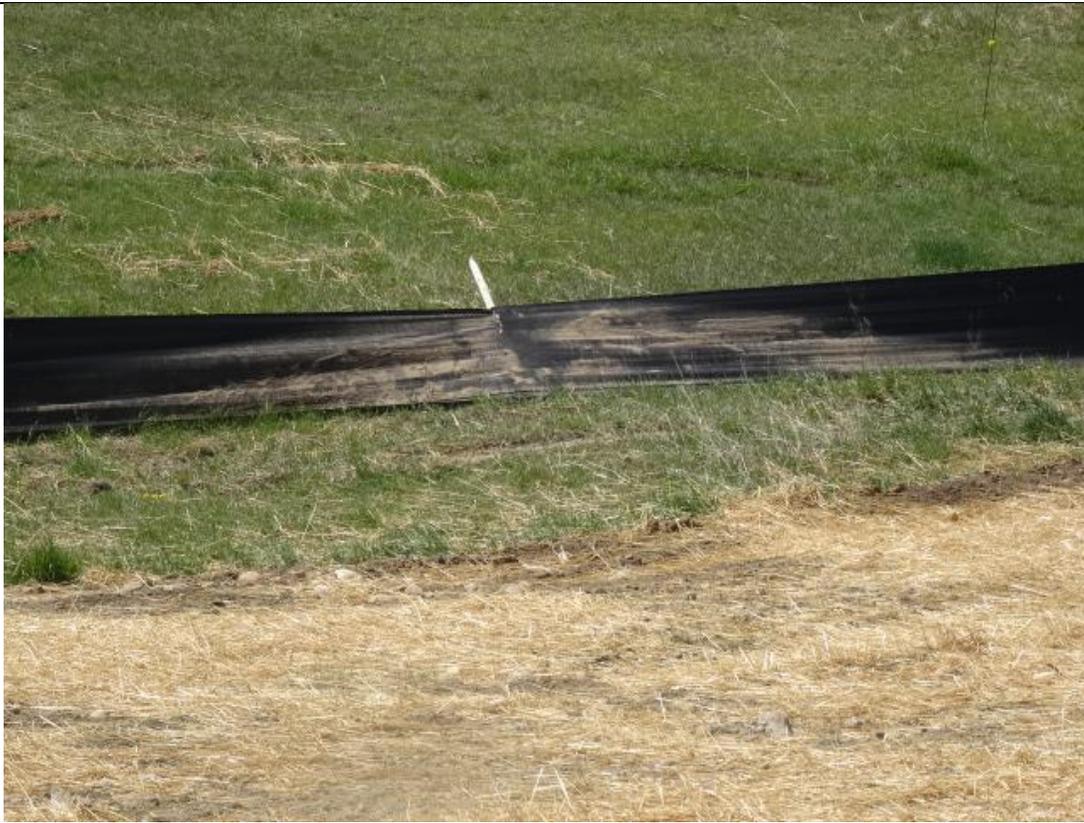
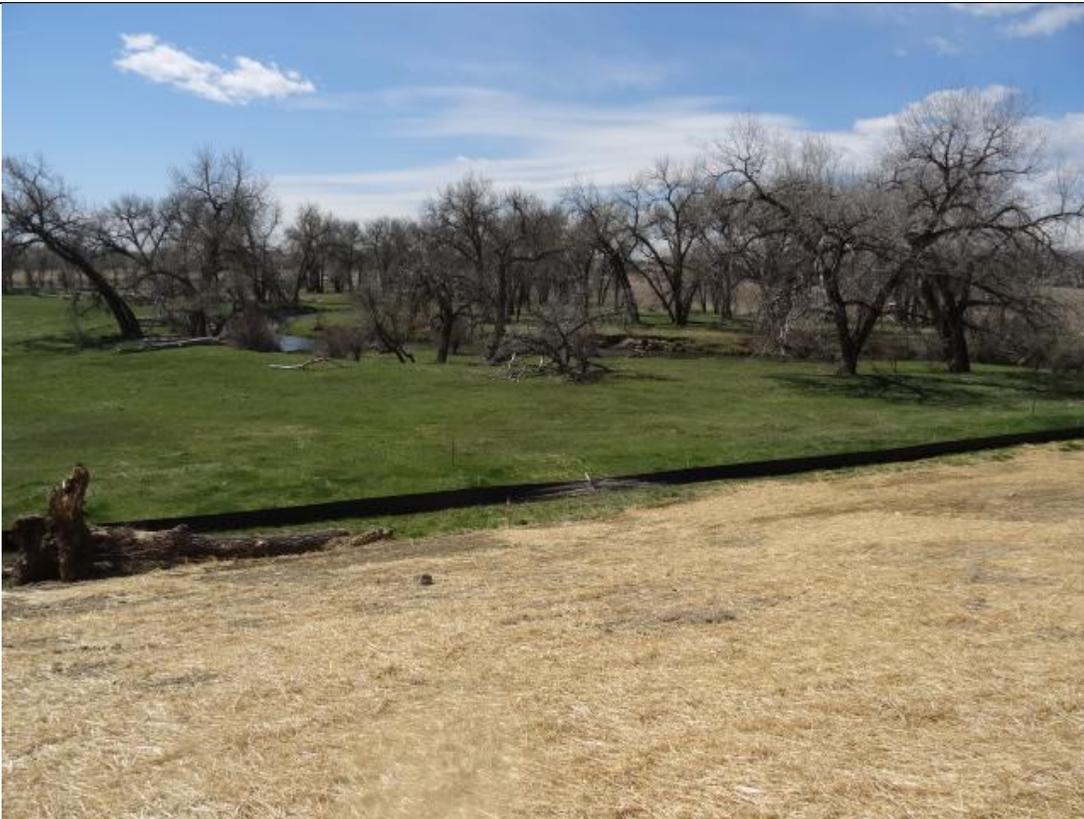
- n. The Inspector observed a silt fence control measure located at the south side of the site and identified in Inspection Report Photographs 39 and 40 (see Exhibit A). The silt fence was not implemented and/or maintained according to the SWMP or common industry standards. The silt fence control measure was not properly staked allowing the silt fence to sag. This deficiency impaired the ability of the silt fence to provide an effective mechanism to manage stormwater runoff. No additional control measures were implemented down gradient of this area. Stormwater from this area of the Project flows south to the Big Thompson River.

**Photograph 39:** Silt fence not maintained per specification (staking). Refer to photo point map for location.

**Photograph 40:** Refer to photograph 39.

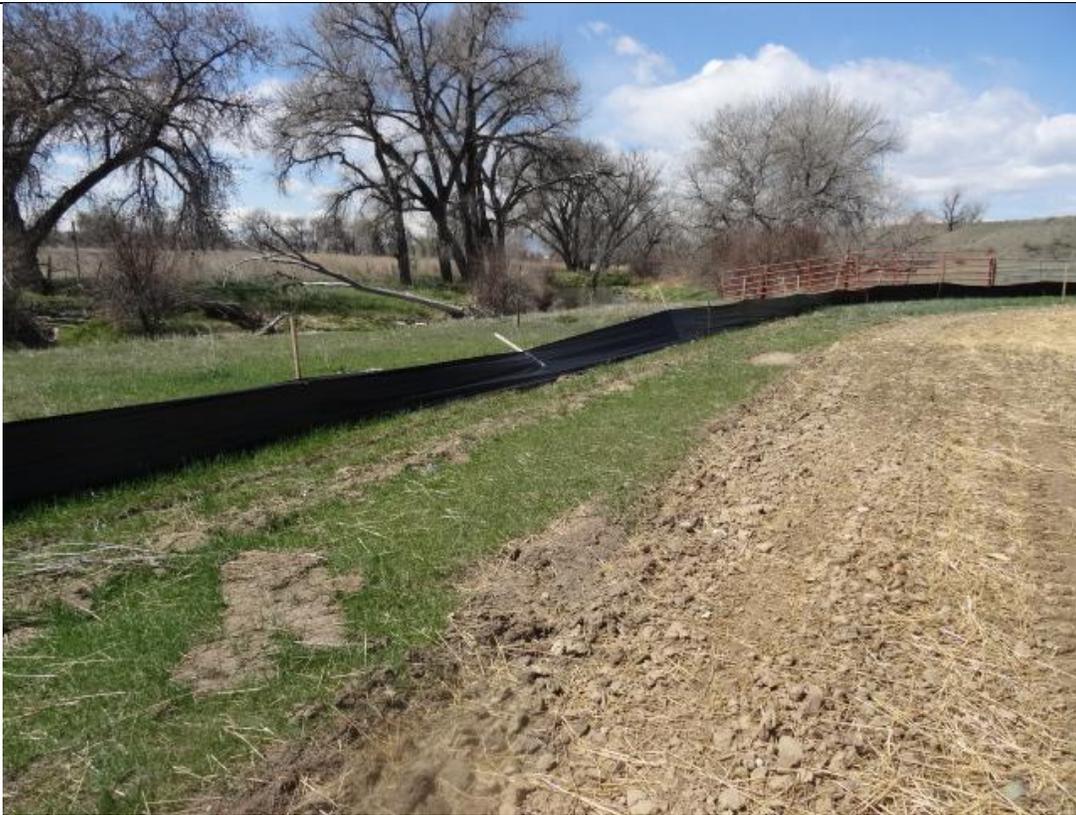
- o. The Inspector observed a silt fence control measure located at the south side of the site and identified in Inspection Report Photograph 41 (see Exhibit A). The silt fence was not implemented and/or maintained according to the SWMP or common industry standards. The silt fence control measure was not properly staked allowing the silt fence to sag. This deficiency impaired the ability of the silt fence to provide an effective mechanism to manage stormwater runoff. No additional control measures were implemented down gradient of this area. Stormwater from this area of the Project flows south to the Big Thompson River.

Photograph 41: Silt fence not maintained per specification (staking). Refer to photo point map for location.

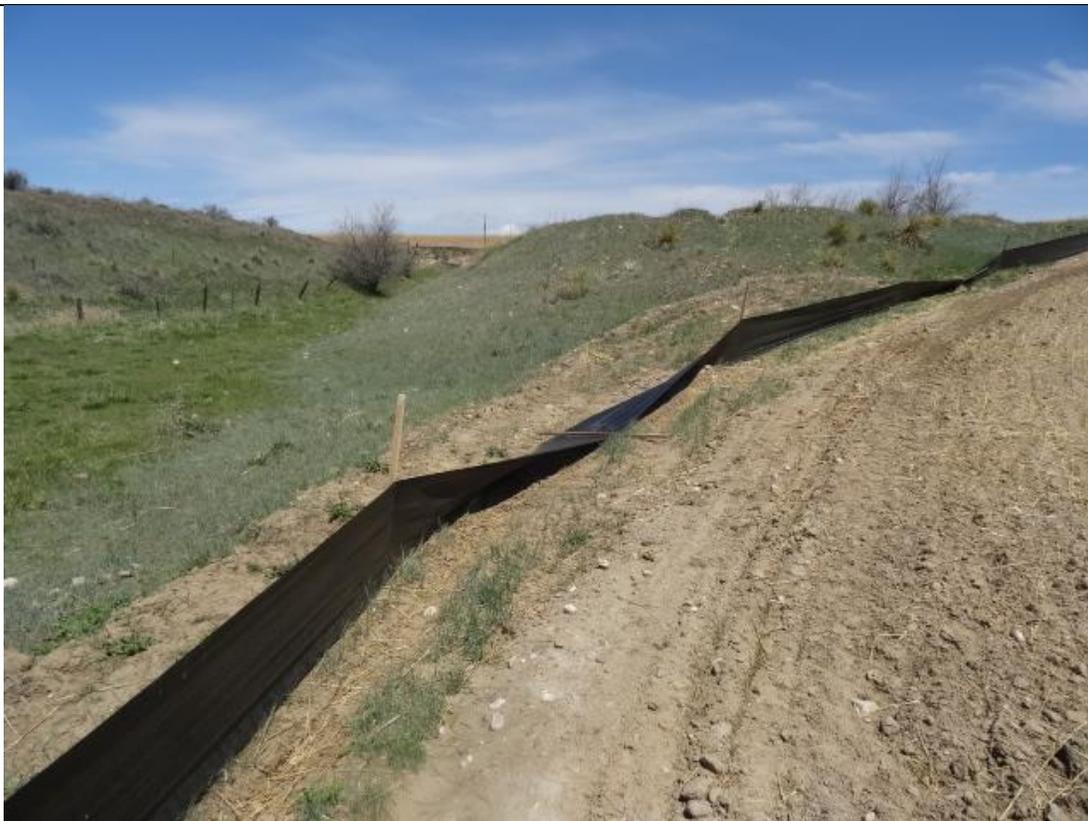
- p. The Inspector observed a silt fence control measure located at the south side of the site and identified in Inspection Report Photograph 42 (see Exhibit A). The silt fence was not implemented and/or maintained according to the SWMP or common industry standards. The silt fence control measure was not properly staked allowing the silt fence to sag. This deficiency impaired the ability of the silt fence to provide an effective mechanism to manage stormwater runoff. No additional control measures were implemented down

Photograph 42: Silt fence not maintained per specification (staking). Refer to photo point map for location.

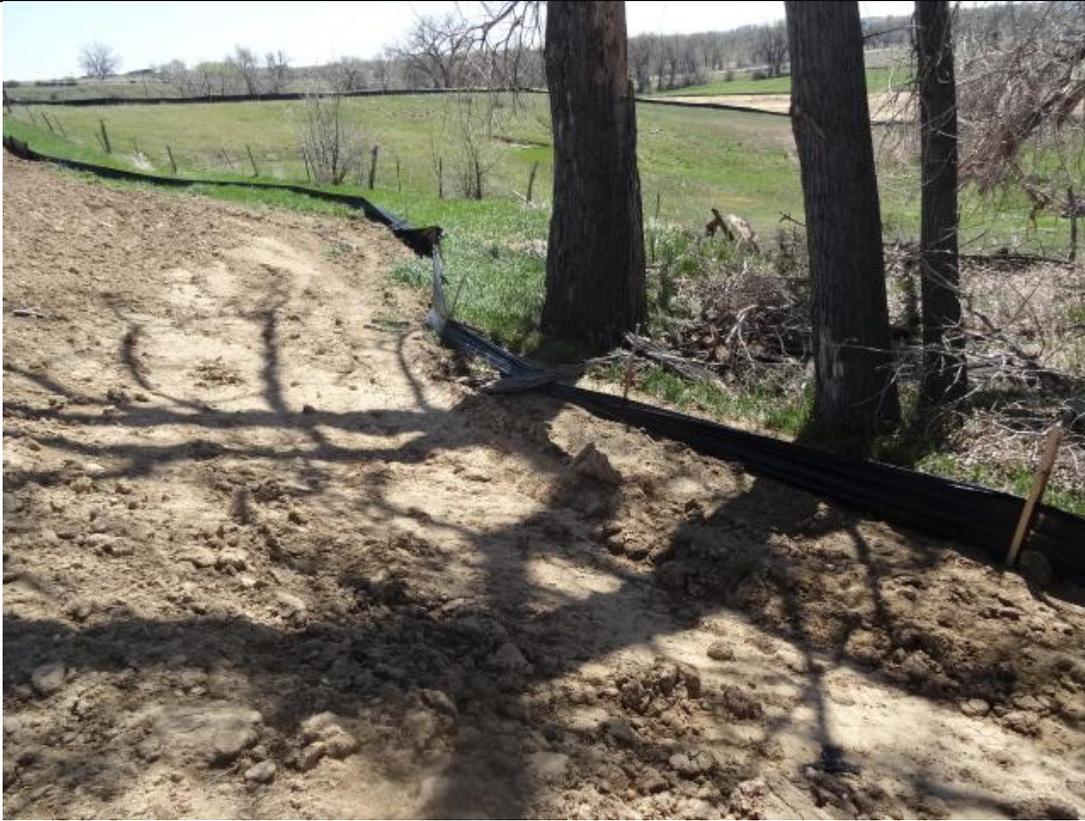
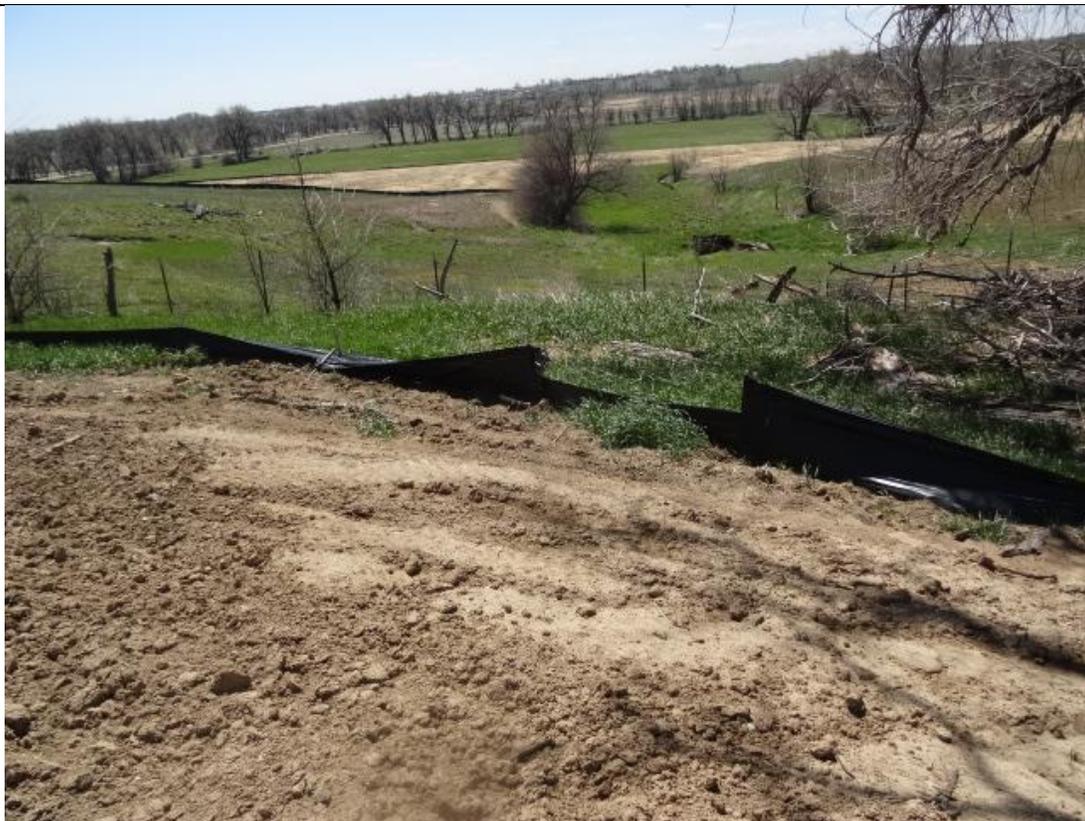
- q. The Inspector observed a silt fence control measure located at the central portion of the site and identified in Inspection Report Photographs 43 and 44 (see Exhibit A). The silt fence was not implemented and/or maintained according to the SWMP or common industry standards. The silt fence control measure was not properly staked allowing the silt fence to sag. This deficiency impaired the ability of the silt fence to provide an effective mechanism to manage stormwater runoff. No additional control measures were implemented down gradient of this area. Stormwater from this area of the Project flows south to the Big Thompson River.

Photograph 43: Silt fence not maintained per specification (staking). Refer to photo point map for location.

Photograph 44: Silt fence not maintained per specification (staking, joints). Refer to photo point map for location.

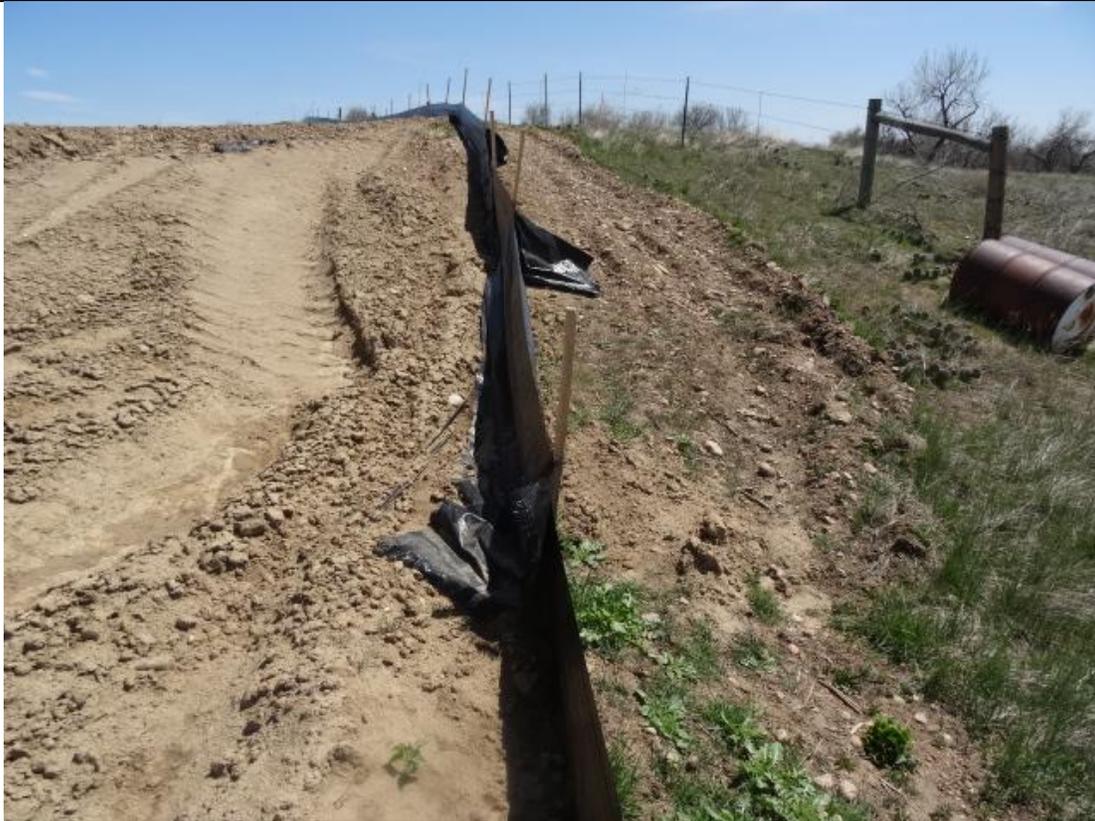
- r. The Inspector observed a silt fence control measure located at the west side of the site and identified in Inspection Report Photograph 45 (see Exhibit A). The silt fence was not implemented and maintained according to common industry standards. The silt fence control measure was not joined at the posts and rotated 180 degrees so no gaps existed. These deficiencies impaired the ability of the silt fence to provide an effective mechanism to manage stormwater runoff. No additional control measures were implemented down gradient of this area. Stormwater from this area of the Project flows west and south to the Big Thompson River.

Photograph 45: Silt fence not installed per specification (joints). Refer to photo point map for location.

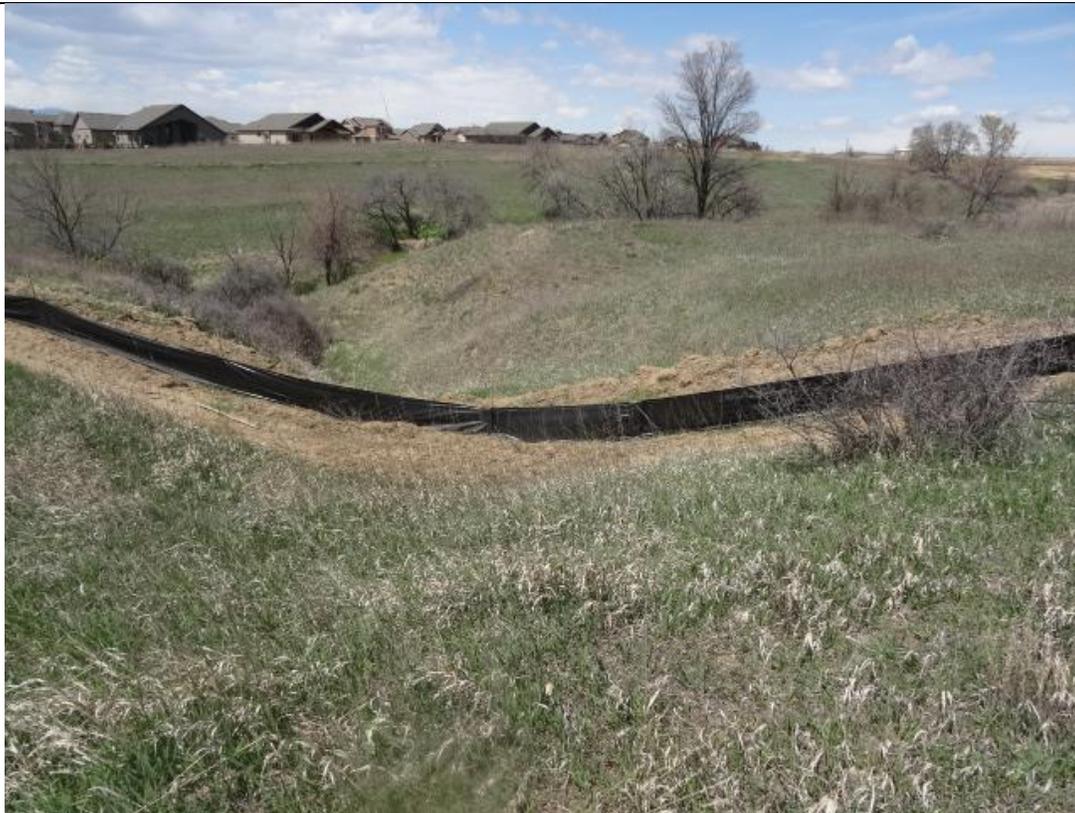
Photograph 46: Silt fence not installed per specification (concentrated flow). Refer to photo point map for location.
