ALAMOSA RIVER WATERSHED RESTORATION PROJECT

Conducted by: Alamosa – La Jara Water Conservancy District and the Alamosa Watershed Restoration Foundation

Contract Period: 2001-2006

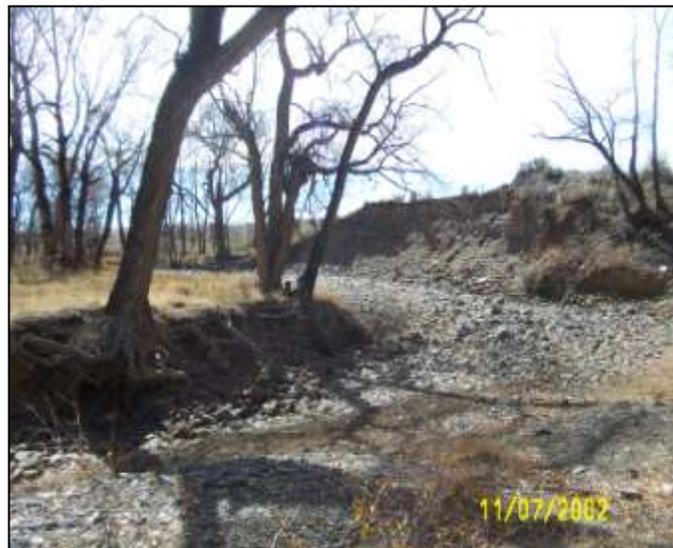
The river below Terrace Reservoir is highly unstable and suffers from severe erosion of the stream banks. This condition is the result of a major channel straightening project conducted in the early 1970s.

Before treatment. 2002

The channel is down-cutting in areas and is over-widened and braided in others, causing high bedload deposition that adds to the overall instability. The lack of perennial flow in the stream, during most of the year, inhibits the vegetation growth on the stream banks between the Gunbarrel and County Road 8. All these issues contribute to the high erosion rates and to the bedload entering the river system. The estimated amount of material that was being generated in the 2.5 mile project area prior to construction totaled 3212 cu yards per year, or 4,176 tons per year.

The goals of this project was to apply Best Management Practices (BMP's) to restore the health of the riparian zone, and to restore the balance of sediment transport continuity through re-establishment of a geomorphically stable stream.

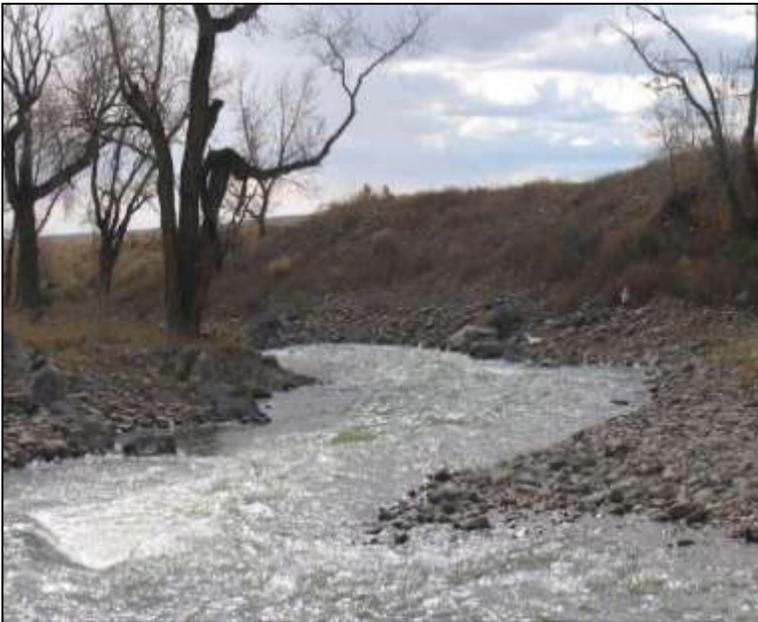
After treatment and 2 runoff seasons (2006)

This involved physically constructing the correct dimensions or width to depth ratios in the channel, reestablishing the meanders, creating the riffle/ pool sequence that occurs in a natural stable condition, and reconnecting the stream to the old flood plain.

Rock vanes were built in the outside bends to direct the stream flows back into the center of the stream, relieving the sheer stress on the riverbanks.

Rock cross vanes were placed in the bottom of the stream for grade control. This is to prevent further down-cutting of the channel bottom.
