STREAM RESTORATION

RIO GRANDE RIPARIAN STABILIZATION PROJECT

Conducted by: Rio Grande Conservation District

Contract Period: December 2001 through May 2006

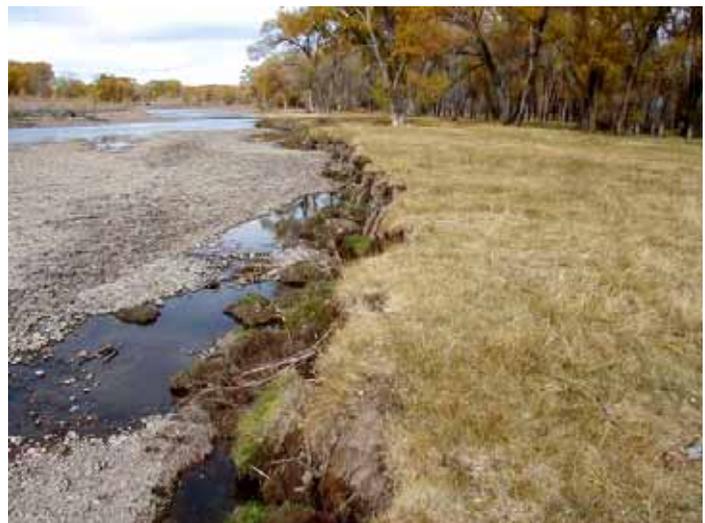
The primary water quality problem was caused by the lateral movement of the channel resulting in loss of stream bank stability and degradation of the riparian habitat, sedimentation in the channel and the resultant deposition of the bed load material down stream. Channel movement had resulted in deterioration of the riparian habitat and contributed an excessive amount of woody debris to the system through the degradation and loss of large herbaceous plant materials.

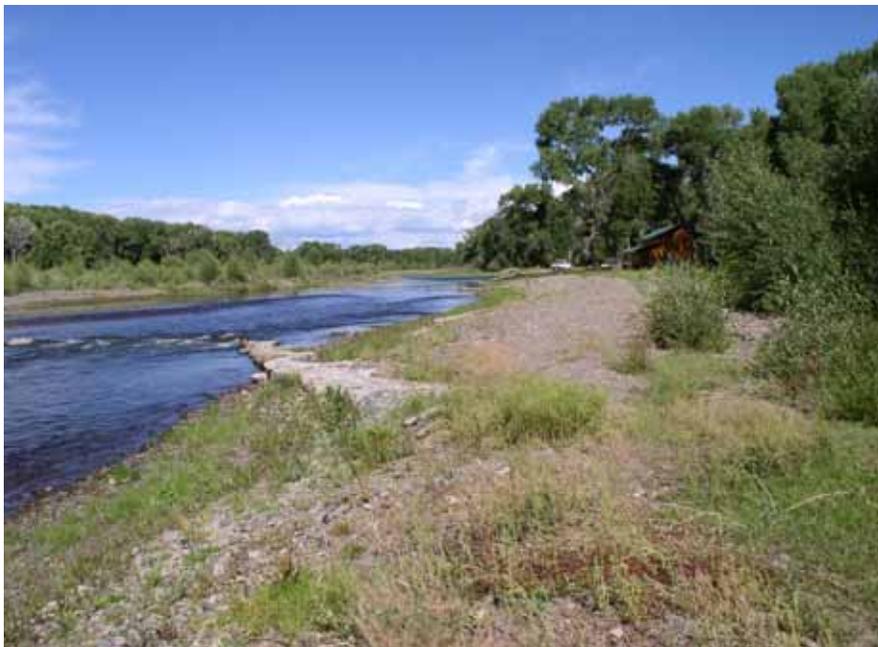
Poor irrigation regulation resulted in saturated banks that created a loss of bank stability. Other problems encountered were sedimentation, constriction of the floodplain because of the demands of housing and inappropriate fence locations.
