## WATERSHED

# Assessing the Transferability of a Water Erosion Model: The Turkey Creek Watershed Case Study

Conducted by: Colorado Geological Survey

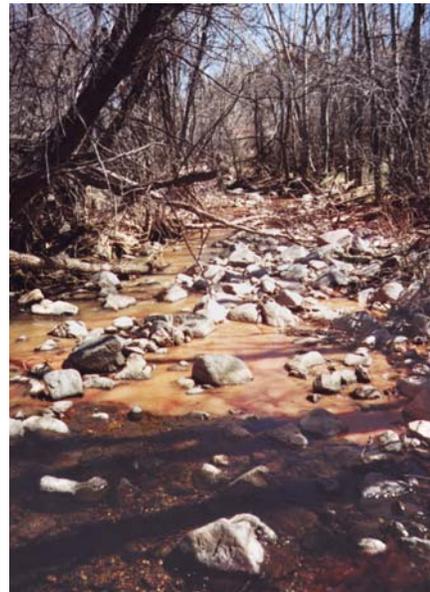
**Example of sediment from urban development.** Downstream of urban development, Turkey Creek changes from clear to murky water with high amounts of suspended solids. Water flows from foreground to background. 2002
