Gold King Mine spill

Animas River Basin - Southwest Colorado - August 2015

COLORADO
Water Quality Control Division
Department of Public Health & Environment

Report compiled January 2016

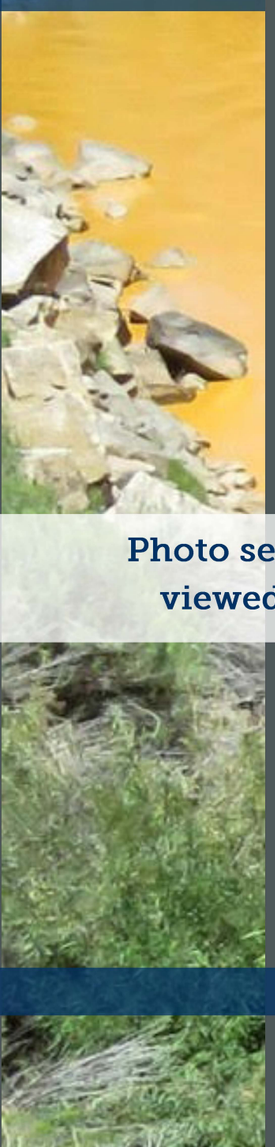
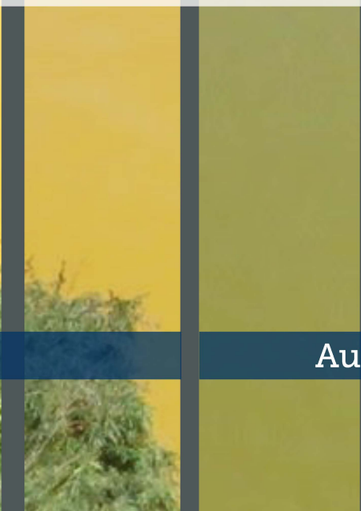
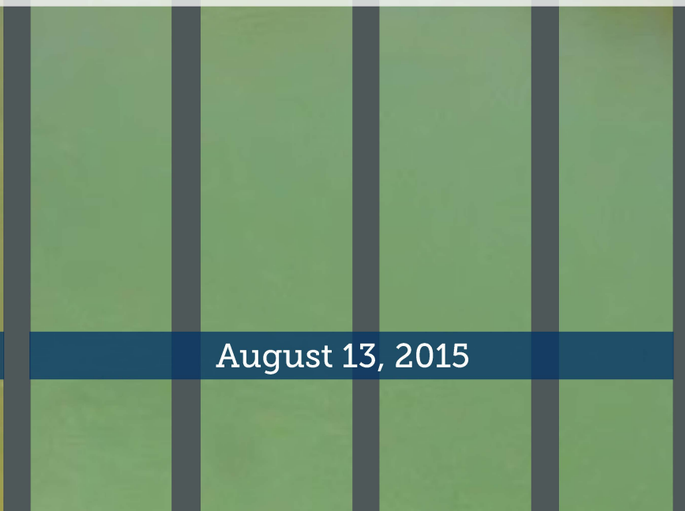
Photo series showing the daily progression of wastewater from the Gold King mine spill moving downstream via the Animas River as viewed from Trimble Bridge in Durango, Colorado (August 6 – August 20, 2016). Photos courtesy of the Joint Information Center.
