**Preliminary Report
Engineering Geology and Surface Fault Rupture Hazard Evaluation
Energy Fuels Resources Corporation
Piñon Ridge Mill Site, Montrose County, Colorado**

**PRELIMINARY REPORT
ENGINEERING GEOLOGY AND
SURFACE FAULT RUPTURE HAZARD
EVALUATION
ENERGY FUELS RESOURCES CORPORATION
PIÑON RIDGE MILL
MONTROSE COUNTY, COLORADO
KLEINFELDER PROJECT NO. 83088**

April 4, 2008

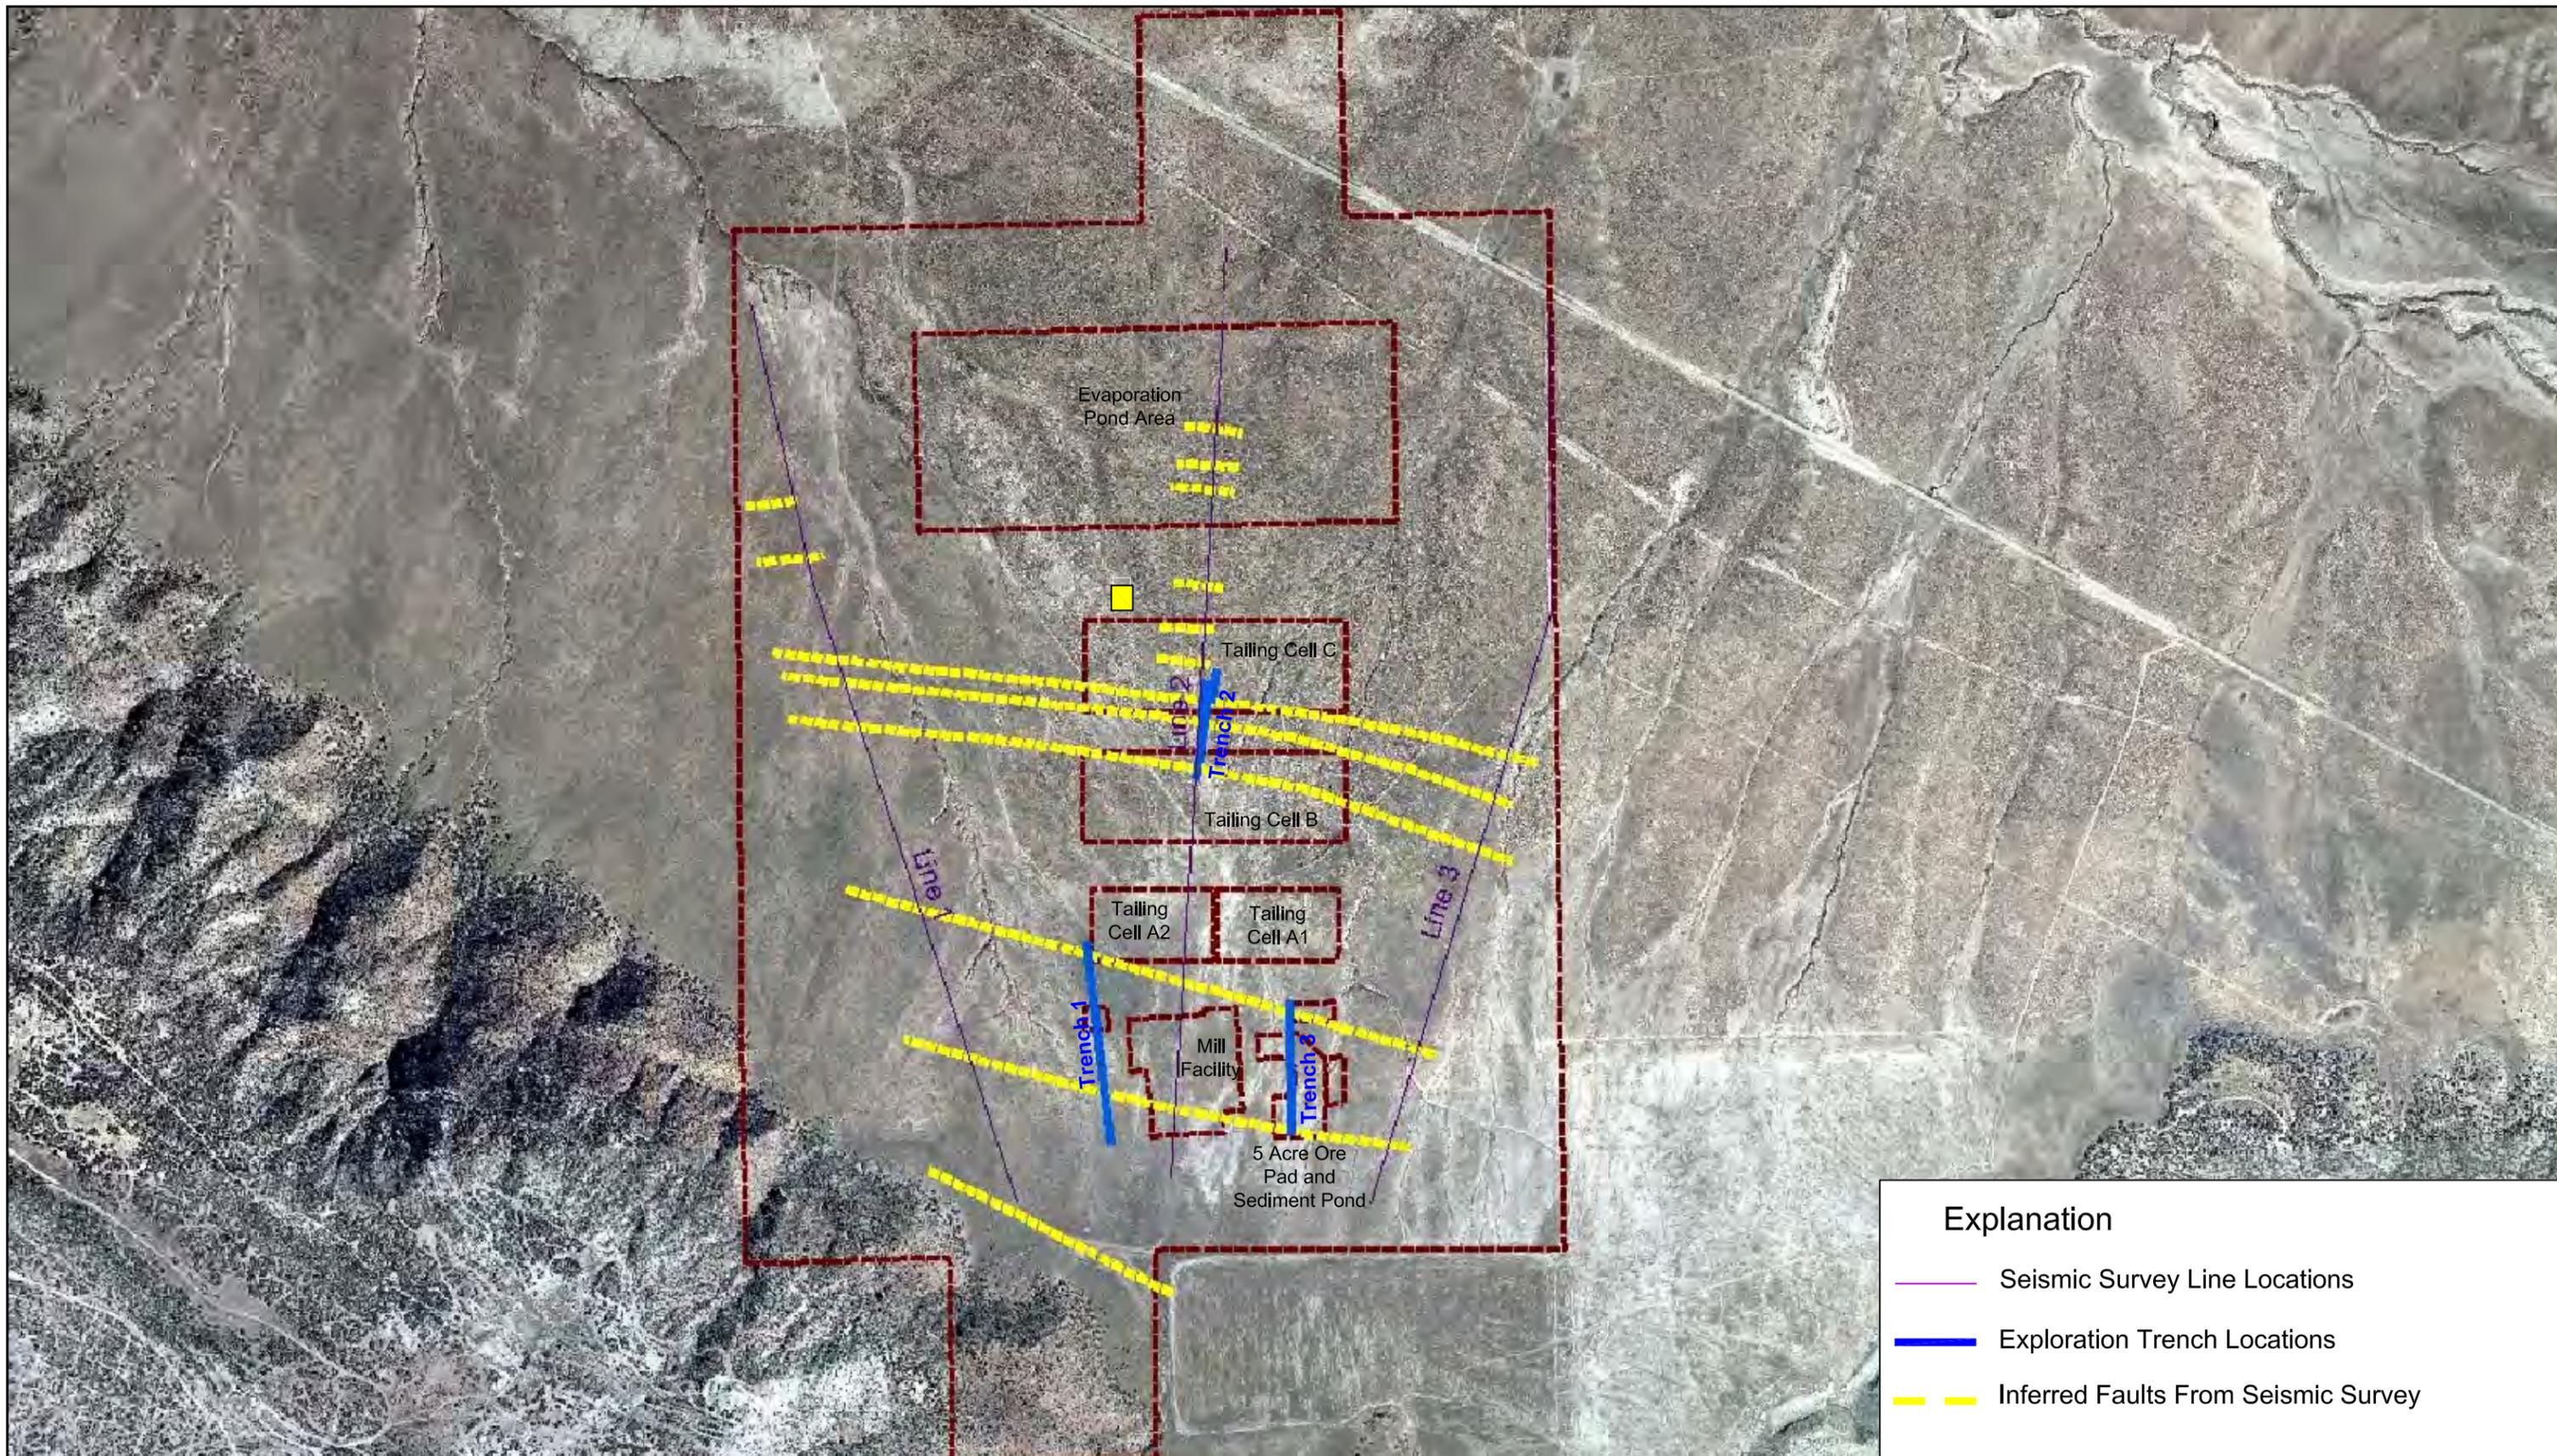
APPROVED BY:	AK
DRAWN BY:	PD
CHECKED BY:	RM
DATE:	FEB 2009
SCALE:	NOT TO SCALE
FIGURE	3

Seismic refraction and reflection surveys were conducted by Geological Associates in November 2007 along three lines (S1, S2, and S3), on the east (S3), west (S1), and central (S3) portions of the Site as shown in Figure 3. Interpretation of the seismic

surveys indicates possible fault offset of Paleozoic and Mesozoic units below the soil units. The thickness of the soil is inferred to range between 30 and 80 feet with the greatest thickness interpreted along the southern portion of line S3. The inferred faults are shown in Figure 3.

The trenches were excavated to evaluate the presence or absence of recent fault movement in the vicinity of the proposed mill tailings impoundment areas. Trench 1 and Trench 3 were excavated on the west and east sides, respectively, of the mill footprint and extended beyond the north to south dimension of the mill footprint. Trench 2 was excavated within the tailings impoundment area. The trenches were logged continuously in the field at a scale of 1 inch to 5 feet. Most of the trench was excavated to a depth of 4 feet. Where warranted by geologic conditions, the trench was excavated to a depth of 8 feet. Trench locations are shown in Figure 3.

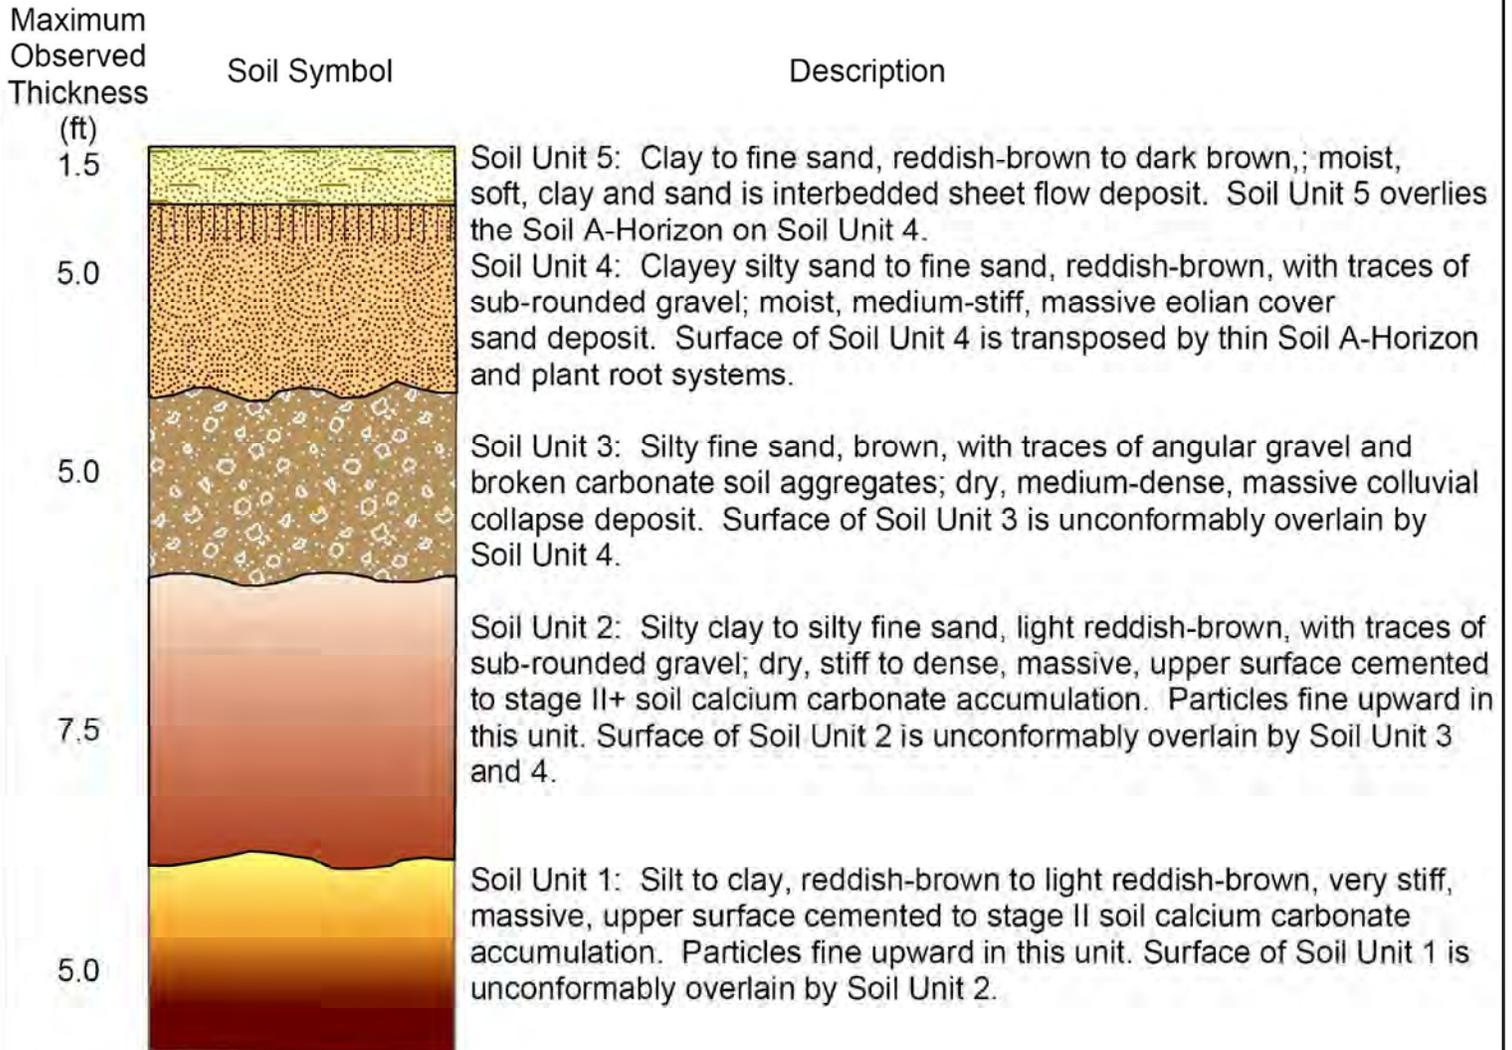
SOIL STRATIGRAPHIC UNITS

The generalized soil stratigraphy for the three trenches is schematically presented in Figure 4 and a description of each soil unit observed in the trenches, from oldest to youngest, is presented below:

Soil Unit 1: Silt to clay, reddish-brown to light reddish-brown, very stiff, massive, upper surface cemented to stage II soil calcium carbonate accumulation (Machette, 1985). Particles fine upward in this unit. Surface of Soil Unit 1 is unconformably overlain by Soil Unit 2. Observed in Trenches 1 and 2 only at a maximum thickness of 5 feet. The bottom of this unit was not observed. Projected soil age, mid-Pleistocene. Soil Unit 1 was observed in each trench to be free of fault offset.

Soil Unit 2: Silty clay to silty fine sand, light reddish-brown, with traces of sub-rounded gravel; dry, stiff to dense, massive, upper surface cemented to stage II+ soil calcium carbonate accumulation (Machette, 1985). Particles fine upward in this unit. Surface of Soil Unit 2 is unconformably overlain by Soil Unit 3 and 4. Observed in each trench at a maximum thickness of 7.5 feet. Projected soil age, mid- to late-Pleistocene. Soil Unit 2 was observed in each trench to be free of fault offset.

Soil Unit 3: Silty fine sand, brown, with traces of angular gravel and broken carbonate soil aggregates; dry, medium-dense, massive colluvial collapse deposit. Surface of Soil Unit 3 is unconformably overlain by Soil Unit 4. Observed in Trench 2 only at a maximum thickness of 5 feet. In the north end of Trench 2, Soil Unit 3, displayed what appears to be a slump or subsidence feature. This is depicted in Figure 18.

Soil Unit 4: Clayey silty sand to fine sand, reddish-brown, with traces of sub-rounded gravel; moist, medium-stiff, massive eolian cover sand deposit. Surface of Soil Unit 4 is transposed by thin Soil A-Horizon and plant root systems. Observed in each trench at a maximum thickness of 5 feet. Based on Archaic age artifacts were found on the surface of the site, Soil Unit 4 is projected to be at least 2,000 years old and possibly as much as 11,000 years in age (Laramore, 2007).

Soil Unit 5: Clayey to fine sand, reddish-brown to dark brown; moist, soft, clay and sand is interbedded sheet flow deposit. Soil Unit 5 overlies the Soil A-Horizon on Soil Unit 4. Observed in trench 1 only at a maximum thickness of 1.5 feet. Because Soil Unit 5 overlies the Soil A-Horizon of Soil Unit 4, this unit is projected to be contemporary in age.

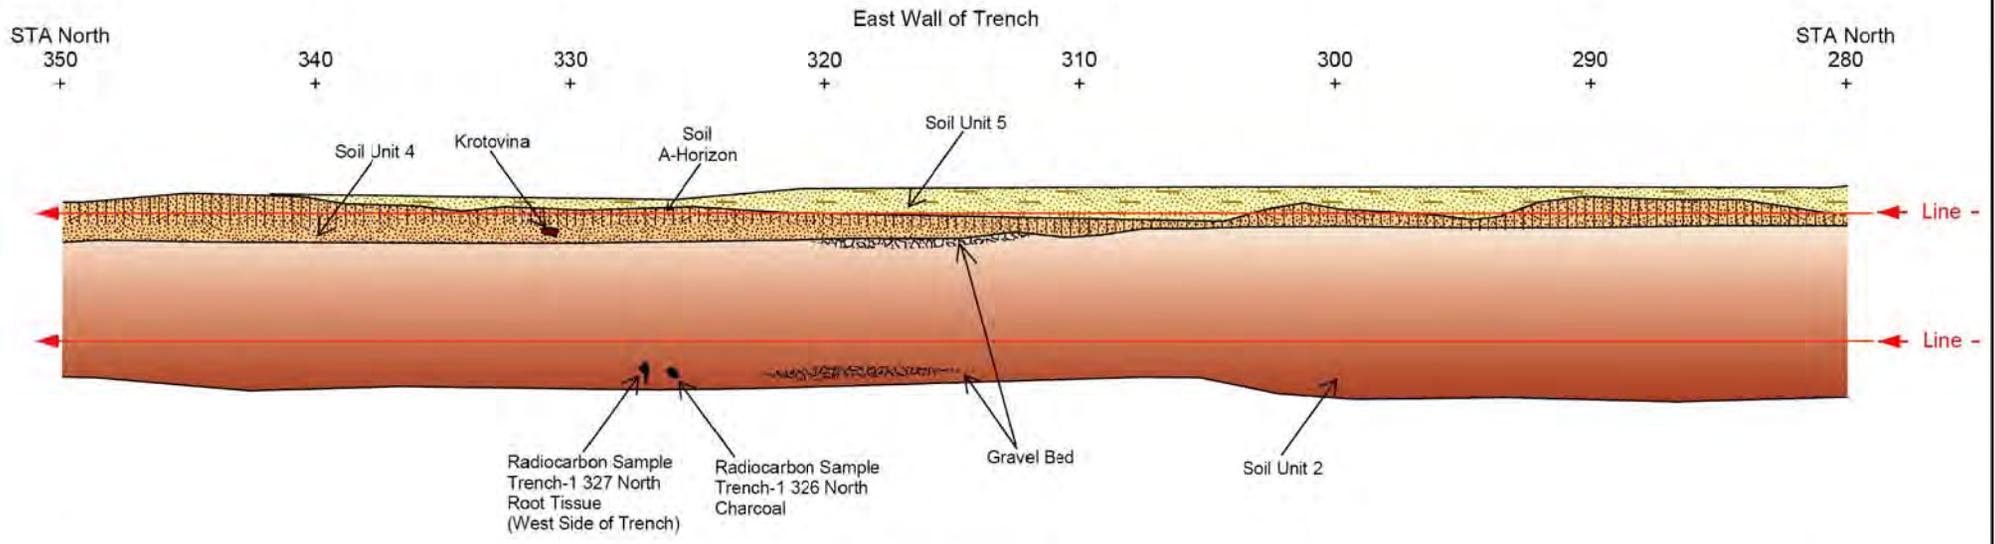
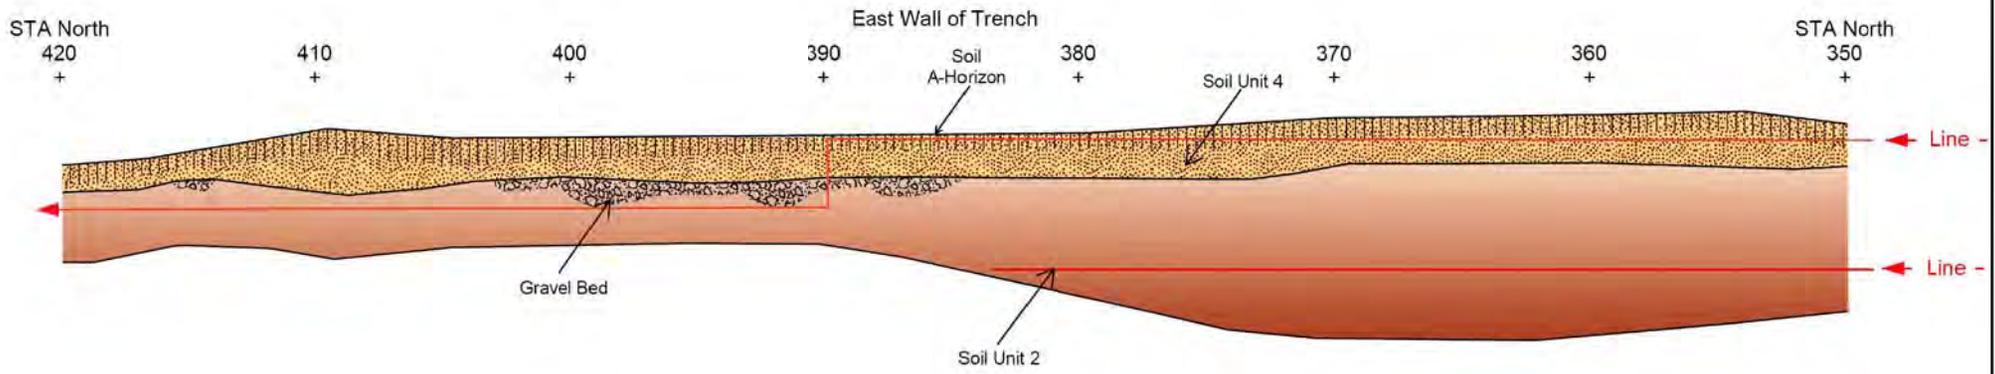
LOG OF TRENCH 1
STA 280 NORTH TO STA 420 SOUTH

The charcoal and root tissue samples obtained from Soil Unit 2 in Trench 1 at station 326 North and 327 North (Figure 7) were submitted to Paleo Research Institute Laboratory (PRI) for radiometric age dating using accelerated mass spectrometry (AMS). Bulk soil samples from Soil Units 2, 3 and 4 in Trench 2 were also submitted to PRI for macro-floral remains search and radiometric dating of the remains by AMS.
