CAPITOL COMPLEX MASTER PLAN
FINDINGS & RECOMMENDATIONS (F & R) NEEDS ASSESSMENT
POWER PLANT BUILDING, 1341 SHERMAN STREET (DENVER)

NOVEMBER 2014

FINDINGS & RECOMMENDATIONS (F&R) NEEDS ASSESSMENT

POWER PLANT BUILDING
1341 SHERMAN STREET (DENVER)

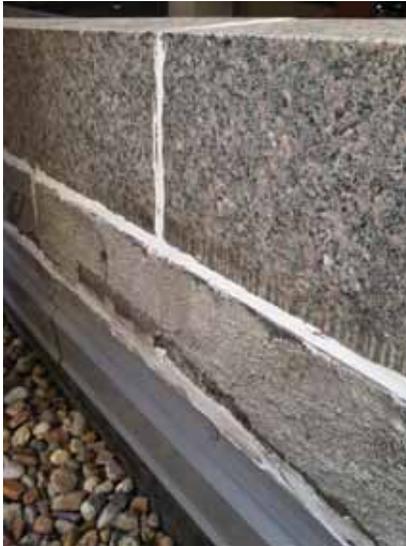
around the exterior of the building (see Fig. 2.1.A.2). The marble panels are generally soiled, which is to be expected after seventy-plus years. It was noted that the mortar between the joints of the marble veneer panels is generally deteriorating and leaving the building envelope vulnerable to water penetration (see Fig. 2.1.A.3 and Fig. 2.1.A.4). The granite panels along the foundation were observed to be in generally fair condition overall with wear-and-tear and deteriorating mortar between the joints noted (see Fig. 2.1.A.5 and Fig. 2.1.A.6). The granite parapet on the west side of the ballasted grade-level roof between the Power Plant Building and the Capitol Annex Building appears to have had new sealant applied recently (see Fig. 2.1.A.7). The sealant appears to have been applied poorly, with gaps noted along the length of the material.

Fig. 2.1.A.7 Sealant observed at the granite parapet on the west side of the ballasted grade-level roof between the Power Plant Building and the Capitol Annex Building does not match the historic character of the site and was applied poorly.

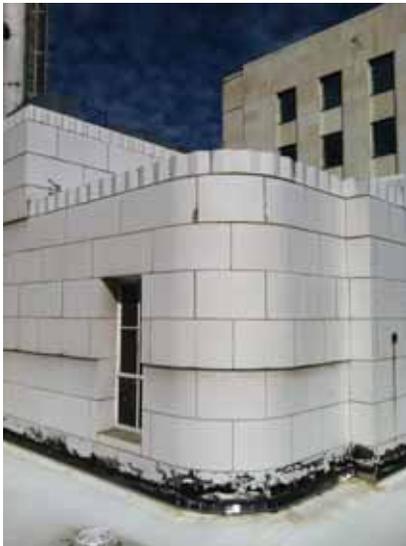
The glazed white terracotta tiles along the east facade of the second story construction and wrapping around both sides to clad a portion of the north and south facades, are in fair condition overall with areas of spalling, cracking, and soiling observed during the site survey visit (see Fig. 2.1.A.8, Fig. 2.1.A.9, Fig. 2.1.A.10, and Fig. 2.1.A.11). It was noted that the mortar between the joints of the glazed white terracotta tiles is generally deteriorating and leaving the building envelope vulnerable to water penetration (see Fig. 2.1.A.12 and Fig. 2.1.A.13).

Fig. 2.1.A.8 Generally soiled and deteriorating glazed white terracotta tiles observed at the second story construction.

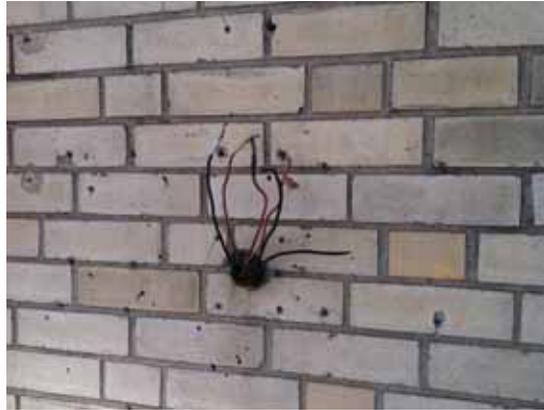
The brick along the south facade at the first story and along the north and south facades at the second story is in generally fair condition overall with soiling (see Fig. 2.1.A.14 and Fig. 2.1.A.15), damage (see Fig. 2.1.A.16 and Fig. 2.1.A.17), and deteriorating mortar observed (see Fig. 2.1.A.18). The concrete foundation along the south facade at the first story was observed to be cracking in several areas (see Fig. 2.1.A.19).

Fig. 2.1.A.16 Disconnected, loose wires and multiple unrepaired holes observed at the second story brick facade on the north side of the building.

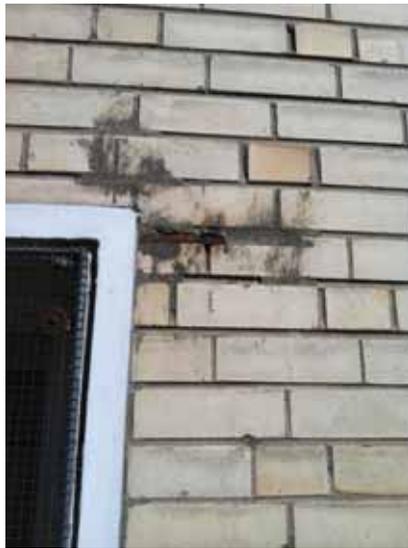
Fig. 2.1.A.17 Areas of damaged brick observed during the site survey visit.

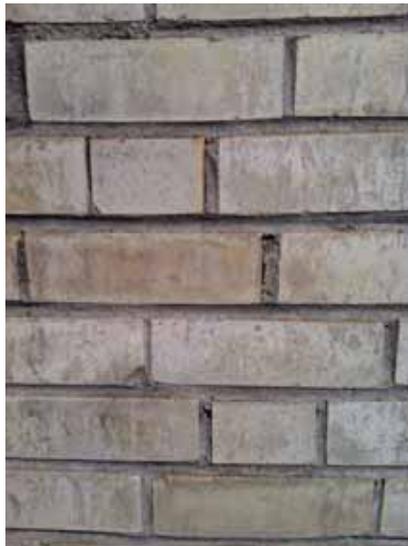
Fig. 2.1.A.18 General deterioration of the mortar at the brick walls around the exterior of the building.

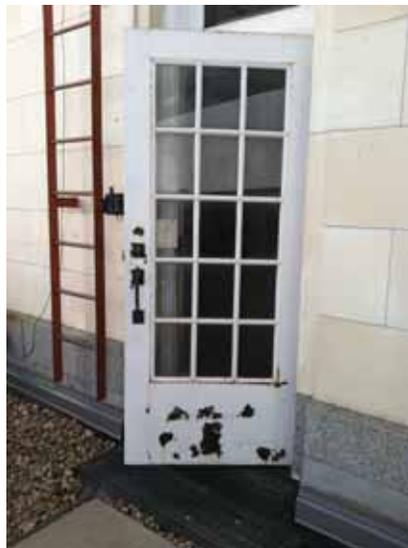
Fig. 2.1.A.29 Exterior door on the west end of the north side of the building with corrosion and deteriorating paint.

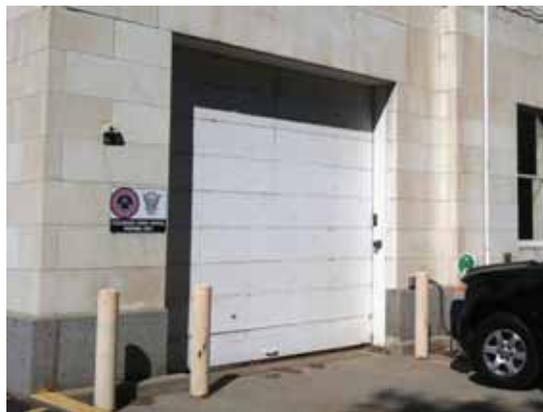
Fig. 2.1.A.30 Corrosion observed at the overhead rolling door on the south end of the east side of the building.

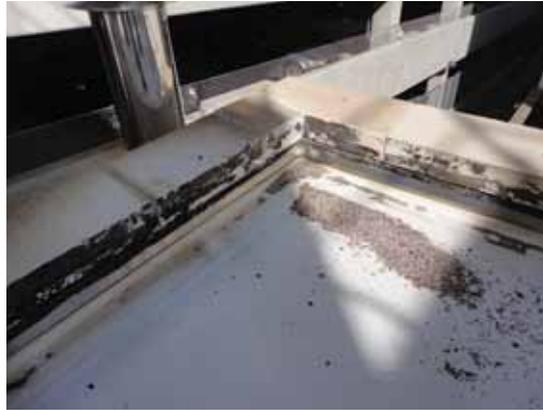
to be collecting and standing. It was noted during the site survey visit that soil is collecting around the roof drains on the first story roof, with deterioration of the membrane observed in these areas (see Fig. 2.1.A.34 and Fig. 2.1.A.35). Debris was observed to be collecting in the corners of the roof and appears to include pieces of terracotta in a few areas (see Fig. 2.1.A.36, Fig. 2.1.A.37, and Fig. 2.1.A.38). There is a deteriorating membrane that was observed above the flashing along the sides of the parapets and walls at the first and second story roofs (see Fig. 2.1.A.39 and Fig. 2.1.A.40).

Fig. 2.1.A.36 Debris, including pieces of terracotta, collecting in the corners of the first story roof.

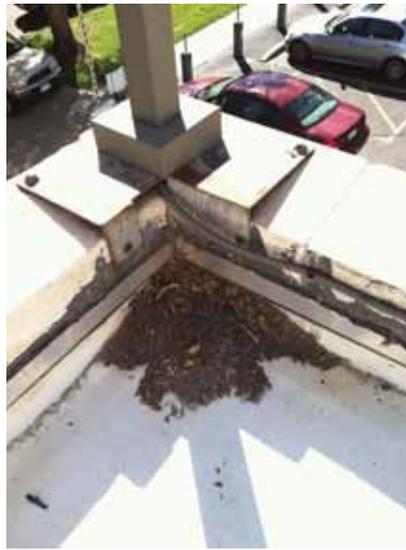
Fig. 2.1.A.37 Debris collecting in the corners of the first story roof.

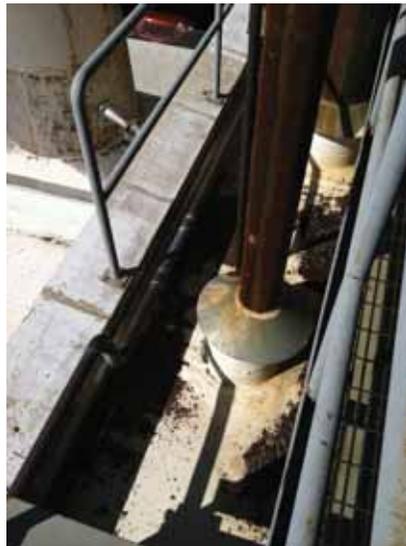
Fig. 2.1.A.38 Debris collecting in areas of the second story roof.

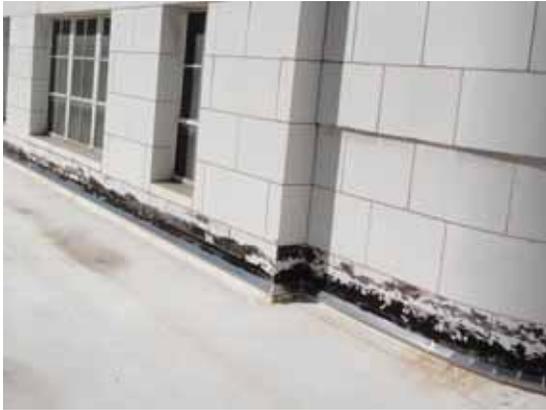
Fig. 2.1.A.39 Deteriorating membrane observed around the perimeter of the parapets and walls of the first and second story roofs.

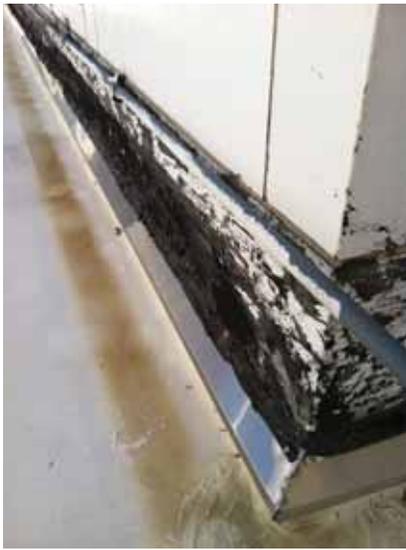
Fig. 2.1.A.40 Deteriorating membrane observed around the perimeter of the parapets and walls of the first and second story roofs.

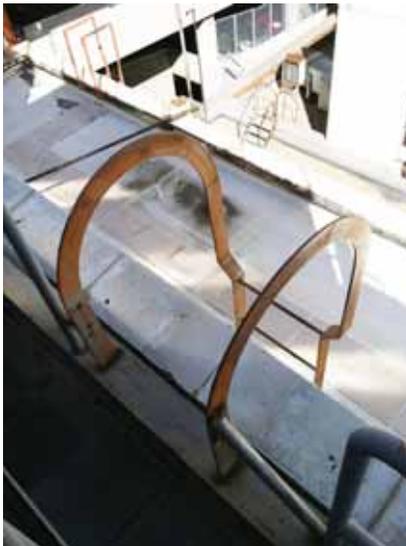
The first story roof is accessed by a fixed metal ladder without a cage on the west end of the north side of the building from the grade-level roof. The second story roof is accessed by a second fixed metal ladder without a cage found on the north side of the first story roof. It was noted that the ladders are corroding, especially the ladder leading up to the second story roof from the level of the first story roof (see Fig. 2.1.A.41).

Fig. 2.1.A.41 Corrosion observed at the metal ladder, without a cage, leading up to the second story roof.

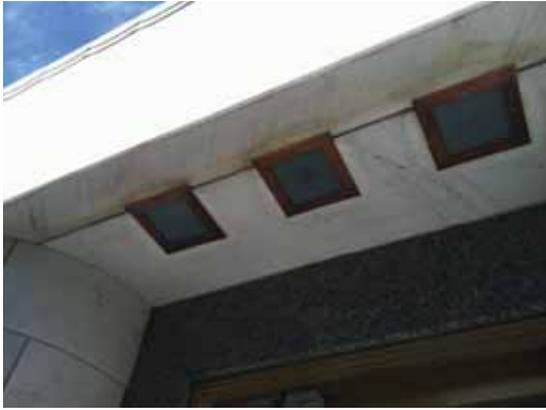
There is evidence of water damage at marble cladding on the main Sherman Street Entrance canopy (see Fig. 2.1.A.42).

Fig. 2.1.A.42 Evidence of water damage at the Sherman Street Entrance canopy.

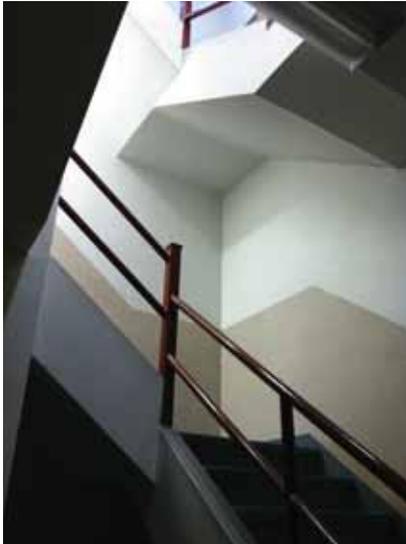
Fig. 2.1.B.4 Handrails currently exist on only one side of the stairs in the east stairway and the guardrail openings exceed 4 inches in diameter.

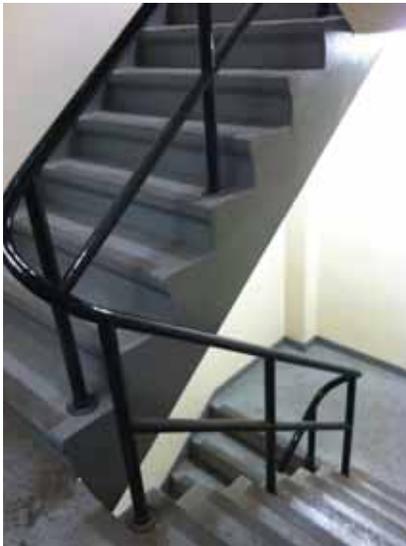
Fig. 2.1.B.5 Handrails currently exist on only one side of the stairs in the west stairway and the guardrail openings exceed 4 inches in diameter.

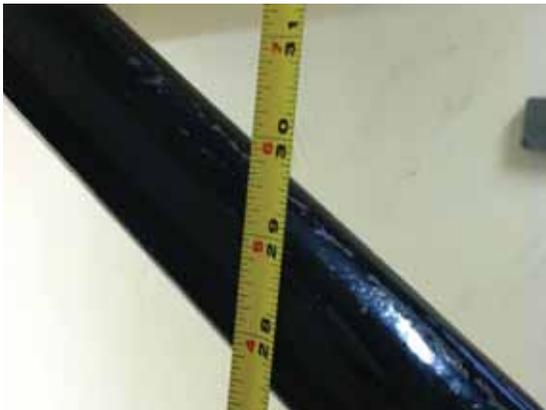
Fig. 2.1.B.6 The height to the top of the railings within the west interior exit stairway.

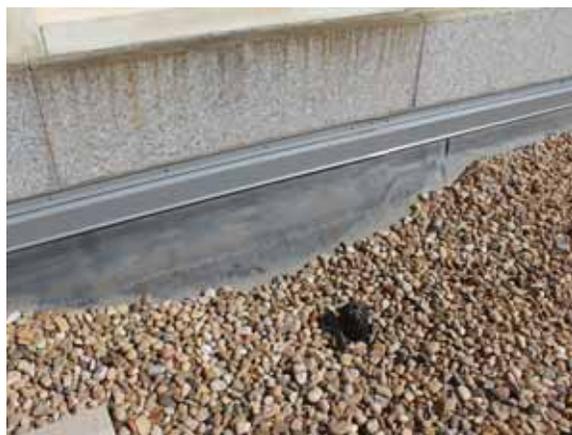
Figure 2.3.A.2 – Area Drain in Utility Yard

site slopes east towards Sherman Street at approximately 1%. Existing runoff is generally conveyed overland from the site towards Sherman Street. Runoff is collected by area drains within the utility yard (Fig. 2.3.A.2) and by street inlets at the intersections of E. 14th Avenue and Sherman Street and E. 13th Avenue and Sherman Street.

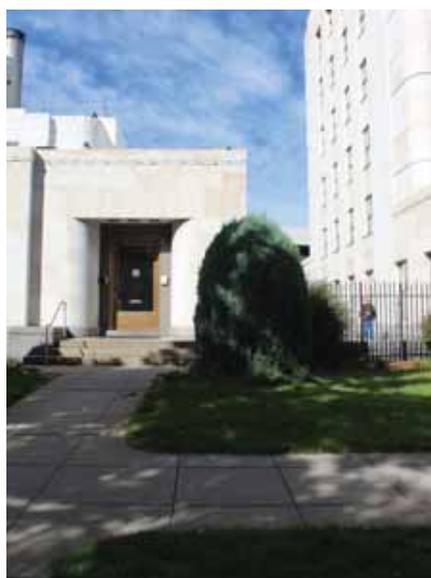
Figure 2.3.A.3 – Sherman Street Entrance Steps

The Sherman Street entrance is accessed via steps (Fig. 2.3.A.3). There is also a gated entrance into the utility yard (Fig. 2.3.A.4). The building is set back from the public sidewalk and treelawn (Fig. 2.3.A.5). Landscaped areas are generally flat containing grass, established trees and bushes.

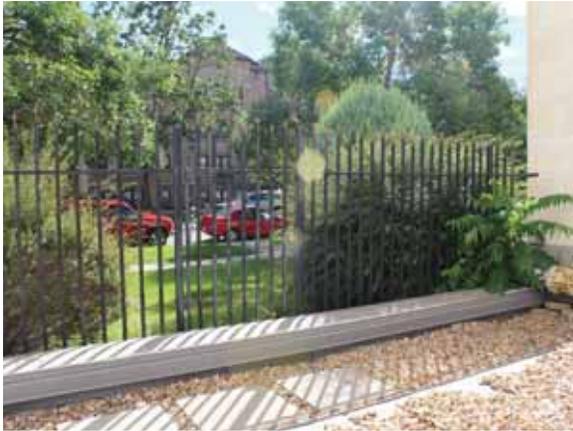
Figure 2.3.A.4 – Utility Yard Gated Entrance

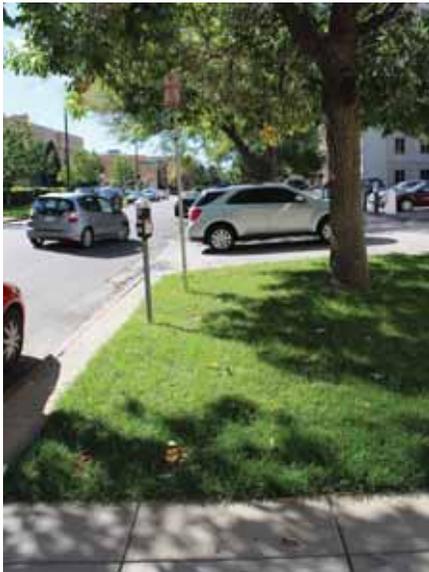
Figure 2.3.A.5 Sherman Street ROW including Sidewalk and Treelawn, looking South

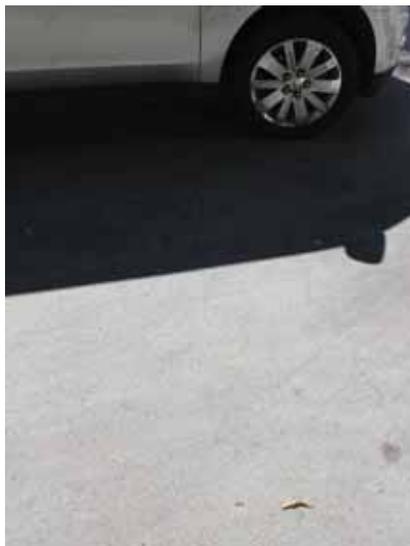
The site paving is generally in good condition. A few locations of broken concrete and concrete cracking was observed. Repair or replace broken or cracked concrete.

Figure 2.3.A.7 Site Concrete Crack

- Cracks approximately 1/8" wide or smaller showing no differential movement can be sealed using an approved joint sealant. Cracks should be routed and cleaned per an approved industry method prior to sealing.
- Concrete panels showing numerous excessive cracking and/or differential movement should be replaced.
- Replacement shall be completed in full stone segments, i.e. to the nearest joint location. Repair the subgrade materials and place new curb & gutter or sidewalk. Replace backfill materials and repair/replace any landscaping/paving disturbed during repair operations.

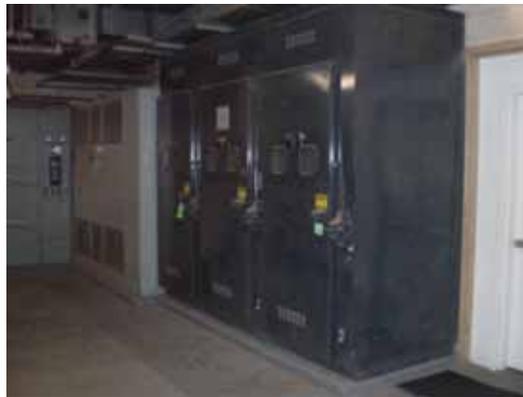
Fig. 2.4.A.1 – Medium voltage switchgear

- The main electrical switchgear sections that are 25+ years old should be tested to see if they are working properly. If they are not working properly, they will need to be replaced.
- All panelboards past their useful life should be replaced including the wire feeding the panelboard for the main source.
- This building needs an electrical renovation project. All electrical equipment that is 30+ years old should be replaced including the main gear, transformers, panelboards, switches, wire, receptacles, and lighting.

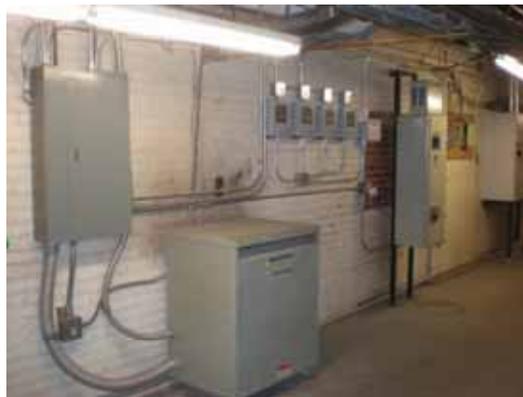
In the sub-basement there are panelboards and transformers feeding motor loads (see Fig. 2.4.A.2). On the first floor there are panelboards and transformers feeding office loads.

Fig. 2.4.A.2 – Panelboard and transformer

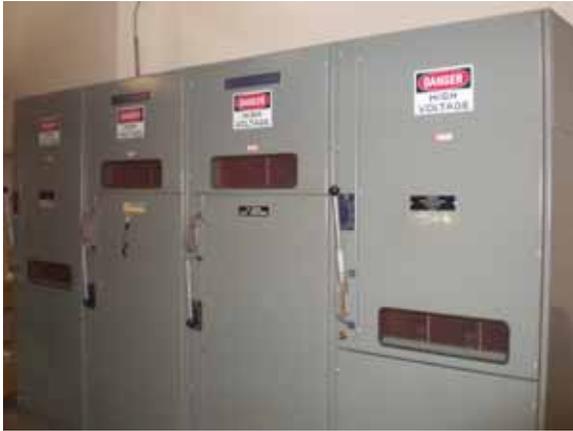
There is also another medium voltage switch that feeds the judicial building transformer (see Fig. 2.4.A.3). This switch appears to be less than 10 years old.

Fig. 2.4.A.3 – New medium voltage switchgear serving judicial building

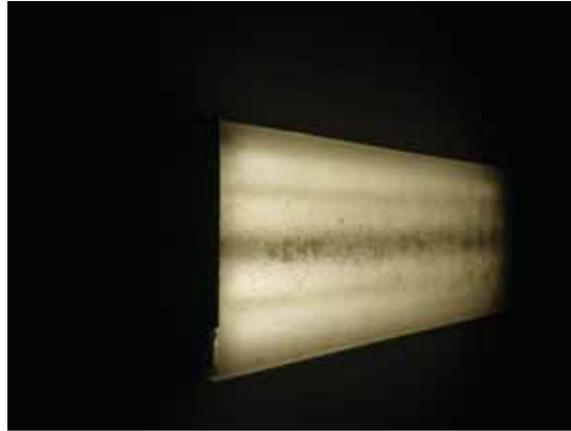
The lighting fixtures are a combination of linear T8 fluorescent fixtures and historical fixtures in the mechanical rooms and office areas. Most of the fixtures are in poor shape and some have been damaged (see Fig. 2.4.A.4 and Fig. 2.4.A.5). Lighting is not uniform in the mechanical spaces. If task lights are used to work on the equipment, lower light levels are acceptable.

Fig. 2.4.A.4 – Fluorescent light fixture

- Replace existing damaged lighting fixtures with new ones. Since this is a low priority building for lighting, T8 fixtures are the low-cost option. LED fixtures would help reduce maintenance cost but are initially expensive.
- More lighting fixtures are needed in the areas that are not uniform. The light fixtures for this space could be replaced with either new T8 fluorescent or LED fixtures. The advantage of the LED fixtures is their long life and low maintenance cost. LED fixtures are more robust than T8 fixtures and would survive the environment better. In the mechanical spaces, an average of five to ten foot candle levels is acceptable. In the office spaces, 30 foot candle levels are recommended.
- More lighting controls are required. Motion sensors are not recommended in mechanical spaces but in the office spaces, they would help decrease energy use.

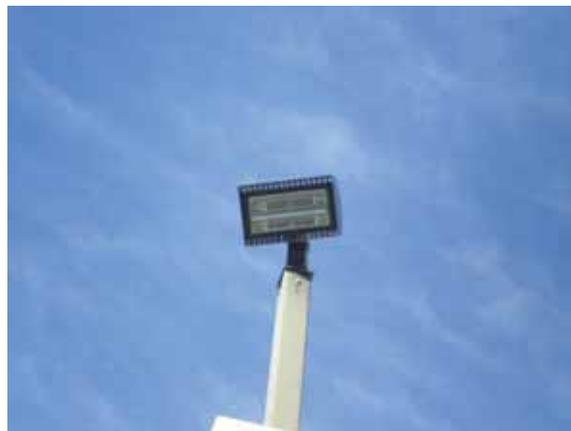
Fig. 2.4.A.6 – Exterior light fixture

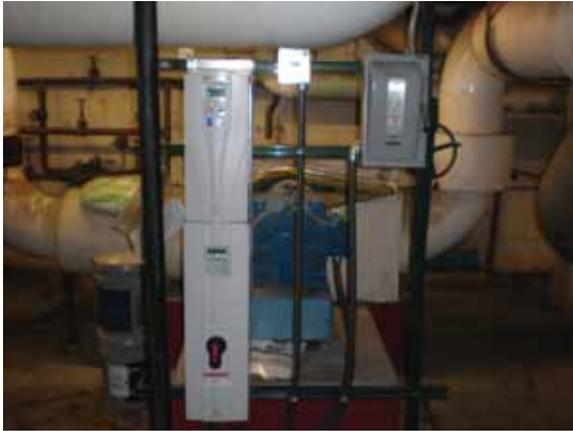
Fig. 2.4.A.7 – VFD for chilled water pump motor

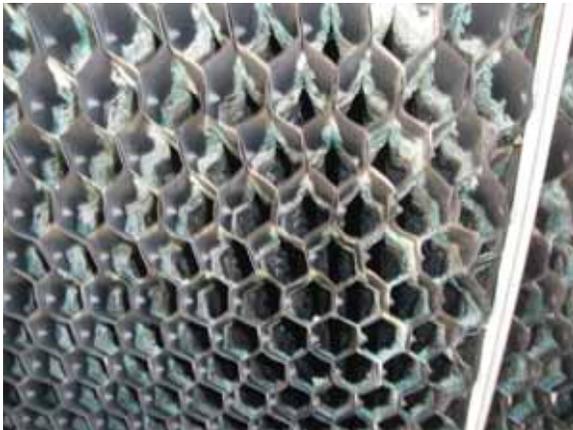
Fig. 2.4.A.8 – Tower fill material

- There is no man cage provided for ladder for the roof. This is required per OSHA.
- There is scale on the tower fill material. Consult the manufacturer and ensure that scale deposits are removed. This will increase the efficiency of the tower. Generally, scale deposits can occur due to chemical content in the water; the water quality is not maintained as required. Also, scales and deposits can occur on the fill material if the tower is operated with a water flow less than the manufacturer's recommended minimum flow.

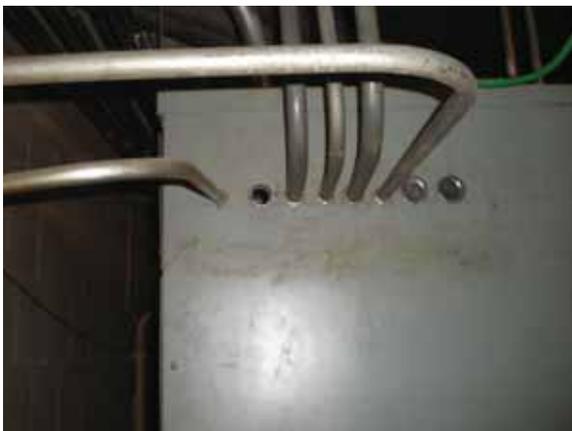
Fig. 2.4.B.1 – Opening in electrical gear

- Provide seals in all unsealed holes in the electrical gear.
- Provide drip pans that are properly sealed above electrical gear that has water above it.
- Remove abandon conduit and wire within the building back to its source.
- Fix any lightning protection that has been damaged or disconnected.
- Provide fire rated caulk in all openings through fire rated walls.
- Provide GFI receptacles for all locations within six feet of an open water source.

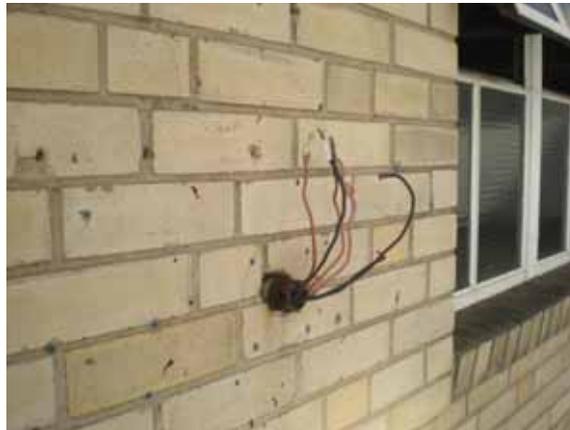
On the north exterior wall, an electrical device was removed but the conduit and wire is still in place (see Fig. 2.4.B.3). The wire needs to be completely removed back to the nearest junction box and the conduit needs to be sealed or removed. This condition is allowing water to get into the conduit and into the building.

Fig. 2.4.B.3 – Abandoned conduit and wire

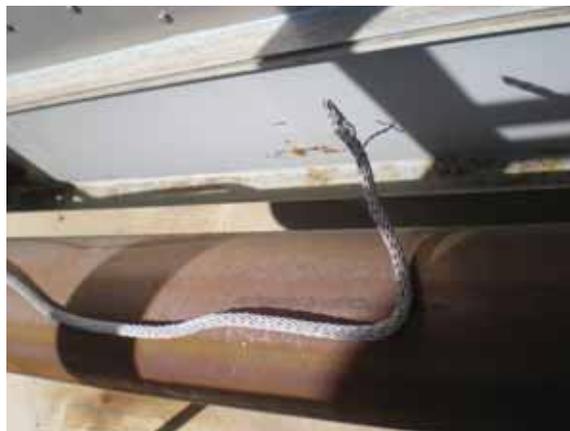
The lightning protection wiring for one of the cooling towers is not connected on either end (see Fig. 2.4.B.4). This is not a violation of code; however, this wire should be removed or attached.

Fig. 2.4.B.4 – Lightning protection not connected

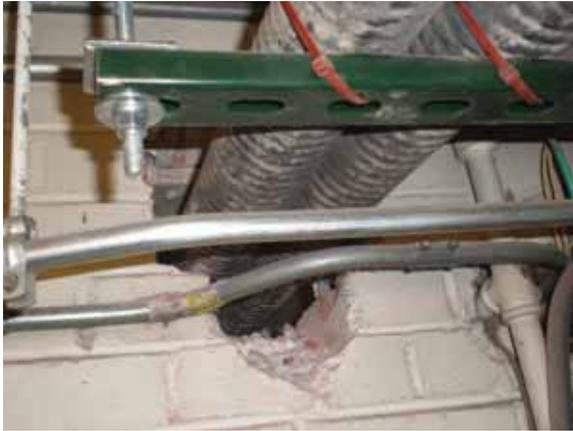
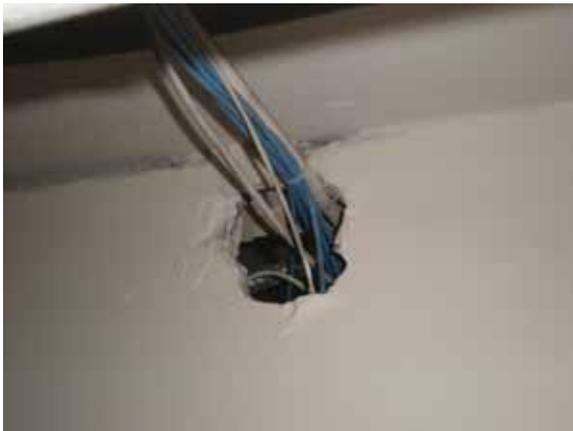
There are a number of holes in fire rated walls that are not sealed properly (see Fig. 2.4.B.5 and Fig. 2.4.B.6). These holes are required to be seal with a fire rated caulk.

Fig. 2.4.B.5 – Openings in fire walls not sealed

Fig. 2.4.B.6 – Openings in fire walls not sealed

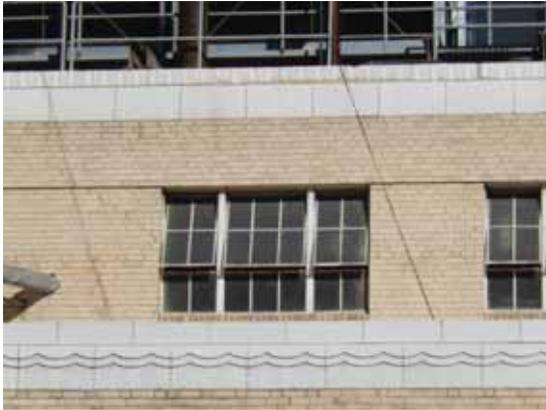
Zone 1 Exterior Facade:
Operable second floor metal
windows

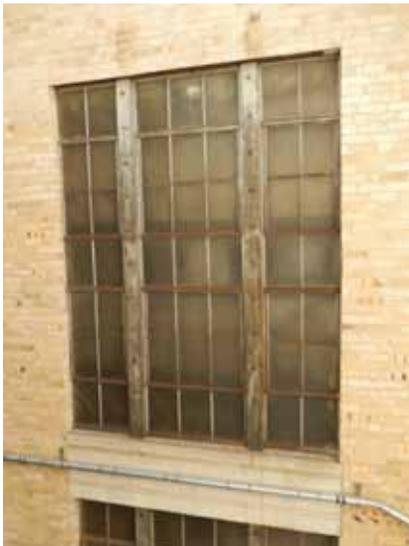
Zone 1 Exterior Facade: Steel windows
on the west elevation

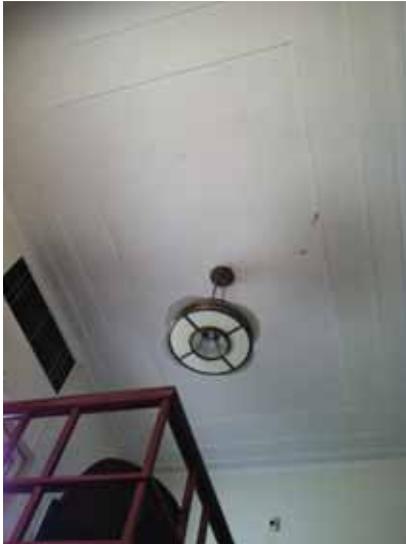
Fig. 3.1.C.1 Wear-and-tear observed at the plaster ceiling in the entrance lobby on the First Floor.

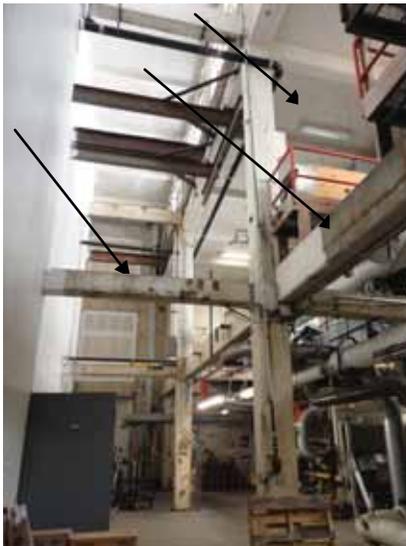
The open ceilings throughout the industrial areas on the Basement and Sub-basement Floors consist of concrete, steel beams encased in concrete, and areas with exposed steel decking. Cracking and spalling of the concrete was noted at the ceilings and beams throughout (see Fig. 3.1.C.3, Fig. 3.1.C.4, and Fig. 3.1.C.5). There was a deteriorating ceiling access cover noted on the Sub-basement Floor (see Fig. 3.1.C.6). There were areas of exposed metal decks observed throughout the Sub-basement Floor that are partially coated with spray-on fire-proofing (see Fig. 3.1.C.7).

Fig. 3.1.C.3 Cracking, spalling, and other damage of the concrete observed at the ceilings and beams throughout the industrial areas.

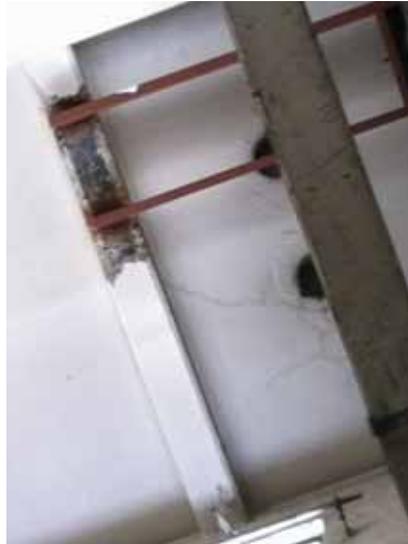
Fig. 3.1.C.4 Cracking, spalling, and other damage of the concrete observed at the ceilings and beams throughout the industrial areas.

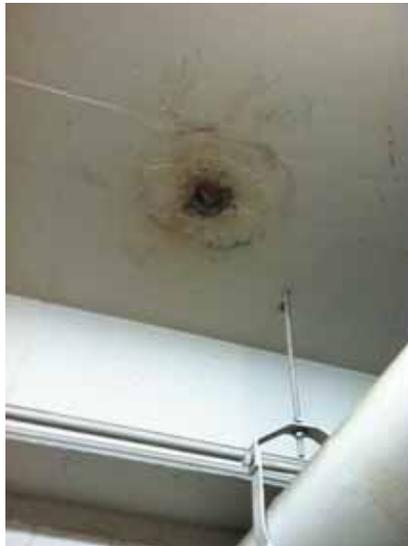
Fig. 3.1.C.5 Cracking, spalling, and other damage of the concrete at the ceilings and beams on the Sub-basement Floor.

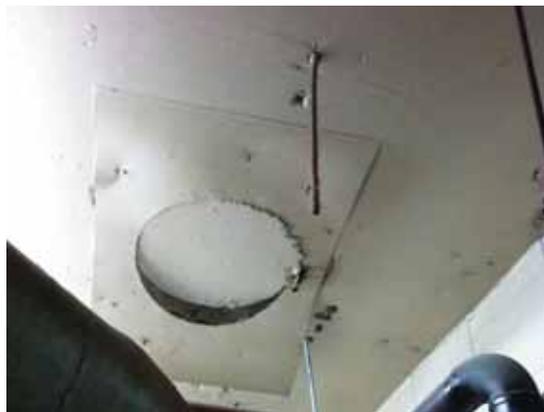
Fig. 3.1.C.6 Deteriorating ceiling access cover observed on the Sub-basement Floor.

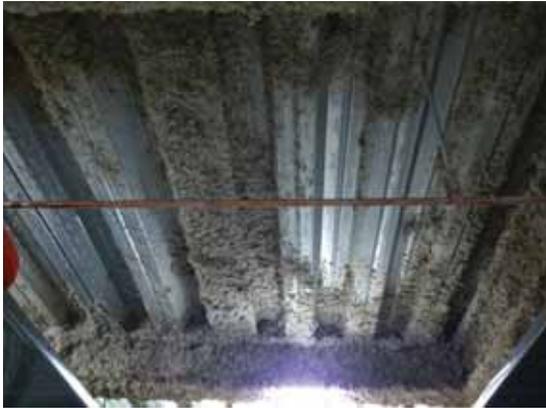
Fig. 3.1.C.7 A few spots of exposed beams noted at the areas coated with spray-on fire-proofing throughout the Sub-basement Floor.

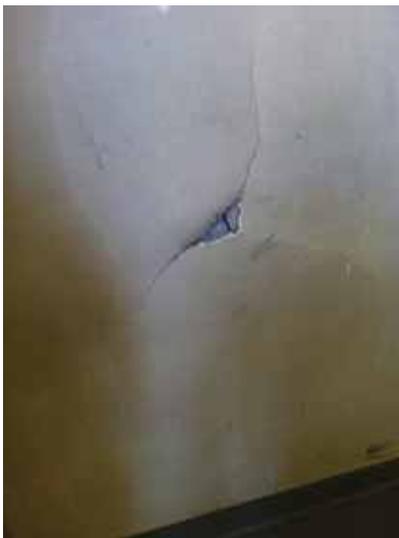
The plaster and gypsum board walls in the entrance lobby, east stairway, restrooms, and office areas included in the site survey visit are in fair condition overall with general wear-and-tear and soiling noted (see Fig. 3.1.C.8 and Fig. 3.1.C.9). The wainscoting material on the walls of the entrance lobby, east stairway, and Men's Restroom is in fair to poor condition overall with general wear-and-tear and soiling noted (see Fig. 3.1.C.10). The wallcovering on the east wall of the Women's Restroom was noted to be in fair condition overall with general wear-and-tear noted.

Fig. 3.1.C.8 General wear-and-tear and cracking and spalling of the plaster wall noted in the west stairway.

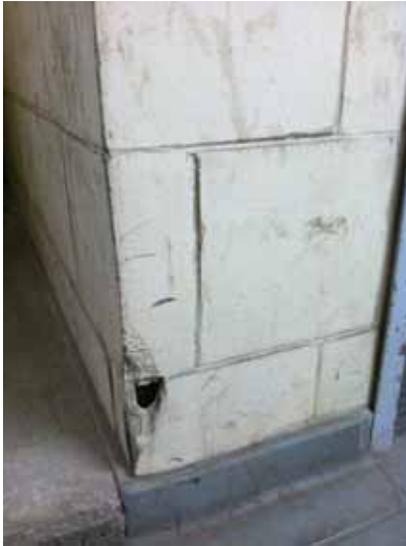
The walls throughout the industrial areas on the Basement and Sub-basement Floors consist of concrete, brick, and masonry block. Cracking, spalling, and deterioration were noted at areas of the walls throughout (see Fig. 3.1.C.11, Fig. 3.1.C.12, and Fig. 3.1.C.13). Soiling and water damage were noted at areas of the walls throughout (see Fig. 3.1.C.14 and Fig. 3.1.C.15).

Fig. 3.1.C.12 Wear-and-tear and deterioration of the masonry block walls throughout the industrial areas observed during the site survey visit.

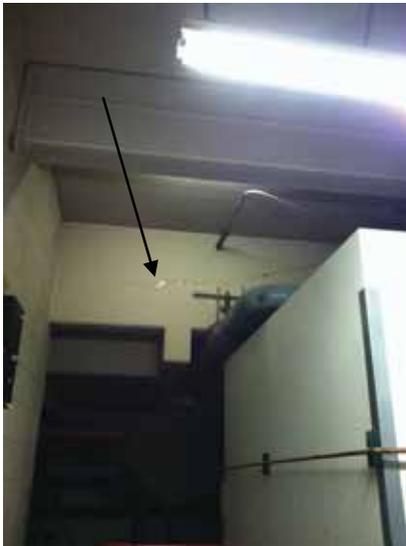
Fig. 3.1.C.13 Cracking of the concrete noted at areas of the walls throughout the industrial areas.

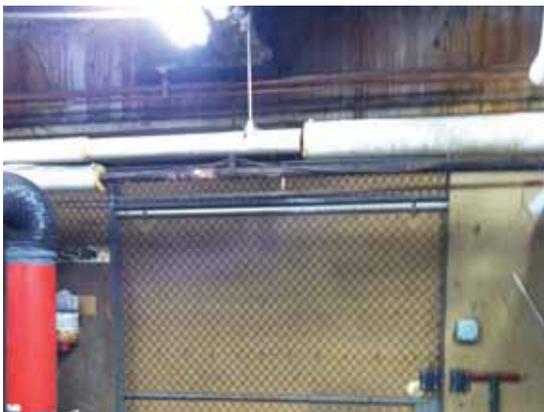
Fig. 3.1.C.14 Evidence of water damage observed at areas of the walls throughout the industrial areas.

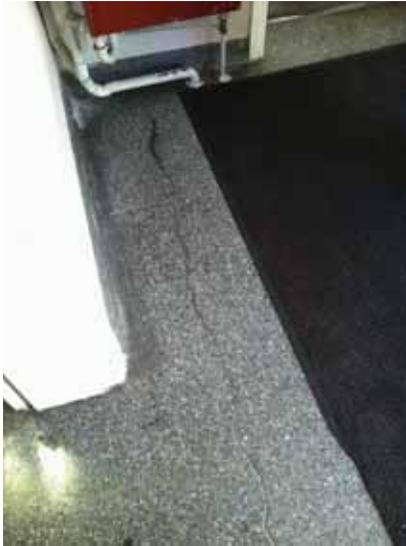
Fig. 3.1.C.16 Cracked terrazzo flooring observed in the entrance lobby on the First Floor.

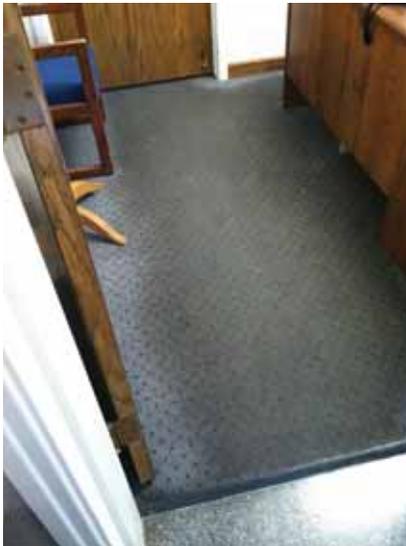
Fig. 3.1.C.17 Worn and soiled carpet observed during the site survey visit.

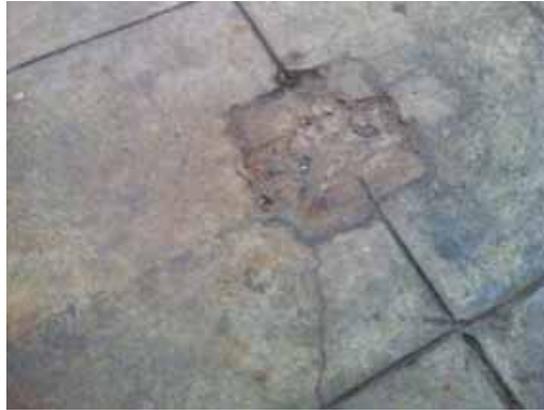
Fig. 3.1.C.19 Cracked and spalling concrete flooring with evidence of corrosion.

- Repair or replace the cracked, or otherwise damaged, areas of terrazzo flooring, to match existing.
- Replace all carpet throughout.
- Repair or replace any damaged concrete floors throughout. Repaint areas of concrete floors with worn and deteriorating paint.

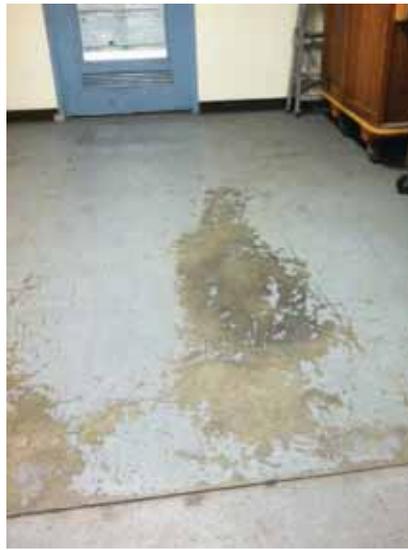
Fig. 3.1.C.20 Typical condition of terrazzo flooring in restrooms noted throughout.

- Remove the worn and soiled wallcovering from the Women's Restroom. Replace with new wallcovering or paint to match the other bathroom walls.
- Clean and refinish the terrazzo flooring using an approved method.

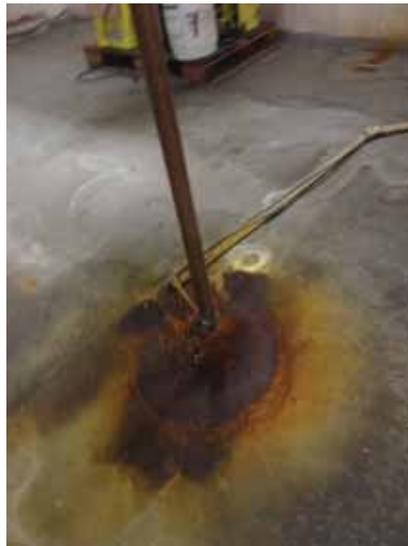
Fig. 3.1.C.21 Water damage and soiling due to corrosion observed at the concrete flooring.

- Determine the cause of any water damage or soiling at the floors throughout and repair as necessary.
- Determine the cause of the standing water observed on the Sub-basement Floor and repair as necessary.
