CAPITOL COMPLEX MASTER PLAN
FINDINGS & RECOMMENDATIONS (F & R) NEEDS ASSESSMENT
700 KIPLING BUILDING, 700 KIPLING STREET (LAKEWOOD)

NOVEMBER 2014

FINDINGS & RECOMMENDATIONS (F&R) NEEDS ASSESSMENT

700 KIPLING BUILDING
700 KIPLING STREET (LAKEWOOD)

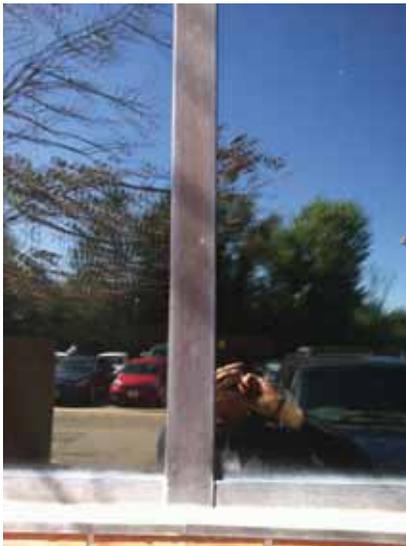
Fig. 2.1.A.13 Typical corrosion noted at the metal window frames.

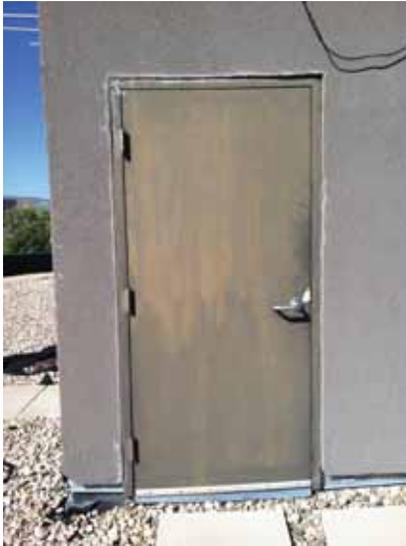
The single sets of glazed entrance doors at the West Entrance and the East Entrance are in fair condition and appear to be original to the building. Air gaps due to deteriorated or missing weatherstripping were noted, allowing air leakage from the building (see Fig. 2.1.A.15). The door and door frame to the Penthouse on the Roof are corroding and the sealant between the frame and the stucco wall is deteriorating (see Fig. 2.1.A.16).

Fig. 2.1.A.16 Corroding door to the Penthouse.

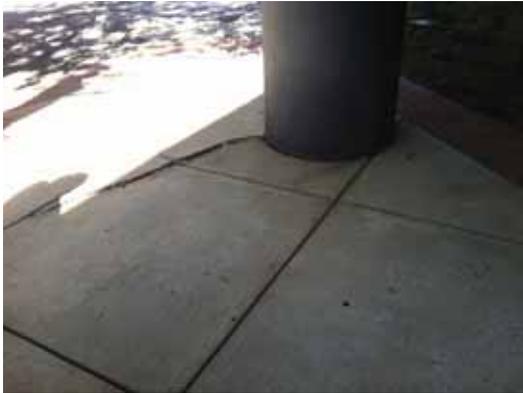
Fig. 2.1.A.29 Cracked concrete pavers are creating a tripping hazard.

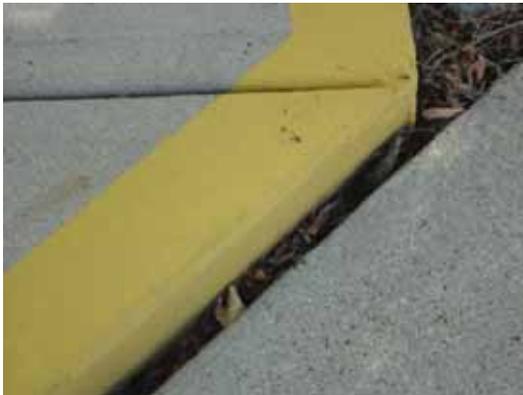
Fig. 2.1.A.30 Gap between concrete pavers is creating a tripping hazard.

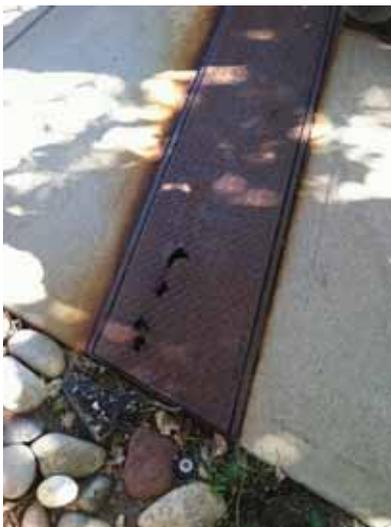
Fig. 2.1.A.31 Corroded metal cover flush with concrete pavers is creating a tripping hazard.

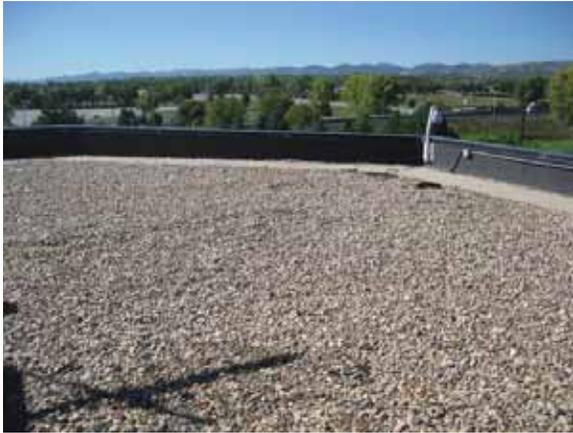
Fig. 2.2.C.1

Parapets along the roof edge were found to be of inadequate height. A fall protection system should be provided for access near exposed edges to meet current safety codes.

Inadequate parapet heights were observed at the upper and lower roof levels (Fig. 2.2.C.1). The parapet height along the entire roof edge was measured to be approximately 24 inches tall. Parapets should be at least 42 inches tall or fall protection provided for access near the exposed edges to meet current safety codes.

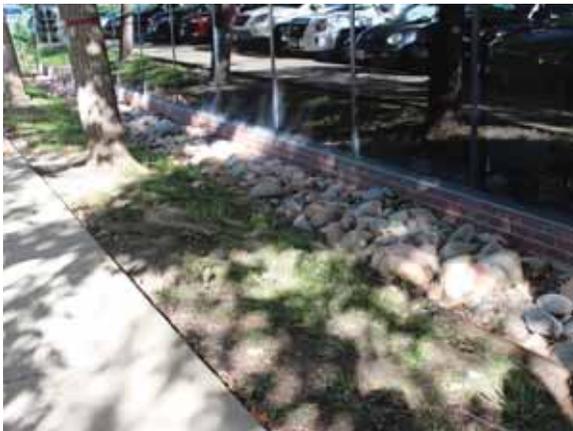
Site slopes were analyzed by visual inspection and topography was evaluated using Google Earth. The landscaped areas surrounding the building are generally flat or slope back towards the building. Current geotechnical recommendations and standard practice for slopes away from the building are 10:1 for 10 feet and 2% in hardscape areas. The building does not appear to have these slopes (Fig. 2.3.B.1). In addition, the perimeter of the building features a rock skirt with a landscape edger approximately 3-4 inches above the subgrade. Since there is no roof overhang at this location and there is no path for drainage away, water has the potential to be trapped along the buildings foundation. This is concern as it can cause building settlement, mold, and numerous other problems. The building perimeter may need to be re-graded and landscape replaced. Perforated landscape edgers and area drains for sump locations may need to be installed.

Figure 2.3.B.1 – Slopes along Building Perimeter

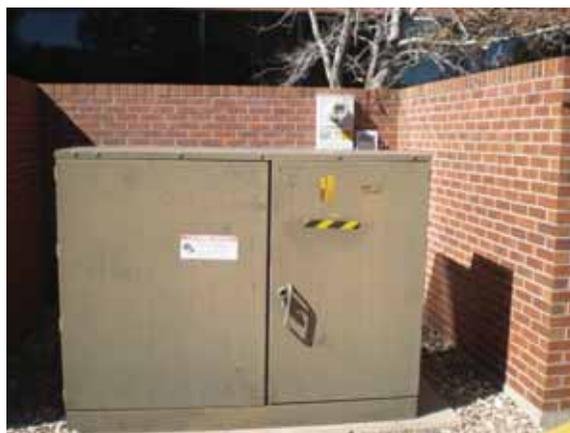
The electrical systems have been upgraded throughout the years to meet the needs of the departments that work in the building. The 13.2kV feeders come into the medium voltage transformer from Xcel energy (see Fig 2.4.A.1). The transformer rating appears to be a 750kVA but the label has worn off overtime. The transformer then feeds a 480/277V, 1600 amp switchgear that feeds the rest of the building including the 208/120V loads. Each floor has panelboards in various locations but most of them are located in the electrical room with the IT equipment (see Fig 2.4.A.2).

Fig 2.4.A.1 – Building transformer

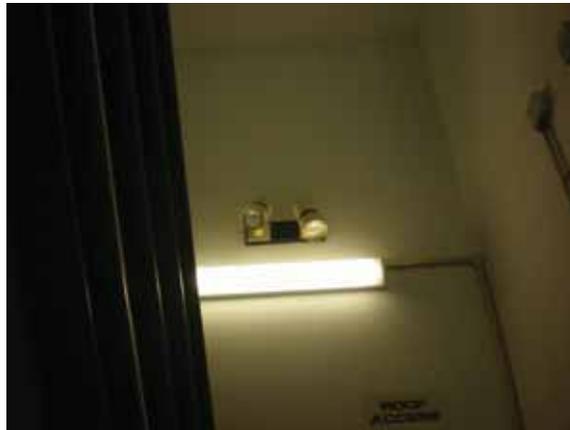
The exit signs appear to be in good working condition. Emergency lighting is provided by a combination of twin-head wall packs and battery ballast in the luminaires (see Fig 2.4.A.5). Most of the twin-head wall packs appear original to the building.

Fig 2.4.A.5 – Twin-head wall packs in stair well

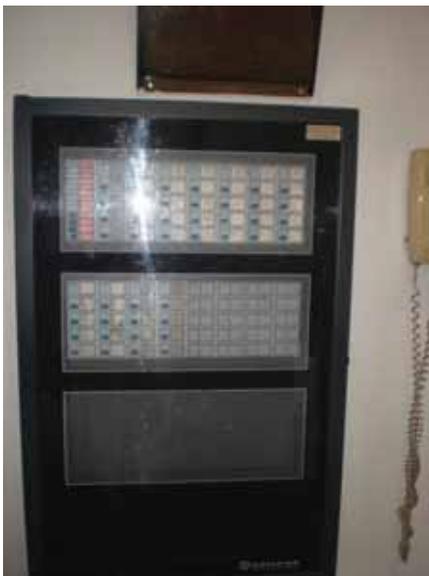
Most of the fire alarm system appears to be original to the building (see Fig 2.4.A.8). The fire alarm system appears to be compliant with the codes in effect at the time of installation. The spaces are detected by duct smoke detectors in the duct work supplying the air to each space.

Fig 2.4.A.8 – Fire alarm control panel

1. Upgrade fire alarm. This recommendation encompasses life safety issues and is due to fire protection code issues and the age of the system.

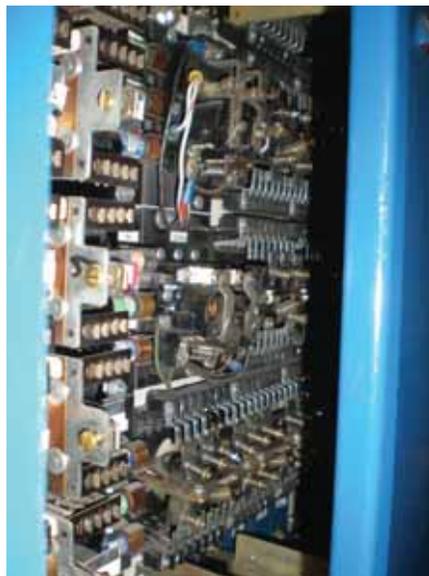
The elevators appear to be in need of a cab and controls upgrade (see Fig 2.4.A.9).

Fig 2.4.A.9 – Elevator controls

2. Modernize elevators. This recommendation encompasses life safety issues and is due to the age and condition of the elevator systems.

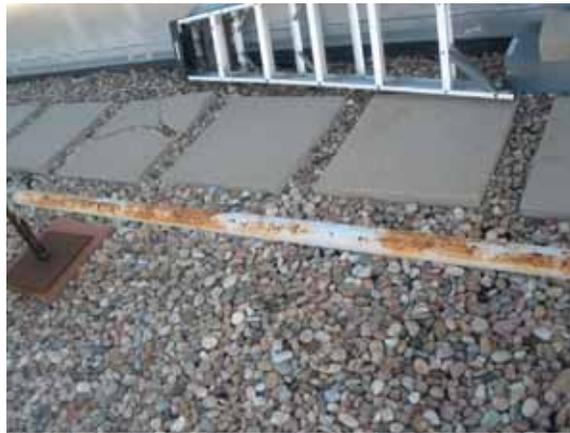
Fig 2.4.A.11– Gas piping on roof

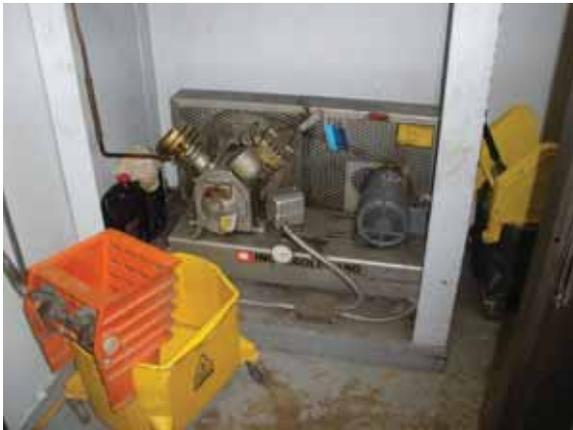
Fig 2.4.A.14 – Air compressor

- Replace sprinkler piping in the building.
- An air compressor is installed in the janitor closet. There is no proper cooling and exhaust in the room to meet the compressor's heat load requirements. Provide some type of cooling arrangement for the room to extract the heat generated by the compressor operation.

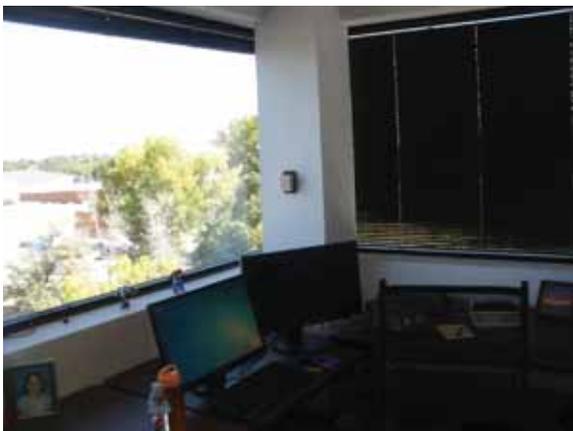
Fig 2.4.A.15 – Room thermostat close to exterior glass

- The room thermostat in one of the corner offices on the third floor is located too close to an exterior glass wall. As a result, the thermostat does not indicate correct space conditions causing the space to become over-cooled or over-heated. Relocate the thermostat to an interior wall to improve occupant comfort conditions.

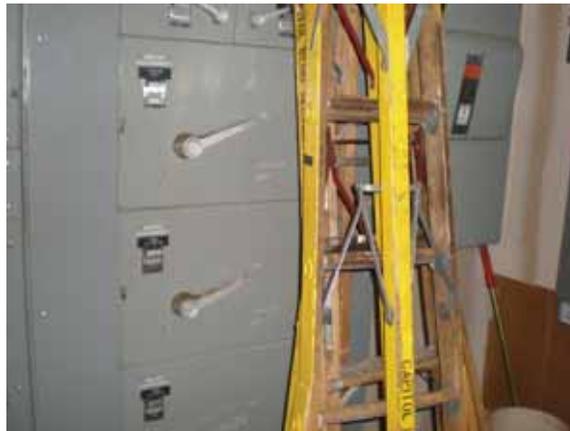
Fig 2.4.B.3 – Ladder on panel

- Install a permanent means of connection of power for the satellite on the roof.
- Remove all storage items from the electrical panelboards dedicated clearance space.
- Ensure all interior fire rated walls have all penetrations sealed properly.
- Seal the roof to prevent water leaking into the electrical room.
- Remove or relocate IT racks located in the dedicated clearance space of the panelboards in the electrical rooms.

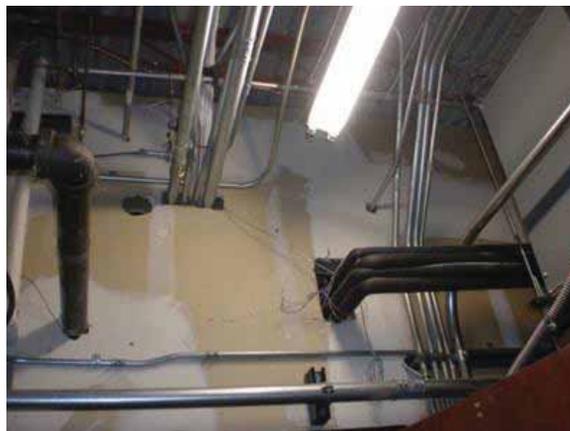
Fig 2.4.B.4 – Holes in fire rated walls

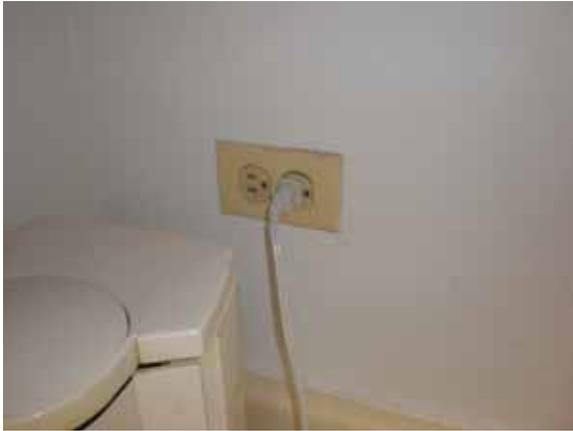
Fig 2.4.B.5 – No GFI protection in break room

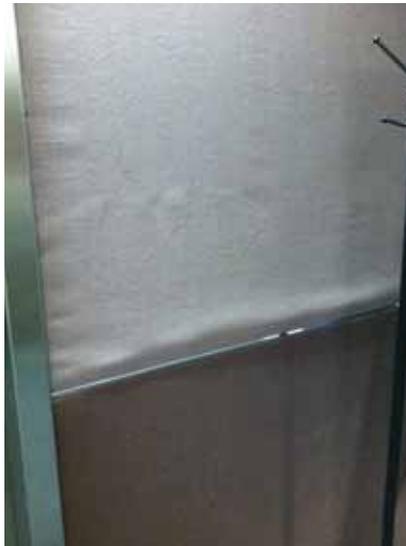
Fig. 3.0.C.4 Typical instance of loose fabric wall panels deteriorating in the elevator lobbies throughout the Second through Fourth Floors.

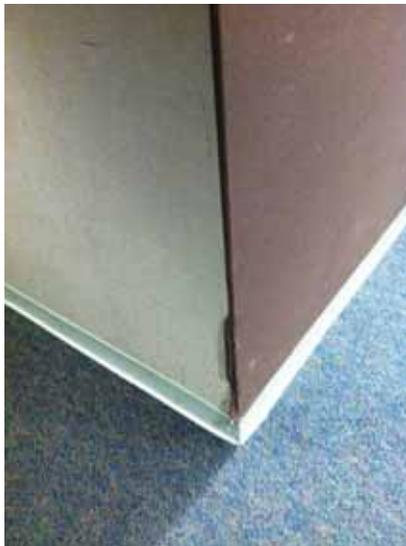
Fig. 3.0.C.5 Typical instance of deteriorating and damaged fabric wall panels in the elevator lobbies throughout the Second through Fourth Floors.
