**SYSTEM INVENTORY AND
ASSESSMENT STUDY FOR
COLORADO SPRINGS
UTILITIES WATER SYSTEM
CONVERSION**

**CASCADE METROPOLITAN
DISTRICT NO. 1**

Volume 1 - Study

PROJECT NO. 15061.100

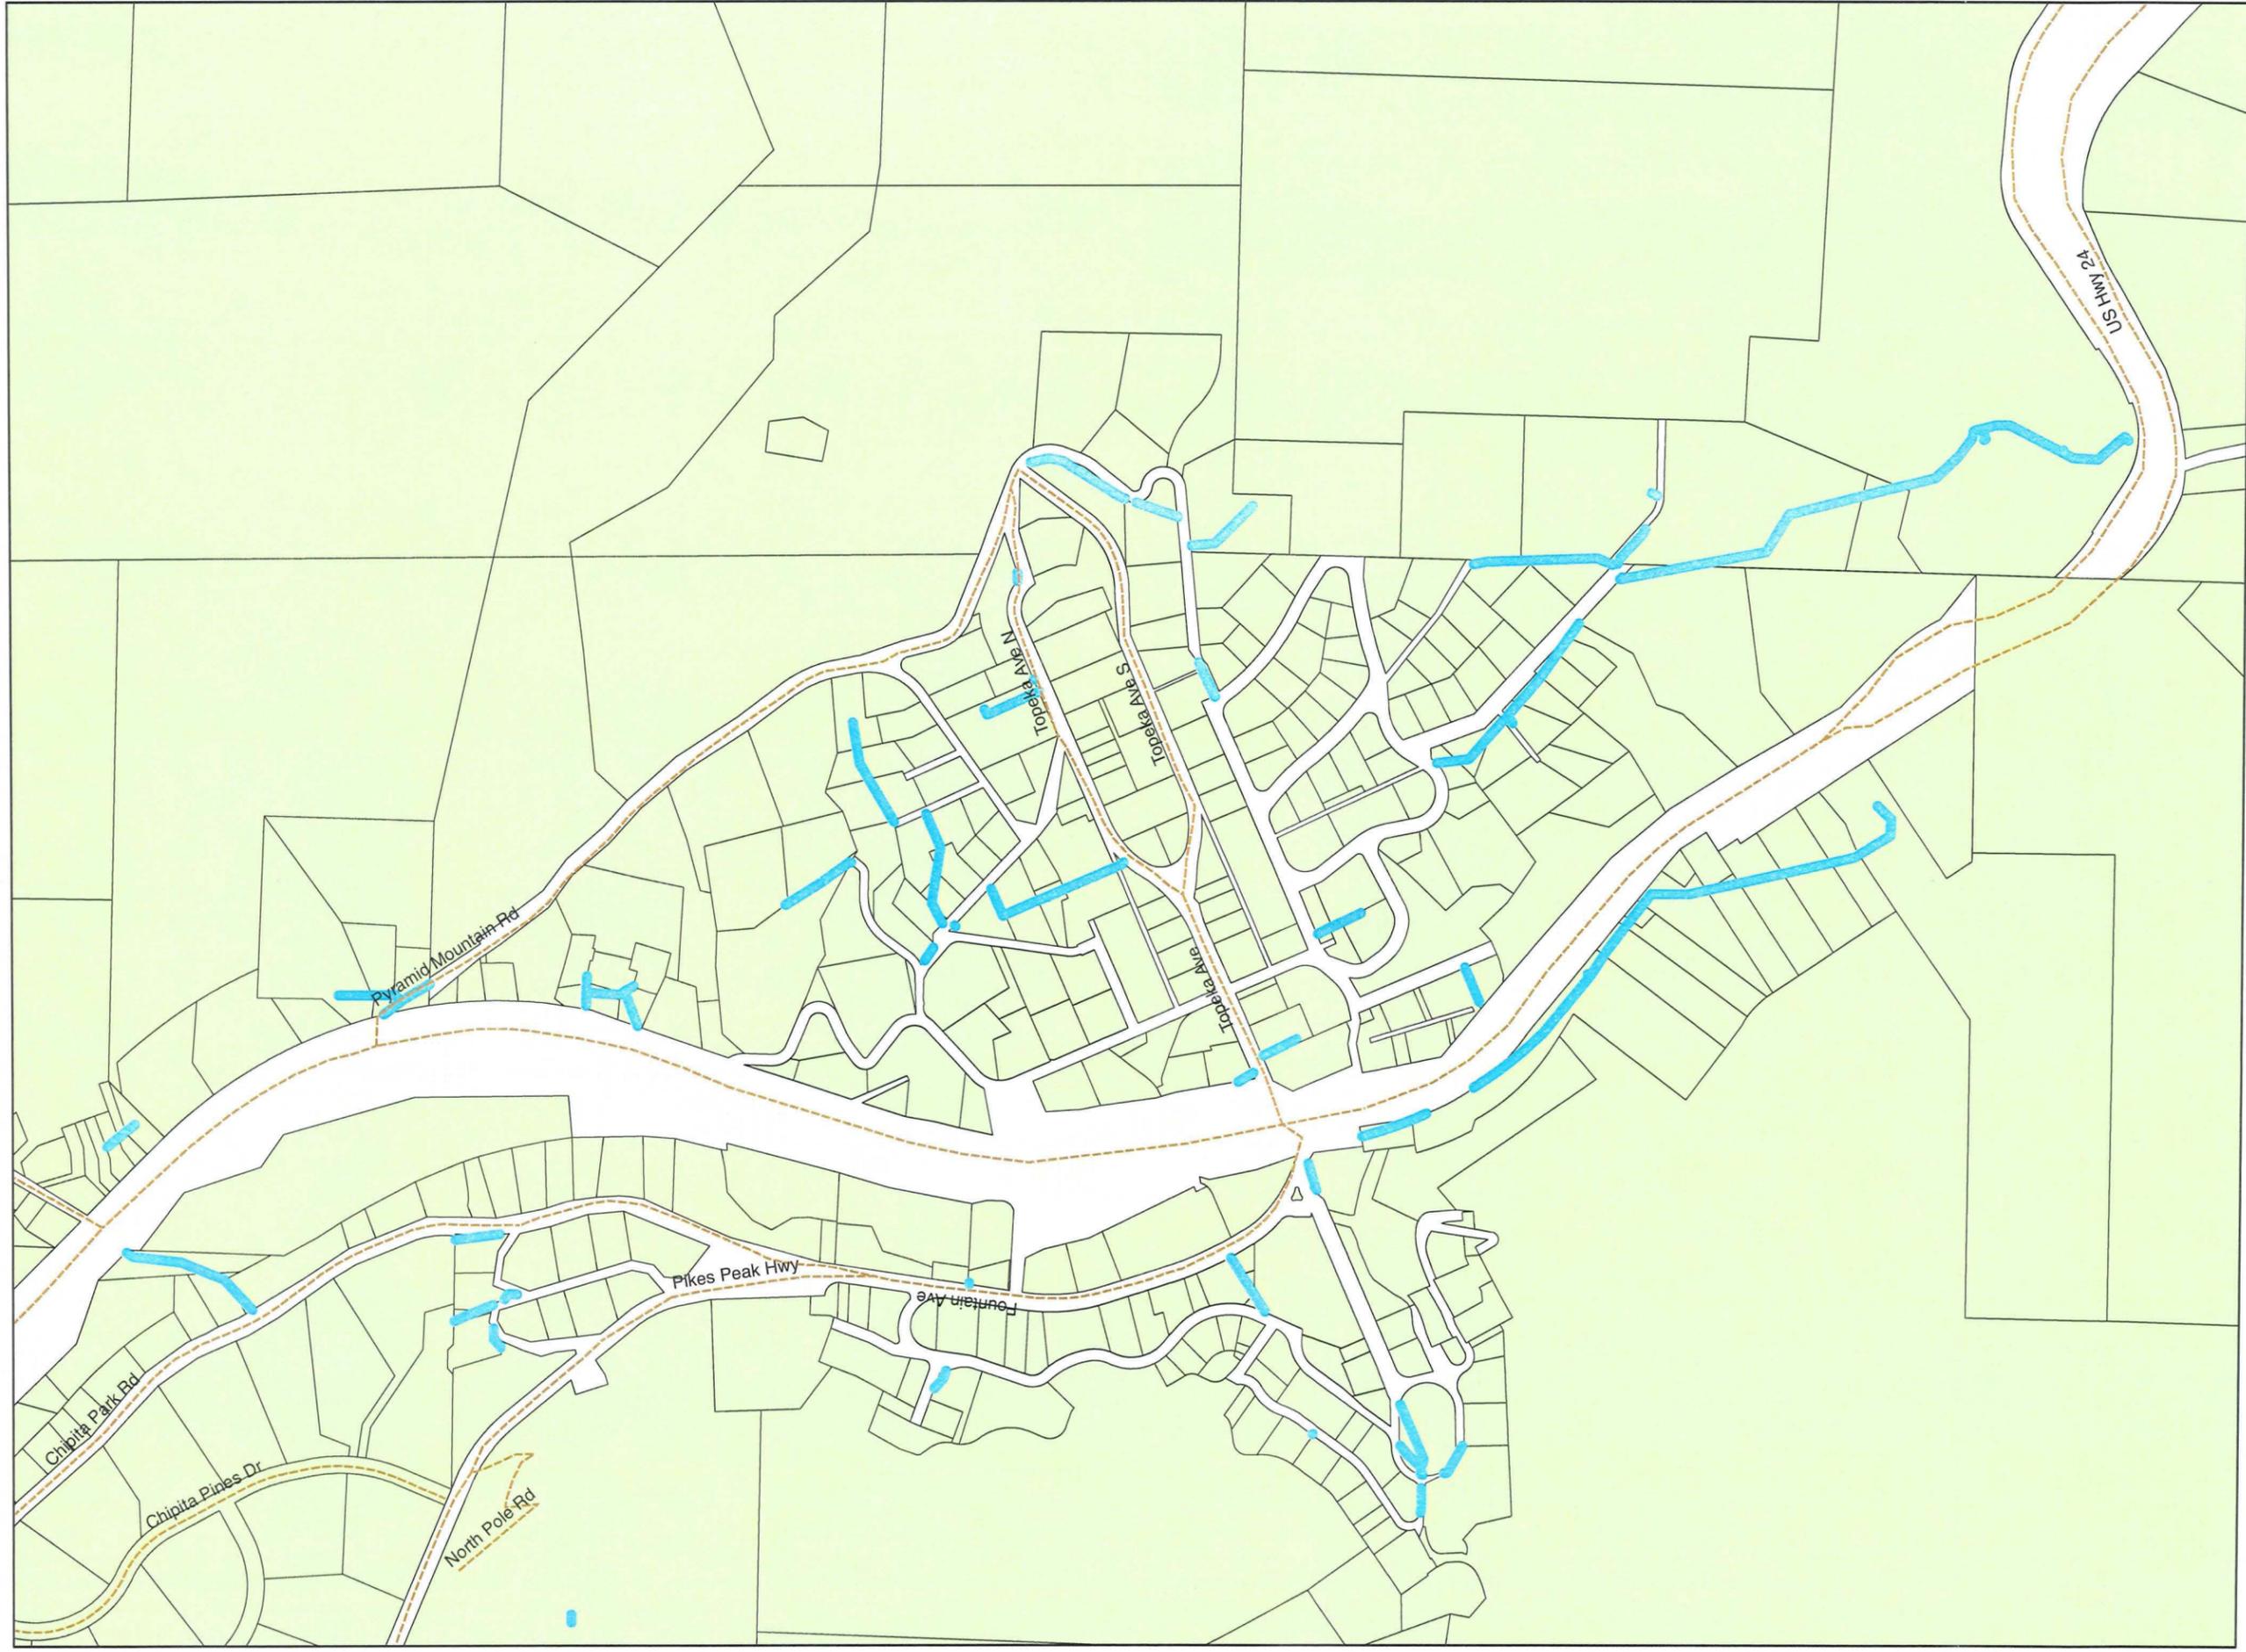
The following is a map and a list of properties where CMD1 assets encroach upon a property where no recorded document exists. The map shows the assets highlighted for reference. The parcel list identifies the parcel utilizing the El Paso County Assessor's Schedule Number as the reference.

Figure 1 – Assets Not Within Easement/R-O-W	37
Figure 2 – Water Purchase and Sales By Year	56

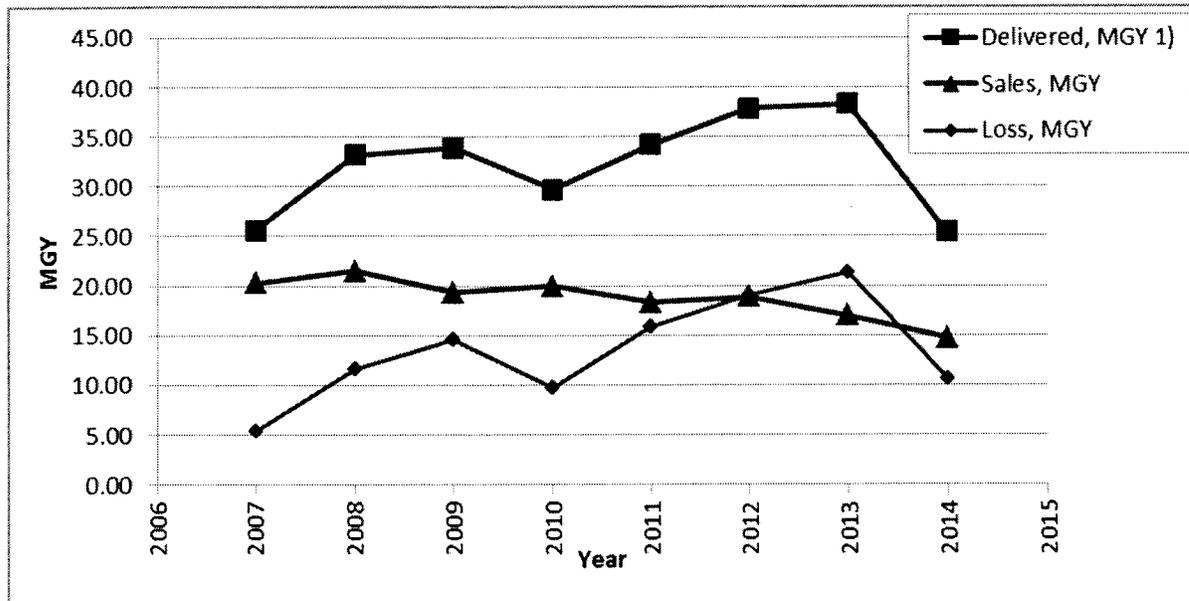
FIGURE 2
WATER PURCHASE AND SALES BY YEAR

An annual summary of the water delivery, water sales and unaccounted-for water data is presented in the following Table 12 and Figure 2.

The above Table and Figure show water deliveries to CMD1 increasing annually from 2007 through 2013 with a significant reduction in 2014. Water sales have declined steadily from 2007 through 2014. Unaccounted-for water in general has increased from 2007 through 2013 with a significant decline in 2014. This is directly reflected in the 2014 delivery reduction value. Water sales reduction is likely attributed to conservation by individual customers as well as a result of more accurate metering combined with increasing water rates. The dramatic drop in unaccounted-for water is a direct result of leak repairs.
