MISCELLANEOUS

SITE ADJACENT SOILS/PATHWAY MANAGEMENT (RAP Sections 24 and 29)

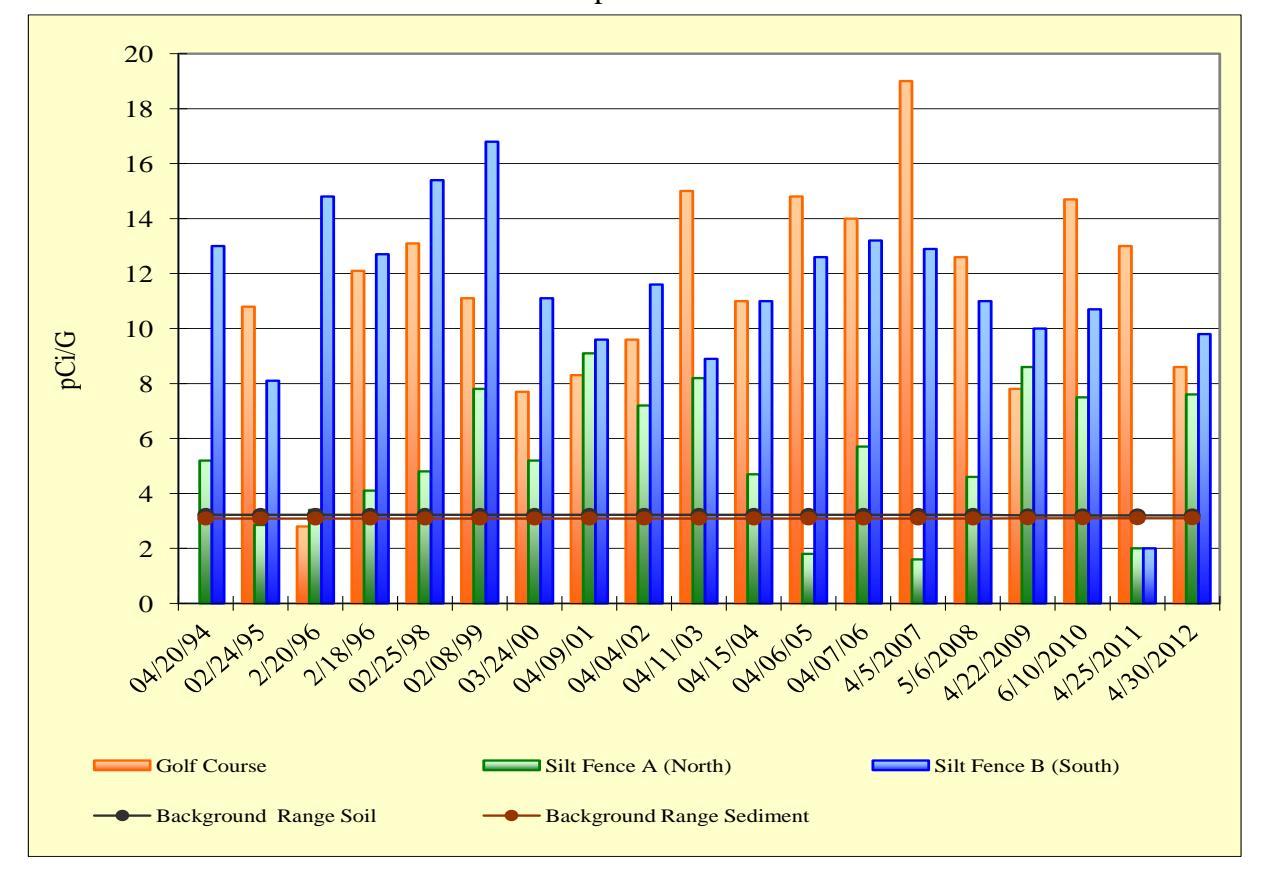
Figure 8-1 ²³⁰Th Silt Fence pCi/G

Silt fence soils were collected in 2012. Silt fence soil sample analytical results for 2012 include data available for natural uranium and natural thorium decay chain radionuclides as well as molybdenum. All results are generally within historical range. Thorium-230 and Radium-226 results from soil samples taken at the nearby AS-210 Shadow Hills Estate site (see Section 4) are
