Catalyst Plant Demolition Report

This report summarizes the Mill Facility Removal demolition of the Catalyst Plant (Demonstration Plant). This demolition activity commenced in March 2011 and was completed by mid April 2011 and was completed in accordance with all applicable legal and regulatory requirements. The project goals of safe work and using the ALARA philosophy to minimize dose to workers and the public were achieved.

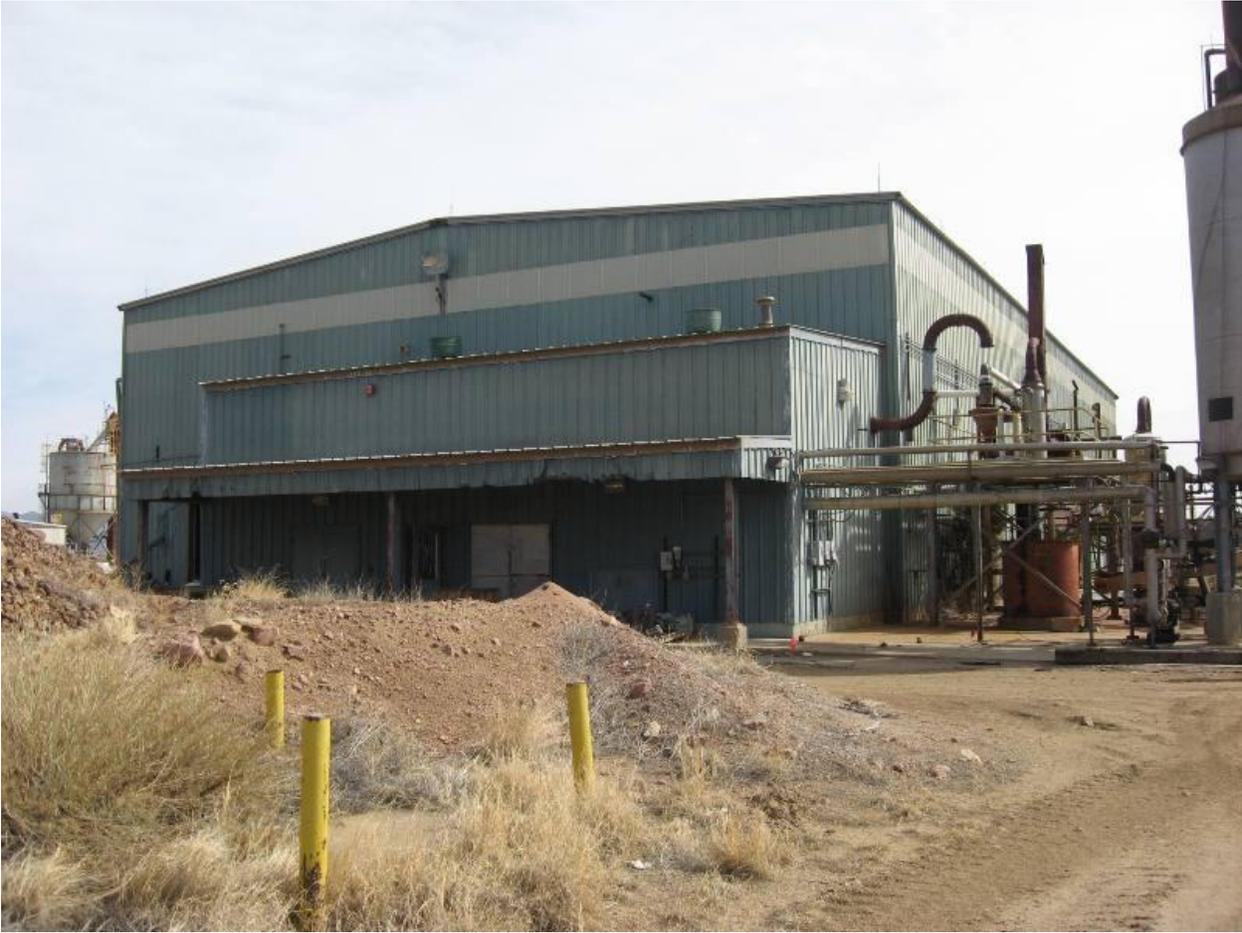
PRE-DEMOLITION

Page 5 is a pre-demolition view with page 6 showing a post-demolition view of the Catalyst Plant.
