Colorado State Conservation Board 2009 Matching Grants Project:  
Dolores Conservation District: McElmo Creek Riparian Restoration Project

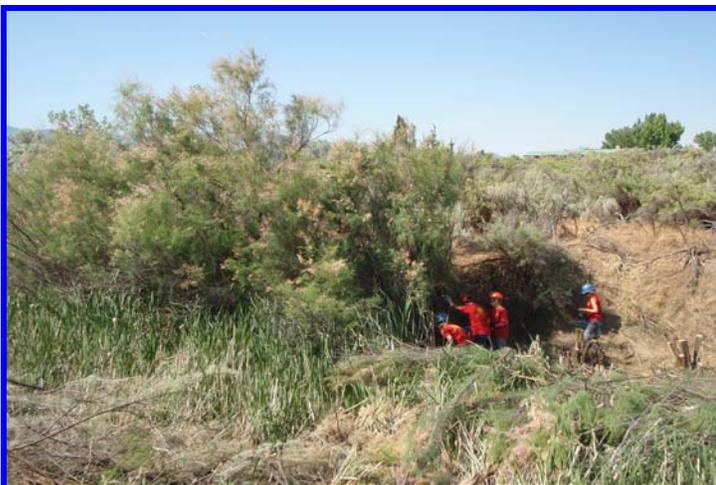
*The Southwest Conservation Corp remove tamarisk and chemically treat the cut stumps (above left). Re-establishing native plants is the next critical step and that can be the hardest part of restoration efforts (above right).*

- Two sites were planted with "pockets" of native plants as reseeding source for 292 acres after removal of tamarisk by hand and chain saws and chemical treatment of cut stumps
