EAGLE MINE SUPERFUND SITE  
**EAGLE MINE NEWS**

Summer 2011

## Water, water everywhere for spring inspection

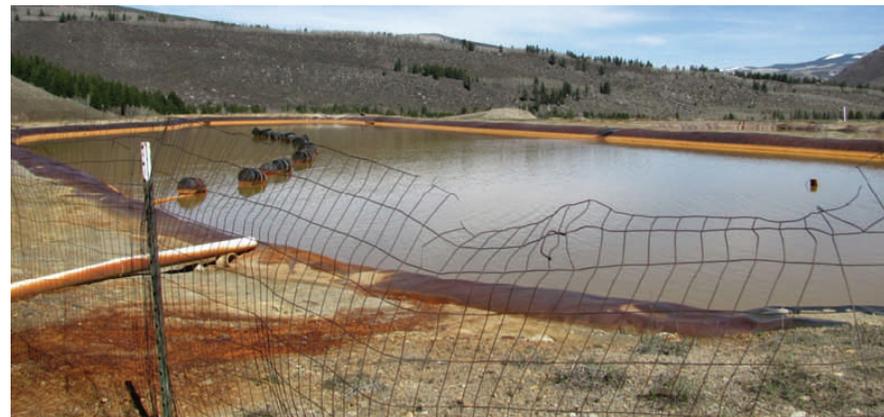
*A lower water level in the upper surge pond will help prevent an overflow if a storm comes through the area. The fencing also needs maintenance.*

- Lower the upper pond water level by at least one foot.
- Repair the surge pond fence.
- Remove excess water in the Temporary Cell and Sludge Disposal Cell.

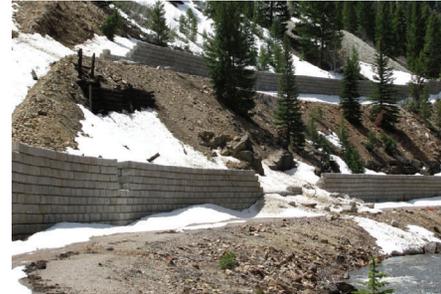
*EPA will repair sections of the concrete wall damaged over the winter.*

- The major issues were avalanche damage to the concrete block wall and leaky pipe from the Doghole seep. Mike Holmes will contact EPA's Removal Program.
