Colorado State Conservation Board 2008 Matching Grants Project:
San Juan Conservation District: Conservation Helping Hand

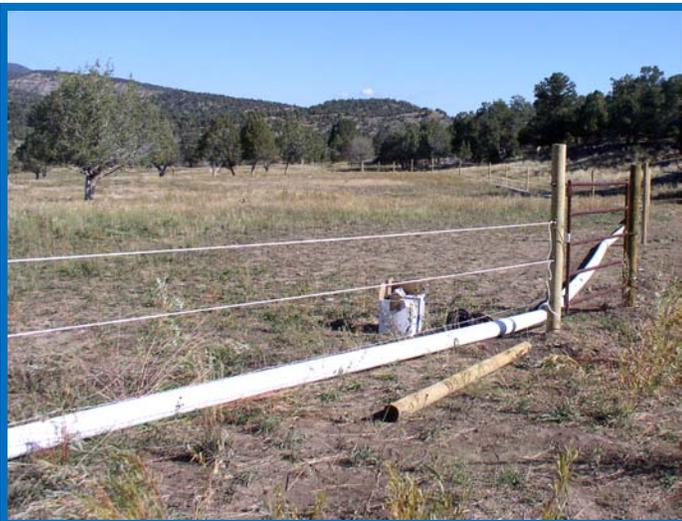
In flood irrigated pastures, installation of gated pipe controls water flow and increases water efficiency from 35-40% to 60%.

- Two landowners installed **gated pipe irrigation systems** for **20-25% improvement in irrigation efficiency.**
- Two landowners installed **water diversion structures** to improve irrigation efficiency by **15%** and significantly **reduce sediment** entering the creek.

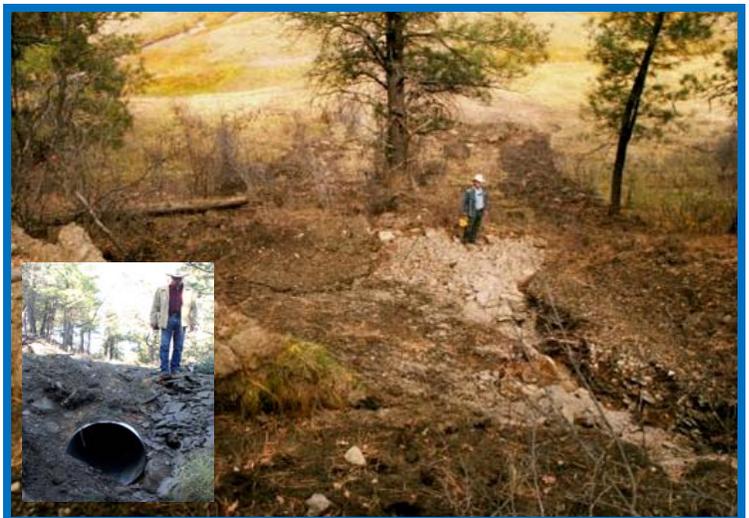
Water flow in ditches can seriously erode soils (large picture). Installing ditch diversions (insert) greatly curbs erosion to reduce sediment downstream and improve water use efficiency.
