# EAGLE MINE NEWS

EAGLE MINE SUPERFUND SITE • Fall 2015

## Gold King Mine blowout:

# Could it happen at Eagle Mine?

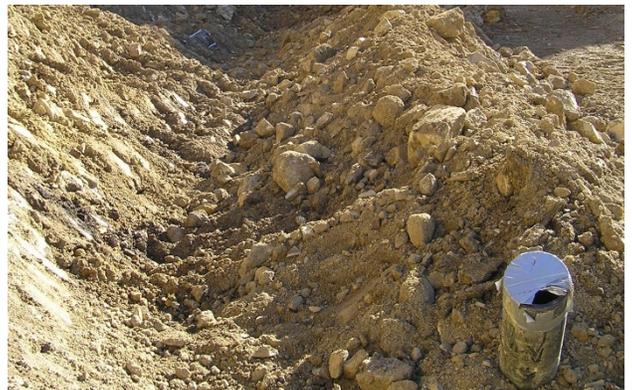
CBS collected additional samples from potential sources of arsenic loading in the spring of 2015.

In August 2014, the agencies directed CBS to augment existing surface water data on arsenic by conducting additional sampling to identify potential sources of arsenic loading during the following spring melt-out period (March/April 2015). CBS collected the required data and submitted it to the agencies in June 2015.
