**RE: Expedited Settlement Agreement, Number EI-150713-1  
4390 Tennyson Street**

## EXPEDITED SETTLEMENT AGREEMENT

RE: 4390 W. 44<sup>th</sup>, Denver CO

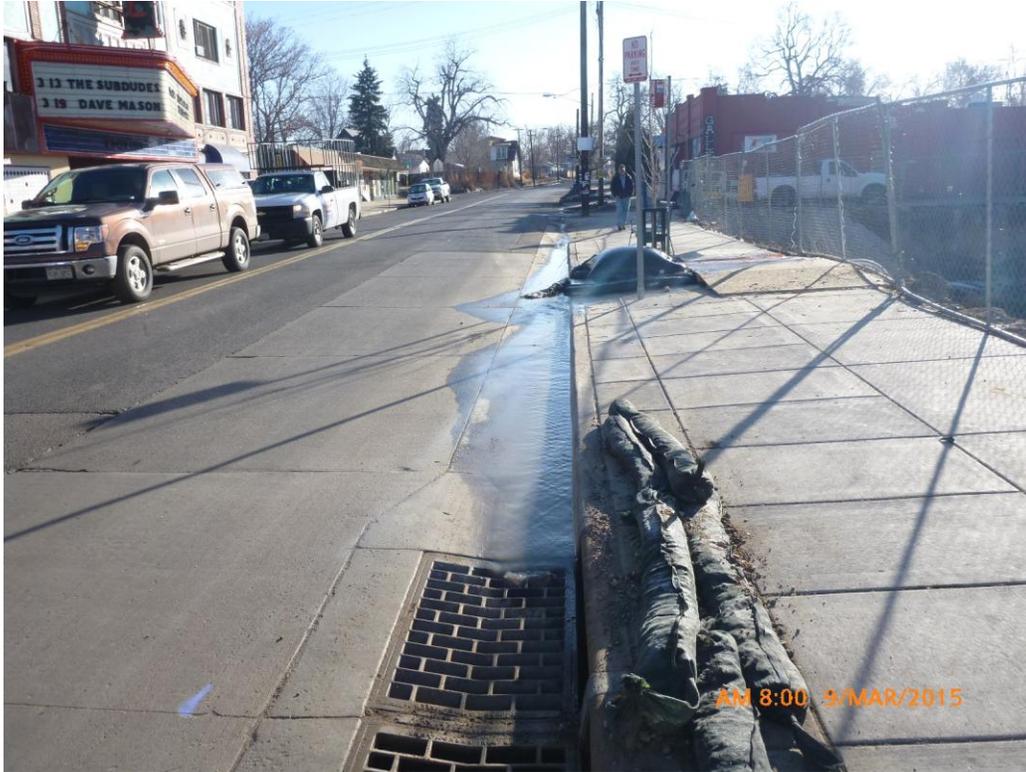
Photograph 1: Pumped water discharge point

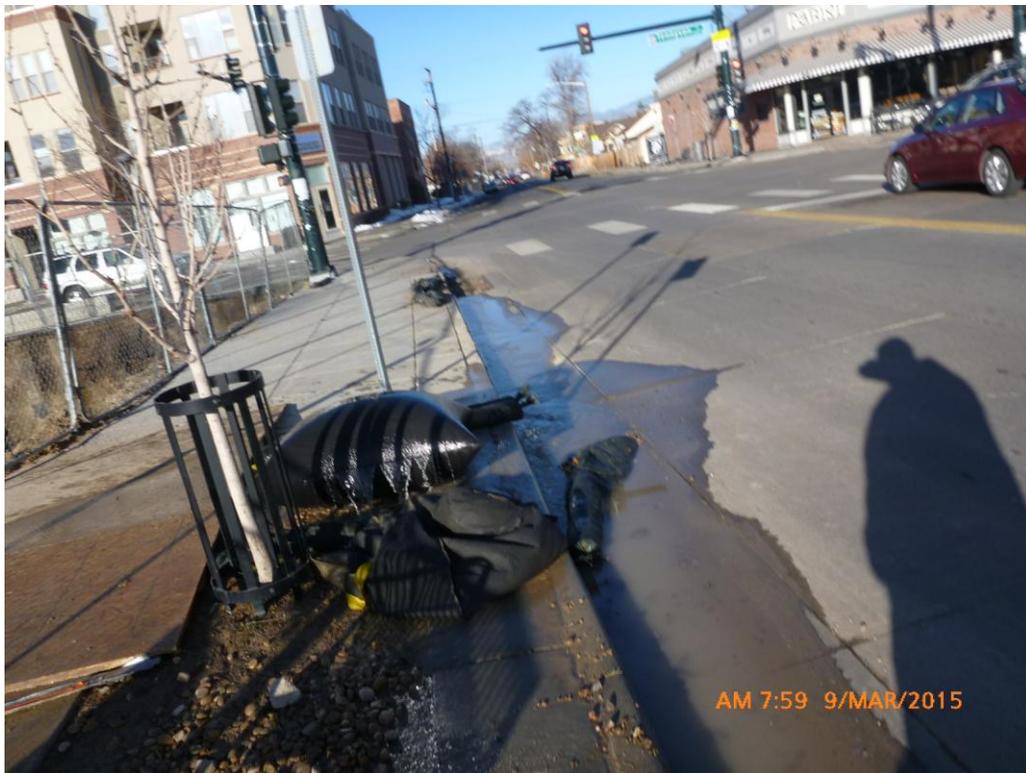
On Friday, March 6, 2015 CCD received a citizen notification via the Denver 311 non-emergency services and communications line that dewatering at the above mentioned site was exceeding the capacity of the dewatering bag resulting in sediment discharges to the flowline and inlet. Staff was not available to inspect late Friday afternoon but inspection was scheduled for first thing Monday morning.

On Monday, March 9, 2015 site was inspected at start of day and found to be in non-compliance with dewatering requirements regarding adequacy of BMPs to prevent sediment discharge to the storm sewer. A Stop Work order for all activities at site was issued, effective immediately, with orders to remediate the storm line via Jet-Vac (200' minimum or until the line was clear), clean the flowline / gutter, and sample the water being discharged to test for potential pollutants.

Photograph 2: pumped water from site entering storm drain

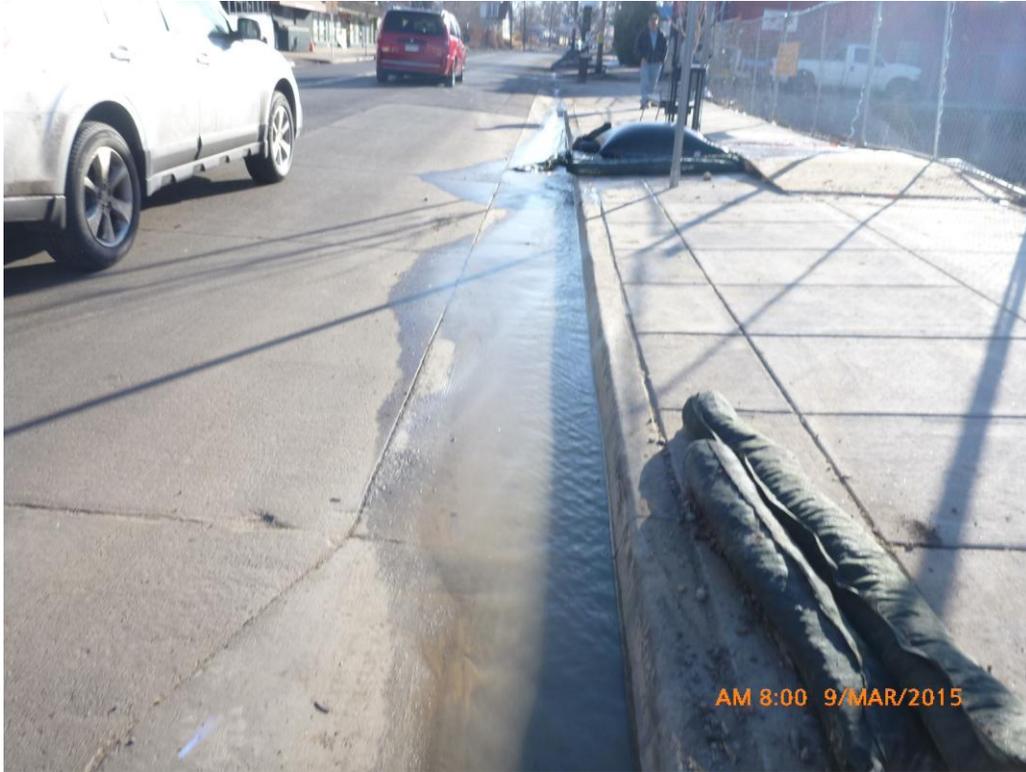
Photograph 3: Pumped water along flowline

As of Thursday, March 19, 2015, remediation of the fouled line has not yet been completed due to issues related to lane closures. Owner has been notified that site will return to Stop Work status unless cleaning of the line is accomplished by 4:00 p.m. Friday, March 20, 2015.

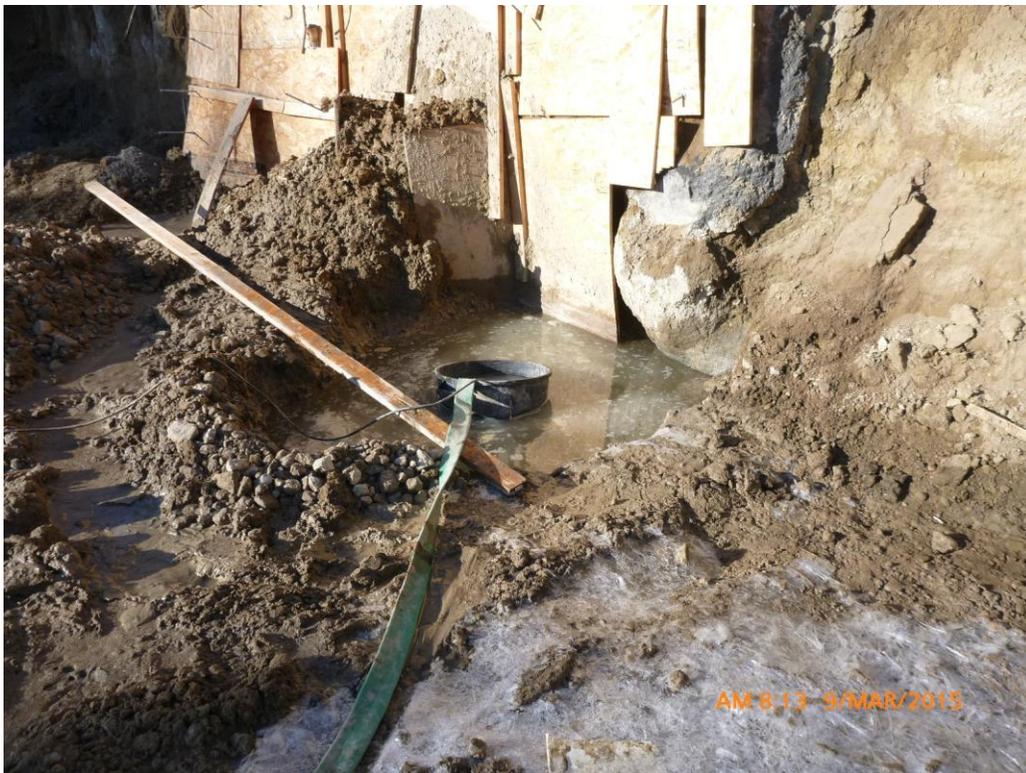
At time of inspection, one pump was observed actively discharging. Pump was located in the immediate vicinity where historic fuel tanks were previously identified. (West side of site excavation.) Note: Photos available / previously provided. A discarded water bottle found at site was used to collect a qualitative sample of the source water being pumped. Upon later observation the sample was found to have a strong odor, such as that of degraded petroleum. Follow-up sampling as completed by the owner's contracted environmental consultant would later be identified as "Grab - 03" in a report titled "4390 W. 44<sup>th</sup> Avenue.rpt - 10MAR 15 Operation Pump Location.pdf."

Photograph 4: Excavation along west edge of site directly under photograph 7

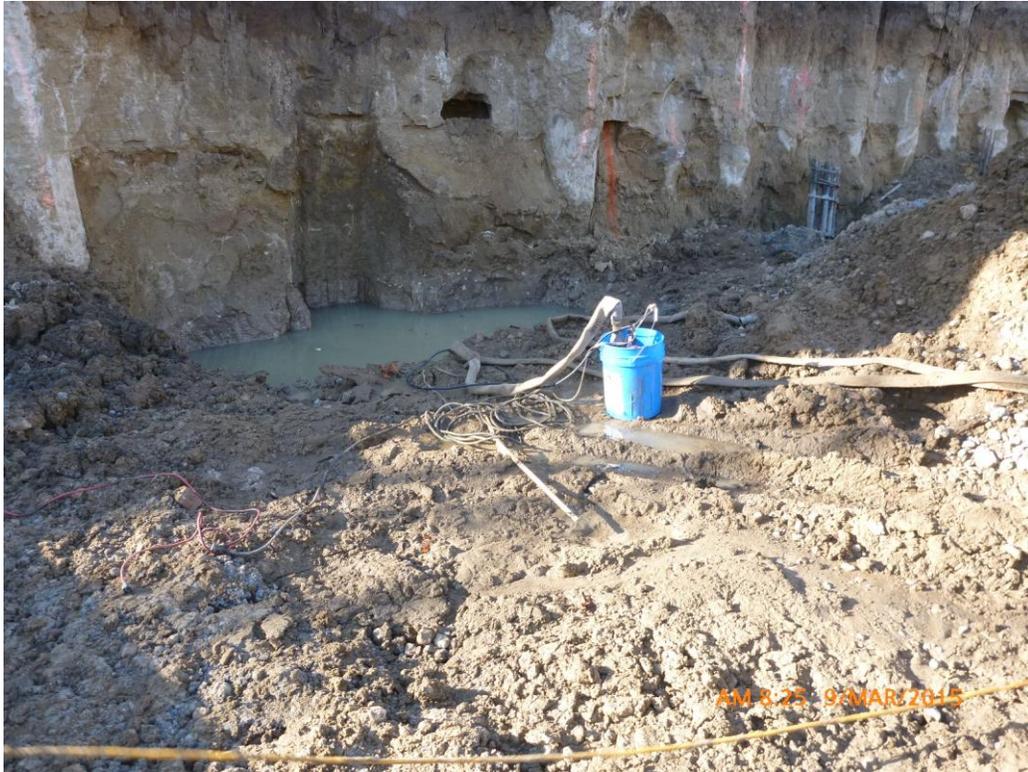
A second pump was present at site but not "set-up" or active. The pump appeared to be staged where it had previously or would eventually discharge additional groundwater, located immediately adjacent to an area that had been drilled for a caisson. (South side of site.) Note: Photos available / previously provided. Sampling taken from this location by owner's contracted environmental consultant would later be identified as "Grab -2" in a report titled "4390 W. 44<sup>th</sup> Avenue.rpt - 10MAR 15 Non-operational pump location.pdf."

Photograph 5: Drilled caisson hole on south side of site, roughly parallel with pickup truck in photograph 6

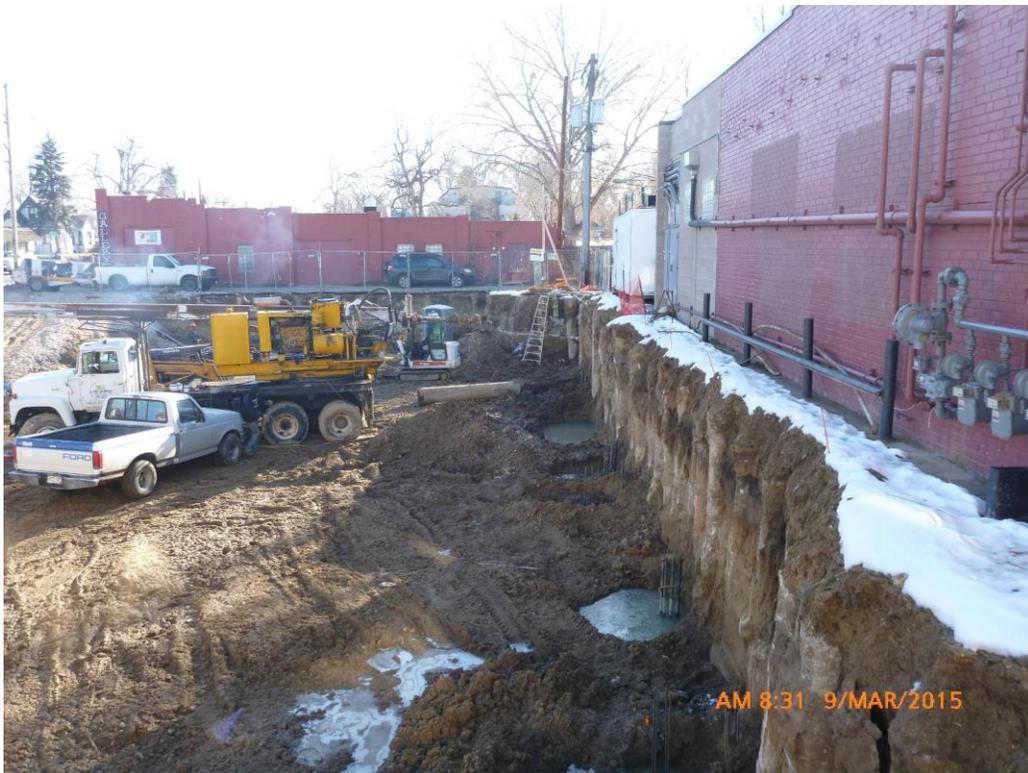
At time of inspection and stop work, the areas being dewatered appeared to involve groundwater, not stormwater. Snowmelt in the area had already been evacuated, there was no significant ponding present in the excavation, and the only sources of water observed were in limited areas that appeared to have recently been drilled for caissons.

Photograph 6: Facing east. Two drilled caisson holes on south side of site.

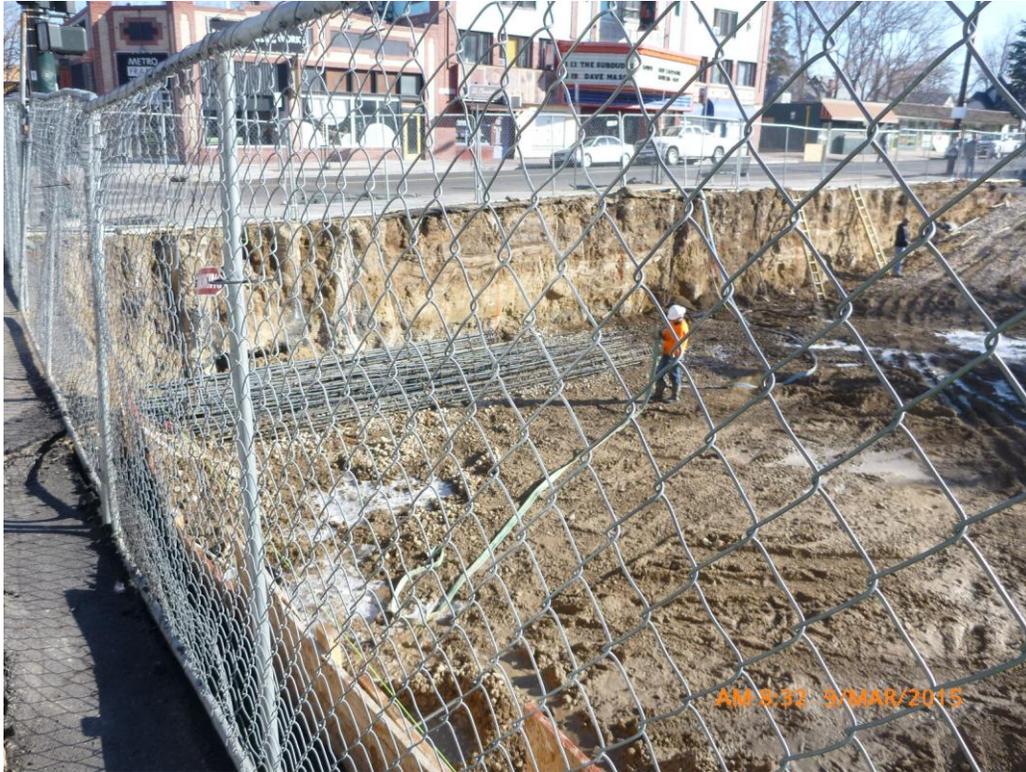
Photograph 7: Along west side of site. Directly above location of groundwater pumping
