## EXPEDITED SETTLEMENT AGREEMENT

Number: EI-160120-1

## Stormwater Inspection Report

<b>Permittee:</b> Martin Marietta Materials, Inc	<b>Cert. No.</b> COG500479	<b>Date(s):</b> May 7, 2015 <b>Time In:</b> 9:30 AM <b>Time Out:</b> 2:00 PM
<b>Facility:</b> Spec Aggregate Quarry	<b>Industrial Type:</b> Sand and Gravel	<b>Receiving Water(s):</b> Apex and Lena Gulch - Clear Creek
<b>Facility Address:</b> 18401 West Colfax Avenue, Golden, Jefferson County, Colorado 80401		
<b>Persons present:</b> Joe Campbell (WQCD); Walt Wright, Keith Buescher (Martin Marietta)		
<b>Legally Responsible Person(s)/Title(s):</b> David Hagerman (Vice President)		<b>Inspector:</b> Joe Campbell (CDPHE - Water Quality Control Division)

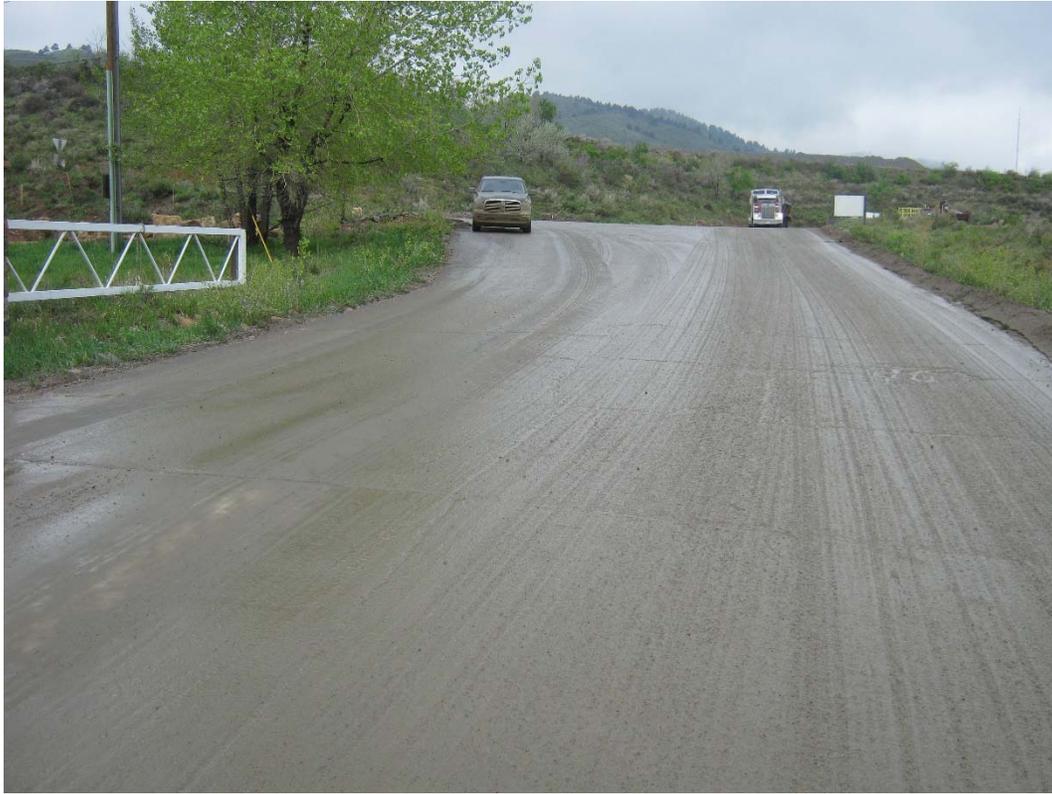
1. It was noted during the inspection that control measures were not implemented to manage tracking of sediment offsite from the main exit of the facility onto West Colfax Avenue (See Photographs 1 - 3).

- Pollutant Source: Sediment from disturbed areas.
  - Control Measure Observation: Control measures were not implemented to control stormwater run-off from the above listed pollutant source. Specifically, tracking of sediment offsite from the disturbed areas onsite was observed along West Colfax Avenue.

- Stormwater runoff from this area is discharged as follows: Stormwater runoff flows south and west off of West Colfax Avenue and directly to Lena Gulch. No additional control measures were implemented down gradient of this location to manage runoff from the pollutant sources.

**Photograph 1:** Vehicle tracking offsite onto West Colfax Avenue (looking back north onsite)

- Control measures must be implemented to manage stormwater runoff from all potential pollutant sources.
    - Practices must be implemented for all areas of potential vehicle tracking, and can include: minimizing site access; street sweeping or scraping; tracking pads; graveled parking areas; requiring that vehicles stay on paved areas on-site; wash racks; contractor education; and/or sediment control measures, etc.

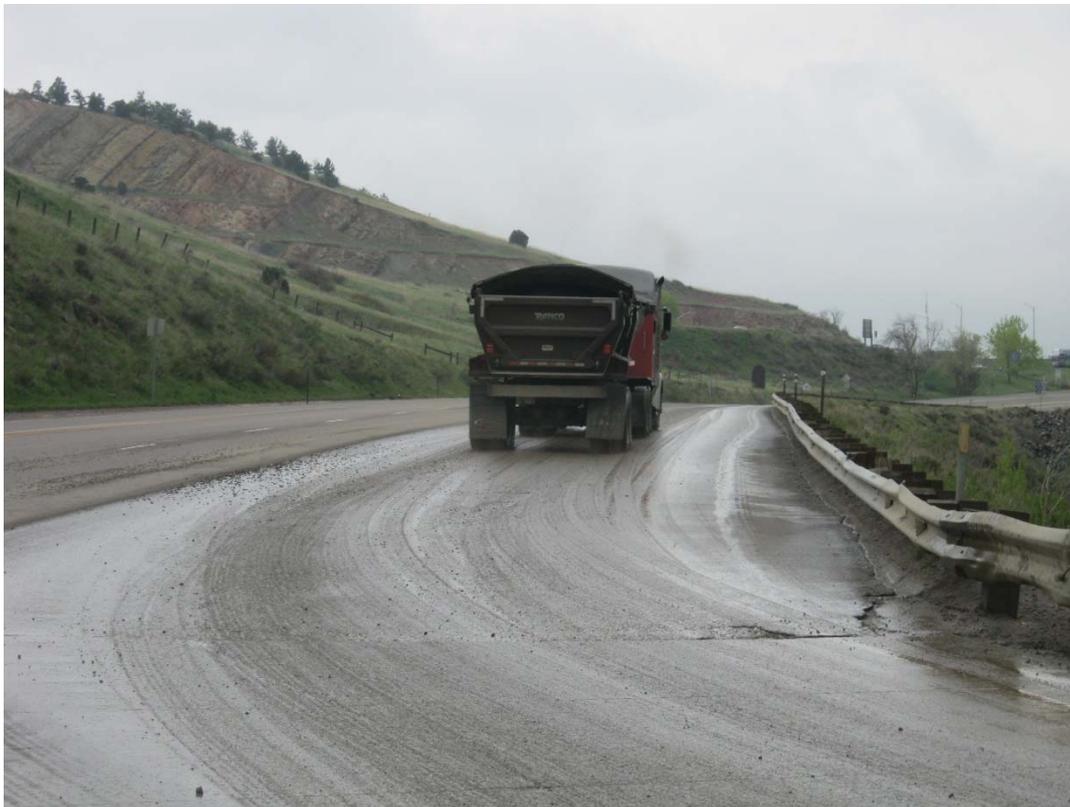
**Photograph 2:** Vehicle tracking offsite onto West Colfax Avenue

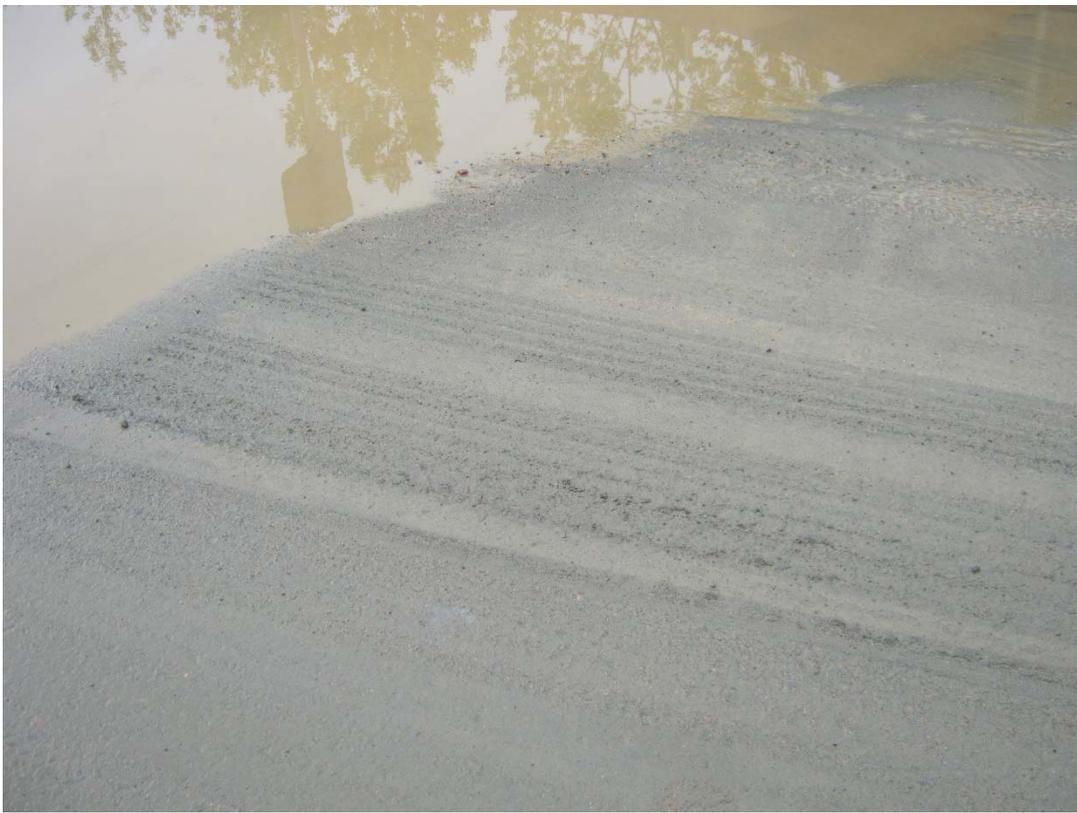
**Photograph 3:** Vehicle tracking offsite onto West Colfax Avenue

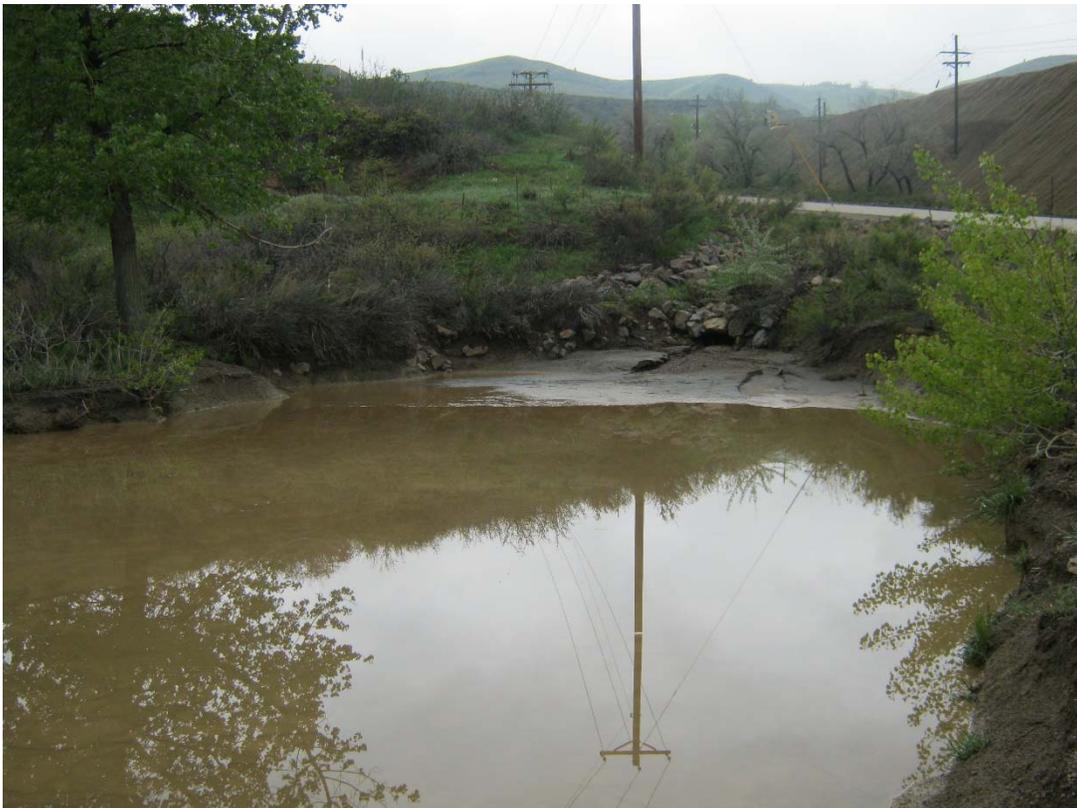
2. It was noted during the inspection that inadequate control measures were implemented to manage sediment from disturbed areas on the eastern portion of the facility (See Photographs 4 - 5).

- Retention Pond #3 was over 1/3 full of sediment and was past its useful storage capacity for sediment. Additionally, the rock lined drainage swale at the outlet of the sediment basin was clogged with sediment.

- Control Measure Finding: An installation and implementation specification for a sediment basin was provided in the SWMP, but was not implemented. Specifically,

- As stated in the installation and implementation detail in the SWMP (Urban Storm Drainage Criteria Manual, Volume 3) sediment is to be dredged from the basin, as needed to maintain control measure effectiveness, typically when the design storage volume is no more than one-third filled with sediment.

**Photograph 4:** Retention Pond #3. Over 1/3 full of sediment.

- Maintain all control measures used to achieve the effluent limits required by this permit in effective operating condition.
    - Implement control measures consistent with the installation and implementation specifications provided in the SWMP.

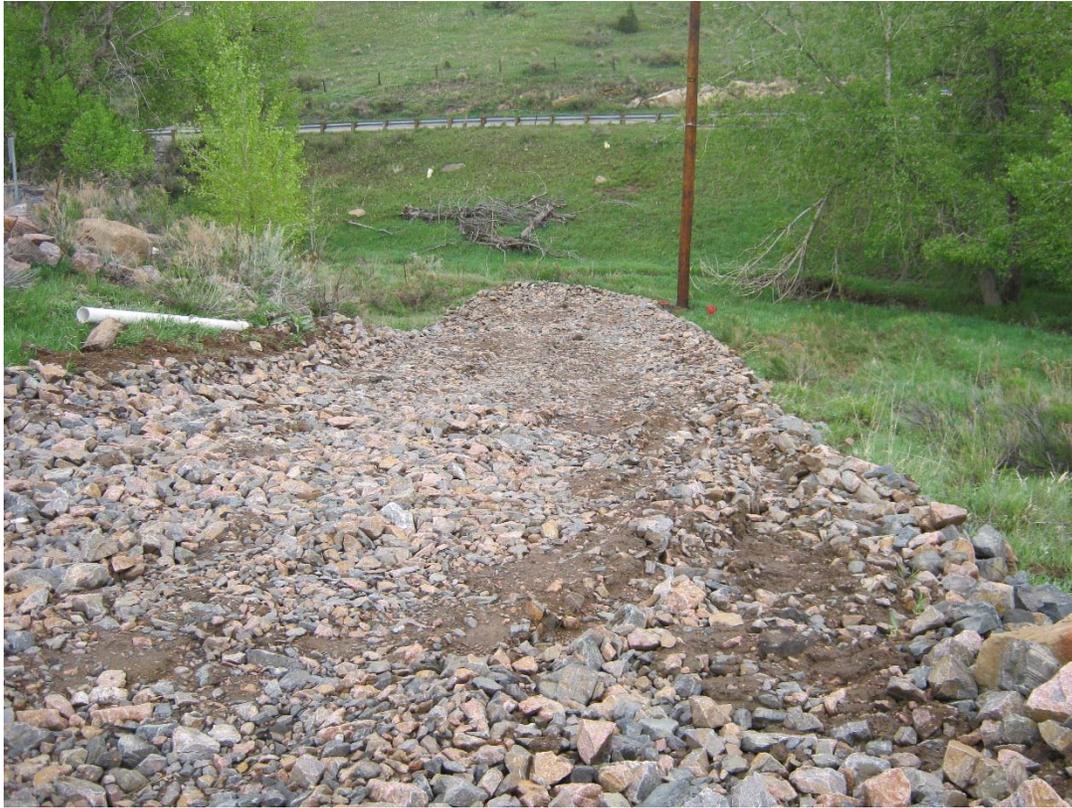
- Stormwater runoff from this area is discharged as follows: Stormwater runoff flows east through a riprap lined drainage swale and directly to Lena Gulch. No additional control measures were implemented down gradient of this location to manage runoff from the pollutant sources.

**Photograph 5:** Discharge point of Retention Pond #3. Rock lined swale with sediment deposition.

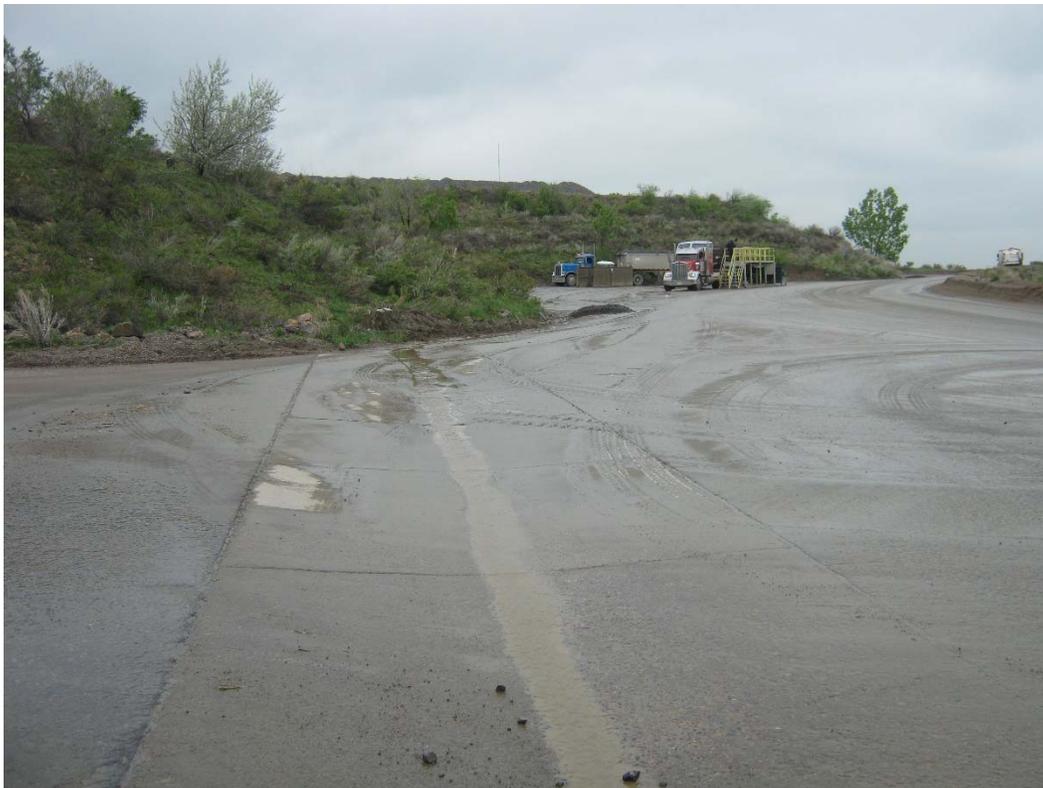
3. It was noted during the inspection that inadequate control measures were implemented to manage sediment from disturbed areas along the main exit of the facility onto West Colfax Avenue (See Photographs 6-10).

- Stormwater runoff from this area is discharged as follows: Stormwater runoff flows north and directly to Lena Gulch. No additional control measures were implemented down gradient of this location to manage runoff from the pollutant sources.

**Photograph 6:** Stormwater drainage from the eastern portion of the facility flowing south to Lena Gulch.

- Select, install, implement, and maintain appropriate control measures, following good engineering, hydrologic and pollution control practices.
- Design control measures following good engineering, hydrologic and pollution control practices to prevent pollution or degradation of state waters and document in the SWMP.
- Stabilize exposed areas and contain runoff using structural and/or non-structural control measures to minimize onsite erosion and sedimentation, and the resulting discharge of pollutants.

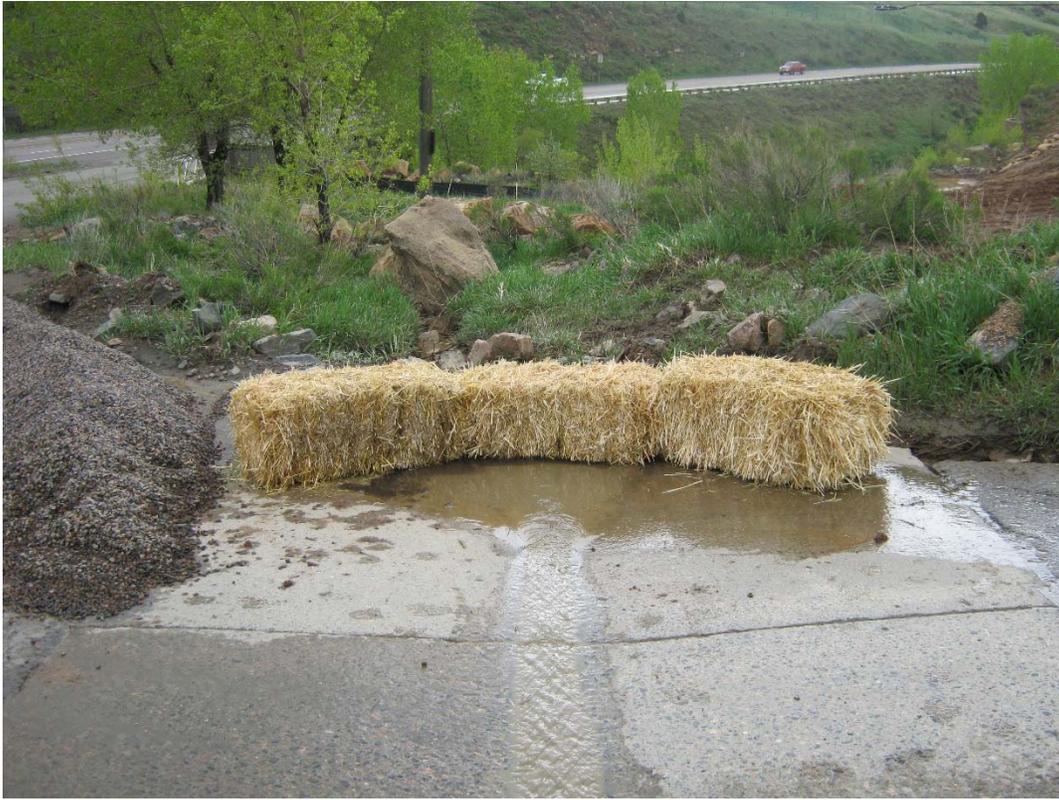
- Pollutant Source: Sediment from disturbed areas and tracking.
  - Control Measure Observation: A straw bale control measure was implemented to manage stormwater runoff from the location and pollutant source noted above; however the control measure was inadequate. Specifically,

- The straw bale control measure was utilized in an area of concentrated flow and were installed on an impervious surface (i.e. not staked or trenched in).

- Control Measure Finding: An installation and implementation specification for a straw bale control measure was provided in the SWMP, but was not implemented. Specifically,

- As stated in the installation and implementation detail in the SWMP (Urban Storm Drainage Criteria Manual, Volume 3) straw bales are not to be utilized within an area of concentrated flow and are to be staked and trenched into the ground.

**Photograph 7:** Inadequate straw bale control measure installed on an impervious surface. Downgradient of Photo #6.

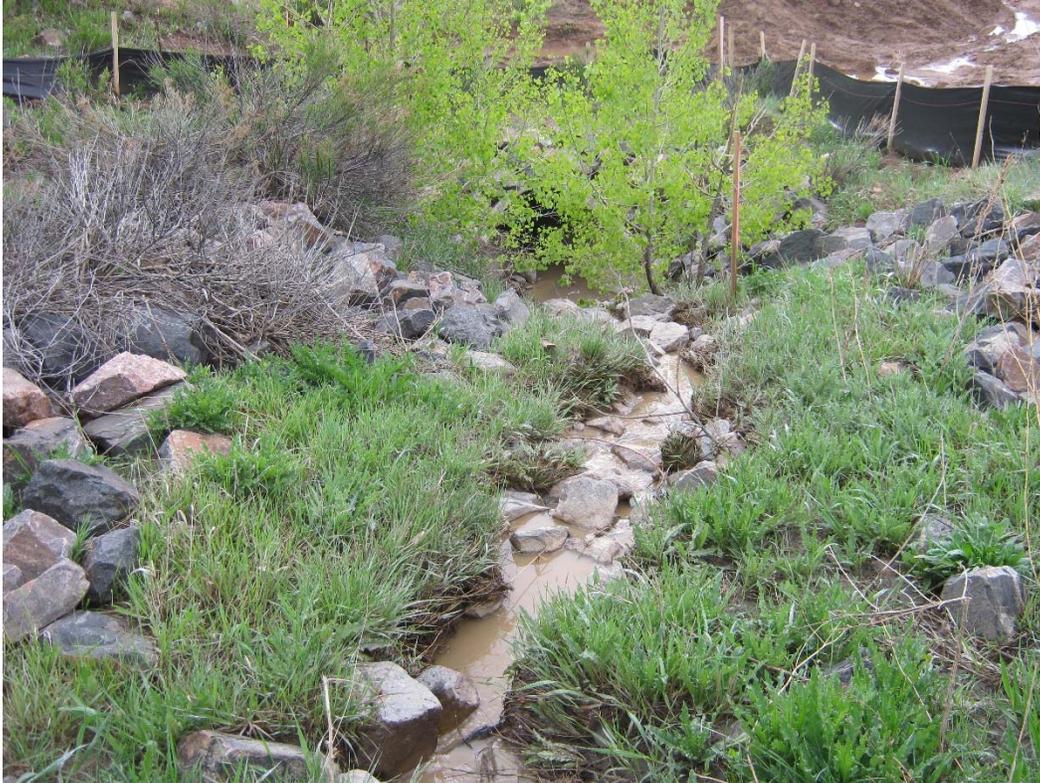
- Result: There was a discharge of pollutants to the following State Water(s): Lena Gulch
  - Expectations: The Division expects the permittee to design and implement control measures, as required by the permit, and make the following corrections:

**Photograph 8:** Discharge of pollutants offsite and into state waters (Lena Gulch). Downgradient of Photo #7.

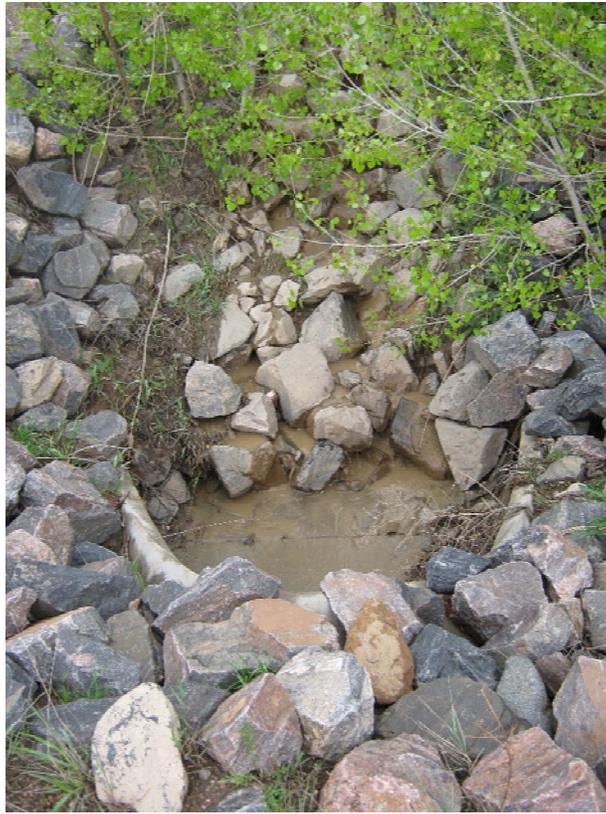
**Photograph 9:** Sediment in culvert further downgradient towards Lena Gulch.

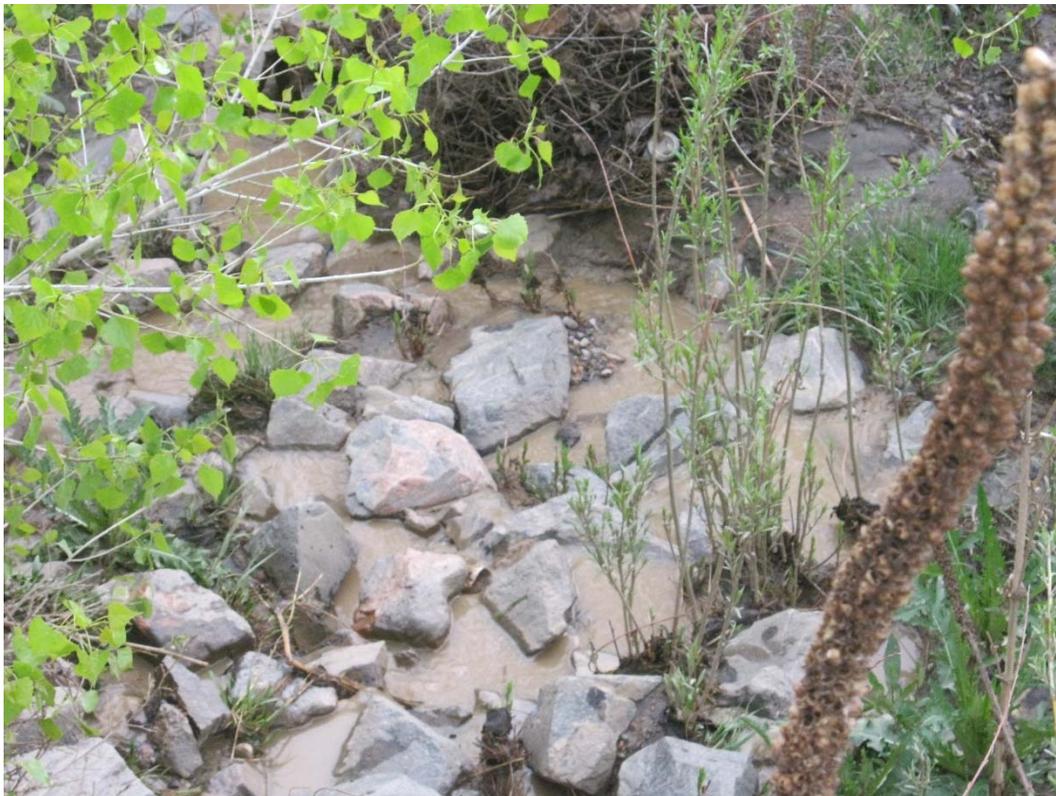
**Photograph 10:** Discharge of pollutants to Lena Gulch.
