MINING

DINERO REMEDY MITIGATION AND MONITORING PROJECT

Conducted by: Colorado Mountain College Natural Resource Management Institute and U.S. Bureau of Land Management

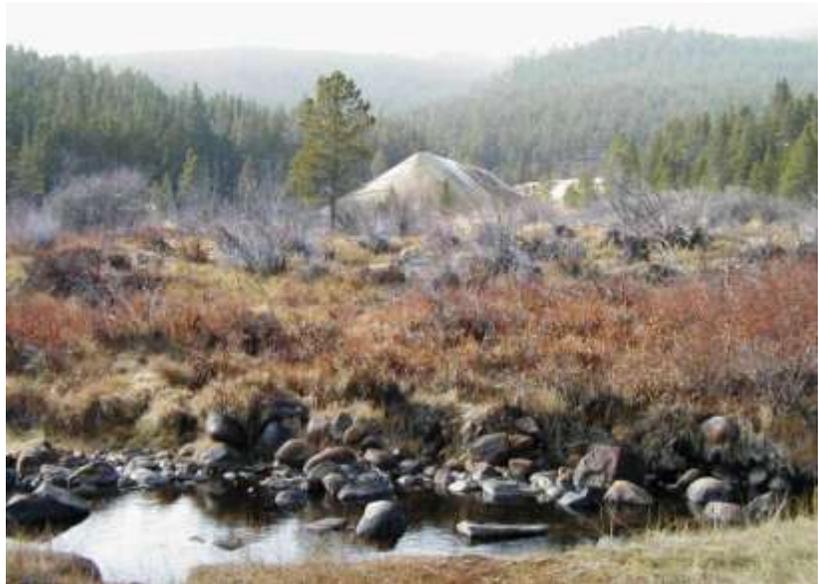
The primary issue of the complex was the presence of two very large waste piles (75,000 cubic yards) located directly in the stream flow path in Sugarloaf Gulch (the primary drainage of the Dinero Complex) and their affect on the water quality of Lake Fork.

Dinero Mine Waste piles above the Sugarloaf wetland prior to their relocation.

The piles were successfully removed in the summer of 2004 to an adjacent repository where they were capped and reclaimed. The overall goal was to reduce the loading of

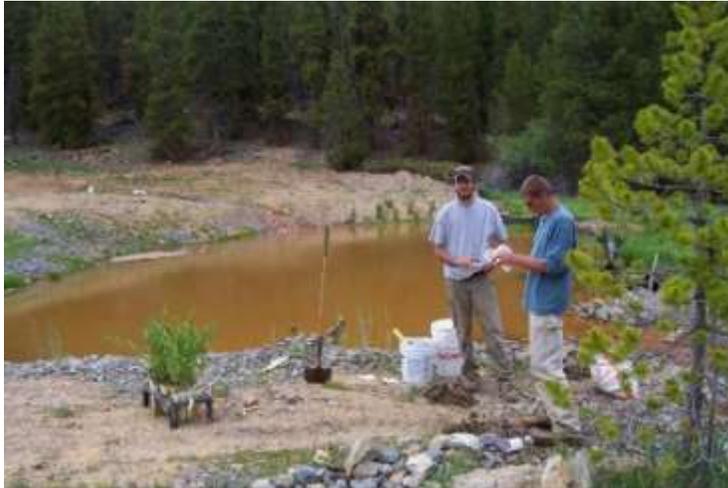
below the Dinero Tunnel.

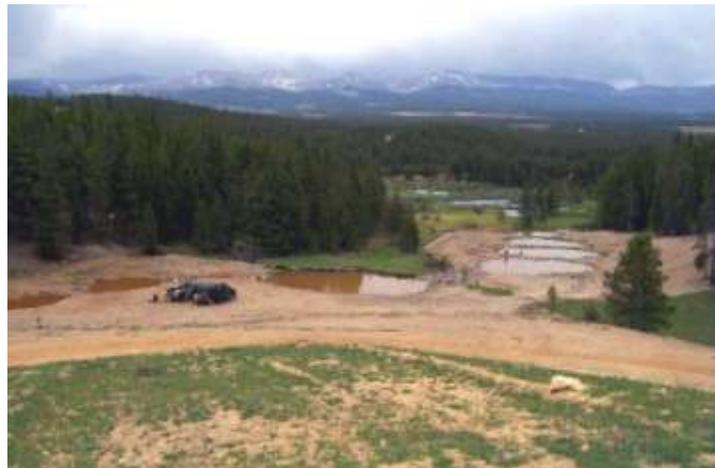
View of mitigated mine waste footprints and retention ponds.

The project successfully mitigated the Dinero mine waste footprints. However, as of September 2008, the target metals loading reduction goal of 50% for aluminum, cadmium, manganese, and zinc into the Lake Fork has not been achieved. The LFWWG anticipated that a period of 3 to 5 years would be needed before any noticeable reduction in metals loading would occur due to the extensive construction activities that occurred because of the mine waste relocation.
