Department of Public
Health & Environment

RE: Service of Notice of Violation/Cease and Desist Order, Number: SO-151007-1

NOTICE OF VIOLATION / CEASE AND DESIST ORDER

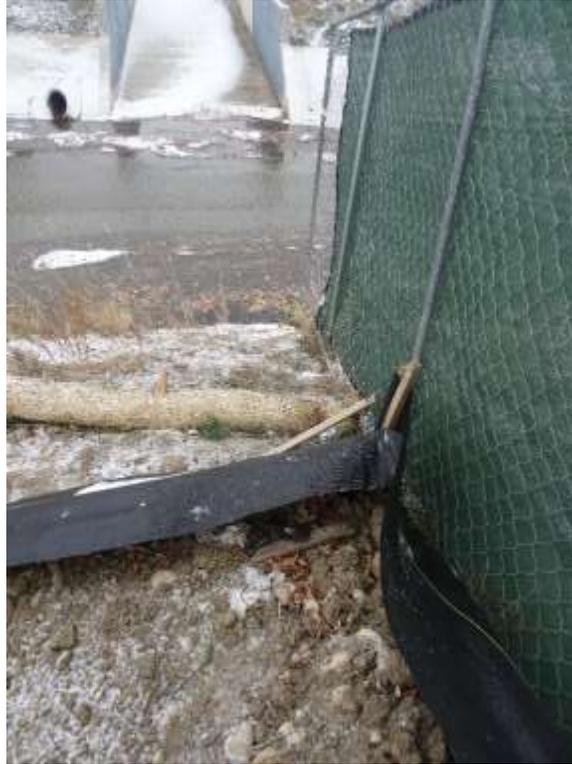
Photograph 27: Location of potential bypass relative to Dry Creek directly north, less than 50 feet

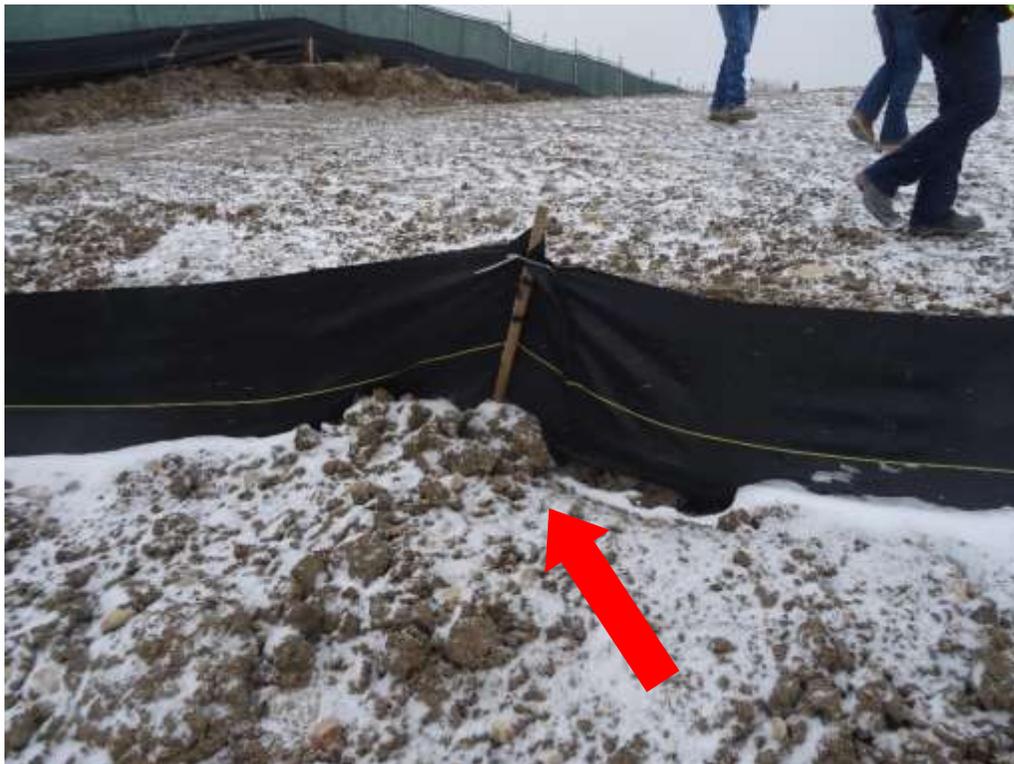
Photograph 30: Silt fence not trenched into the ground as required, sediment build up greater than 6"

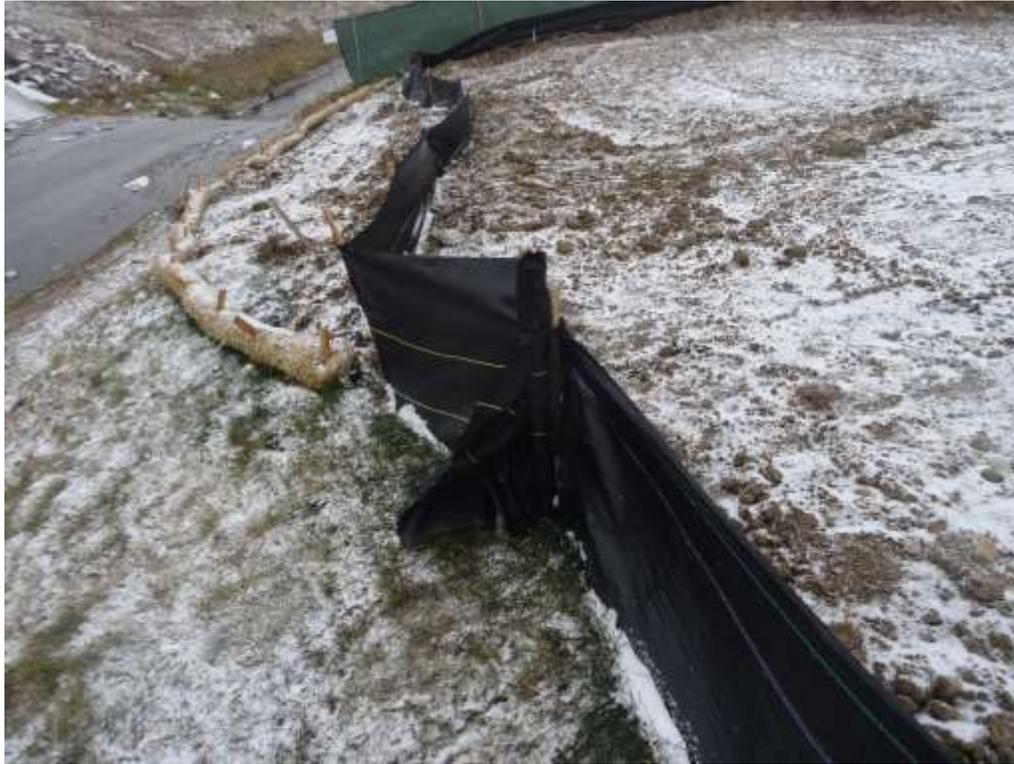
Photograph 31: Silt fence joints not wrapped as required to prevent bypass

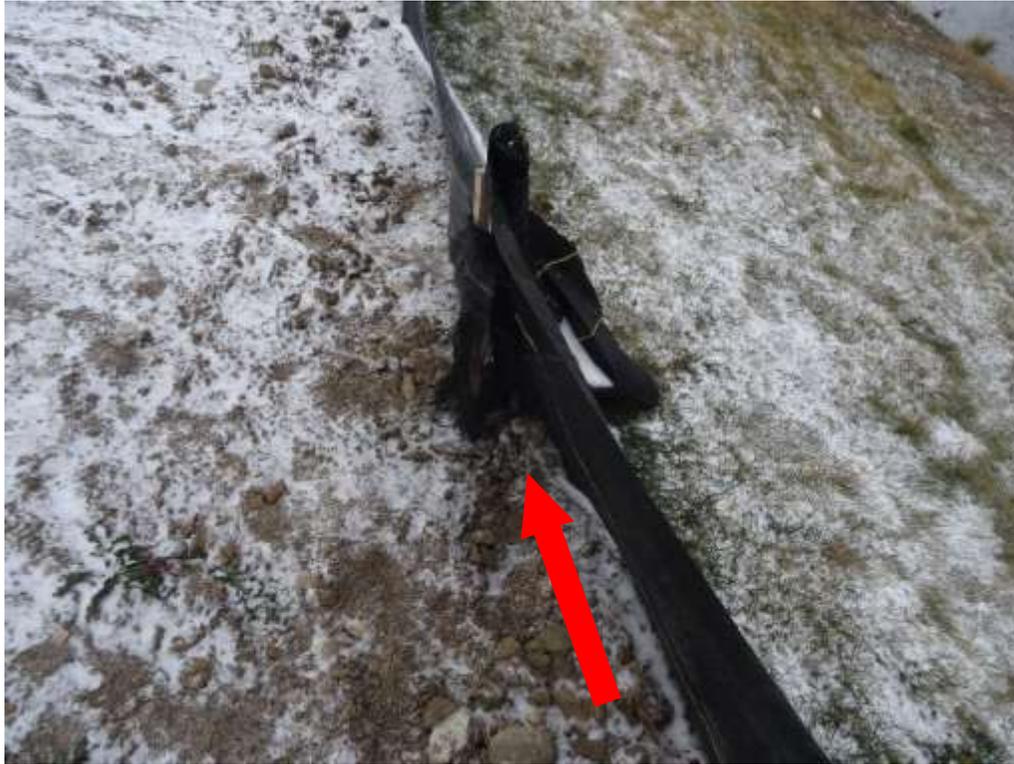
Photograph 33: Silt fence joint not wrapped as required to prevent bypass, large gap where arrow points

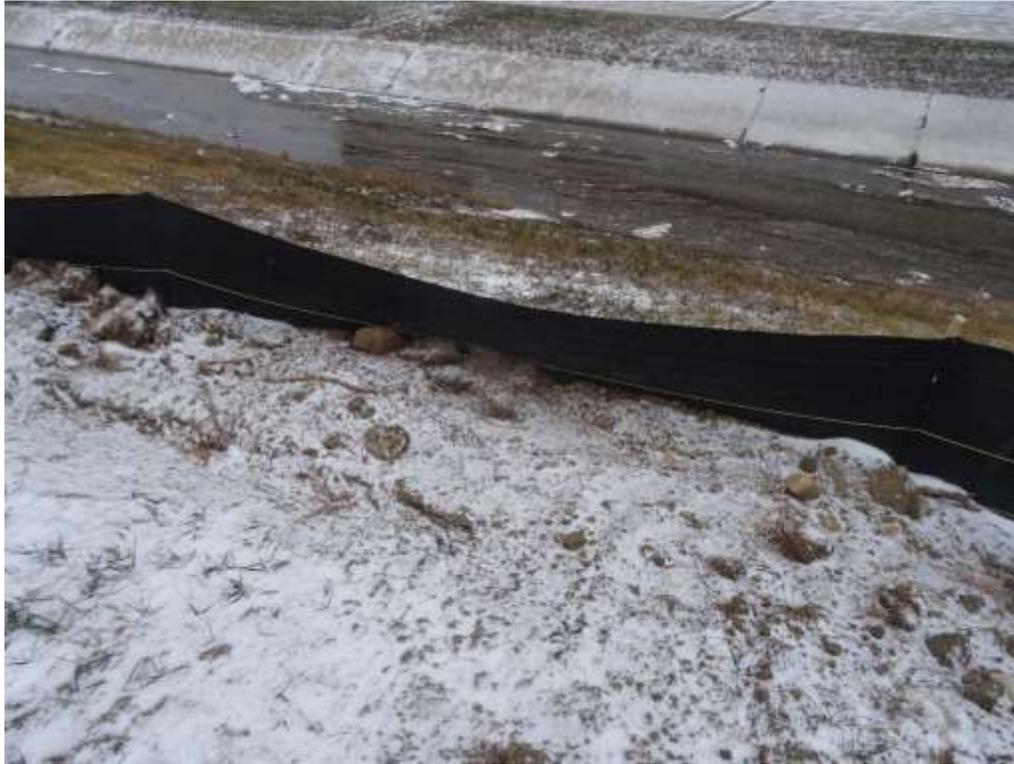
Photograph 35: Sediment built up along fence, maintenance needed

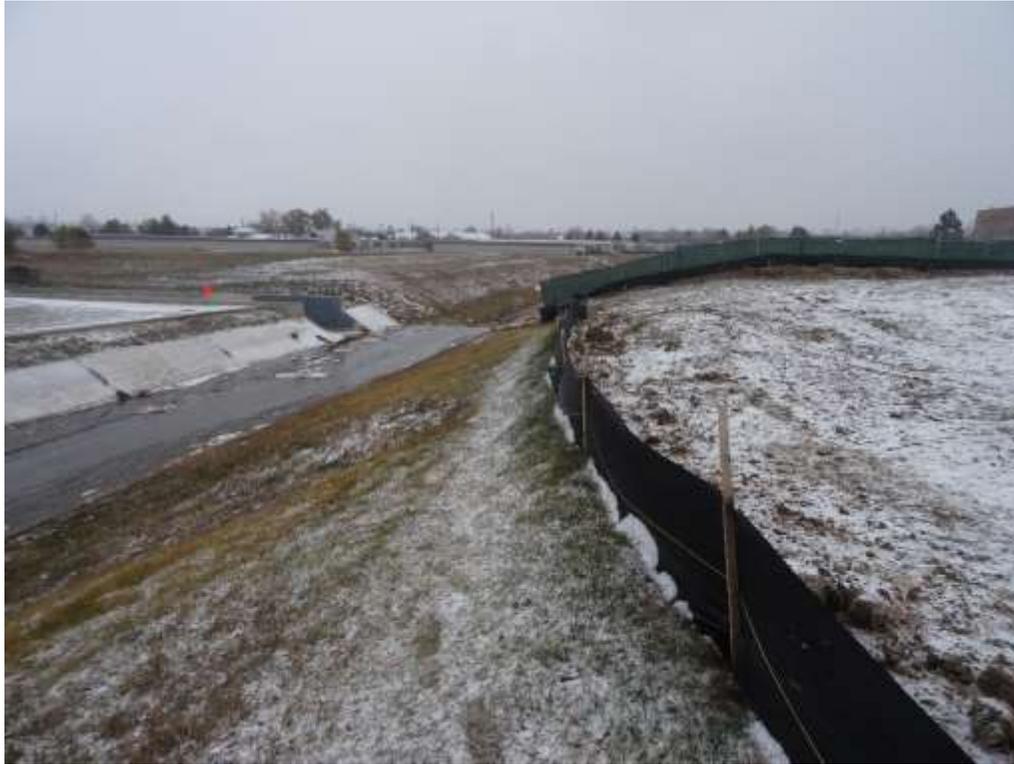
Photograph 37: Silt fence along northeast corner, Dry Creek directly north of the site and disturbance

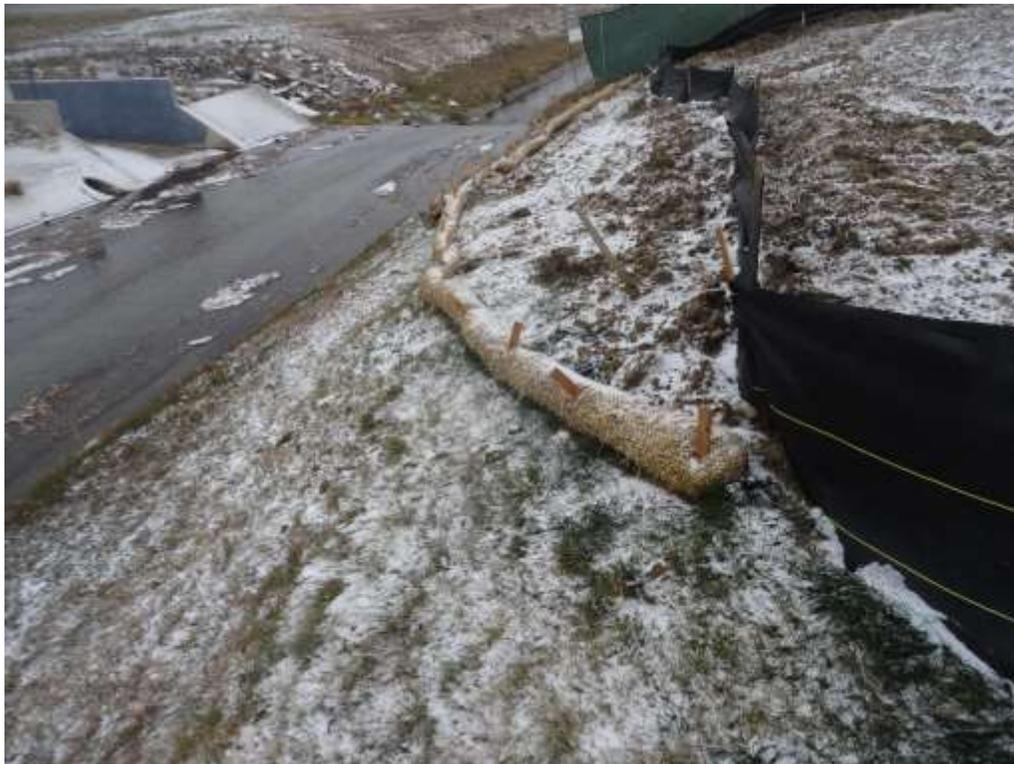
Photograph 42: Straw wattle not trenched in per spec, stakes not in ground at depth required

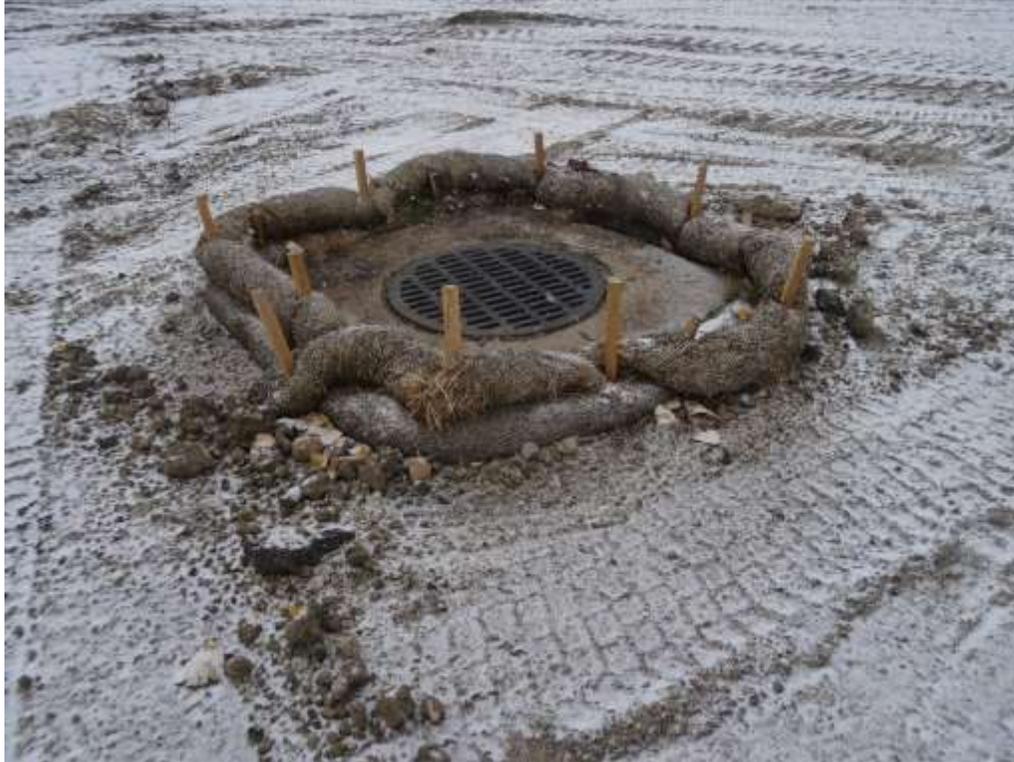
Photograph 43: Straw wattle not trenched and installed as required in the specification. Wattle is tearing and in need of maintenance

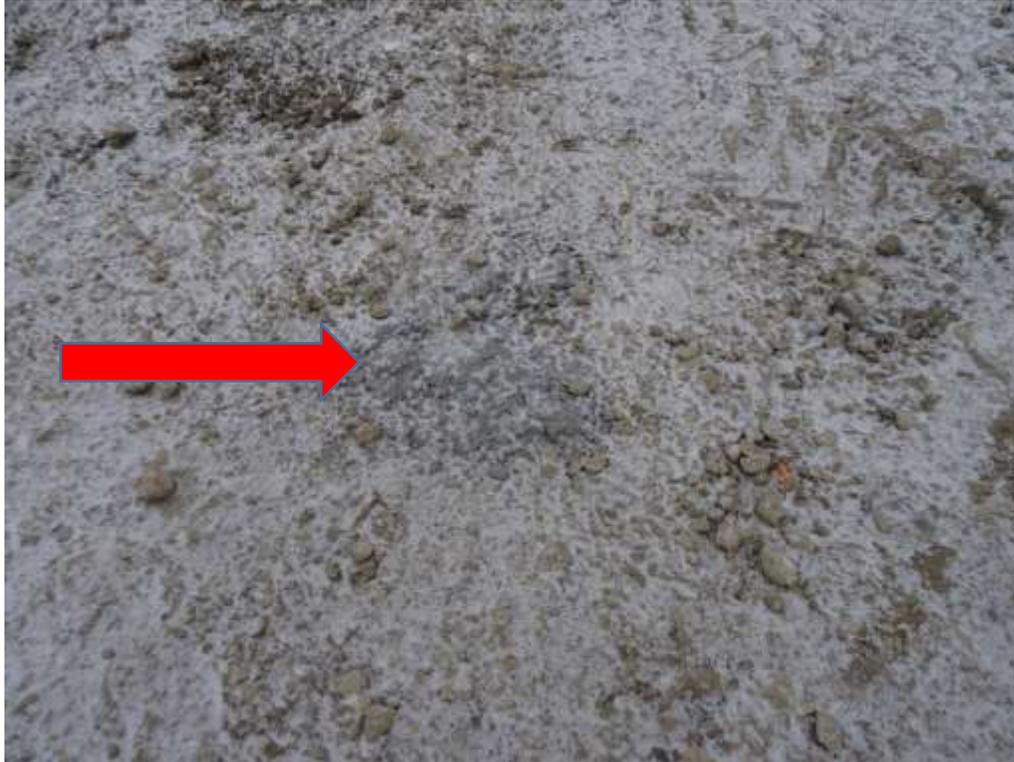
Photograph 45: Concrete waste deposited to ground, not disposed of in designated washout

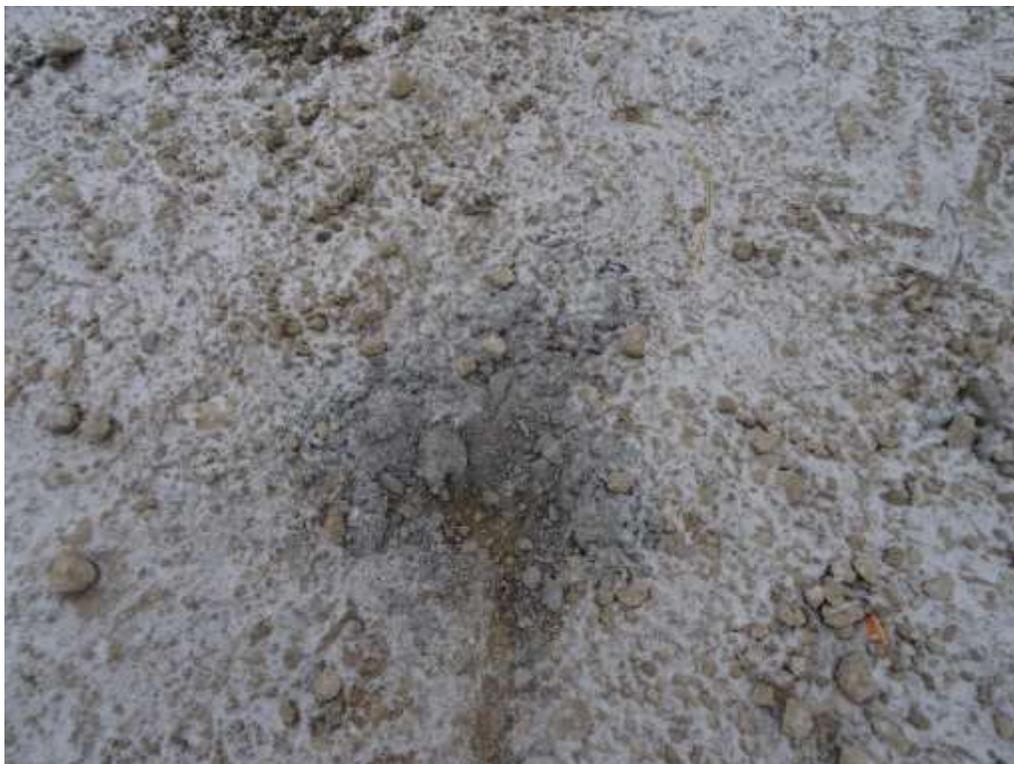
Photograph 46: Concrete waste deposited to ground, not disposed of or contained in designated concrete washout

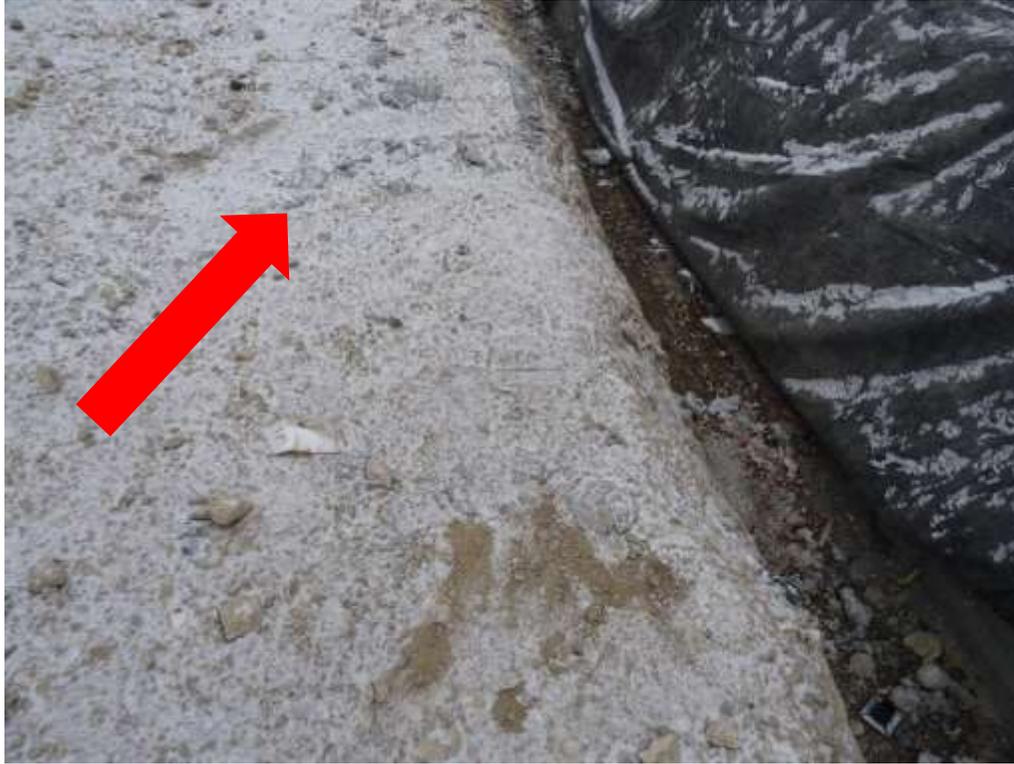
Photograph 47: Concrete waste deposited to ground, not disposed of in designated washout

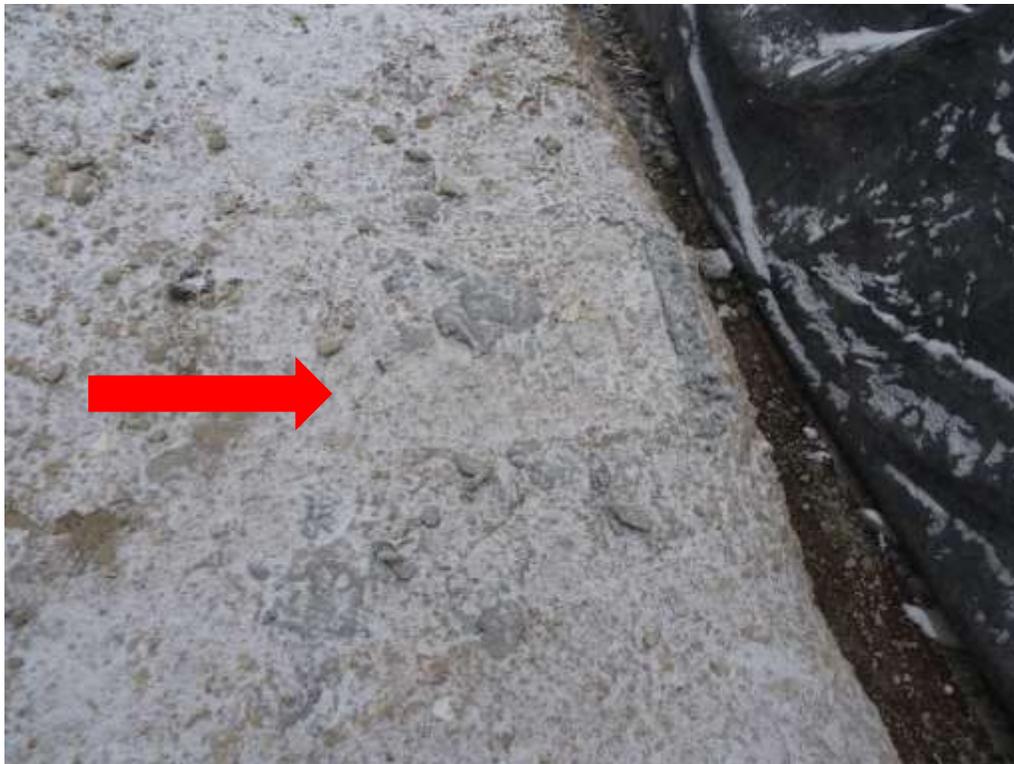
Photograph 48: Concrete waste deposited to ground, not disposed of in designated washout

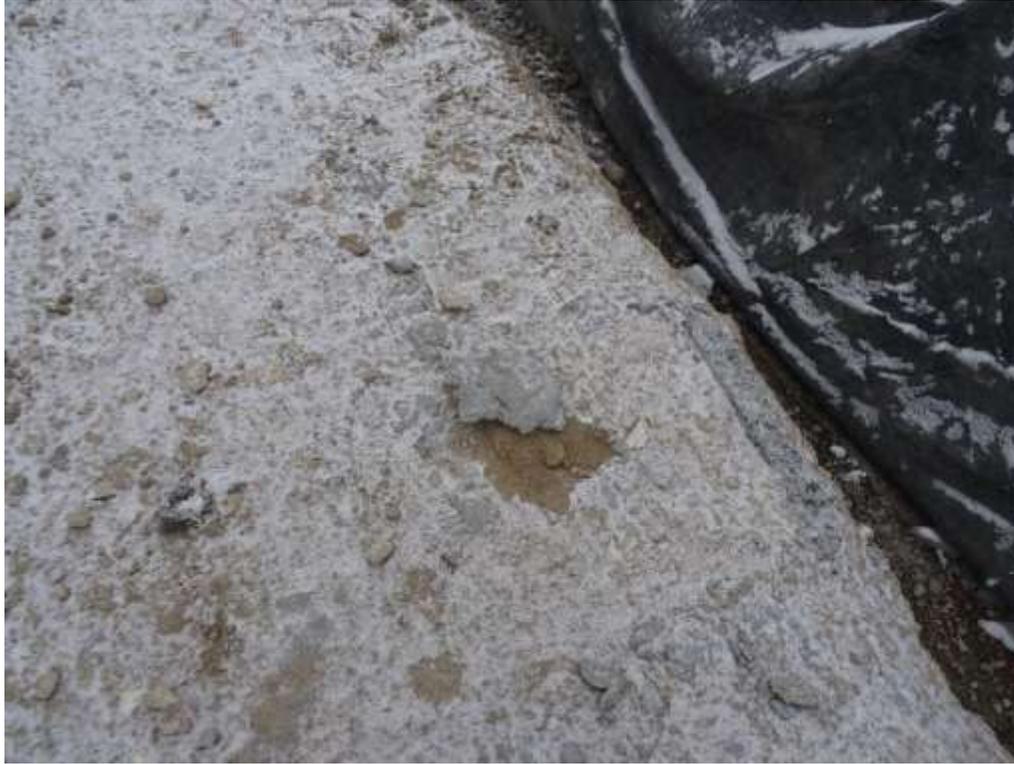
Photograph 49: Concrete waste deposited to ground, not disposed of in designated washout

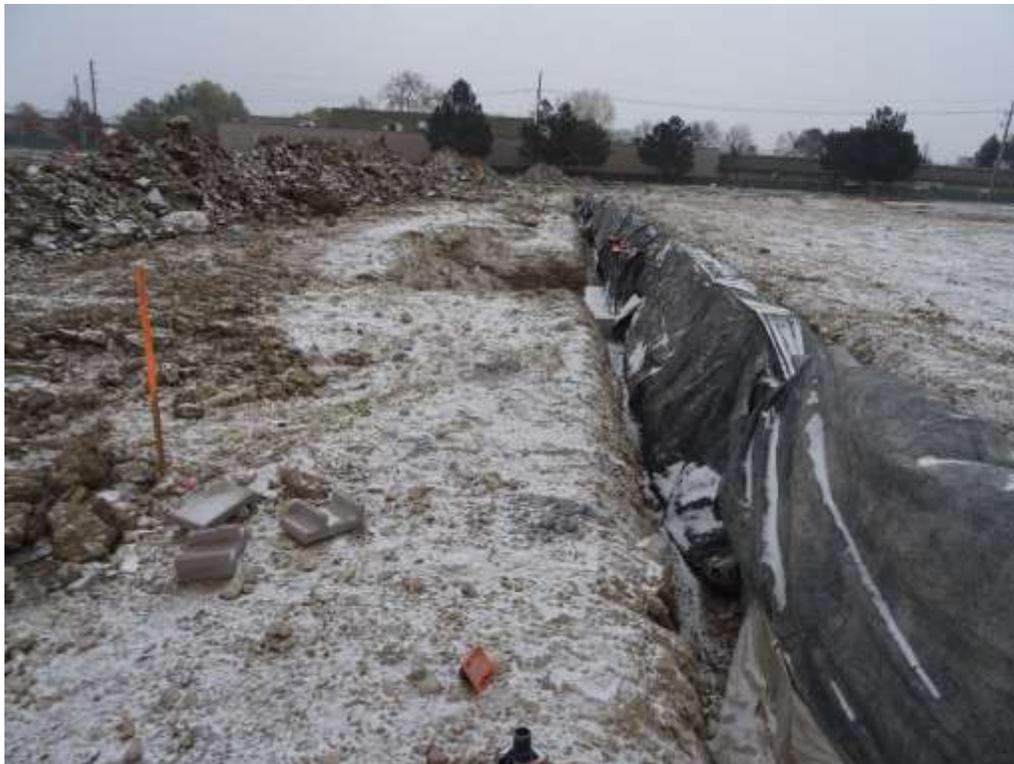
Photograph 50: Concrete waste deposited to ground, not disposed of in designated washout

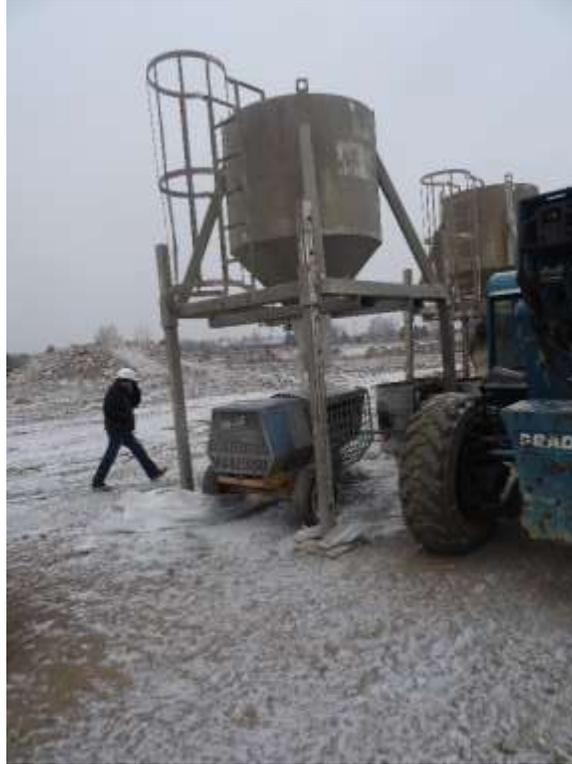
Photograph 51: Grout mixing station without secondary containment

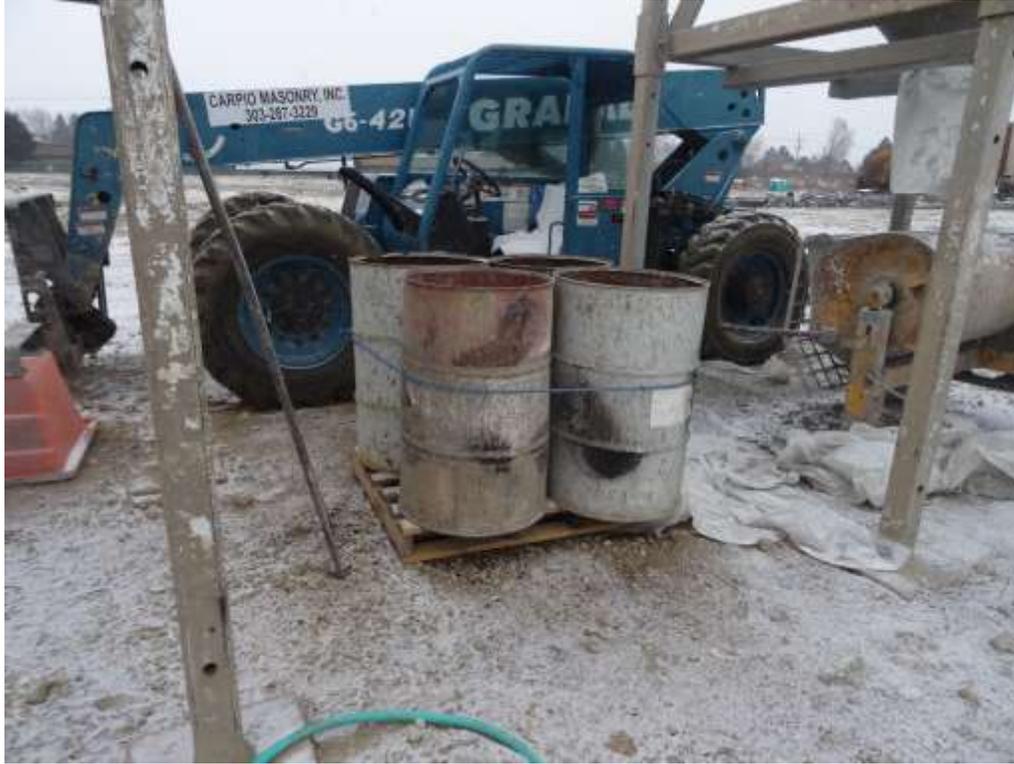
Photograph 53: Open drums with mixing/waste materials not protected or contained

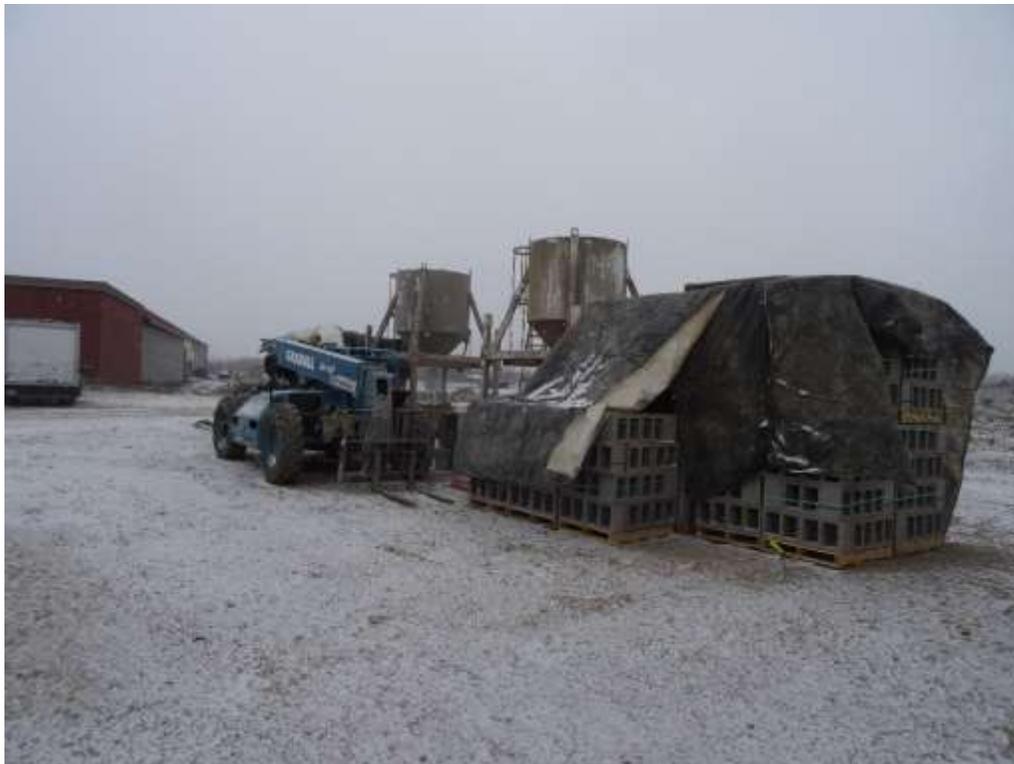
Photograph 54: Grout mixing station looking south, no containment for the pollutant source

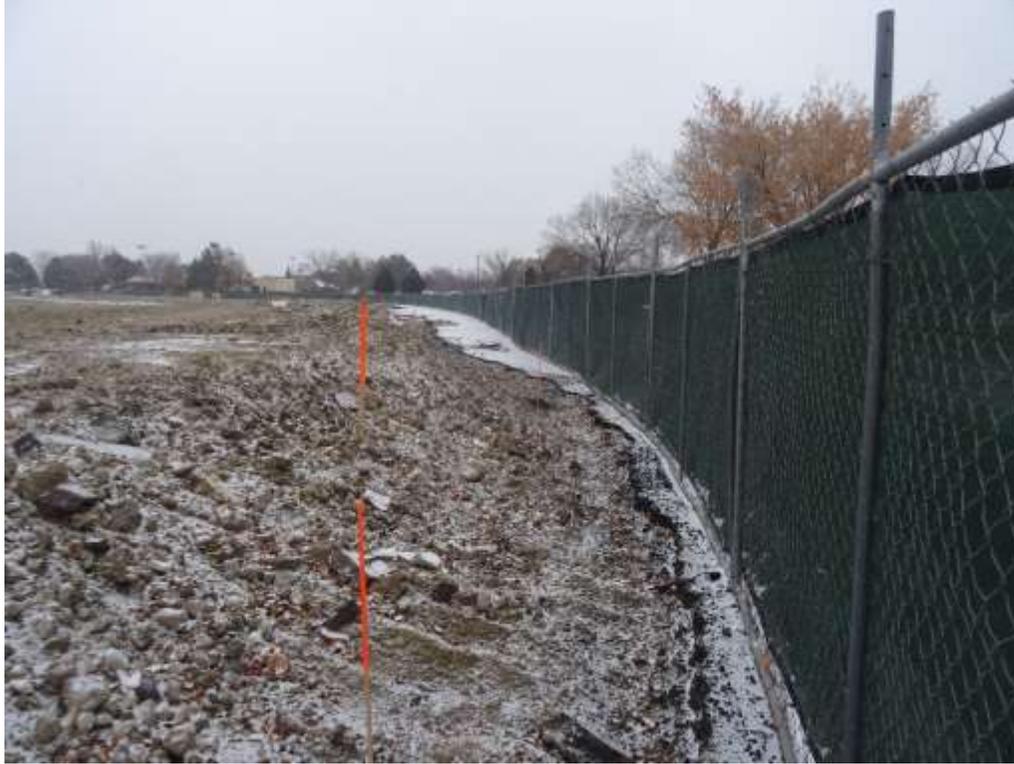
Photograph 55: Grade cut not implemented at consistent height, not maintained as sediment builds up

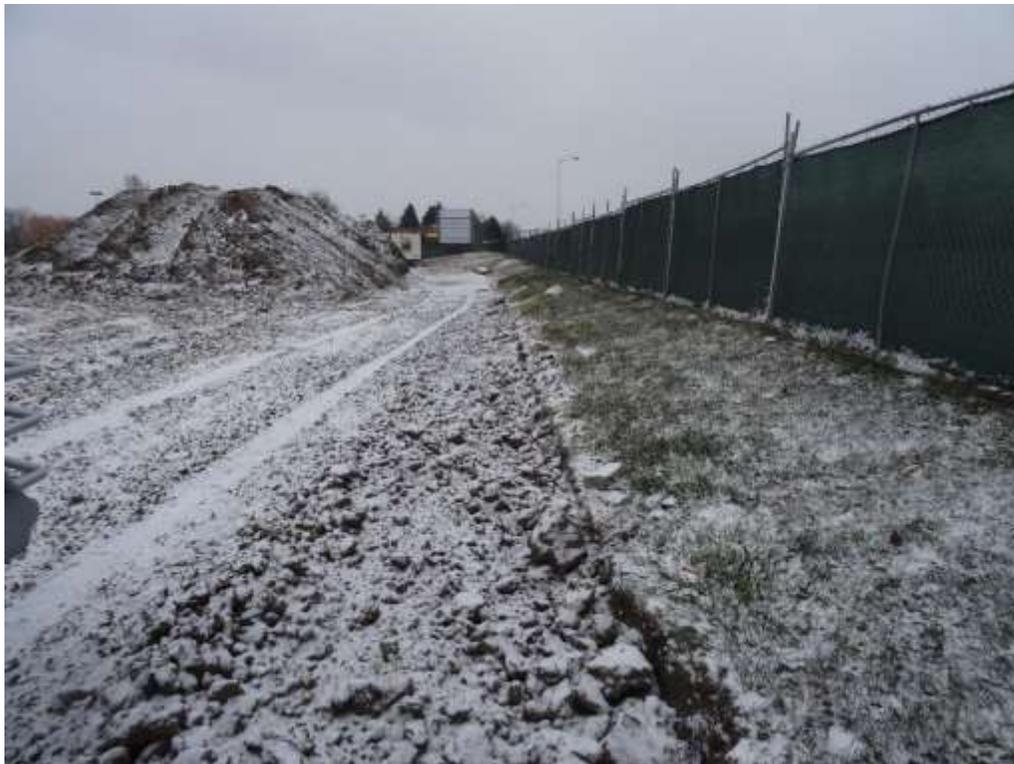
Photograph 56: Grade cut not implemented at consistent height, not maintained as sediment builds up

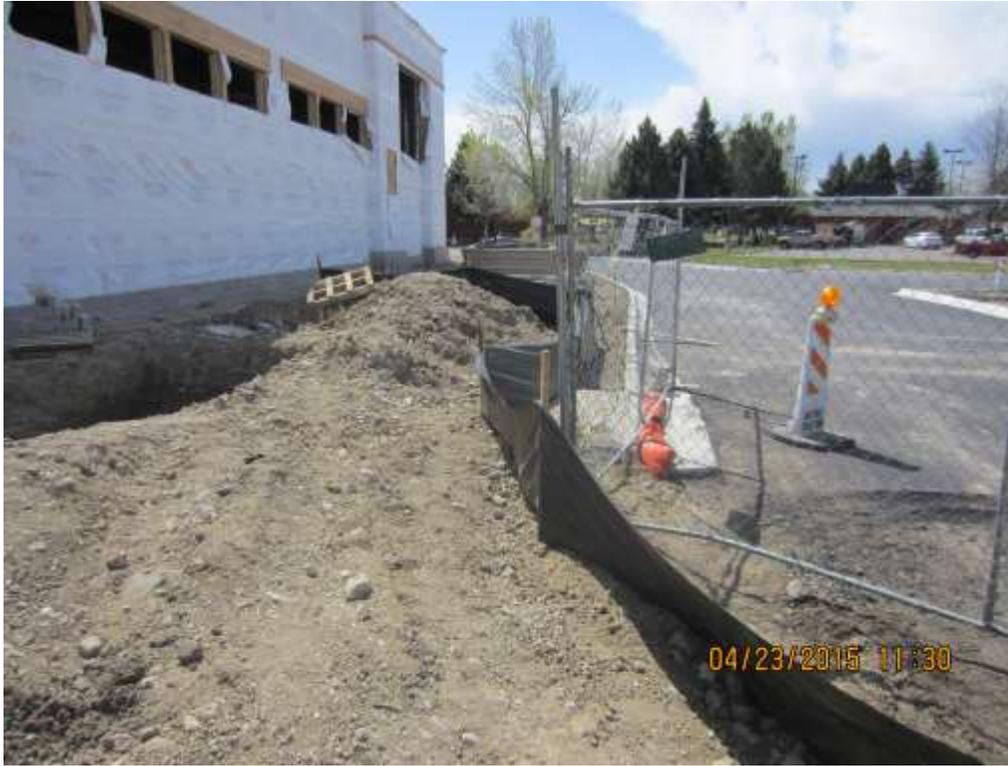
Photograph 1: Silt fence not installed or maintained per the specification provided in the SWMP

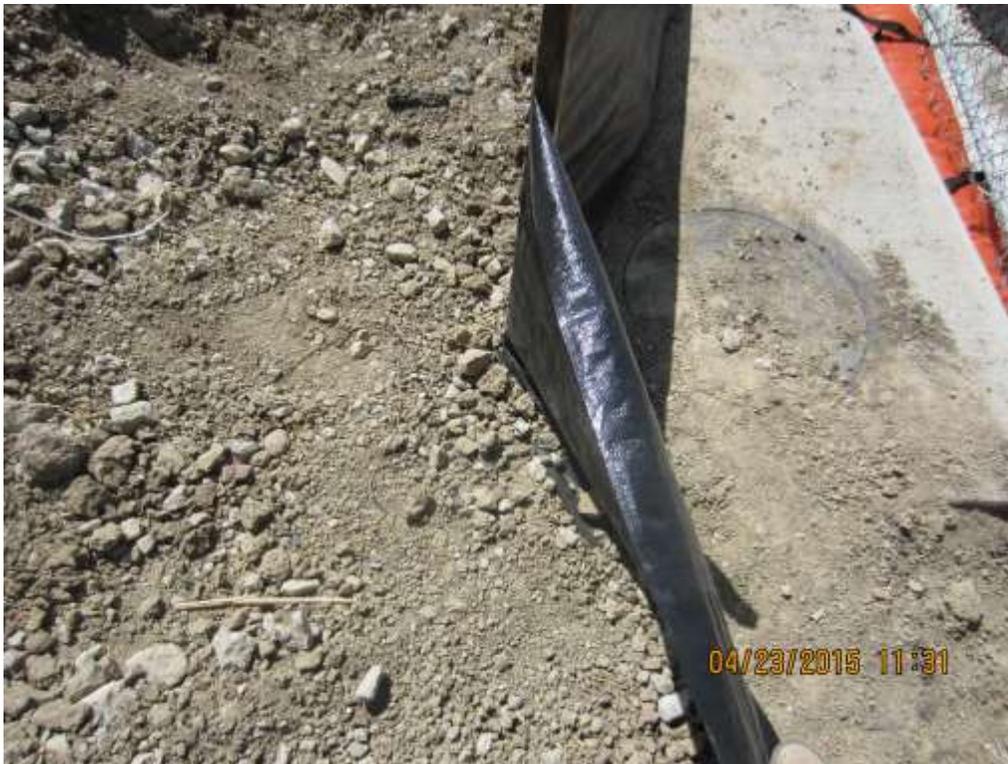
Photograph 2: Silt fence not installed or maintained per the specification provided in the SWMP

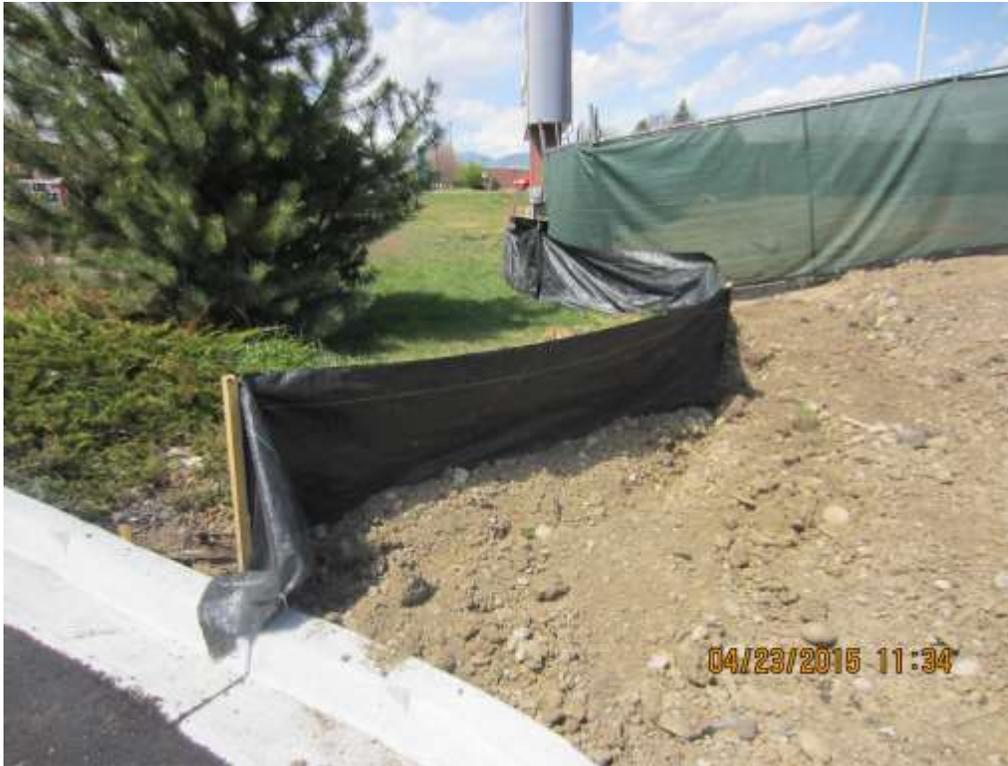
Photograph 3: Silt fence not installed or maintained per the specification provided in the SWMP

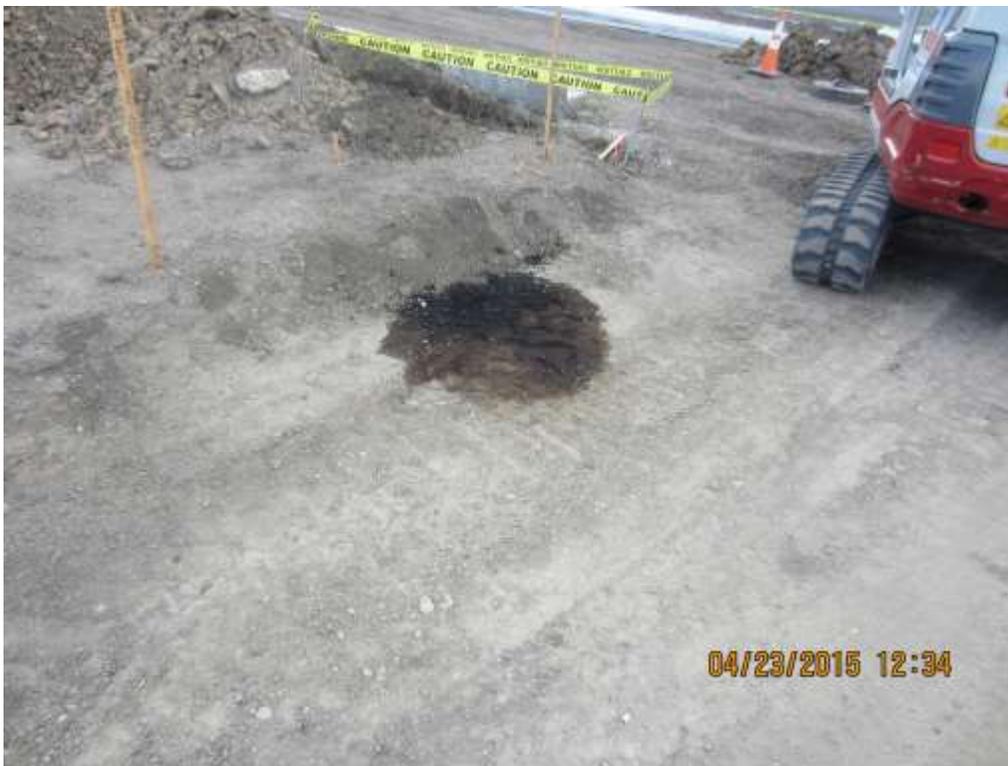
Photograph 4: Hydraulic fluids on the ground, not maintained per specifications provided in SWMP

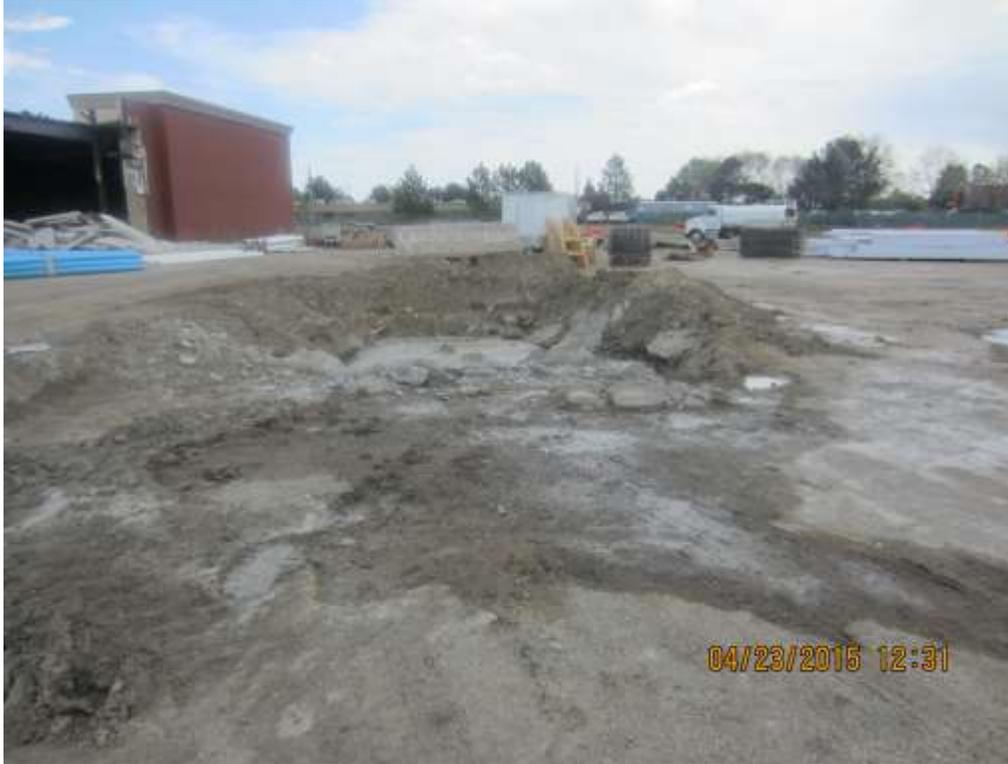
Photograph 5: Concrete washout area not installed or maintained as required by the SWMP

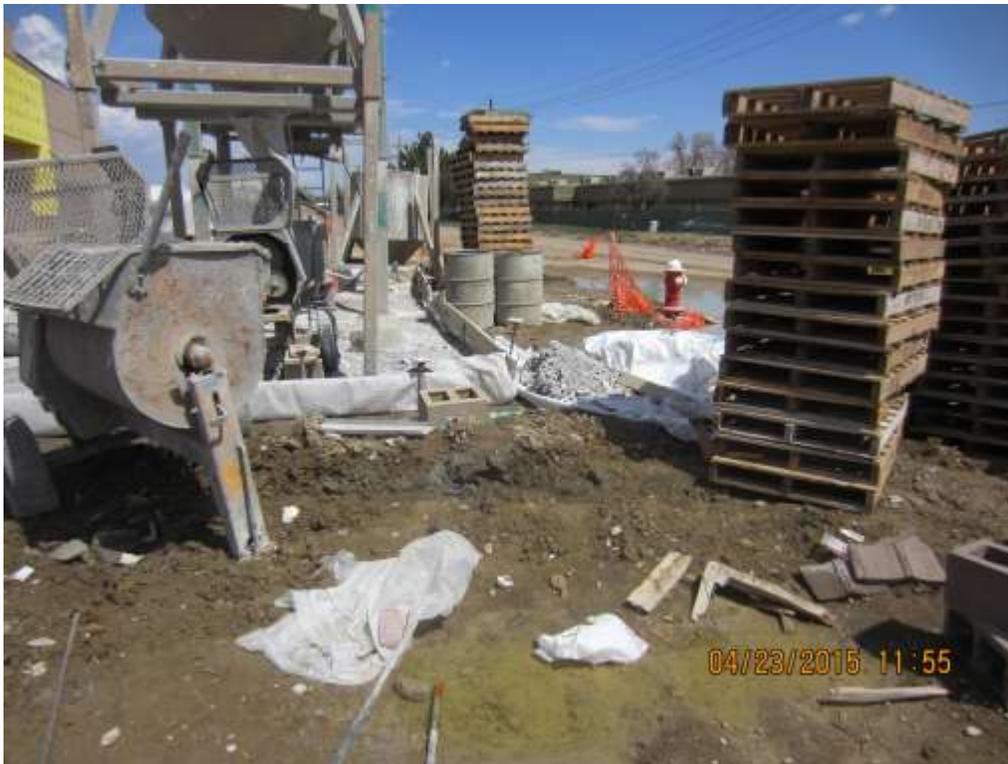
Photograph 6: Masonry containment not installed or maintained as required in the SWMP

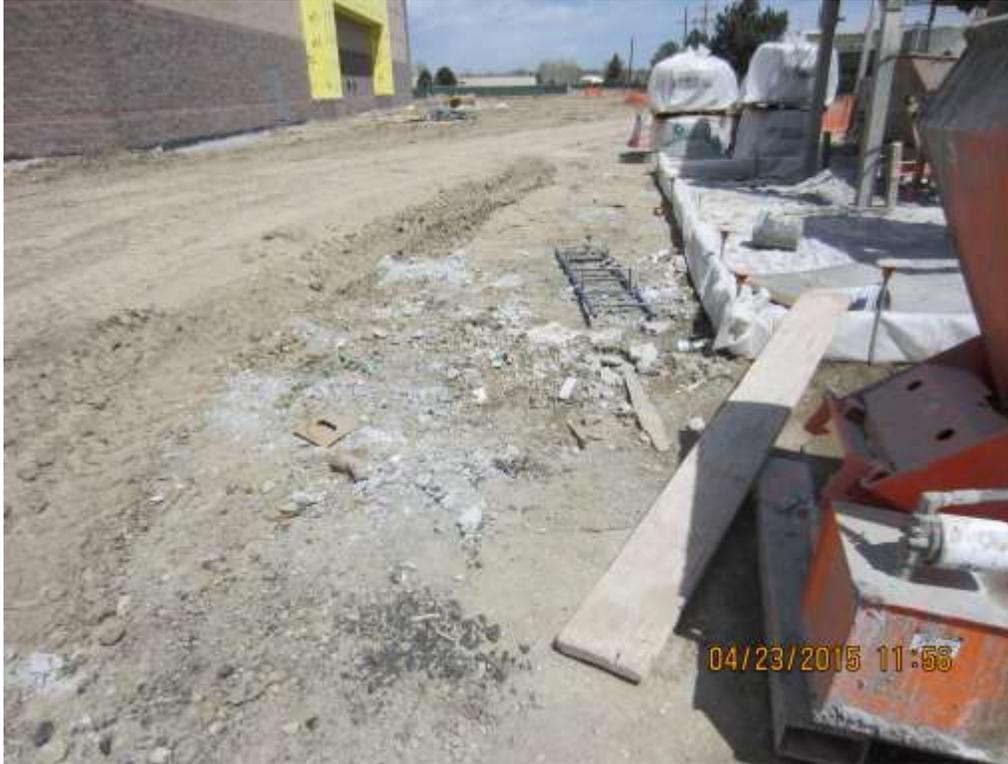
Photograph 7: Masonry containment not installed or maintained as required in the SWMP

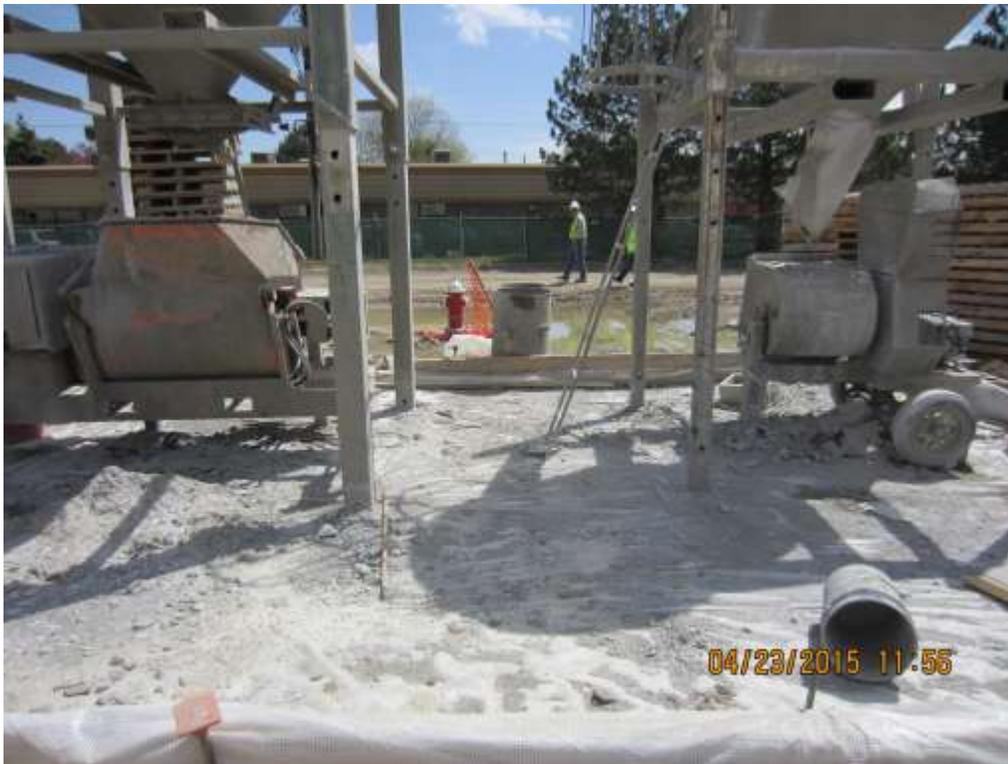
Photograph 8: Masonry containment not installed or maintained as required in the SWMP

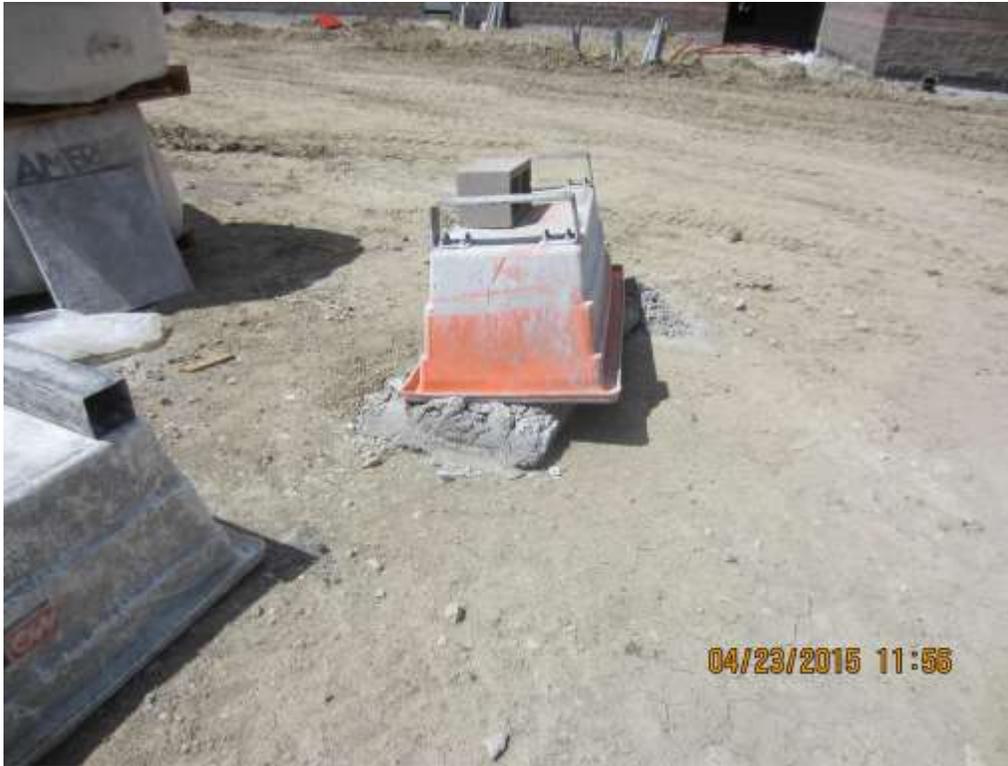
Photograph 9: Masonry containment not installed or maintained as required in the SWMP

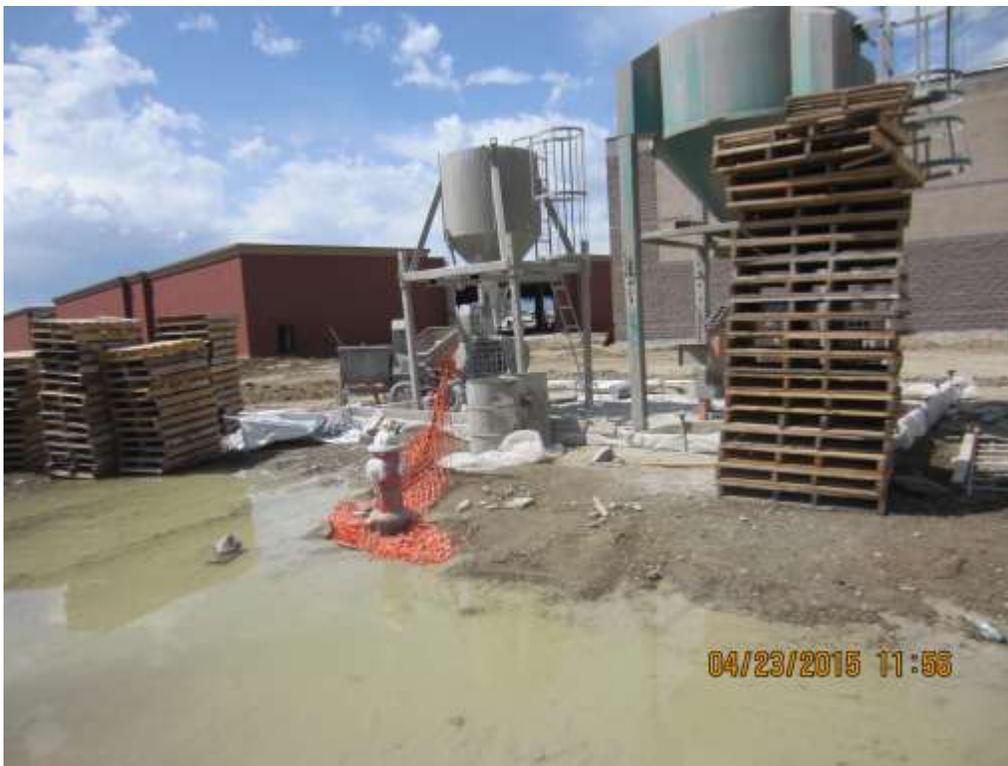
Photograph 10: Masonry containment not installed or maintained as required in the SWMP

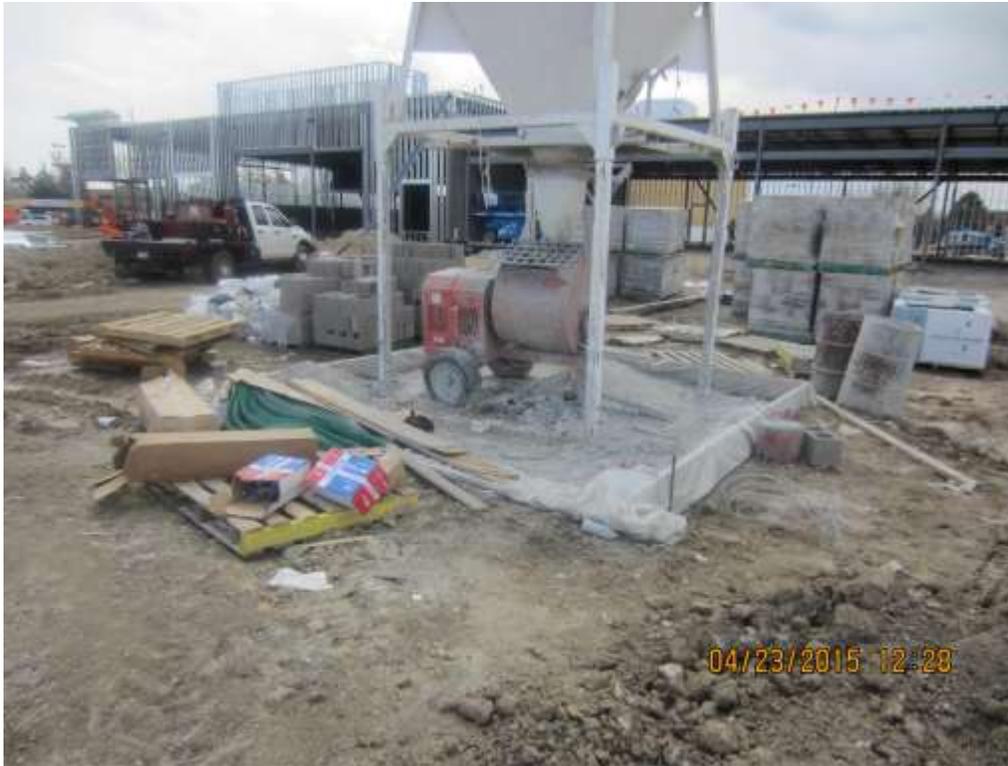
Photograph 11: Masonry containment not installed or maintained as required in the SWMP
