Department of Public
Health & Environment

RE: Service of Notice of Violation/Cease and Desist Order, Number: SO-151007-1

NOTICE OF VIOLATION / CEASE AND DESIST ORDER

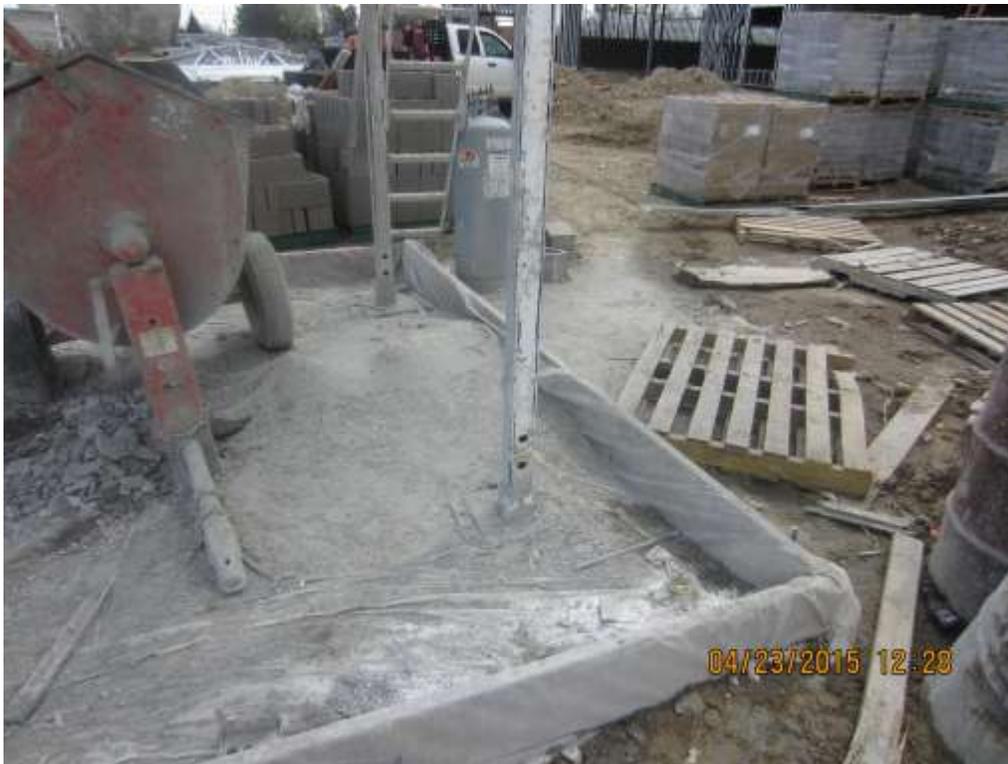
Photograph 12: Masonry containment not installed or maintained as required in the SWMP

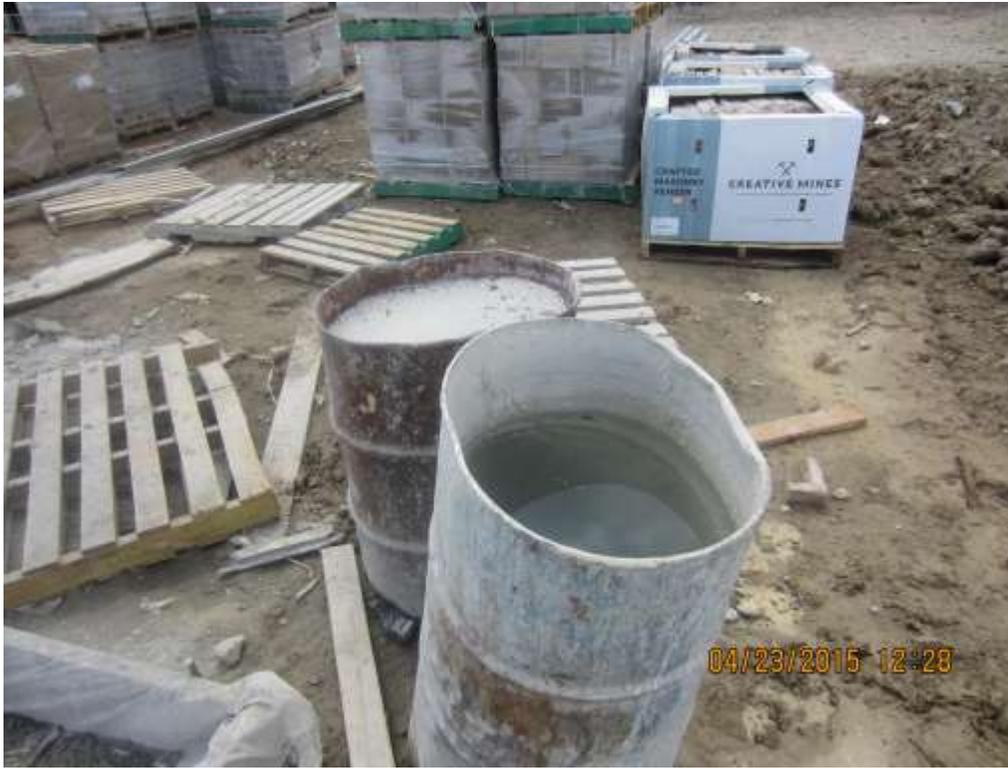
Photograph 13: Masonry containment not installed or maintained as required in the SWMP

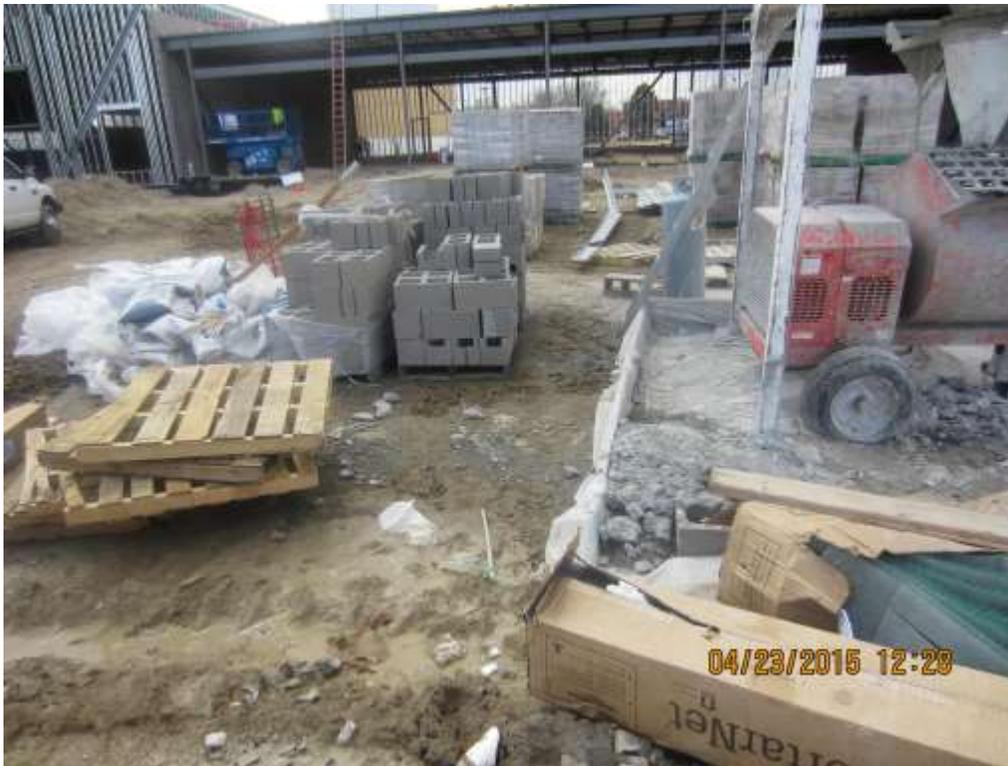
Photograph 14: Masonry containment not installed or maintained as required in the SWMP

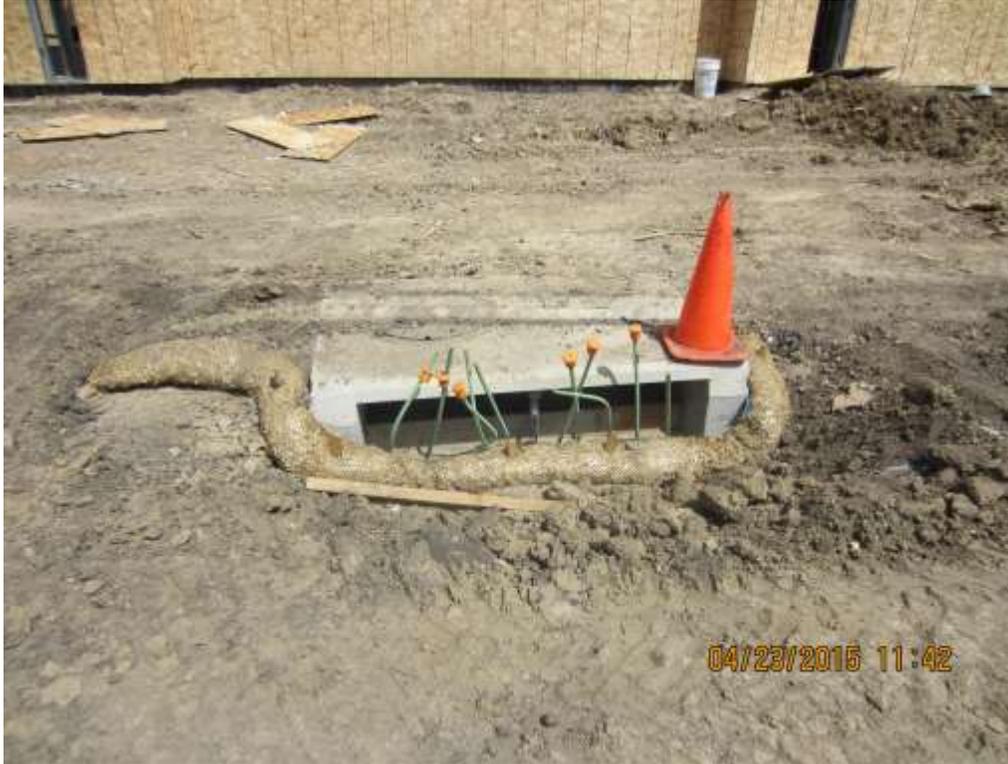
Photograph 15: Straw wattle inlet protection not installed or maintained as required by the SWMP. Controls were not implemented on the back side of the inlet box.

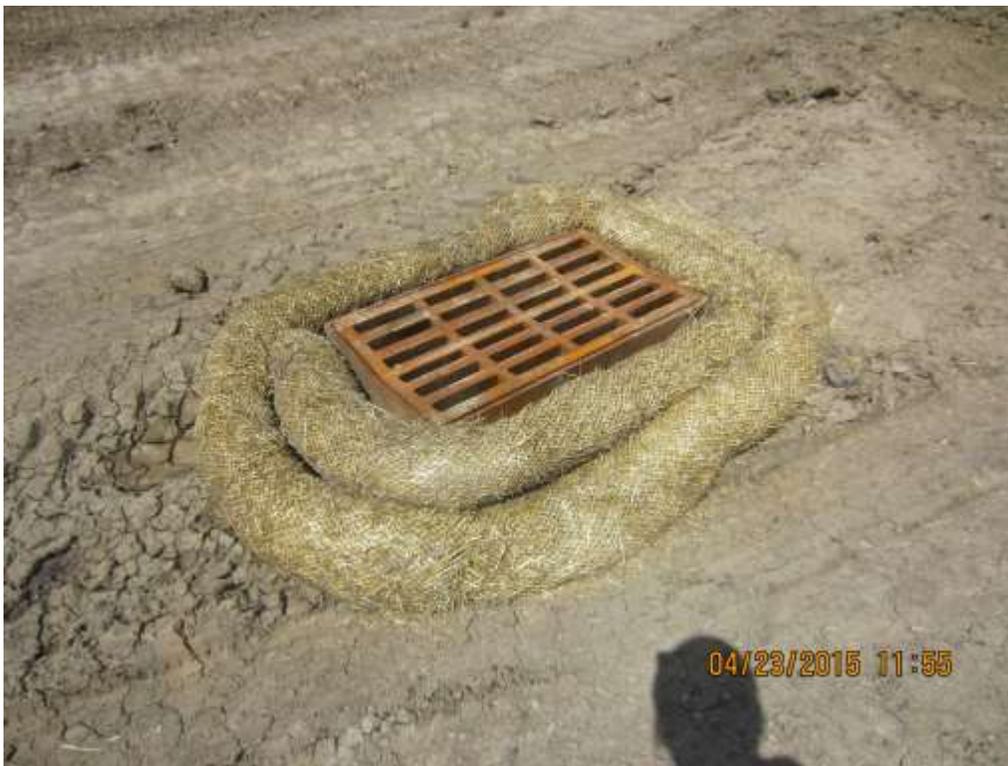
Photograph 16: Straw wattle inlet protection not installed or maintained as required by the SWMP

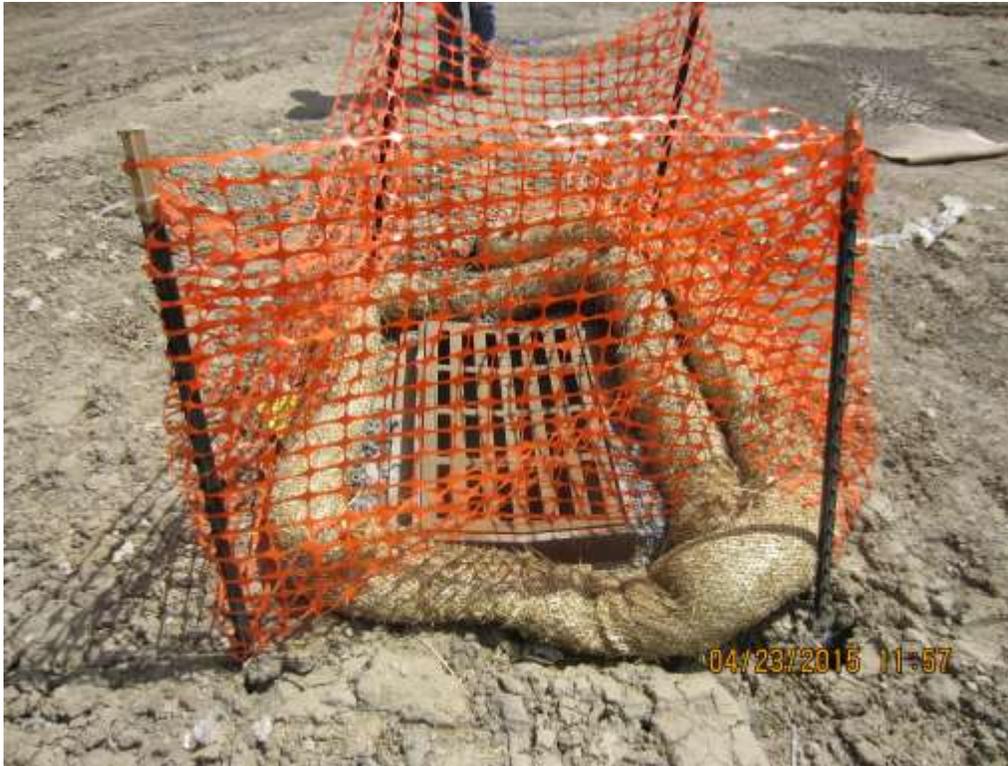
Photograph 17: Straw wattle inlet protection not installed or maintained as required by the SWMP

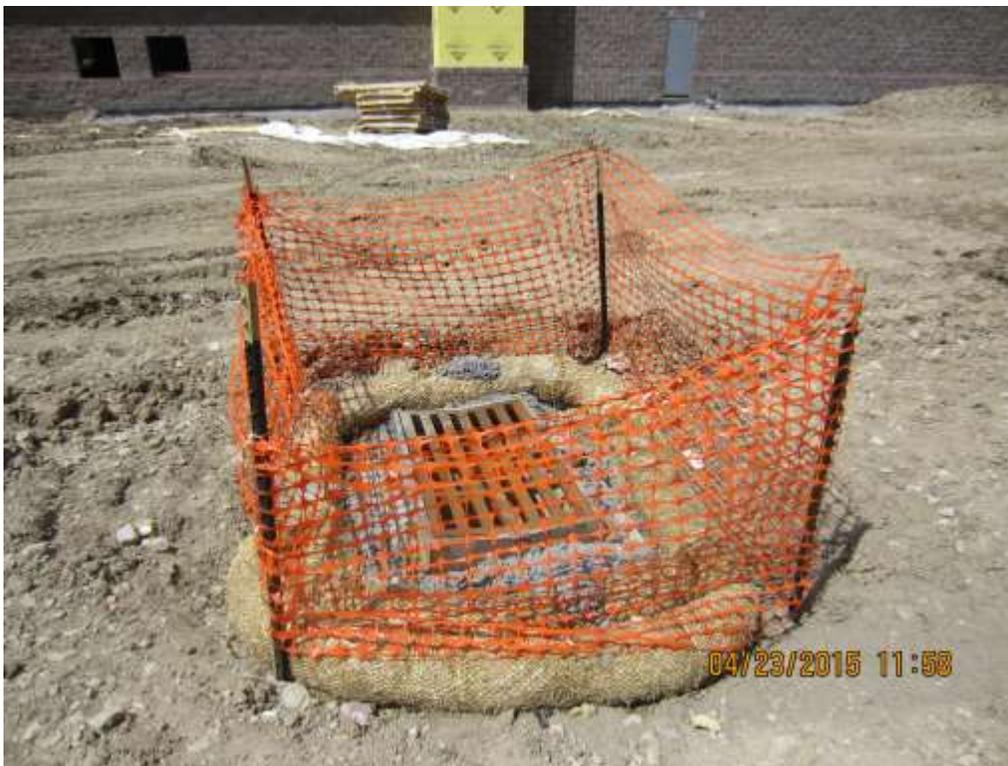
Photograph 18: Straw wattle inlet protection not installed or maintained as required by the SWMP, concrete waste surrounding this inlet grate and on the grate

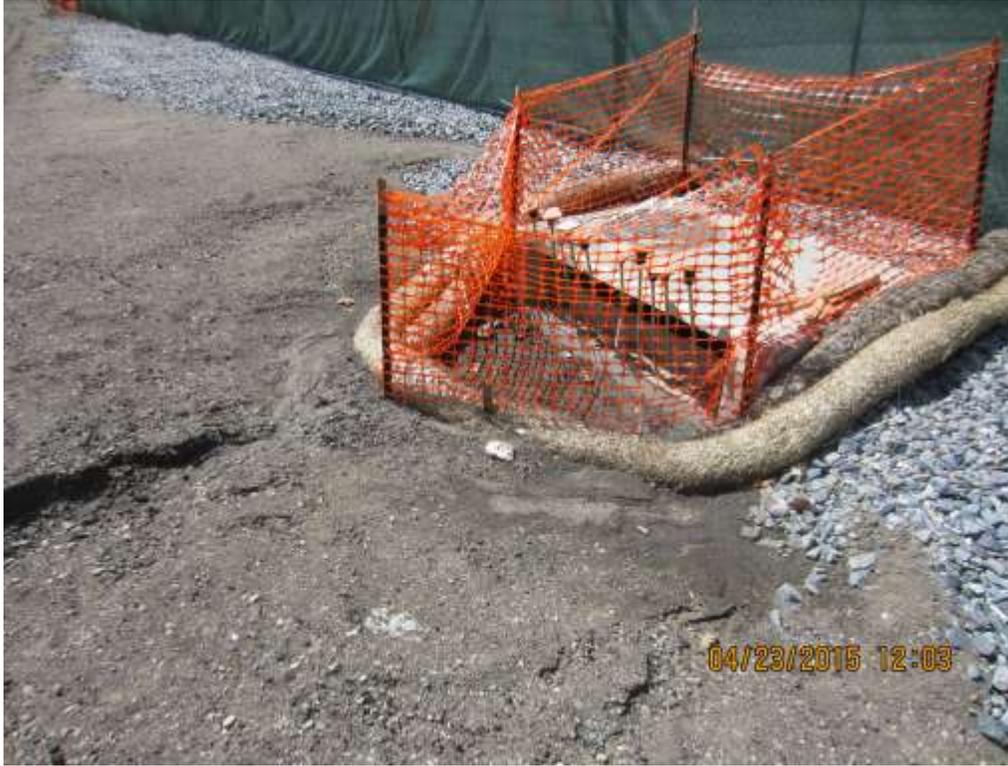
Photograph 19: Straw wattle inlet protection not installed or maintained as required by the SWMP

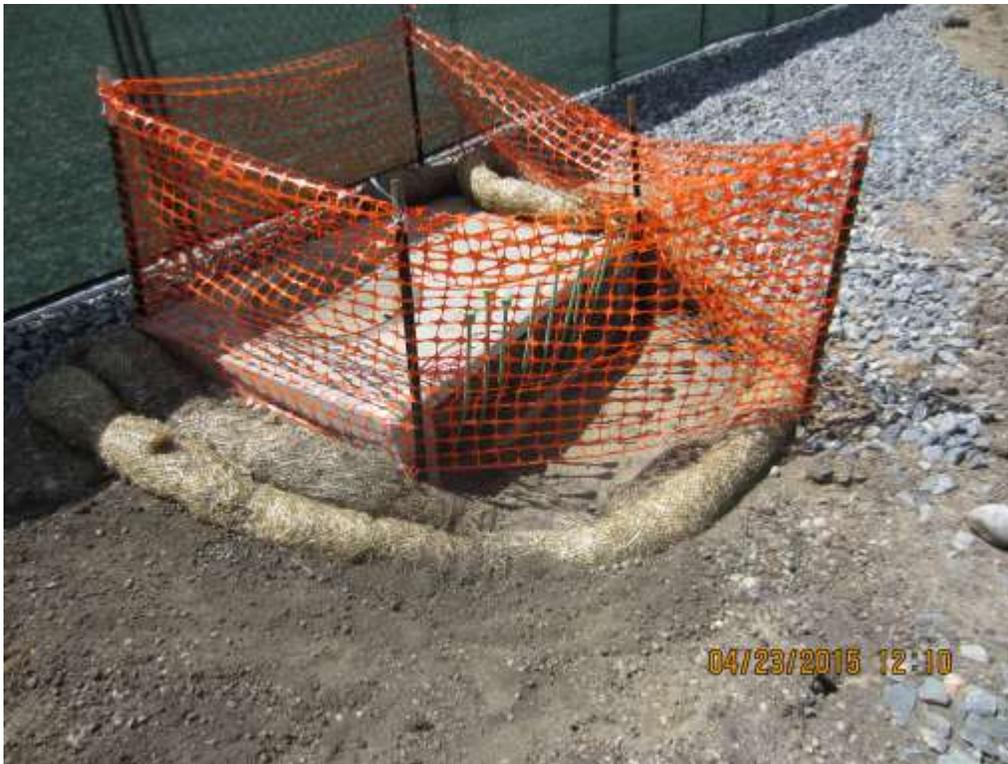
Photograph 20: Straw wattle inlet protection not installed or maintained as required by the SWMP

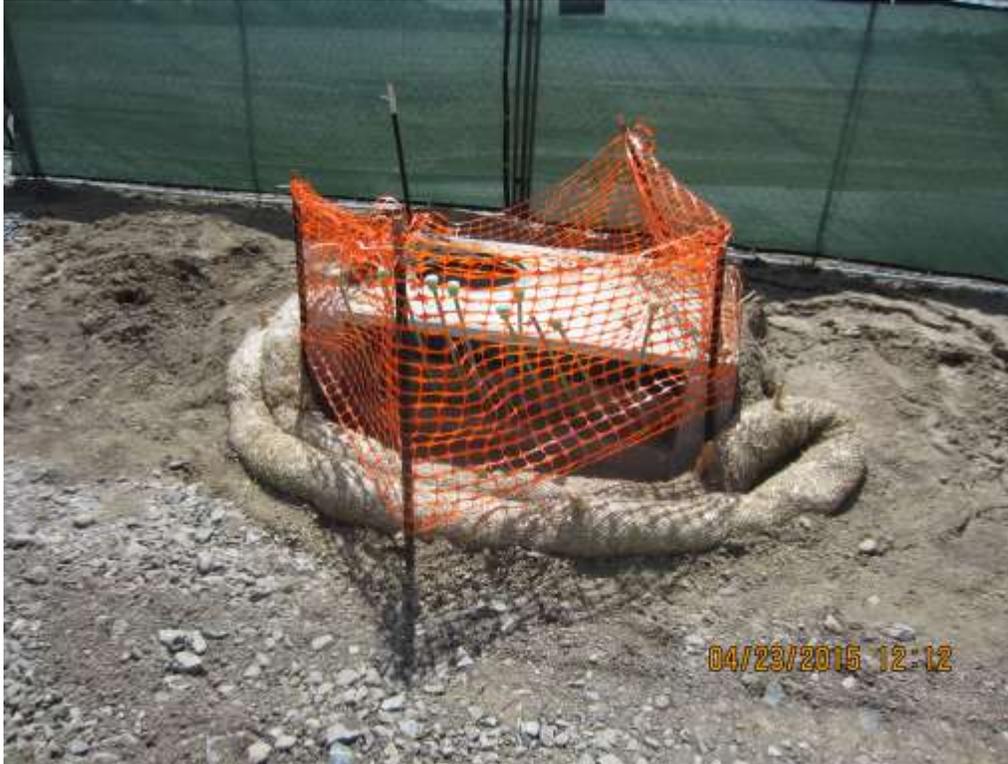
Photograph 21: Straw wattle inlet protection not installed or maintained as required by the SWMP

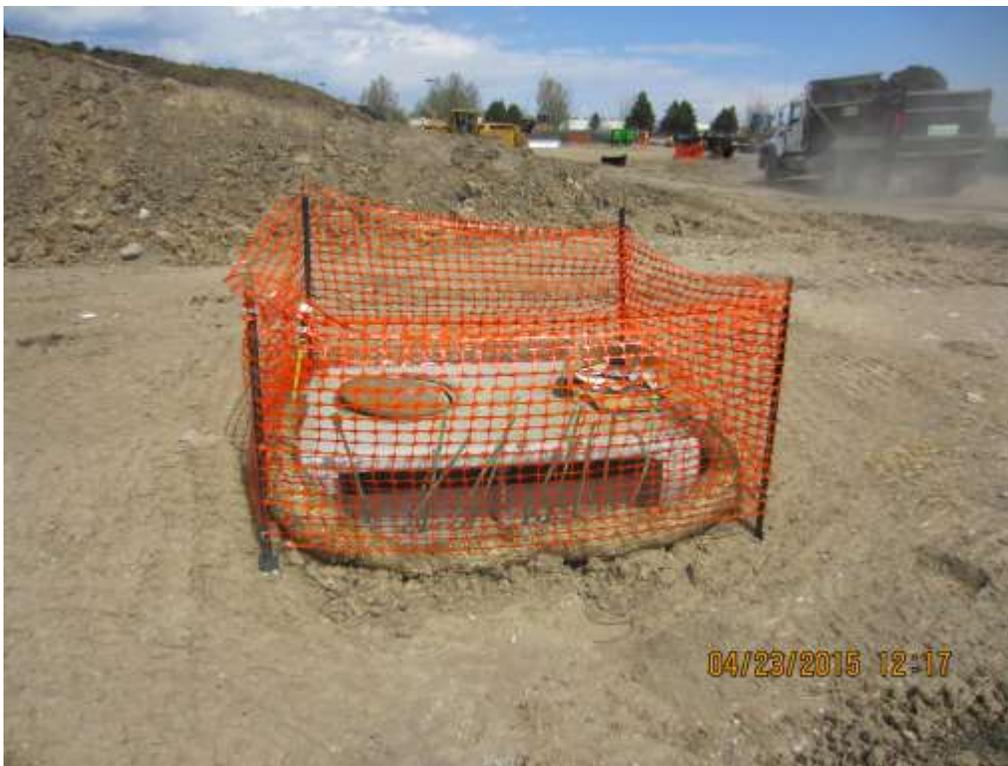
Photograph 22: Straw wattle inlet protection not installed or maintained as required by the SWMP

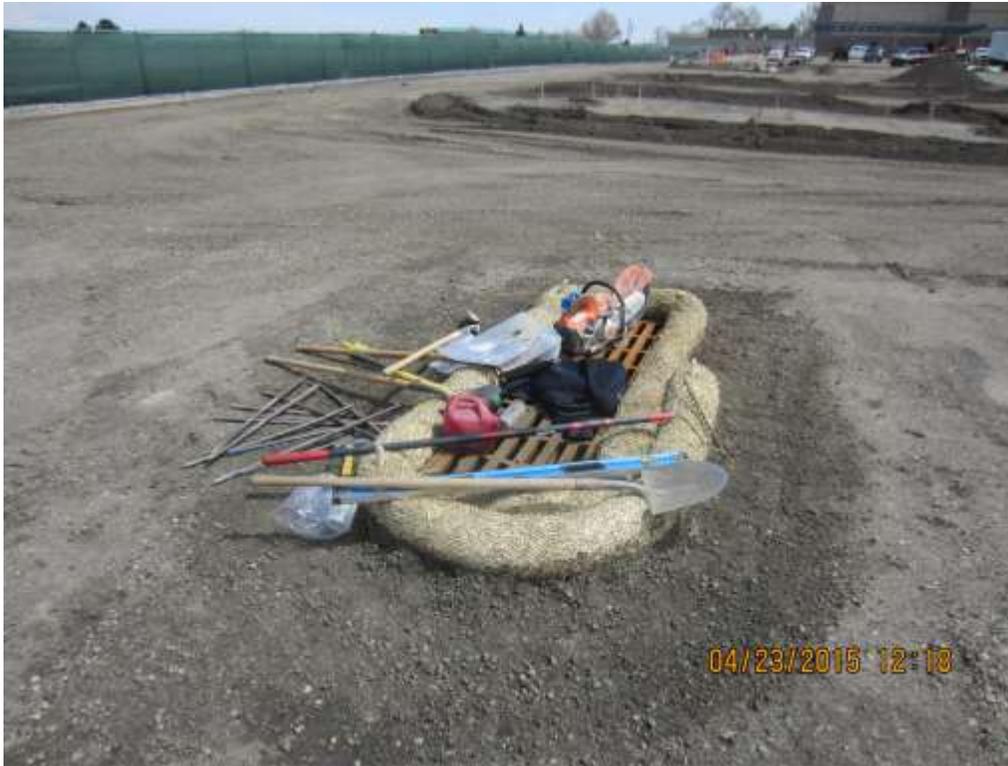
Photograph 23: Straw wattle inlet protection not installed or maintained as required by the SWMP, fuel and building materials stored on inlet

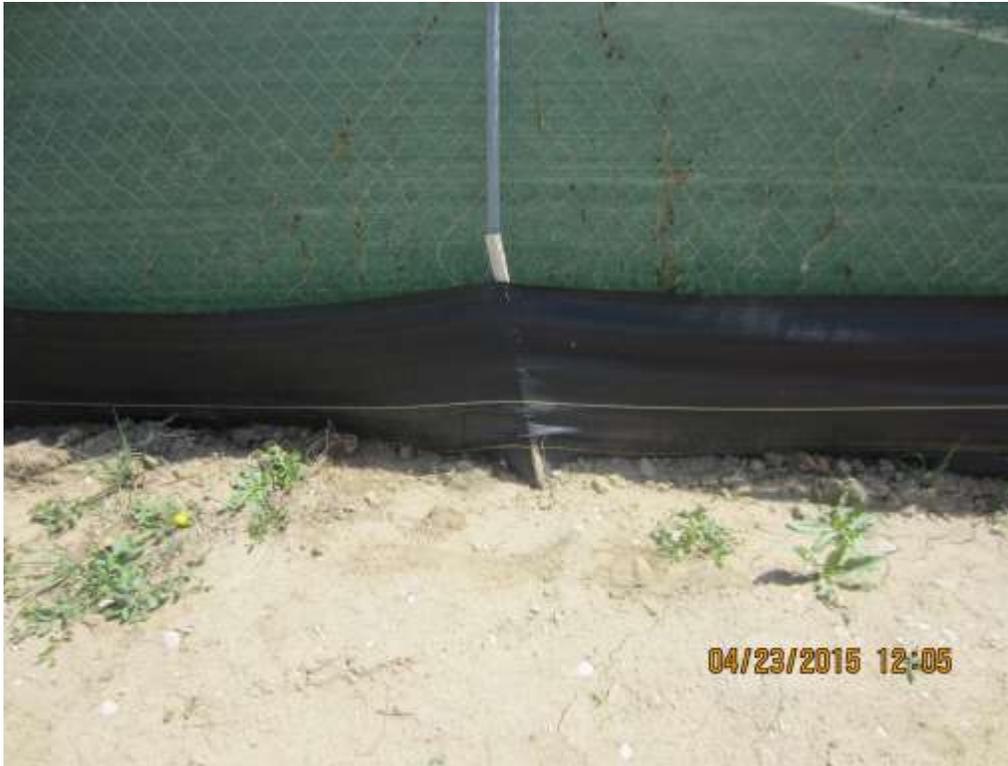
Photograph 25: Silt fence not installed or maintained per the specification provided in the SMWP

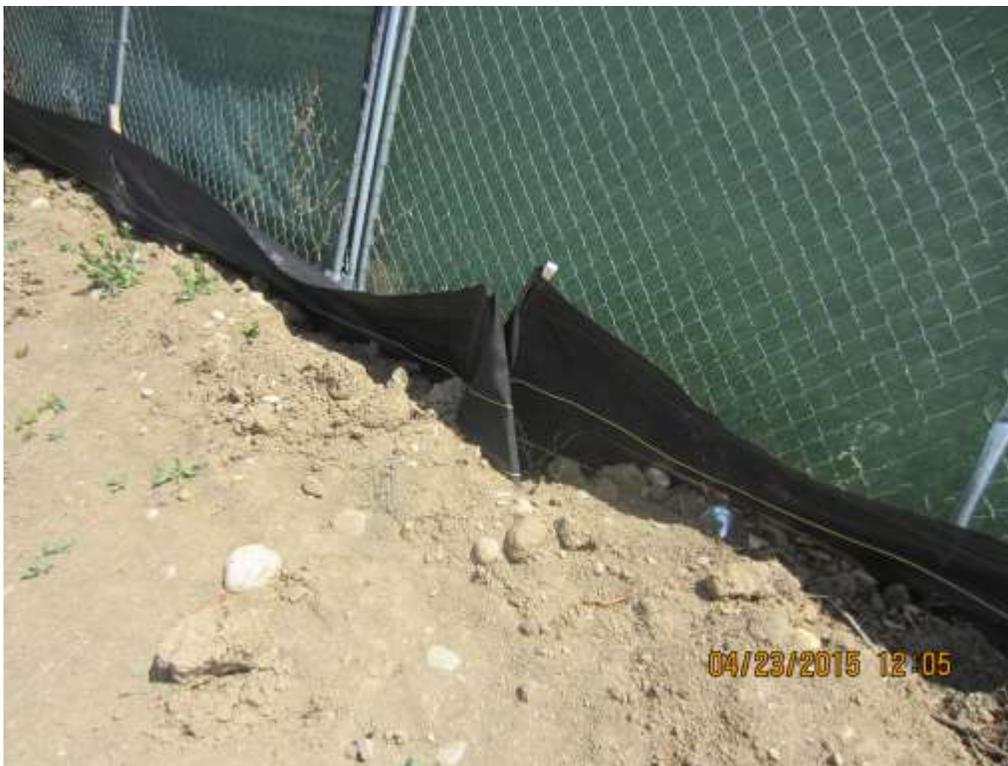
Photograph 26: Silt fence not installed or maintained per the specification provided in the SMWP

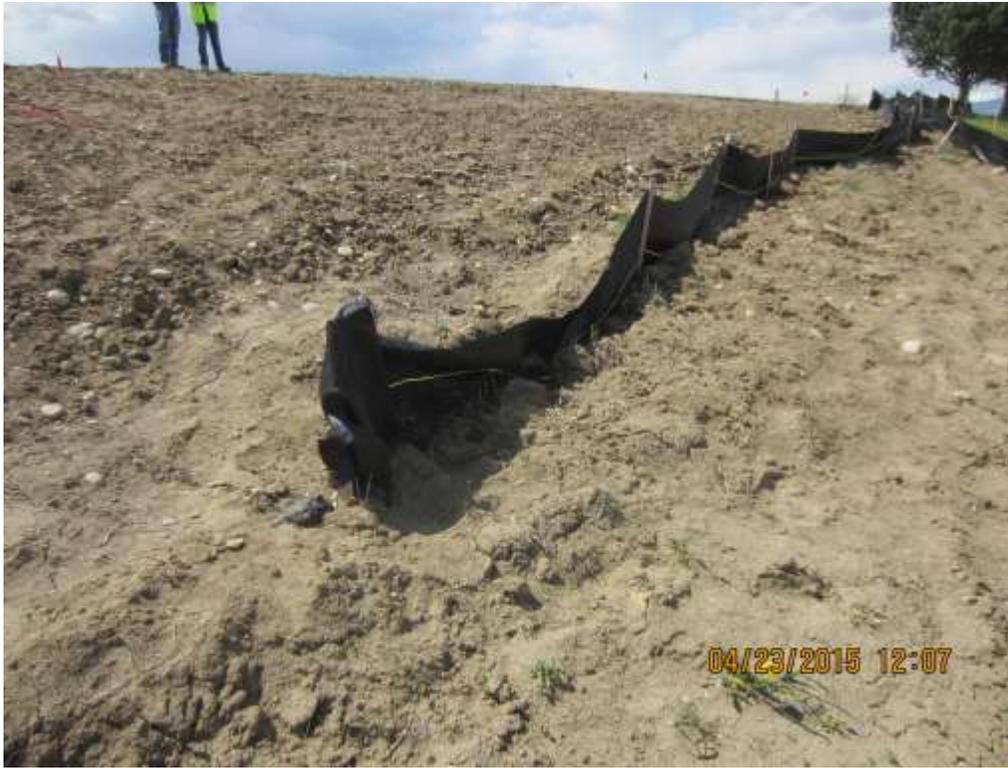
Photograph 27: Silt fence not installed or maintained per the specification provided in the SMWP

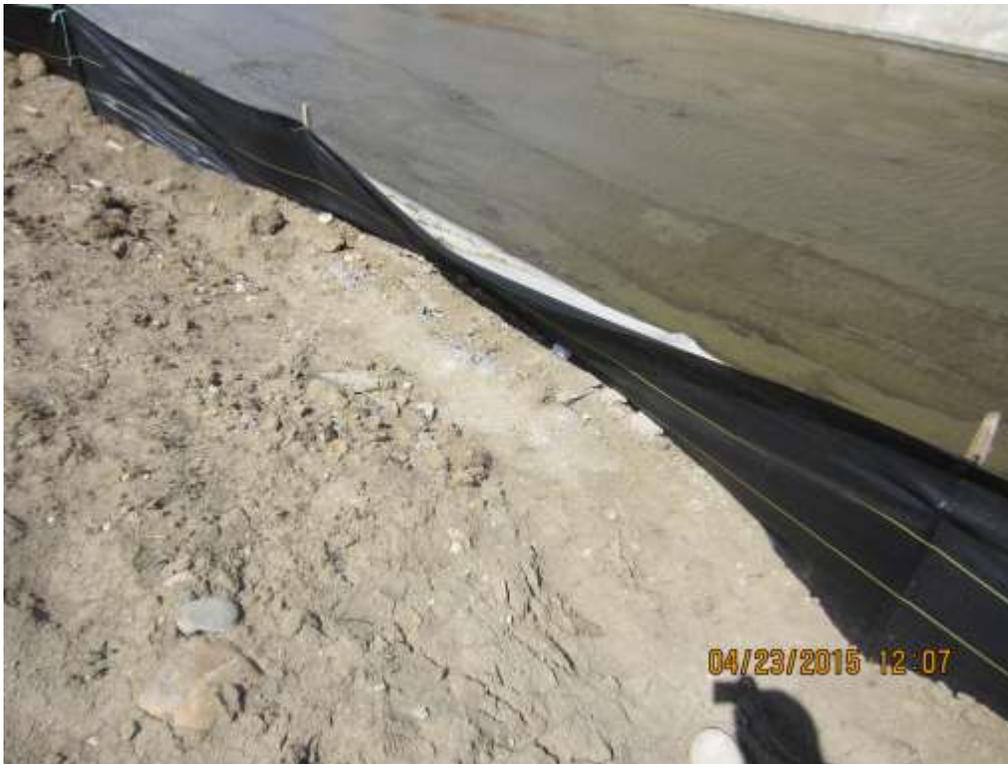
Photograph 28: Silt fence not installed or maintained per the specification provided in the SMWP

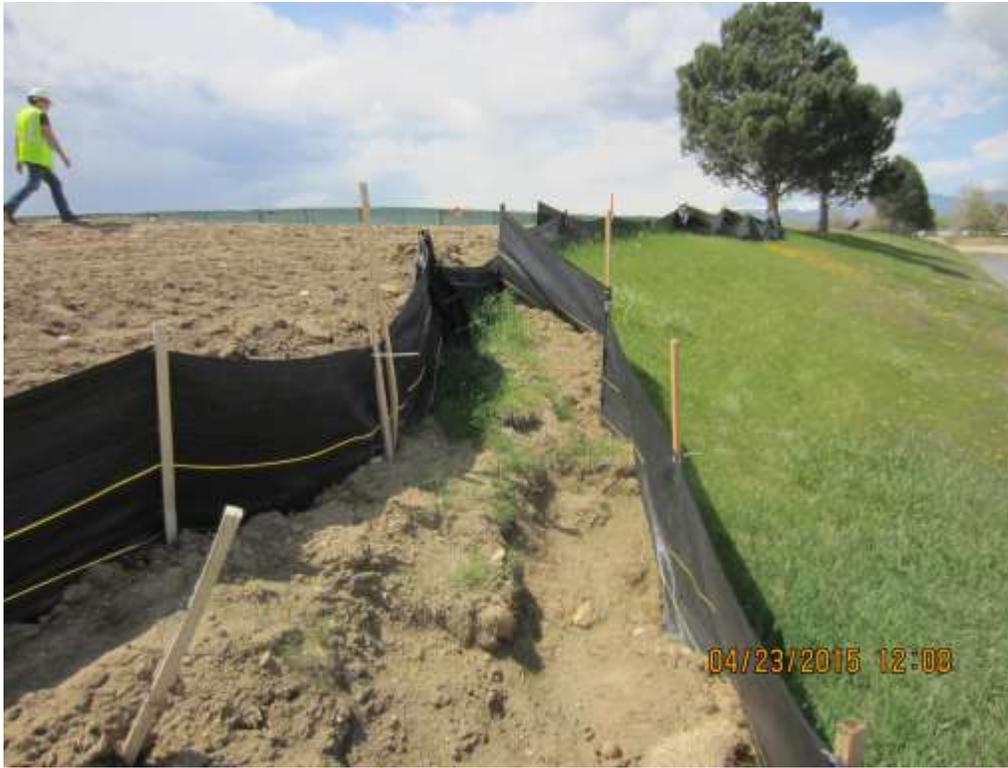
Photograph 29: Silt fence not installed or maintained per the specification provided in the SMWP

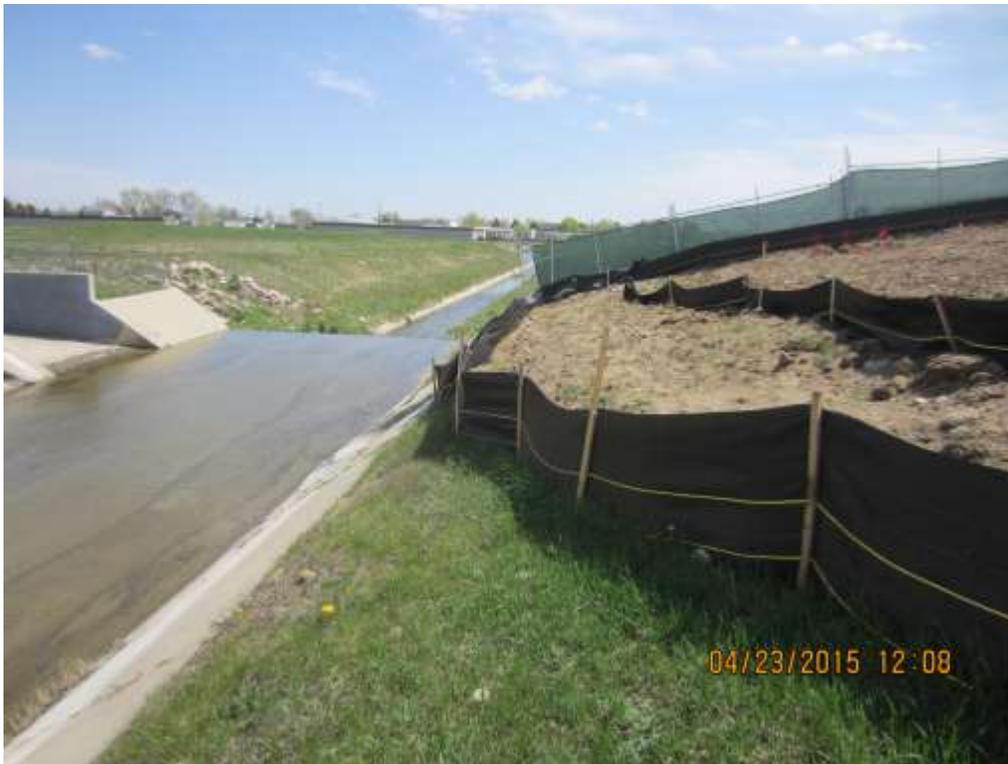
Photograph 30: Silt fence not installed or maintained per the specification provided in the SMWP, Dry Creek on left

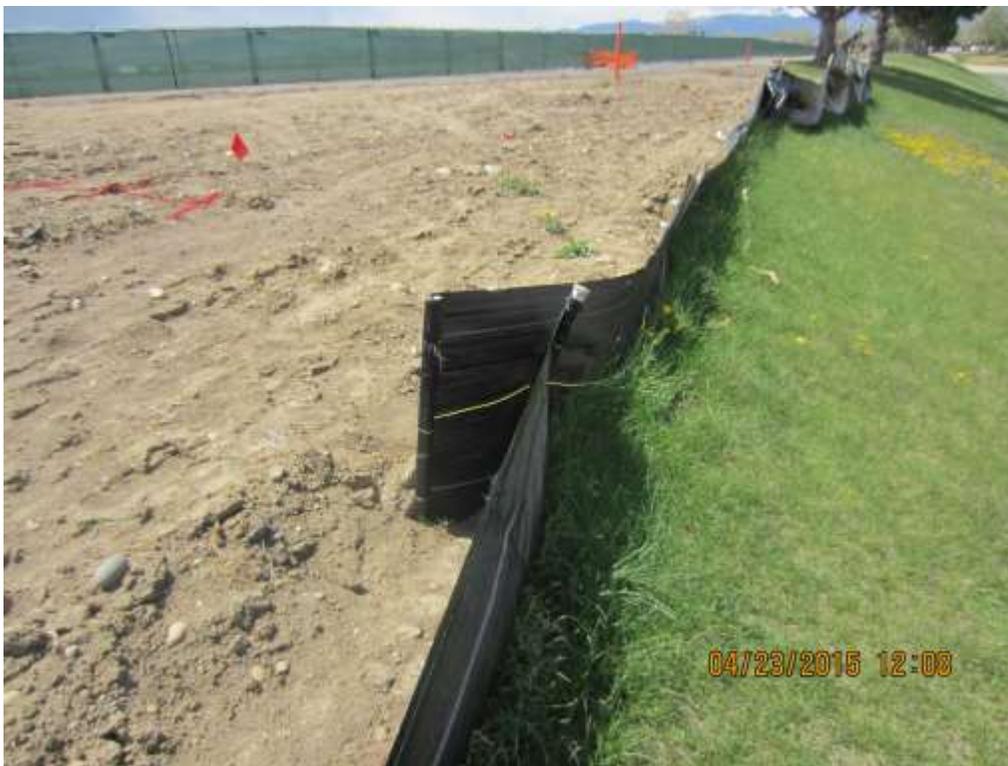
Photograph 32: Silt fence not installed or maintained per the specification provided in the SMWP

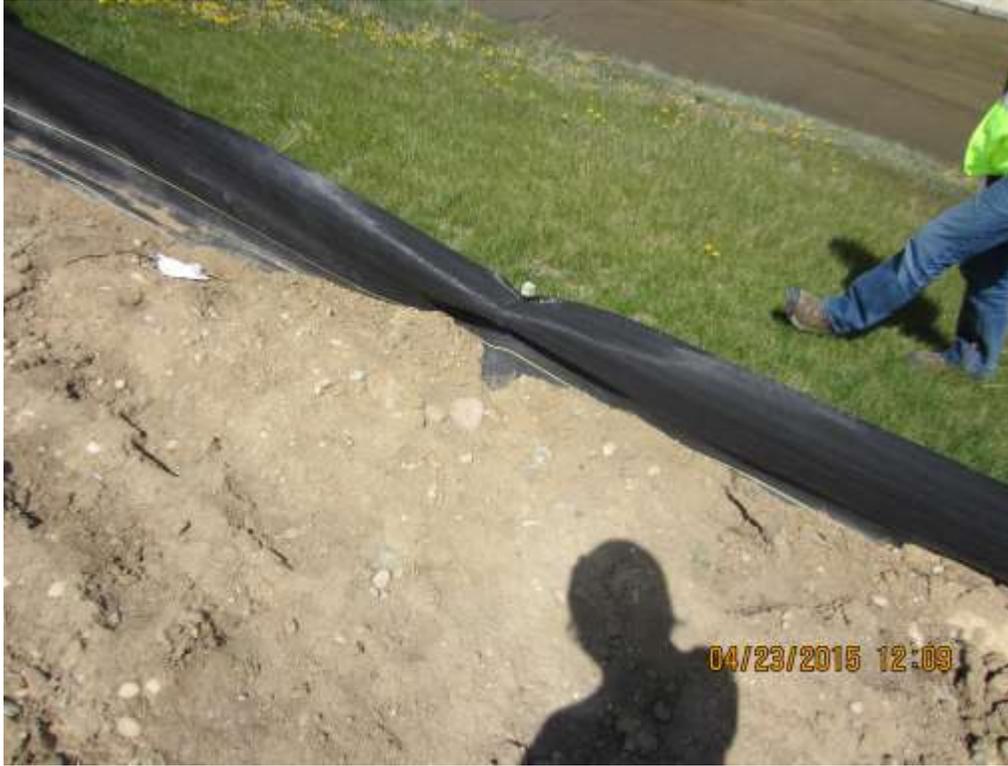
Photograph 33: Silt fence not installed or maintained per the specification provided in the SMWP

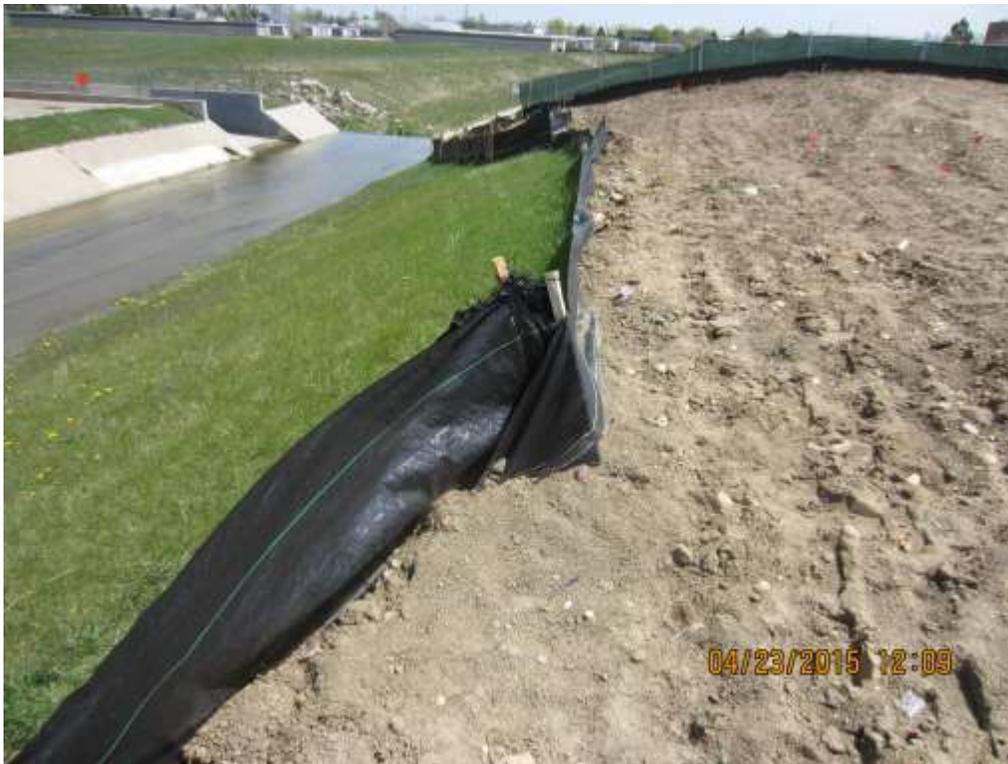
Photograph 34: Silt fence not installed or maintained per the specification provided in the SMWP, Dry Creek on left

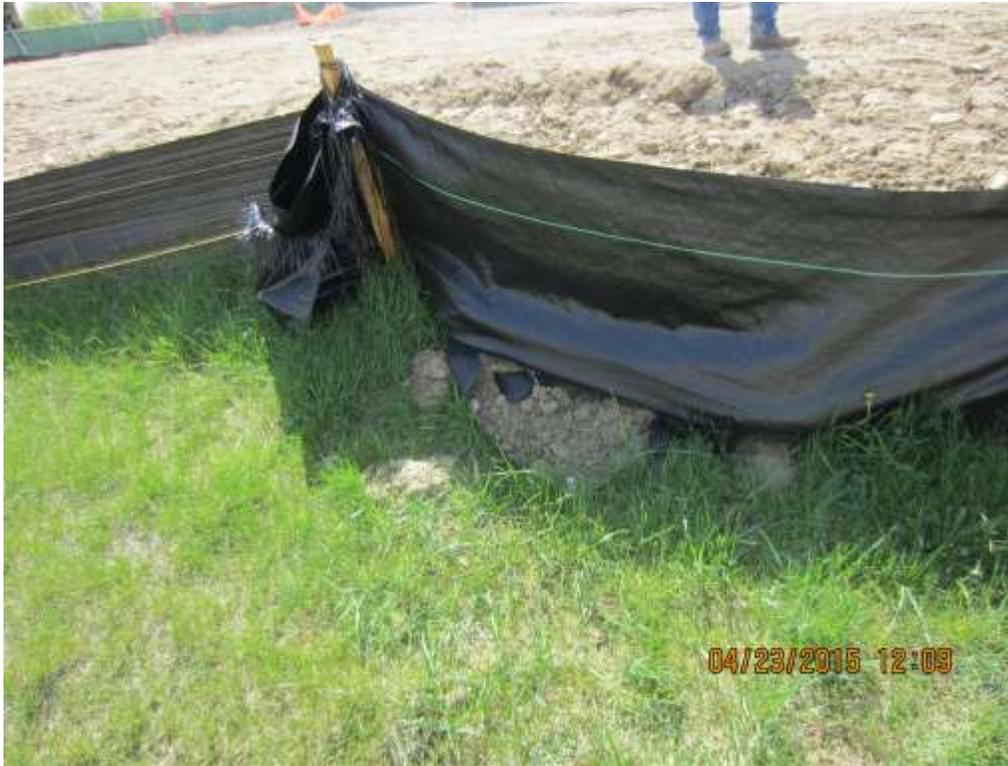
Photograph 35: Silt fence not installed or maintained per the specification provided in the SMWP

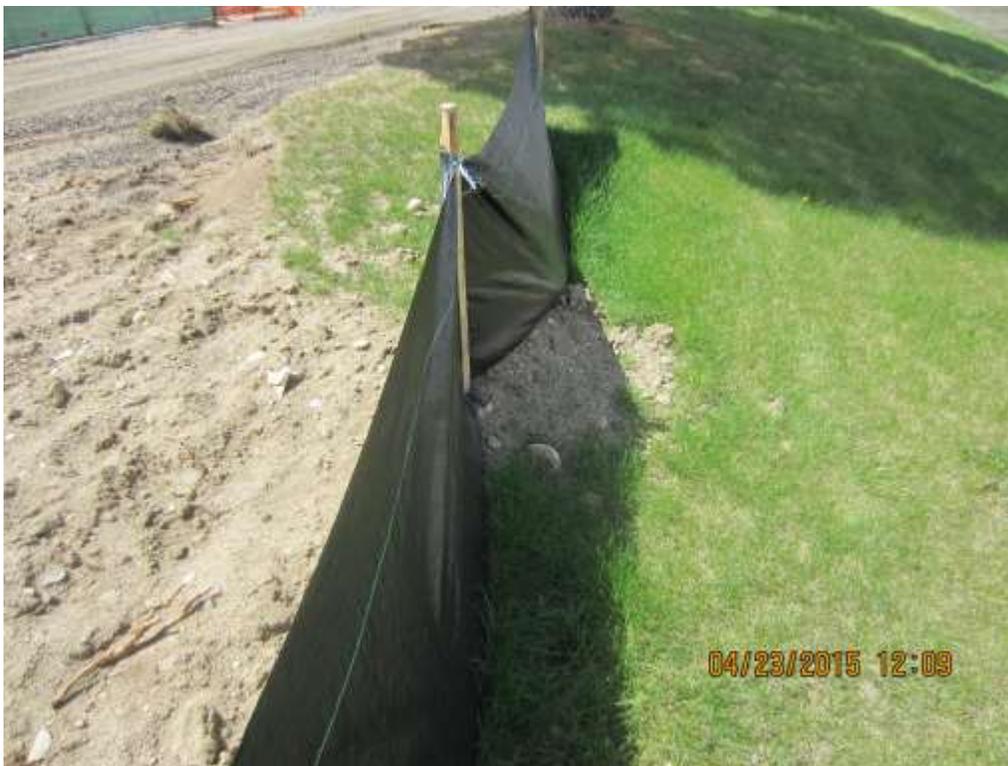
Photograph 36: Silt fence not installed or maintained per the specification provided in the SMWP

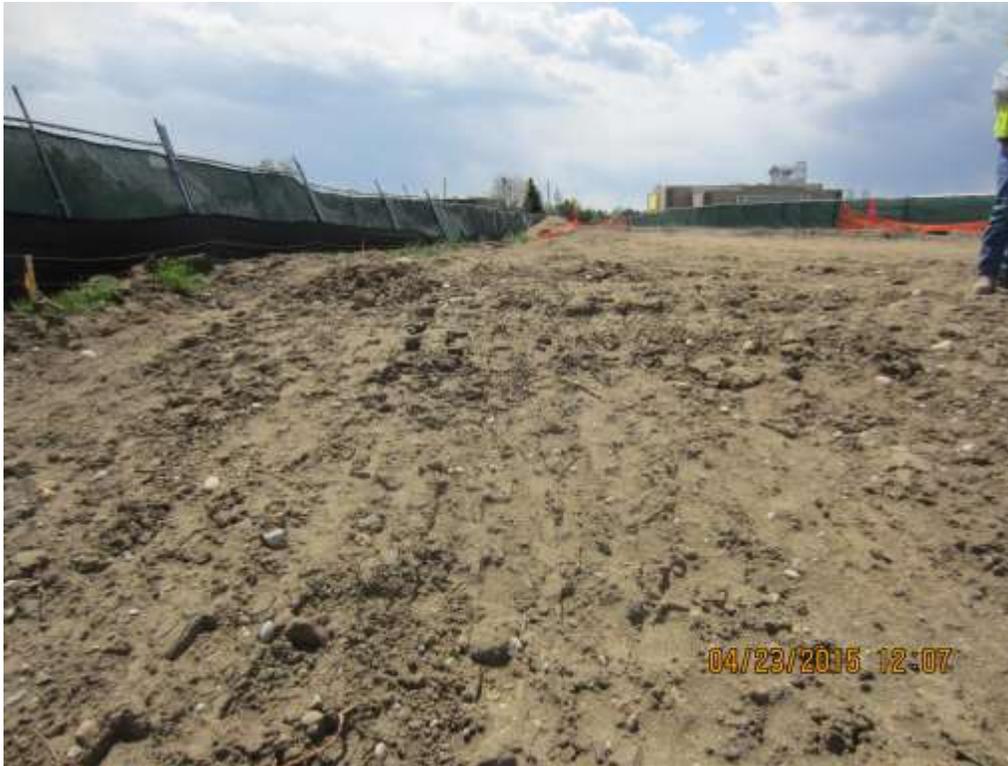
Photograph 37: Surface roughening not installed or maintained as required in the SWMP

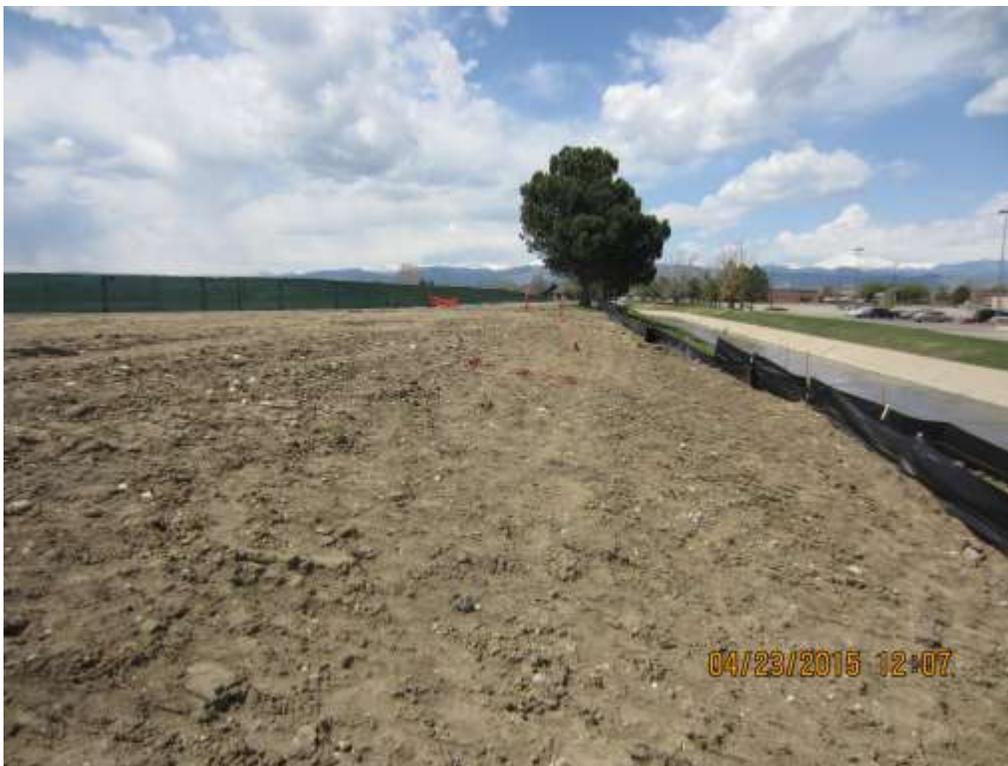
Photograph 38: Surface roughening not installed or maintained as required in the SWMP

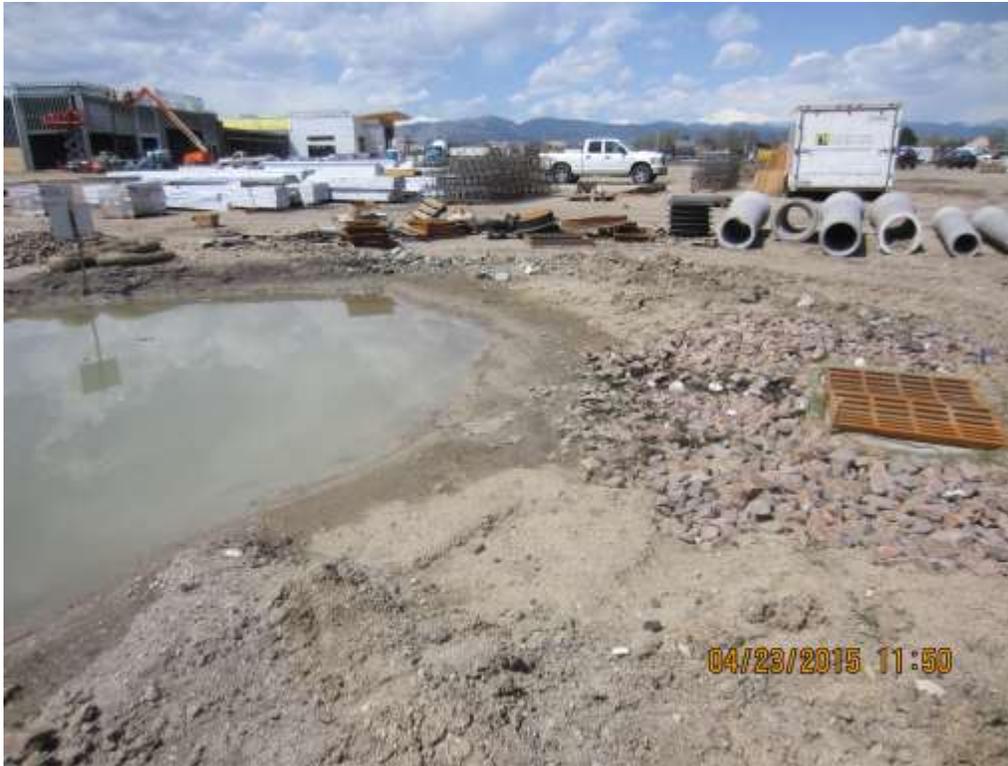
Photograph 39: Wheel wash not installed or maintained in accordance with good engineering, hydrologic, or pollution control practices

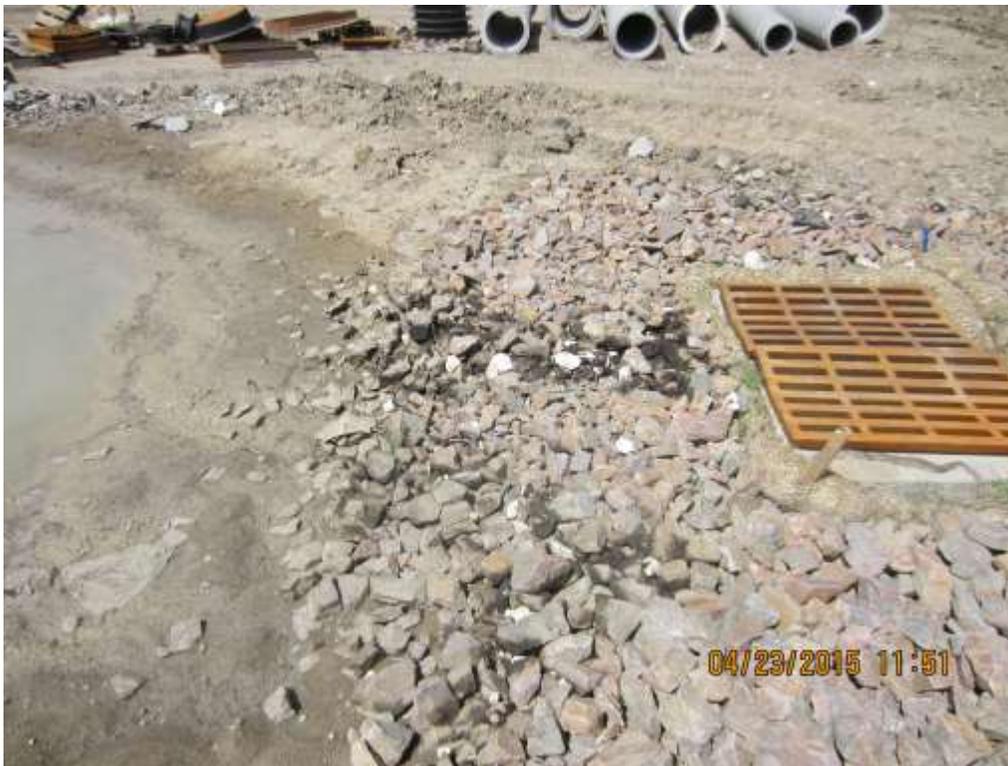
Photograph 40: Wheel wash not installed or maintained in accordance with good engineering, hydrologic, or pollution control practices, hydraulic fluid spills leading to inlet

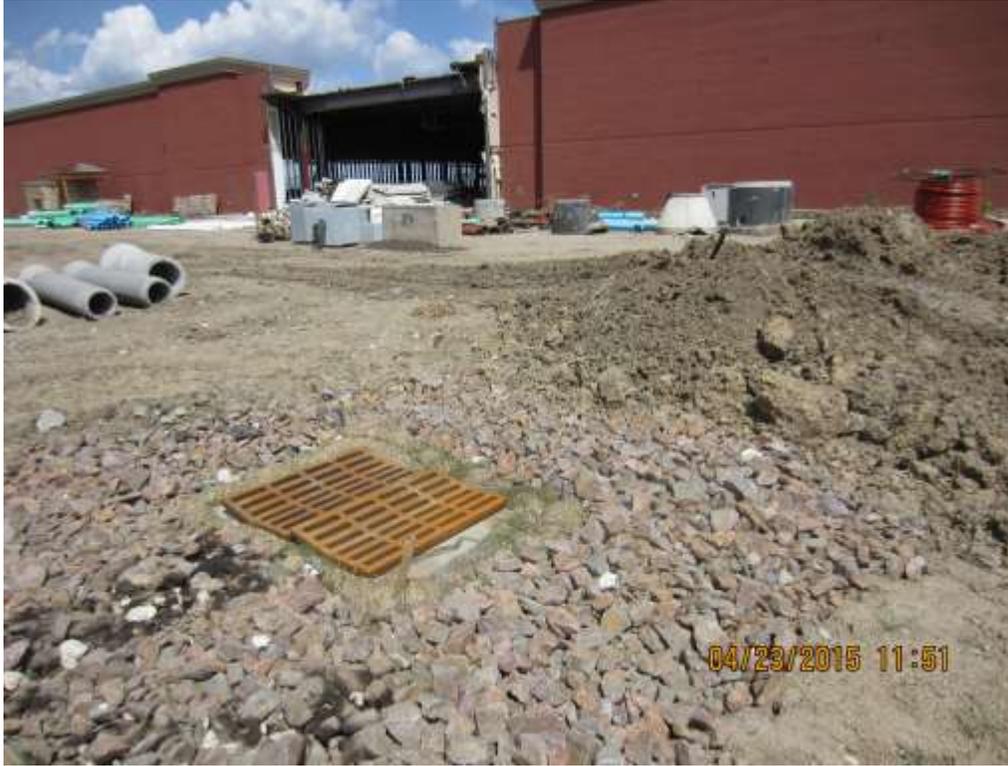
Photograph 41: Wheel wash not installed or maintained in accordance with good engineering, hydrologic, or pollution control practices, spoils pile encroaching on inlet without adequate controls

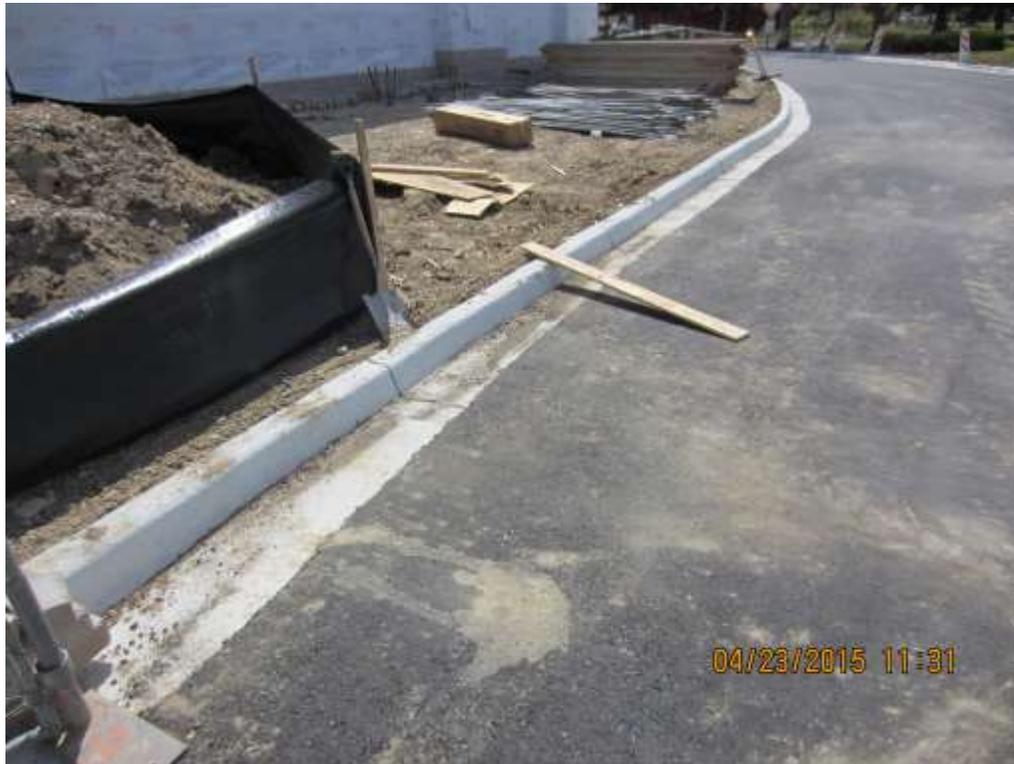
Photograph 43: Grade cut perimeter control not installed or maintained in accordance with good engineering, hydrologic, and pollution control practices
