Department of Public
Health & Environment

RE: Service of Notice of Violation/Cease and Desist Order, Number: SO-151007-1

NOTICE OF VIOLATION / CEASE AND DESIST ORDER

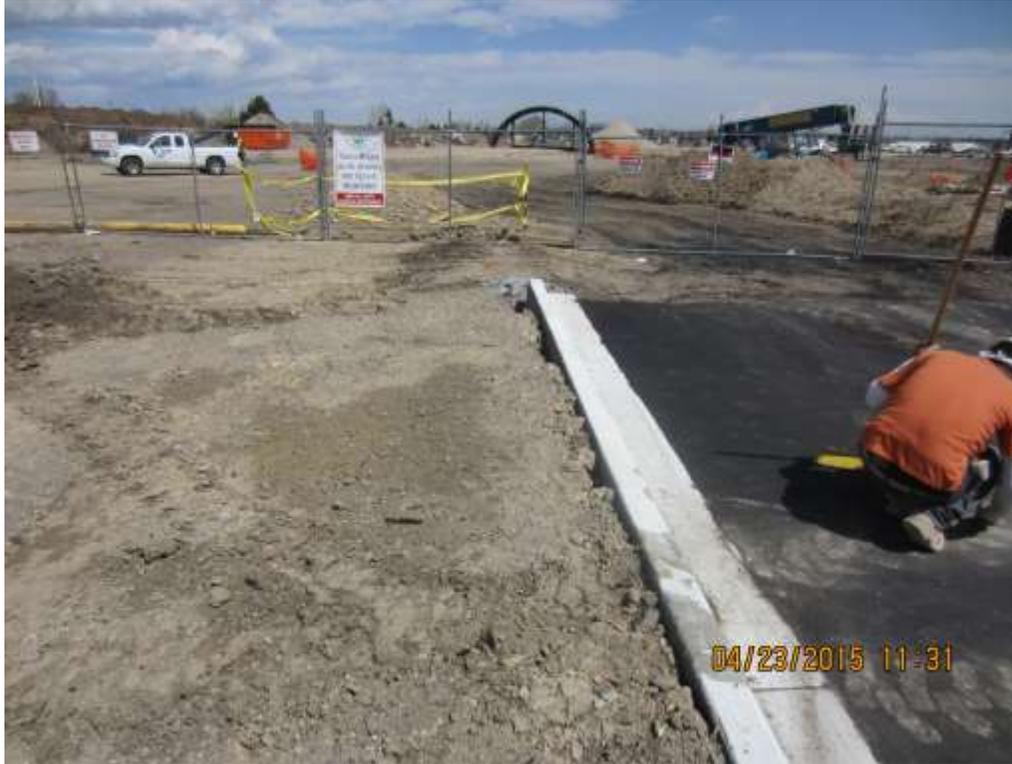
Photograph 44: Grade cut perimeter control not installed or maintained in accordance with good engineering, hydrologic, and pollution control practices

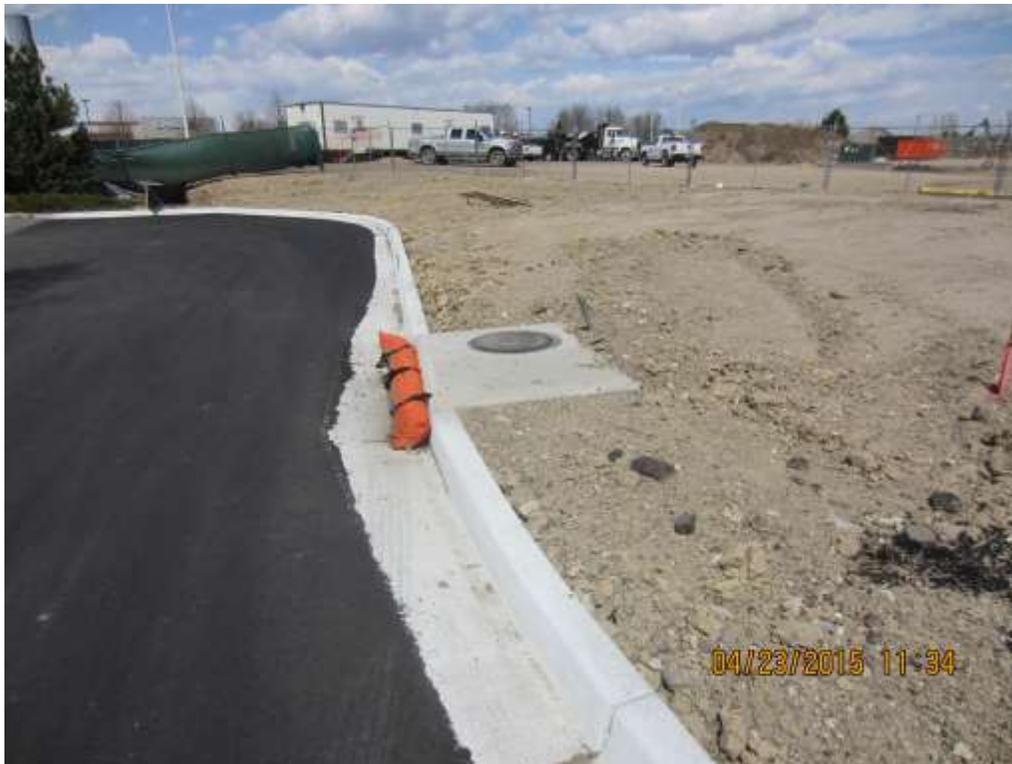
Photograph 45: Grade cut perimeter control not installed or maintained in accordance with good engineering, hydrologic, and pollution control practices

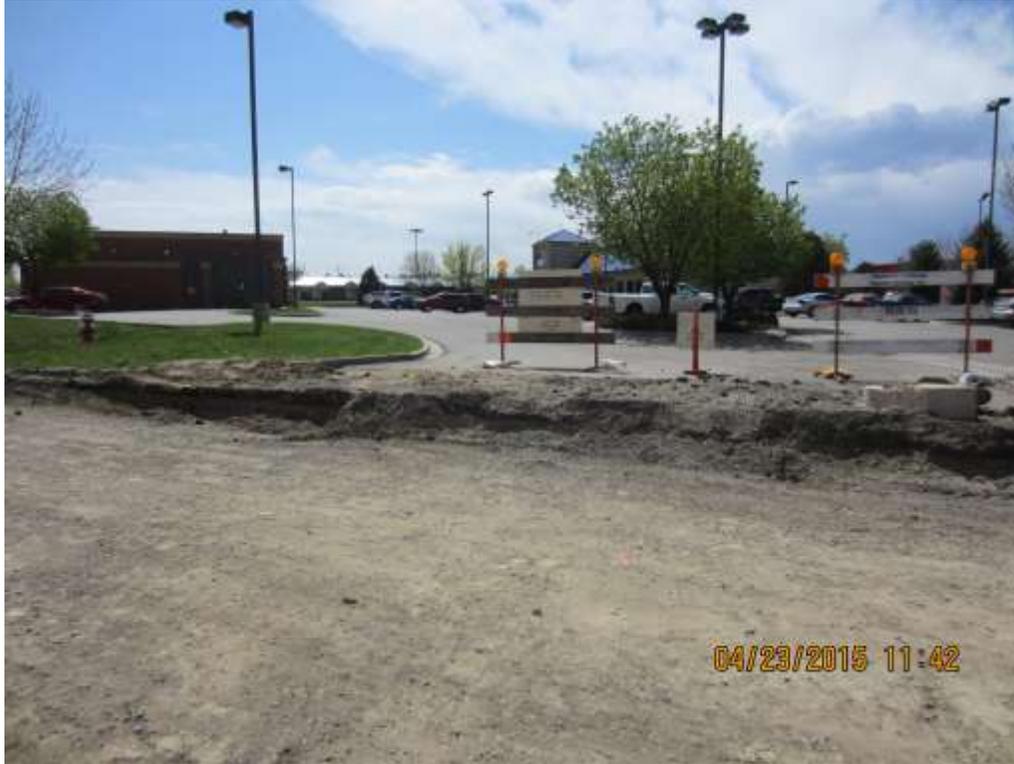
Photograph 48: Grade cut perimeter control not installed or maintained in accordance with good engineering, hydrologic, and pollution control practices

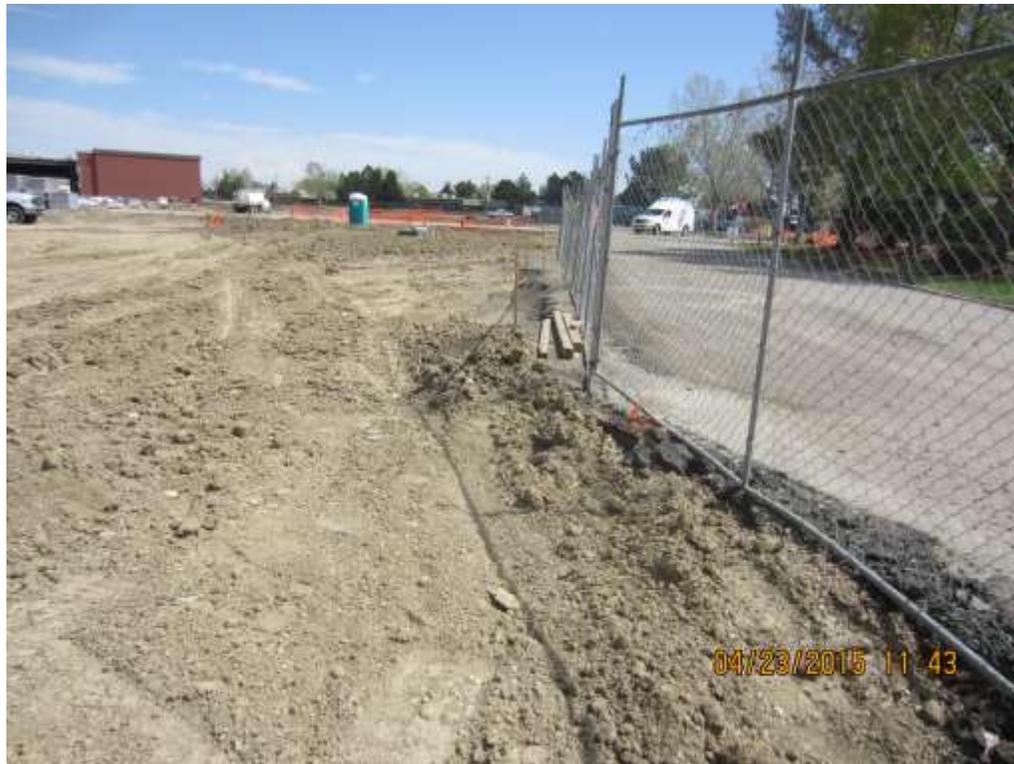
Photograph 49: Grade cut perimeter control not installed or maintained in accordance with good engineering, hydrologic, and pollution control practices

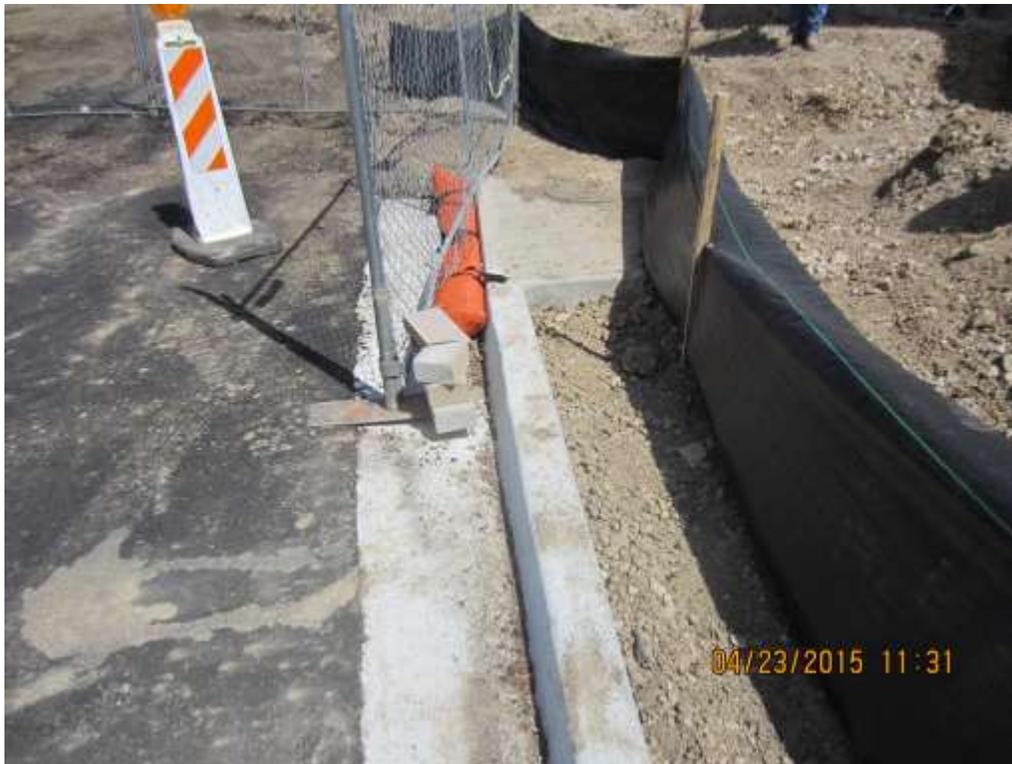
Photograph 55: No control at the back of inlet box for overtopped soils

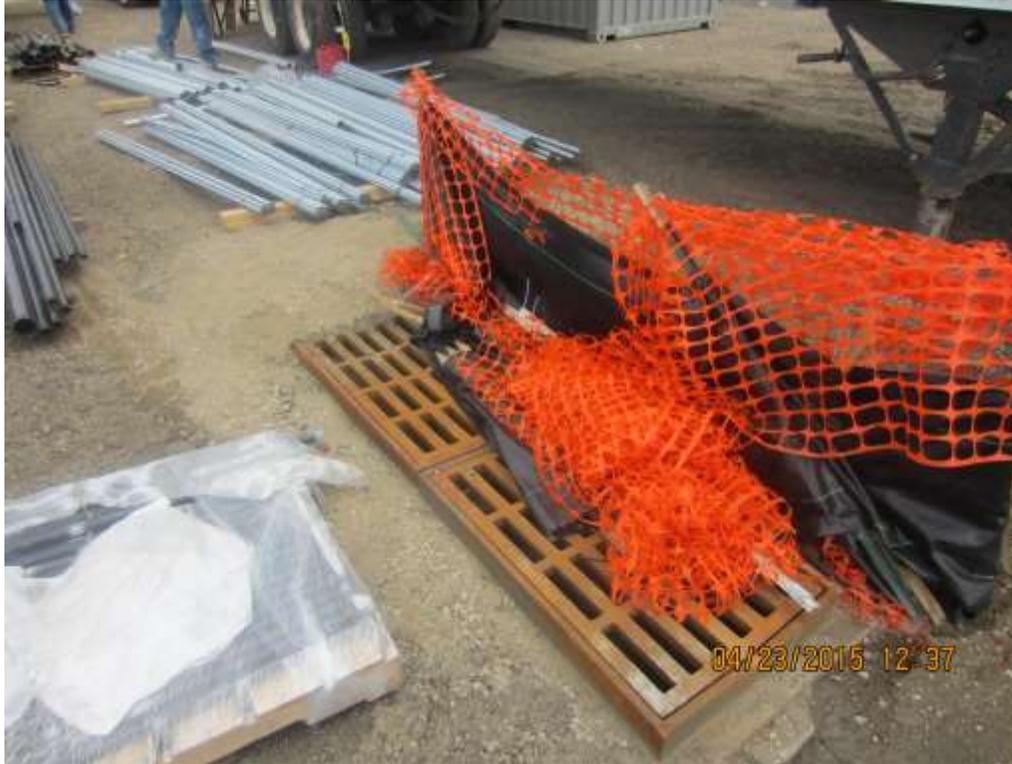
Photograph 76: Silt fence inlet protection not installed or maintained per the specification provided in the SWMP

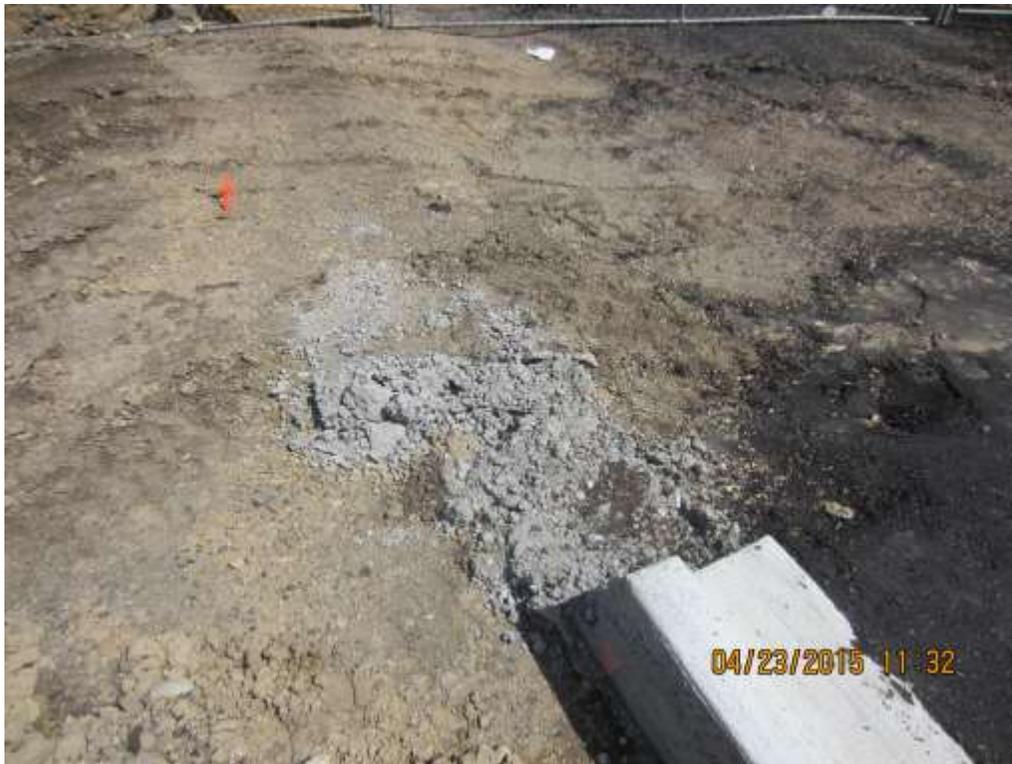
- Concrete washout and significant amounts of concrete waste (excess from foundations, curbs, forms, etc.) were observed on the ground on the site and not managed in accordance with the requirements in the SWMP.

Photograph 77: Concrete waste not managed in accordance with the requirements in the SWMP
