RE: Expedited Settlement Agreement, Number ES-160908-1
Dove Hill Estates Ph II / CDPS Permit Certification No. COR03N464

EXPEDITED SETTLEMENT AGREEMENT

Number: ES-160908-1

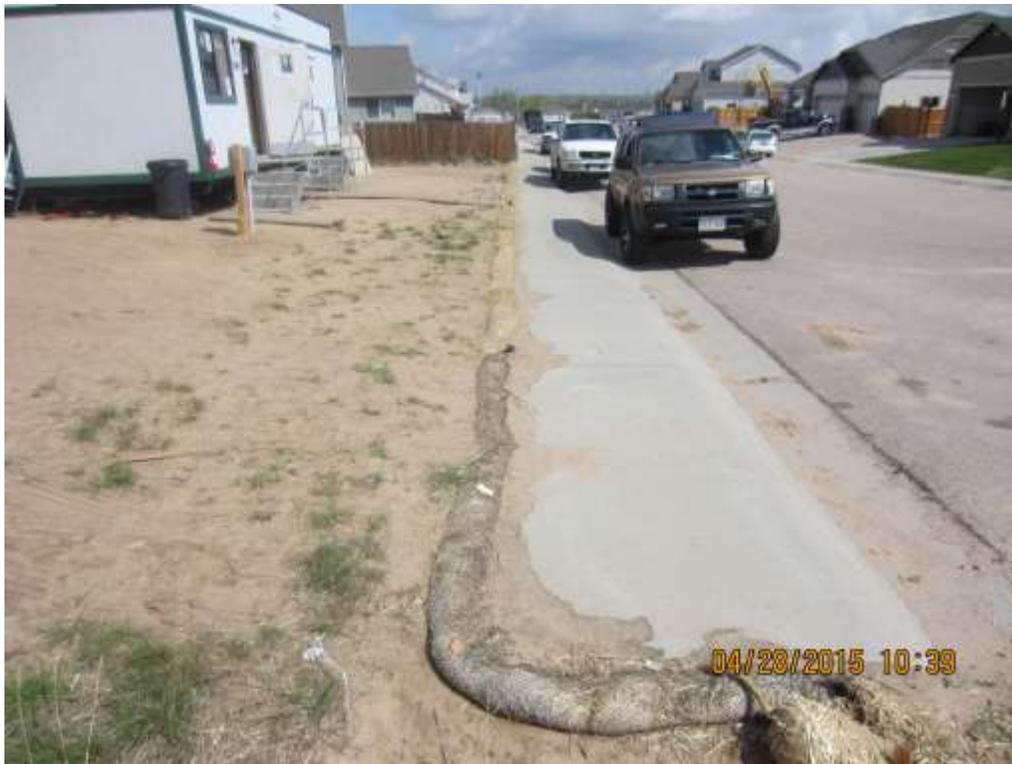
Photograph 12: Straw wattle not installed or maintained as required in the SWMP

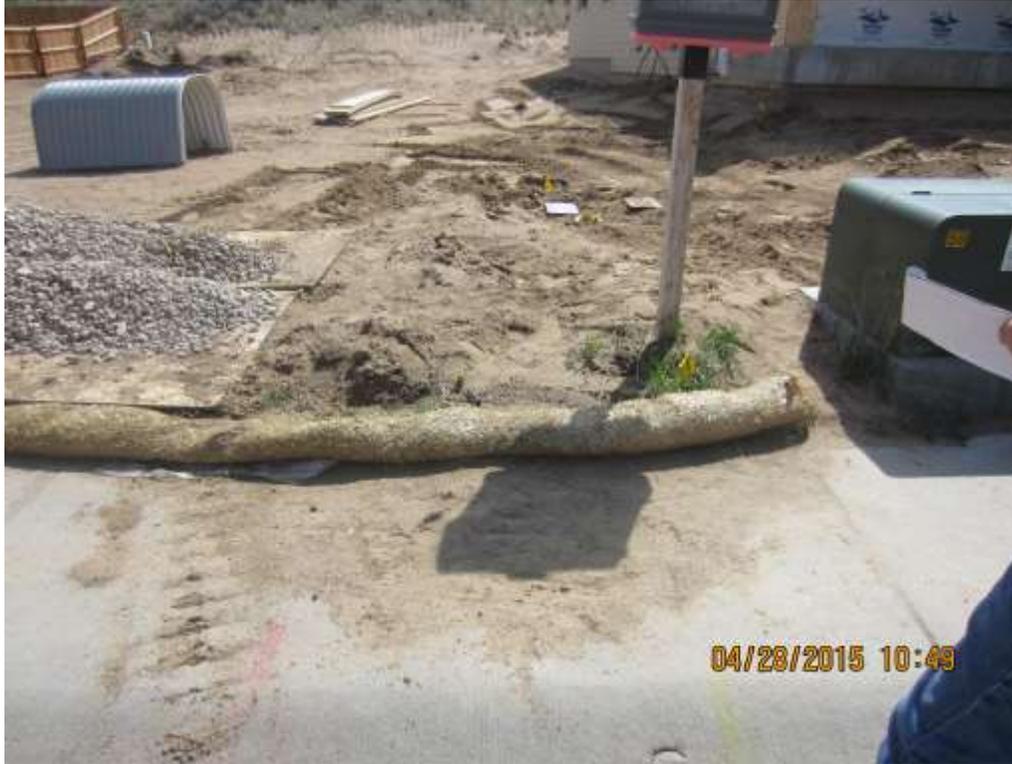
Photograph 17: Straw wattle not installed or maintained as required in the SWMP

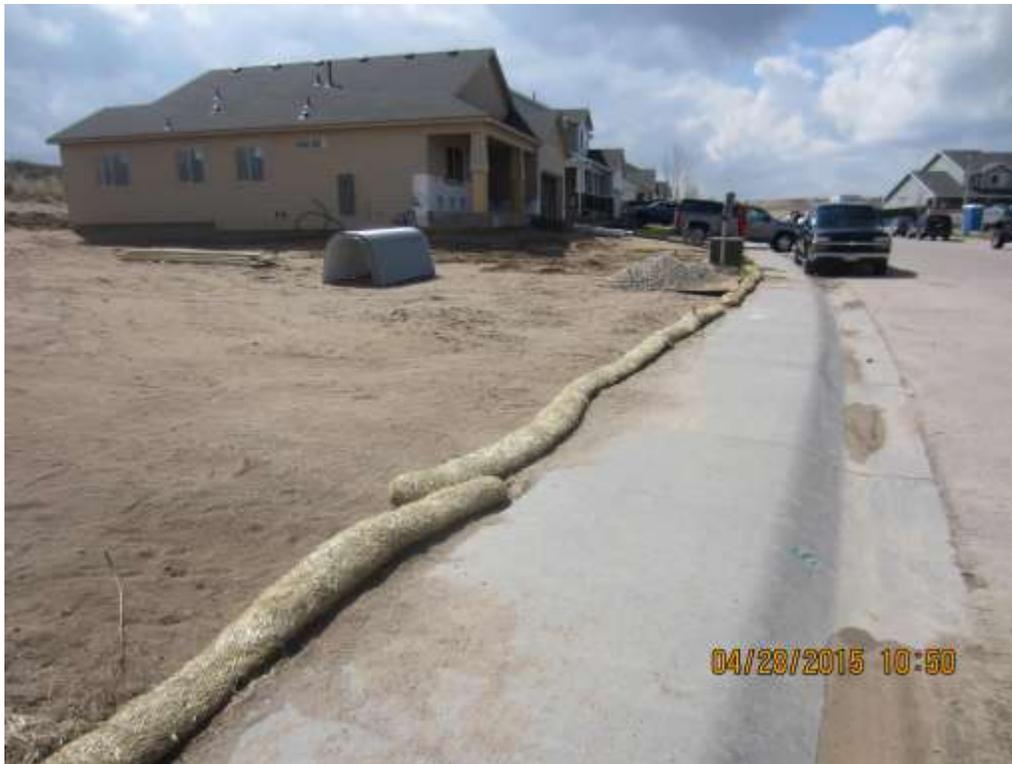
Photograph 18: Straw wattle not installed or maintained as required in the SWMP

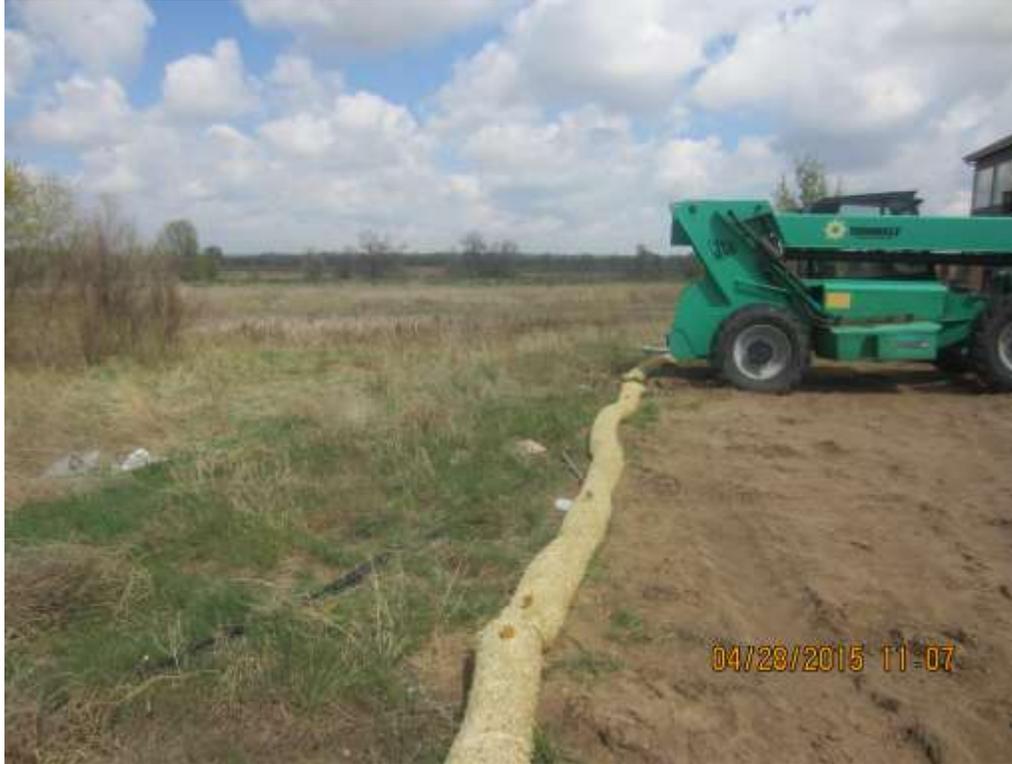
Photograph 23: Straw wattle not installed or maintained as required in the SWMP

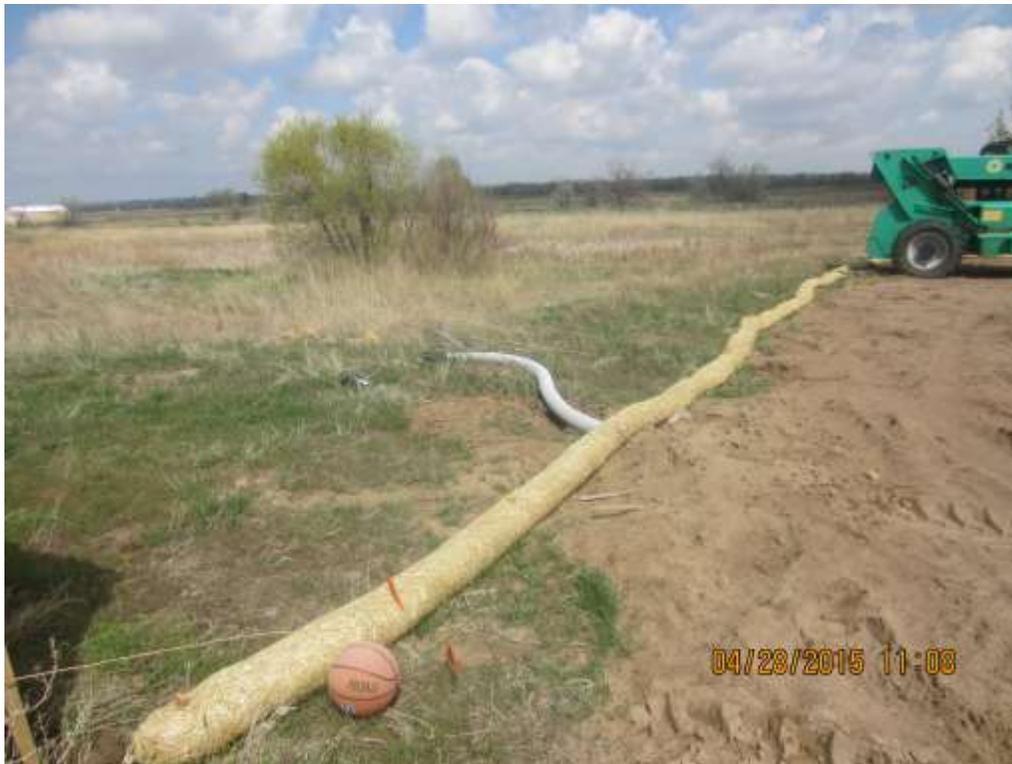
Photograph 24: Straw wattle not installed or maintained as required in the SWMP

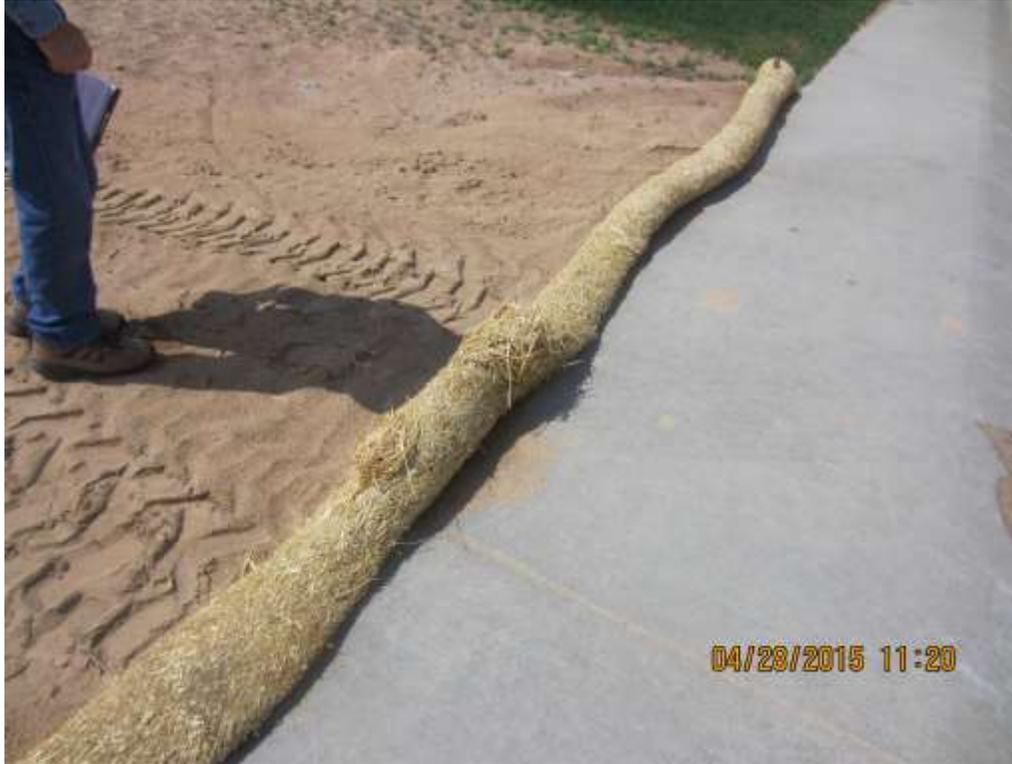
Photograph 27: Straw wattle not installed or maintained as required in the SWMP

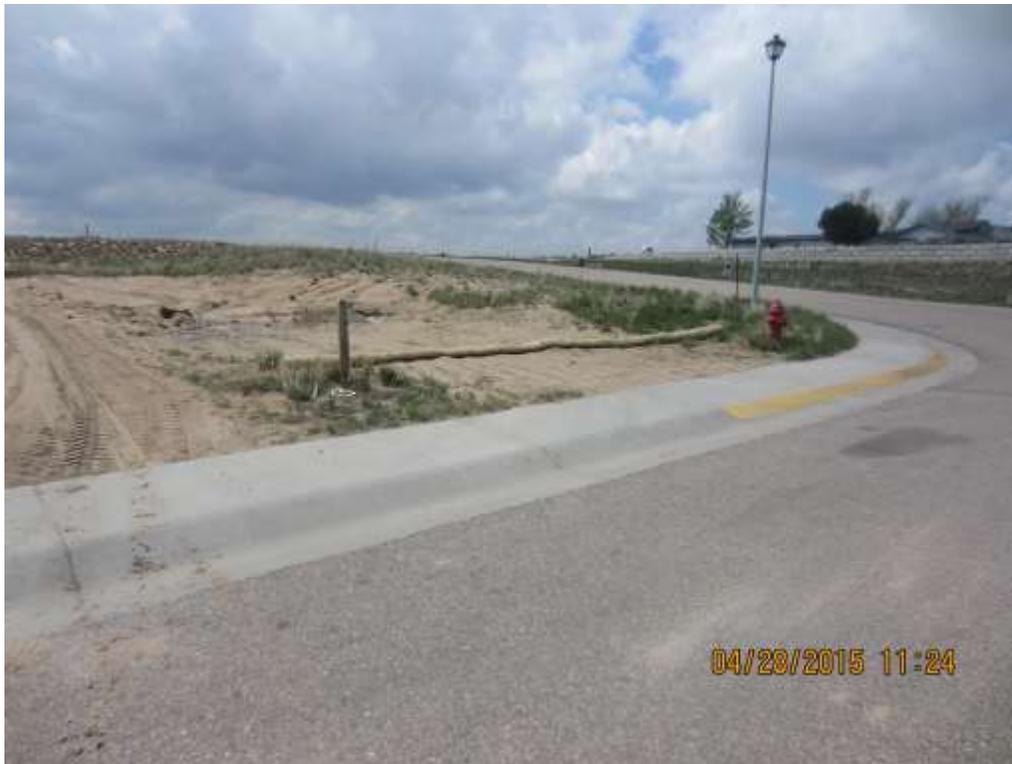
Photograph 28: Straw wattle not installed or maintained as required in the SWMP

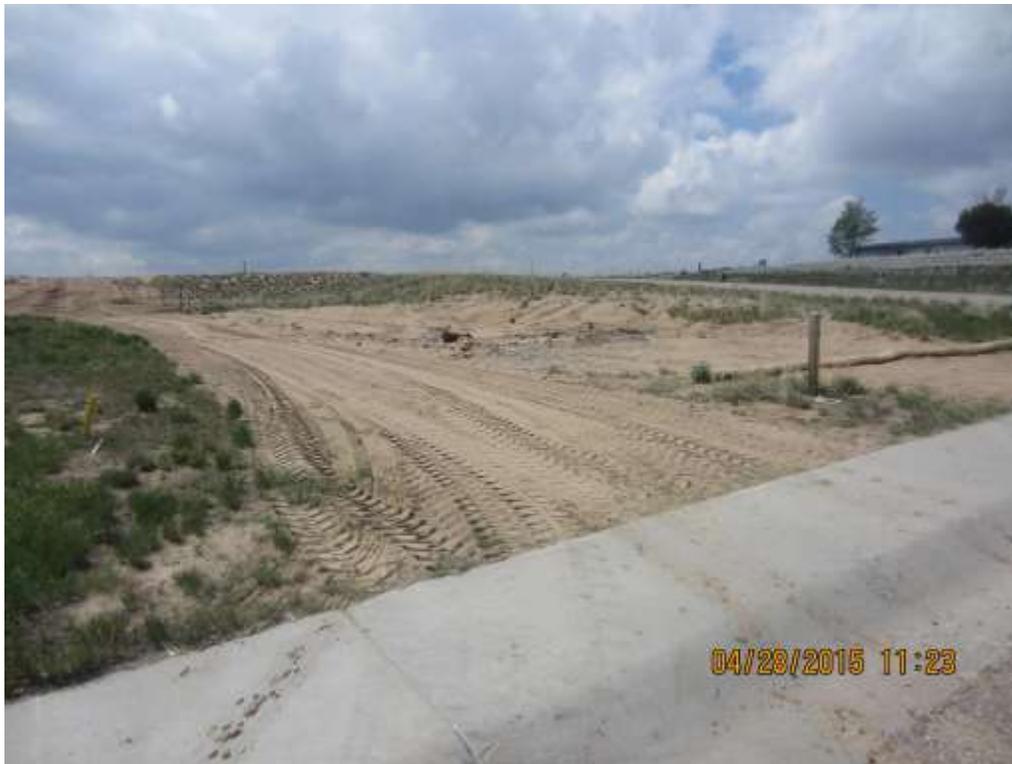
Photograph 32: Surface roughening not implemented as required in the SWMP

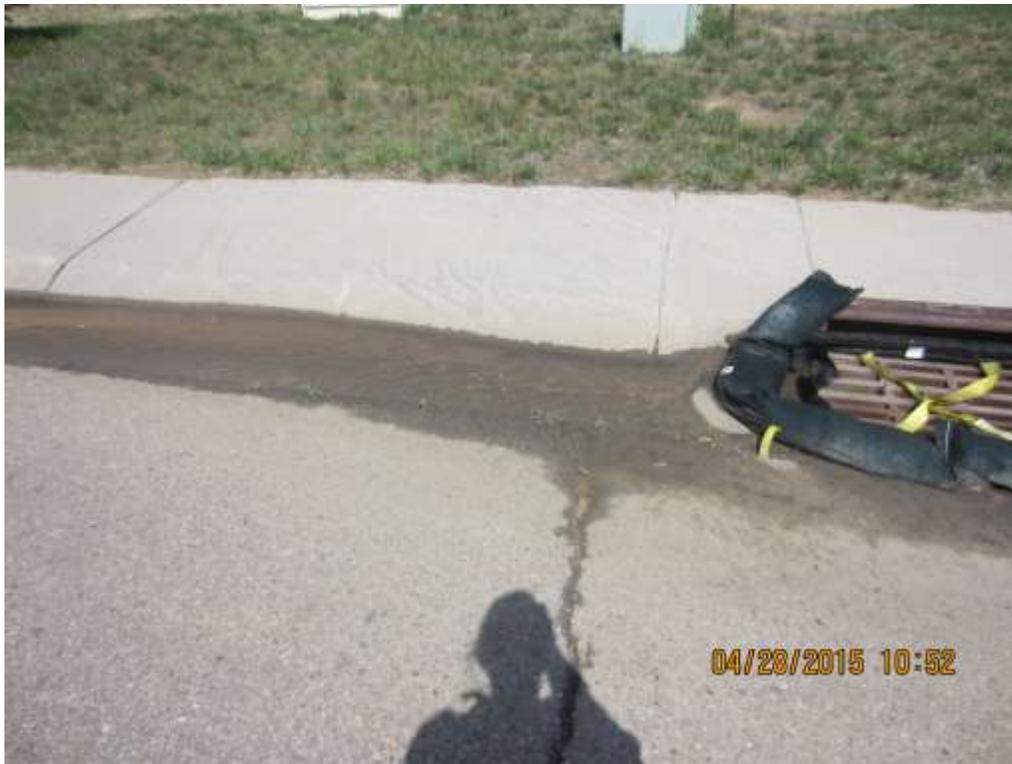
9. It was noted during the inspection that inadequate control measures were implemented to manage pollutant contributions to stormwater from sediment from disturbed areas located on the east and west sides of Sunset Road (refer to photograph(s) 35-37).

- Control Measure Observation: An inlet protection bag and rock sock control measure were implemented to manage stormwater runoff from the locations and pollutant source noted above, however the control measure was inadequate. Specifically,

Photograph 36: Inlet protection in need of maintenance to remove accumulated sediment

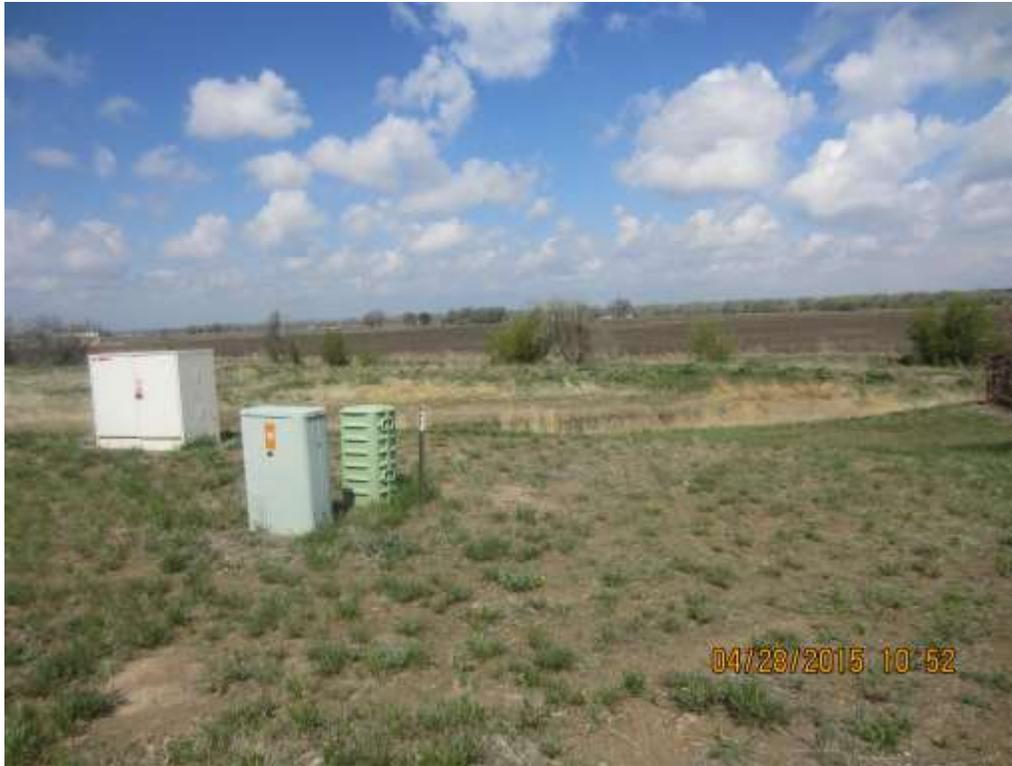
Photograph 39: Adjacent wetland area on the north side of the site (photo looking north)

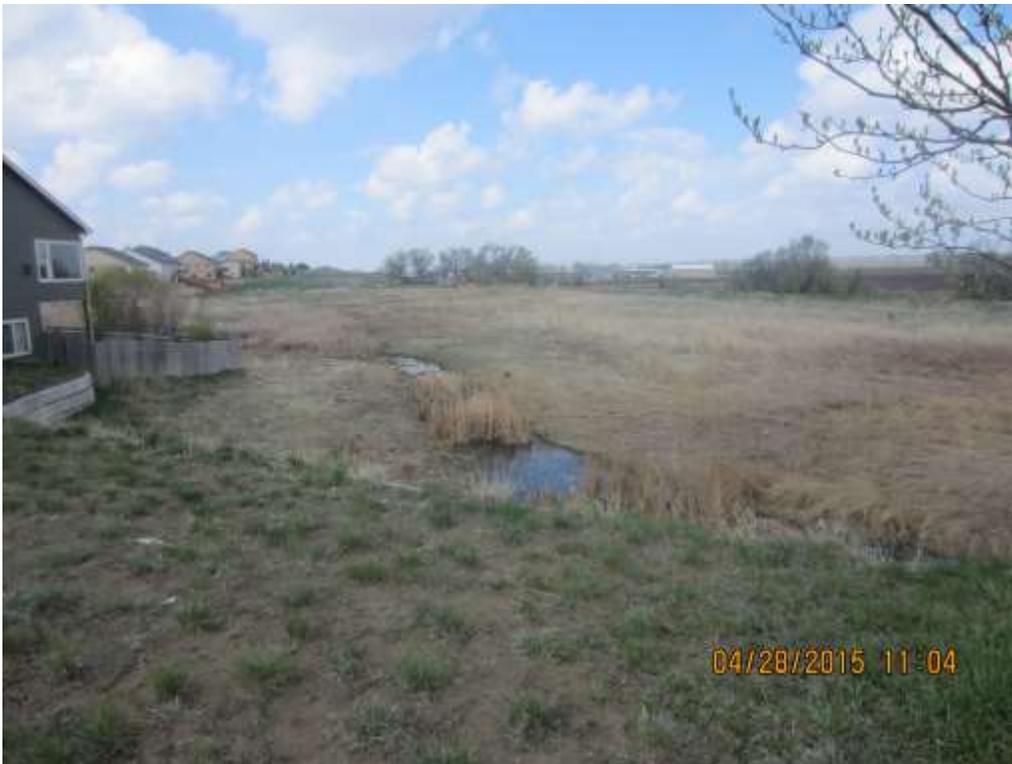
Photograph 40: Adjacent wetland area on the north side of the site (photo looking northwest)

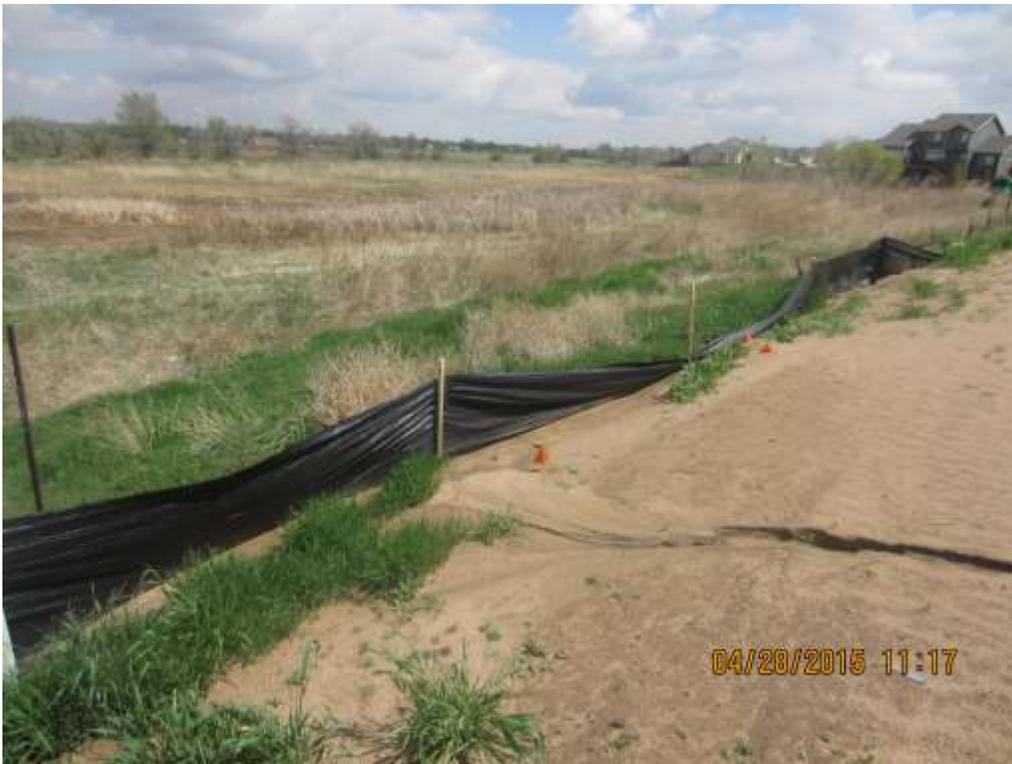
Photograph 62: Silt fence not installed or maintained per specification, wetland at top of photo

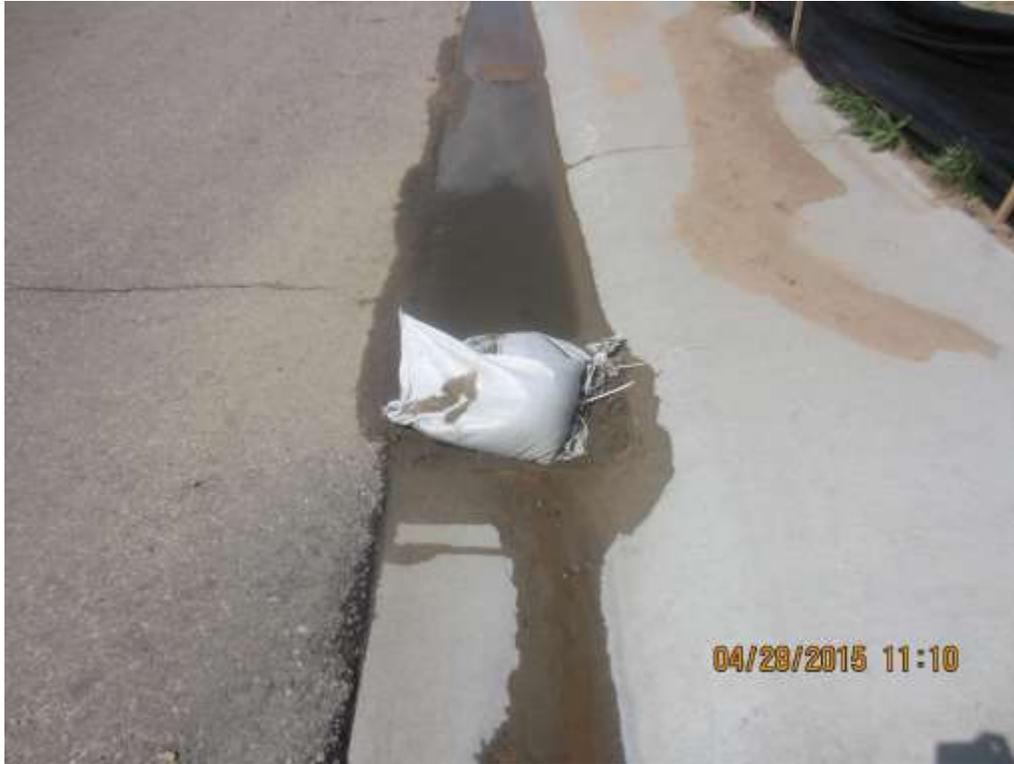
Photograph 75: Sand bag curb checks in need of maintenance

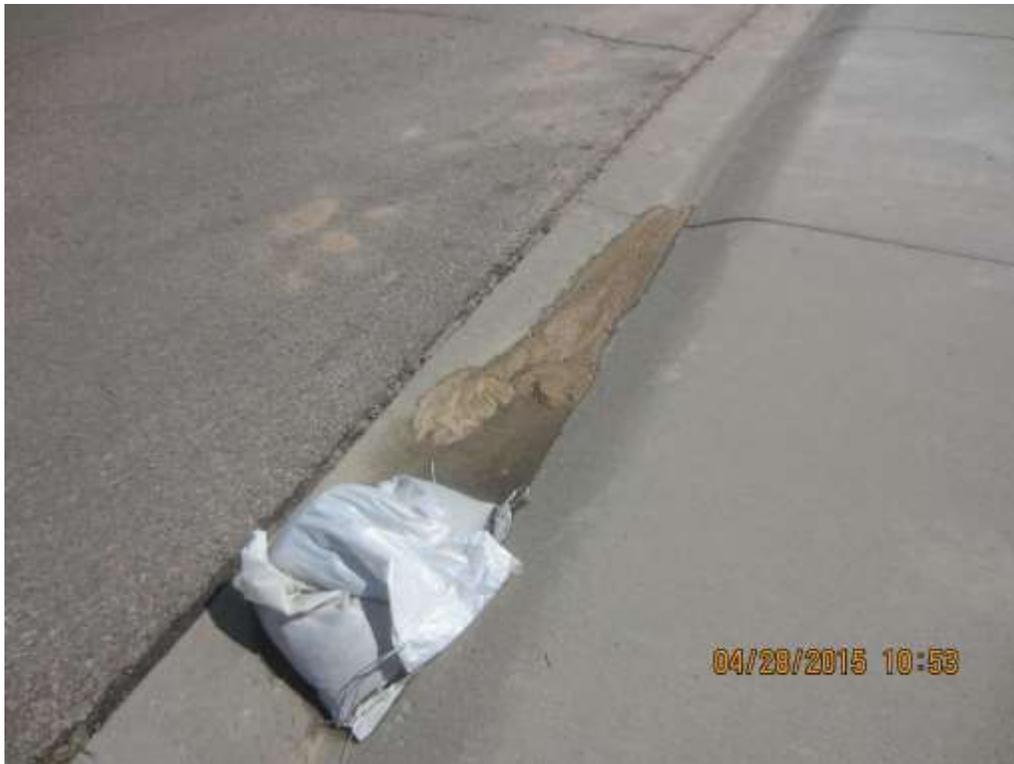
Photograph 76: Sand bag curb checks in need of maintenance

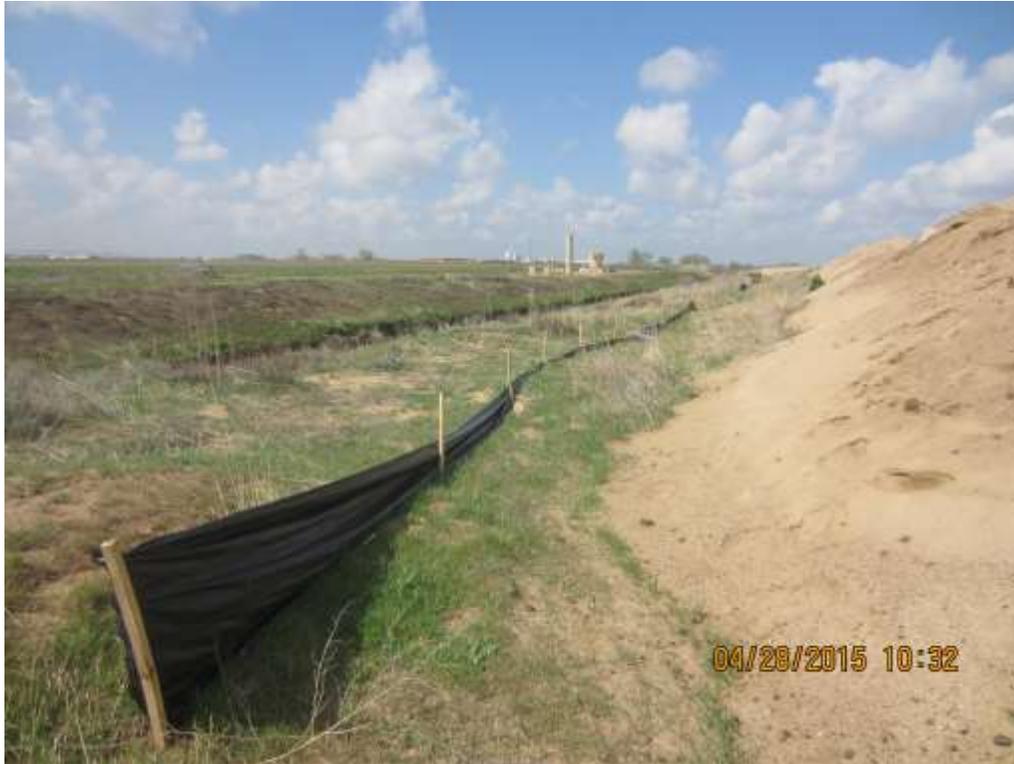
11. It was noted during the inspection that inadequate control measures were implemented to manage pollutant contributions to stormwater from sediment from stockpiles located on the south side of the site (refer to photograph(s) 79-84).

- Control Measure Observation: A silt fence control measure was implemented to manage stormwater runoff from the location and pollutant source noted above, however the control measure was inadequate. Specifically,

Photograph 83: Silt fence stockpile control not installed or maintained per specification

- Silt fence should be repaired or replaced when signs of tearing, sagging, or wear are observed.
- Silt fence used at the toe of the slope shall be placed one to ten feet beyond the toe of the slope to provide storage capacity.

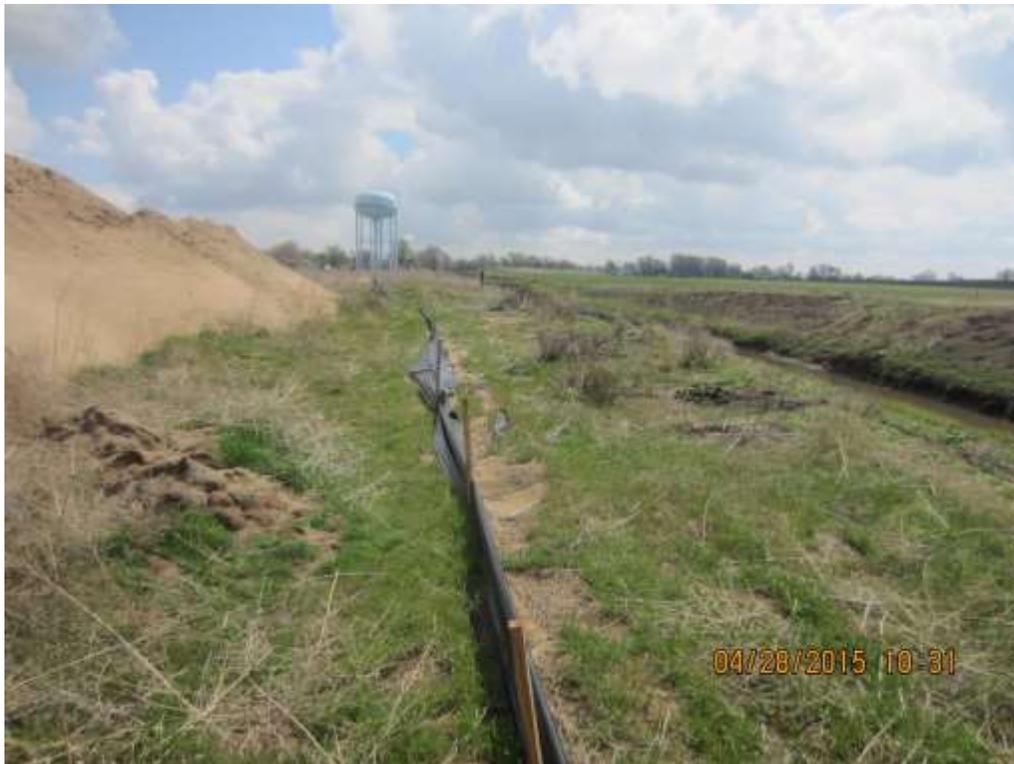
Photograph 84: Silt fence stockpile control not installed or maintained per specification

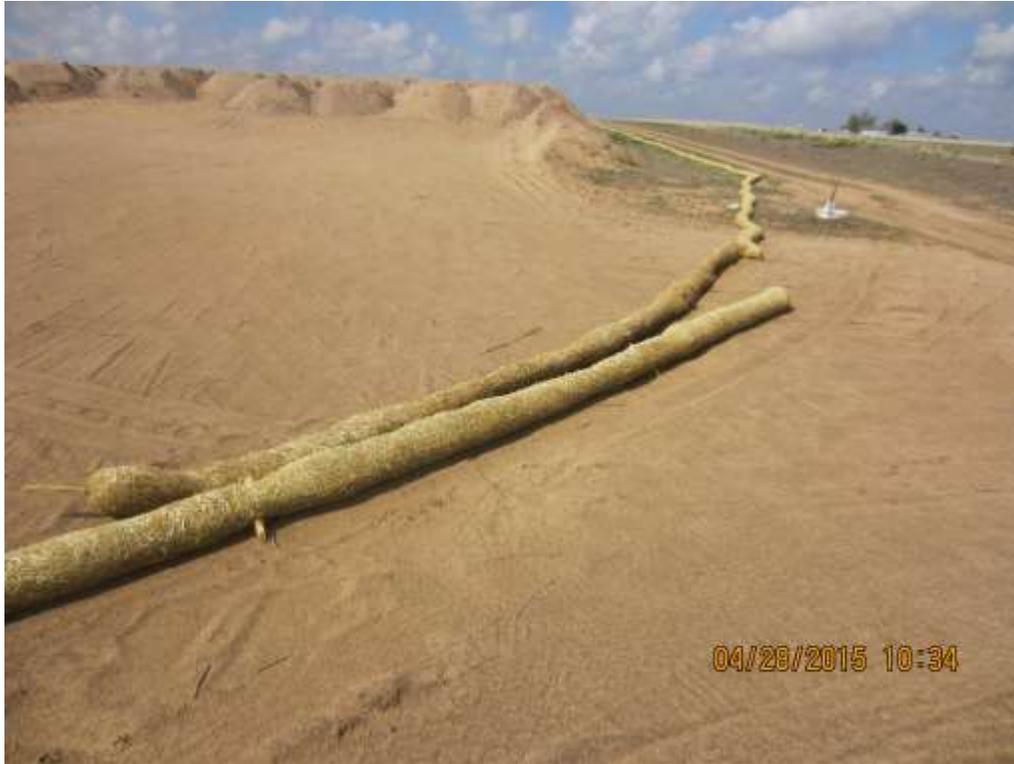
13. It was noted during the inspection that inadequate control measures were implemented to manage pollutant contributions to stormwater from sediment from stockpiles located on the north side of the soil stockpile staging area (refer to photograph(s) 85-88).

- Control Measure Observation: A straw wattle control measure was implemented to manage stormwater runoff from the location and pollutant source noted above, however the control measure was inadequate. Specifically,

- The straw wattles were not installed as required by the specification provided in the SWMP. The wattles were not trenched in or staked properly.
 - Several locations of straw wattles were observed to be in need of maintenance to repair or replace damaged sections that had tears or holes.

Photograph 85: Straw wattle around stockpiles, not installed or maintained per specification

- Damaged straw wattles shall be replaced or repaired and accumulated sediment removed to maintain functionality of the control measure at its intended capacity.

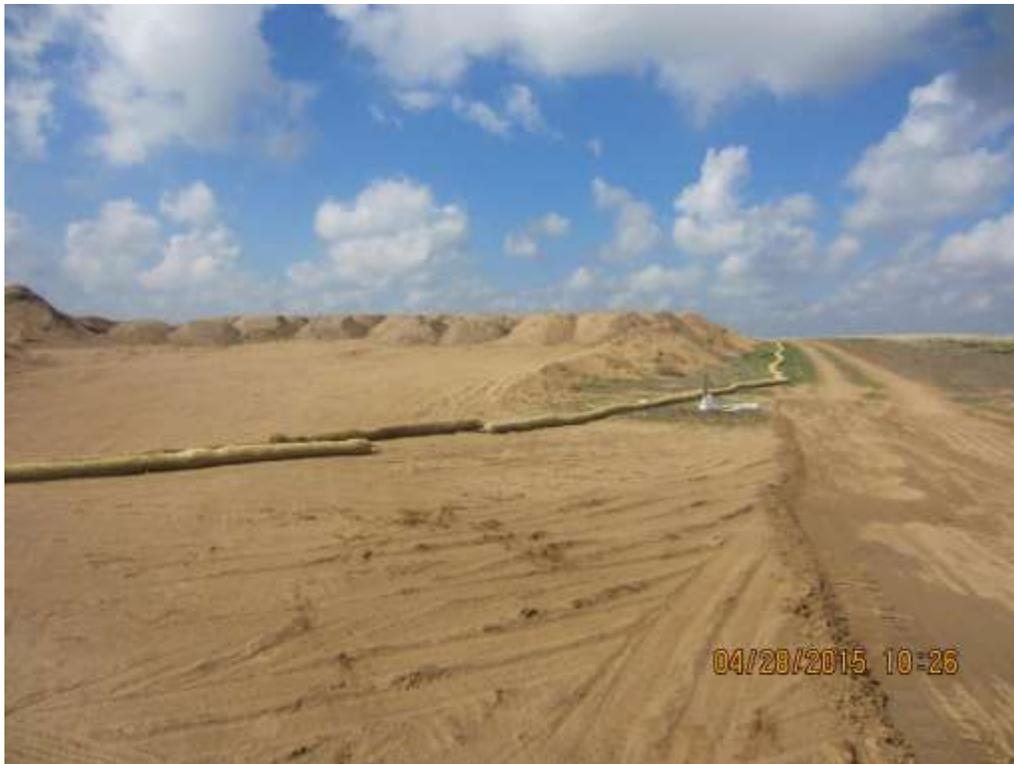
Photograph 86: Straw wattle around stockpiles, not installed or maintained per specification

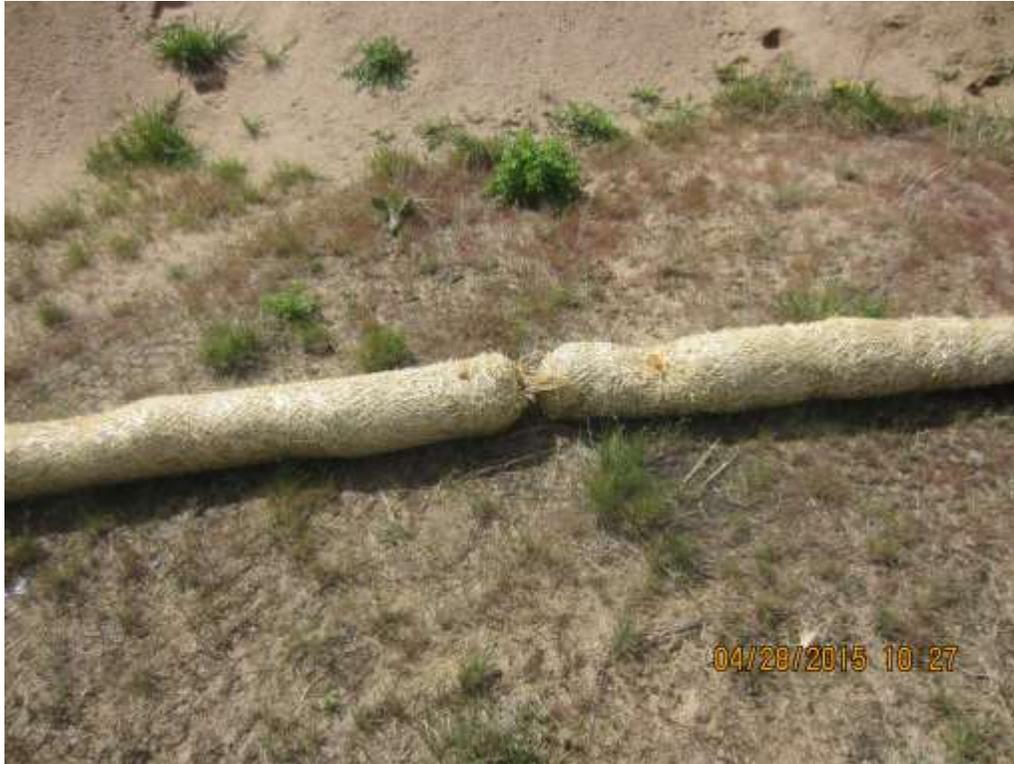
Photograph 87: Straw wattle around stockpiles, not installed or maintained per specification
